**NATIONAL TRANSPORTATION SAFETY BOARD**  
Office of Aviation Safety

**AIRCRAFT EXAMINATION SUMMARY**

**A. ACCIDENT**      **CEN20LA219**

Location:      Beecher, IL  
Date:      June 8, 2020  
Time:      0946 Central Daylight Time (CDT)  
Operator:      Private  
Aircraft:      Flight Design GMBH CTLS  
Registration:      N257V

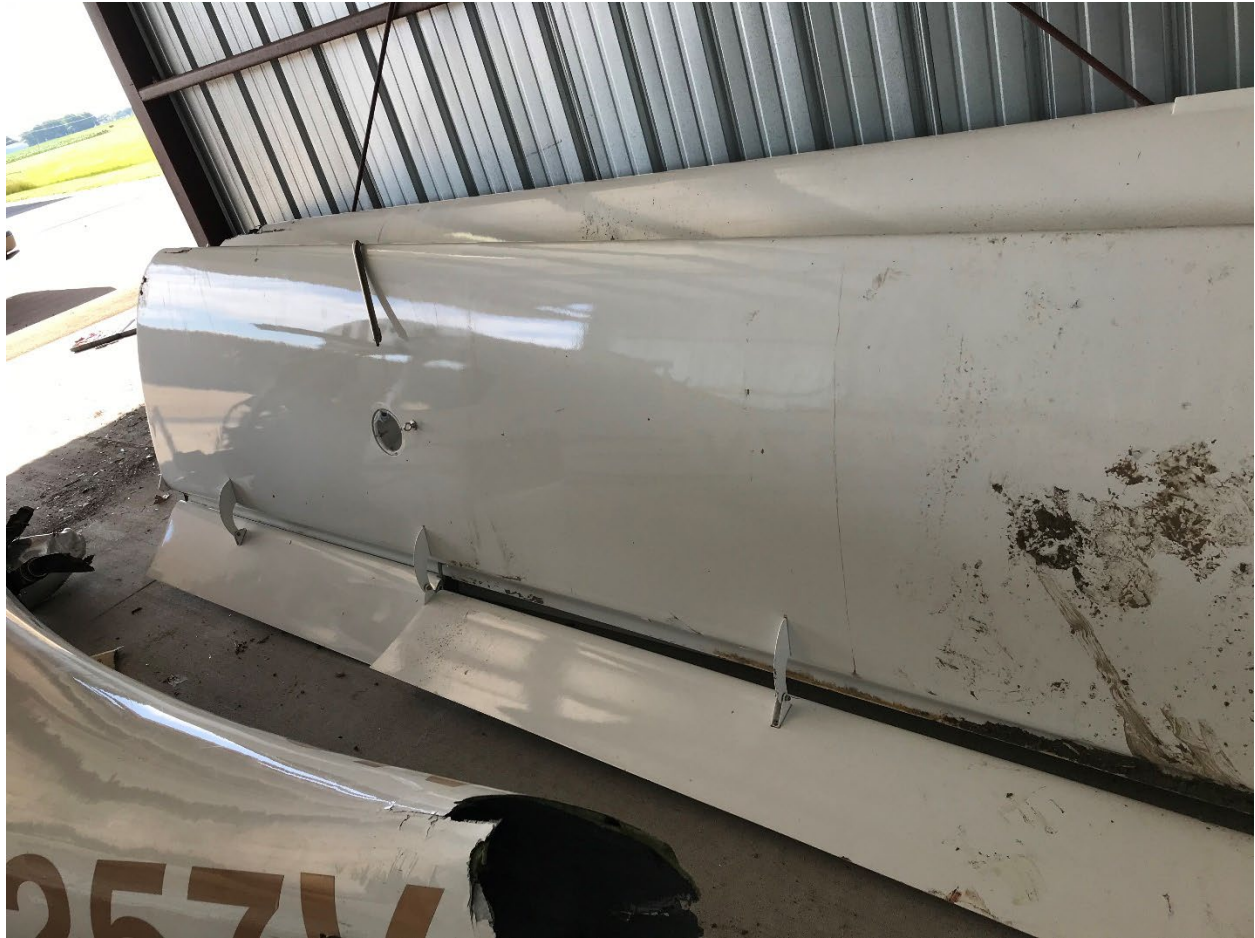
*Figure 2 – Wings*

The airplane's wings had been removed for transport and remained predominately intact. There was impact damage to the leading-edge tip of the left wing. The ailerons and flaps of both wings remained attached.

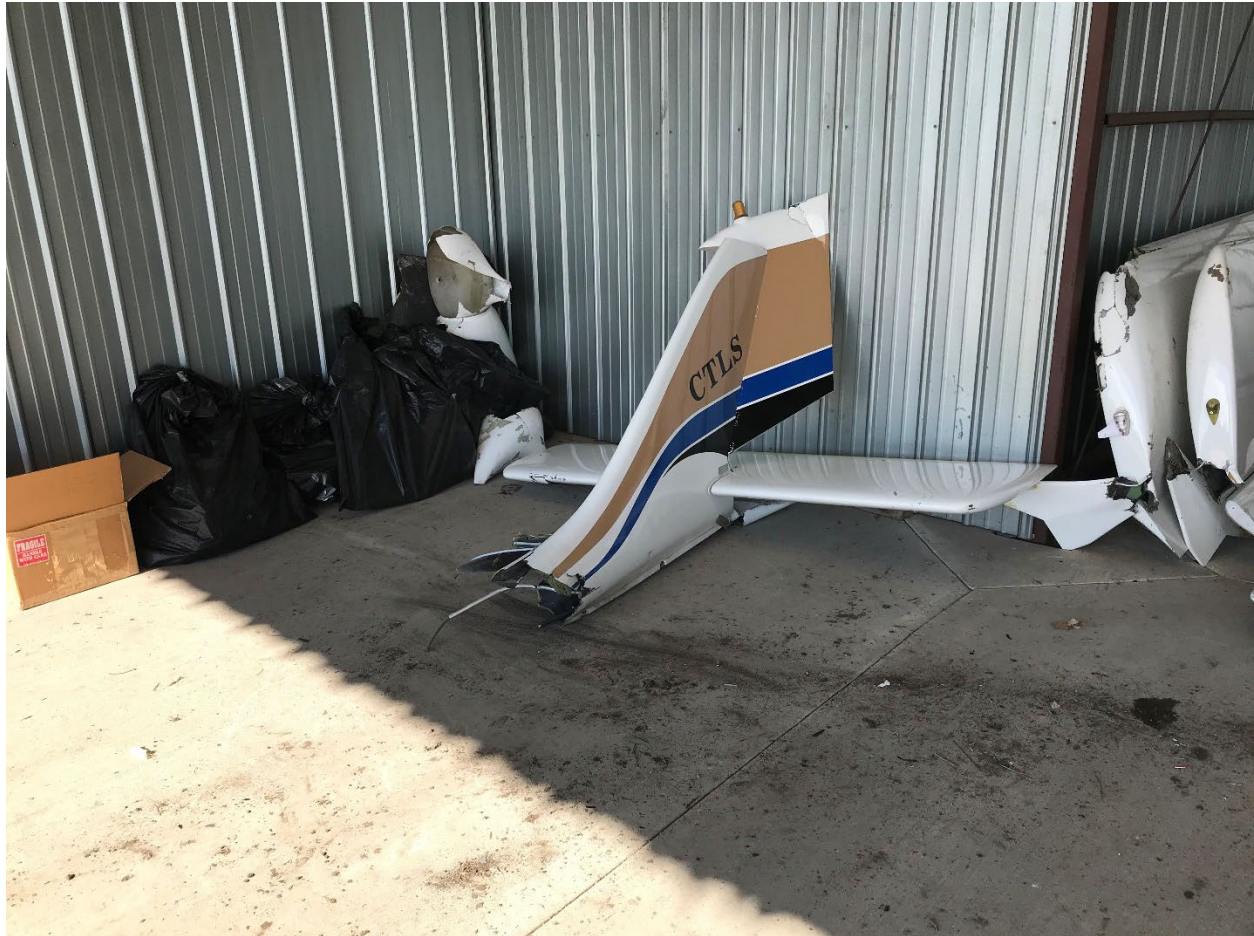
*Figure 3 – Empennage*

The empennage and tail cone were separated from the rest of the fuselage. The tail surfaces were intact, and the rudder and elevator remained attached to the empennage.

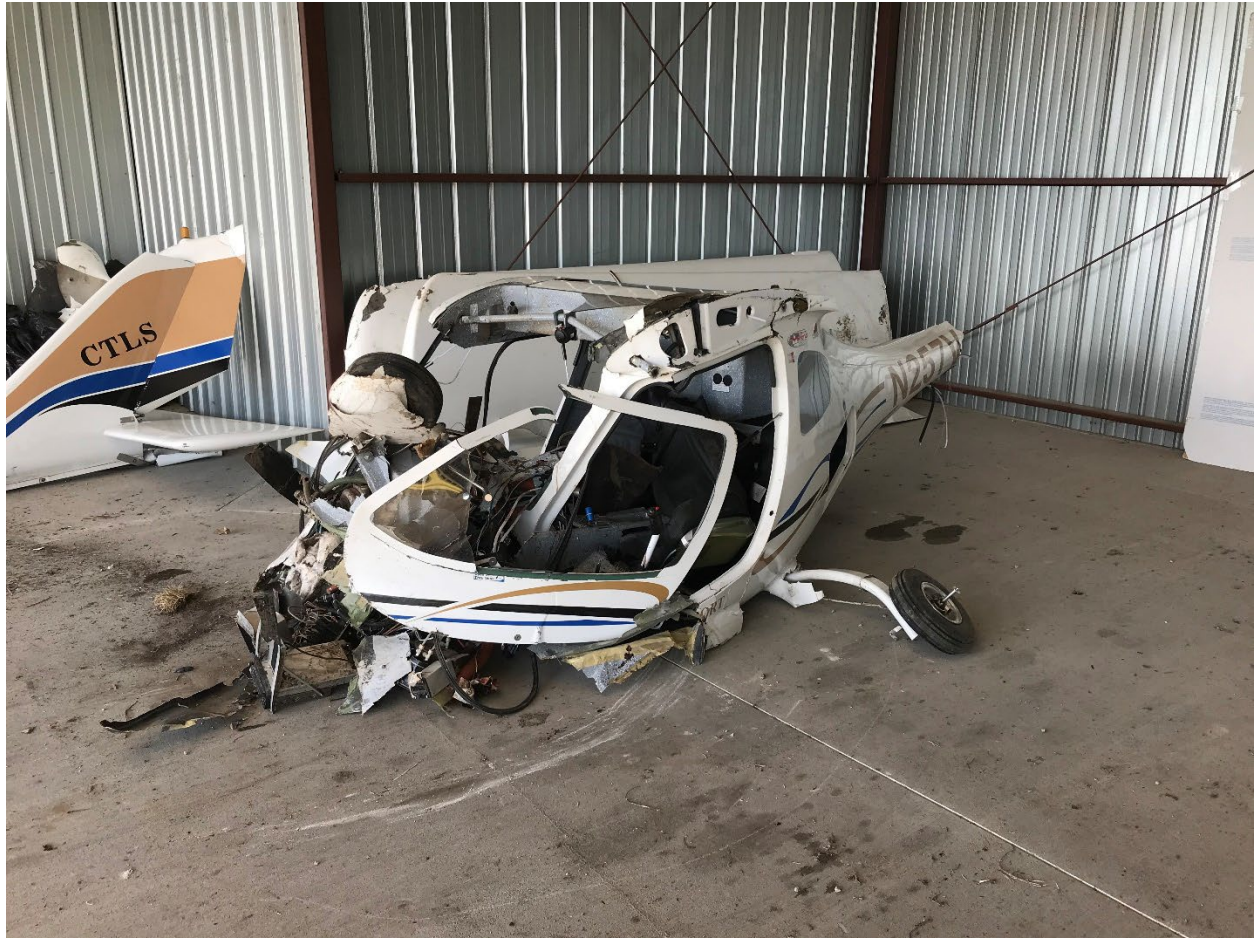
*Figure 4 – Fuselage during examination*

The forward fuselage had extensive crushing damage. Examination of the control system revealed continuity from the cockpit controls to each surface except for breaks associated with wing removal and impact damage. The fuel system was examined and no pre-impact anomalies were noted.

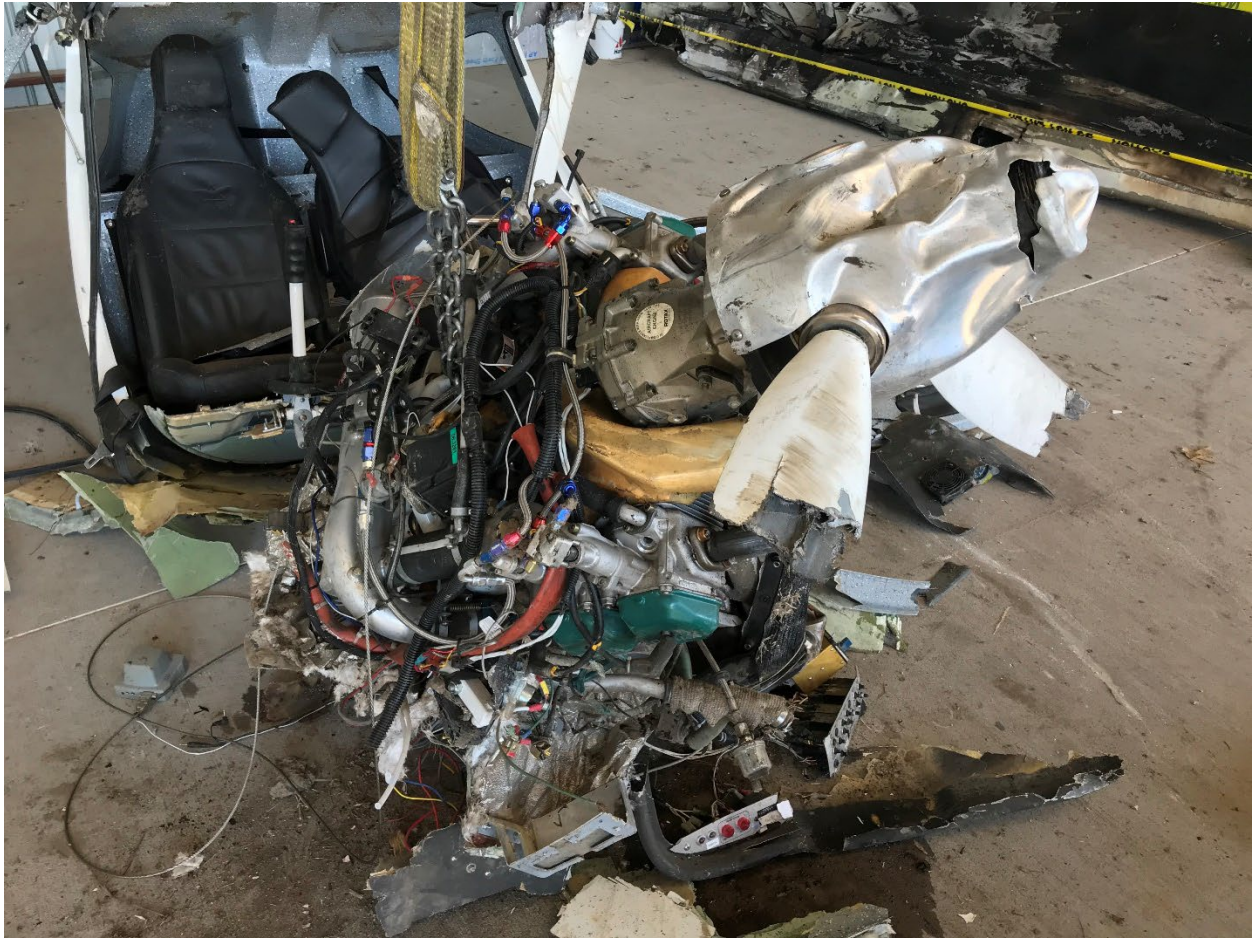
*Figure 5 – Engine during examination*

The engine crankshaft rotated, and rotation confirmed suction and compression on all cylinders, and continuity of the valve train and the propeller reduction drive unit. The top set of spark plugs were removed and exhibited normal burn signatures. The engine's turbocharger was free to rotate. Inspection of the fuel lines and fuel system components revealed no obstructions. Disassembly of the spring-loaded diaphragm type fuel pressure regulator revealed no anomalies obstructions or debris. Field testing of the engine's electronic ignition system was not possible

The 3-blade controllable pitch composite propeller remained attached to the engine propeller flange. One blade was separated at the hub, a second blade was separated about one foot from the hub and the third blade was separated about 1-1/2 feet from the hub. All three blade roots were still in the propeller hub
