# National Transportation Safety Board

CEN20LA245

## **WRECKAGE EXAMINATION SUMMARY**

Location: Winfield, Texas  
Date: June 24, 2020  
Time: 1401 central daylight time  
Airplane: Cessna 182R, Registration No. N958HP

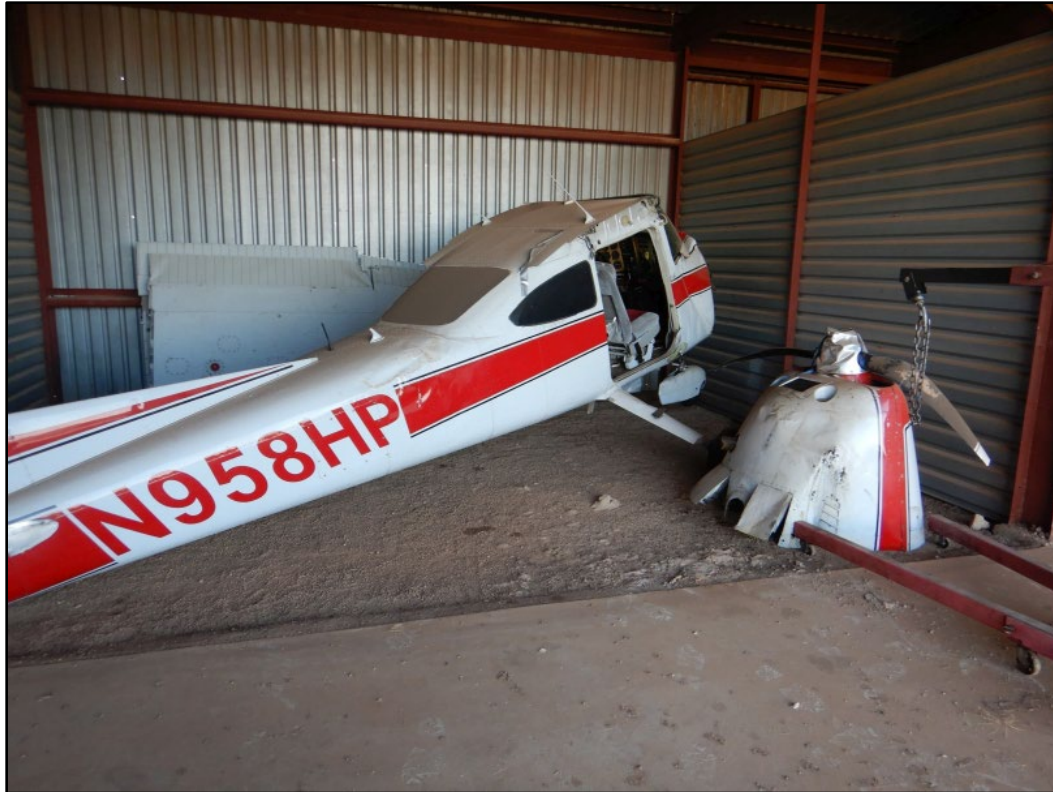
**Figure 1** - Fuselage, Engine, and Propeller

The engine separated from the airframe during impact. The upper and lower cowlings remained attached to the engine compartment structure. After wreckage recovery, the engine was stored vertically resting on the accessory section. There was one 1.5" x 2.5" tapered hole in the aft right side of the oil pan. The hole was consistent with impact-related damage. Oil was present on the ground under the engine. The remaining oil in the pan drained from the hole when the engine was repositioned horizontally for the examination. The drained oil was dark brown/black in color with no evidence of metallic debris.

The propeller remained attached to the engine propeller shaft flange. The propeller spinner exhibited aft crush damage and slight rotational deformation. One propeller blade was bent aft about midspan, loose in the hub, and exhibited minor chordwise scratches near the blade tip. The other blade exhibited slight aft bending, slight twisting toward low pitch, minor leading-edge damage, and minor chordwise scratches near the blade tip.

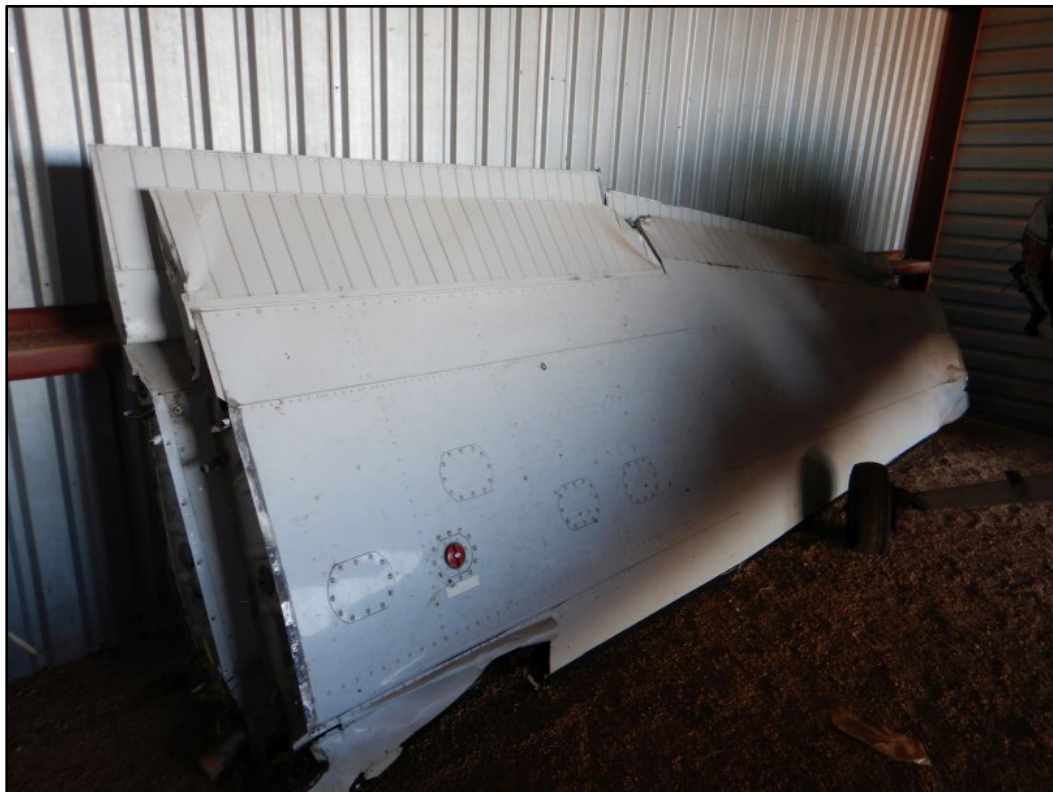
**Figure 2** - Left and Right Wings

The right wing exhibited leading edge crush damage 12-18 inches outboard the fuel tank cap, and the damage extended aft about 12 inches breaching the right-wing fuel tank. Both fuel screens inside the right fuel tank exhibited no obstructions or debris. The right fuel tank exhibited no evidence of corrosion, debris, or staining. There were no anomalies observed with the right fuel tank cap.

The left wing exhibited leading edge damage from the wing root to just outboard the fuel tank cap. The left-wing fuel tank remained intact, and there was no debris observed in the tank. There were no anomalies observed with the left fuel tank cap.

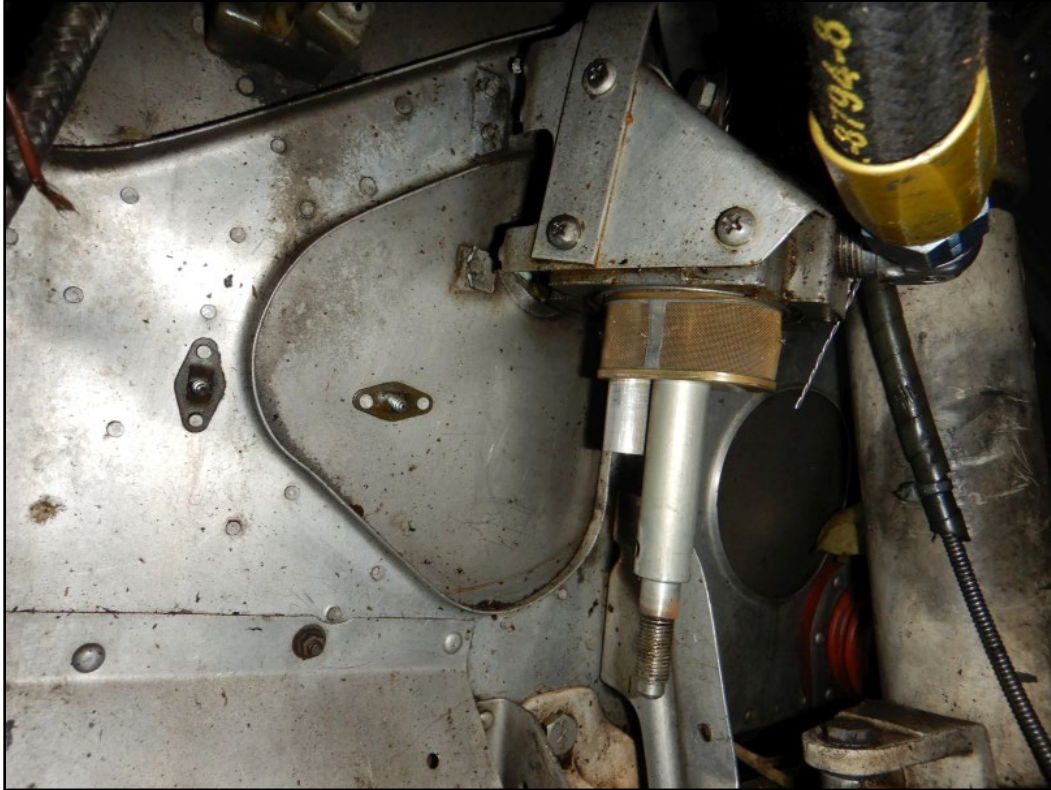
**Figure 3** - Airframe Fuel Filter Assembly

The airframe fuel filter assembly did not contain any fuel, water, or debris. The FAA Inspector who examined the wreckage onsite reported that the fuel filter assembly contained fuel and no contamination.

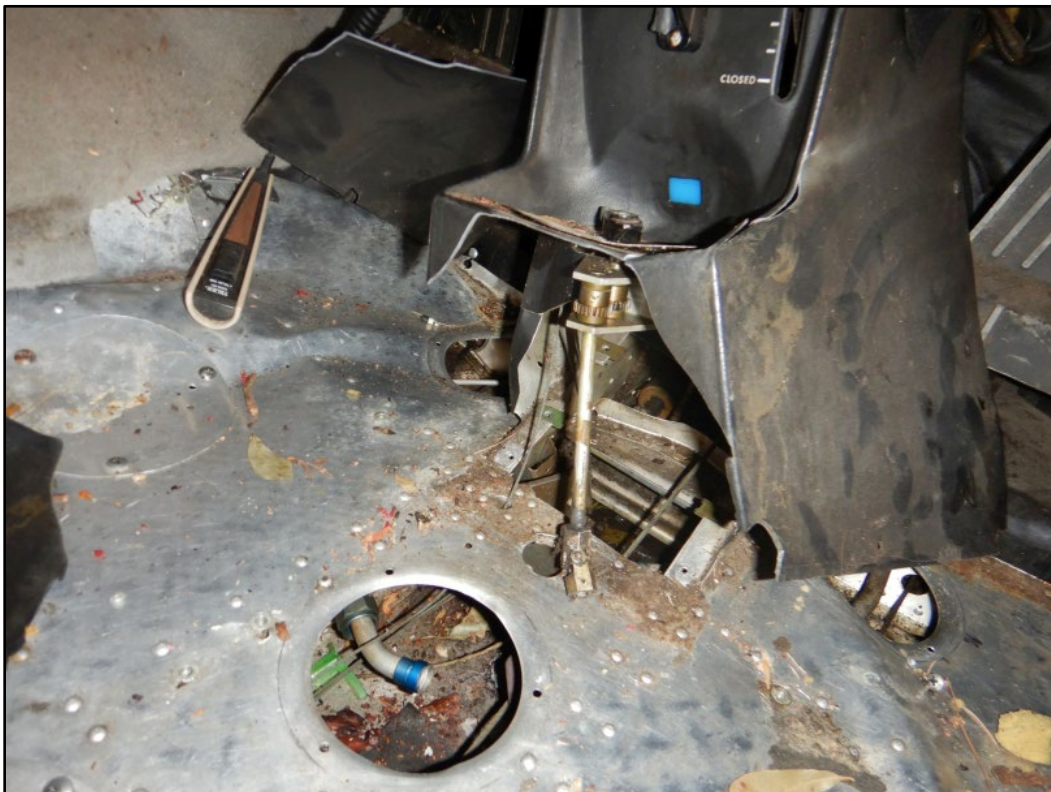
**Figure 4** - Fuel Selector Valve Control Rod

The cockpit fuel selector lever was found in the BOTH position; however, the shaft between the cockpit fuel selector lever and the fuel selector valve disconnected during impact. The fuel selector valve was removed and tested. When air was blown into the outlet port of the fuel selector valve it exited through the left fuel tank inlet port. The valve was manually rotated from the LEFT position to the BOTH, RIGHT, and OFF positions. There were no anomalies observed with the fuel selector valve, and tactile detents were present at each commanded position.

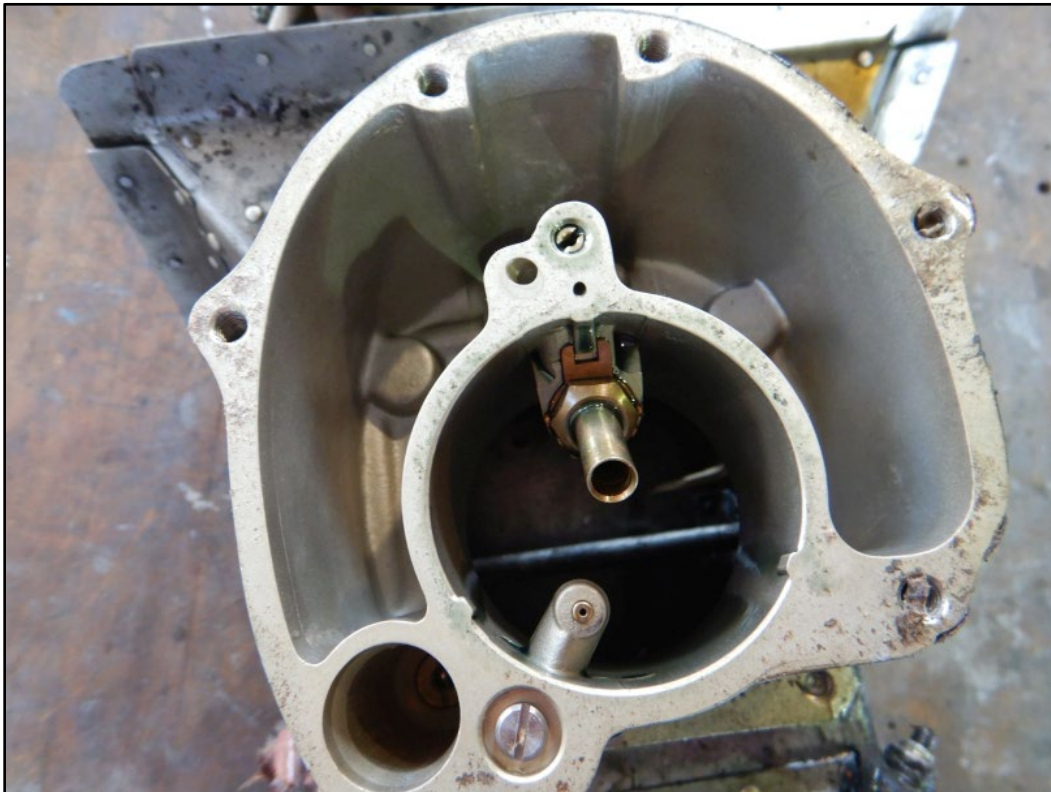
**Figure 6** - Carburetor Bowl

Examination and disassembly of the carburetor did not reveal any mechanical anomalies that would have prevented normal operation. The throttle and mixture arms moved freely when manipulated by hand. No fuel was discharged from the accelerator pump when the throttle arm was actuated. The inlet fuel screen was clean with no observed obstruction or debris. The carburetor bowl was void of any fuel, but

there was the odor of 100 low-lead aviation fuel present. The carburetor floats were in good condition. The floats were made of blue epoxy and exhibited no evidence of holes, staining, or discoloration. There were no anomalies observed with the carburetor's needle valve or its corresponding valve seat.
