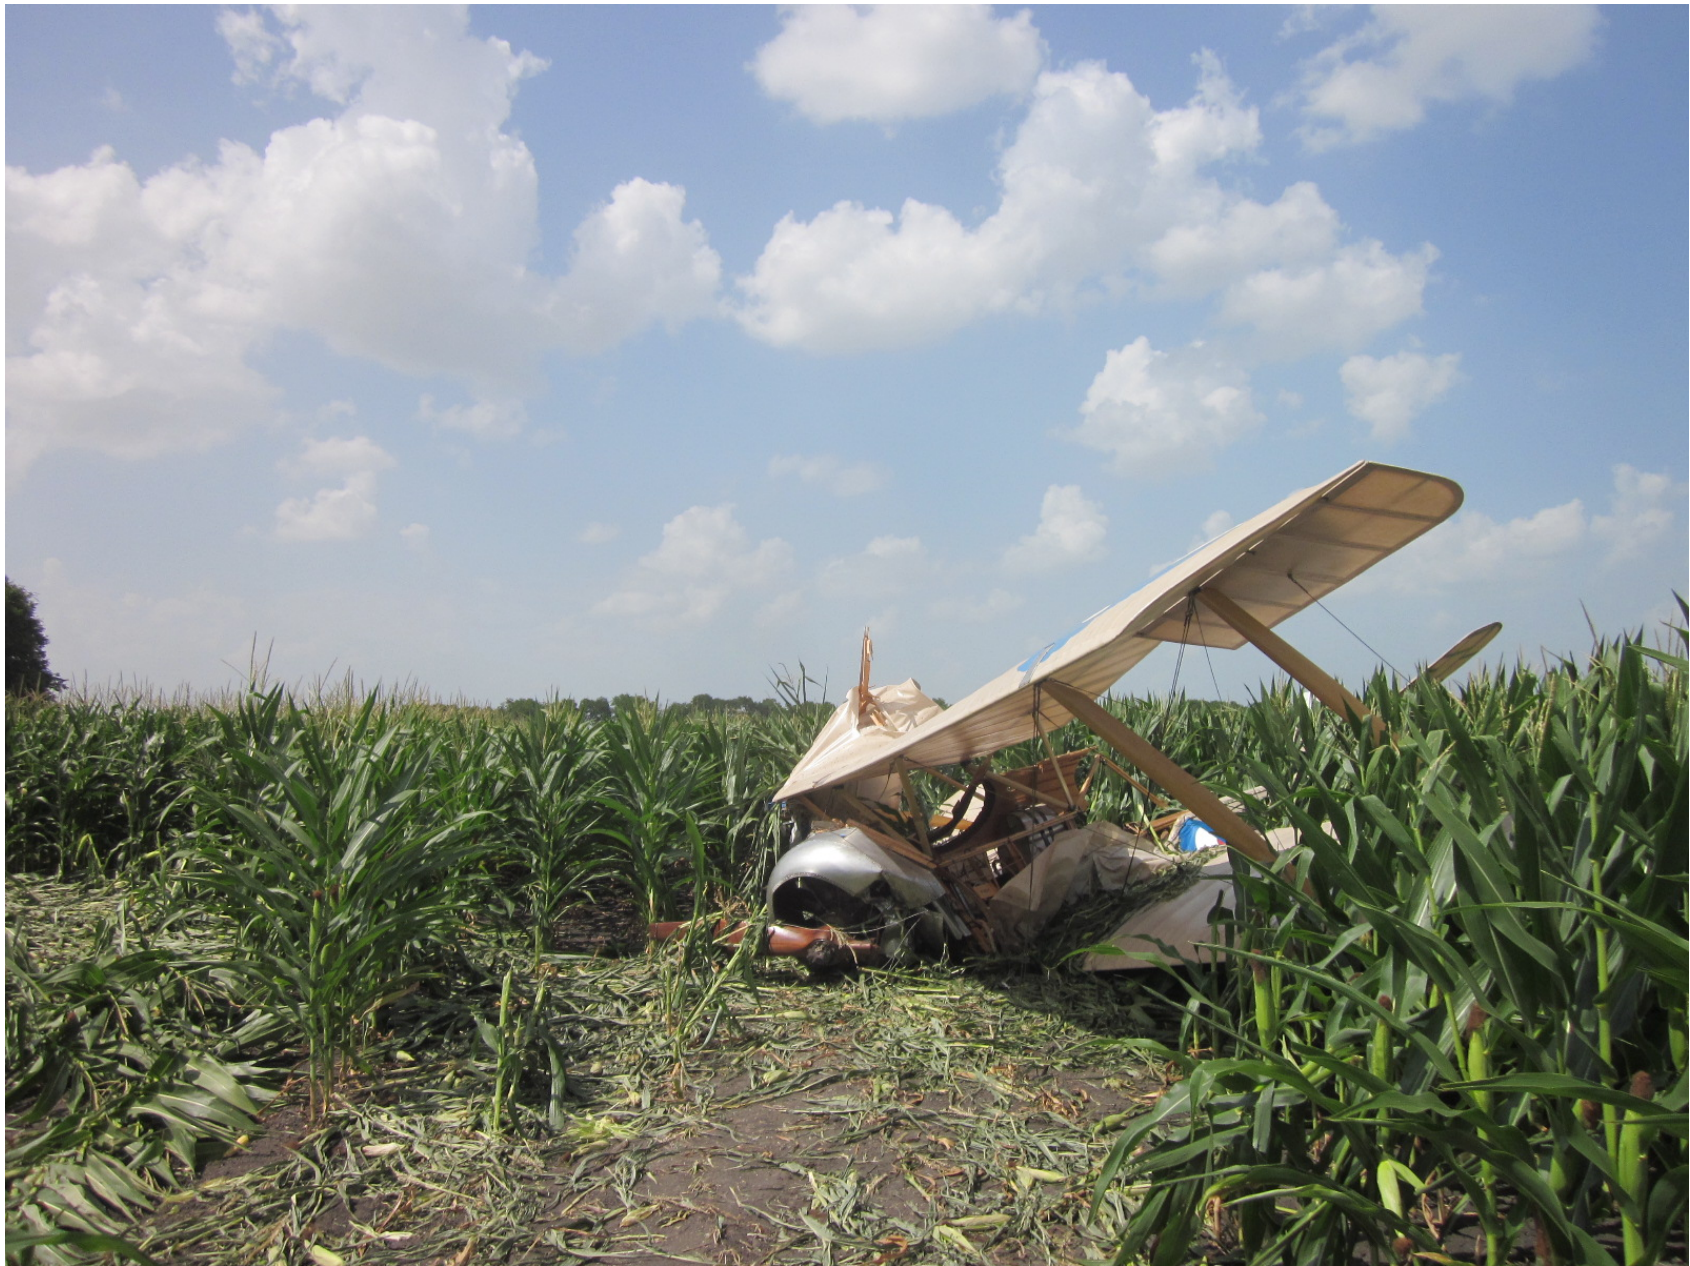
**Photo 1 – Wreckage (FAA Photo)**

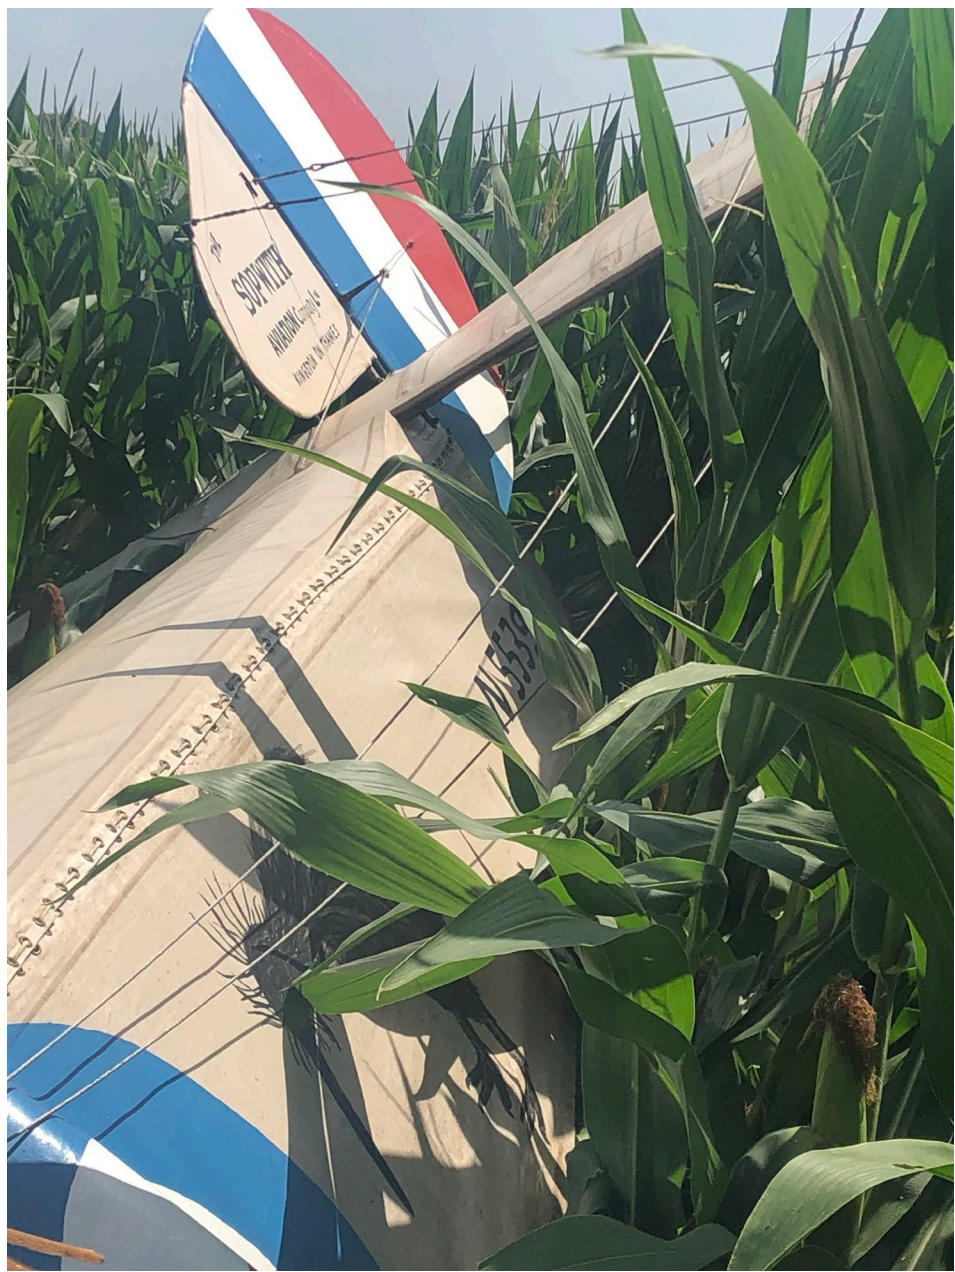
**Photo 2 – Empennage (FAA Photo)**
