# NATIONAL TRANSPORTATION SAFETY BOARD

## MATERIALS LABORATORY FACTUAL REPORT

Report No. 21-033

Place : Eveleth, Minnesota  
Date : July 5, 2020  
Vehicle : Piper PA32, N4079R  
NTSB No. : CEN20LA263  
Investigator : John Brannen, AS-CEN

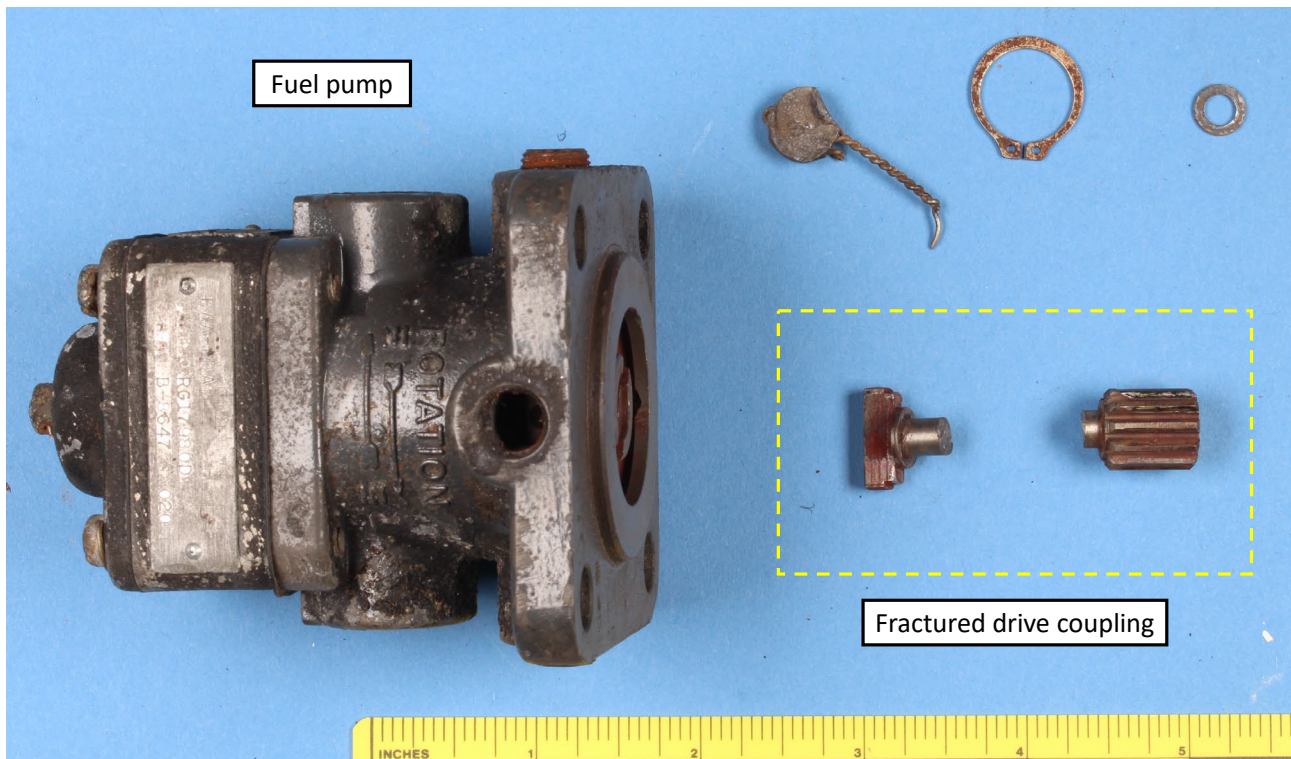
The as received components are shown in figure 1 with the fractured fuel pump drive coupling (outlined by a yellow dashed box) placed in approximate operational position relative to the adjacent fuel pump. An identification plate riveted to the side of the fuel pump indicated a part number RG17980D and serial number B-8647 020. The drive coupling was fractured into two pieces at the reduced diameter section approximately 0.1 inch from the shoulder of the splined end along a plane transverse to the axis of rotation. Other components shown in figure 1 outlined by a white dotted line were submitted and included a fragment of safety wire with a lead seal, a tapered section retaining ring, and a flat washer.

Figure 1: A photograph of the as received components.

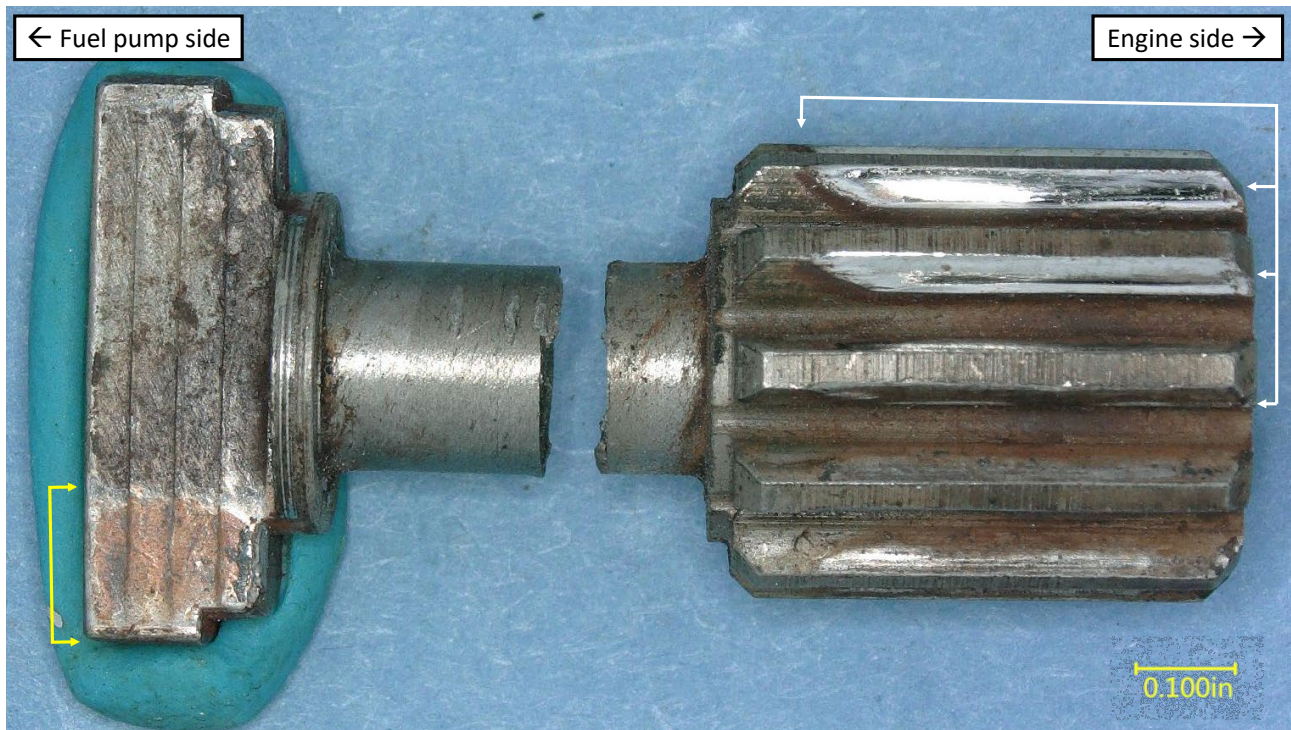
Figure 2 shows a closer side view of the fractured drive coupling. One piece contained a splined end, the other piece contained a tongue end designed to fit within a groove in the fuel pump shaft when assembled. Wear marks were observed on successive flanks on one side of the spline grooves as evidenced by smooth shiny depressions which resembled polished metal. These areas extended radially from a well-defined step at approximately mid-flank to the crest and spanned approximately 85% of the face width from the engine side of the spline. Three examples visible in figure 2 are indicated by white arrows. Wear marks on the opposite side of the spline grooves were less pronounced. The tongue portion of the drive coupling exhibited a shiny, reflective, and battered wear mark on the contact face indicated by the yellow bracket in figure 2. A similar mark was observed on the opposite side and

opposite face of the tongue (not visible in figure 2). A matching wear pattern was observed in the fuel pump shaft groove, one side of which is shown in figure 3 and highlighted by a yellow bracket.

Figure 2: A digital microscope image showing a side view of the fractured drive coupling. Wear marks observed on one side of the spline grooves on the engine side are indicated by white arrows. A wear mark observed on the tongue at the fuel pump side is indicated by yellow arrows. A similar mark was observed on the opposite face at the other end of the tongue (not visible in this photograph).

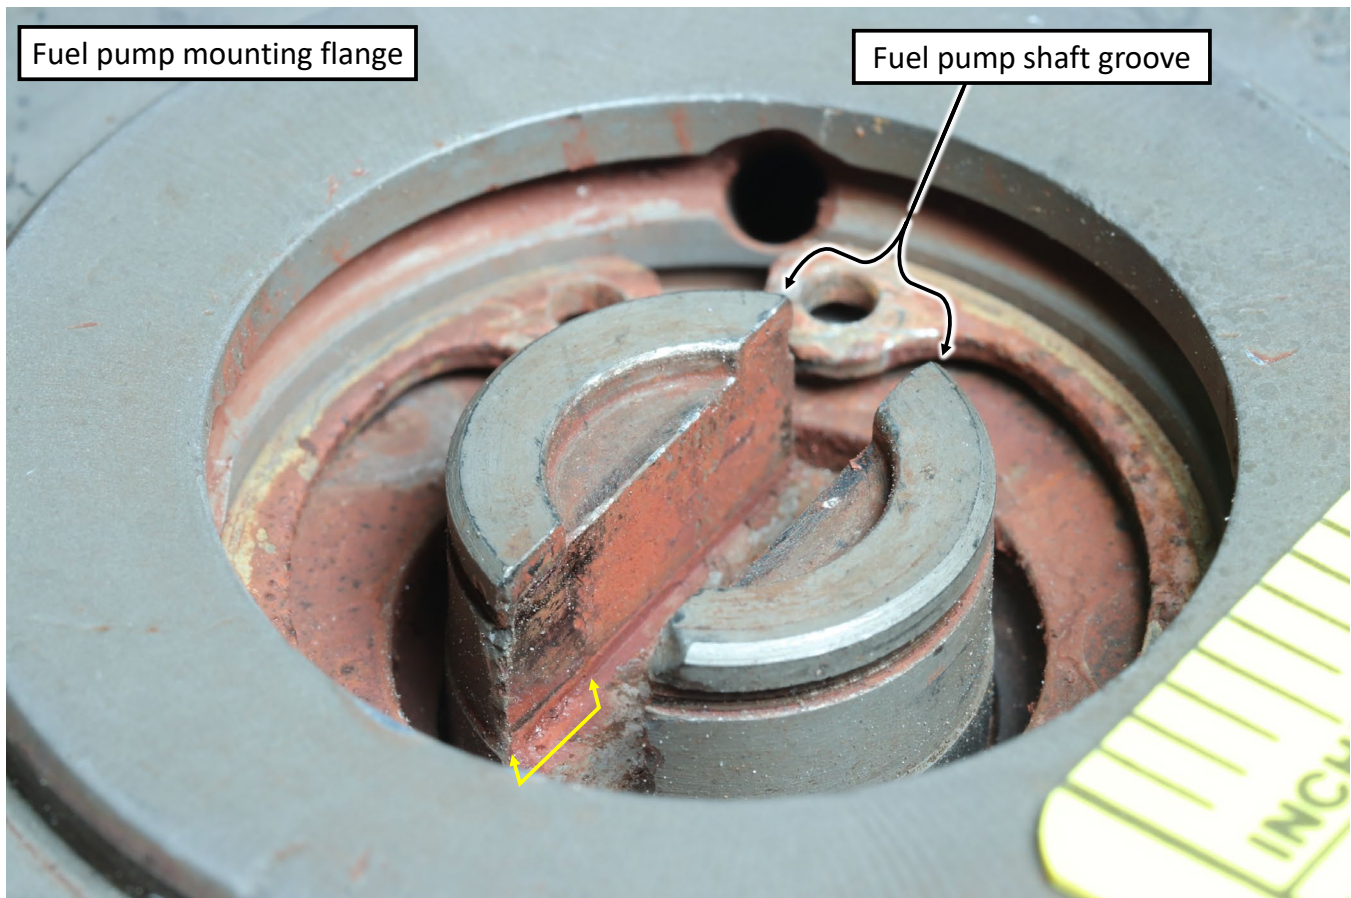
Figure 3: A photograph showing the fuel pump drive shaft component installed in the fuel pump. The yellow bracket indicates the boundaries of a wear mark observed on the groove face which coordinates with the mark observed on the tongue surface of the fractured drive coupling. A similar mark was observed on the opposite face at the other end of the groove (not visible in this photograph).

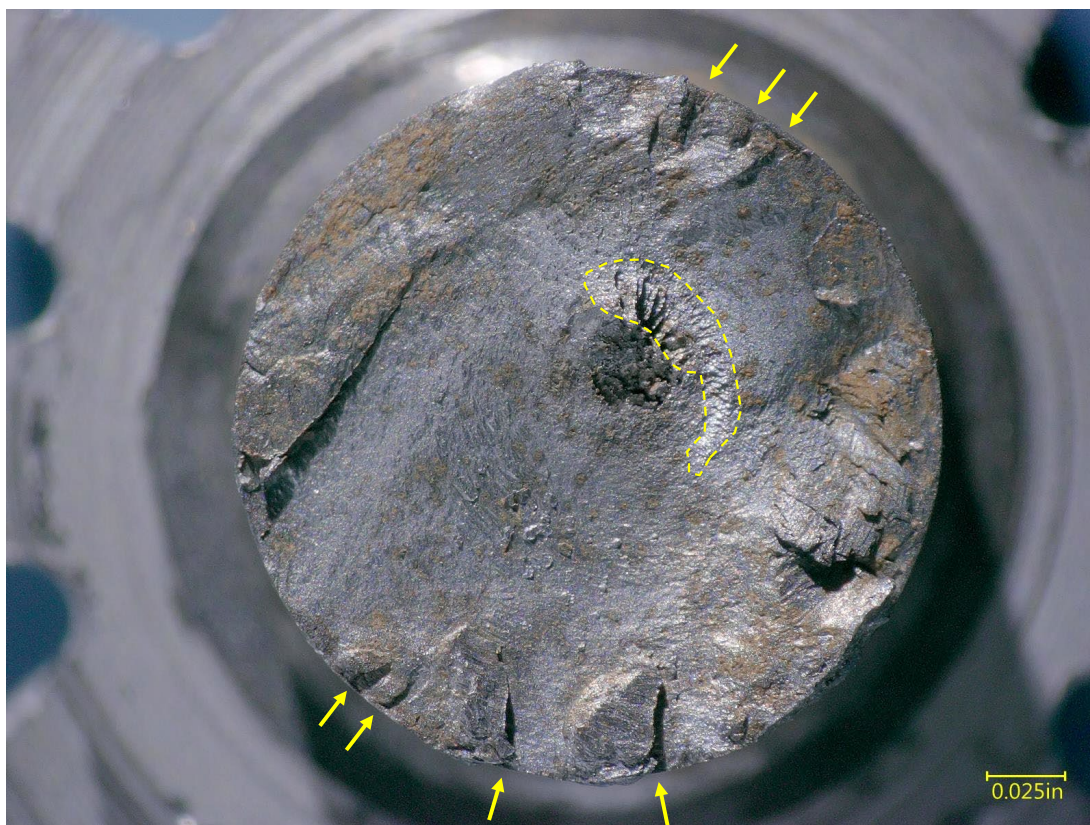
The drive coupling fracture surface was cleaned using ultrasonic agitation and a mild soap and water solution followed by acetone to facilitate viewing under a 4X – 80X zoom stereomicroscope. The fracture surface was relatively flat with a dull-gray swirled appearance. The outer edge was smoother and exhibited evidence of smearing. Features that resembled ratchet marks<sup>1</sup> were observed at several locations around the edge of the fracture surface as indicated by yellow arrows in figure 4. Further cleaning by immersion in an ambient bath of Evapo-Rust® cleaner was employed to facilitate higher magnification examination using a scanning electron microscope (SEM). A rougher, slightly off-center region with a swirled appearance showed evidence of microvoid coalescence<sup>2</sup> in the form of parabolic dimples as shown in the SEM fractograph on the left in figure 5, which was consistent with torsional overstress loading at final separation. Adjacent to this rough central region, outlined by a yellow dashed line in figure 4, was an area which exhibited a brighter, faceted appearance. Closer examination of this region revealed river patterns<sup>3</sup> and fracture features consistent with transgranular cleavage fracture propagating towards the rougher central region. Finer elongated dimples, as shown in the SEM fractograph on the right in figure 5, were observed at approximately mid-radius in the region between the outer edge and rougher central region which was consistent with mode II (in-plane) or III (out-of-plane) shear loading. Areas of the fracture surface near the edge were examined more closely under high magnification and no features indicative of fatigue, such as striations, were observed but the morphology was generally smeared.

Figure 4: A digital microscope image of the drive coupling fracture surface (splined side). The fracture surface was relatively flat and on a plane transverse to the axis of rotation. A swirl pattern was apparent around a rougher region slightly off-center. Adjacent to the rougher region was a brighter faceted area as highlighted by the yellow dashed line. Smearing was observed generally around the surface near the outer edge. Features resembling ratchet marks were observed around the outer edge as indicated by yellow arrows.

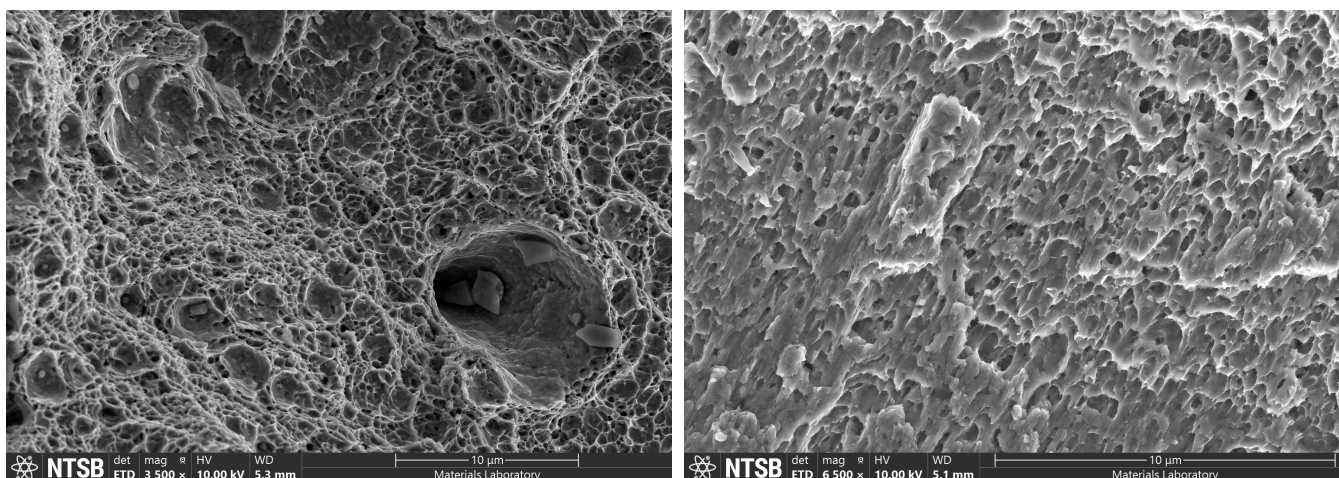
Figure 5: Left: A secondary electron image acquired from the drive coupling fracture surface in the rougher central region. Parabolic-shaped dimples were observed, features consistent with torsional overstress separation. Right: A secondary electron image showing elongated dimples observed on the drive coupling fracture surface at approximately mid-radius from the central axis to the outer surface, consistent with torsional-shear loading and overstress separation.

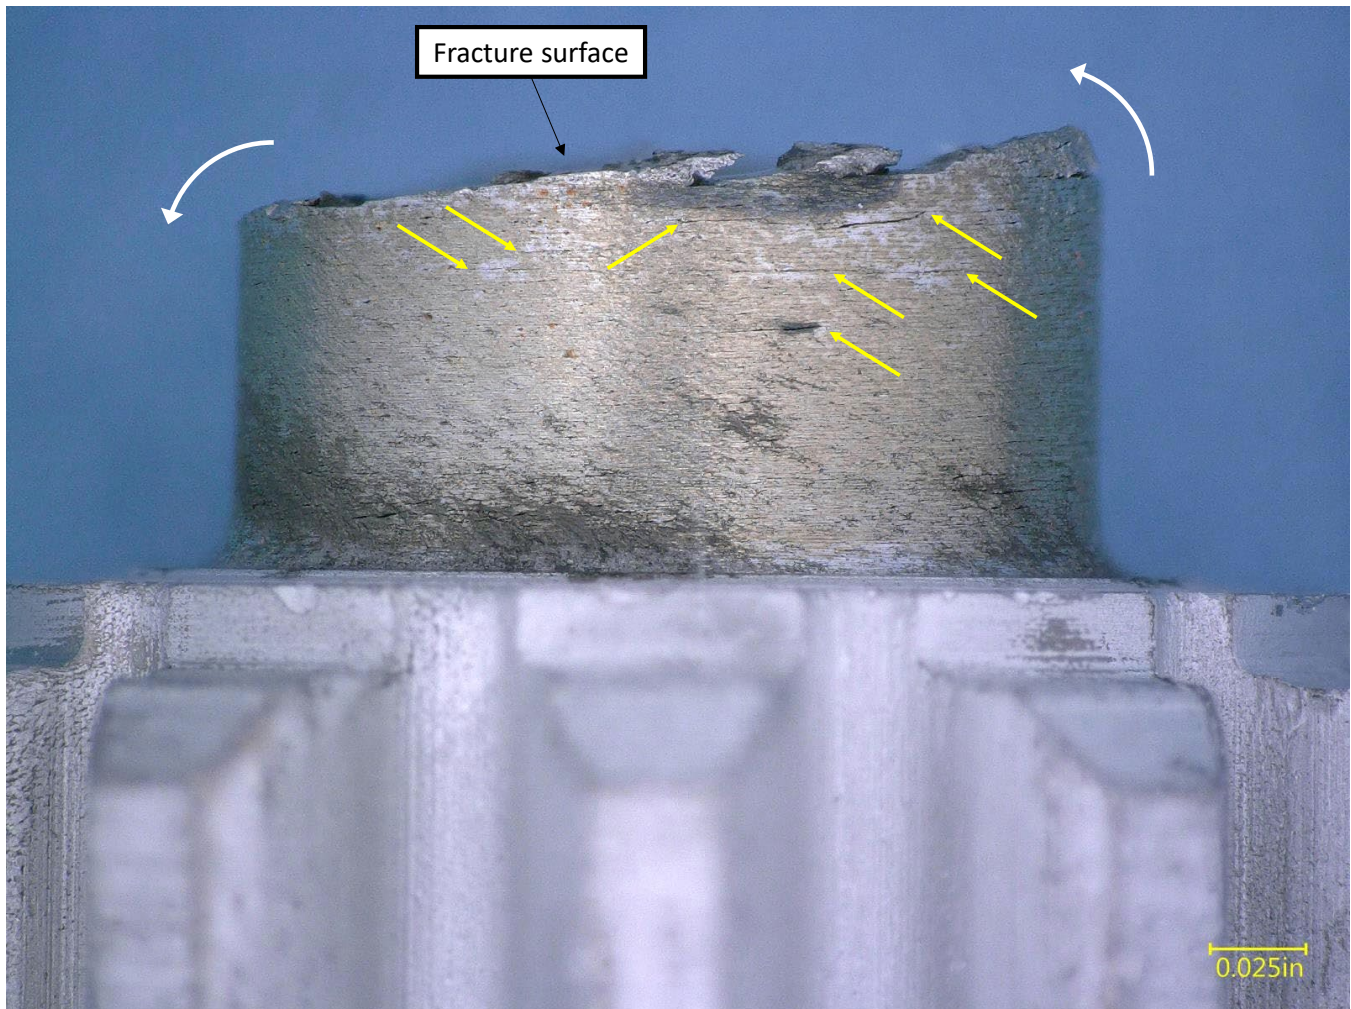
The surface of the reduced section of the drive coupling adjacent to the fracture surface exhibited a small degree of bending deformation, indicated by curved white arrows in figure 6, and circumferential secondary cracks, the largest examples indicated by straight yellow arrows. A cross section view of the reduced section revealed relatively short crack profiles extending into the shaft from the outer surface as shown in figure 7. The largest crack observed was approximately 0.009 inch below the fracture surface and was approximately 80 microns (0.003 inch) in length. Microhardness indentation measurements were consistent with a through hardened component and averaged 405 HK which when converted in accordance with ASTM E 140, corresponded to approximately 40 HRC or 182 ksi tensile strength. X-ray fluorescence spectroscopy (XRF) confirmed the coupler material to be consistent with a low alloy steel, predominantly iron with less than 2% each of other common alloying elements such as chromium, manganese, molybdenum, and nickel detected.

Figure 6: A digital microscope image of the drive coupling surface adjacent to the fracture surface. White curved arrows indicate bending deformation. Yellow arrows indicate relatively flat horizontal secondary cracks observed near the fracture surface.

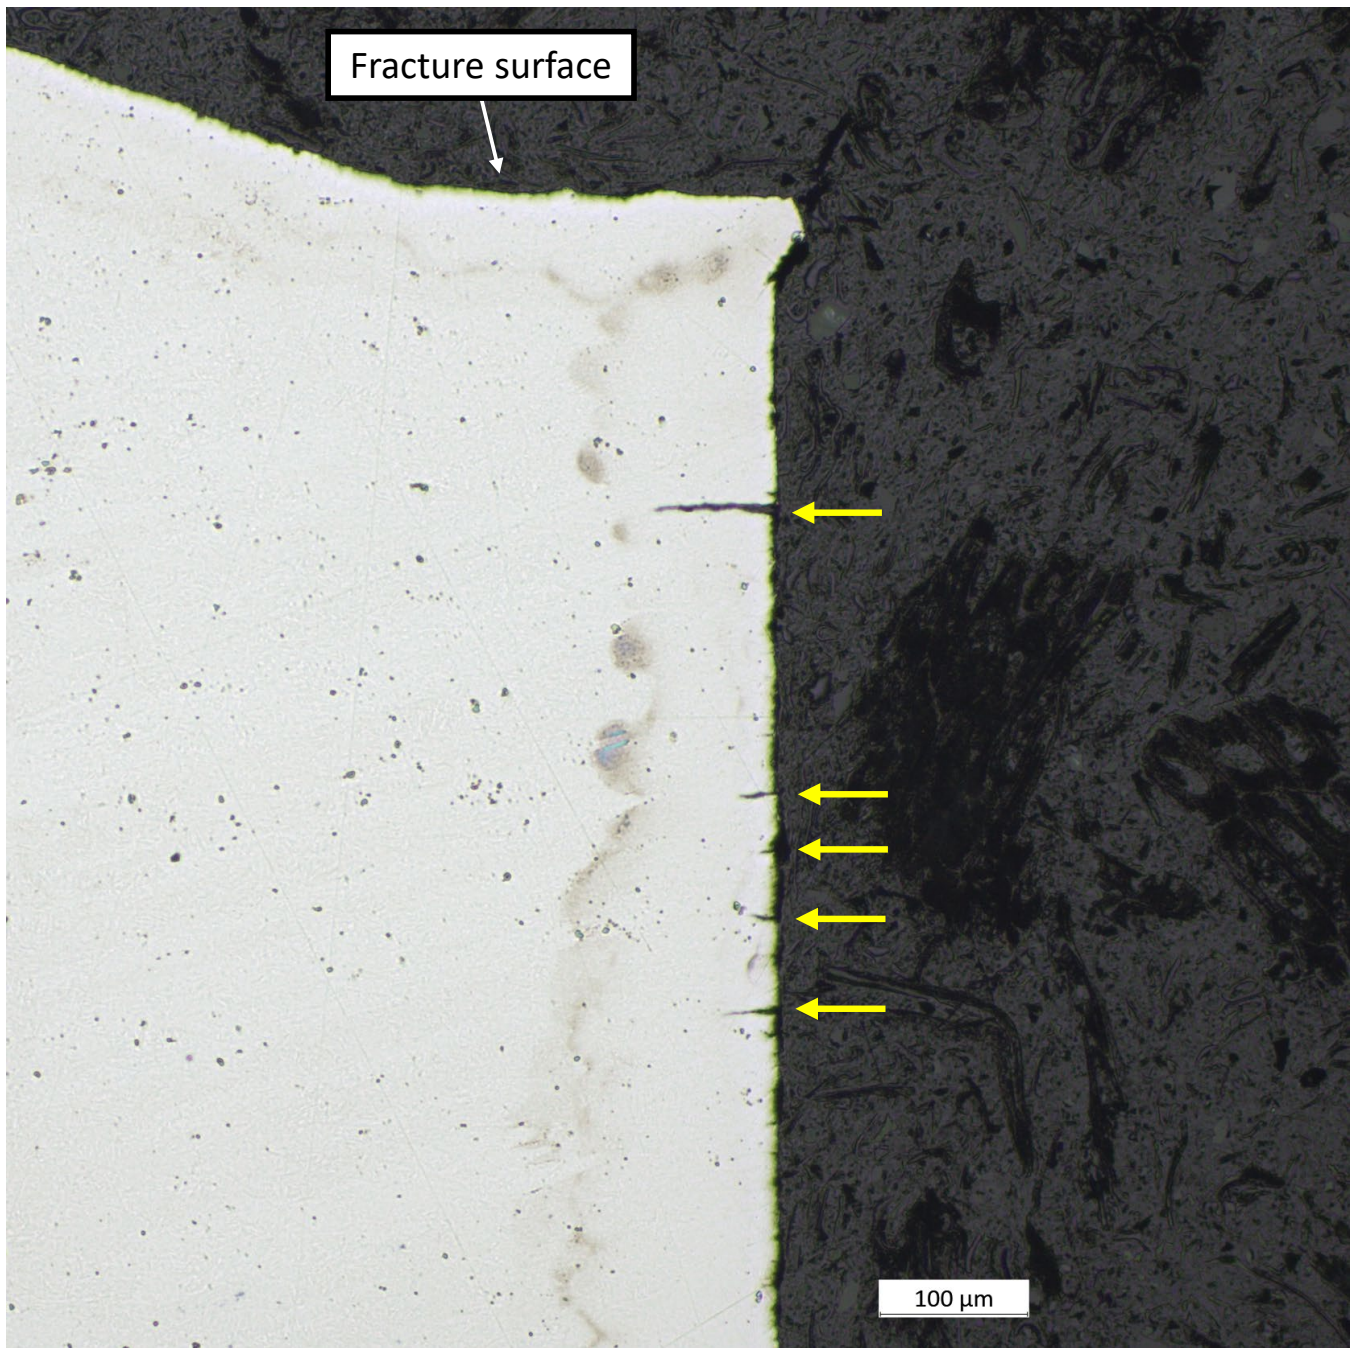
Figure 7: A bright-field metallographic cross section view through the drive coupling reduced section near the fracture surface. Secondary cracks observed extending into the drive coupling from the outer surface, as indicated by yellow arrows, were relatively flat. The maximum observed crack length was approximately 80  $\mu\text{m}$  (0.003 inch). 2% Nital Etch.

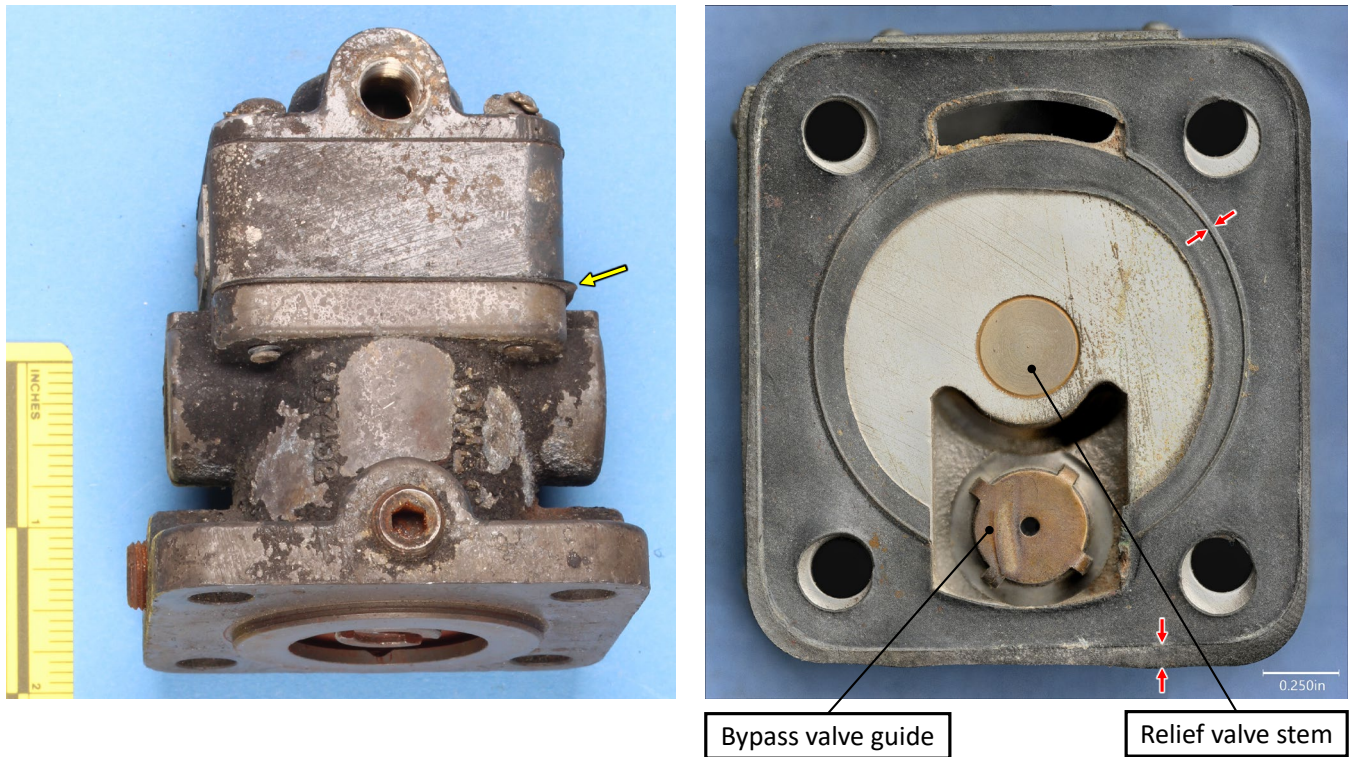
The fuel pump was later disassembled to examine the interior. The pump drive shaft was not easily rotated by hand and, once freed, only moved approximately 90° before seizure. Prior to disassembly, it was observed that the gasket between the pump housing and valve housing protruded as much as 0.076 inch from the exterior of the pump as shown in figure 8. Upon separation of the valve housing from the pump housing, the gasket exhibited regions of permanent set on the interior contact area evidenced by raised features around the outer perimeter and inner circular area as indicated by red arrows in figure 8. The pump gaskets were consistent with unmodified original equipment.<sup>4</sup> The bypass valve guide was removed from the valve housing to reveal the bypass valve. No spring was present between the bypass valve guide and the bypass valve. Figure 9 shows the opposite side of the bypass valve guide as shown in figure 8, the bypass valve guide port, and both sides of the bypass valve. Circular shaped contact marks were observed around the outer edges of the bypass valve guide and circular shaped rub marks around both sides of the bypass valve evidenced by a dull lighter colored band. The rub mark on one side of the bypass valve was relatively centered about a 0.32 inch diameter circle and extended to the outer edge of the circular valve which was approximately 0.392 inch in diameter as measured using a digital microscope. The rub mark on the other side of the bypass valve was off-center about a 0.33 inch diameter circle and extended to the outer edge of the circular valve resulting in an observed rub mark band width ranging from 0.018 inch to 0.042 inch. The inner edge of the bypass valve port contact area was measured to be approximately 0.330 inch. The outer diameter of the bypass valve port and the inner diameter created by the bypass valve guide prongs both measured approximately 0.405 inch.

Figure 8: Left: A photograph showing a view of the fuel pump prior to disassembly. The protruding gasket is indicated by a yellow arrow. Right: A digital microscope image (stitched montage) showing a view of the relief valve housing and gasket at the pump housing interface after disassembly. Red arrows indicate examples of raised features consistent with a permanent set condition observed in the gasket material.

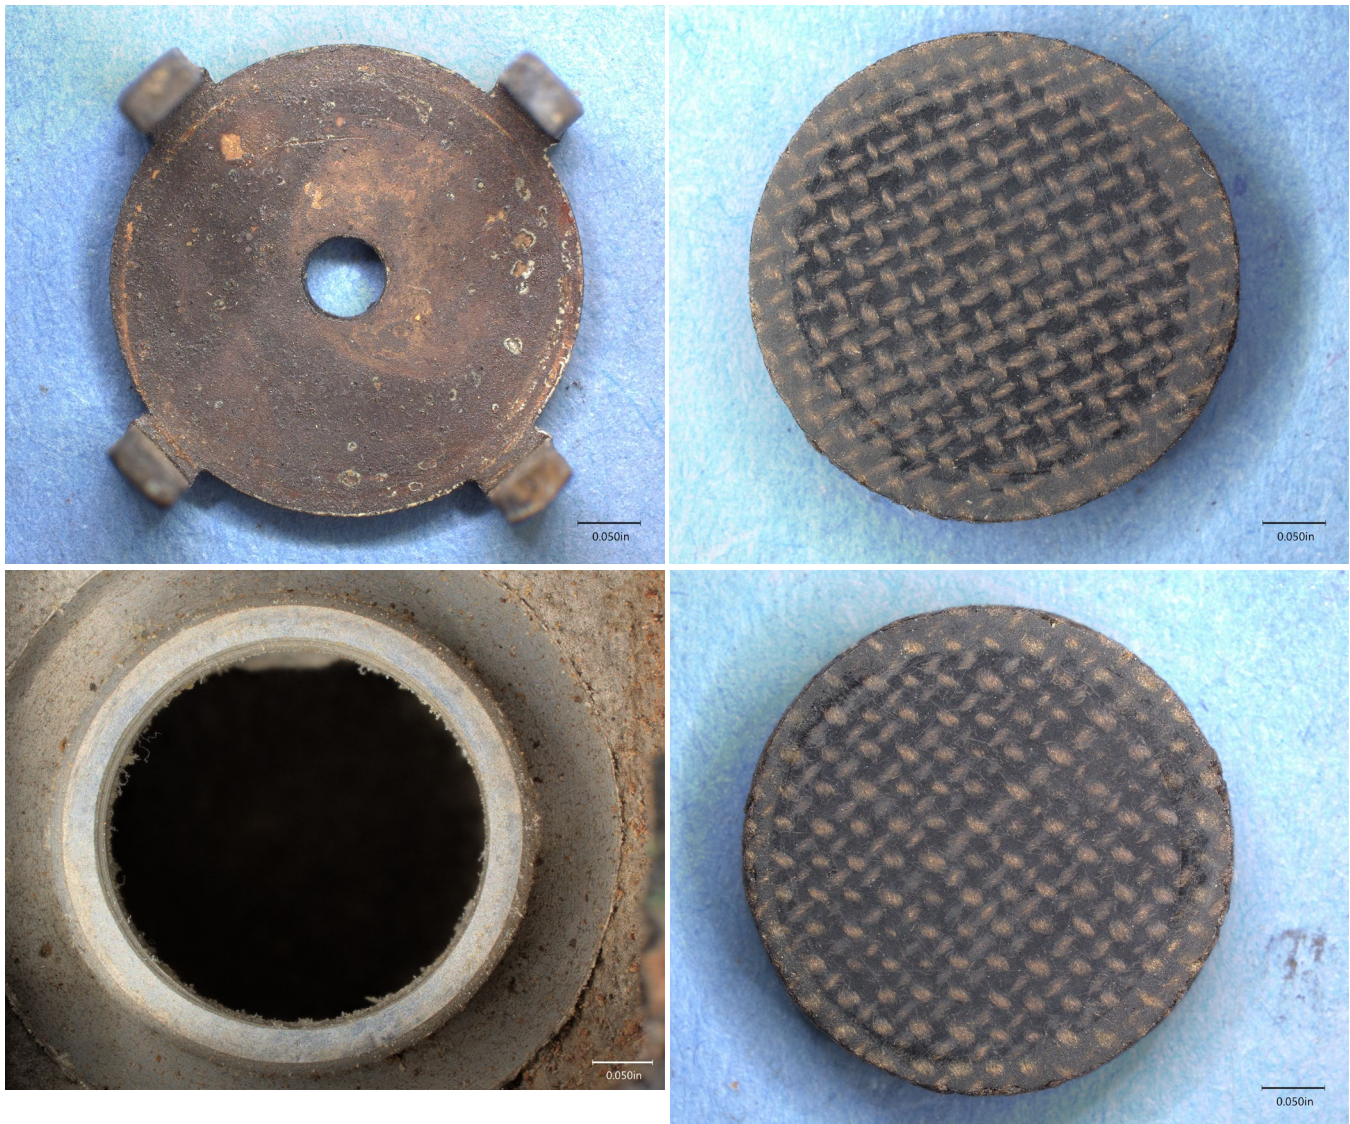
Figure 9: Digital microscope showing a view of the opposite side of the bypass valve guide as viewed in the previous figure after disassembly (upper left), the bypass valve port on the valve housing (lower left), and both sides of the bypass valve (upper and lower right). Circular off-center contact marks are evident around the outer edge of the bypass valve guide surface. Circular shaped rub marks were evident around the perimeter of the bypass valve on both sides as evidenced by a dull lighter appearance.

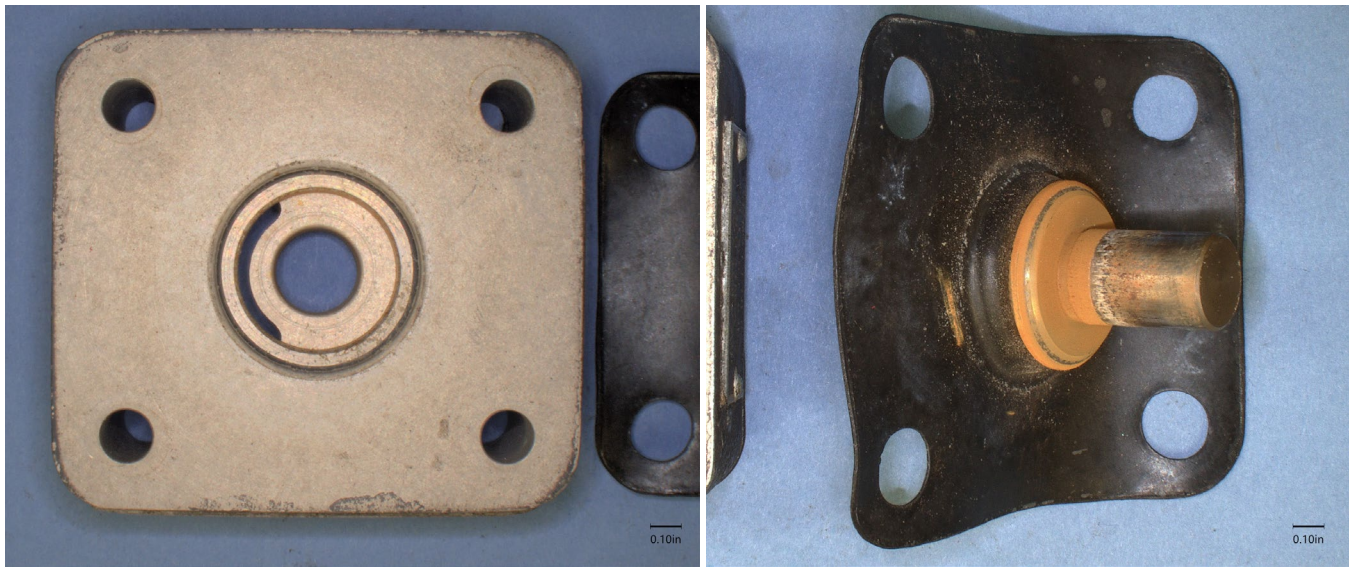
The valve cover assembly was removed from the valve housing to expose the safety relief valve assembly, as shown in figure 10, which consisted of a valve affixed to a gasket. A portion of the valve was covered in a reddish orange powdery substance consistent with iron oxide (rust). The portion of the valve retained in the valve housing was less covered with rust and a ring-shaped area on the tapered portion of the valve which interfaced with the valve seat on the housing was predominantly free of rust. No visible cracks or tears were observed in the gasket material.

Figure 10: A digital microscope image showing a tilted view of the relief valve assembly (right) removed from the valve housing (left). A reddish orange powdery substance consistent with rust was observed covering the valve near the valve seat interface.

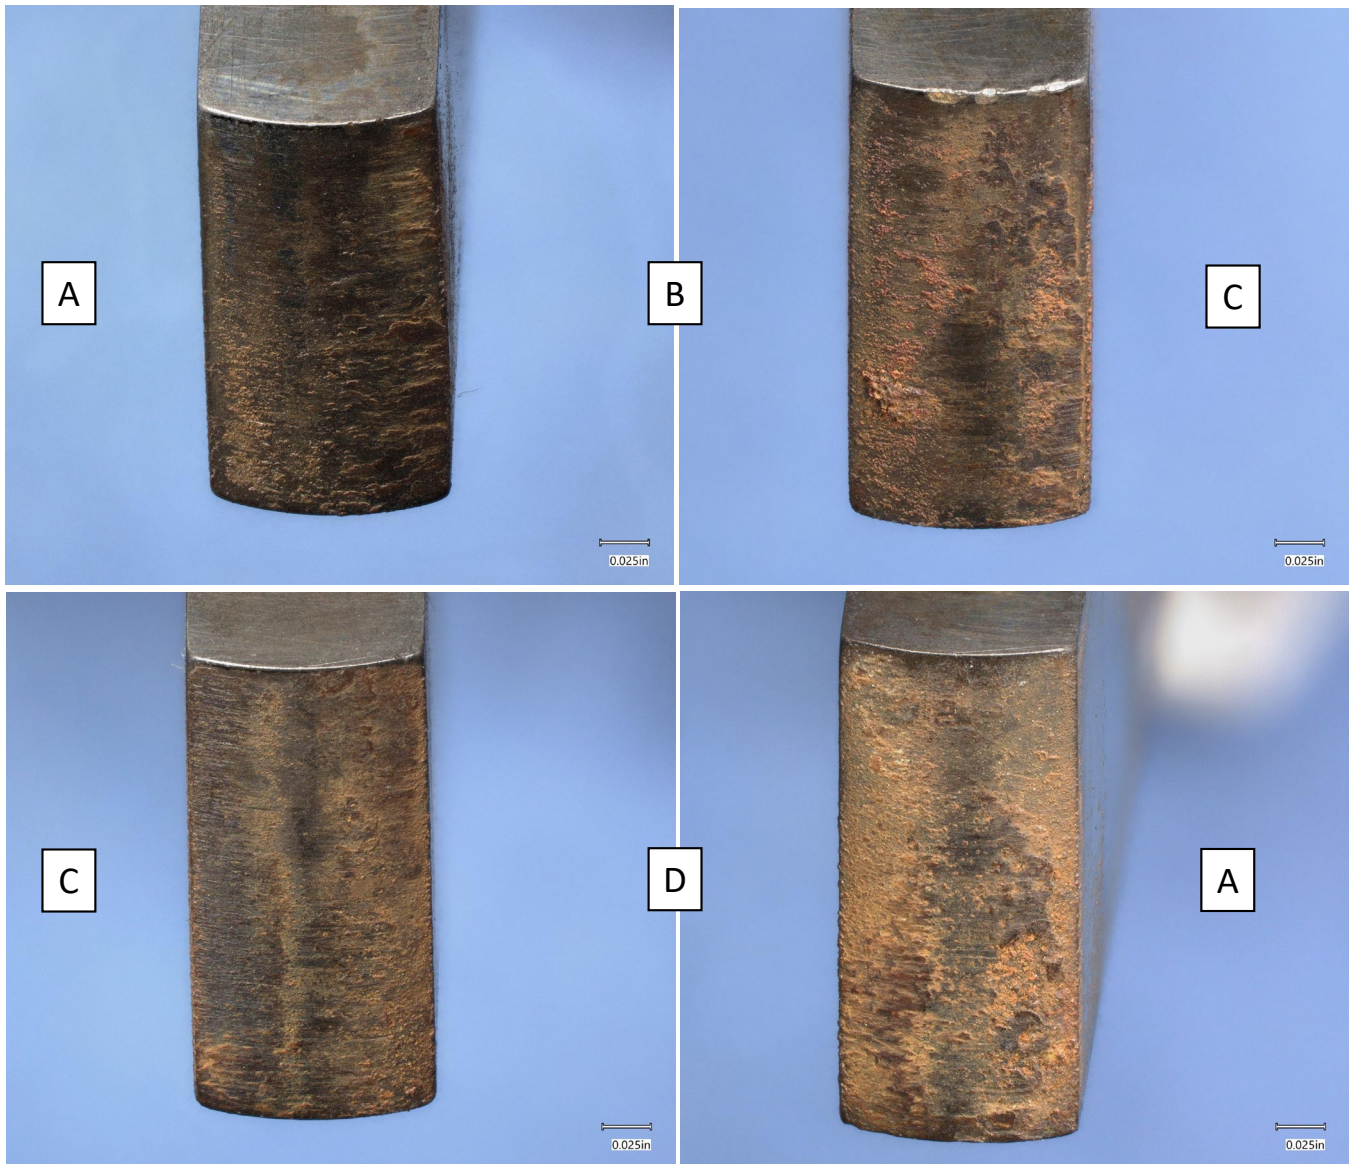
and featureless. The ends of the vane which interfaced with the pump inner housing are shown in figure 11 with the labels identifying the adjacent rotor quadrant. Smeared material transfer marks and other oxidized particles were observed, consistent with adhesive wear and ferrous wear debris.

Figure 11: Digital microscope images of the fuel pump vane edges as removed from their relative rotor quadrant position (A-D). Material transfer and debris were observed consistent with adhesive and abrasive wear mechanisms.

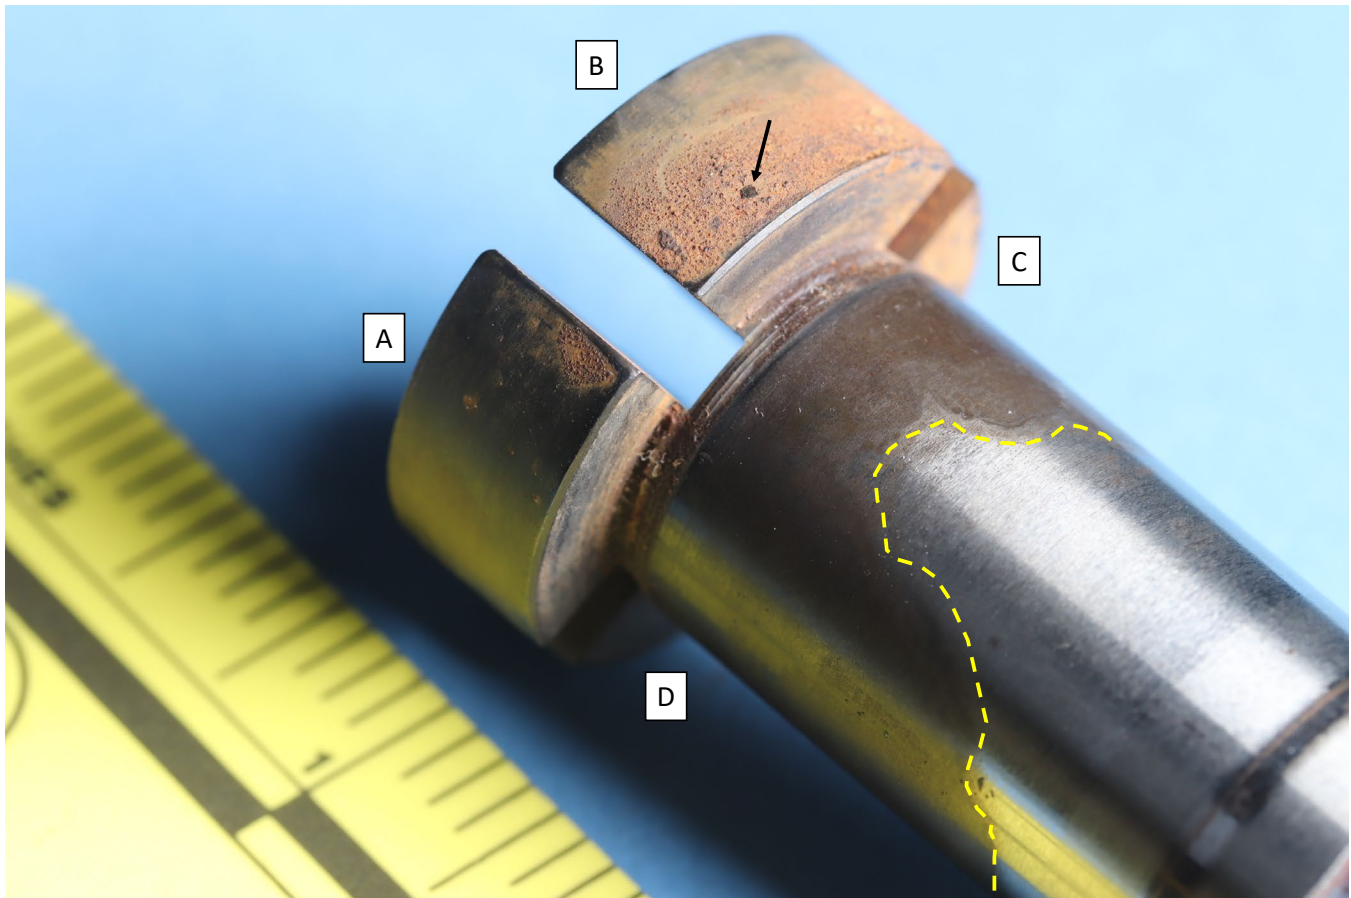
Figure 12 shows a photograph looking along the pump drive shaft at the rotor with the vanes removed. The yellow dashed line highlights the boundary of the thermal damage/heat tint observed on the shaft emanating from the rotor end. Closer examination of the outer surface of the rotor quadrants revealed wear debris present on the lower portions of quadrants A and C nearest quadrant B and over the majority of quadrant B. Energy dispersive x-ray spectroscopy (EDS) was performed in the vicinity of one of the larger wear debris particles identified by the black arrow in figure 12. The spectra acquired from areas indicated by yellow boxes in the electron image at the top left in figure 13 are shown overlaid at the bottom of the same figure. The larger yellow box in the electron image corresponded to a portion of the rotor surface relatively free of wear debris. The smaller yellow box corresponded to an area on the particle of interest. A white dashed box was used to highlight the location of the wear particle of interest in the field of view. The other inset images in figure 13 are elemental dot maps acquired over the same field of view showing where the elements iron (Fe), aluminum (Al), silicon (Si), carbon (C), and titanium (Ti) were detected and the white dashed box outlining the location of the particle of interest was reproduced on each map. These elements showed the greatest degree of contrast between the particle location and the surrounding rotor surface. The yellow dot map shows detection of iron (Fe), the predominant element contained in the fuel pump shaft and rotor. The area where the particle was located was essentially devoid of yellow, consistent with a foreign non-ferrous particle. Higher concentrations of carbon, aluminum, chlorine, silicon, and titanium were detected over the area of the particle which were consistent with common elements found in soil minerals. Other elements detected as indicated by smaller peaks in the spectra were consistent with elements found in soil minerals and common alloying elements in steel.

Figure 12: A photograph of the fuel pump rotor and a portion of the shaft. The pump vanes were removed from the slots between lettered rotor quadrants. Wear debris were observed on the sidewalls of rotor quadrants A, B, and C and an example of a larger wear debris particle is indicated by the black arrow. The yellow dashed line highlights the boundary of the dark region observed on the shaft which emanated from the rotor, consistent with thermal damage/heat tint.

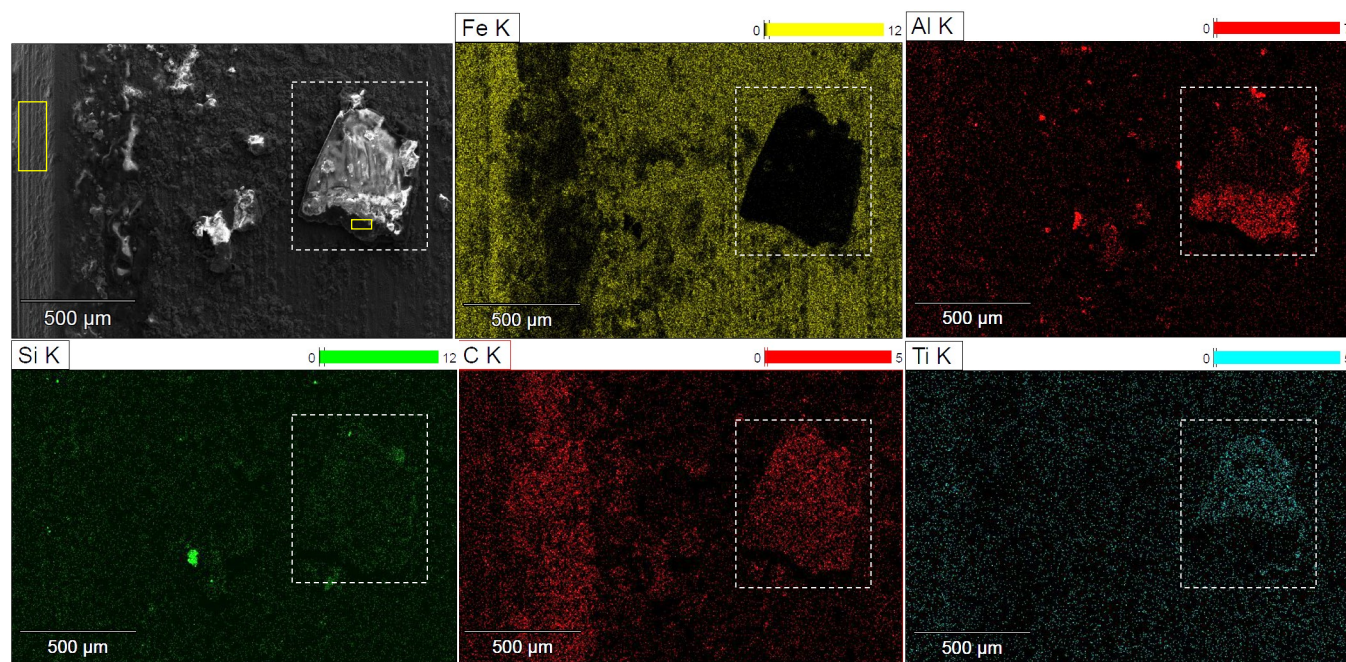
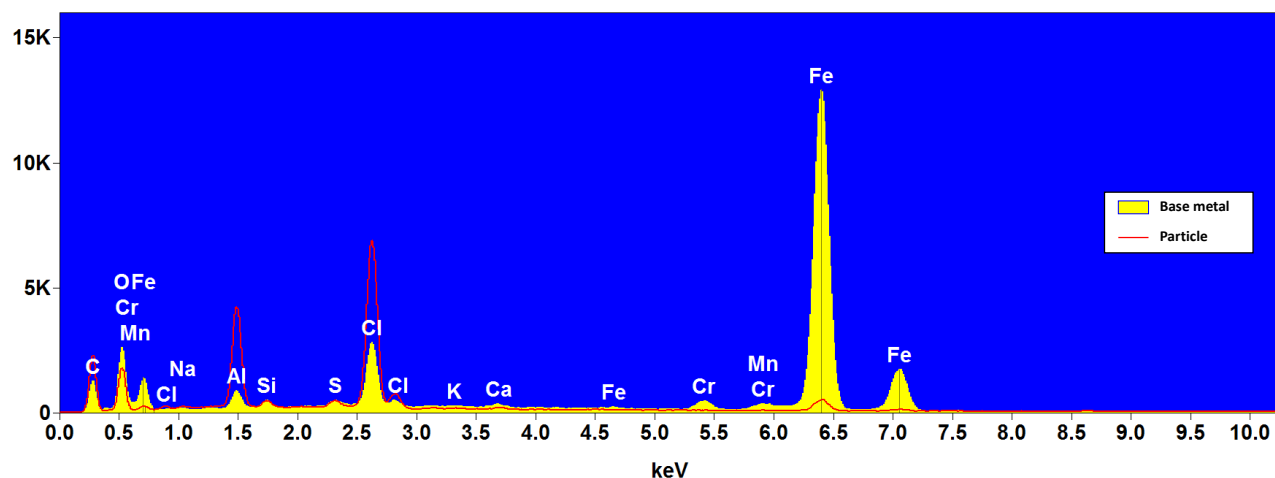
Fuel pump rotor sidewall wear debris particle

Figure 13: The upper left image shows a secondary electron image of a wear particle observed on the rotor sidewall of quadrant B. The yellow boxes indicate locations where the EDS spectra overlaid at the bottom of the figure were acquired. A dashed white box surrounds the particle location in the electron and elemental map images. Elemental maps from the same field of view as the electron image were generated to show compositional variation observed between the particle and surrounding rotor surface.

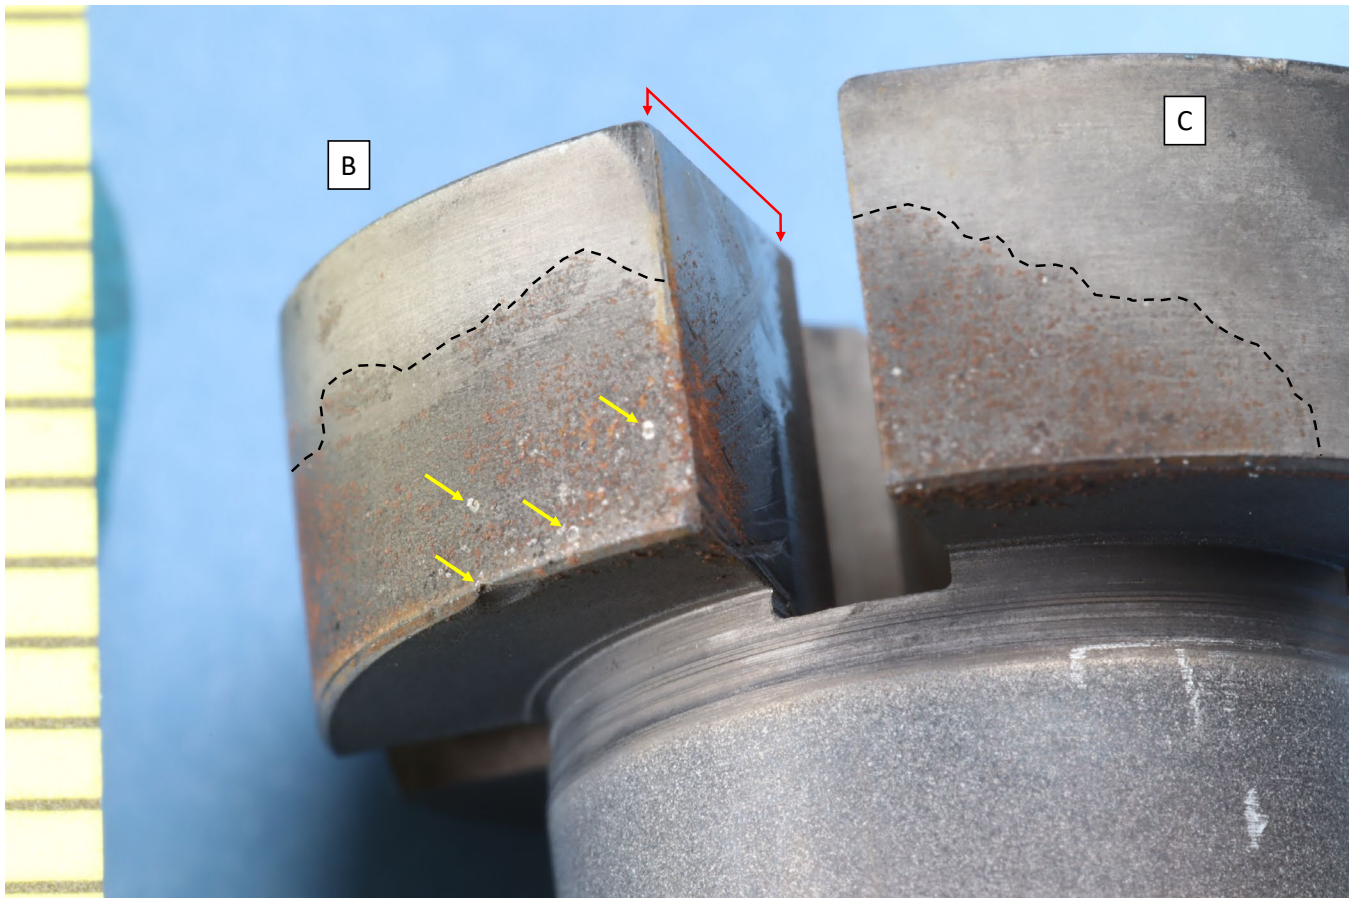
The fuel pump drive shaft was cleaned using a soft bristled brush and mild detergent followed by ultrasonic cleaning in acetone. Figure 14 shows a view of the rotor after cleaning with a portion of the outer surfaces of quadrants B and C visible. The black dashed line highlights the boundary of the rougher area where wear debris were observed. Above this region, the outer surface of the rotor was smoother and exhibited a pattern of parallel circumferential machining marks. Yellow arrows identify examples of larger pits observed on the outer surface of the rotor. These locations were observed more closely using SEM. The area on the slot face of quadrant B, indicated by a red bracket, exhibited a shinier appearance with angled gouges, consistent with abrasive wear. This surface interfaced with a pump vane when assembled.

Figure 14: A photograph of the fuel pump rotor and vane slot between quadrants B and C after cleaning. The black dashed line highlights the boundary of the rougher area where wear debris were observed. Yellow arrows identify larger examples where pits and spalled material were observed. An area on the slot face of quadrant B bound by the red arrows was shinier in appearance and exhibited gouges.
