# NATIONAL TRANSPORTATION SAFETY BOARD

## MATERIALS LABORATORY FACTUAL REPORT

Report No. 21-033

Place : Eveleth, Minnesota  
Date : July 5, 2020  
Vehicle : Piper PA32, N4079R  
NTSB No. : CEN20LA263  
Investigator : John Brannen, AS-CEN

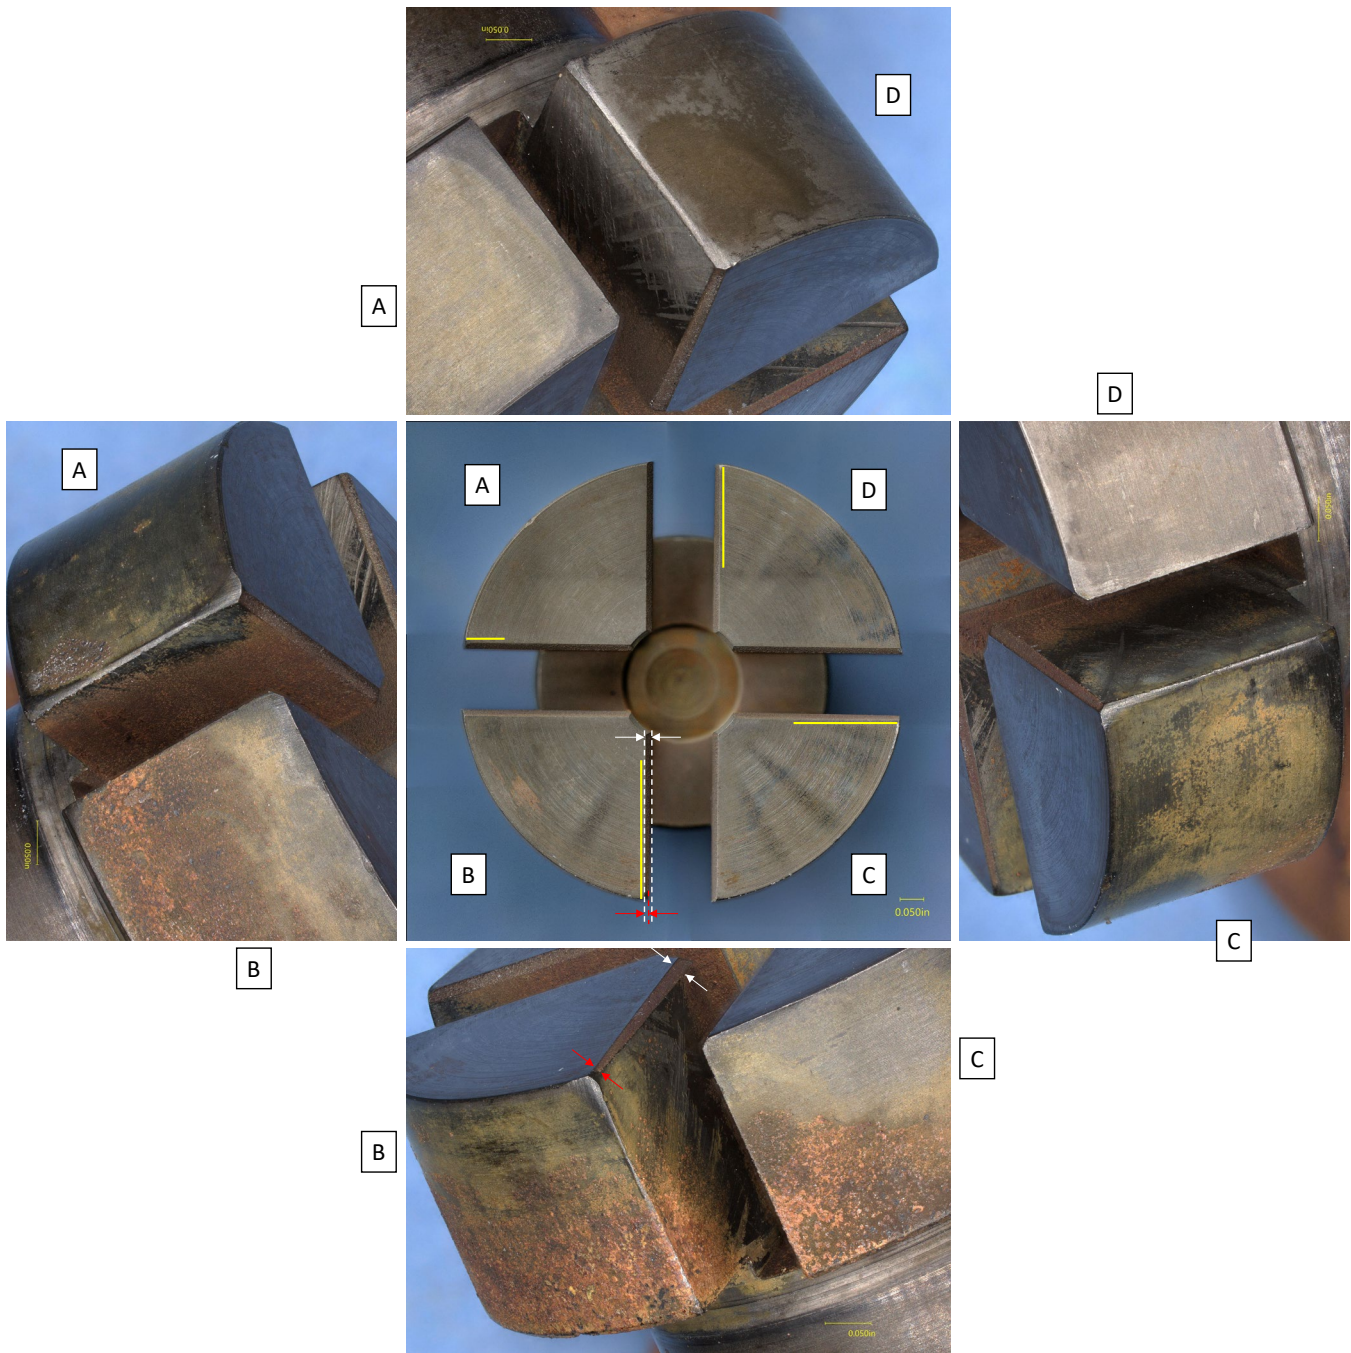
Figure 15 shows a top view of the fuel pump rotor looking down the shaft axis. Around this central image are views of the slot faces and top surface of the corresponding rotor quadrants which exhibited similar evidence of abrasive wear and gouges as shown in the previous figure. The yellow lines in the central image indicate the slot faces where abrasive wear and gouges were observed and correspond to the faces being viewed in the adjacent images. The relative lengths of the yellow lines indicate the approximate maximum length over which the shinier gouged surface was observed from the outer edge to the central hub. On the slot surface of rotor quadrant A facing B, the gouged area extended approximately

0.076 inch from the outer edge inward. Similarly, for rotor quadrant B slot surface facing C, rotor quadrant C slot surface facing D, and rotor quadrant D slot surface facing A, the equivalent measurements were 0.276 inch, 0.206 inch, and 0.201 inch, respectively. The length of the chamfer feature between the top surface of the rotor and the gouged slot faces tapered slightly from the rotor center to the outer surface, consistent with more material loss due to wear closer to the outer surface. This was readily observed on slot faces of quadrant B (facing C) and of quadrant D (facing A) shown in the bottom and top images in figure 15, respectively. The white and red dashed lines and corresponding arrows in the central and lower images indicate an example of the observed taper.

Figure 15: Digital microscope images of the fuel pump rotor and slot faces. The central image shows a view of the top surface of the rotor looking down the drive shaft. Yellow lines in the central image correspond to the slot face being viewed in the adjacent digital microscope images. The relative length of the yellow lines approximates the maximum extent of the gouging along the slot face. White and red arrows indicate an example of decreasing chamfer length between the top and sidewall surfaces from the central axis to the outer diameter on sidewalls where gouges were observed.

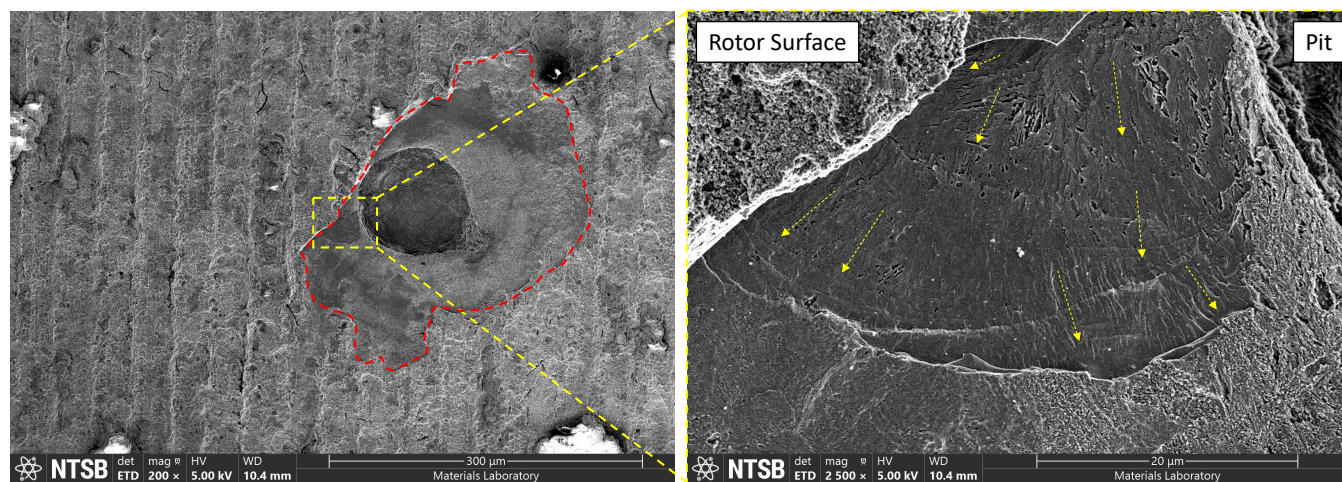
The pits and missing material observed on the outer surface of the rotor as identified in figure 14 were examined more closely using SEM. Figure 16 shows a lower magnification view of one of the pits and the surrounding outer surface of the rotor. The area within the red dashed line including the pit was spalled from the rotor surface. A higher magnification view of the area highlighted in the yellow dashed box is shown to the right. A relatively flat crack path and features consistent with fatigue striations were observed emanating adjacent to the pit. The yellow dashed arrows indicate the general direction of progression of these fatigue features and a ledge feature was observed near the end of the arrows where fracture features were more obscured. The fatigue crack continued to progress under the rotor surface. The subsurface fatigue cracking mechanism and observed pitting/spalling was consistent with contact fatigue wear. Figure 17 shows a secondary electron image from another area of spalled material between the rotor sidewall and base. Features consistent with fatigue striations were observed near this location as well as shown in the higher magnification secondary electron image on the right in figure 17.

Figure 16: A secondary electron image of a pit observed on the rotor surface as identified in figure 10 is shown on the left. The area within the red dashed boundary exhibited spalled material. On the right is a higher magnification secondary electron image of the area in the yellow box showing features consistent with fatigue striations progressing near the pit along a surface approximately parallel to and beneath the rotor surface. Yellow arrows indicate the general direction of crack propagation which continued under rotor surface material that had not spalled.

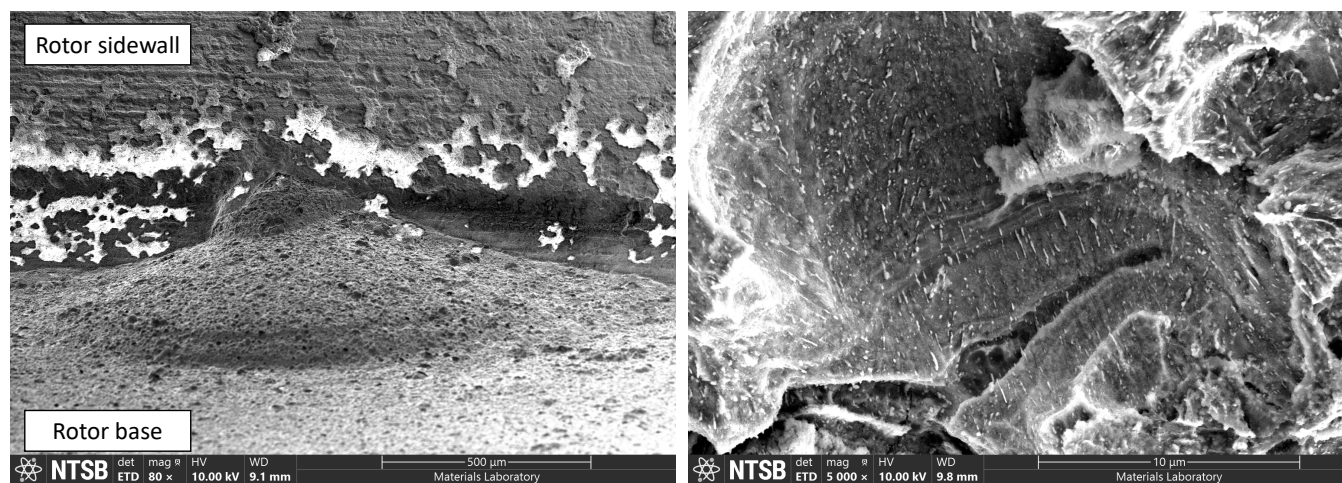
Figure 17: A secondary electron image of an area of spalled material observed at the corner of the rotor sidewall and base as identified in figure 14 is shown on the left. On the right is a higher magnification secondary electron image showing features consistent with fatigue striations, near the spalled material, progressing from lower right to upper left as oriented.
