**Photo 1 – Pre-accident photograph of N50JH in its hangar in Gross Ile, MI (family photo)**

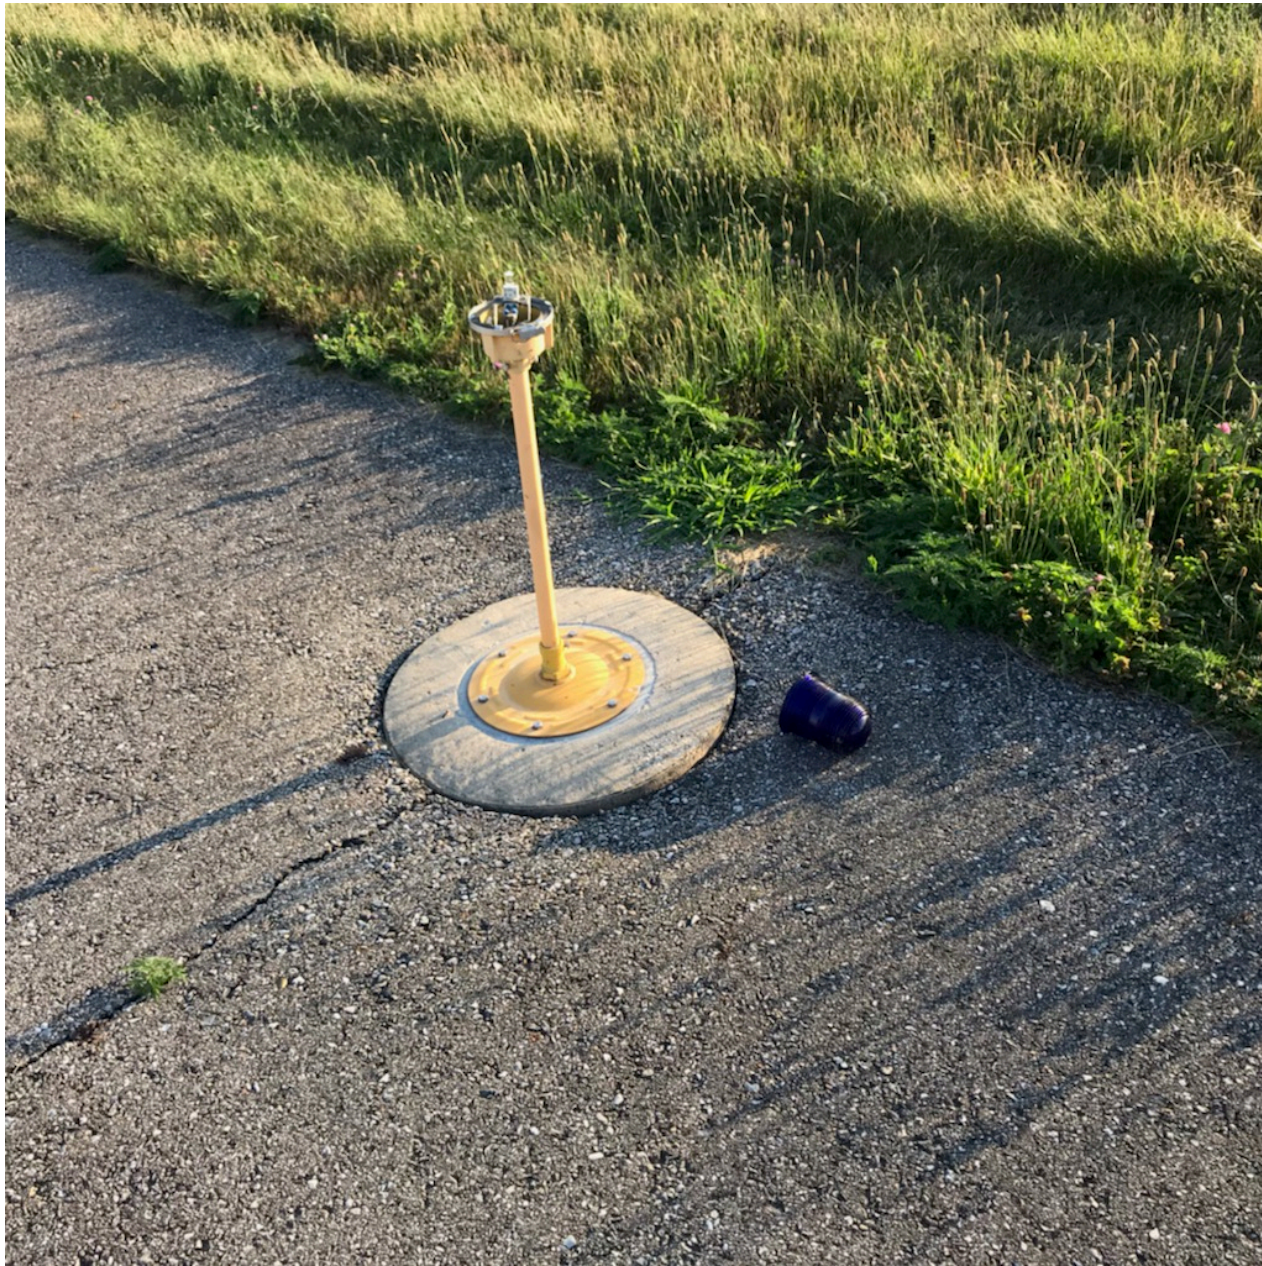
**Photo 2 – Taxiway light struck by N50JH during takeoff, located at intersection of taxiways C and E (FAA photo)**

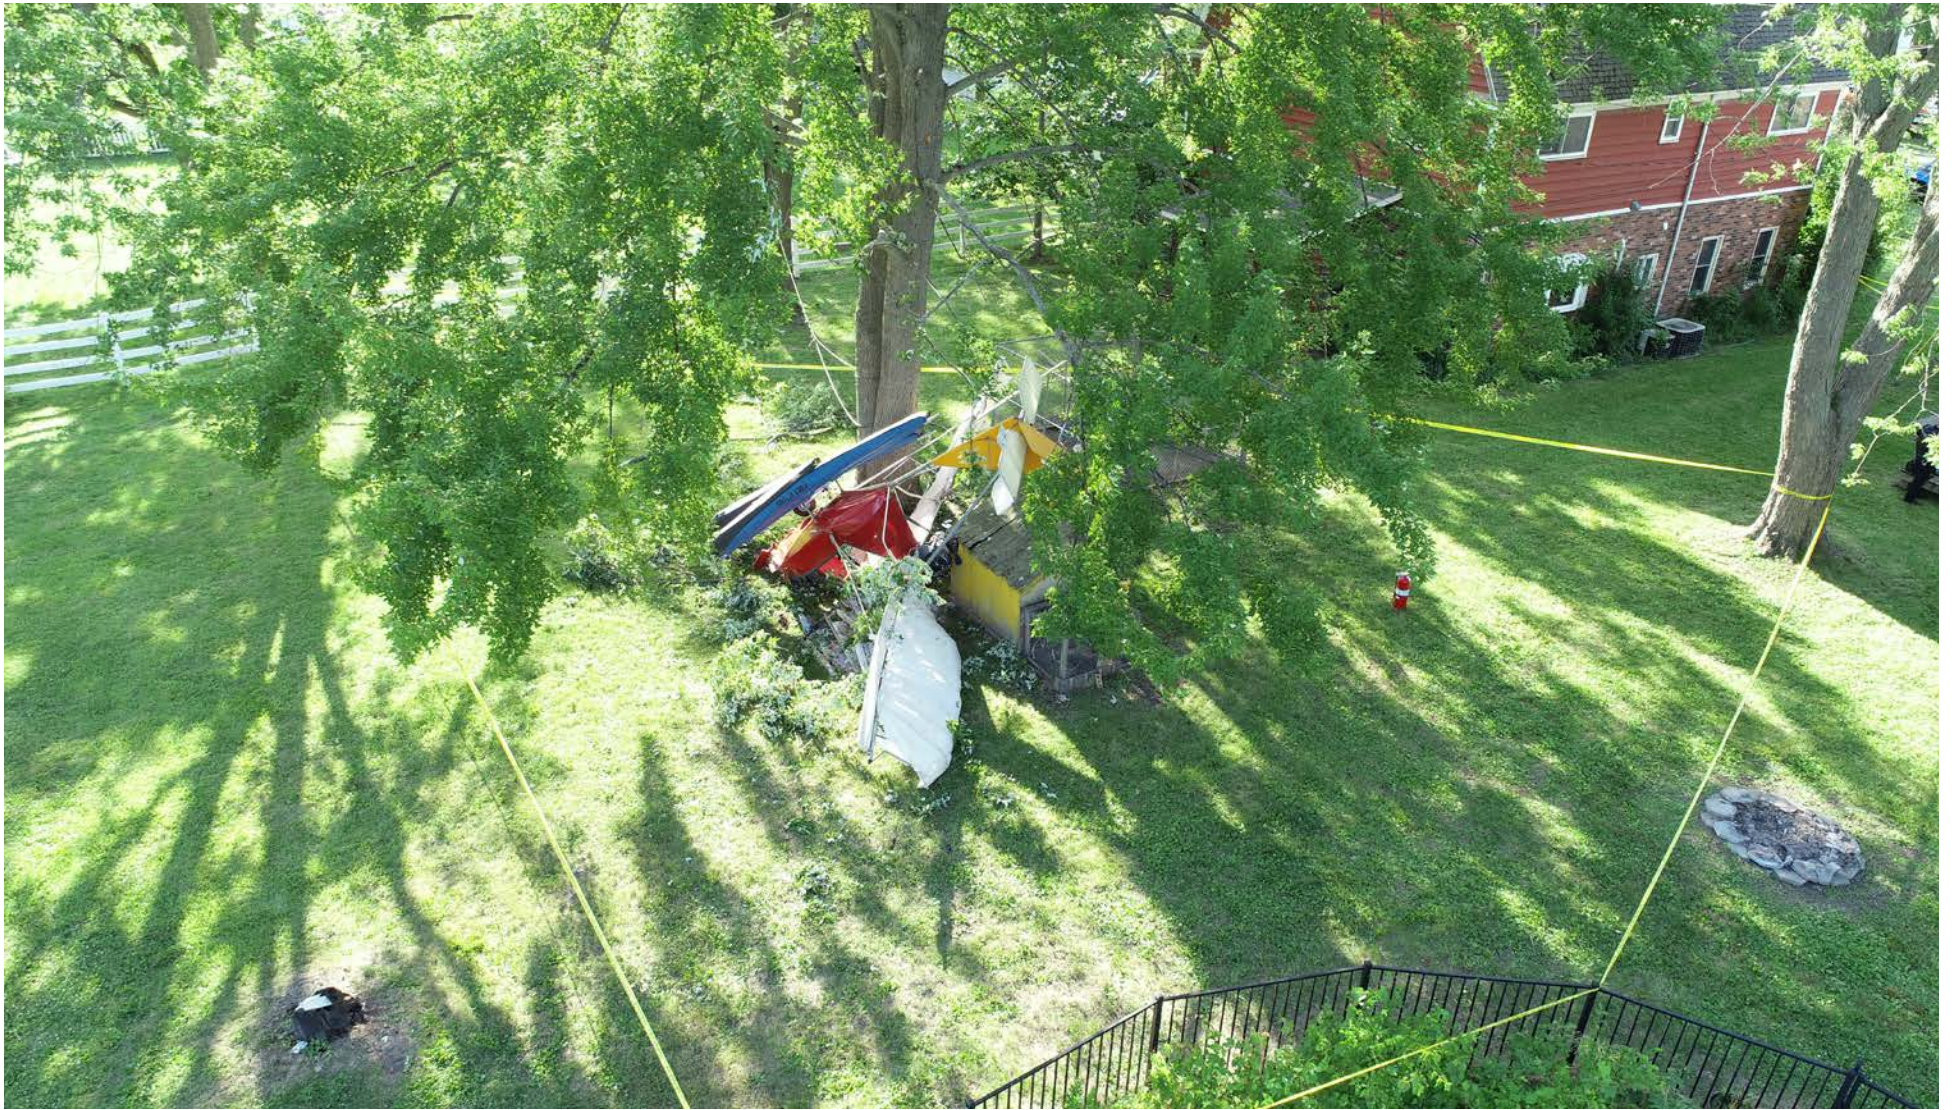
**Photo 3 – Aerial view of accident, located in residential neighborhood ½-mile south of ONZ (police department photo)**

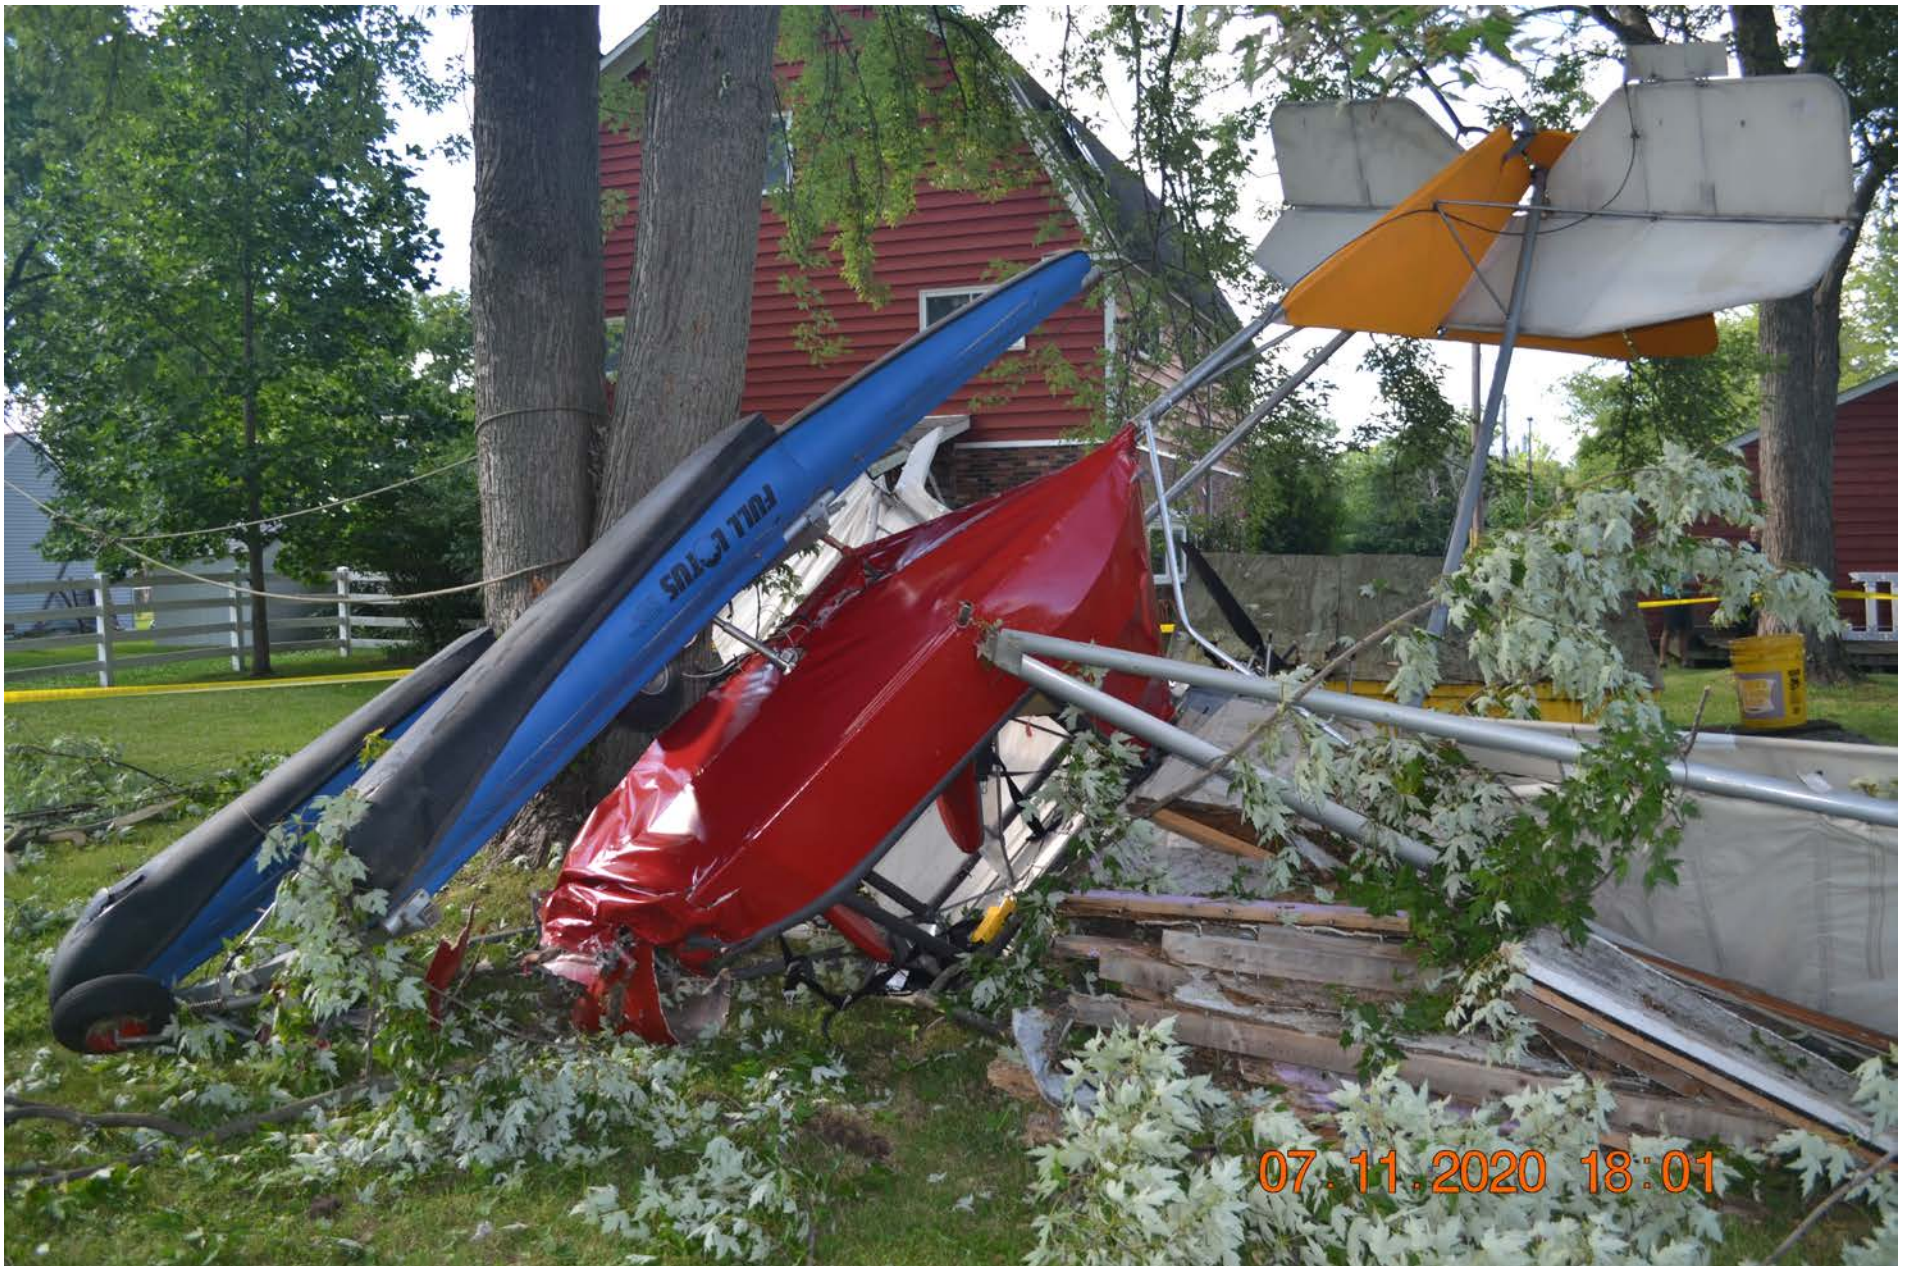
**Photo 4 – Inverted N50JH. Note severed tree branches (FAA photo)**

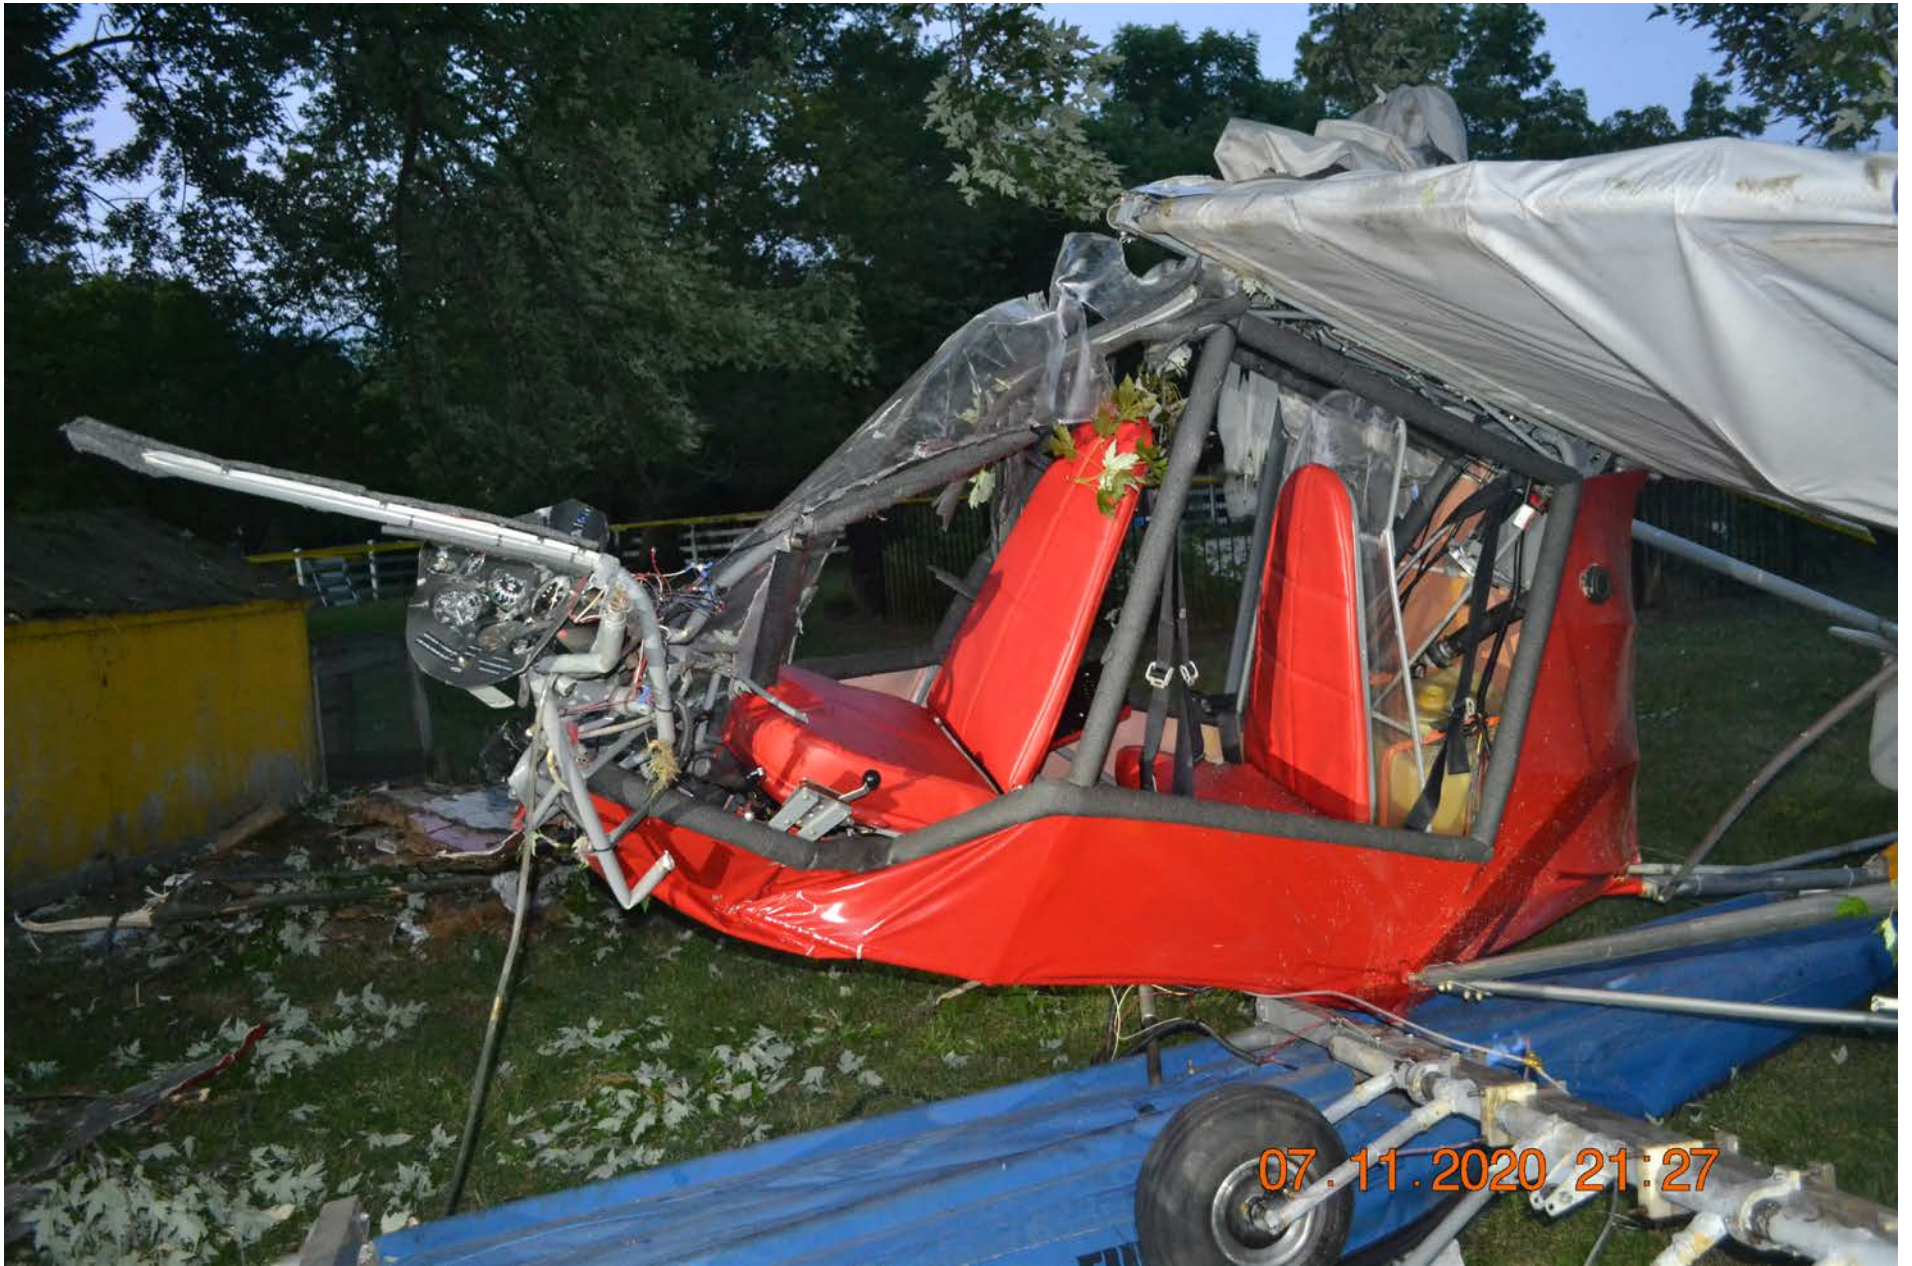
**Photo 5 – The cockpit after airplane was righted (FAA photo)**

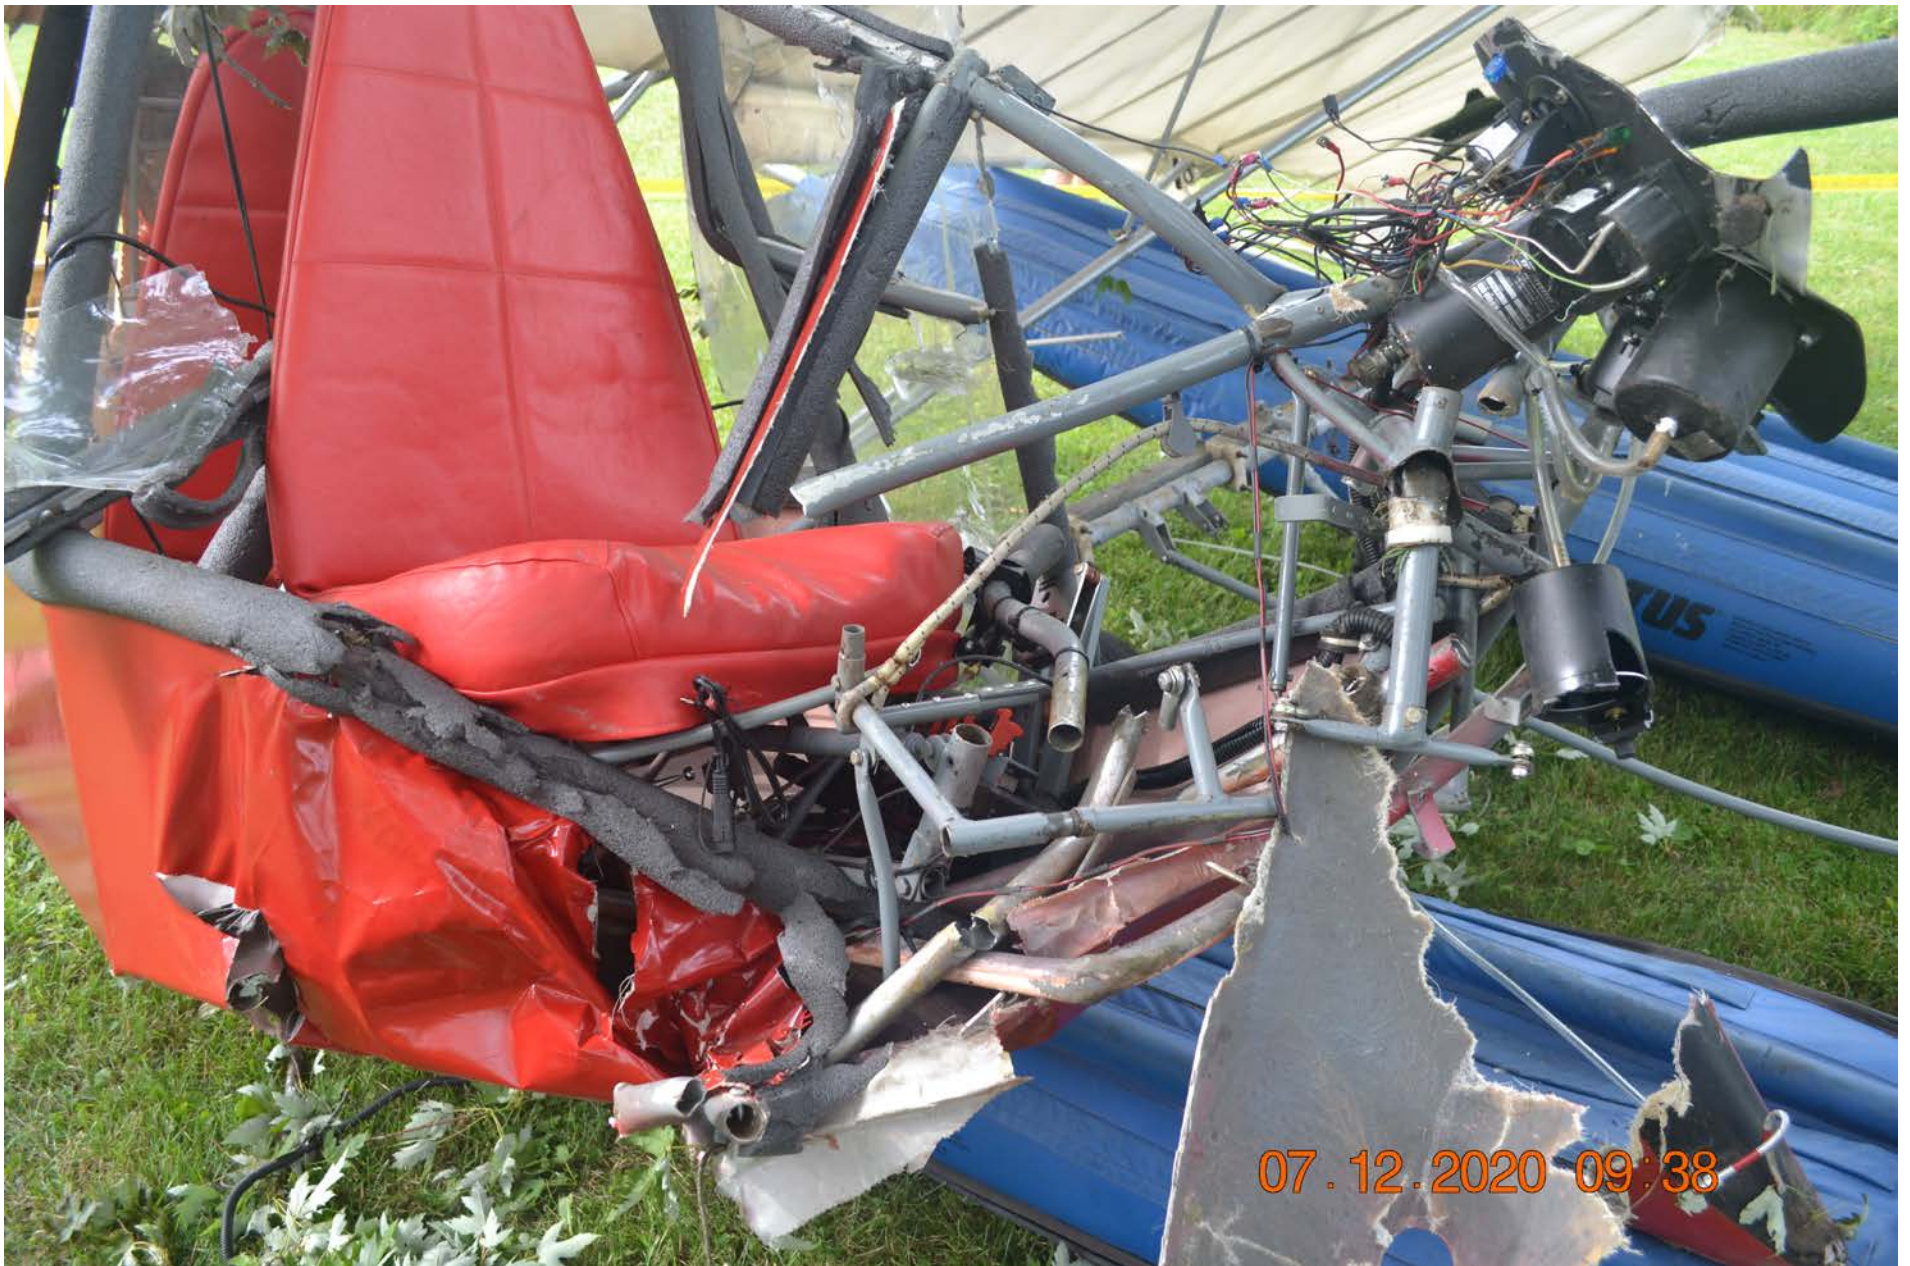
**Photo 6 – The pilot's seat (FAA photo)**

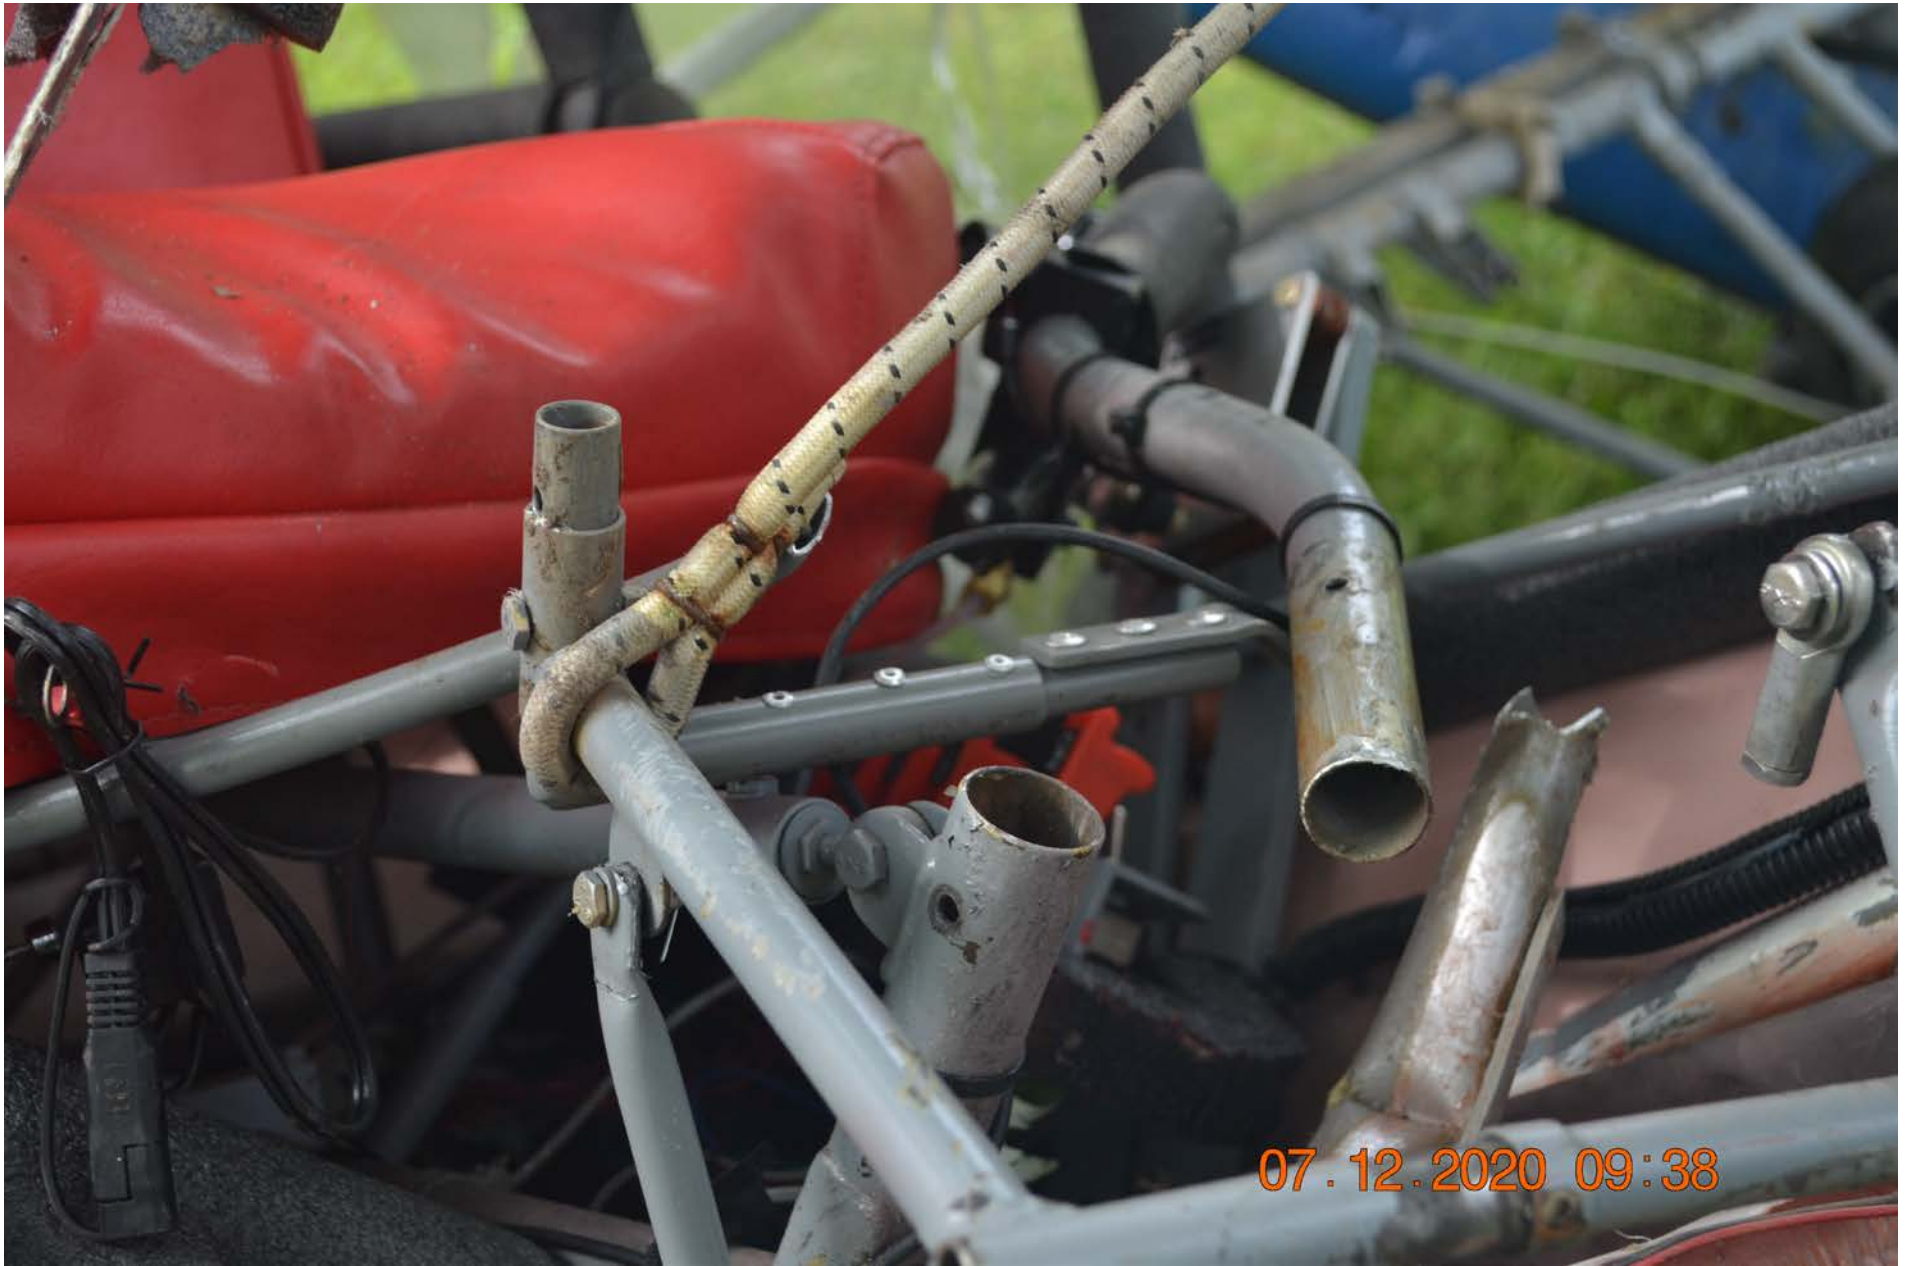
**Photo 7 – Missing control stick (FAA photo)**

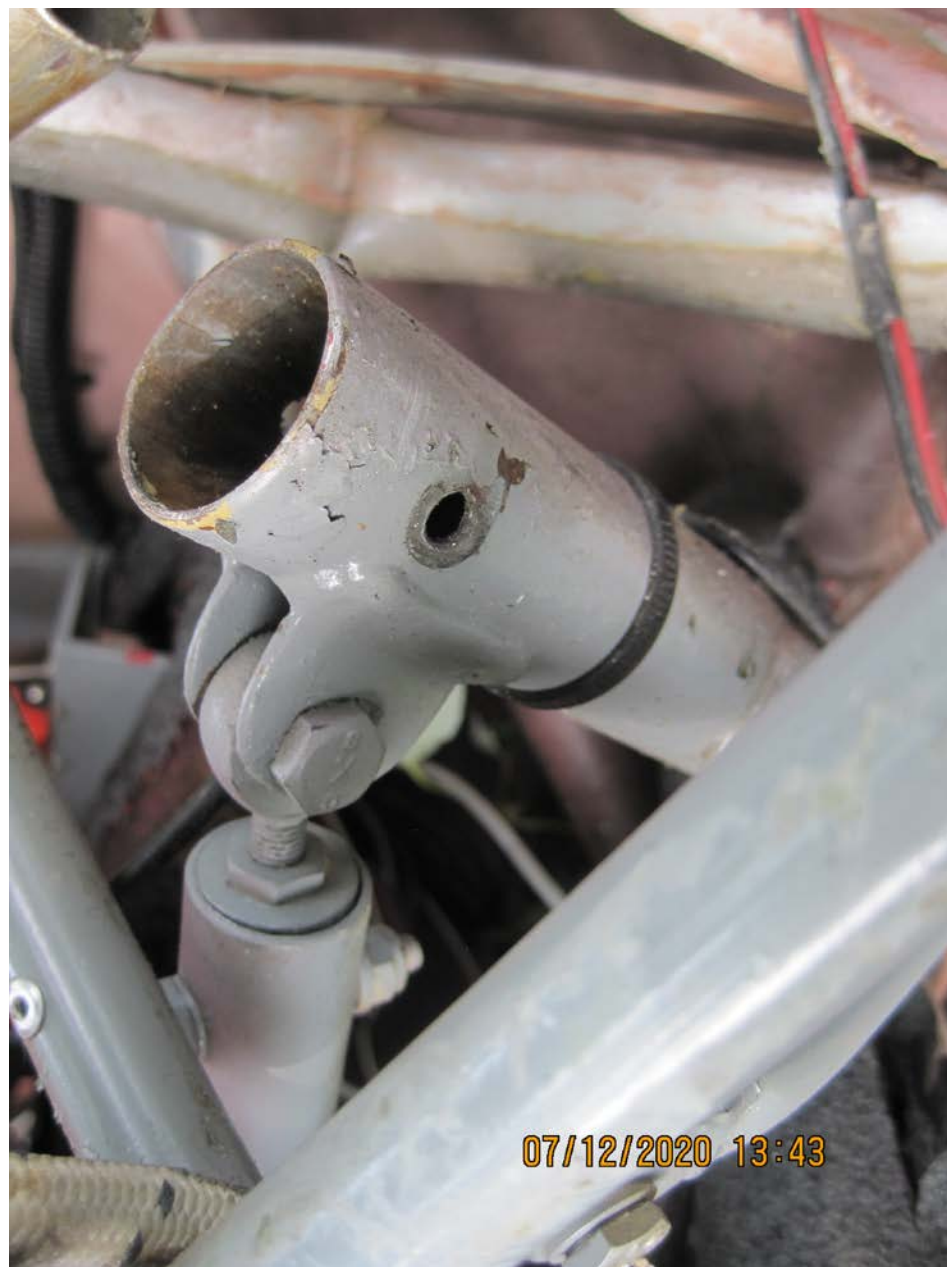
**Photo 8 – Missing control stick socket (FAA photo)**

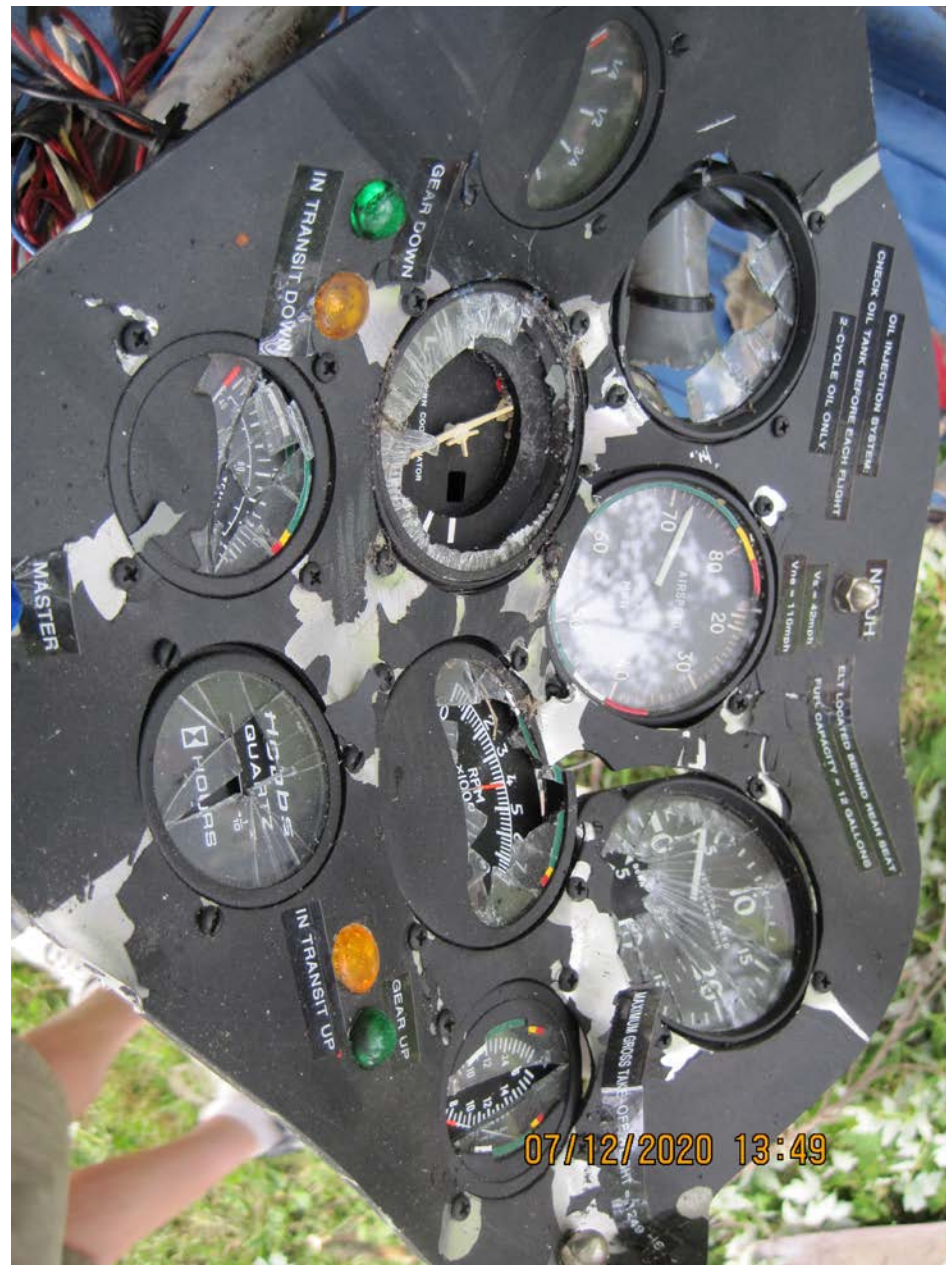
Photo 9 – The instrument panel (FAA photo)

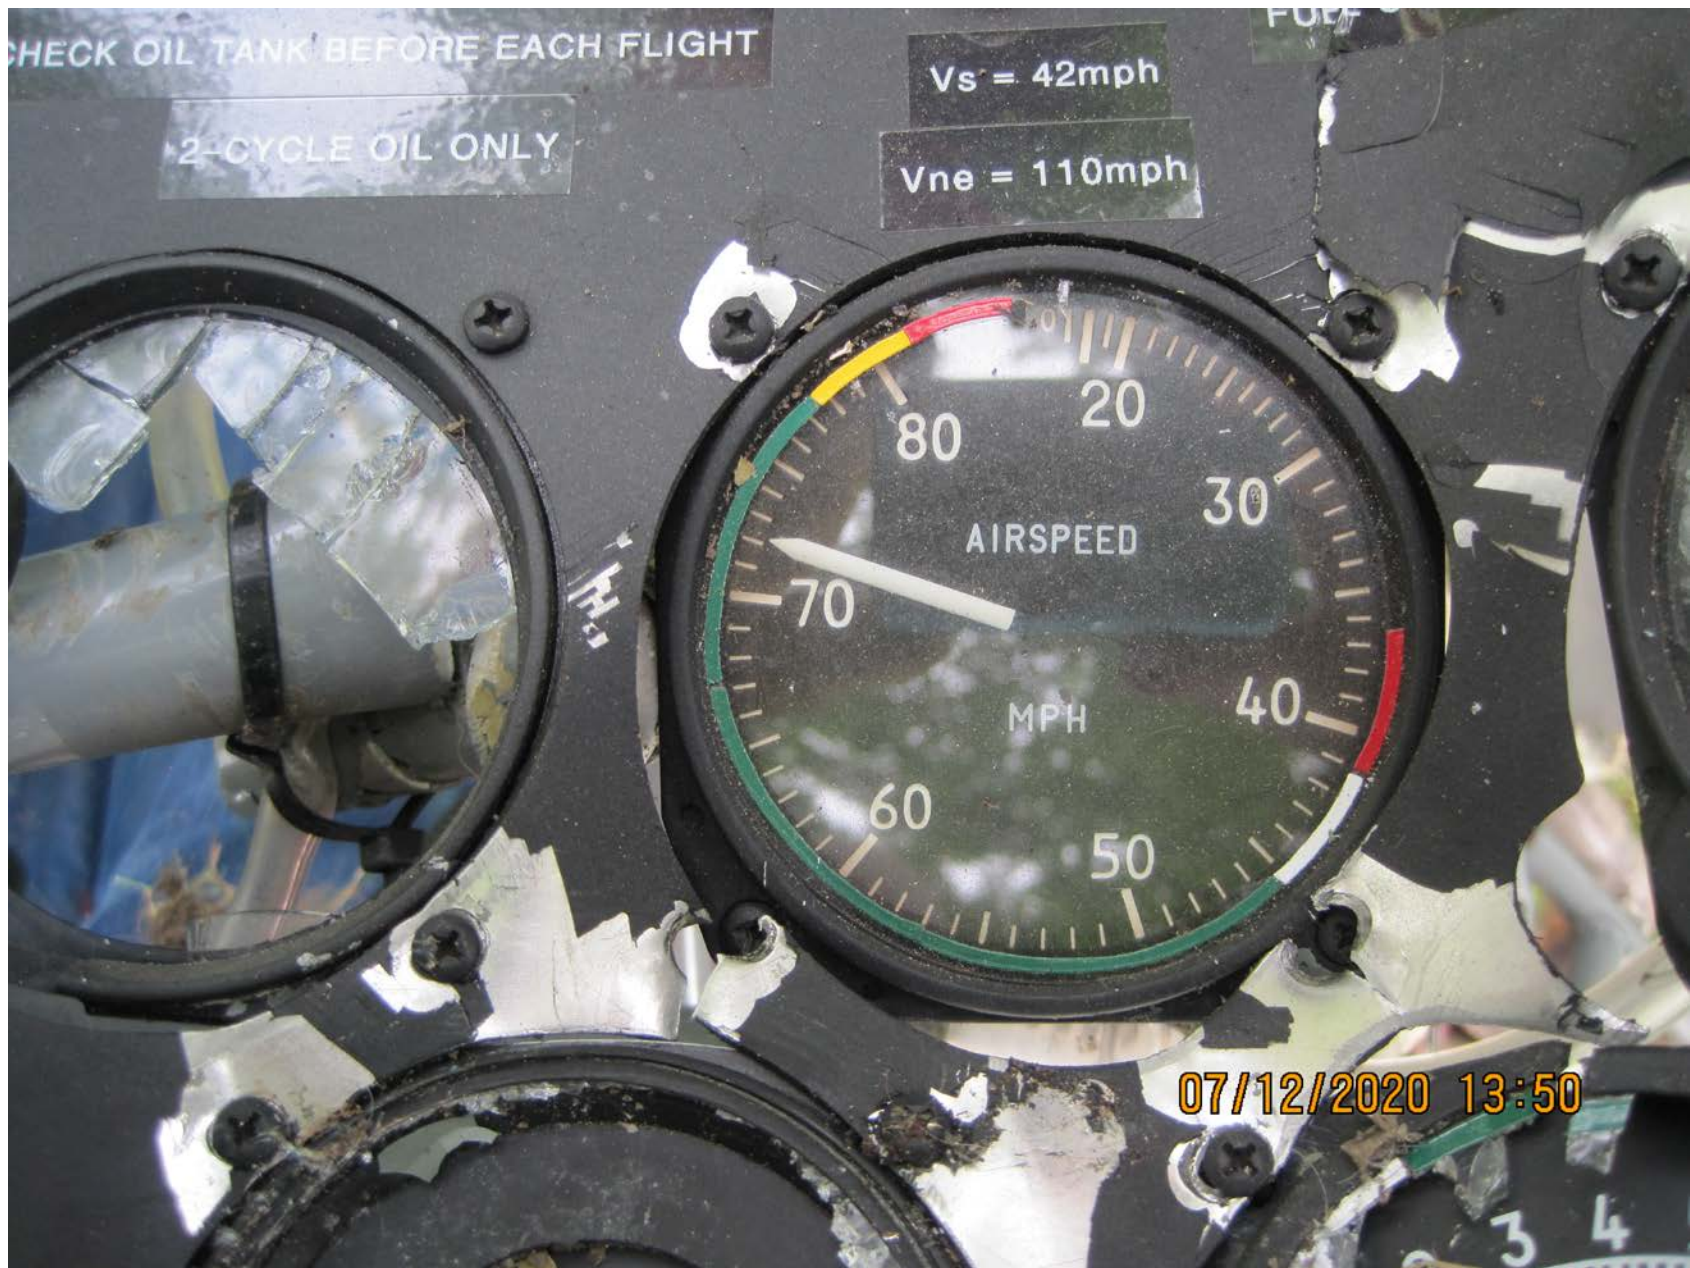
**Photo 10 – The airspeed indicator, registering 72 mph (FAA photo)**

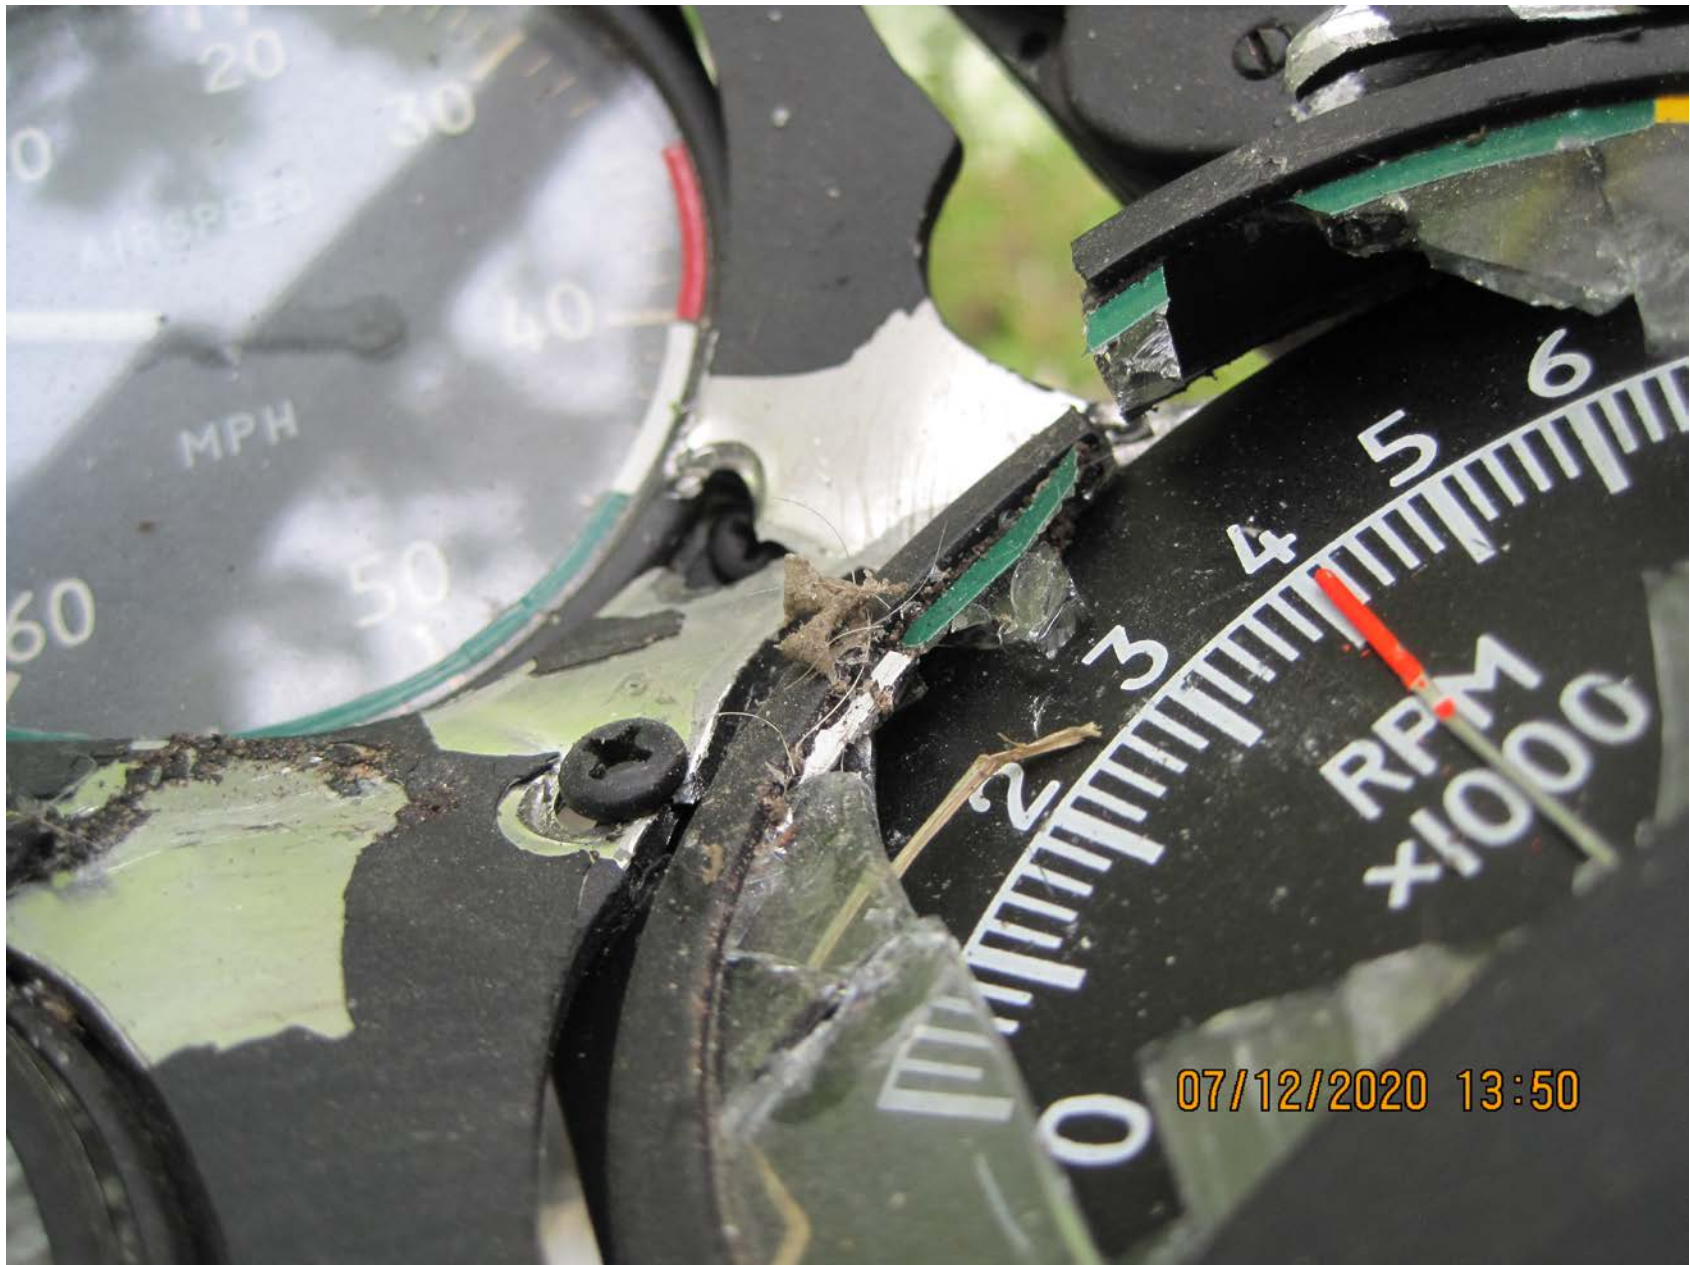
**Photo 11 – The tachometer, indicating 4,000 rpm (FAA photo)**

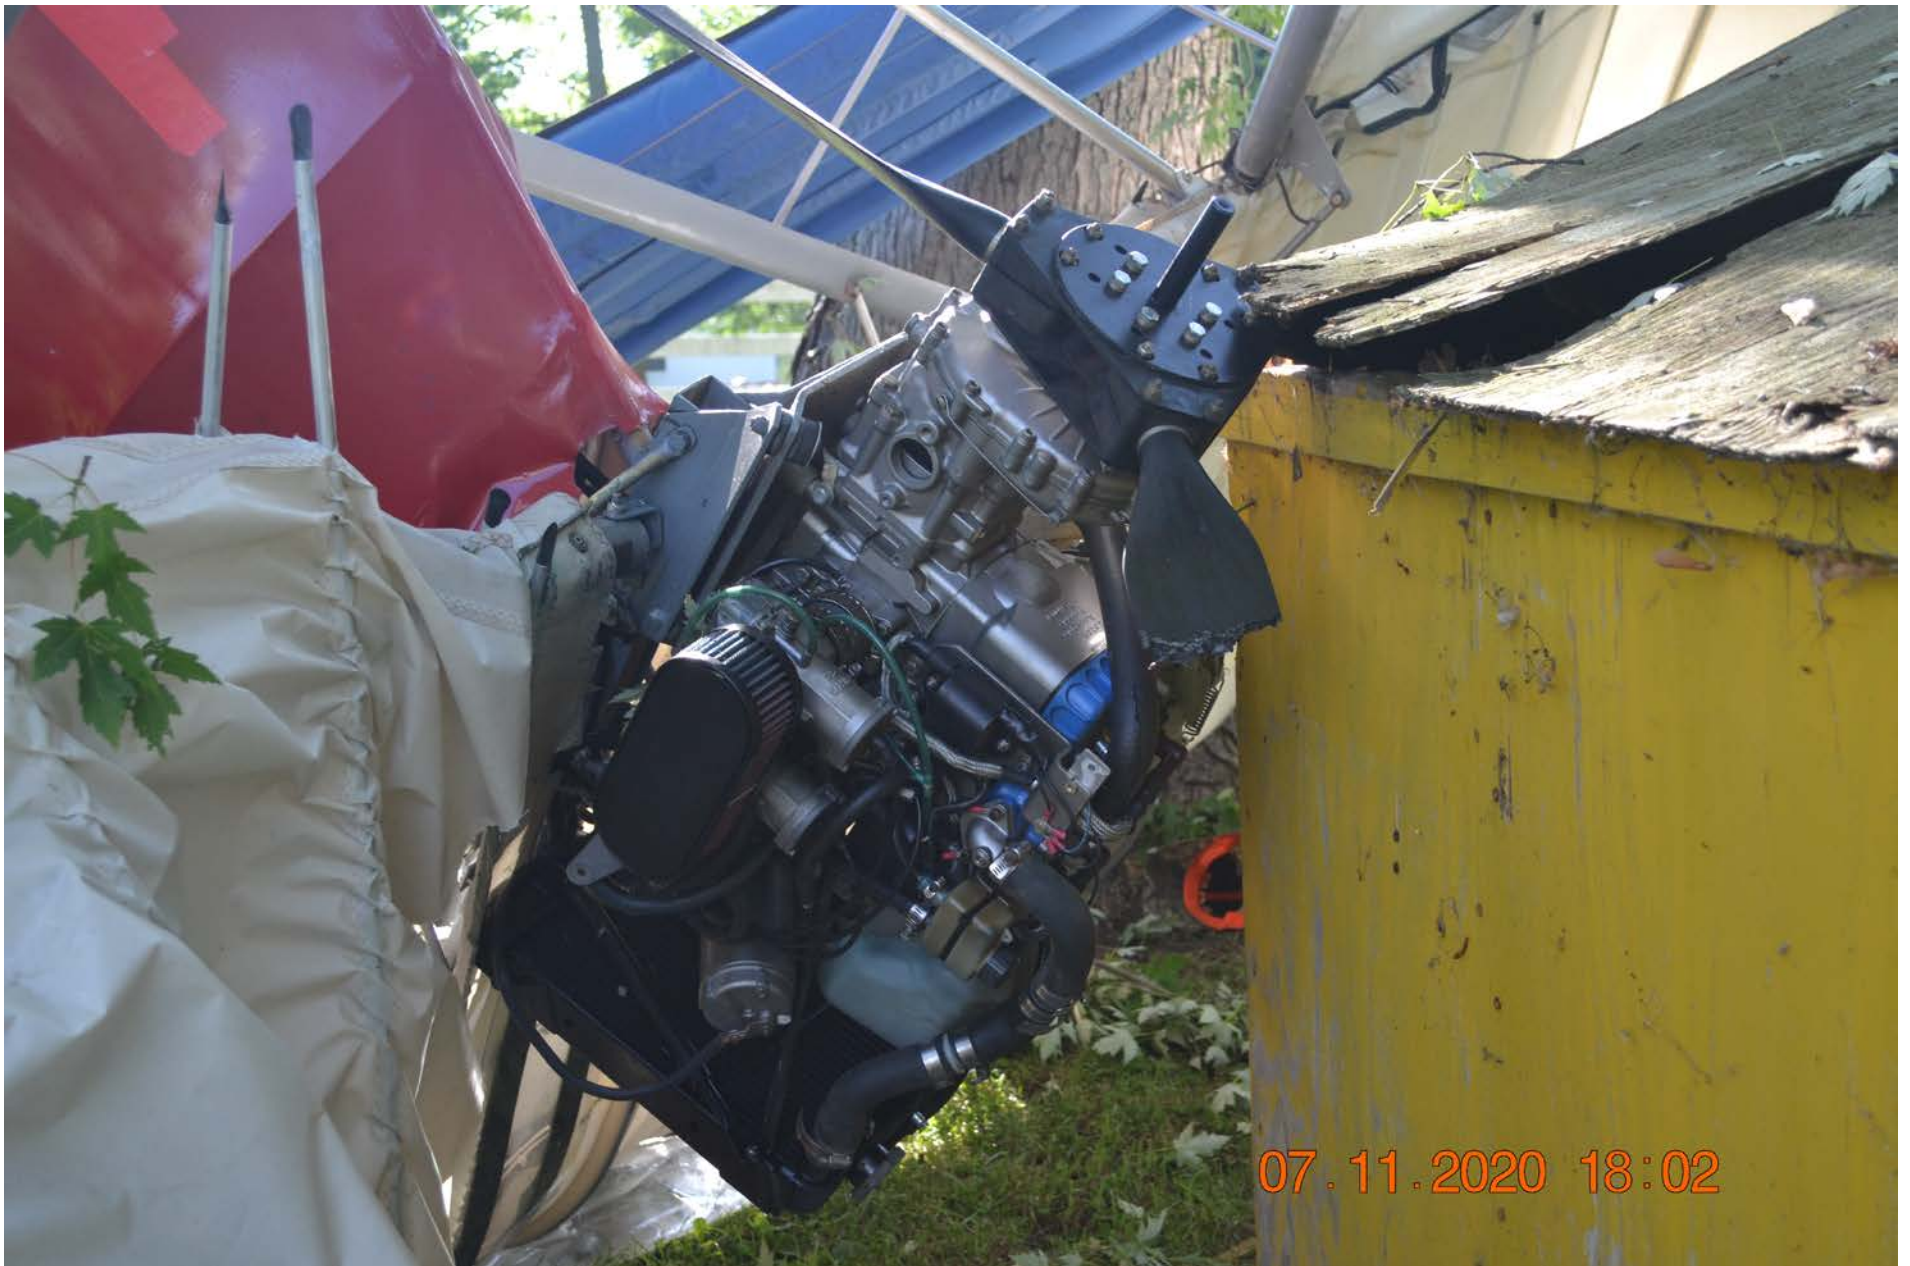
**Photo 12 – The Rotax engine. Note severed propeller blade (FAA photo)**
