# Engine Investigation

Allison  
M250-C20F

Engine #1 CAE 840098  
Engine #2 CAE 840350

Airbus (Aerospatiale) AS355F1  
Registration: N708AC

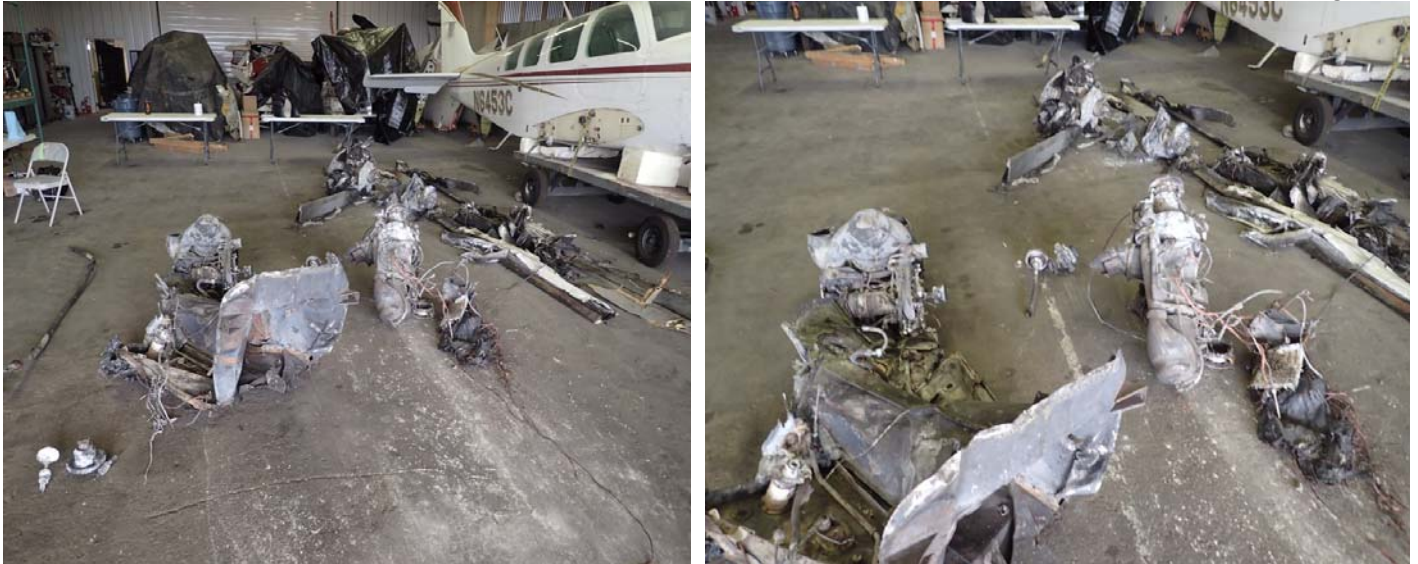
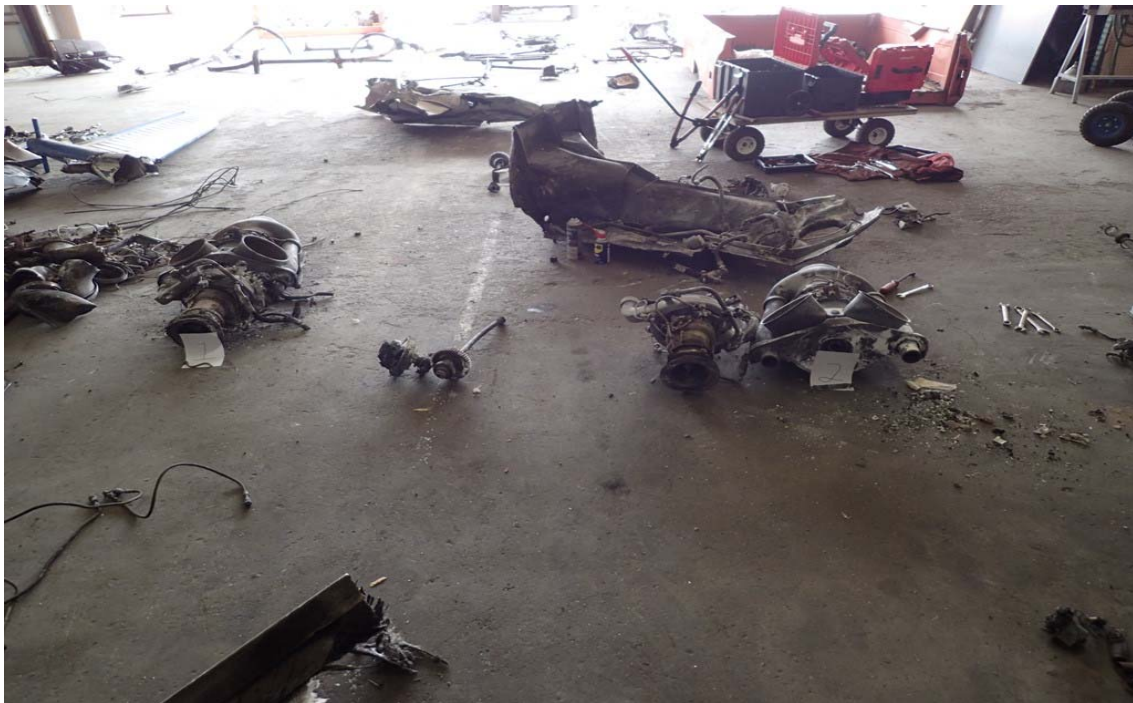
Fig 1

Both engines were initially positioned on a trailer along with the balance of the wreckage with both exhibiting heavy post-crash fire damage and both being entangled in melted wire and sheet metal. Both engines were stripped of airframe material for further examination. The accessory gear boxes from both engines had been consumed in the post-crash fire. The compressor of the #1 engine remained attached by the left side compressor air discharge tube and the spur adapter gear shaft. The compressor from the #2 engine was separate from the engine. The balance of both engines from the exhaust collector supports aft remained in their relative positions. (Fig 1)

Engines as Removed From Wreckage

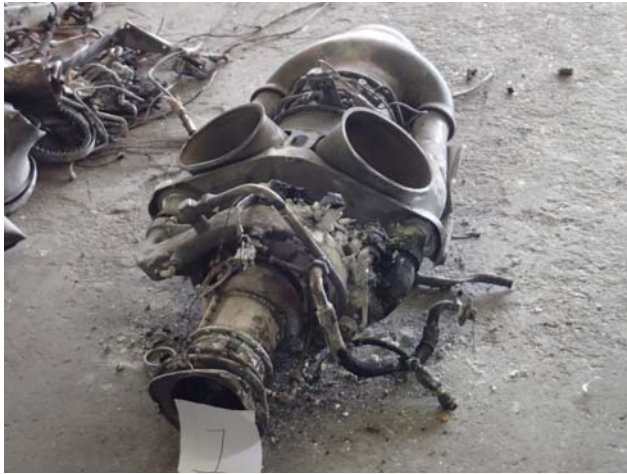
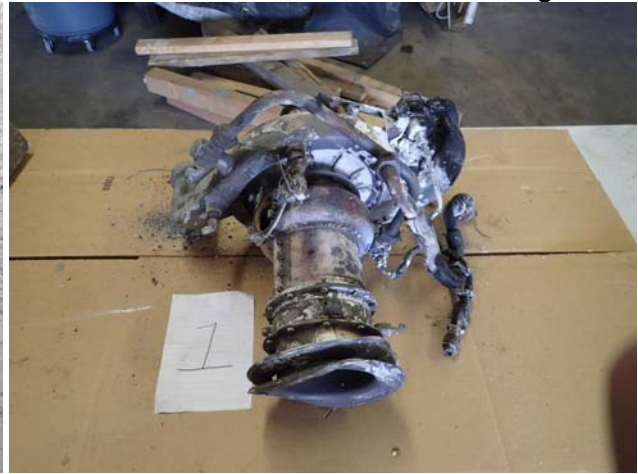
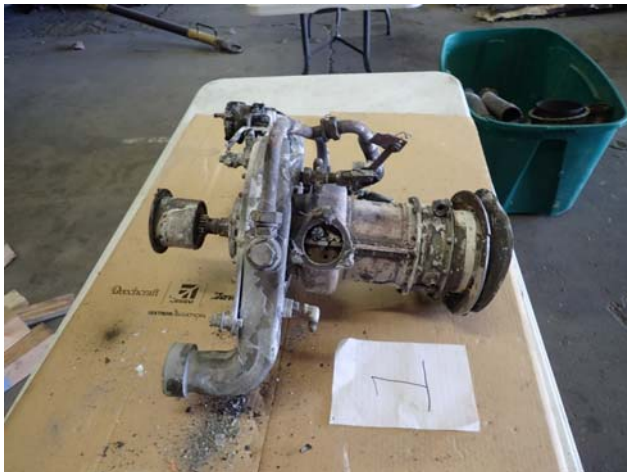
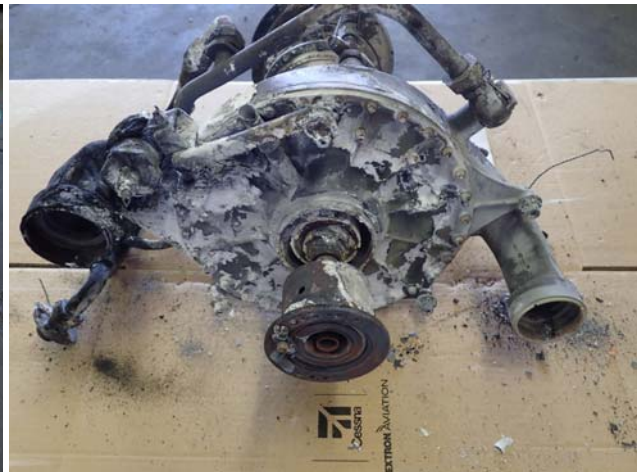
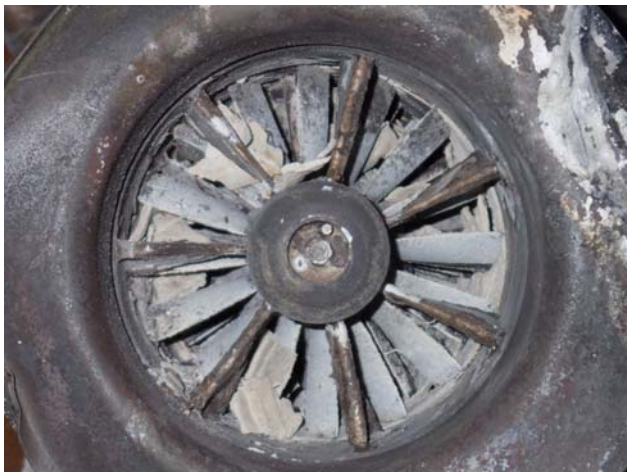
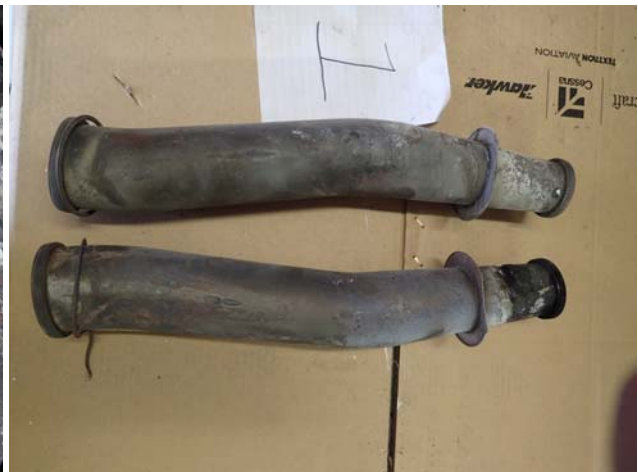
Fig 2

The compressor remained generally in its normal position and connected to the aft portion of the engine by the left side compressor air discharge tube and the spur adapter gear shaft and exhibited overall discoloration from fire exposure. The compressor inlet and guide vanes displayed no evidence of impact damage. The stage one and stage two compressor blades and vanes exhibited no evidence of impact or FOD type damage. The case halves displayed no external damage however the abradable material inside the case halves had burned away resultant of post-crash fire. The compressor bleed valve had been consumed by post-crash fire.

The compressor scroll was generally normal in appearance and other than post-crash fire exposure was visually normal. Both left and right compressor air discharge tubes exhibited no impact damage and other than fire exposure were visually normal. (Fig 2)

Compressor at Removal

Compressor Inlet

Compressor Air Discharge Tubes

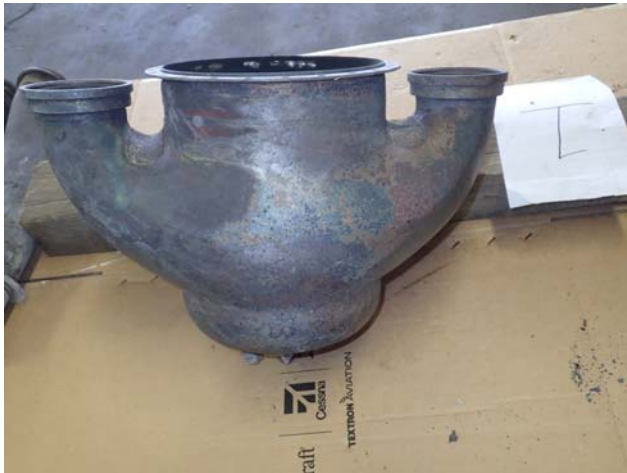
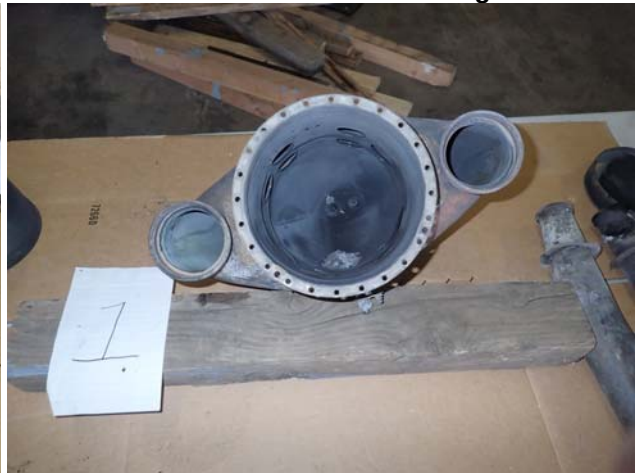
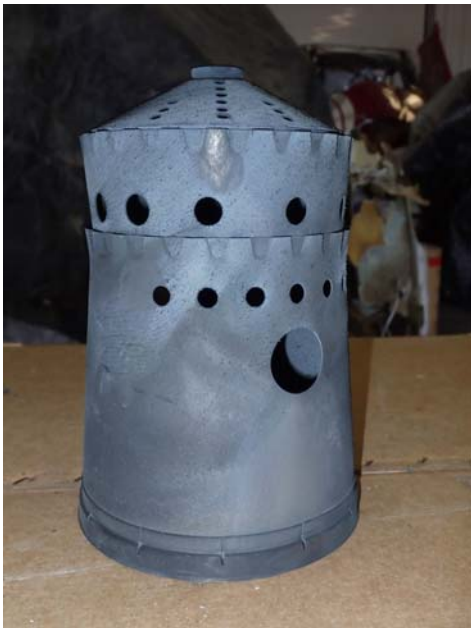
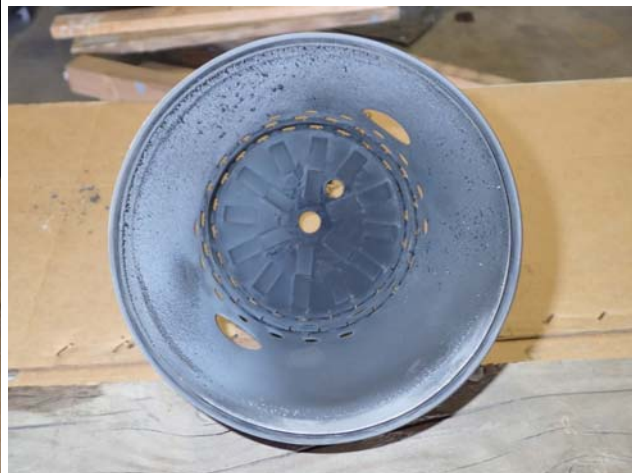
Fig 3

The outer combustion case remained in position and other than discoloration from fire exposure was visually normal. Examination of both the left and right arm pit areas as well as the basket area revealed dirt and debris in all three areas. Removal of the outer combustion case revealed the combustor liner in proper position and undamaged. Removal and examination of the combustor liner revealed it to be visually normal with no evidence of streaking or unusual burn patterns. (Fig 3)

Outer Combustion Case

Combustor Liner

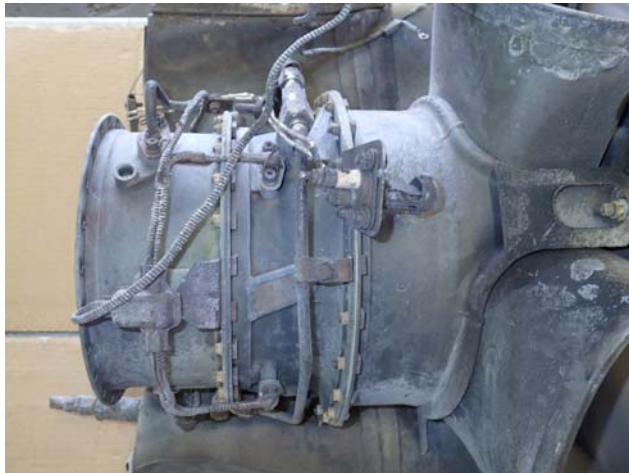
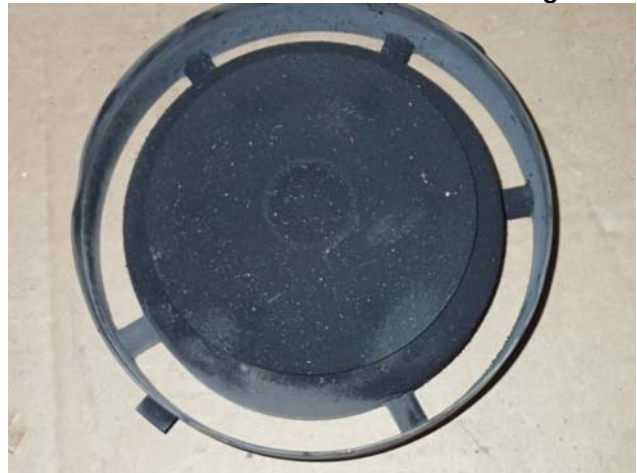
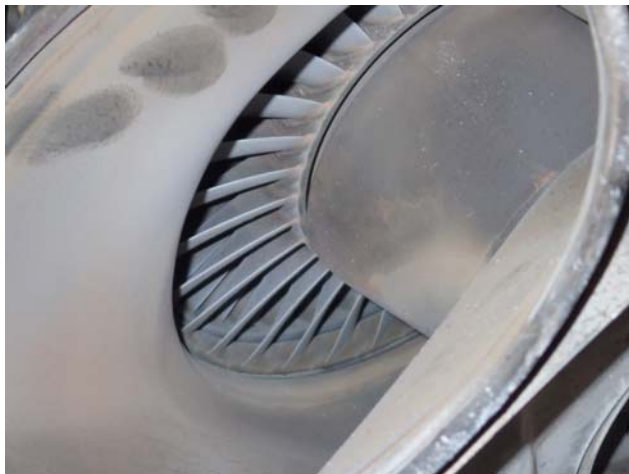
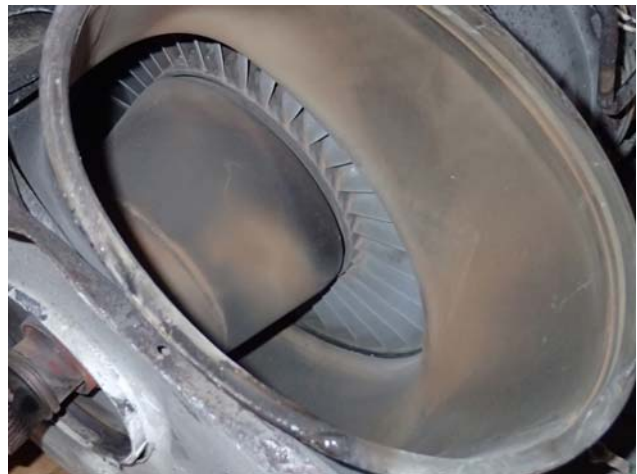
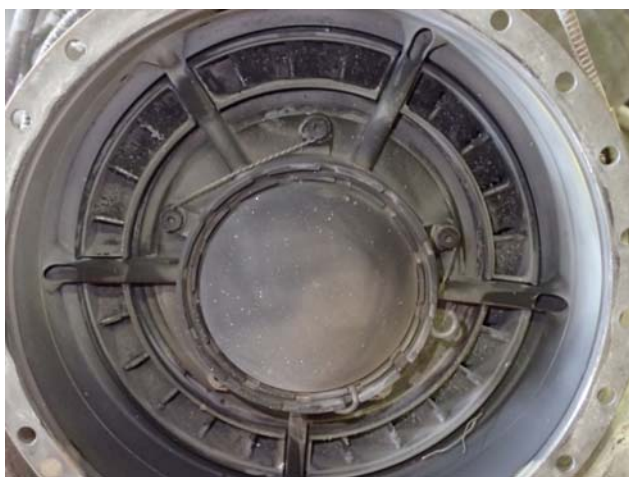
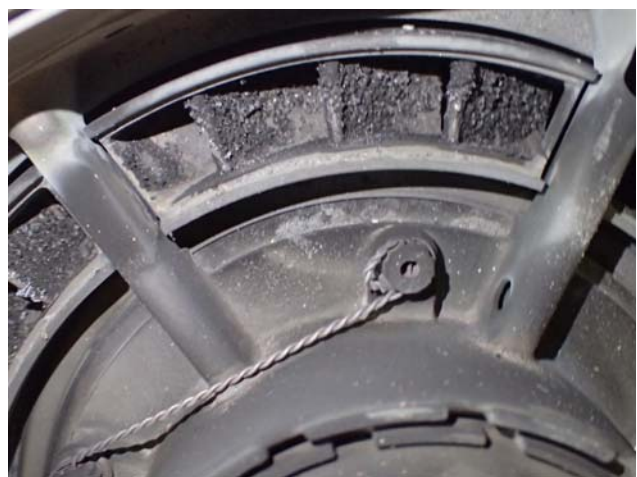
Fig 4

The turbine module remained properly mated to the exhaust collector support and other than discoloration from fire exposure was visually normal. Visual examination of the stage four turbine wheel and stage four turbine nozzle through the exhaust collector support revealed both to be visually normal with no evidence of vane or blade damage.

The stage one nozzle shield was in position and other than a soot coating and dirt adhesion was otherwise normal. The stage one nozzle and stage one turbine wheel were both visually normal with no evidence of blade or vane damage. Dirt ingestion throughout the gas path was noted on the first stage nozzle vanes and first stage wheel blades as well as on the fourth stage nozzle and wheel surfaces. (Fig 4)

Turbine Module

Stage 1 Nozzle Shield

Stage Four Turbine Wheel

Stage One Nozzle

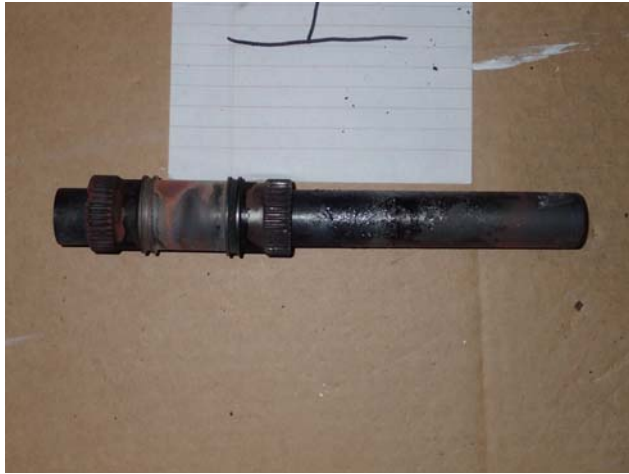
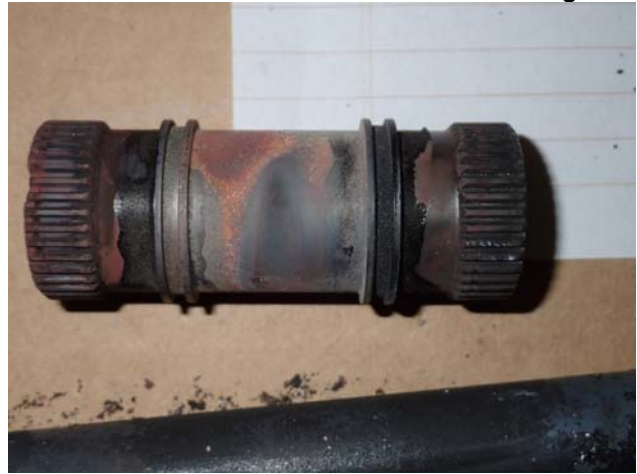
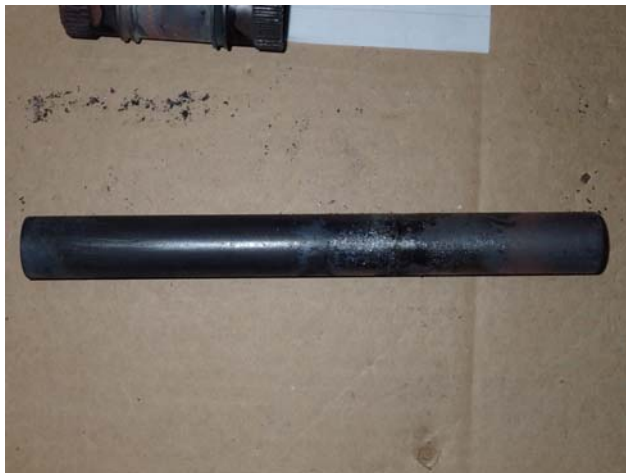
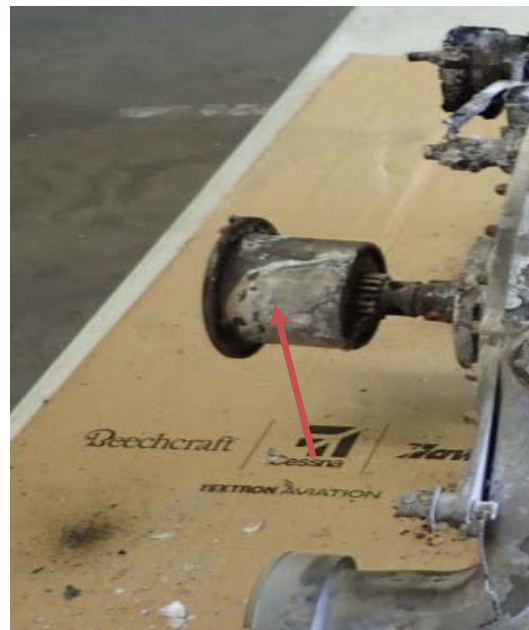
Fig 5

The power turbine to pinion gear coupling and the turbine to compressor coupling remained properly seated inside the turbine module. Other than discoloration from fire exposure and the melting away of the Teflon rings, the power turbine to pinion gear coupling was otherwise normal. The turbine to compressor coupling was visually normal with the exception of discoloration from fire exposure and the internal splines exhibited no evidence of damage. The spur adapter gear shaft remained properly seated within the compressor on the forward end. The aft end was stuck inside the #3/4 bearing housing and could not be removed however the spur adapter gear exhibited no visible damage nor did visible portions of the fore and aft end splines. (Fig 5)

Power Turbine to Pinion Gear Coupling  
with Turbine to Compressor Coupling

Power Turbine to Pinion Gear Coupling

Turbine to Compressor Coupling

Spur Adapter Gear Shaft

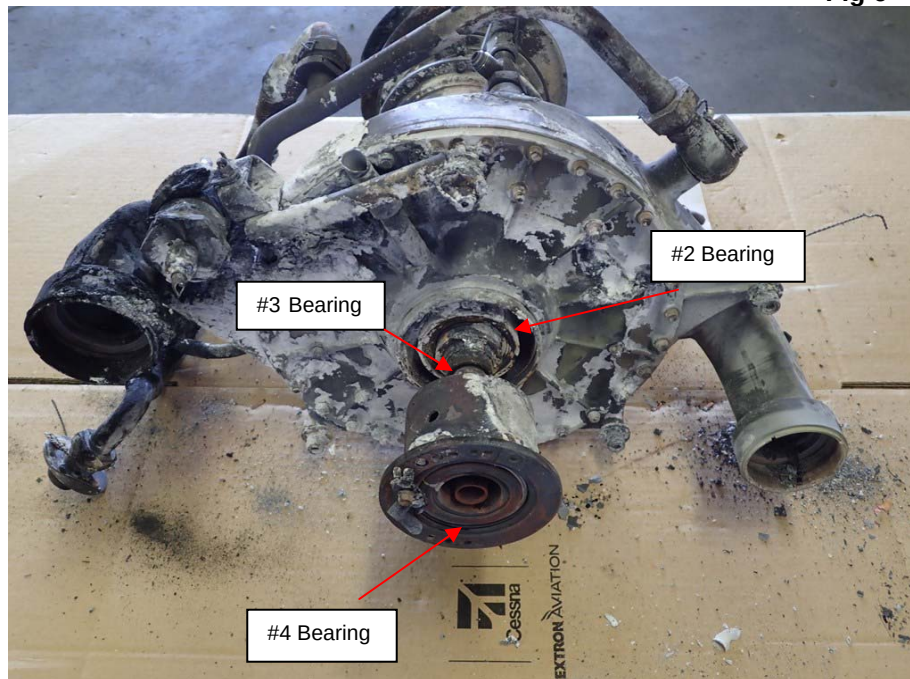
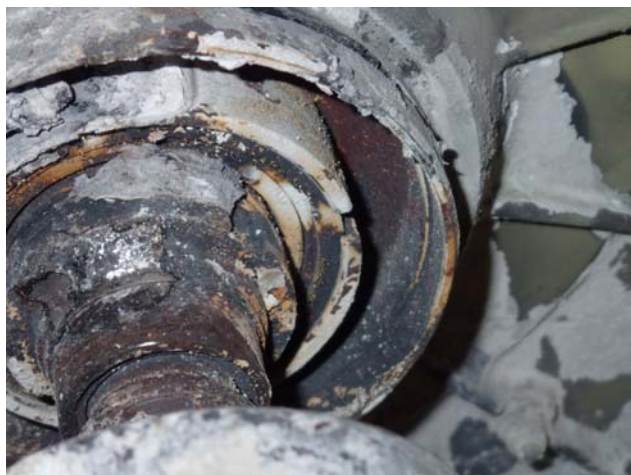
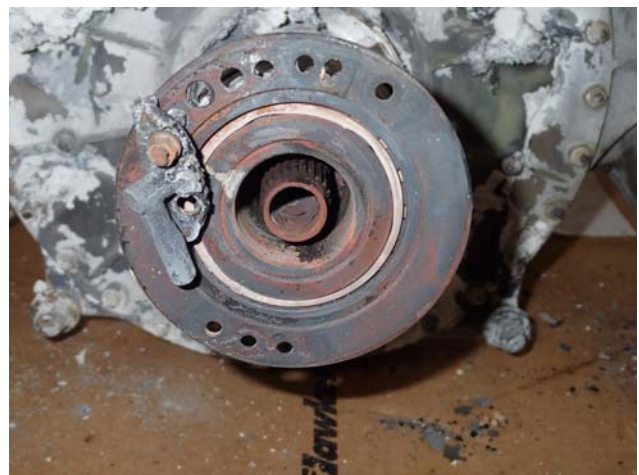
Fig 6

The #2, 3, 4 bearings were visually examined. All three exhibited heavy post-crash fire damage and as such were non rotatable however all balls and rollers displayed no other damage or evidence of spalling. (Fig 6)

# 3/4 Bearing Housing - #2 Bearing

#2 Bearing

#4 Bearing

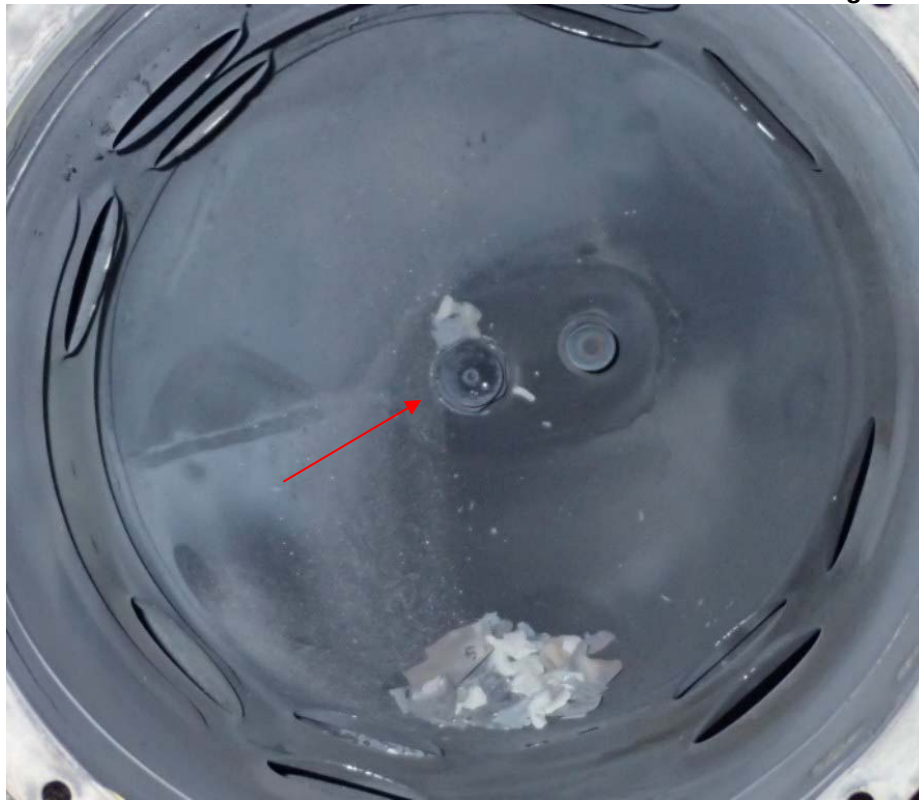
Fig 7

The fuel pump was either not recovered or consumed by the post-crash fire. The fuel nozzle remained in position and was normal in appearance with no excessive carbon on the outer air shroud. Engine fuel lines were heavily impact damaged or exhibited heavy burn damage. (Fig 7)

Fuel Nozzle in Position

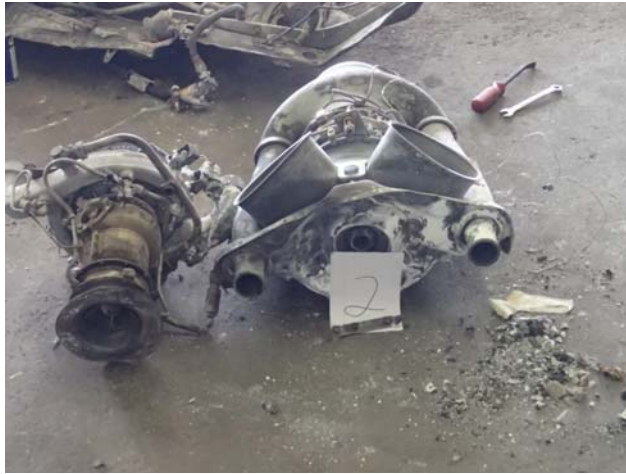
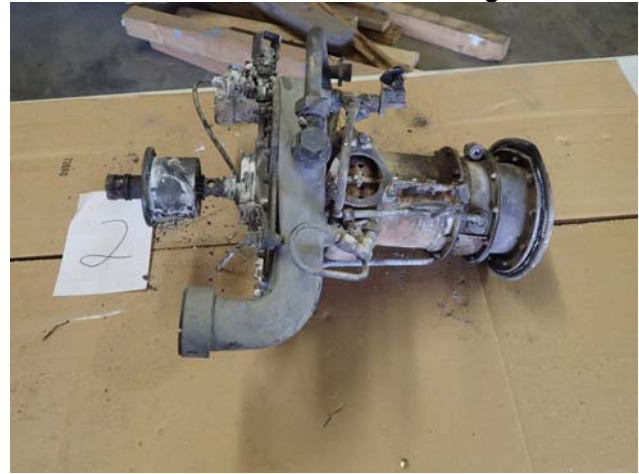
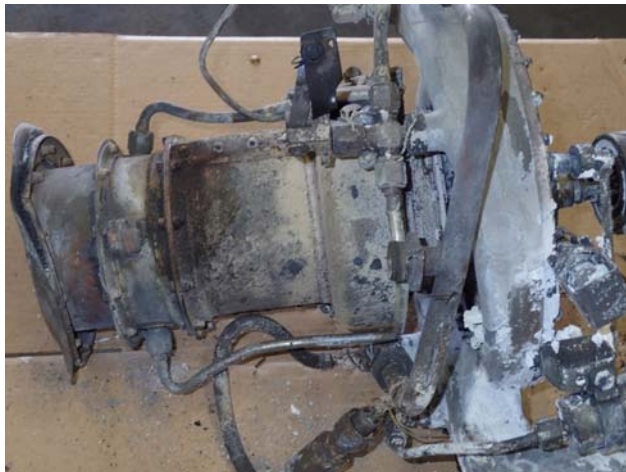
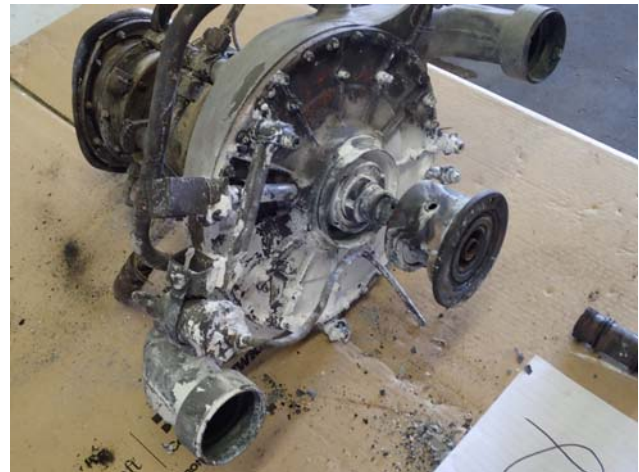
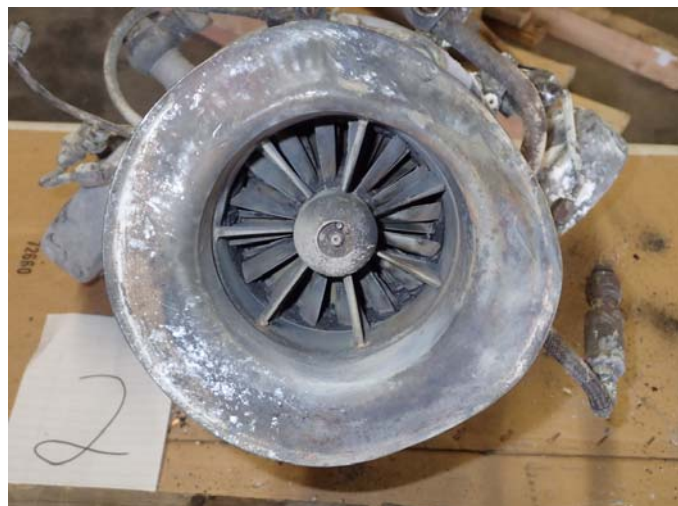
Fig 8

The compressor was separate from the aft portion of the engine and exhibited overall discoloration from fire exposure. The compressor inlet and guide vanes exhibited no evidence of impact damage. The stage one and stage two compressor blades and vanes exhibited no evidence of impact or FOD type damage. The case halves displayed no external damage however the abradable material inside the case halves had burned away resultant of post-crash fire. The compressor bleed valve had been consumed by post-crash fire. The compressor scroll was generally normal in appearance and other than post-crash fire exposure was visually normal. Both left and right compressor air discharge tubes exhibited no impact damage and other than fire exposure were visually normal. (Fig 8)

Compressor as Recovered

Compressor Inlet  
(Return)

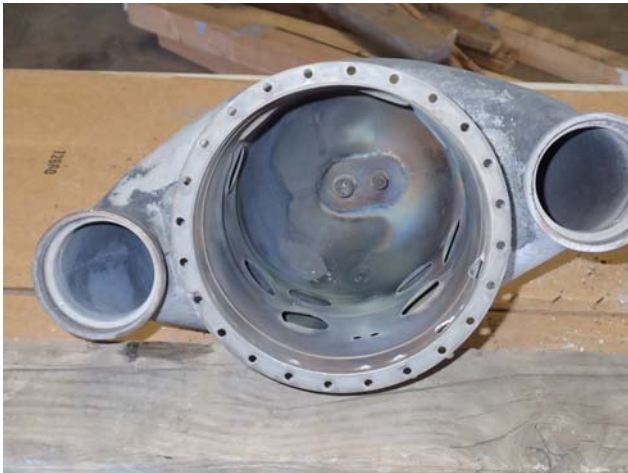
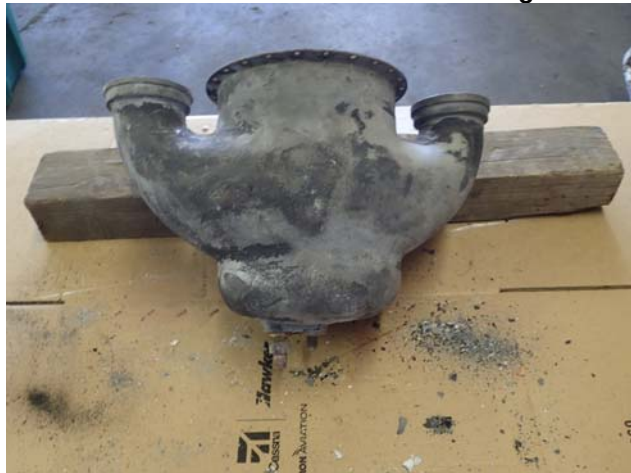
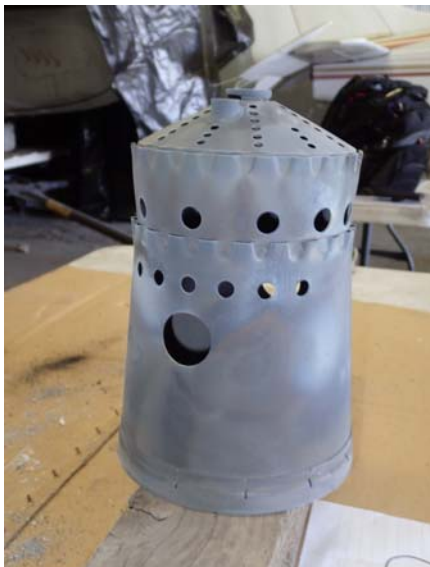
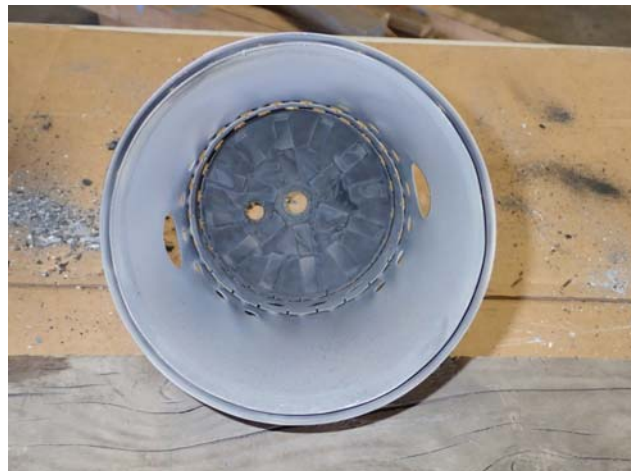
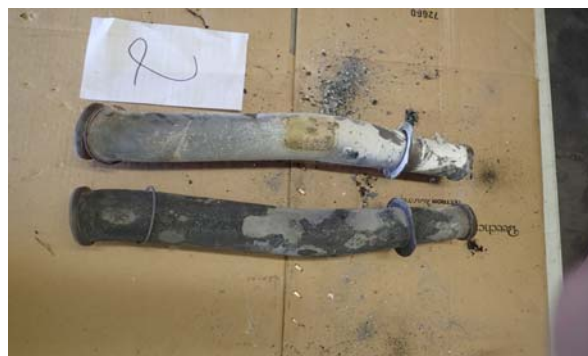
Fig 9

The outer combustion case remained in position and other than discoloration from fire exposure was visually normal. Examination of both the left and right arm pit areas as well as the basket area revealed dirt and debris in all three areas. Removal of the outer combustion case revealed the combustor liner in proper position and undamaged. Removal and examination of the combustor liner revealed it to be visually normal with no evidence of streaking or unusual burn patterns. (Fig 9)

Outer Combustion Case

Combustor Liner

Compressor Air Discharge Tubes

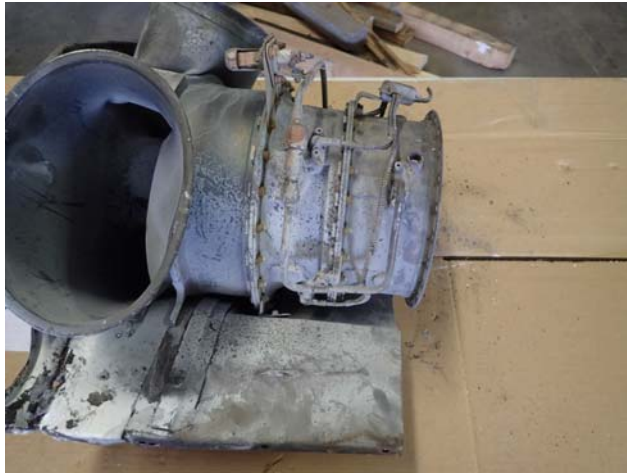
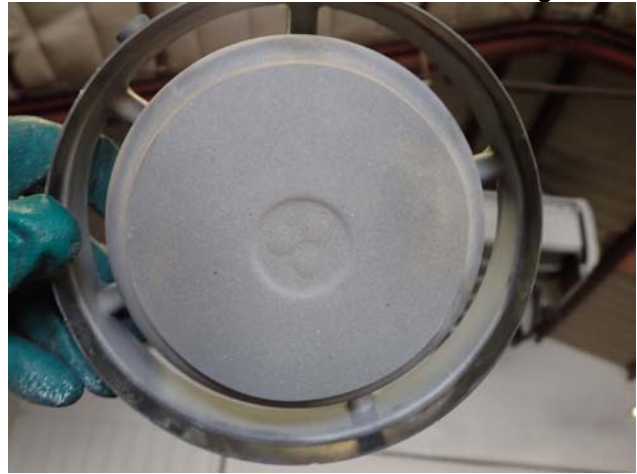
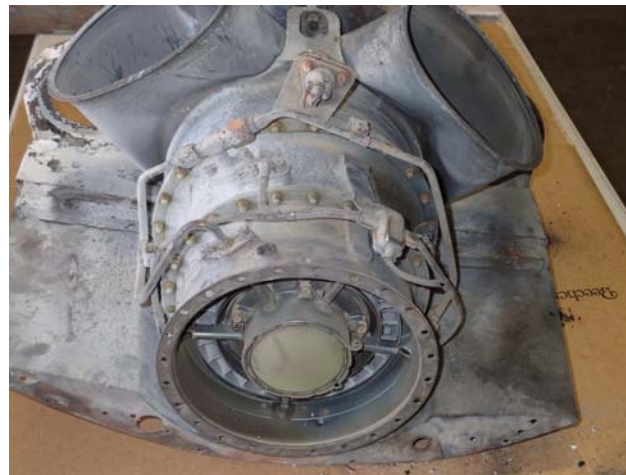
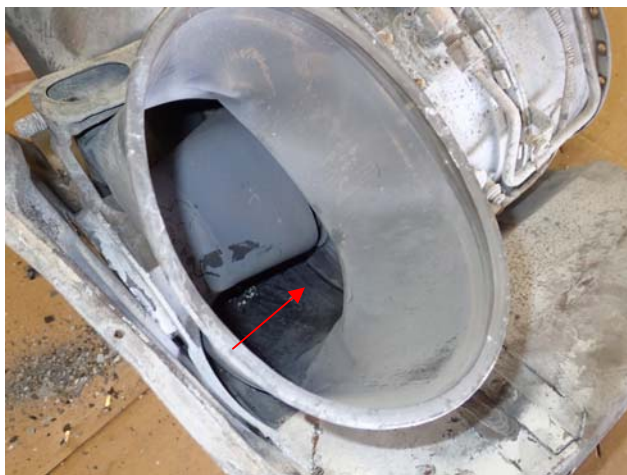
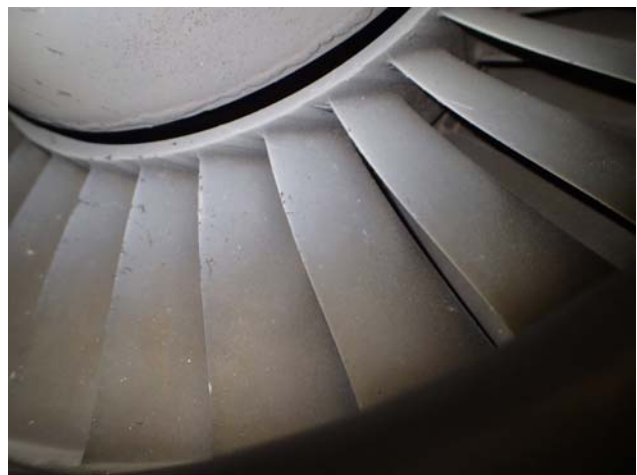
Fig 10

The turbine module remained properly mated to the exhaust collector support and other than discoloration from fire exposure was visually normal. Visual examination of the stage four turbine wheel and stage four turbine nozzle through the exhaust collector support revealed both to be visually normal with no evidence of vane or blade damage.

The stage one nozzle shield was in position and other than dirt adhesion was otherwise normal. The stage one nozzle and stage one turbine wheel were both visually normal with no evidence of blade or vane damage. Dirt ingestion throughout the gas path was noted on the first stage nozzle vanes and first stage wheel blades as well as on the fourth stage nozzle and wheel surfaces. (Fig 10)

Turbine Module

#1 Nozzle Shield

Stage Four Turbine Wheel

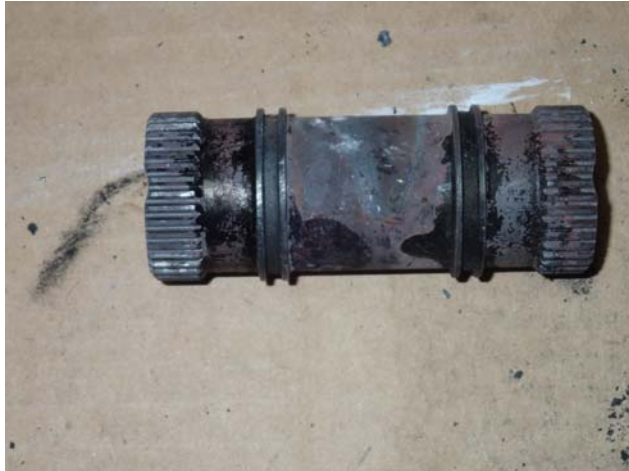
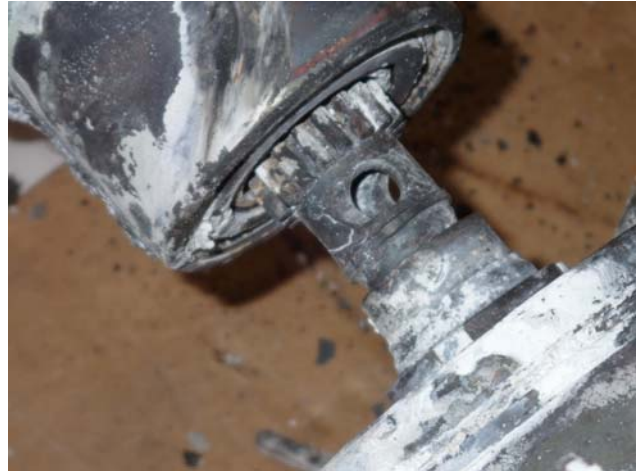
The power turbine to pinion gear coupling was found separate from the balance of the engine. Other than discoloration from fire exposure and the melting away of the Teflon rings, the power turbine to pinion gear coupling was otherwise normal.

The turbine to compressor coupling was not recovered. The spur adapter gear shaft remained properly seated within the compressor on the forward end. The aft end was stuck inside the #3/4 bearing housing and could not be removed however the spur adapter gear exhibited no visible damage nor did visible portions of the fore and aft end splines. (Fig 11)

Power Turbine to Pinion Gear Coupling

Spur Adapter Gear Shaft

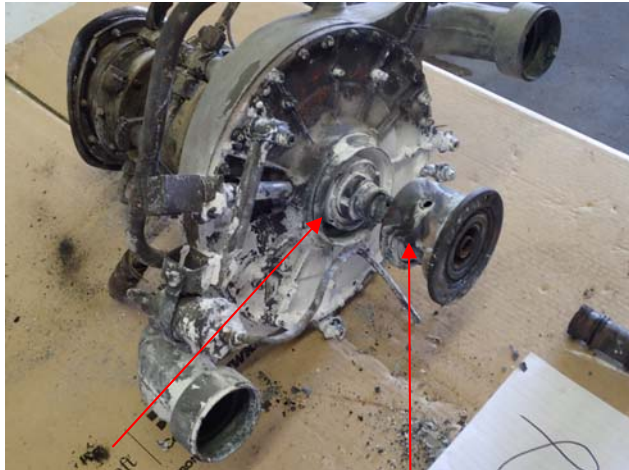
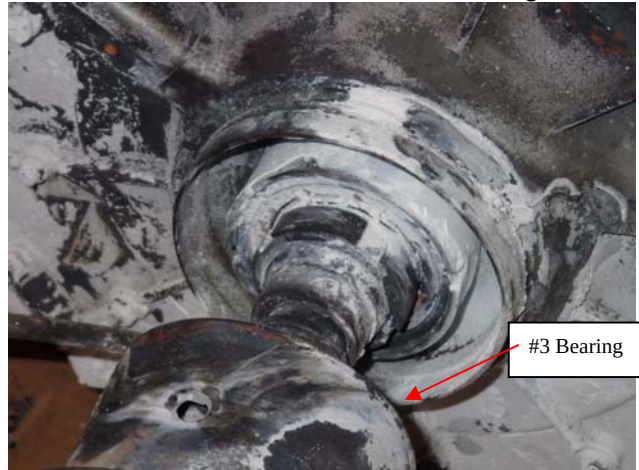
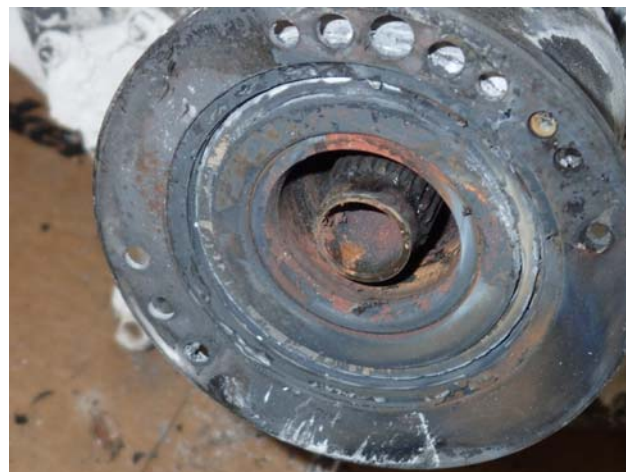
No examination of the oil system could be conducted as the oil pump normally housed in the accessory gear box was consumed by post-crash fire and the majority of oil lines were either consumed by fire or heavily damaged. The #2, 3, 4 bearings were visually examined. All three exhibited heavy post-crash fire damage and as such were non rotatable however all balls and rollers displayed no other damage or evidence of spalling. (Fig 12)

#2 Bearing - #3-4 Bearing Housing

#2 Bearing

#4 Bearing

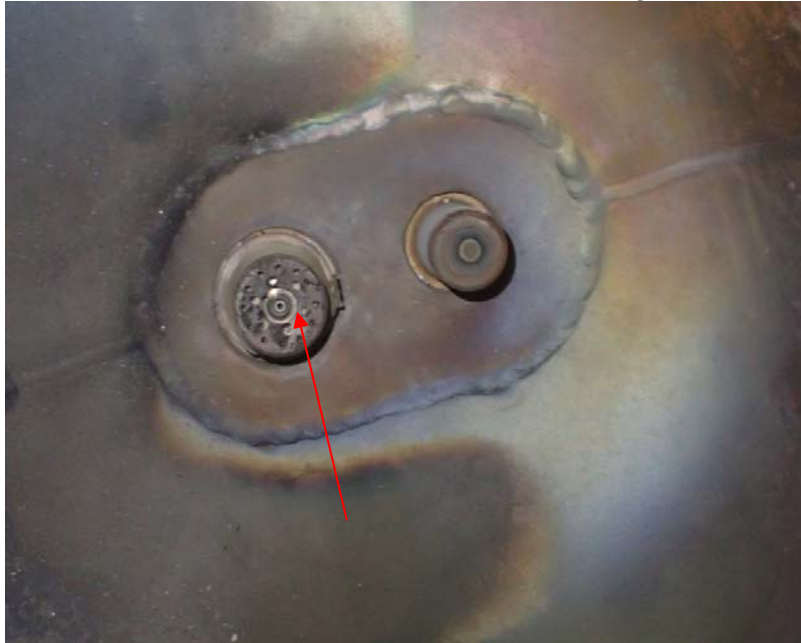
Fig 13

The fuel pump was either not recovered or consumed by the post-crash fire. The fuel nozzle remained in position and was normal in appearance with no excessive carbon on the outer air shroud. Engine fuel lines were heavily impact damaged or exhibited heavy burn damage. (Fig 13)

Fuel Nozzle

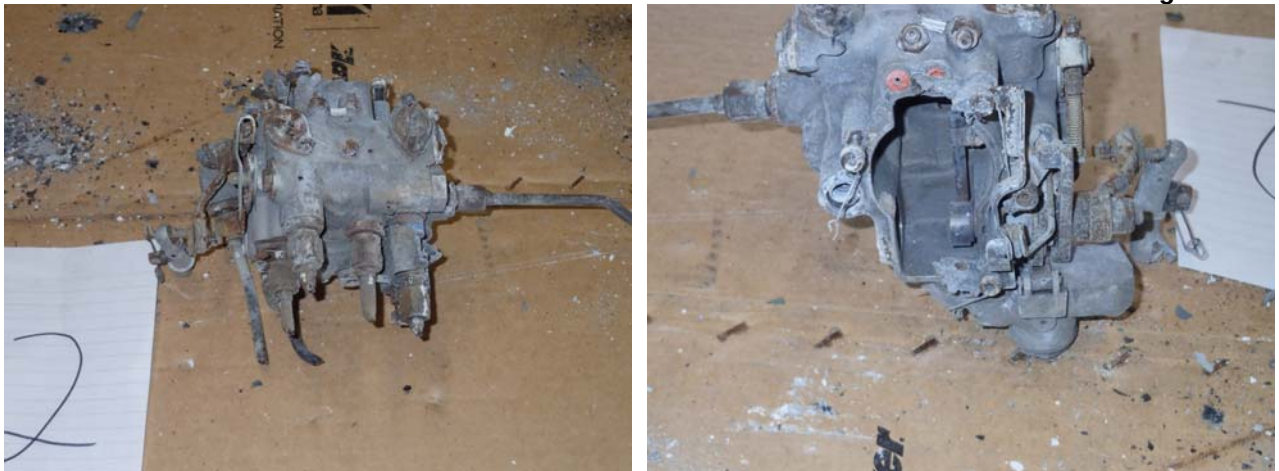
Fig 14

The fuel control unit was recovered in the wreckage and had sustained heavy post-crash fire damage with approximately 25% of the body having burned away allowing for internal fire damage. The power turbine governor was either not recovered or consumed by post-crash fire. (Fig 14)

Fuel Control Unit
