## The National Transportation Safety Board

Office of Aviation Safety  
Central Region  
Memorandum for the Record  
Wreckage Examination  
Findings  
CEN20LA276  
Keokuk, Iowa  
July 12, 2020

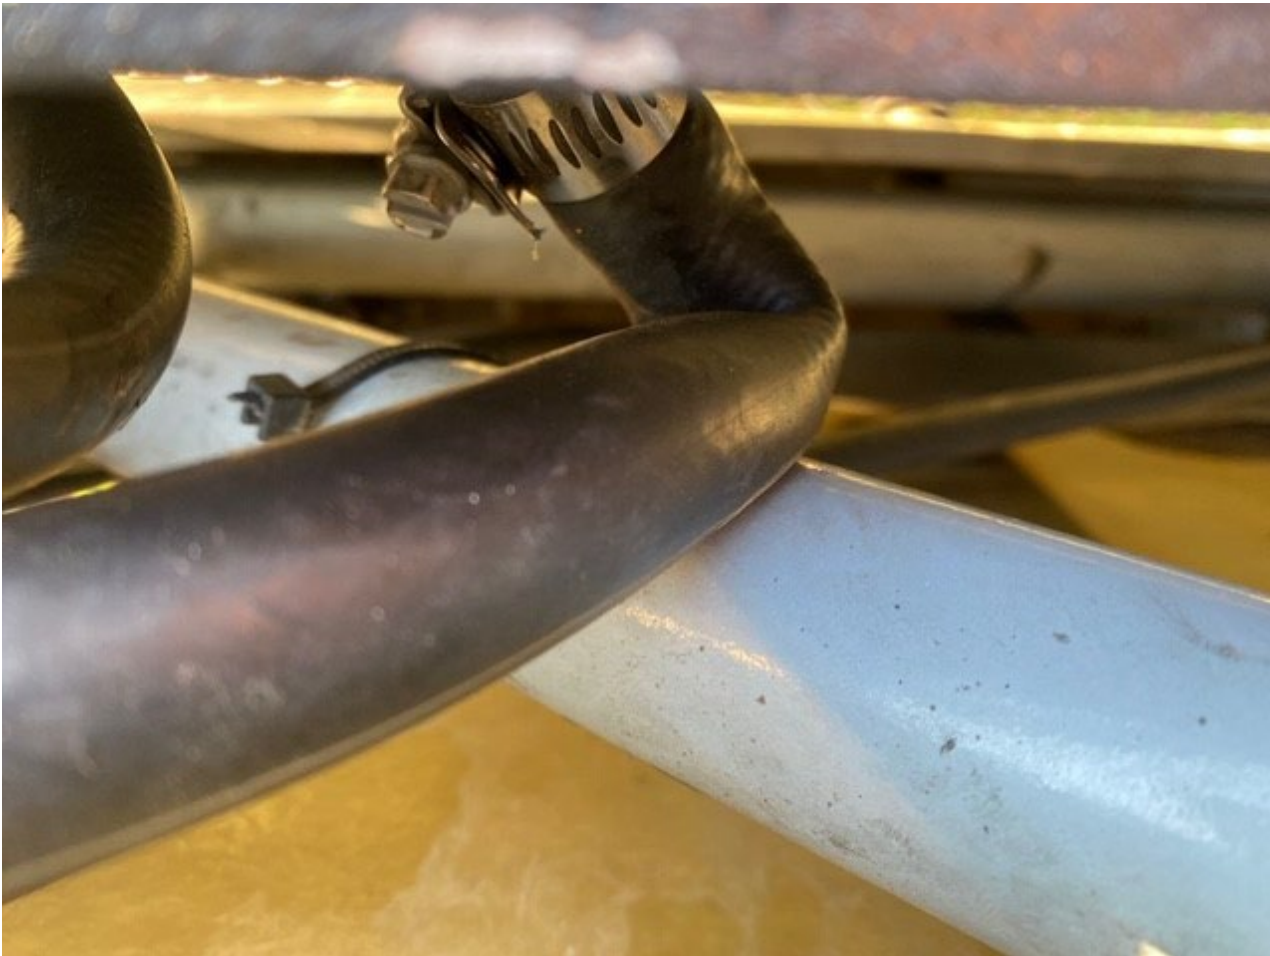
Examination of the wreckage revealed that a rubber fuel vent line in the right wing was found pushed over a structural beam, causing the vent line to be kinked and restricting air from entering the fuel tank.

The kinked fuel vent line was not impact damage related. The vent line was installed incorrectly during maintenance prior to the ferry flight. The FAA confirmed with the maintenance facility that the wings had been removed and reinstalled just prior to the accident flight.

Kinked Fuel Vent Line
