**NATIONAL TRANSPORTATION SAFETY BOARD  
Office of Aviation Safety  
Washington, DC 20594**

**SUMMARY OF AIRFRAME AND ENGINE EXAMINATION**

**CEN20LA278**

Aircraft: [Schweizer Grumman G-164B (S/N 522B) N6917K]

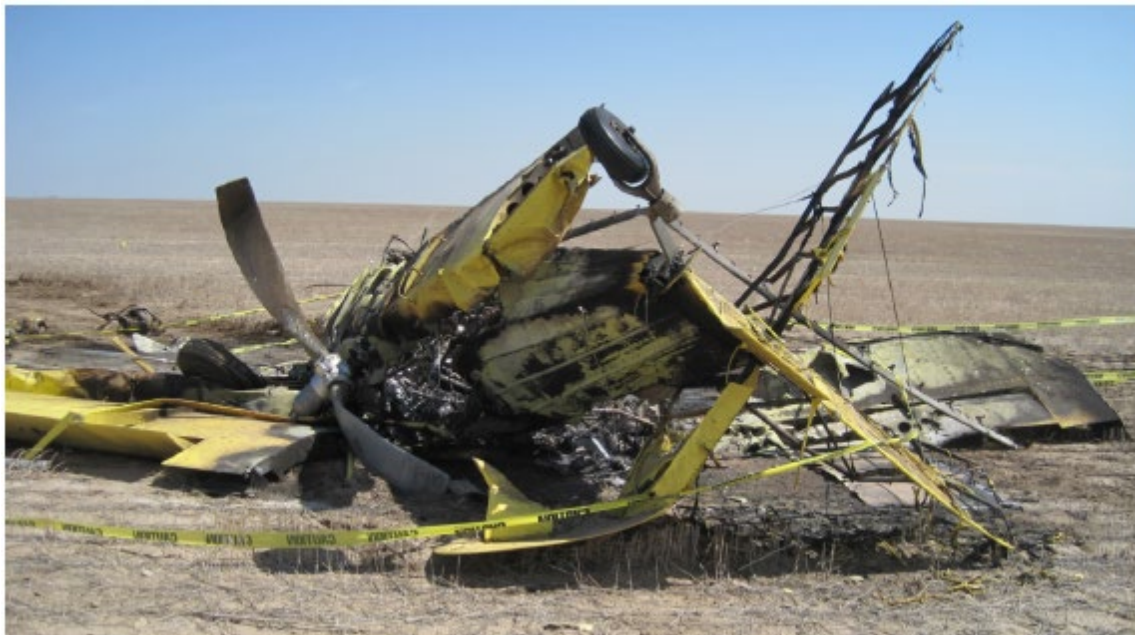
A witness reported observing white smoking coming from the cockpit prior to impact, however the smoke was "granular in nature" and "looked solid." After the accident, the pilot reported to his wife, that while in flight, excessive foam coated the airplane's windshield, and he was unable to see outside of the airplane. The airplane impacted a remote flat field while traveling to the southeast and a postimpact fire ensued. The airplane came to rest about 0.65 miles southeast of the departure end of runway 17 at 8V7. The airplane sustained fire damage and was fragmented from impacting terrain as shown in Figure 1. A Federal Aviation Administration (FAA) aviation safety inspector documented the accident site. The wreckage was recovered and transported to a secure location.

Figure 1 - View of the wreckage in the field (courtesy of the FAA).

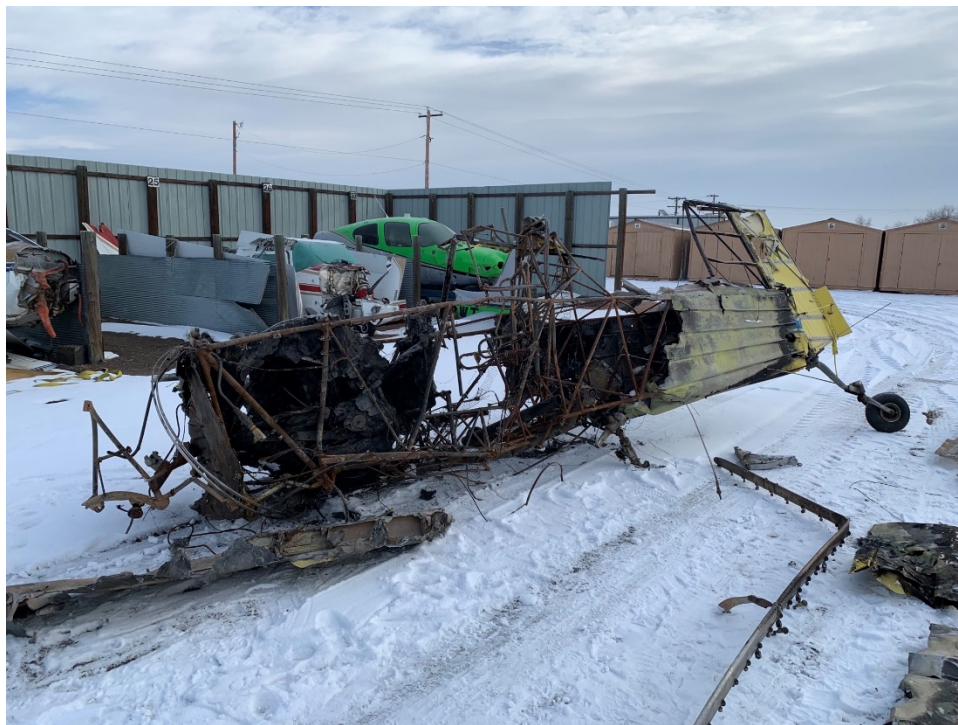
Figure 1, Fuselage

The airplane was laid out in the salvage yard at Beegles' Aircraft. The top and bottom left and right wings and were separated from the fuselage along with the engine, propeller, horizontal stabilizers and elevators. The fuselage consisted of the charred and melted remains of the hopper, cockpit, aft fuselage, vertical stabilizer, rudder and tail wheel.

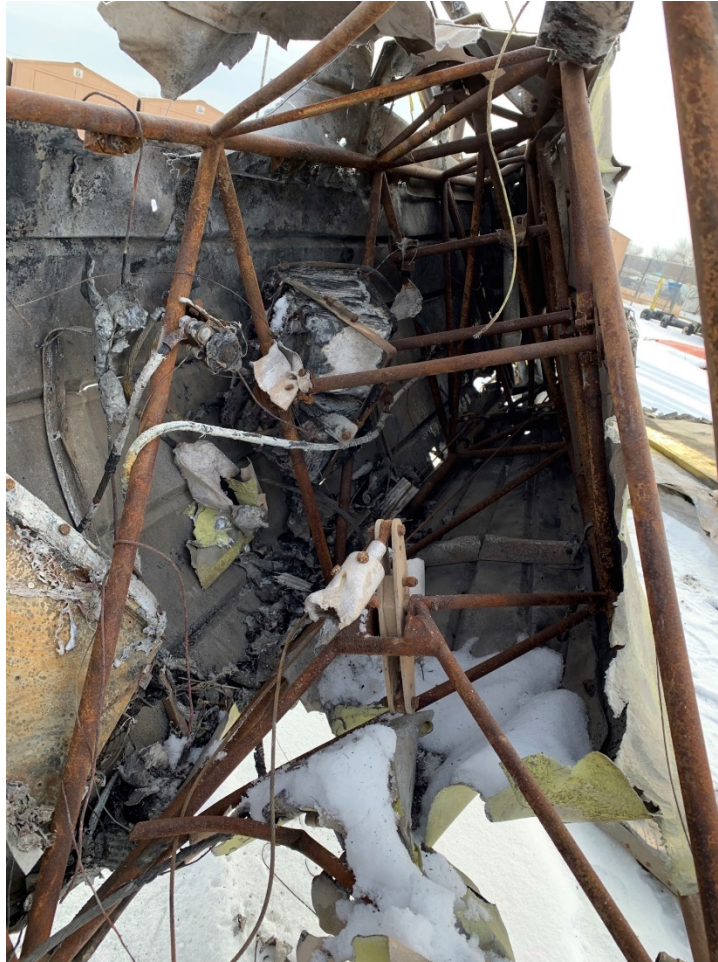
Figure 2, Aft Fuselage and Tail Cone, Elevator Horn and Rudder Cables

The fuselage, including the hopper, cockpit, aft fuselage, vertical stabilizer and rudder, and tailwheel were charred melted and consumed. An examination of the push pull tube to the elevator showed several sections where the tube was fractured, melted and consumed. The portion of the tube connected to the elevator horn was manipulated and moved the elevator actuators in the tail cone. Control cables to the rudder were identified and traced to the remains

of the rudder pedals in the cockpit area. When the cables were manipulated the rudder and tailwheel moved freely.

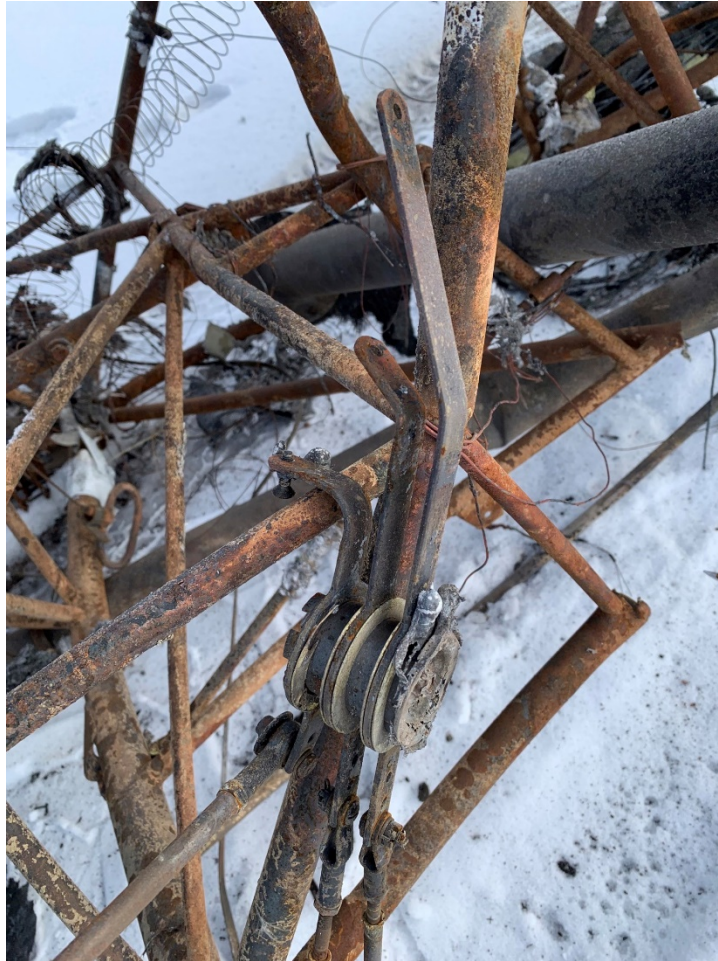
Figure 3, Throttle, Propeller and Mixture Levers

The rudder pedals and control stick were consumed; however the aileron horns at the base of the control stick and the rudder pedal connectors at the ends of the rudder cables were identified. The throttle, propeller, and mixture levers were located and found charred and melted. Control rods from the quadrant to where the engine mounts fractured were intact. The rods were separated near the front of the hopper.

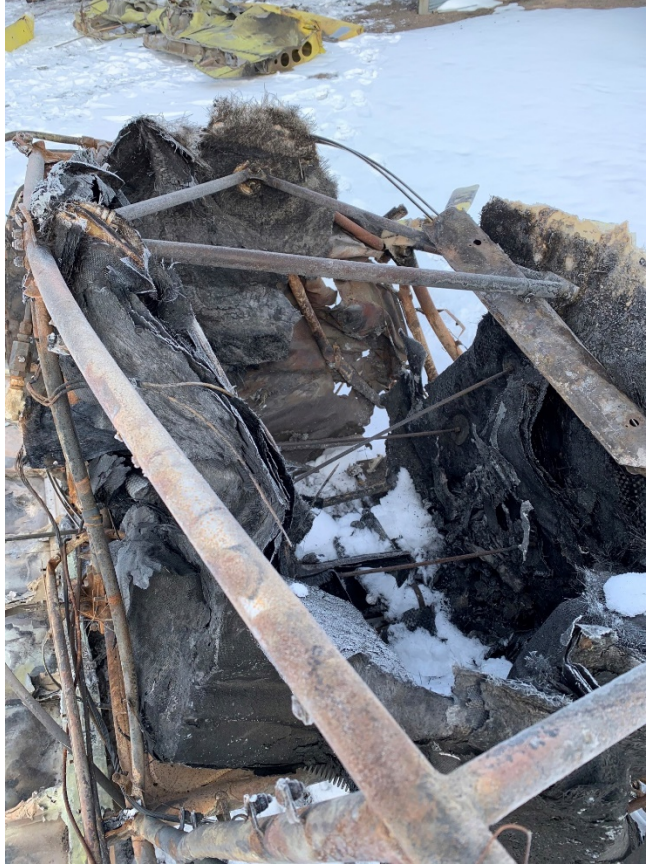
Figure 4, Hopper

The hopper was charred and consumed. The top of the hopper and hopper door was separated. Examination of the hopper door showed the door closed. The door was bent and broken and the seal around the door was charred and consumed. Vent tubes and lines to the spray applicator tubes were traced from the hopper to an area beneath the airplane fuselage.

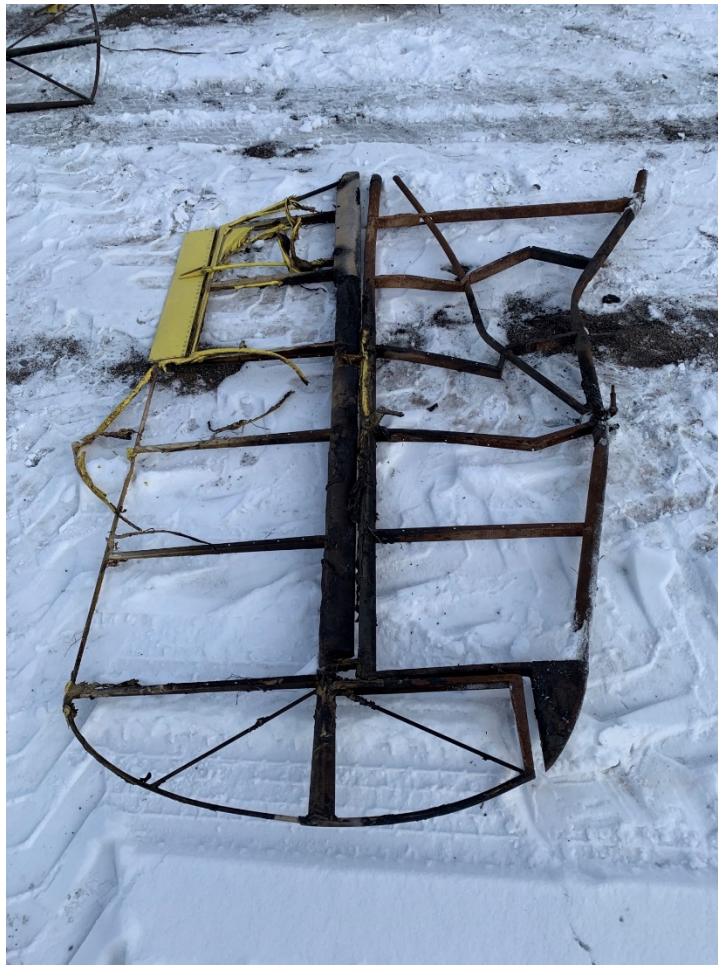
Figure 6, Left Horizontal Stabilizer and Elevator

The remains of the left horizontal stabilizer was examined. The fabric had been melted and consumed. The remaining frame was charred. The elevator remained connected. It was also charred and the fabric had been consumed. The elevator and elevator tube moved freely. The elevator trim tab was intact and at the neutral position in relation to the elevator. The actuator arm was broken and melted.

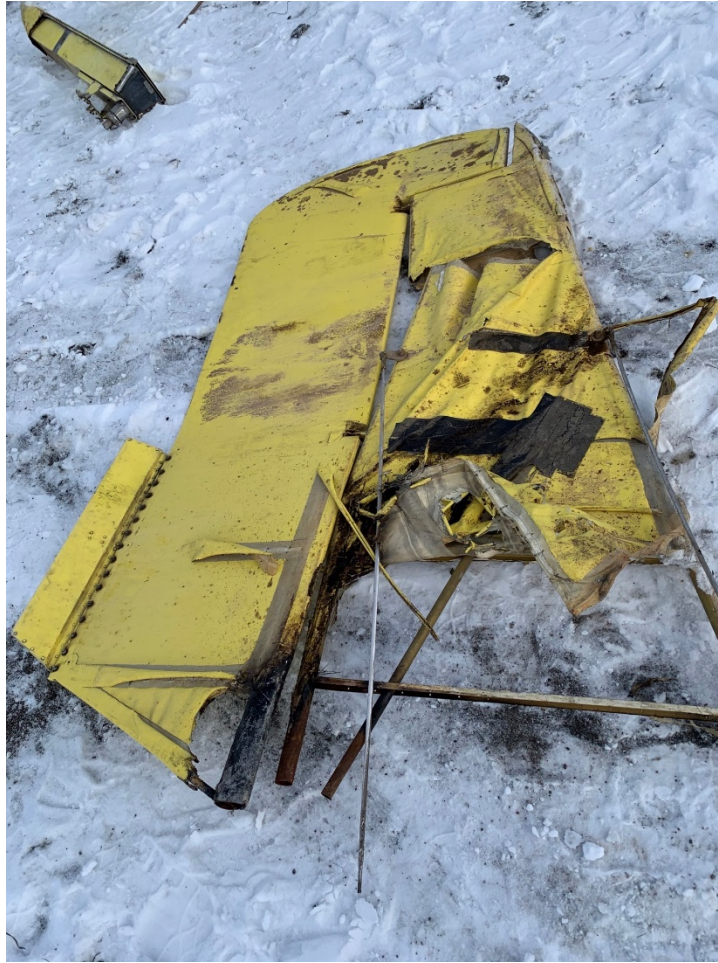
Figure 7, Right Horizontal Stabilizer and Elevator

The right horizontal stabilizer was crushed aft and bent upward slightly. The inboard third of the stabilizer had been melted and consumed. The remaining frame in that area was charred. The outboard portion of the stabilizer was crushed and bent. The elevator remained connected. It was bent upward slightly. A portion of the inboard fabric was melted and consumed. The elevator and elevator tube moved freely. The elevator trim tab was intact and up slightly in relation to the elevator. The actuator tube was broken and melted.

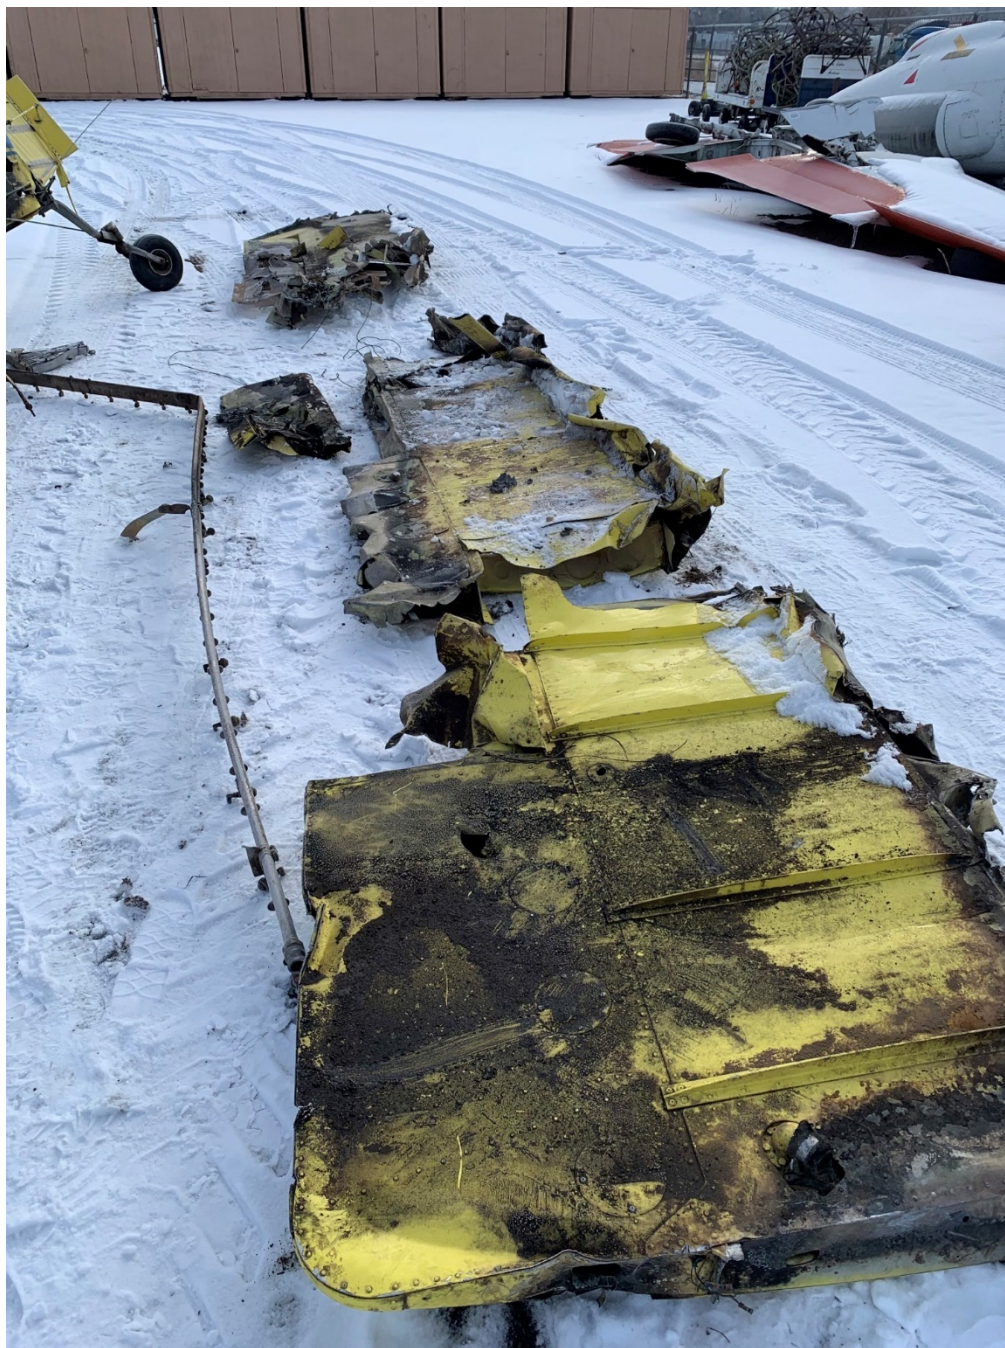
Figure 8, Left and Center Portions of the Top Wing and Top Left Aileron

The airplane's top wing was broken in several places and was charred and consumed. The fuel tank near the center portion was intact but broken open. The left outboard wing was crushed melted and consumed. The aileron and aileron push-pull tube that connects to the bottom wing aileron was mostly consumed.

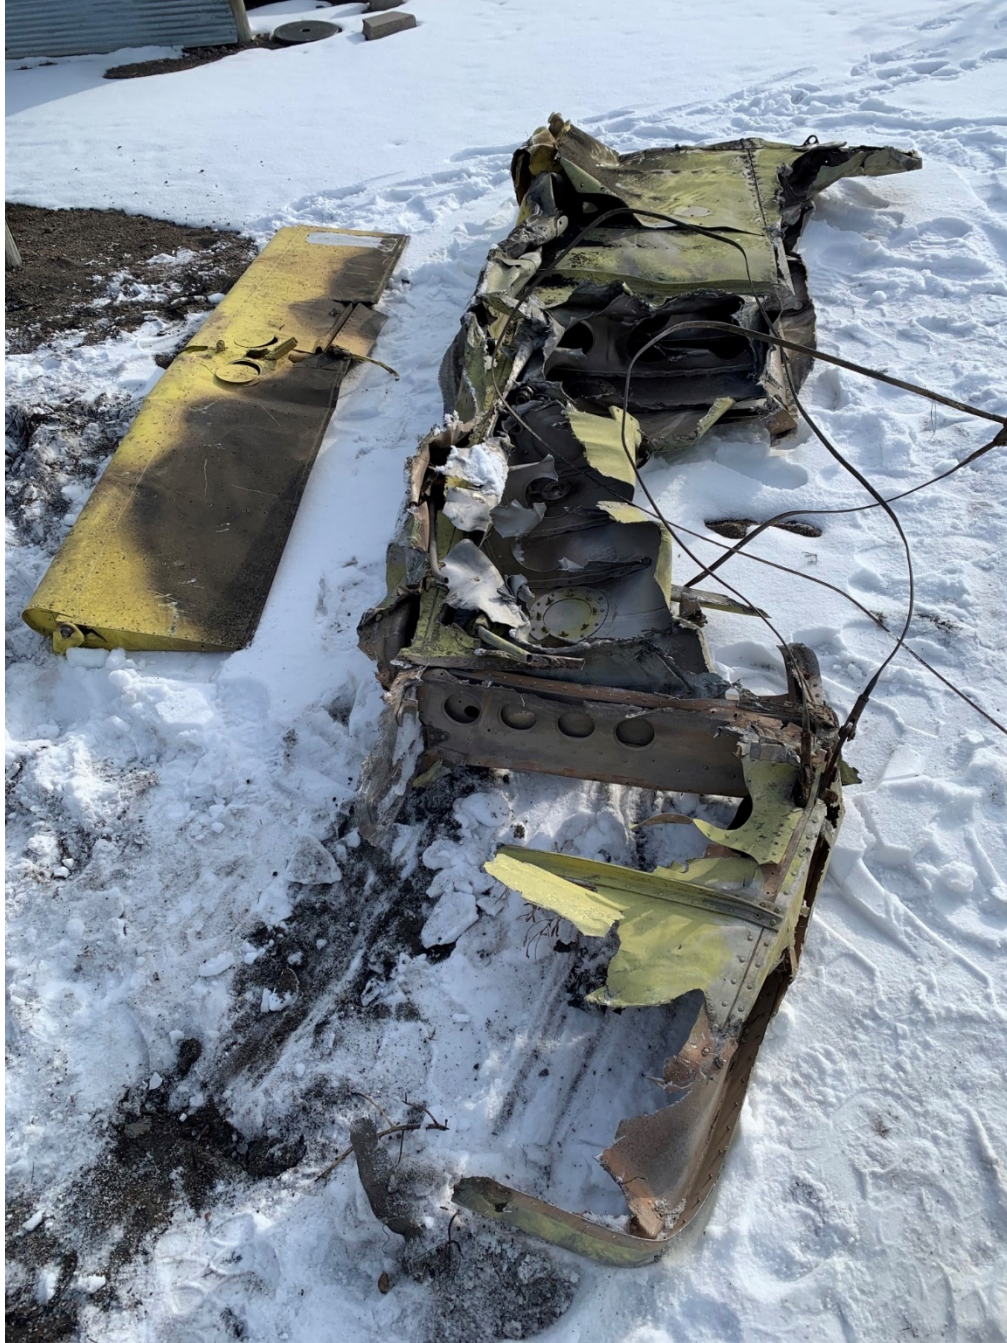
Figure 9, Right and Center Portions of the Top Wing and Top Right Aileron

The right outboard section of the top wing was crushed and broken aft, charred, and consumed by fire. The right aileron was broken out and charred, and the connector at the push-pull tube was broken.

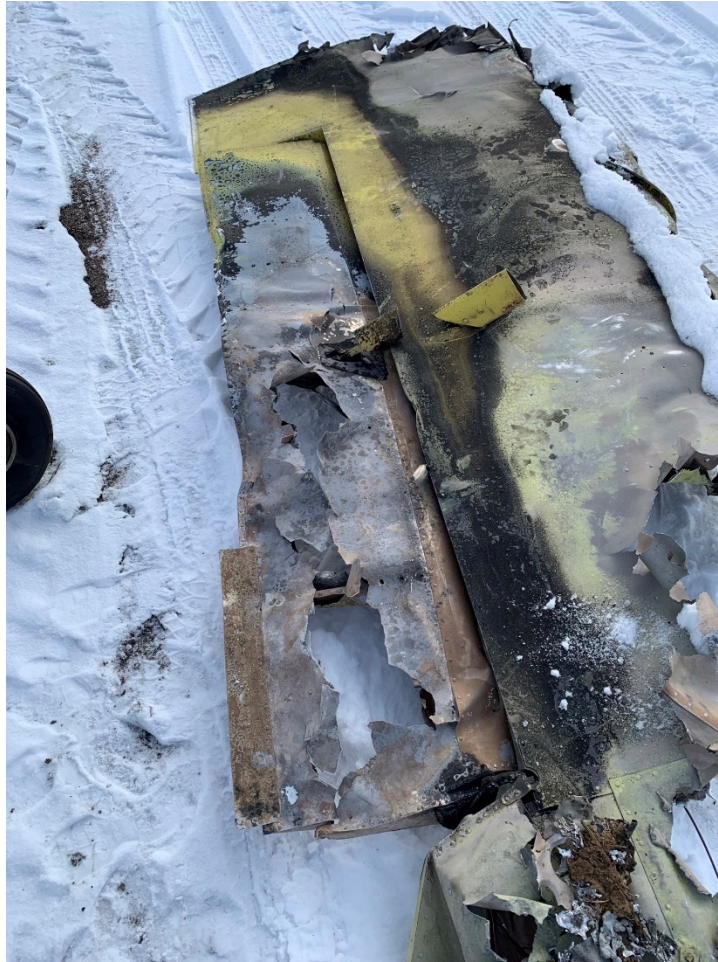
Figure 10, Left Bottom Wing and Aileron

The airplane's left bottom wing was broken aft, charred and melted. The inboard portion of the wing was consumed by fire. The outboard portion of the wing and aileron were charred and melted. The aileron remained connected to the wing. The push-pull rod to the upper wing aileron was melted and consumed. The support strut to the top wing, forward of the aileron was cut. Cables to the aileron were located coming out of the wing section. The cable ends were

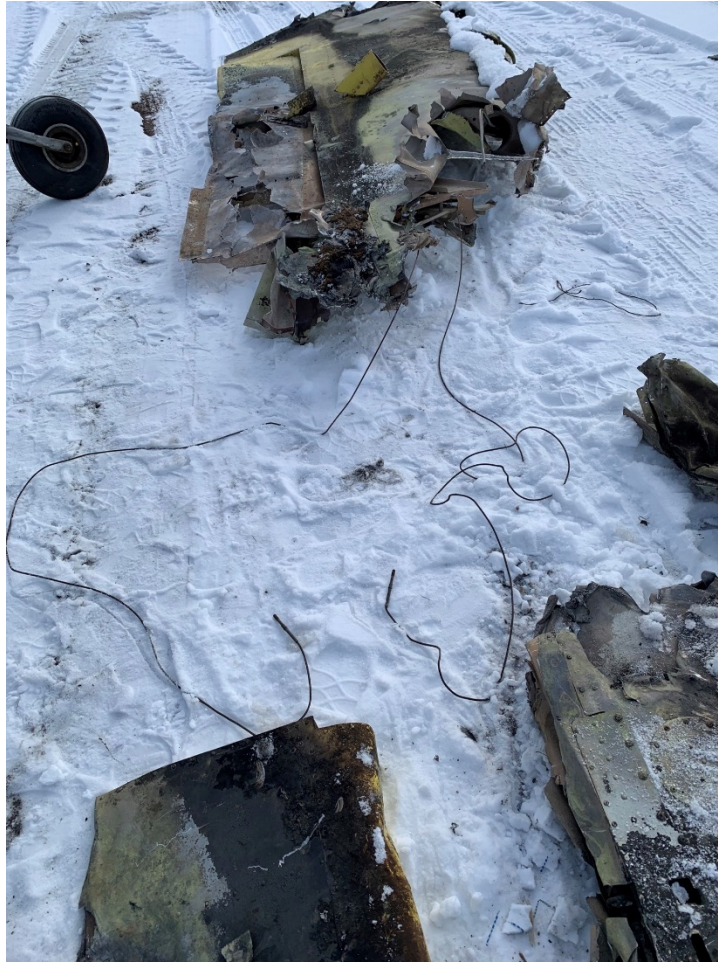
Figure 11, Left Bottom Wing Aileron Cables

separated at two connectors. When pulled, the cables moved the push-pull rod, bellcrank and aileron surface.

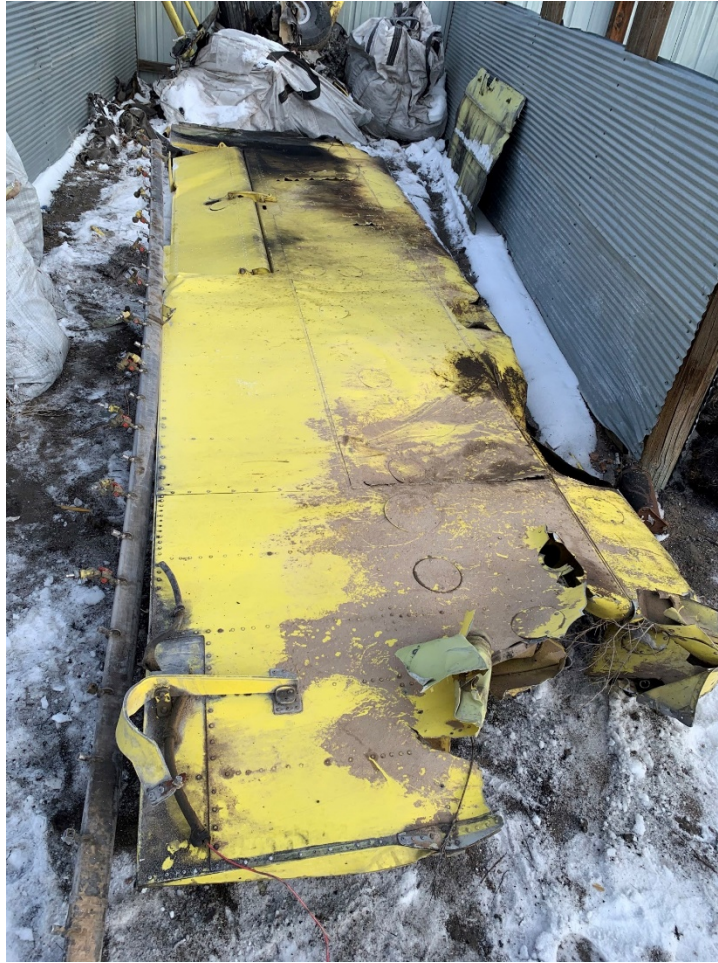
Figure 12, Right Bottom Wing and Aileron Cables

The airplane's right bottom wing was crushed aft along the leading edge to the front spar, from the wing tip to the root. The leading edge, approximately 1/3 rd the distance outboard of the wing root was charred and melted. The bottom surface near the wing tip and bottom right aileron was charred. The bottom right aileron was intact, bent slightly downward near the outboard edge, and remained connected to the wing. The actuator arm to the aileron was connected. The aileron cables were located at the wing root and showed fraying indicative of an overload fracture. Pulling on the cables moved the push-pull rod, bellcrank and aileron surface.

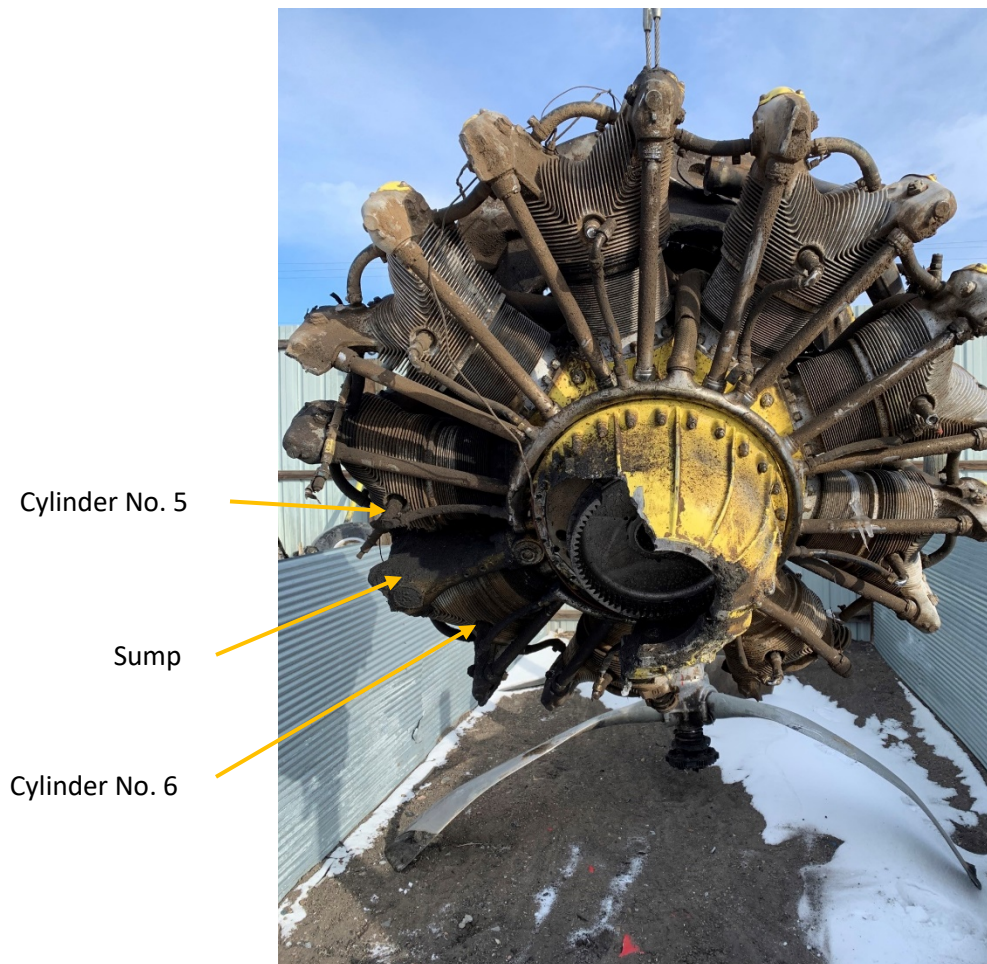
Figure 13, Engine

The engine was separated from the airframe at the mounts. It was lifted by forklift and the exterior was photographed. Half of the reduction gear housing was broken out. One fourth of the reduction drive gear was broken out and several of the gear teeth, opposite the gear fracture were mashed and broken. Several of the push rods in the area where the reduction gear housing was broken out, were broken out, and the three cylinders in that area, Cylinders number 4, 5, and 6, and the sump between cylinders 5 and 6, showed impact and fire damage. An attempt to rotate the reduction drive gear was made with no success. The engine data plate was located on the reduction gear housing by the bottom fracture.

Engine continuity was confirmed. All physical damage to the engine was consistent with ground impact.

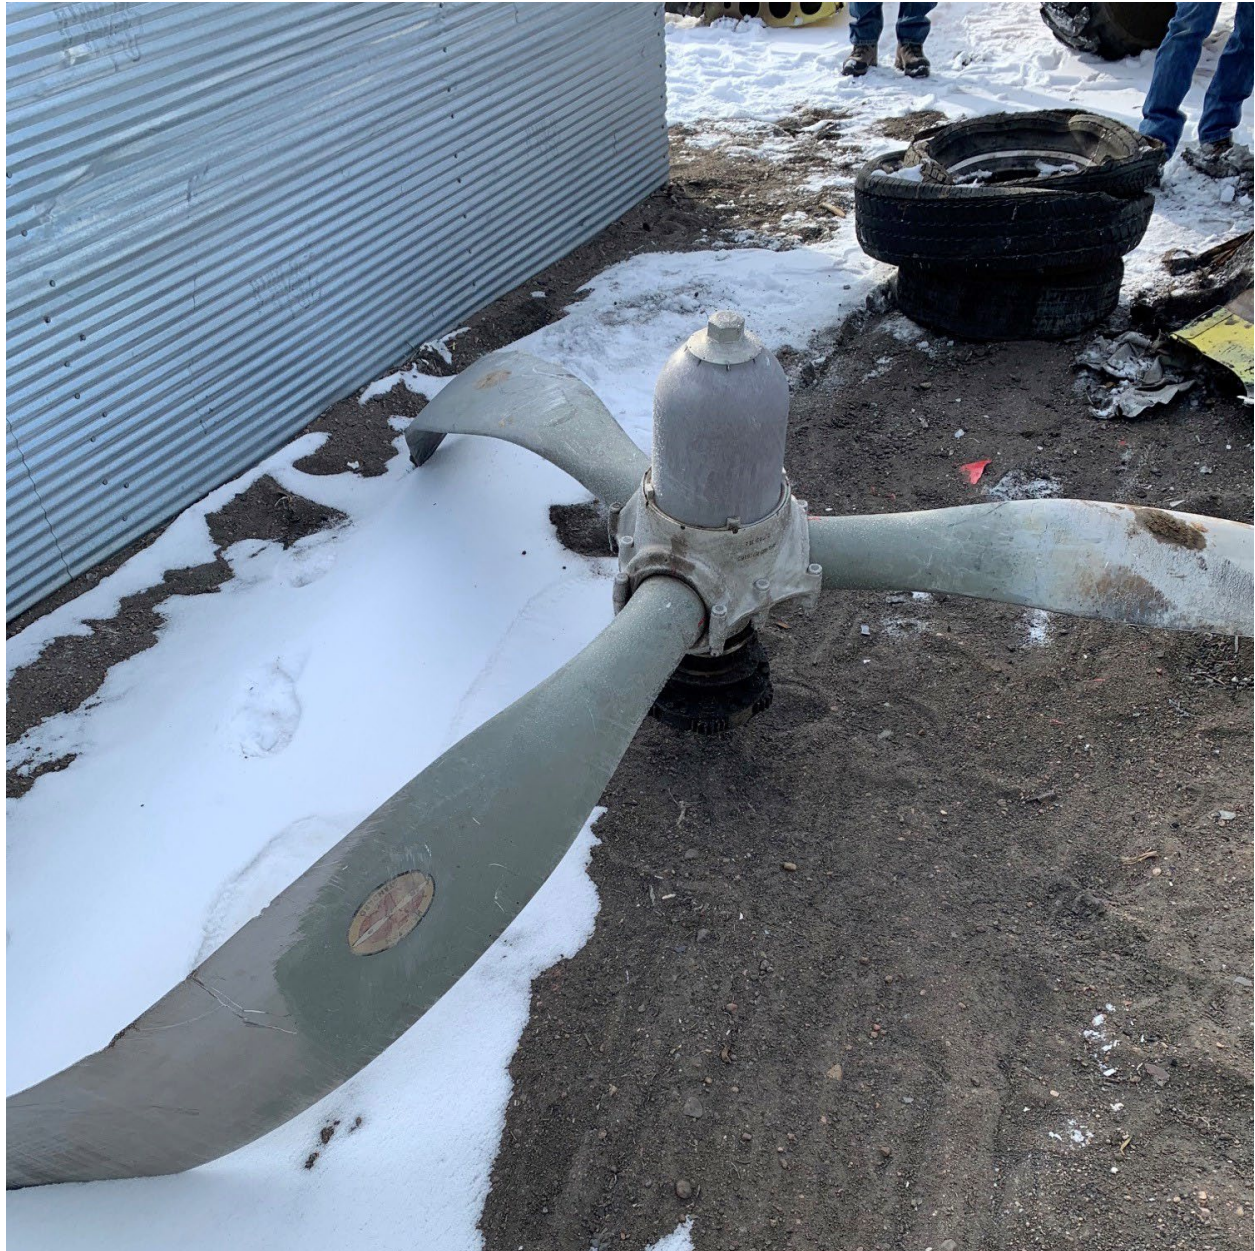
Figure 16, Propeller

The three-bladed Hamilton Standard 23D40-311 propeller was broken out at the reduction gears and gear housing. The propeller hub was intact and all three blades remained in the hub. All three propeller blades showed S-bending and chordwise scratches, and leading edge gouges. The reduction gears were attached to the hub of the propeller. The teeth in several of the gears were mashed and broken.

All physical damage to the propeller was consistent with the propeller turning at high rpm when it struck the ground.
