**NATIONAL TRANSPORTATIONS SAFETY BOARD**  
**Office of Aviation Safety**  
**Washington, DC 20594**

**SUMMARY OF EXAMINATION**

-- CEN20LA279 --

Location: Dalhart, Texas  
Date: July 10, 2020  
Time: 1455 central daylight time  
Aircraft: Air Tractor AT-502B (s/n 502B-0305), N61315

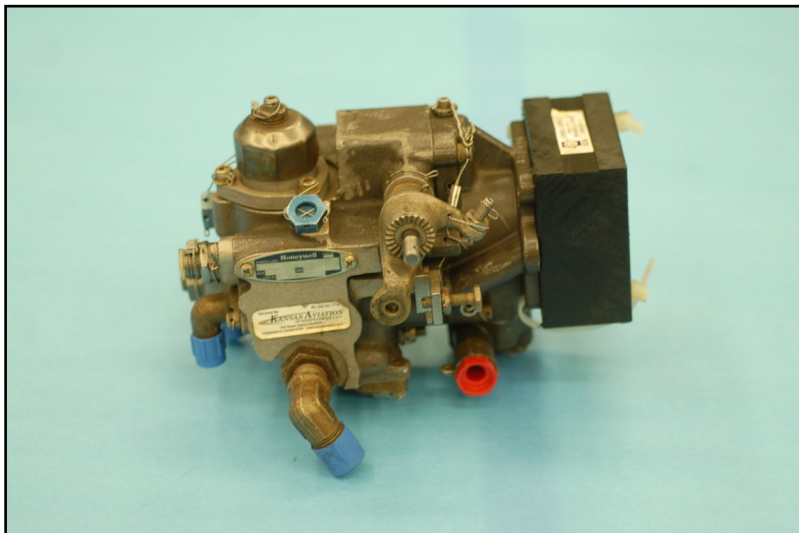
*Figure 1 – Fuel Control Unit*

The fuel control unit appeared to be intact and undamaged. All safety wire was installed and secure. The ground idle appeared to have been adjusted based on the safety wire installed. All other field adjustments remained undisturbed with the lockwire and seals intact.

The input drive shaft did not rotate. A portion of the sheared adapter coupling remained attached to the drive shaft. The mating portion of the adapter was not shipped with the control unit. The control input arm was free to rotate. All fuel ports were clear. The P<sub>x</sub> and P<sub>y</sub> ports exhibited an oily residue. The P<sub>y</sub> port contained a small piece of black debris. The power lever rotated freely. The power lever stop plate and the P<sub>0</sub> elbow fitting were both identified as non-OEM components.

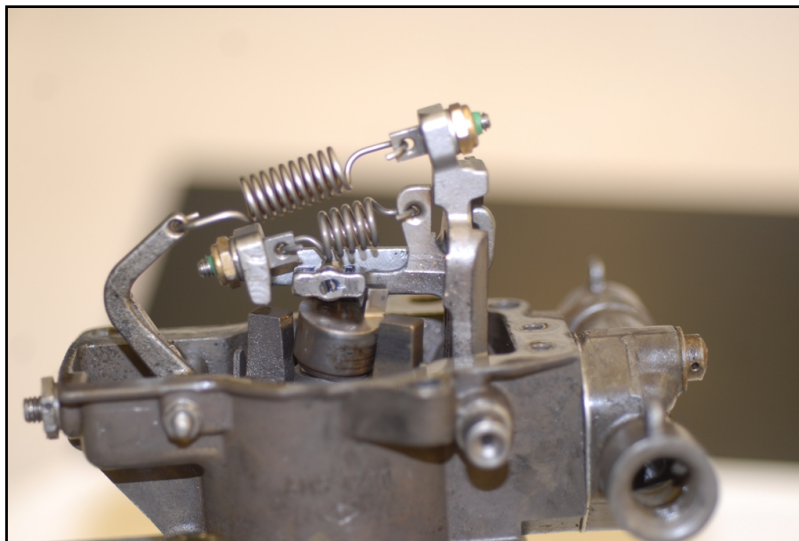
*Figure 3 – Drive Body / Spool Bearing Assembly*

Partial disassembly of the unit revealed that the spool bearing (installed on the input drive shaft) had seized. Six of the seven ball bearings had been liberated from the bearing assembly and were located within the drive body cavity. The  $P_x$  “hat valve” appeared intact. The  $P_x$  and  $P_y$  springs were intact and appeared undamaged. The cam follower lever rotated normally. The flyweights were free to pivot normally. The top of each flyweight exhibited a contact witness mark. The  $P_x$  and  $P_y$  levers were both free to pivot normally. The  $P_y$  orifice appeared normal.

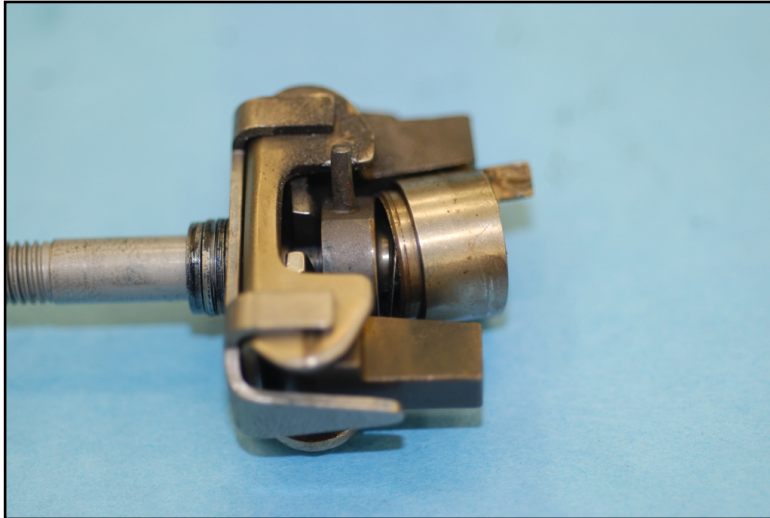
*Figure 4 – Spool Bearing Assembly / Drive Shaft*

Examination of the spool bearing assembly revealed that the bearing cap was bent and partially separated from the bearing bushing. The inner ring, outer ring, and bearing cage were damaged. The rolling elements (ball bearings) exhibited wear track marks.
