# NATIONAL TRANSPORTATION SAFETY BOARD

## MATERIALS LABORATORY FACTUAL REPORT

Report No. 20-046

Place : Welch, Louisiana  
Date : July 2, 2020  
Vehicle : Robinson R44, N7511D  
NTSB No. : CEN20LA286  
Investigator : Courtney Liedler, AS-CEN

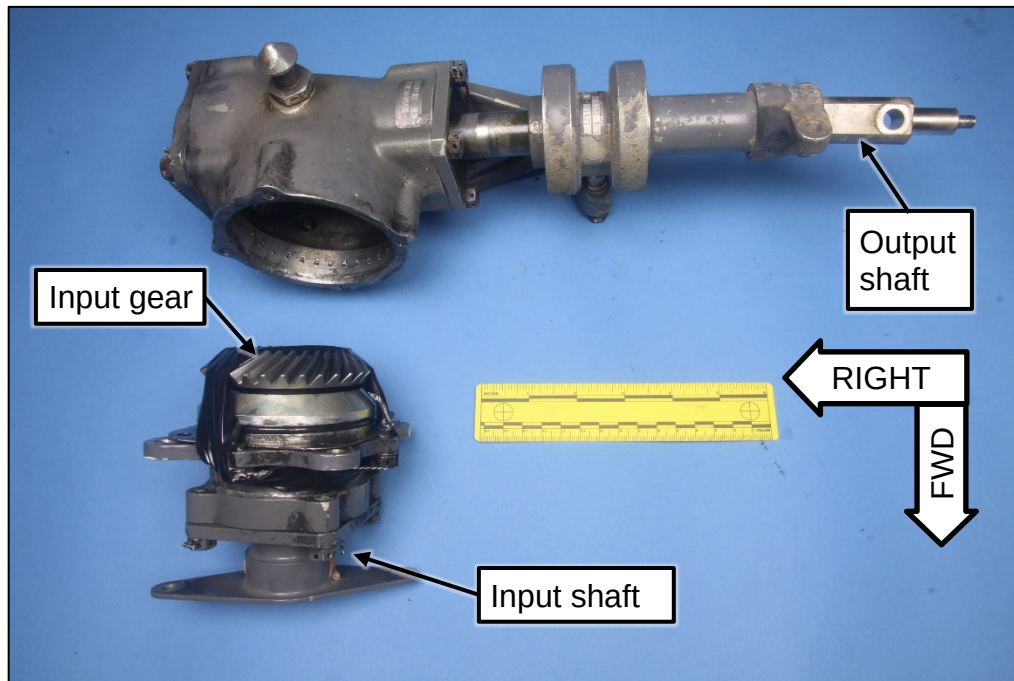
Figure 1. Overall view of the submitted tail rotor gearbox assembly.

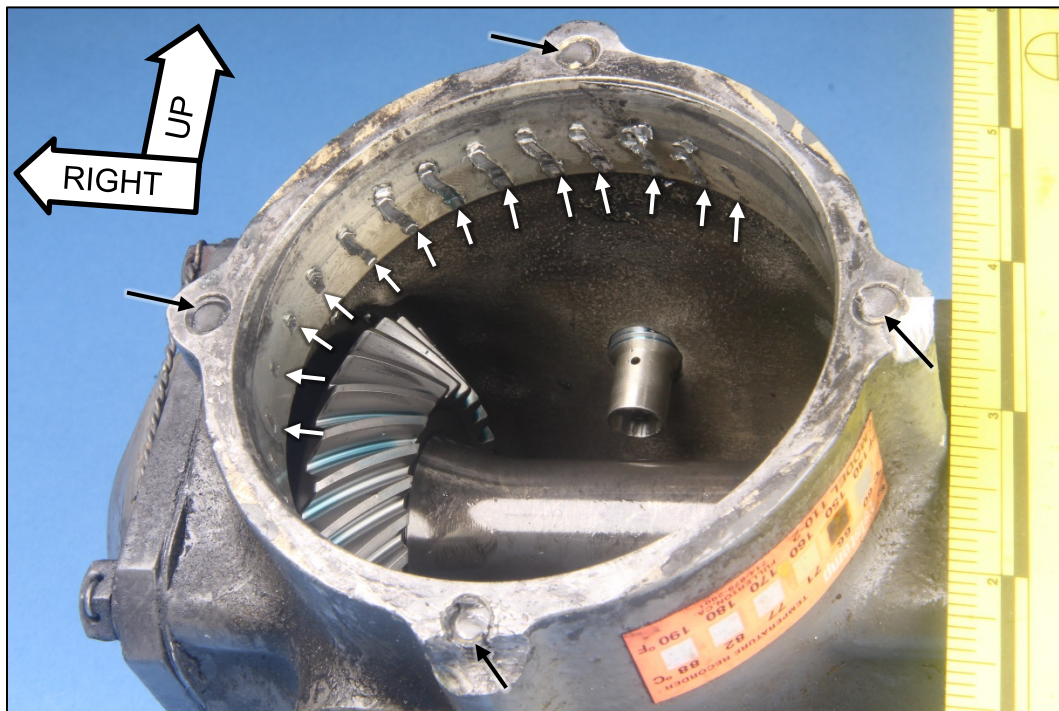
An overall view of the submitted tail rotor gearbox assembly is shown in figure 1. The four bolts attaching the gearbox housing to the input shaft housing were fractured as shown in figure 2 (black arrows). The forward portions of the four fractured bolts including the bolt heads remained within the attachment holes of the input shaft housing, and safety wire remained attached to the heads.

Sliding contact marks corresponding to contact with the tail rotor gearbox input gear were observed on the interior surface of the housing as indicated by white arrows in figure 2. The sliding contact marks were oriented primarily in the longitudinal direction, consistent with little or no rotation to the input gear as the aft portion of the tail rotor gearbox assembly separated from the input shaft housing.

Figure 2. Forward end of the tail rotor gearbox housing showing four fractured attachment bolts (black arrows) and sliding contact marks on the interior surface (white arrows).

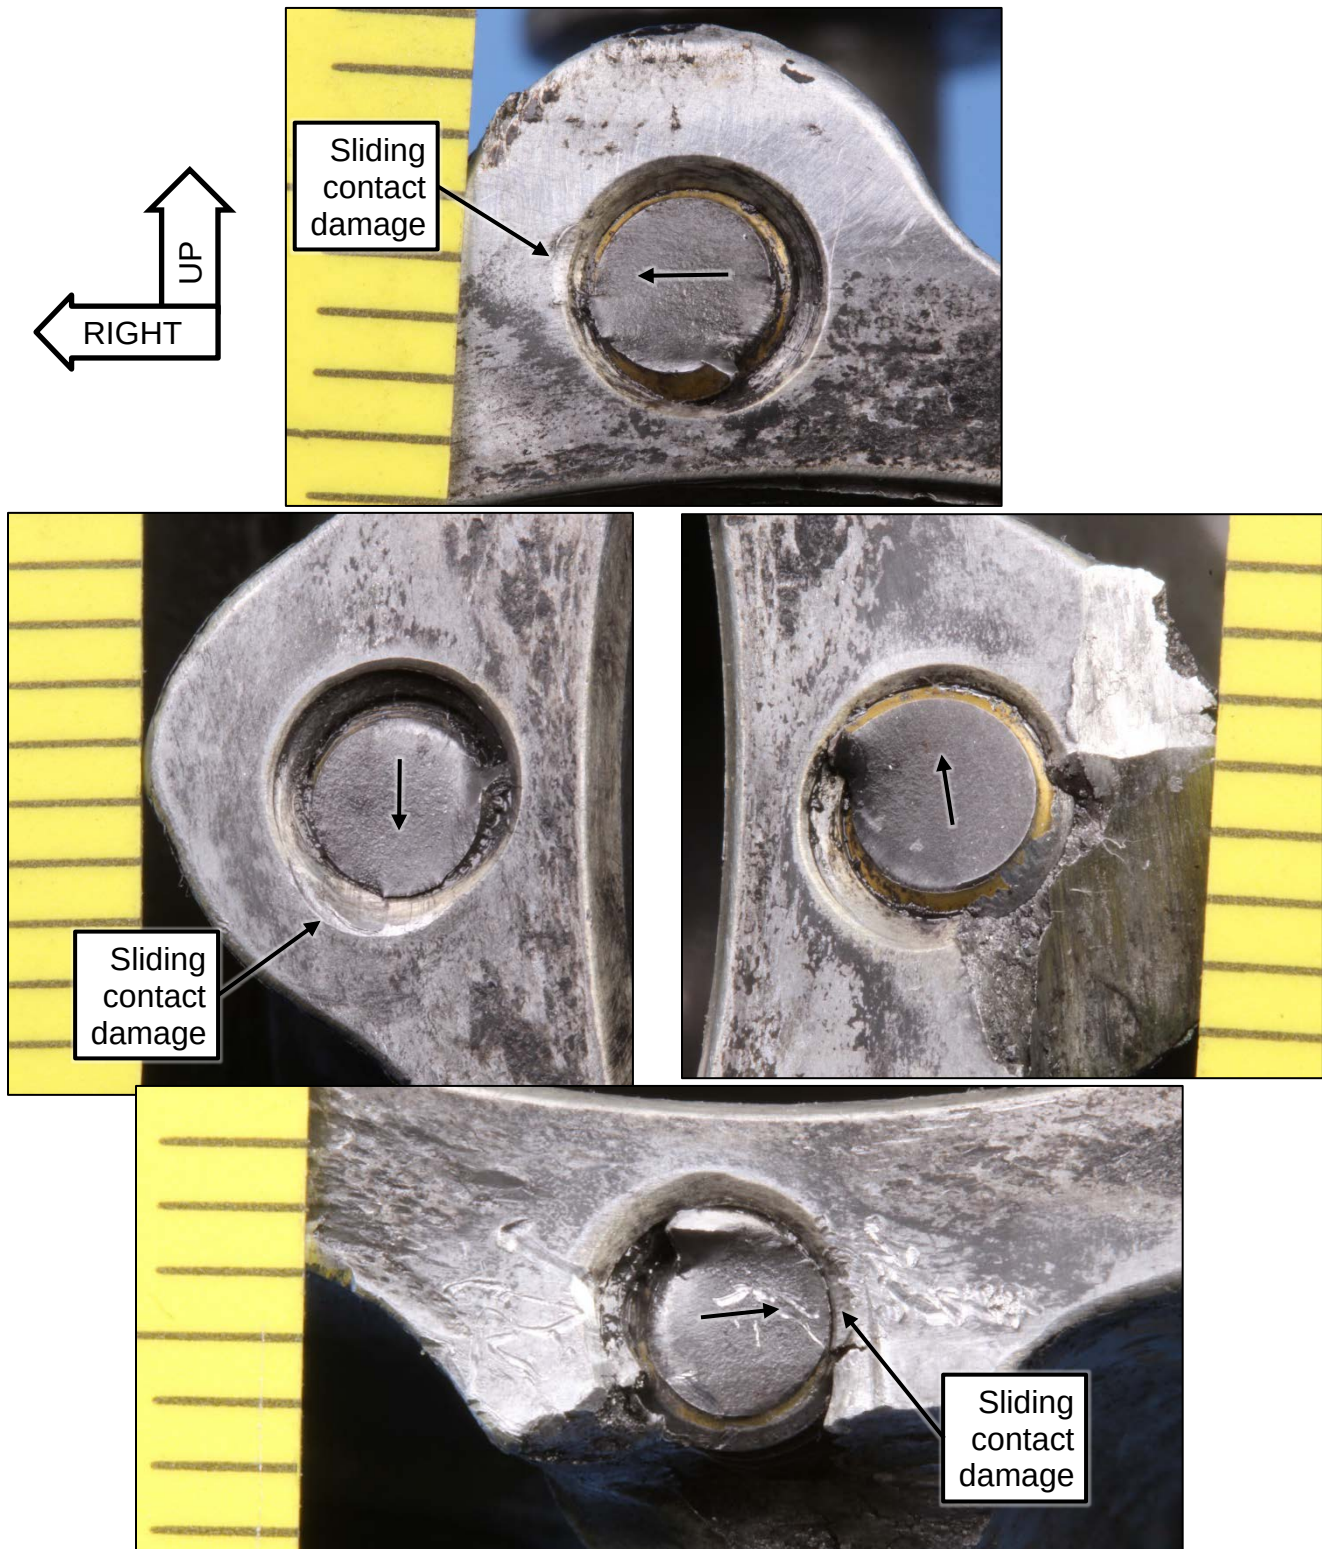
A close view of each bolt fracture surface is shown in figure 3. The fracture surfaces had uniform matte gray features consistent with ductile overstress fracture. The bolt fractures were generally deformed consistent with fracture under shear loads. Unlabeled arrows in figure 3 indicate the direction of motion associated with the mating side of the fracture relative to the aft side of the fracture shown. The edges of the holes at the upper, right, and lower attachment locations showed sliding contact damage on the sides of the holes as indicated in figure 3 consistent with contact with the mating sides of the fractures. The overall shear deformation pattern was consistent with the tail rotor gearbox housing rotating clockwise (as viewed looking aft) relative to the input housing. This clockwise rotation of the gearbox housing is also consistent with the outboard end of the output shaft displacing downward relative to the housing.

Figure 3. Close views of the fractured tail rotor gearbox housing attachment bolts. Unlabeled arrows indicate the direction motion of the mating side of the fracture relative to the fracture surface shown.
