# NATIONAL TRANSPORTATION SAFETY BOARD

## MATERIALS LABORATORY FACTUAL REPORT

Report No. 21-011

Place : Welsh, Louisiana  
Date : July 2, 2020  
Vehicle : Robinson R-44  
NTSB No. : CEN20LA286  
Investigator : Courtney Liedler, AS-CEN

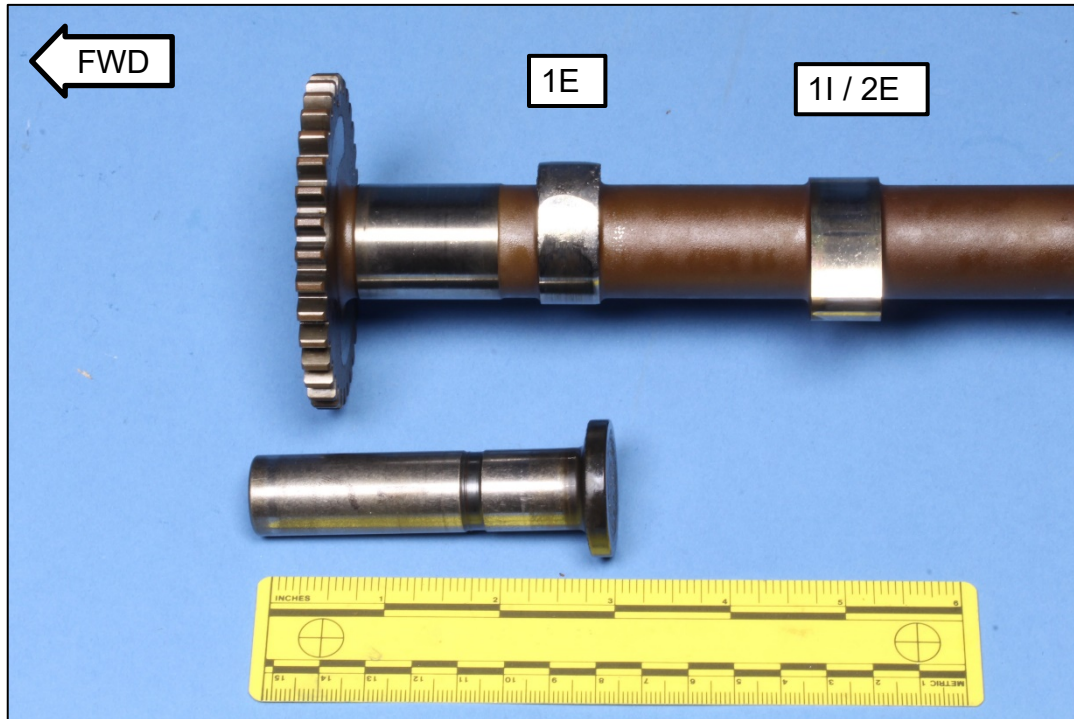
An overall view of the submitted camshaft and tappet bodies is shown in figure 1. The camshaft was intact, but the lobe associated with the number 1 cylinder exhaust valve was substantially worn (figure 2). The contact face on the head of the tappet body from the number 1 cylinder exhaust valve train (1E) was spalled and worn as shown in figure 3. The remaining camshaft lobes and tappet bodies were intact, free of corrosion pits, and appeared undamaged with normal wear patterns on most of the heads. The 6E tappet body had relatively deeper circumferential wear and scuff marks and the 6I tappet body had relatively heavy contact marks on their camshaft lobe contact faces.

Figure 2. Closer view of the tappet body for the number 1 cylinder exhaust valve train and the corresponding lobe on the crankshaft.

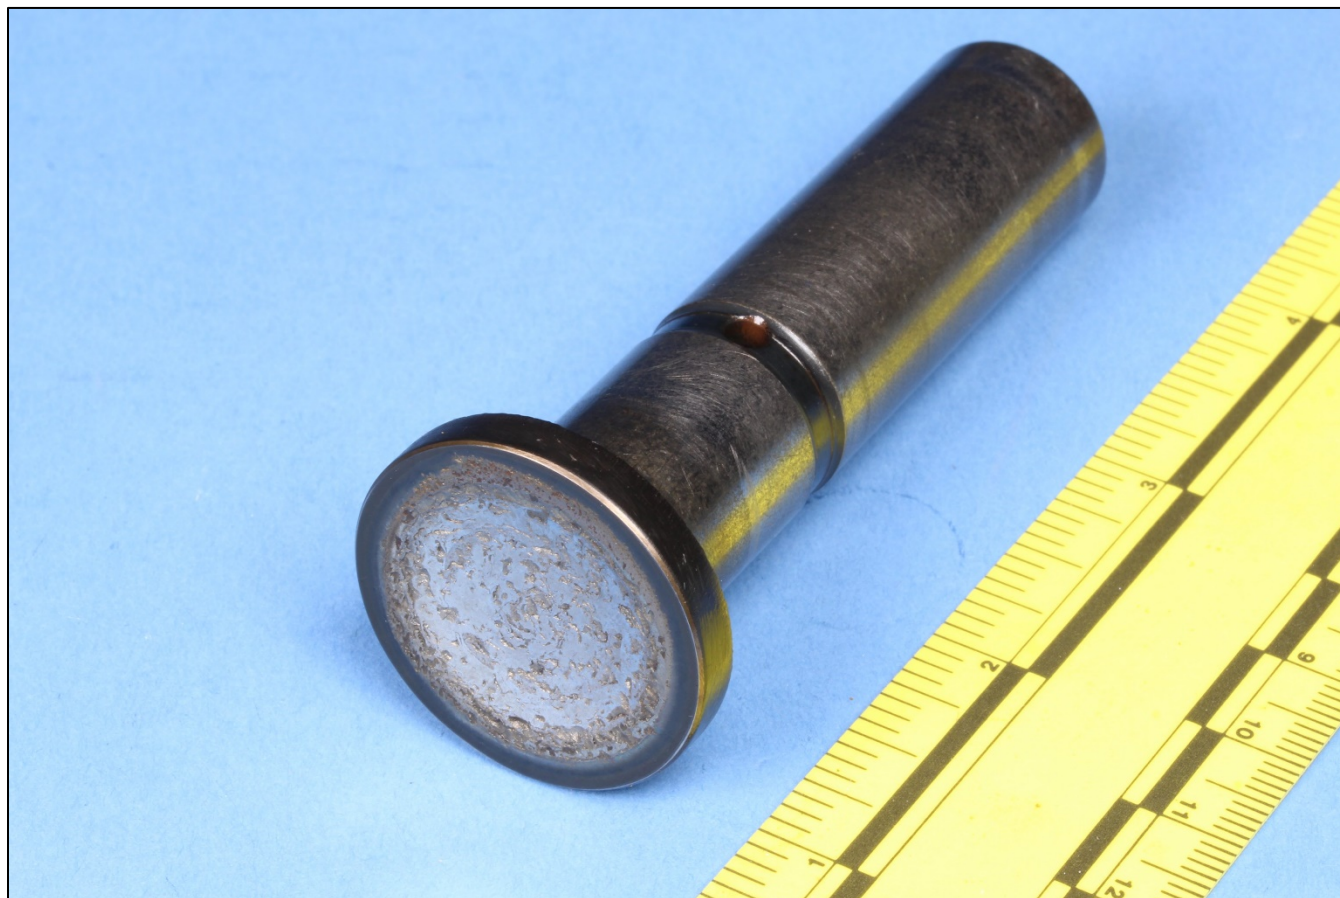
Figure 3. Head face on the number 1 exhaust tappet body.
