# NATIONAL TRANSPORTATION SAFETY BOARD

## MATERIALS LABORATORY FACTUAL REPORT

Report No. 21-016

Place : Welsh, Louisiana  
Date : July 2, 2020  
Vehicle : Robinson R44, N7511D  
NTSB No. : CEN20LA286  
Investigator : Courtney Liedler, AS-CEN

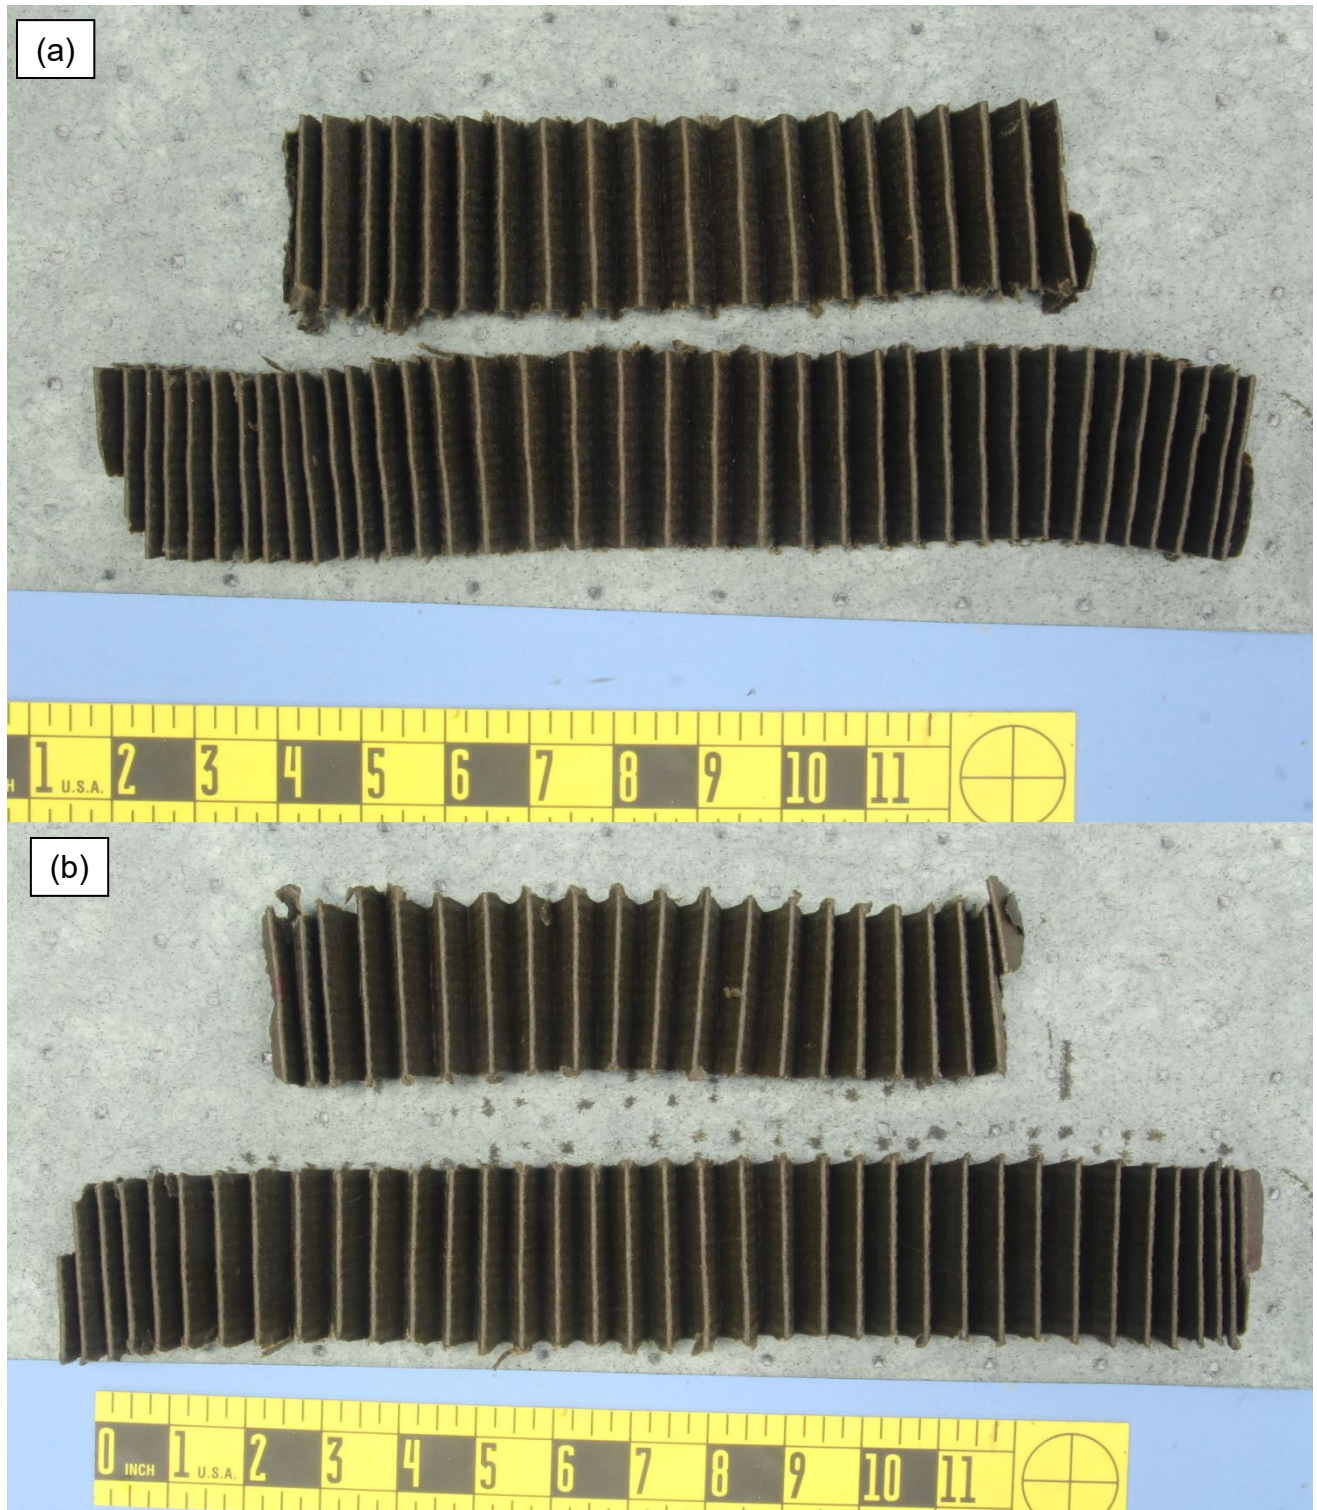
Figure 1 and Figure 2 show the accordion-style oil filter, as received. The filter was in two separate remnants, one approximately 8 inches long, and the other approximately 14 inches long when resting without stretching, as depicted in the figures. Both remnants were still saturated with oil. The ends of the remnants exhibited tears or fractures, as illustrated in Figure 2.

Figure 1 – View of the accordion oil filter, as received from (a) (b) each side.

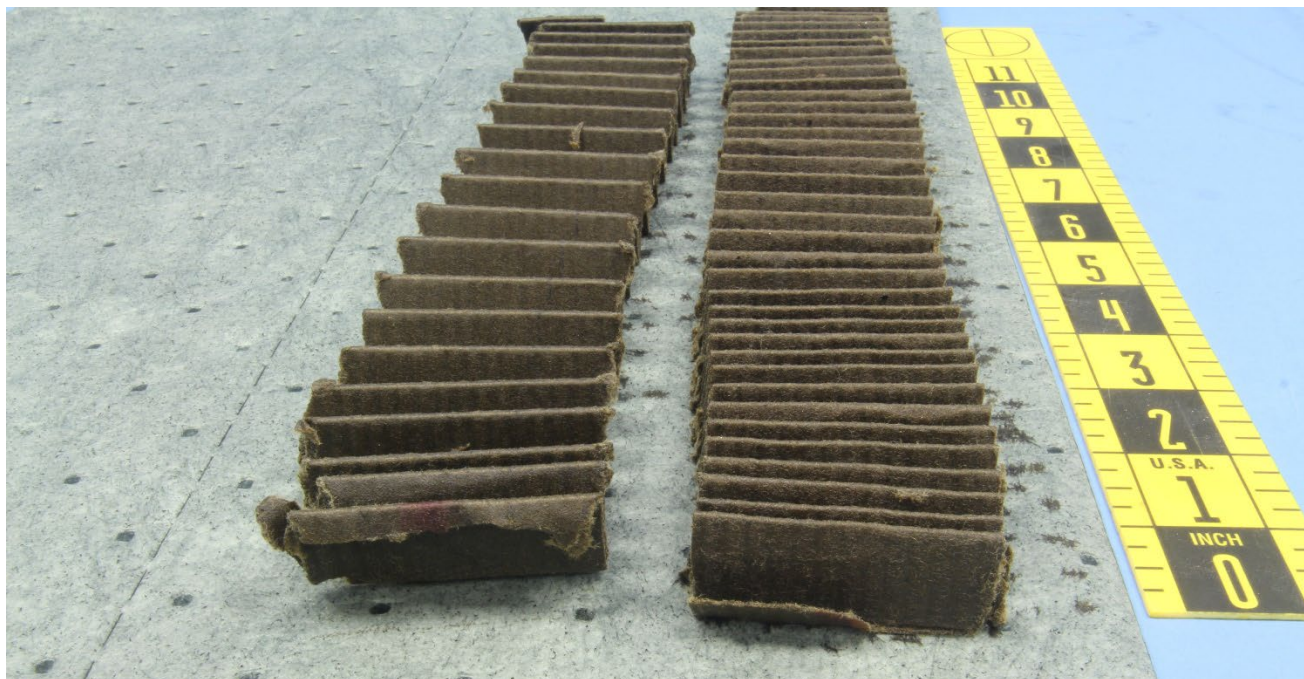
Figure 2 – View of two of the fractured ends of the filter.

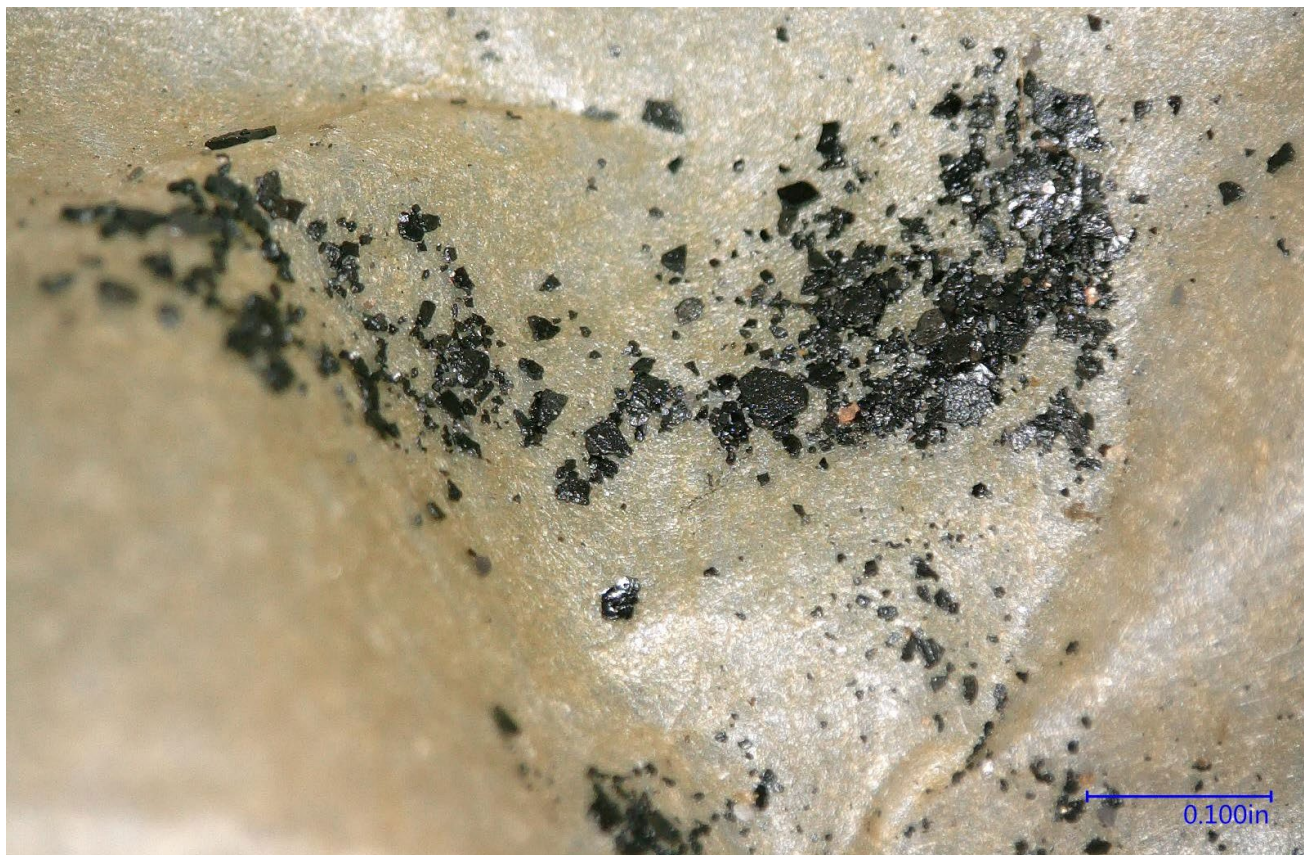
Figure 3 shows some of the particles of debris submitted in a separate paper filter. These particles exhibited an oily appearance as received, and they were cleaned in

acetone using an ultrasonic bath. After cleaning, there were two general categories of particles—those that appeared dark visually, as shown in Figure 3, and those that appeared light in appearance.

Figure 3 – View of the debris sent in a filter, showing most of the dark-colors particles.

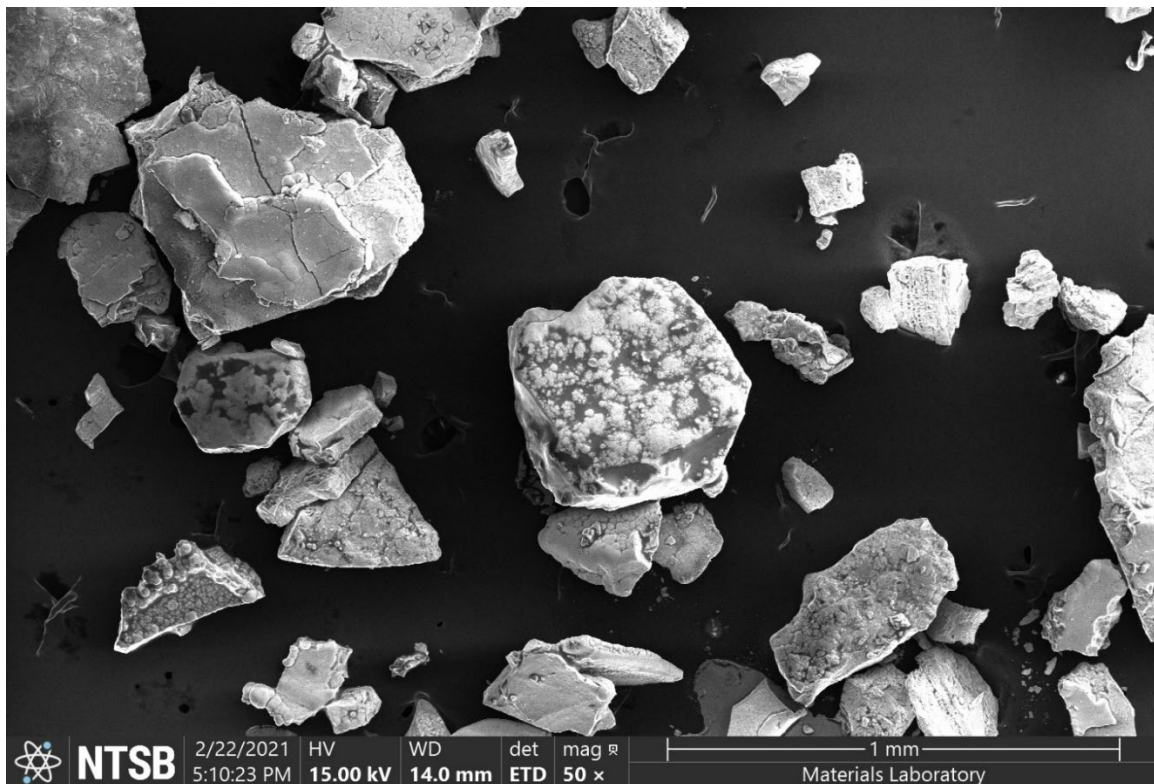
These cleaned particles were examined using a scanning electron microscope (SEM) with an energy dispersive x-ray spectroscopy (EDS) detector. Figure 4 shows a SEM micrograph of a typical area of the particles that exhibited the dark visual appearance. For the most part, these particles exhibited charging electron effects consistent with non-conductive (i.e., nonmetallic) materials. The particles exhibited sharp, jagged facets, and were relatively uniform in backscattered contrast.<sup>1</sup>

Examination of these particles using EDS found them to contain mostly carbon and oxygen, consistent with either organic compounds or combustion products. These particles did exhibit minor amounts of lead, bromine, and sulfur, consistent with combustion products from avgas containing tetraethyllead additives.

Figure 4 – Secondary electron (SE) micrograph of the dark-colored debris.

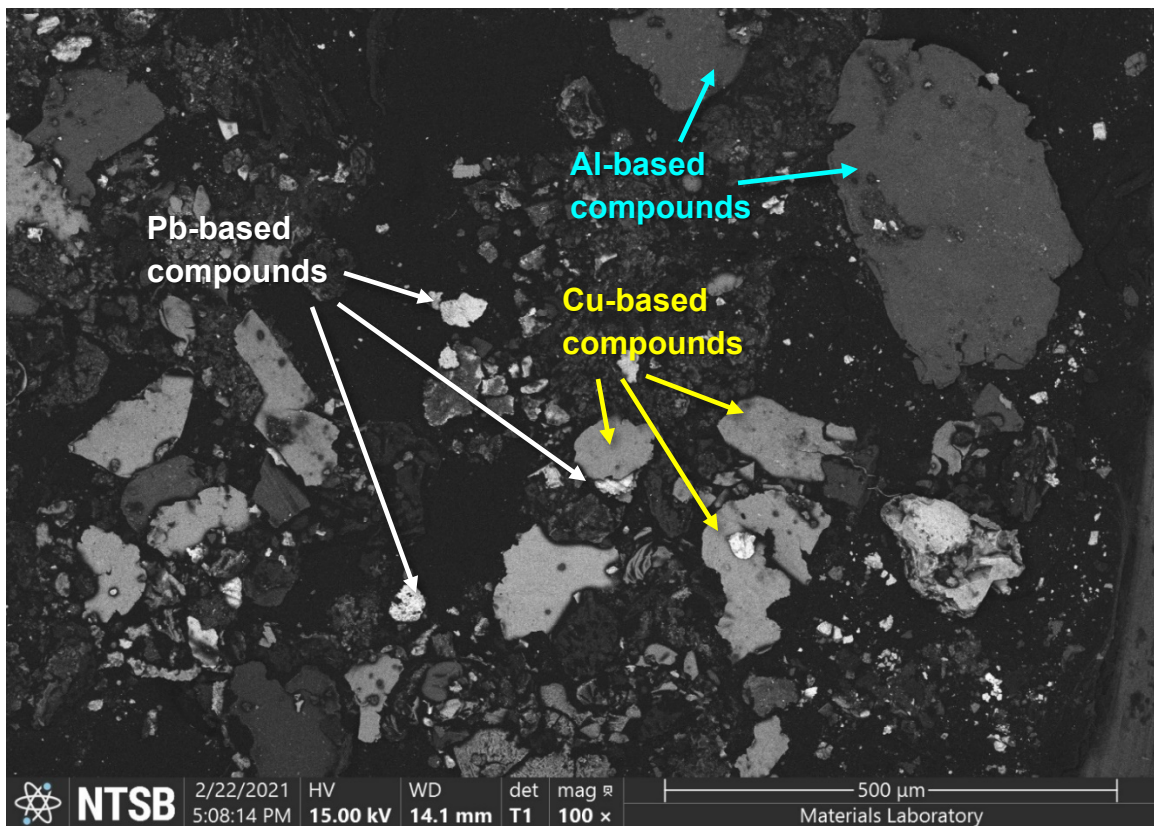
Figure 5 shows a typical backscattered image of the visually lighter particles. These particles contrasted in the backscattered view, consistent with different chemical compositions. These particles were often of different sizes, with rounded edges.

The lightest contrast particles were found to be consistent with tetraethyllead combustion products, exhibiting high levels of lead and bromine when examined using EDS. The flat, darker particles exhibited high levels of aluminum, with minor amounts of magnesium, iron, and chromium. This was consistent with commercial aluminum alloys. The larger, lighter gray particles were mostly copper, with minor amounts of aluminum, manganese, and iron. This was consistent with a copper alloy.

Figure 5 – Backscattered electron (BE) micrograph of the lighter colored debris.

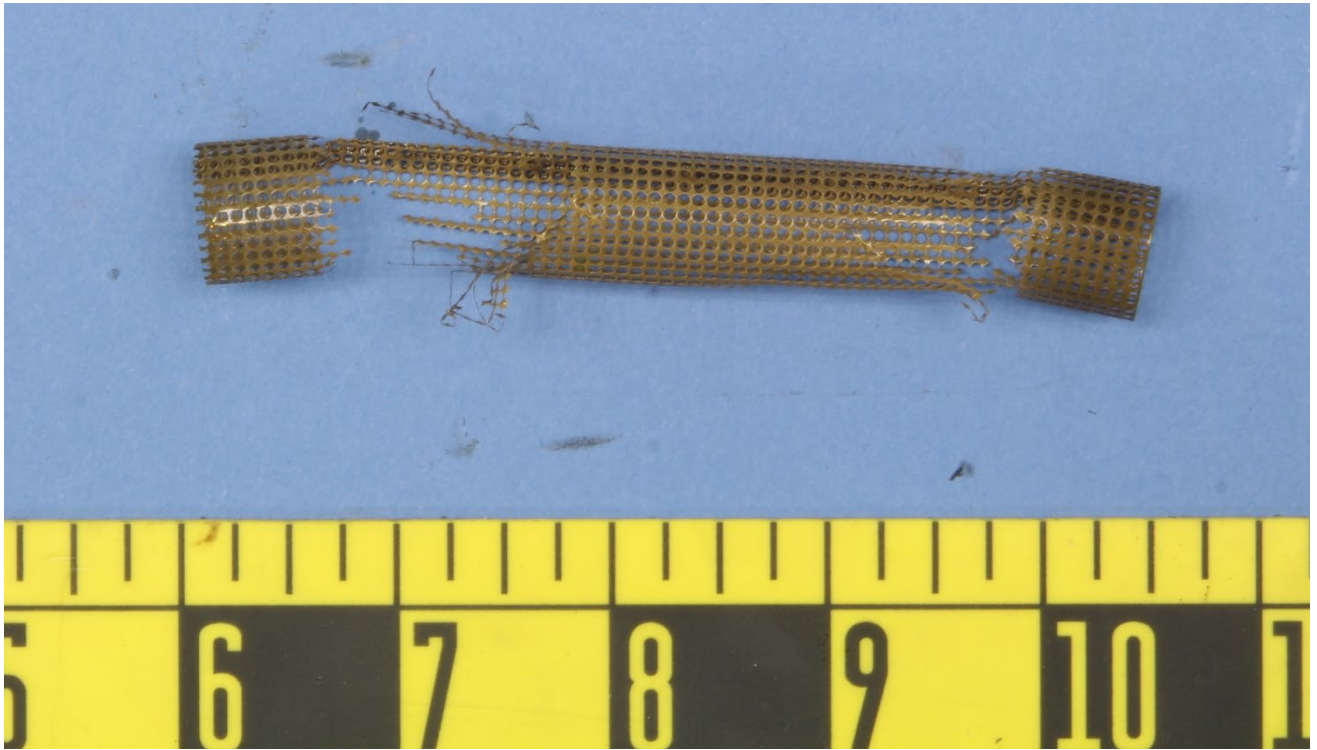
Figure 6 shows the oil suction screen, as received. This screen was cleaned using acetone in an ultrasonic bath to remove the oil residues on the surface. The screen consisted of a perforated cylindrical tube, with small concave webs of interconnected material. As can be seen in Figure 7 and Figure 8, the clusters of webs had fractured 0.5 inches from both ends. There were also areas with missing material, as exemplified in Figure 8.

Figure 6 – View of the oil suction screen, as received.

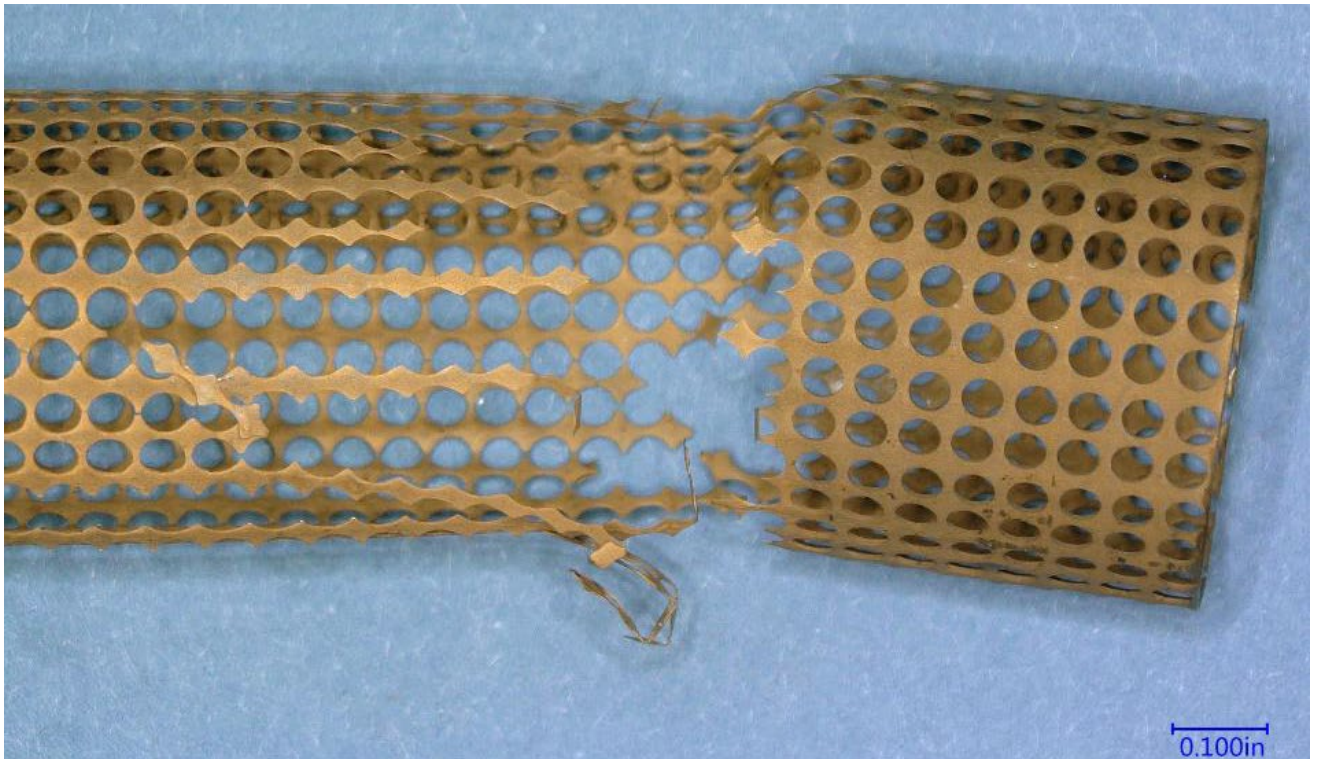
Figure 7 – The right area of fractured webs on the screen in Figure 6, after cleaning with acetone.

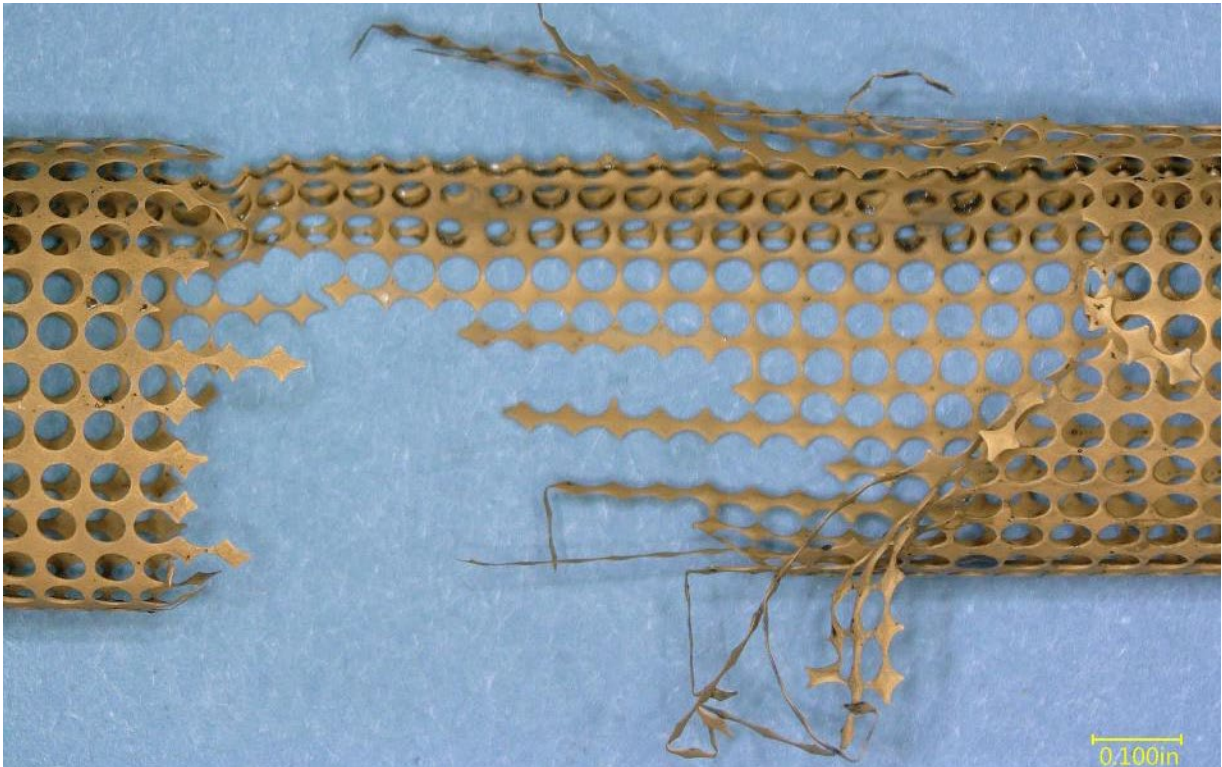
Figure 8 shows some of the fractured webs, as well as a series of intact ones. Some of the fractured webs exhibited areas of localized deformation or necking adjacent to their fractures. Others, though, exhibited a flatter or jagged fracture appearance. As shown in this figure and highlighted in Figure 10, many of the webs and material near the circular holes exhibited areas of thinning consistent with eroded material.

Figure 8 – The left area of fractured webs on the screen in Figure 6, after cleaning with acetone.

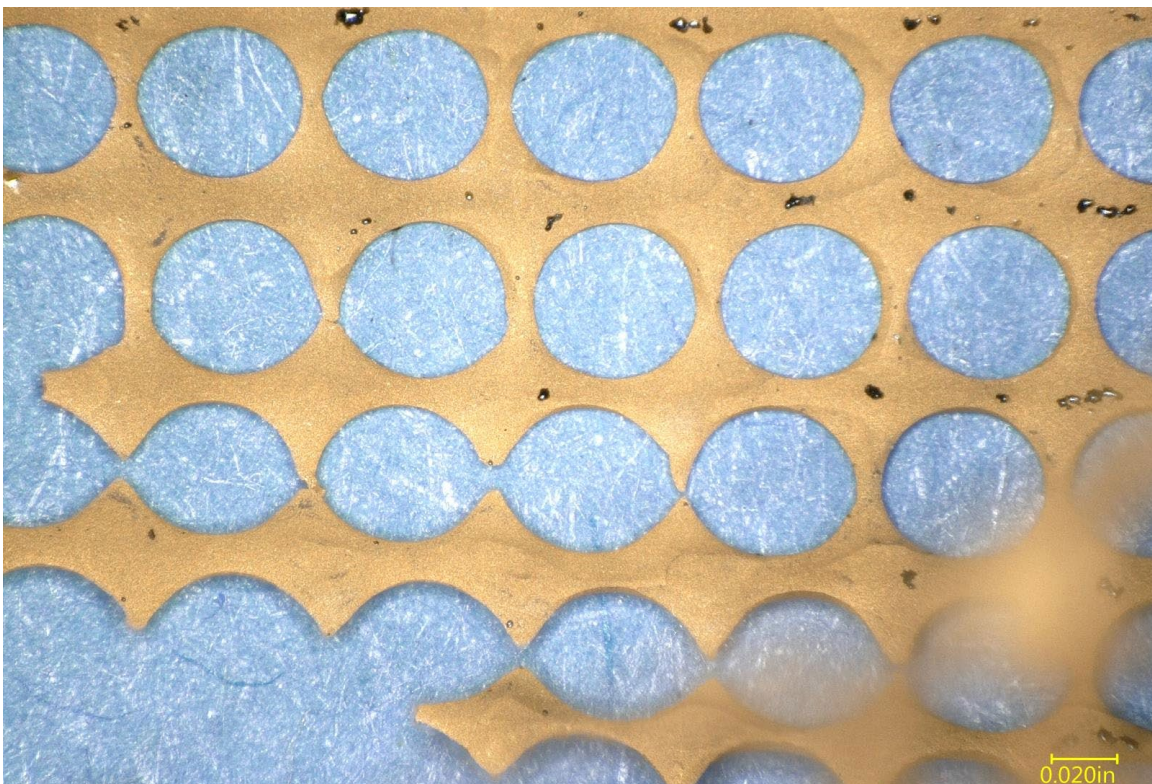
Figure 9 – View of a series of fractured webs in the oil suction screen.

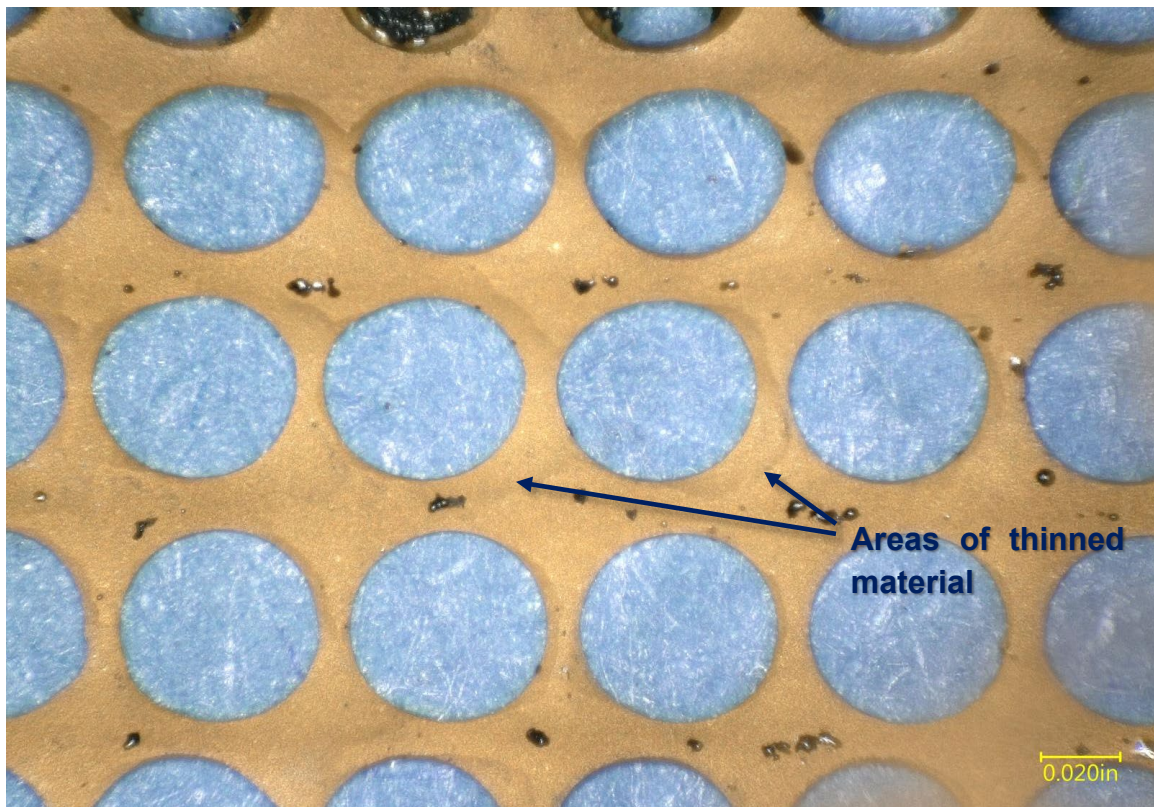
Figure 10 – Closer view of some of the thinned but intact webs of the screen.

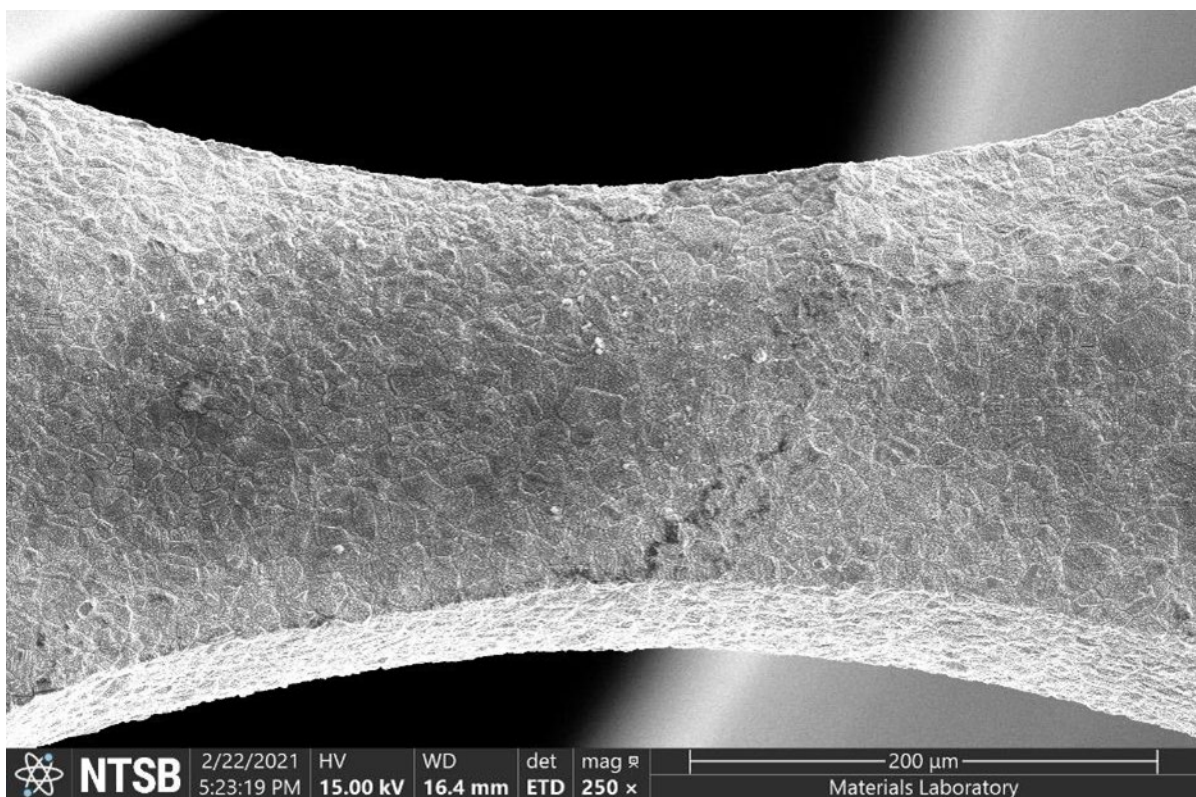
The screen was examined using a SEM. As typified in Figure 11, many of the intact webs of the screen exhibited a concave morphology in their width, and they were relatively

uniform in thickness. Common on this surface and all the exposed surfaces of the screen material was a faceted crystal grain-like or etched appearance, showing a surface texture consistent with those typical of equiaxed grains.

Figure 11 – SE micrograph of on intact web of the oil suction screen.

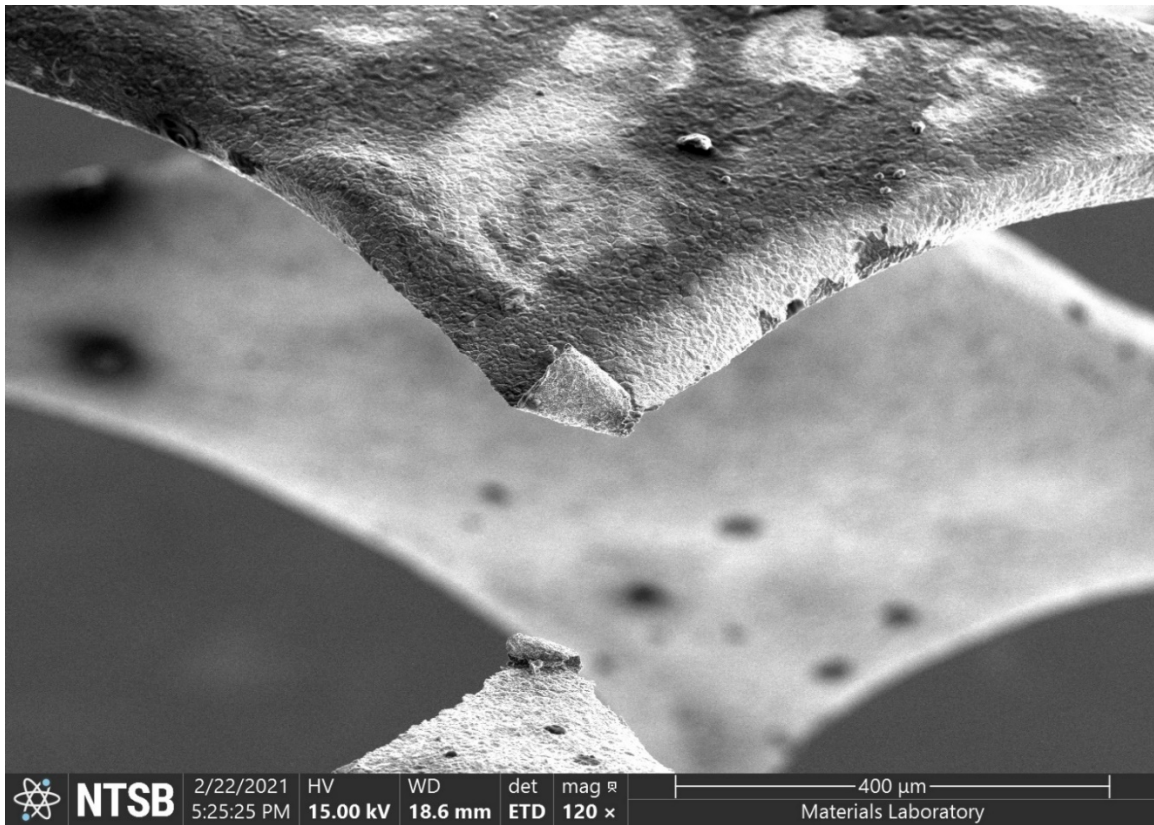
Figure 12 shows one of the fractured screen webs. This figure shows an area that had thinned, both in thickness and width, with the fractured surfaces rolling upward and backward. A closer view shown in Figure 14, illustrates that this web remnant had thinned to just a few micrometers. The grain-like surface appearance was visible on both faces of the screen material.

Figure 12 – SE micrograph of one of the fractured webs from Figure 9.

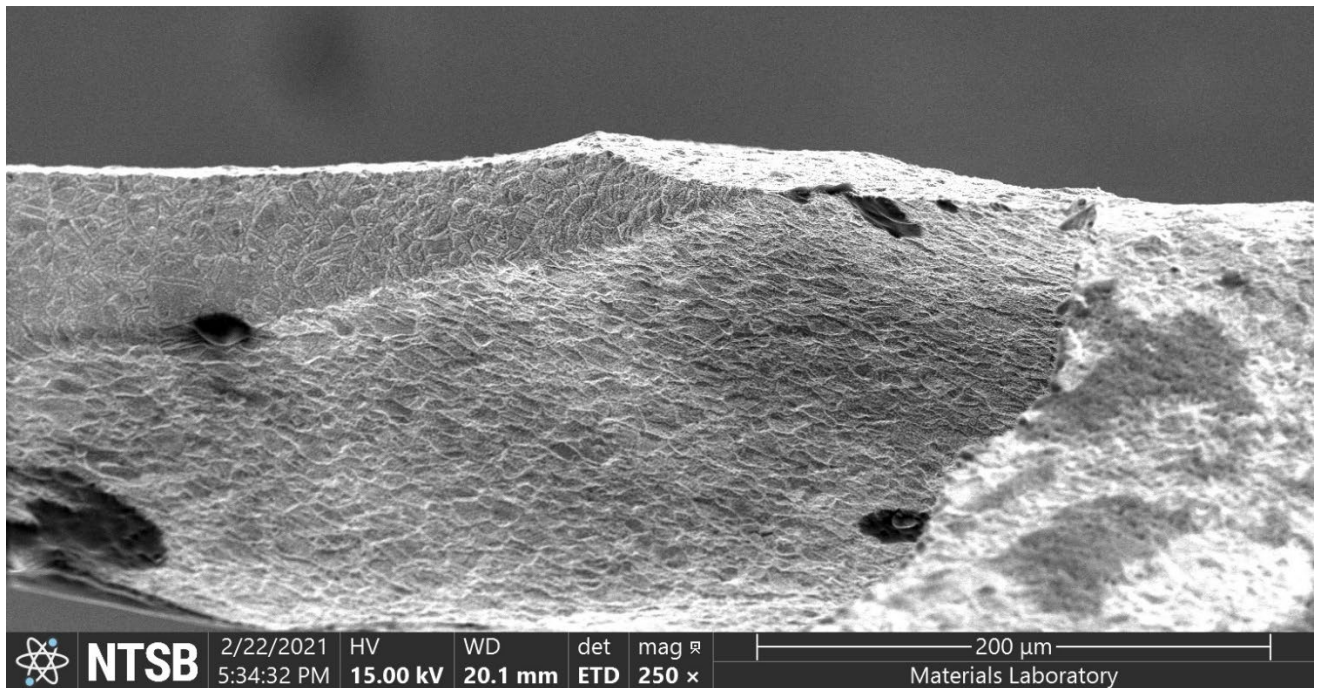
Figure 13 demonstrates the extent of the thinning at one of the fractured webs. Whereas the thickest regions were 50 to 70  $\mu\text{m}$ , the thinnest area adjacent to the fracture surface was just a few micrometers in dimension.

Figure 13 – SE micrograph of a thinned and separated web portion of the screen.

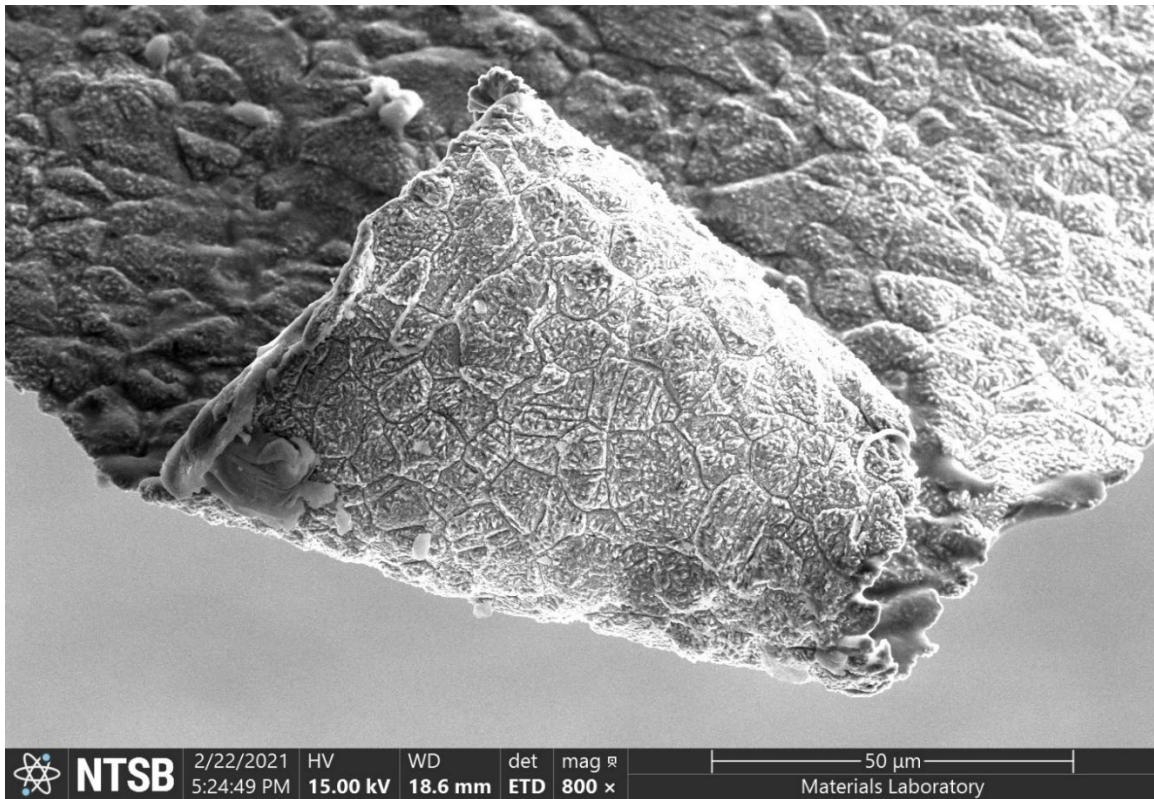
Figure 14 – SE micrograph of a closer view of the thinned web fracture in Figure 12.

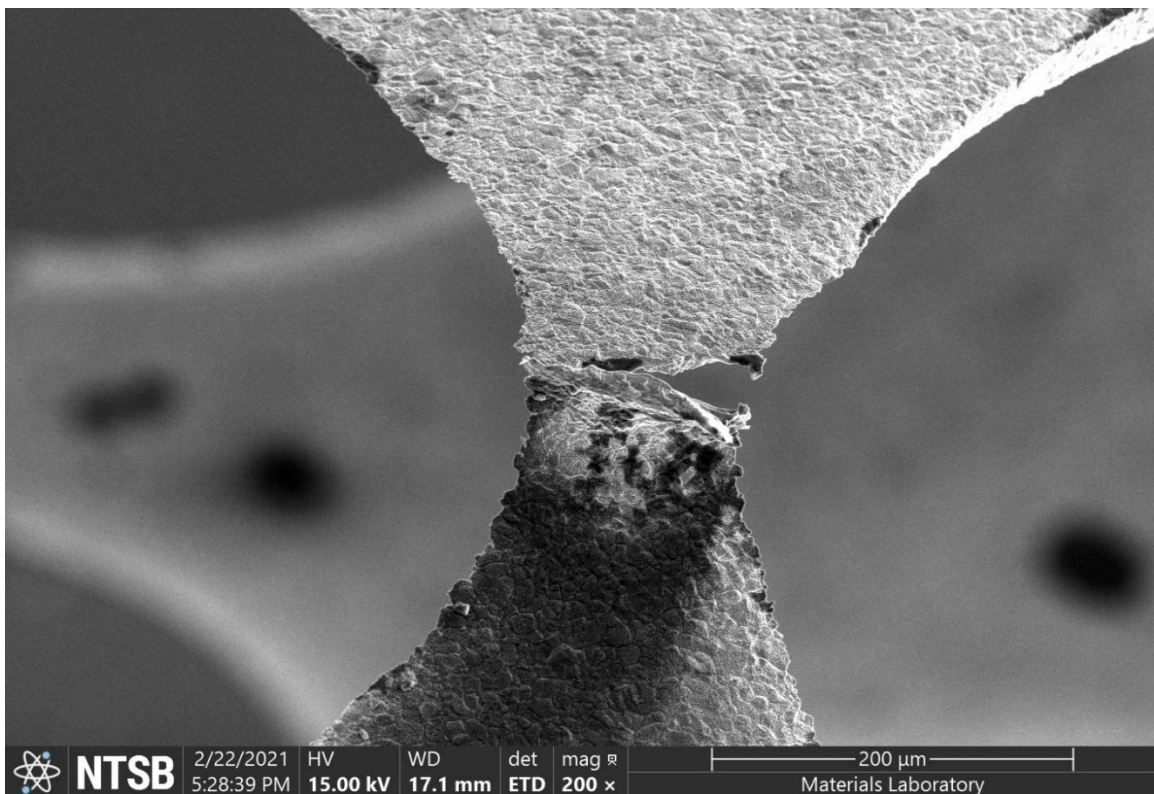
Similarly, Figure 15 shows a cracked, but not completely fractured, web of the suction screen. Here, the web had also thinned to just a few micrometers, and was cracked or fractured over 75% of the width. A closer view in Figure 16 and Figure 17 show the fractured surfaces of this region. As can be seen in the closest view, this surface exhibited striations oriented parallel to the web fragment width. These features were consistent with fatigue crack propagation of this segment (which had not completely propagated through or fractured). The orientation of these fatigue striations was consistent with bending or flexure of this web.

Figure 15 – SE micrograph of a partially fractured web.

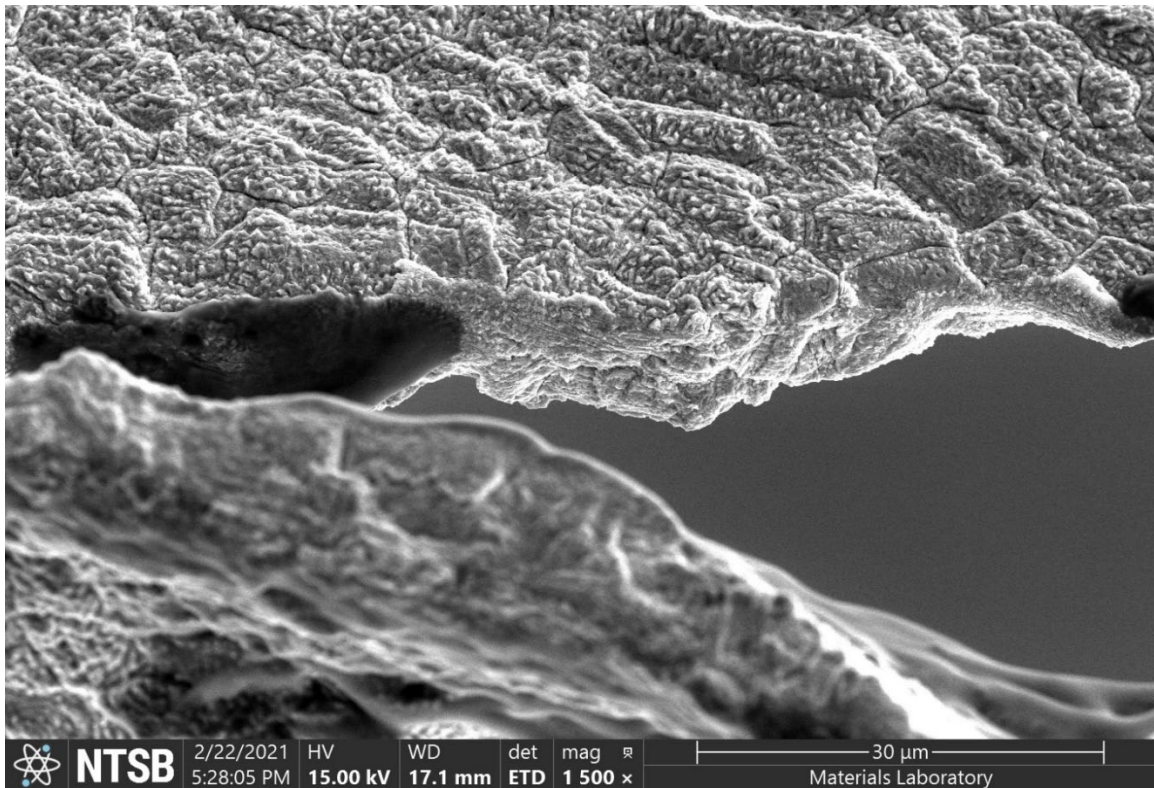
Figure 16 – SE micrograph of a closer view of the fractured part of the web in Figure 15.

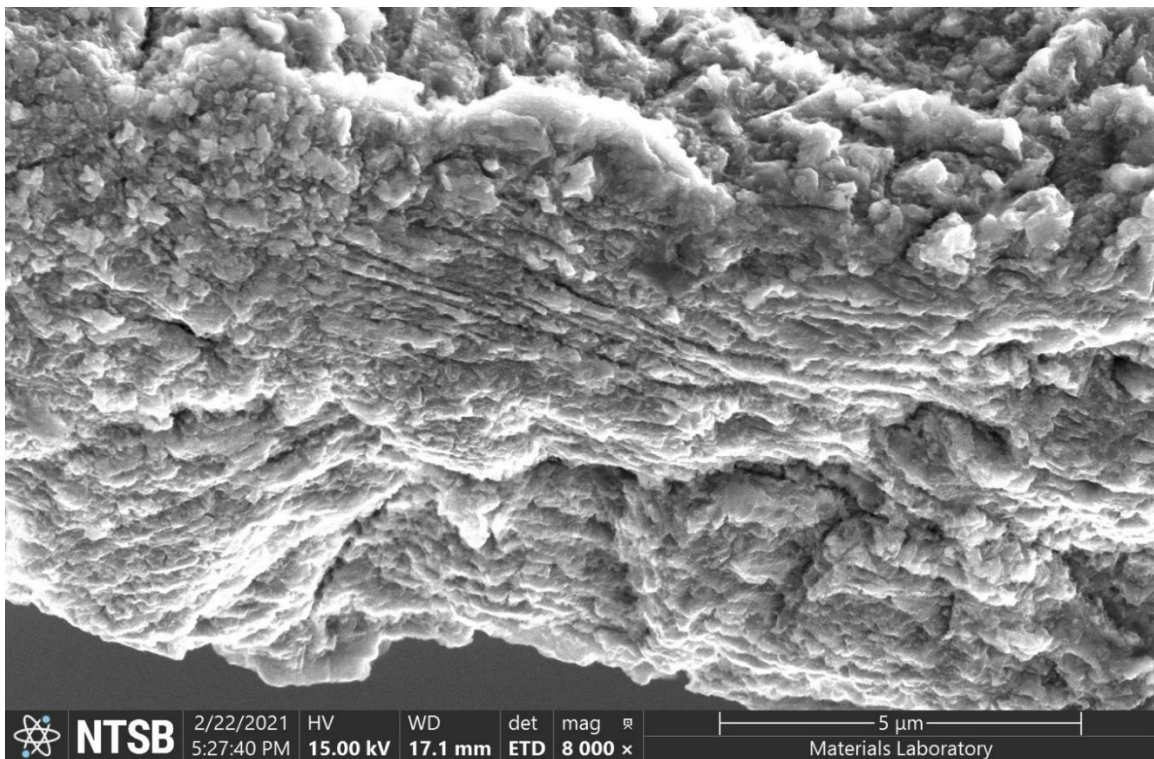
Figure 17 – SE micrograph of the fractured surface in Figure 16, showing fatigue striations.

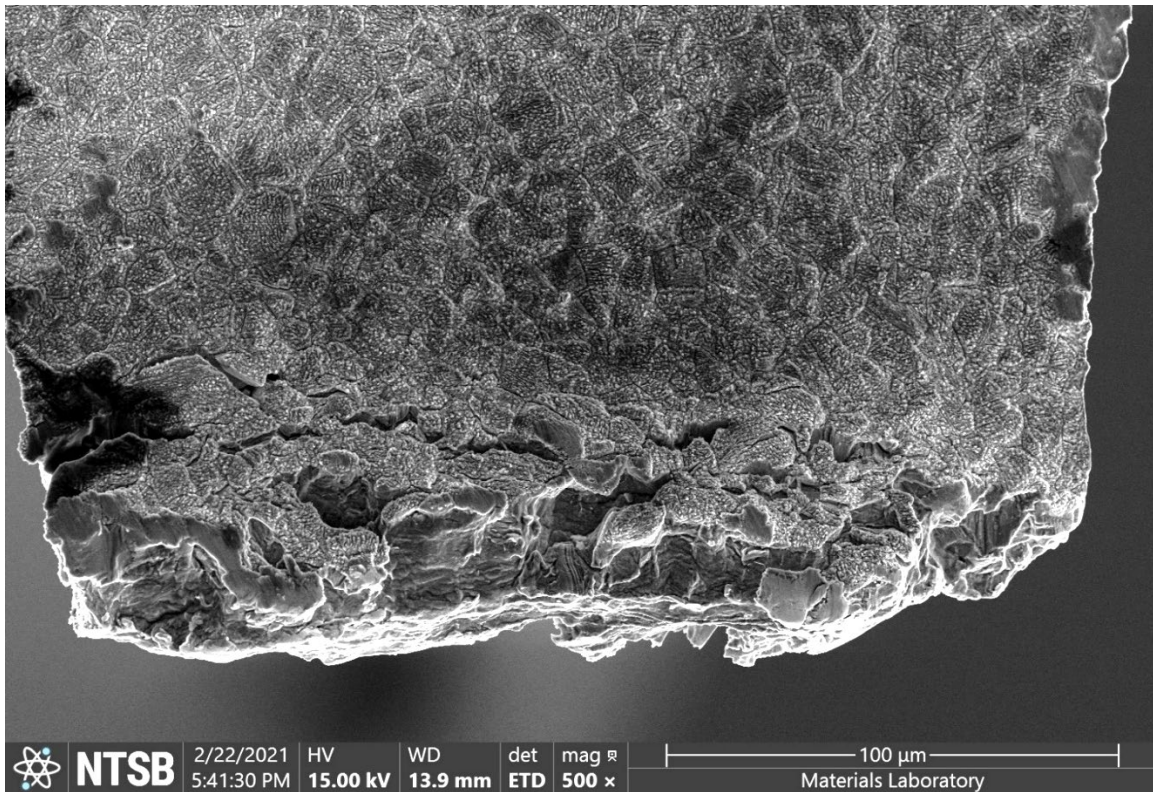
Figure 18 shows another fractured web, exhibiting a thicker cross section along the fracture surface. The area of the web adjacent to the fracture surface exhibited parallel, secondary cracking, which undertook an intergranular morphology along the grain-like features of the surface. A closer view of the fracture surface revealed similarly oriented fatigue striations to those seen on the cracked web in Figure 17.

In addition to these oxides on the surface and underneath, the some of the webs also exhibited small cracks. While some of these cracks exhibited an intergranular quality, such as shown in Figure 18, some were consistent with a transgranular morphology, as shown in Figure 24.

Figure 18 – SE micrograph of a web fracture surface, showing intergranular separation.

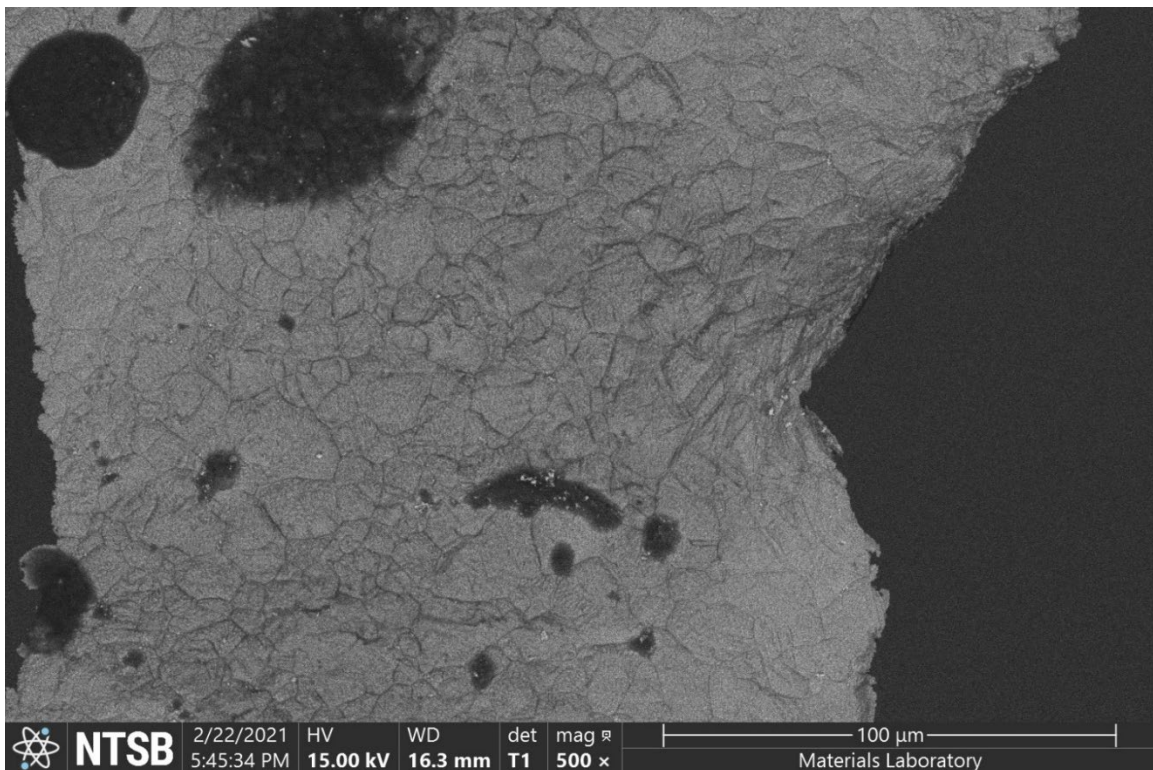
Figure 19 shows a thinned but still intact web segment. This web exhibited initial plastic deformation in the form of localized necking on the right side of the figure. The grain like features exhibited rows of parallel bands near the necked area. These features were consistent with areas of high mechanical strain in individual grains, indicating that the equiaxed surface morphology was consistent with the actual grains of the material.

Figure 19 – BE micrograph of an intact but necked suction web.

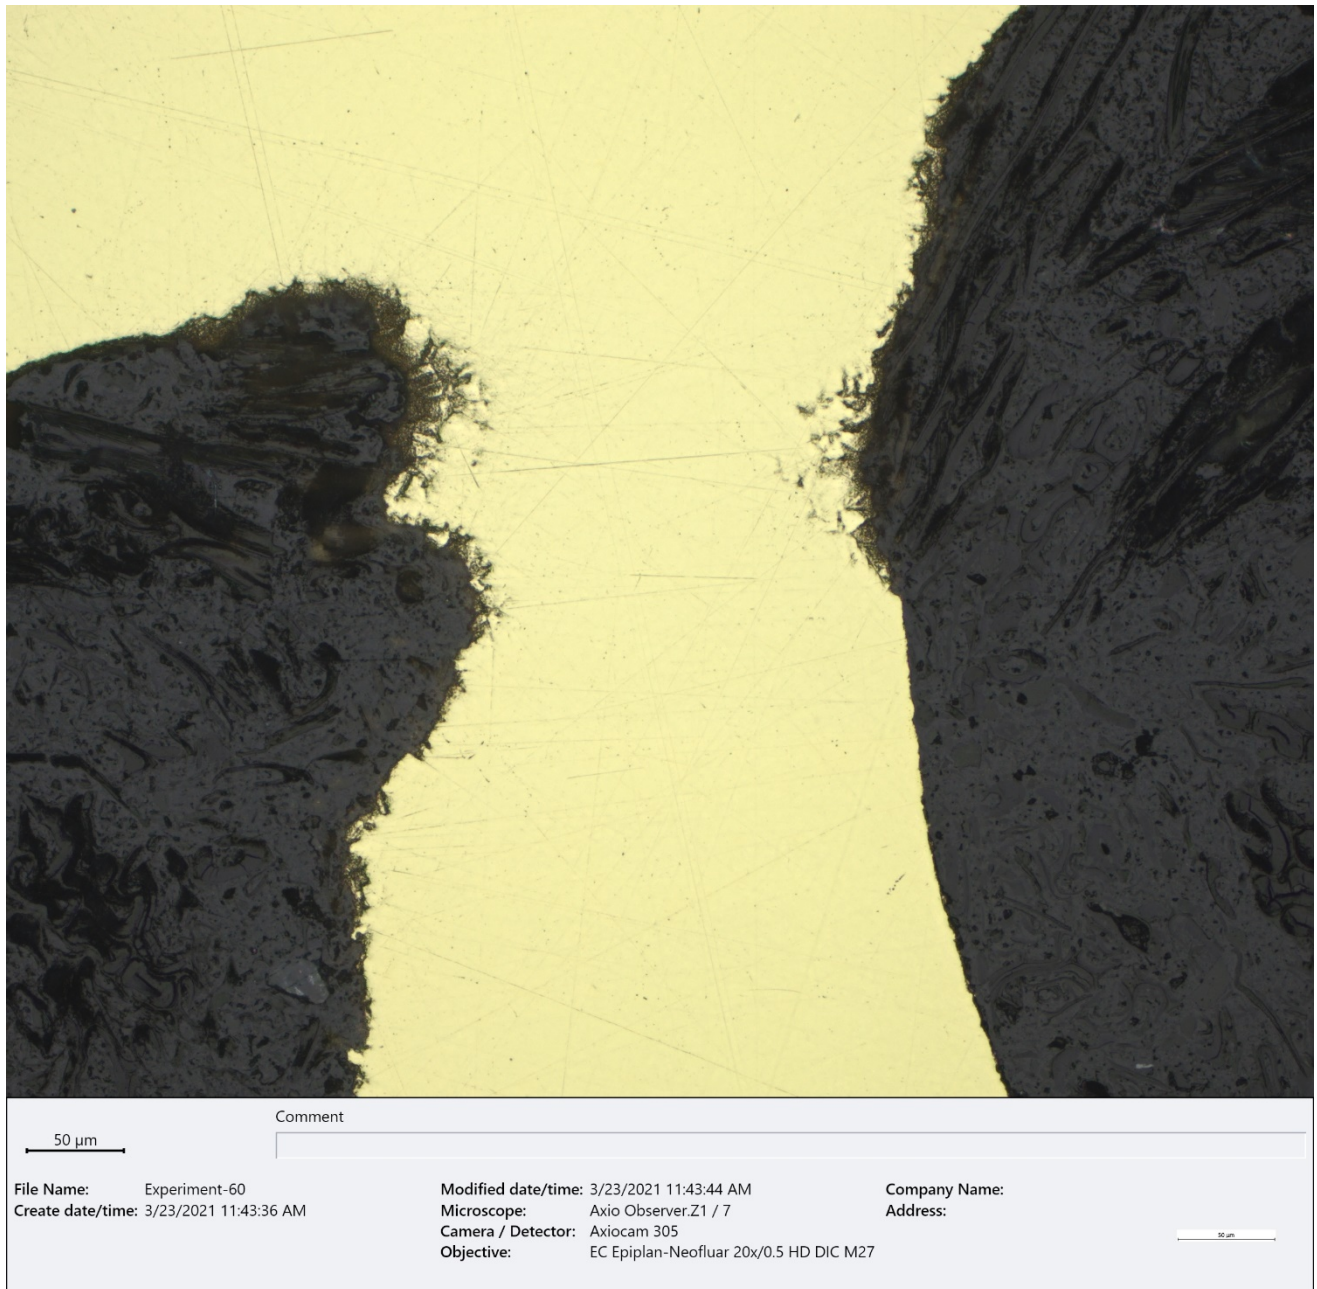
Figure 20 shows the locally thinned portion of the neck of a web. This part exhibited pit-like features of missing material. The surface cross sections of these areas exhibited darker surface material, along with features consistent with penetrating cracks. A similar pit-like feature was observed on another web as shown in Figure 21. This pit exhibited intergranular cracking or penetration.

Figure 20 – Bright-field (BF) optical micrograph of an eroded area of a still intact web cross-section (~200X, as-polished).
