# NATIONAL TRANSPORTATION SAFETY BOARD

## MATERIALS LABORATORY FACTUAL REPORT

Report No. 21-016

Place : Welsh, Louisiana  
Date : July 2, 2020  
Vehicle : Robinson R44, N7511D  
NTSB No. : CEN20LA286  
Investigator : Courtney Liedler, AS-CEN

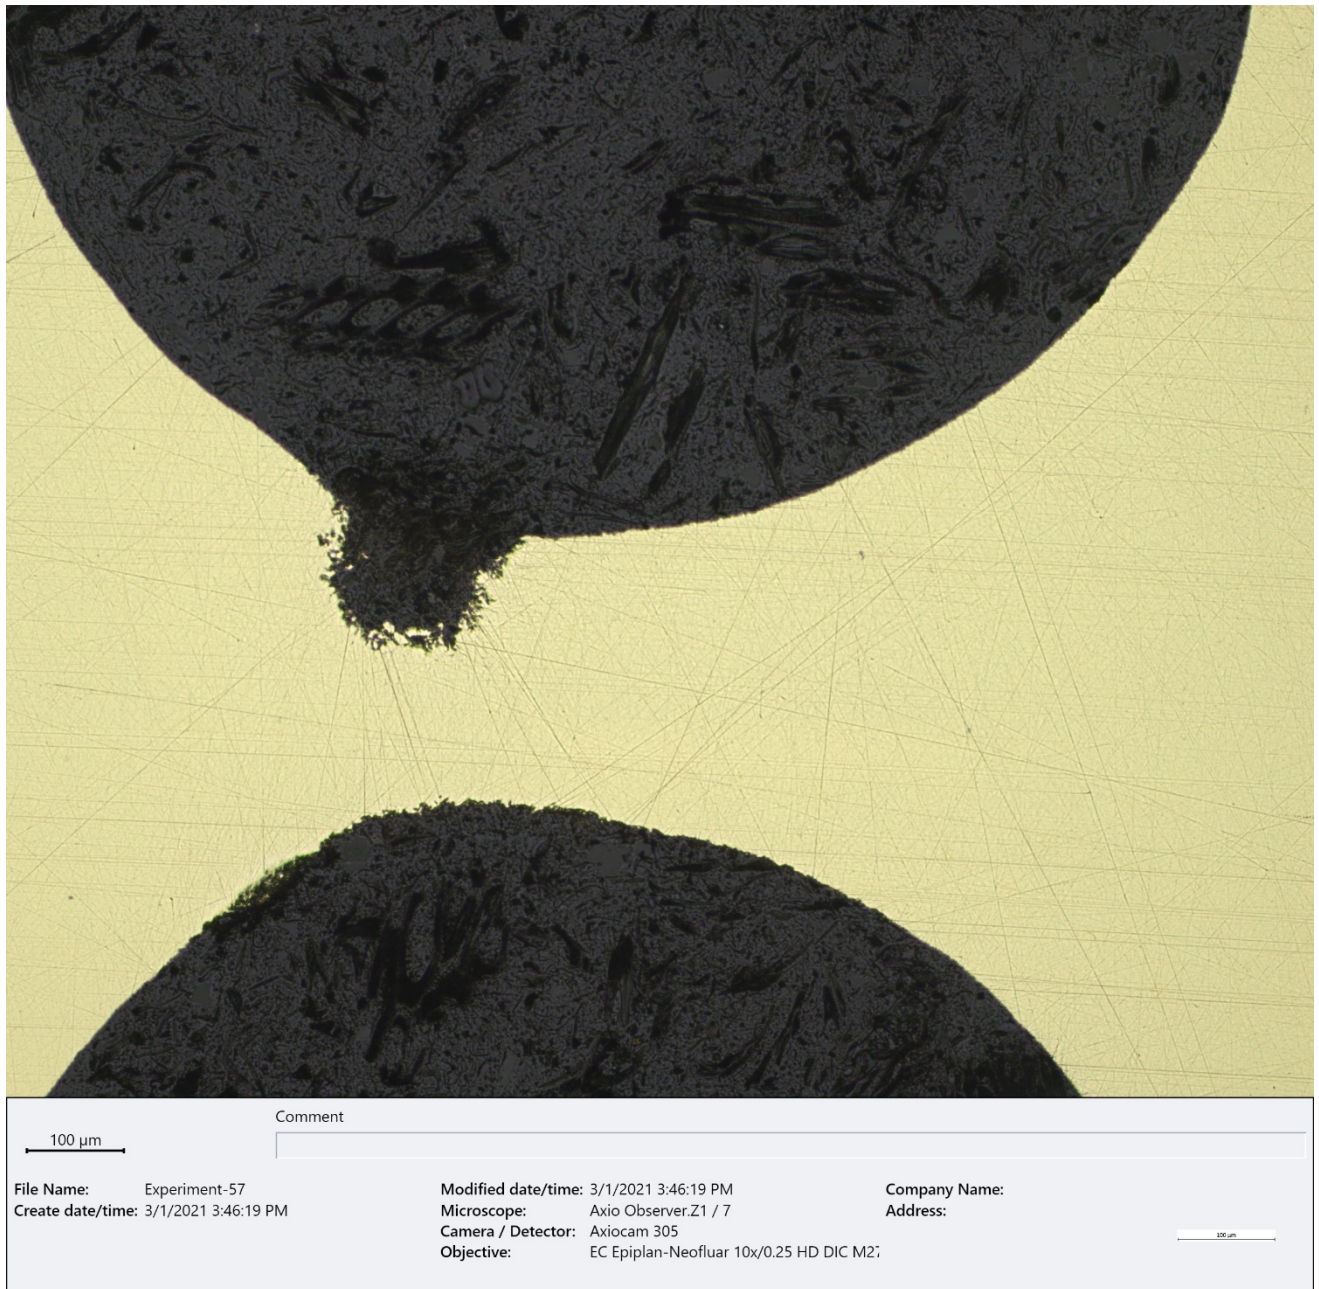
Figure 20 shows the locally thinned portion of the neck of a web. This part exhibited pit-like features of missing material. The surface cross sections of these areas exhibited darker surface material, along with features consistent with penetrating cracks. A similar pit-like feature was observed on another web as shown in Figure 21. This pit exhibited intergranular cracking or penetration.

Figure 21 – BF optical micrograph of an eroded area of a web (~200X, as-polished).

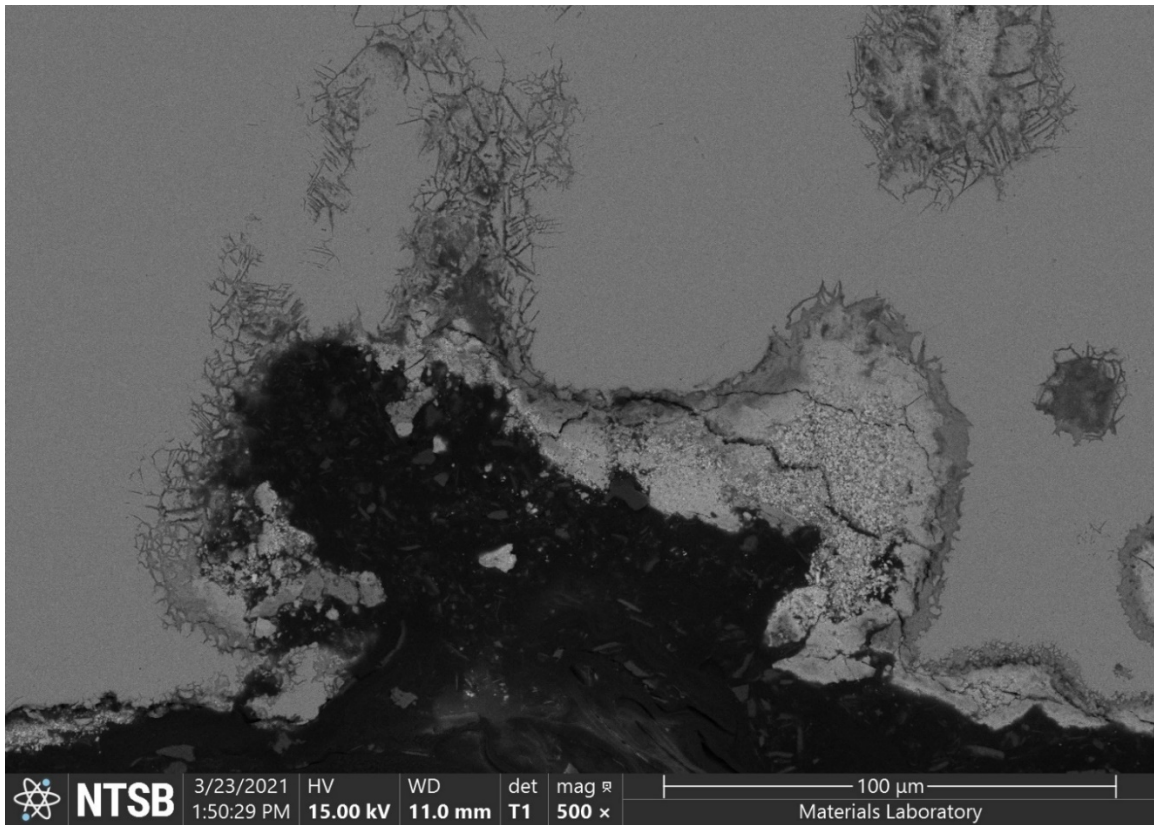
Figure 22 shows a backscattered electron micrograph of another pit-like feature. As demonstrated in the figure, the material in the pit was dissimilar from the copper-rich brass alloy of the screen. In addition, there was branching and parallel cracking features, consistent with intergranular corrosive attack along grain and subgrain boundaries. All these features were consistent with a chemical attack of the screen material.

The surface and pit regions were examined using EDS. This material was consistent with oxides of copper and zinc, consistent with byproducts from the corrosion of brass. However, these regions also exhibited high levels of lead, bromine, and phosphorus.

Figure 22 – BE micrograph of an area of a cross-sectioned web, showing localized corrosion products.

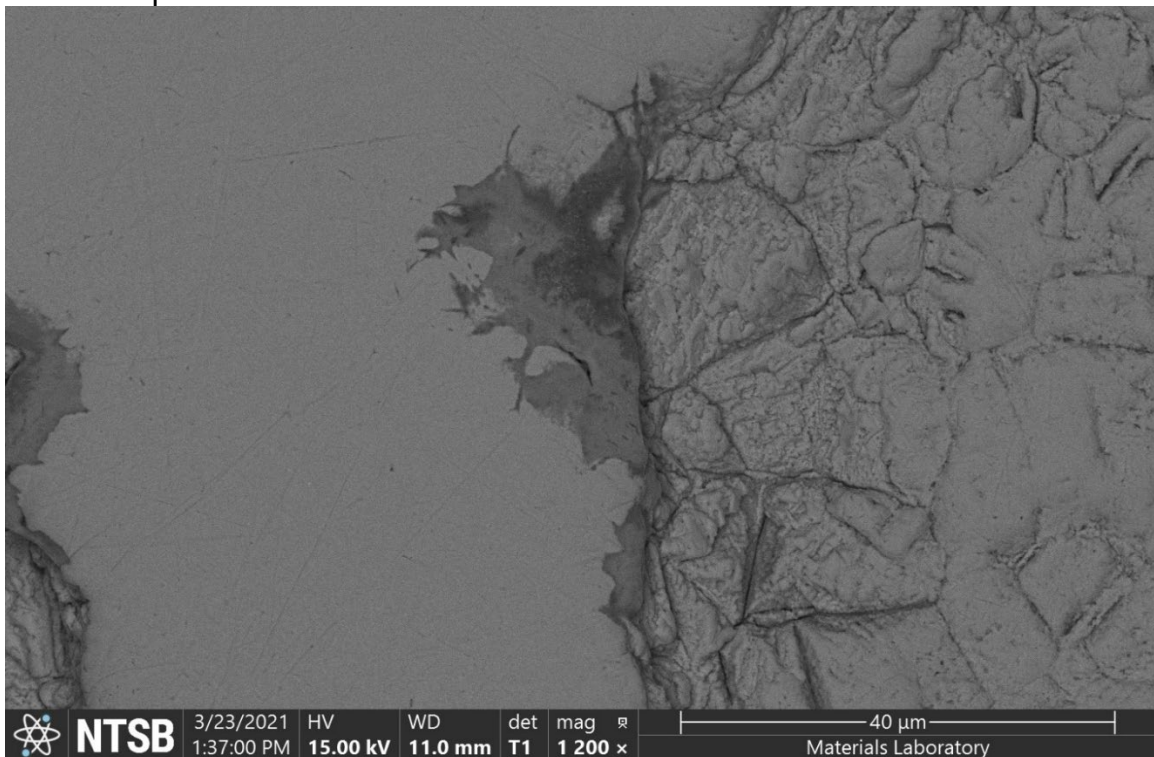
Figure 23 shows a partial cross section through a corroded web surface (the area on the left was polished through, whereas the area on the right was not, which displays the exterior web surface). This figure demonstrates the faceted morphology along the surface grains, revealing an underlying corrosion compound. This compound was consistent with those previously observed—copper/zinc oxides with high levels of lead, bromine, and phosphorus. This material also contained elevated levels of sulfur.

Figure 23 – BE micrograph of an area of partially-cross sectioned screen web, showing intergranular attack and penetrating corrosion product.

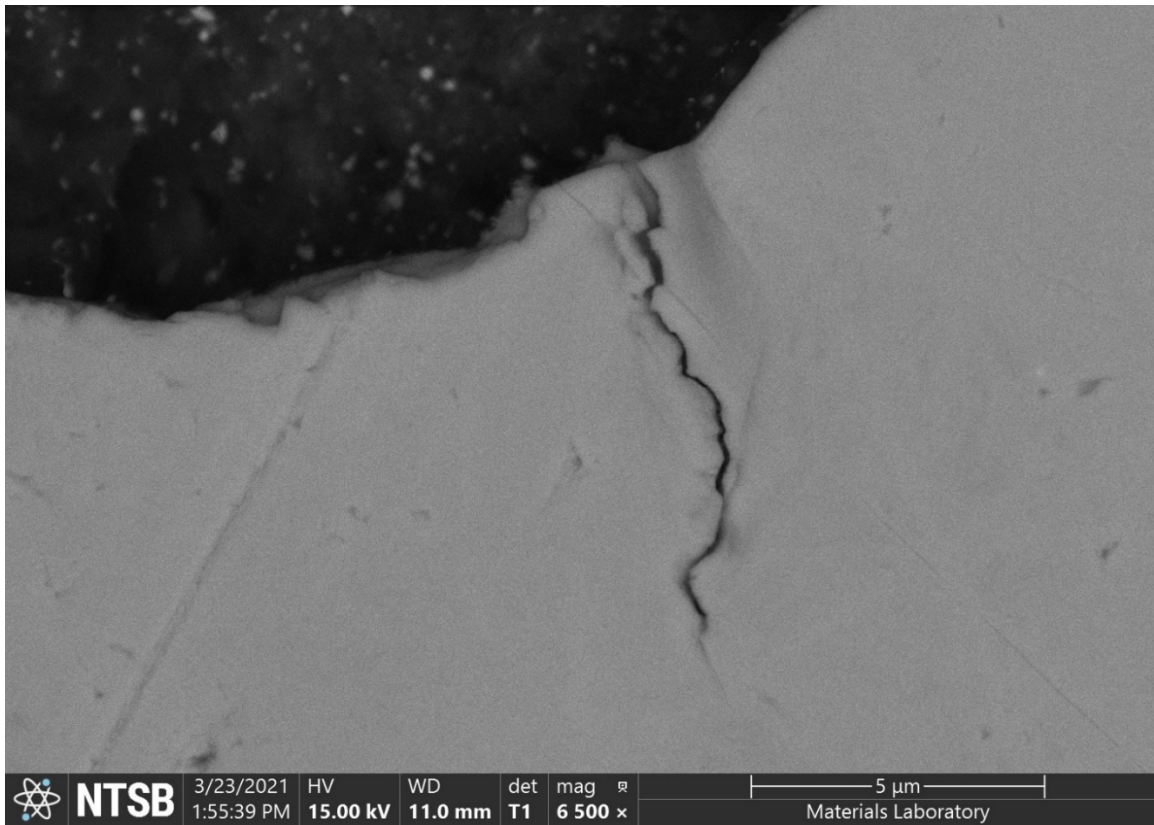
In addition to these oxides on the surface and underneath, the some of the webs also exhibited small cracks. While some of these cracks exhibited an intergranular quality, such as shown in Figure 18, some were consistent with a transgranular morphology, as shown in Figure 24.

Figure 24 – BE micrograph of a crack in a web cross-section absent corrosion.
