## 1. Applicability

All Lycoming and Continental piston engines.

## 2. Purpose

To alert operators and maintainers to the hazard of possible in-flight engine malfunction or loss of engine power which can result from undetected valve tappet body / lifter and camshaft lobe wear.

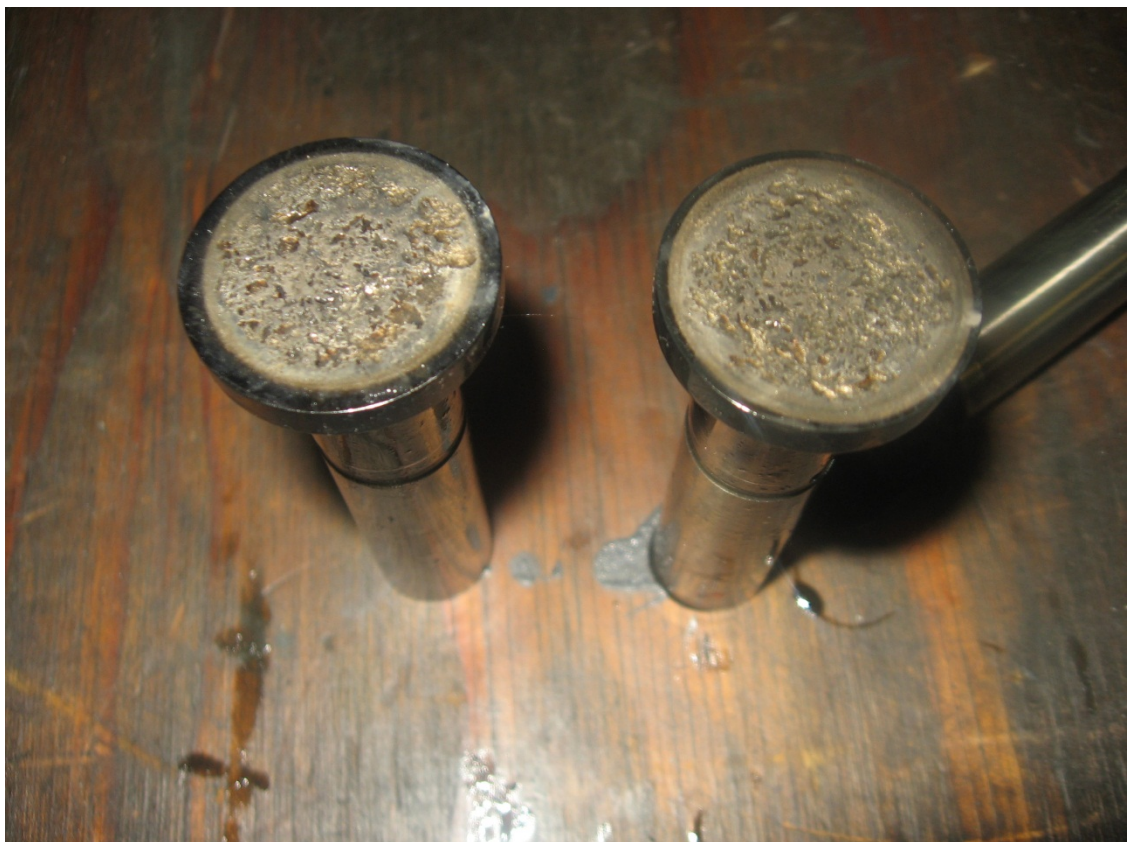
Investigations by various Lycoming engine overhaulers have found that in the majority of cases the filter contamination was directly attributed to severe spalling of the now superseded Lycoming tappet body P/N 15B26064. These tappet bodies were supplied from late 2009 until mid 2012.

**Figure 1** - Advanced spalling of Lycoming tappet body P/N 15B26064.

For example, Lycoming Service Instruction (SI) No. 1543 Dated: February 23, 2012 - "Notification of Approved Tappet P/N 15B26262", advises that tappet P/N 15B26262 is the approved replacement for Tappet P/N 15B26064 with compliance at next overhaul, whenever tappet replacement is necessary, or earlier at owner's discretion.

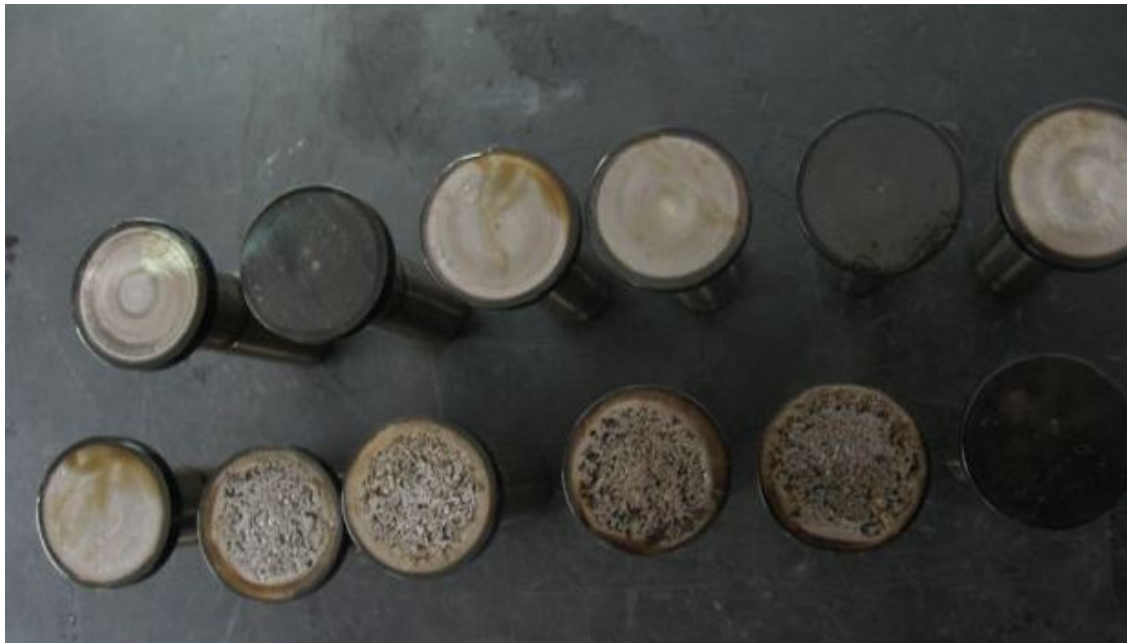
**Figure 2** - Spalled P/N 15B26064 tappets showing the various stages of deterioration that can exist between tappet bodies in one engine.

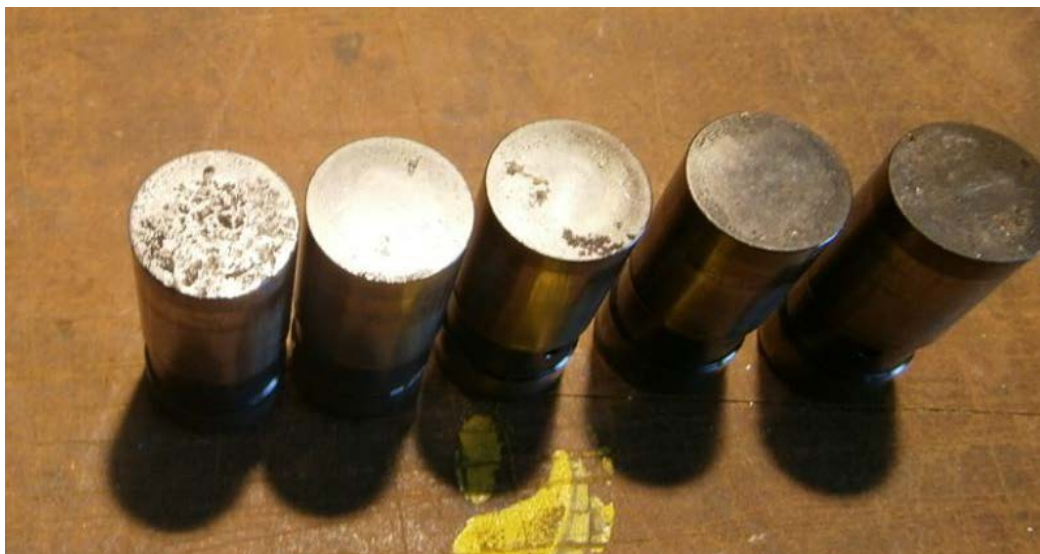
**Figure 3** - Spalled TCM Continental hydraulic valve lifters P/N 653877, Note that P/N 653877 is not currently identified as a mandatory replacement in TCM MSB09-8A which states that lifter failures can present a safety of flight issue.

The FAA have issued AD 2010-11-04 mandating TCM Continental Mandatory Service Bulletin (MSB) No. MSB09-8A, which provides similar information, and may require the replacement of certain part number hydraulic lifters before further flight.

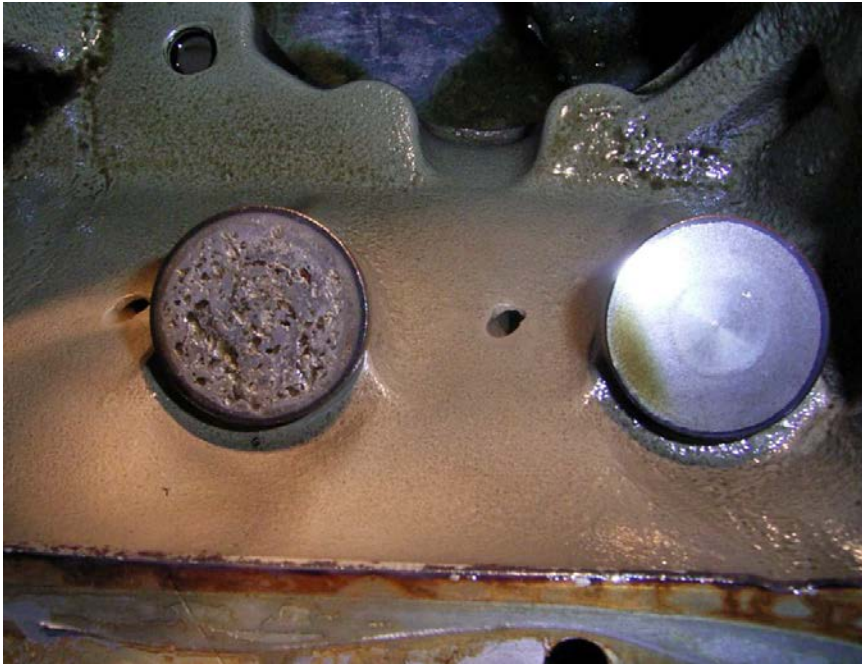
**Figure 4** - Tappet Body P/N SL72877 - Variation in the condition of adjacent tappet body faces

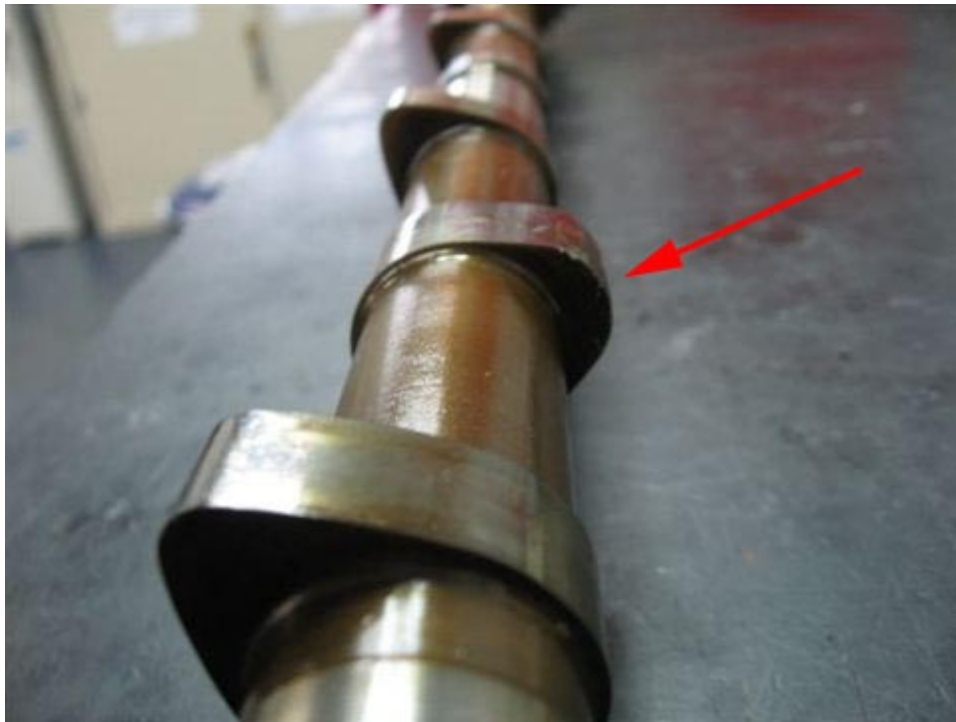
Camshaft wear will result in loss of engine performance due to loss of volumetric efficiency and subtle changes in valve timing. Cam lobe wear may be most pronounced where two valve tappet bodies share the same cam lobe, (e.g. intake valve train).

**Figure 5** - Worn Lycoming camshaft lobe which was operating with a spalled tappet body P/N15B26064.

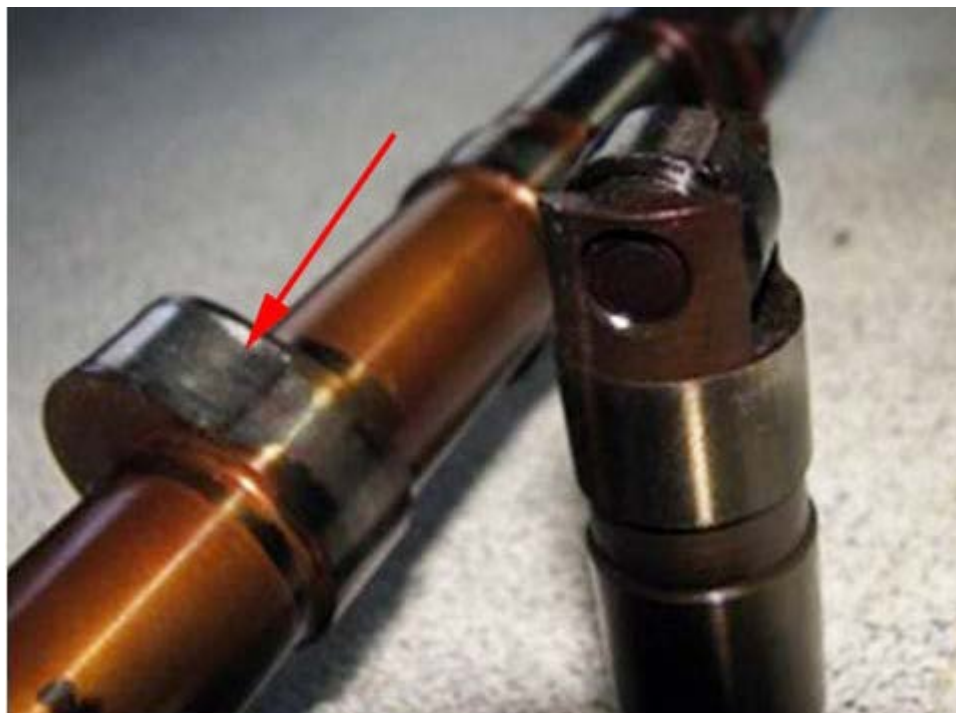
**Figure 6** - Lycoming roller cam follower and worn cam lobe.

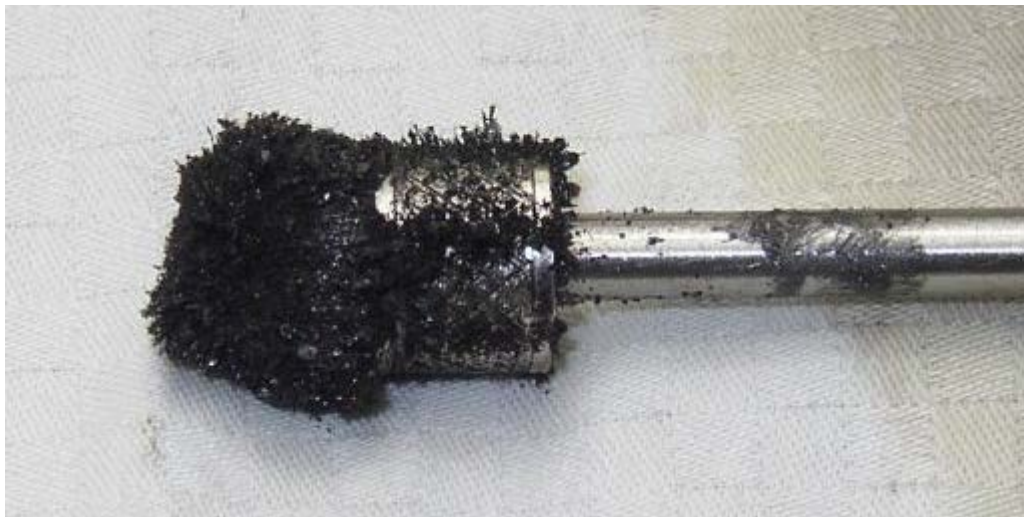
The first indications of abnormal tappet face wear are commonly reported to be very fine magnetic particles in the engine oil pressure filter element. Metallic contamination of the engine oil supply may result in a wide range of problems including; propeller and turbocharger control malfunction, gear tooth wear and a reduction of oil pressure due to wear in engine bearings.

**Figure 7** - Very fine magnetic particles, typically eroded from tappet bodies / lifters and camshaft lobes, extracted from an engine oil filter element.

Whenever metallic debris is detected in the filter or the volume of engine oil filter debris remains at a high level or exceeds the manufacturer's limits, the source of the debris should be identified and any problems corrected prior to further engine operation. Due to the difficulty in detecting the early stages of adverse tappet body wear, the periodic removal of a cylinder and use of a boroscope to inspect the cam and lifter faces may be a more reliable method than using oil filter debris alone to determine cam and tappet serviceability.
