**Air Tractor, Inc.**  
Accident Investigation

**FINAL REPORT**

**CEN20LA306**

**7/25/20**  
**Grant, NE**

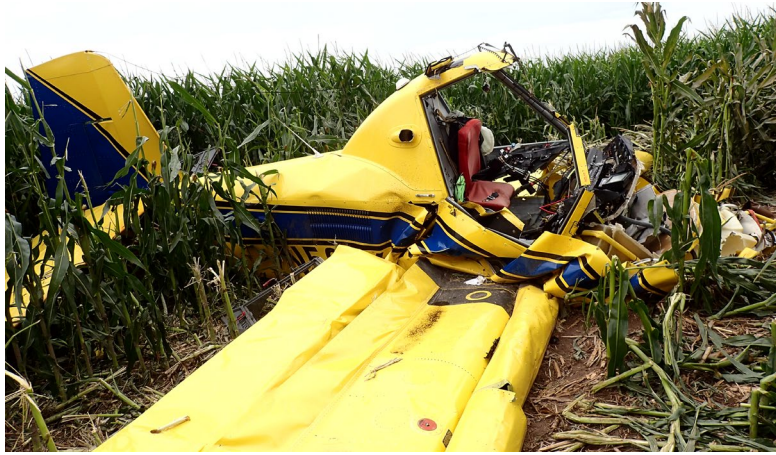
The aircraft was found upright position with crush damage to the forward fuselage and wings. The aft fuselage and empennage were found with minimal crush damage. The fuselage was found on an east-northeast heading. No horizontal debris trail or ground scars were found leading up to the wreckage. A small fire was reported.

**Fuselage Wreckage**

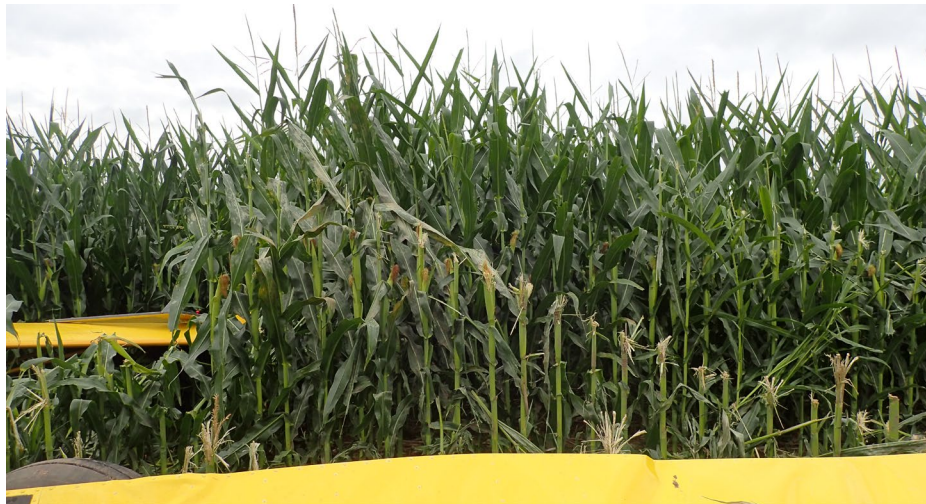
**Damaged Corn Stalks Behind Left Wing**

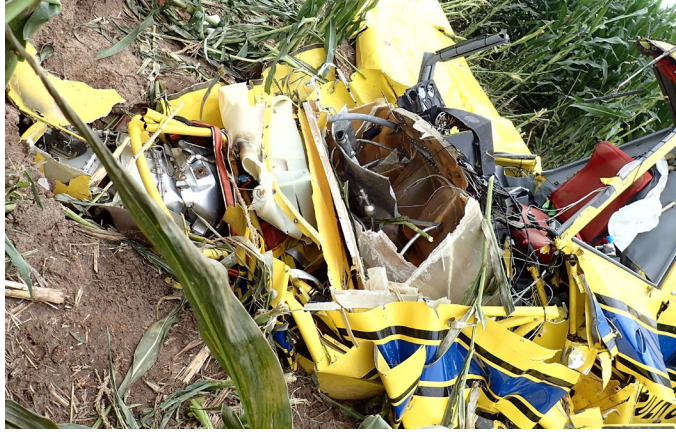
The fuselage aft of the cockpit was found upright and generally intact. The fuselage forward of the cockpit was heavily damaged, crushed aft and upward. The cockpit area was found to have maintained occupiable space. The airplane was equipped with AmSafe Inflatable Restraints (airbags), which were found in the deployed state. The restraints were found unbuckled. Both shoulder harnesses were found to have separated at the buckle.

**Forward Fuselage Wreckage**

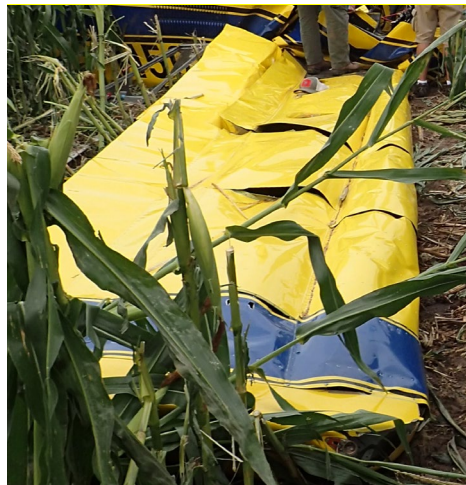
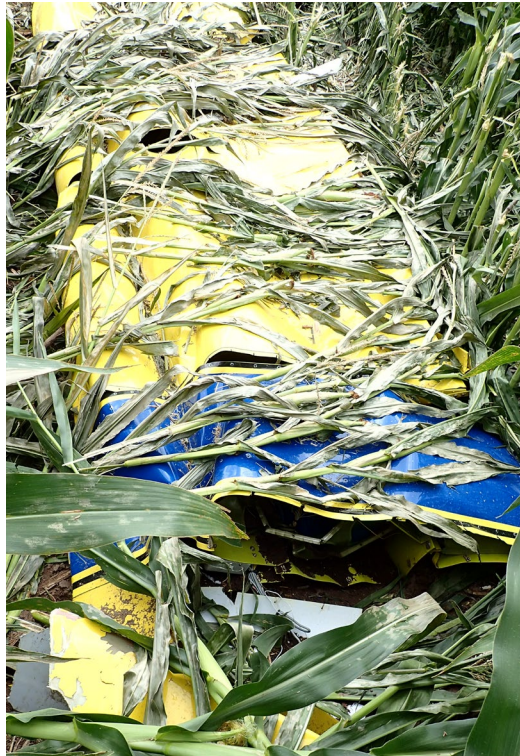
The wing center splice connection was found intact. The wings were found attached to the fuselage. Both wings were found with crush damage aft and up. The left wing rear spar was found separated from the fuselage consistent with overstress. The hardware was found attached to the fuselage frame. Both flaps and both ailerons were found attached to the wings.

**Right Wing Wreckage**

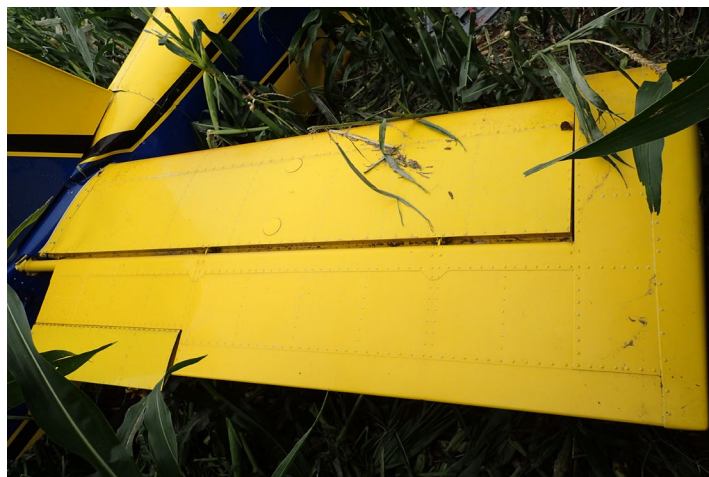
The empennage surfaces were found present at the aft end of the fuselage. The vertical fin remained attached to the aft fuselage. The left horizontal stabilizer was found separated from the upper fuselage attach points consistent with overstress. The right rear horizontal stabilizer attach point was found separated consistent with overstress. The left and right v-struts remained attached to the horizontal stabilizers and to the aft fuselage. The left and right horizontal stabilizers were found with crush damage to the forward inboard corners.

**Right Horizontal Stabilizer**

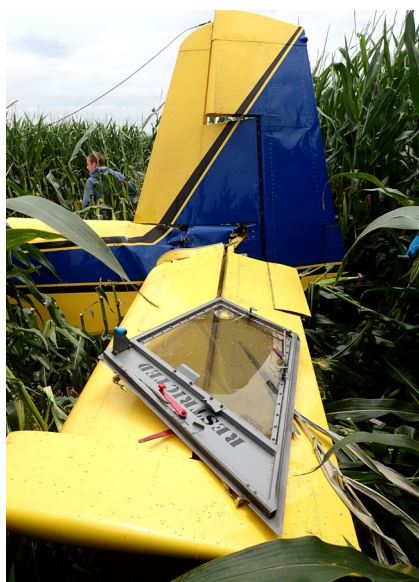
**Empennage Wreckage**

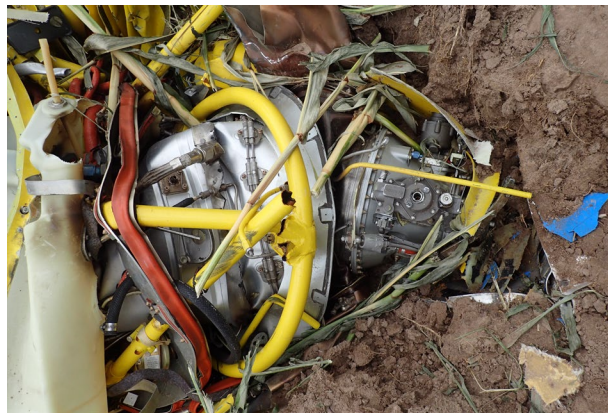
The powerplant remained attached to the engine mount and firewall portion of the fuselage. The engine exhibited impact damage. The engine was confirmed to be a Pratt & Whitney PT6A-34AG engine, serial number PCE-PH0759.

**Engine Wreckage**

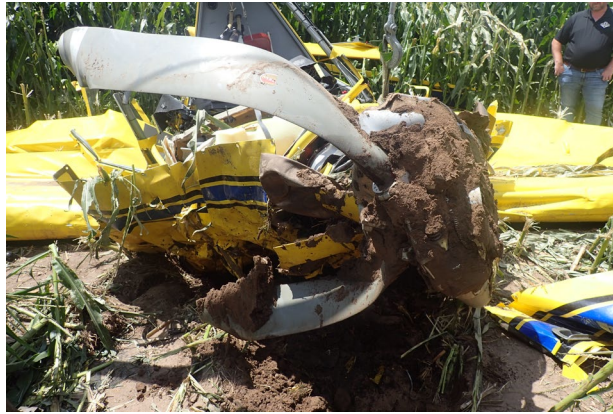
The engine was equipped with three-bladed constant speed, fully reversable, propeller. One of the blades was found separated from the hub with the blade tip separated from the blade. The remaining two blades were found attached to the hub. One of the blades found attached to the hub was found with the blade tip separated.

**Propeller Wreckage**
