**NATIONAL TRANSPORTATION SAFETY BOARD  
Office of Aviation Safety  
Washington, DC 20594**

**SUMMARY OF AIRFRAME AND ENGINE EXAMINATION**

**CEN20LA309**

Location: Corsica, SD  
Date: 7/22/2020  
Time: 1415 MDT  
Aircraft: [Cessna A188B (S/N 18801655) N53163]

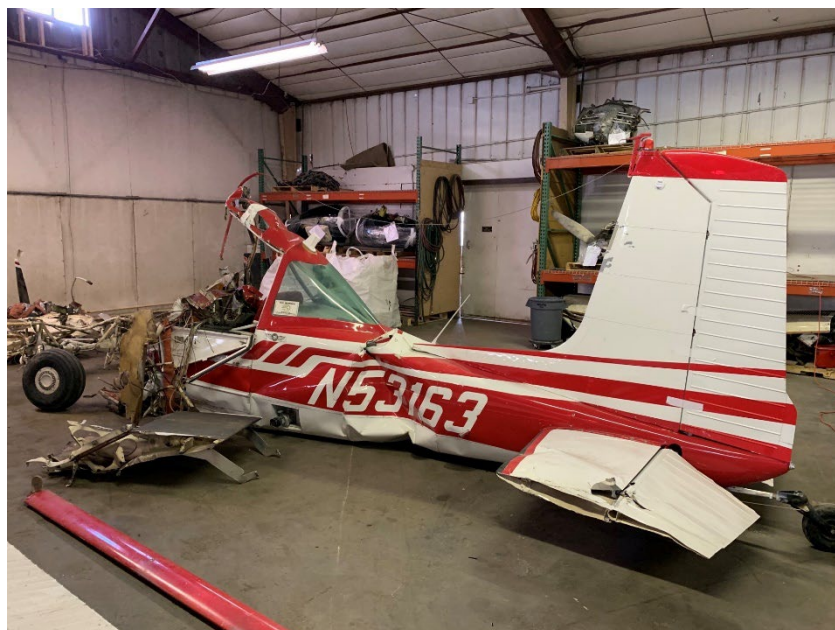
Figure 1, Airplane

The airplane was laid out in one of Beegles’ hangar facilities. The left and right wings and wing struts were separated from the fuselage. The landing gear, hopper, engine, and propeller were also separated and examined as separate components.

Flight control continuity was confirmed. All structural damage to the airplane was consistent with ground impact.

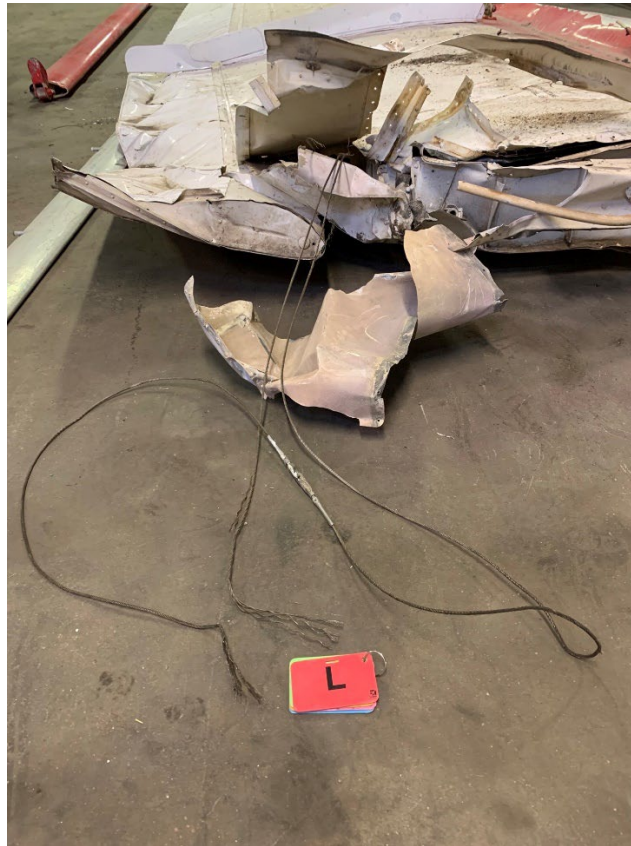
Figure 2. Left Wing Aileron Cables

The left aileron cables were located. Both cables displayed unraveling and appeared to be fractured in tensile overload. A close up look at the unraveled individual strands showed evidence of necking and cup/cone failure indicative of being pulled apart. The left aileron down cable was fractured near the pulley adjacent the control stick and the carry through cable was fractured near the right wing root. The cables were traced to the bellcrank and rod to the aileron. Everything was connected. When pulled the cables moved the aileron surface. The aileron itself was in good condition.

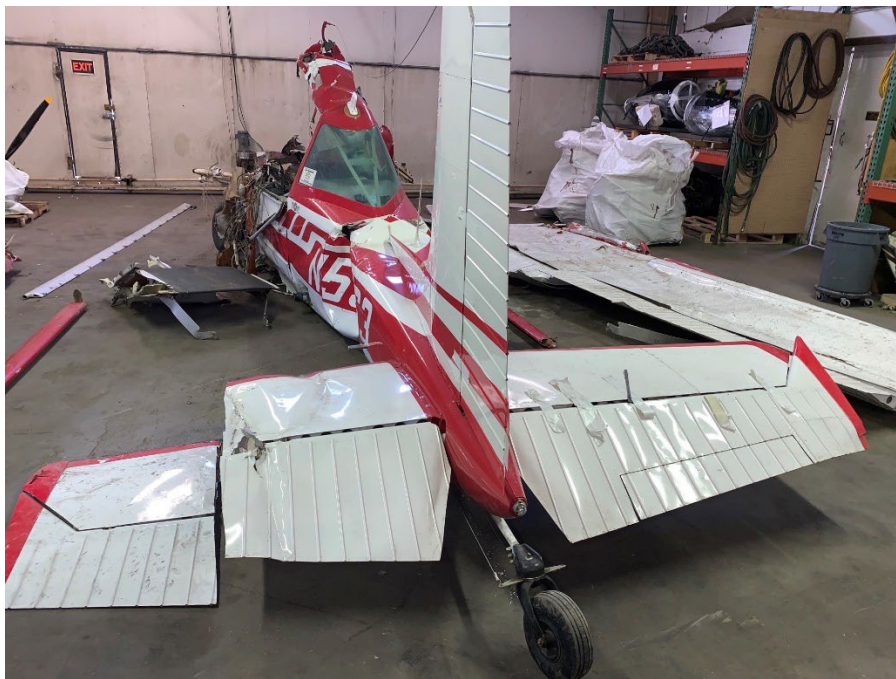
Figure 3, Empennage

The elevator, rudder, and tail wheel cables were continuous from the surface actuators through the fuselage to the cockpit. The left horizontal stabilizer and left elevator had been cut longitudinally about 24 inches outboard of the fuselage by recovery personnel. The right horizontal stabilizer, right elevator and elevator trim tab, vertical stabilizer and rudder remained attached to the fuselage. The vertical stabilizer and rudder showed no damage. The tail wheel was also undamaged. The elevator trim tab actuator was extended 1.6 inches.

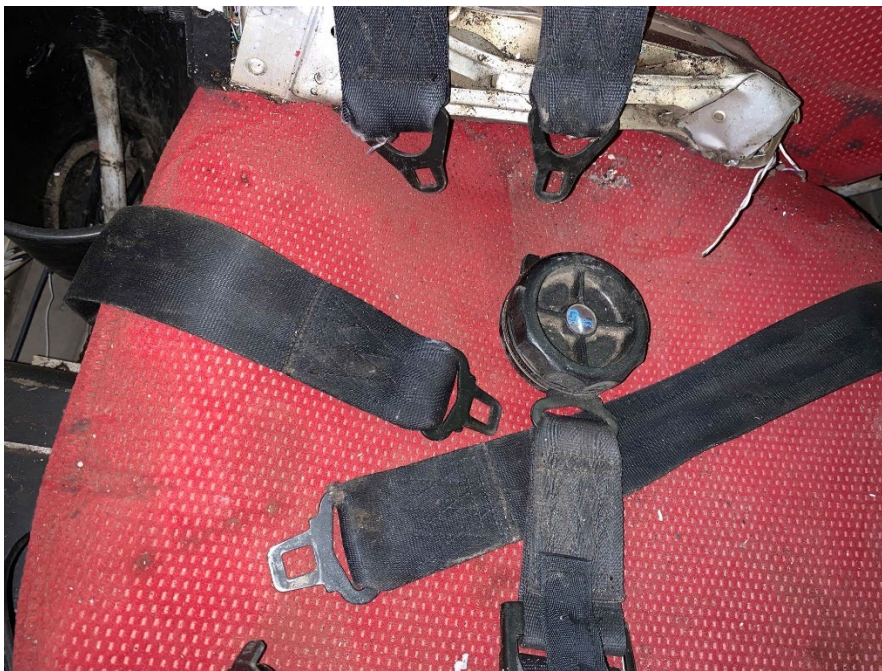
Figure 4, Restraints

The five-point restraint system was intact. All straps were undamaged save some minor fraying on the left shoulder strap and the right lap belt at the bayonets. Examination of the witness marks on the bayonets on the lap belt and shoulder harness restraints were consistent with the belts being fastened when the crash occurred.

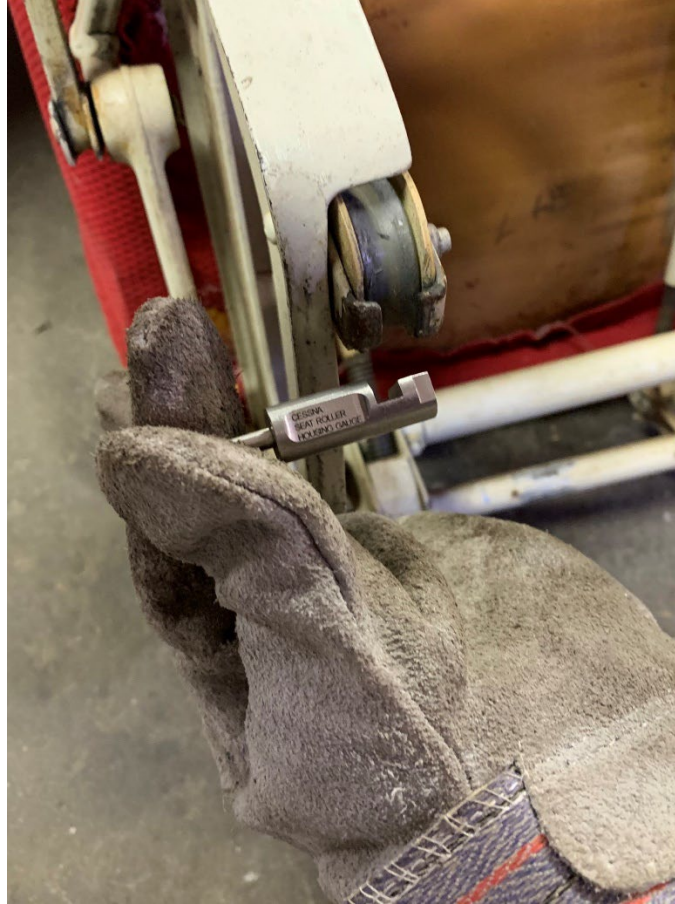
Figure 5, Seat Roller Housing

The pilot seat right front roller assembly had come off the right seat rail. The left front roller assembly was also loose from the rail. The pilot seat adjustment pin was found broken at the guide pin hole. Witness marks on top of the left seat rail indicated the seat was likely pinned in the 1<sup>st</sup> or second hole aft at the time of impact. The seat rails met all measurement tolerances.

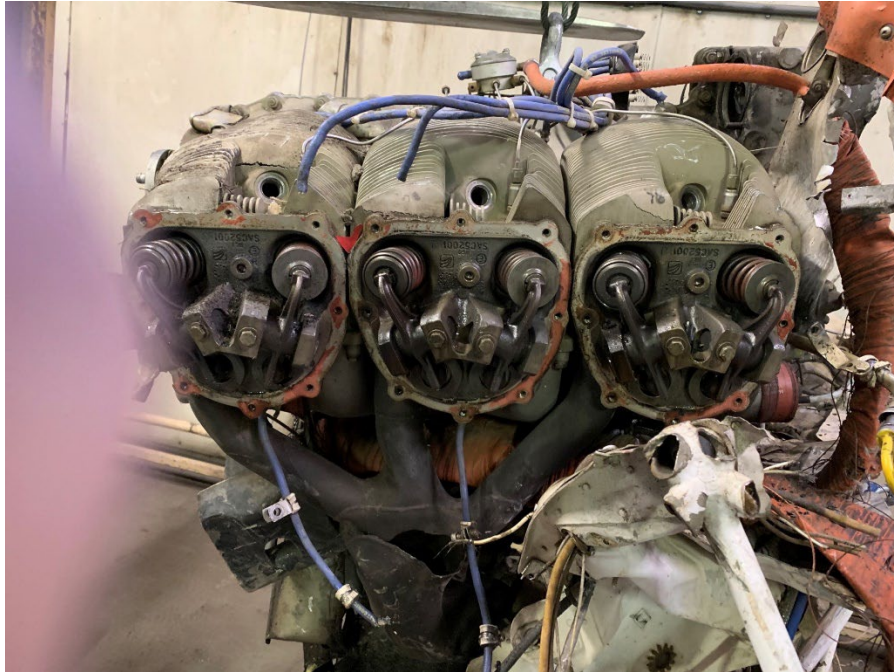
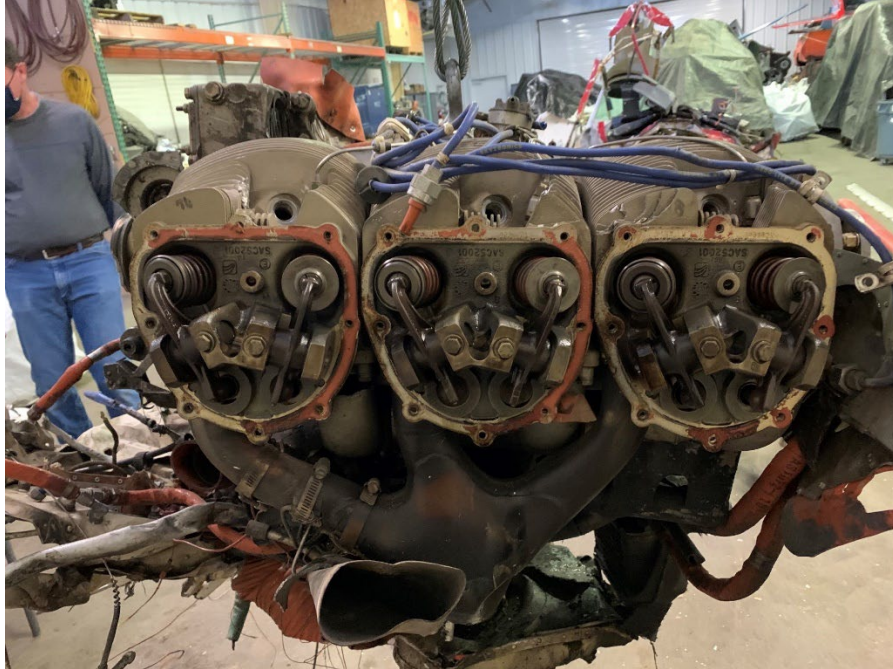
The rocker box covers were removed, and the crankshaft was manually turned. Intake and exhaust valves on all six cylinders moved normally. The crankshaft and camshaft rotated smoothly and the camshaft gear drove the two magnetos drives. Push rods to the rocker arms moved smoothly. Thumb compression was conducted at the top spark plug holes. All cylinders showed good compression. Accessory drive gears all moved freely.

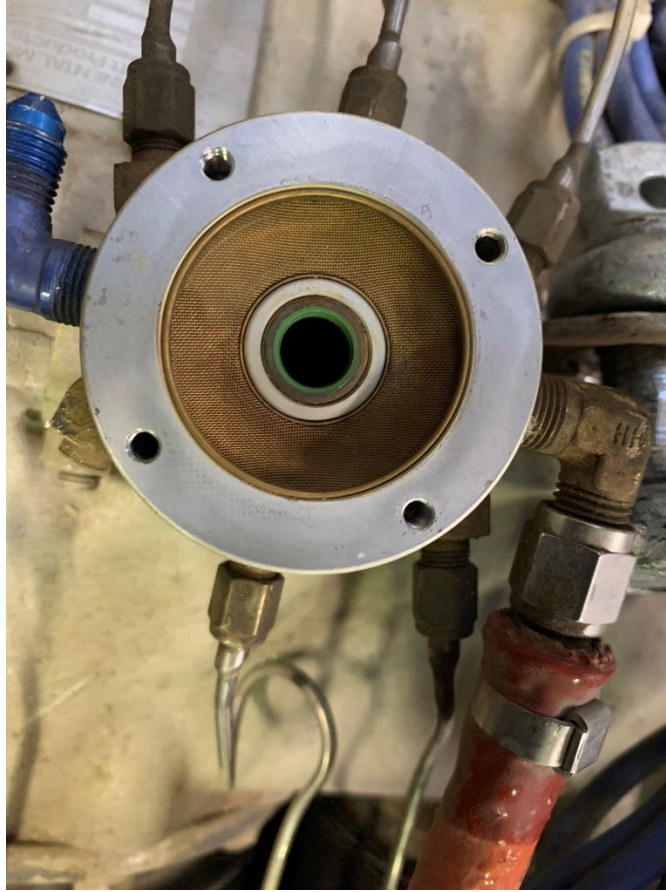
Figure 8, Fuel Distribution Manifold Screen

The fuel distributor cap was removed, and the screen examined. There was no debris beneath the screen. The 6 fuel injectors were removed and examined. They were clean.

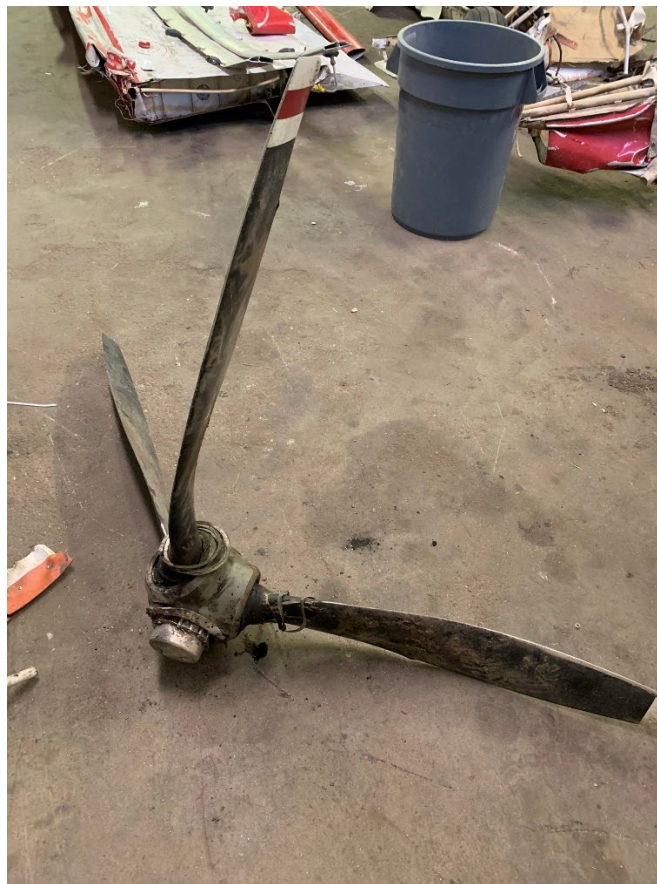
Figure 10, Propeller

The three-bladed McCauley propeller was separated from the flange. All three blades cuffs were broken at the hub. Part of the hub was broken out. The three blades were broken aft and in fair condition. One blade was bent aft 10 degrees approximately 2 inches outboard of the hub. The second blade showed forward bending at mid span. The third blade was straight and showed little damage. All three blades showed some leading edge polishing and chordwise scratches. Two blades showed trailing edge nicks.

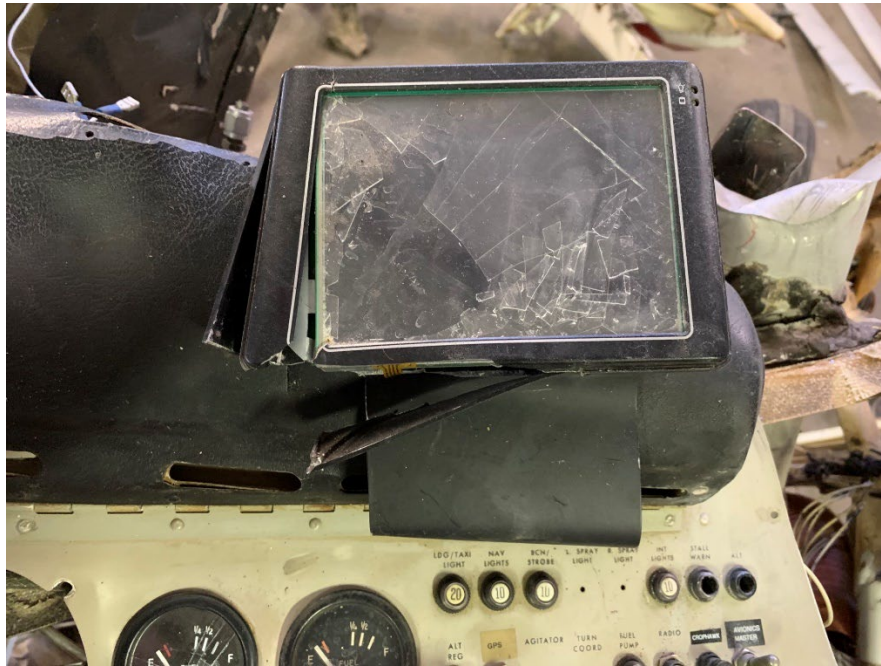
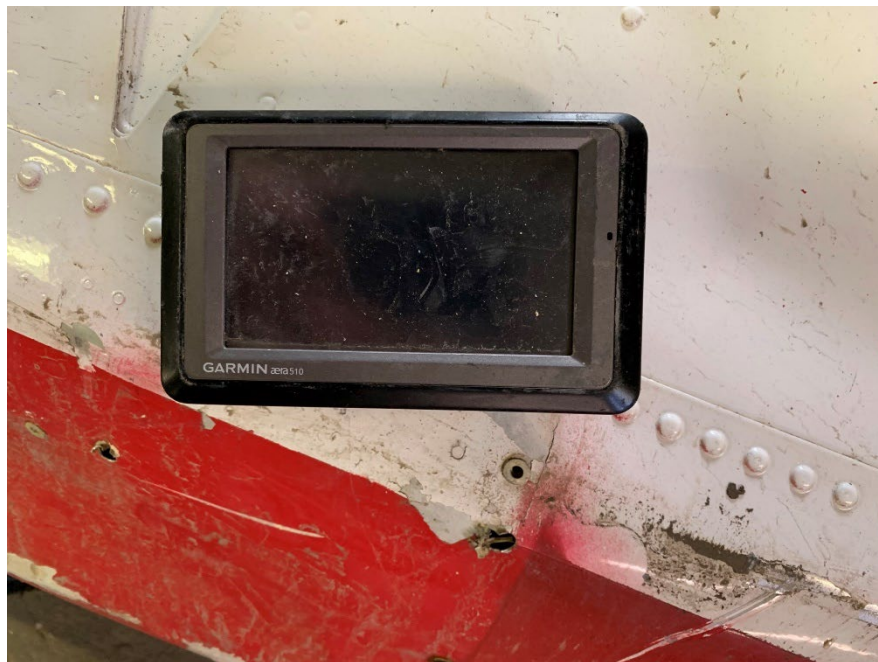
A Garmin handheld GPS and a DynaNav computer satellite locator [Part No. PDX-057T-8A-512 Serial No. 57TS10020012] with SD cards were removed from the cockpit and

instrument panel; they were retained on behalf of the NTSB Investigator-in-Charge for download and read out.
