**NATIONAL TRANSPORTATIONS SAFETY BOARD  
Office of Aviation Safety  
Washington, DC 20594**

**SUMMARY OF AIRPLANE EXAMINATION**

-- CEN20LA314 --

Aircraft: Piper PA-28R-200, N15302

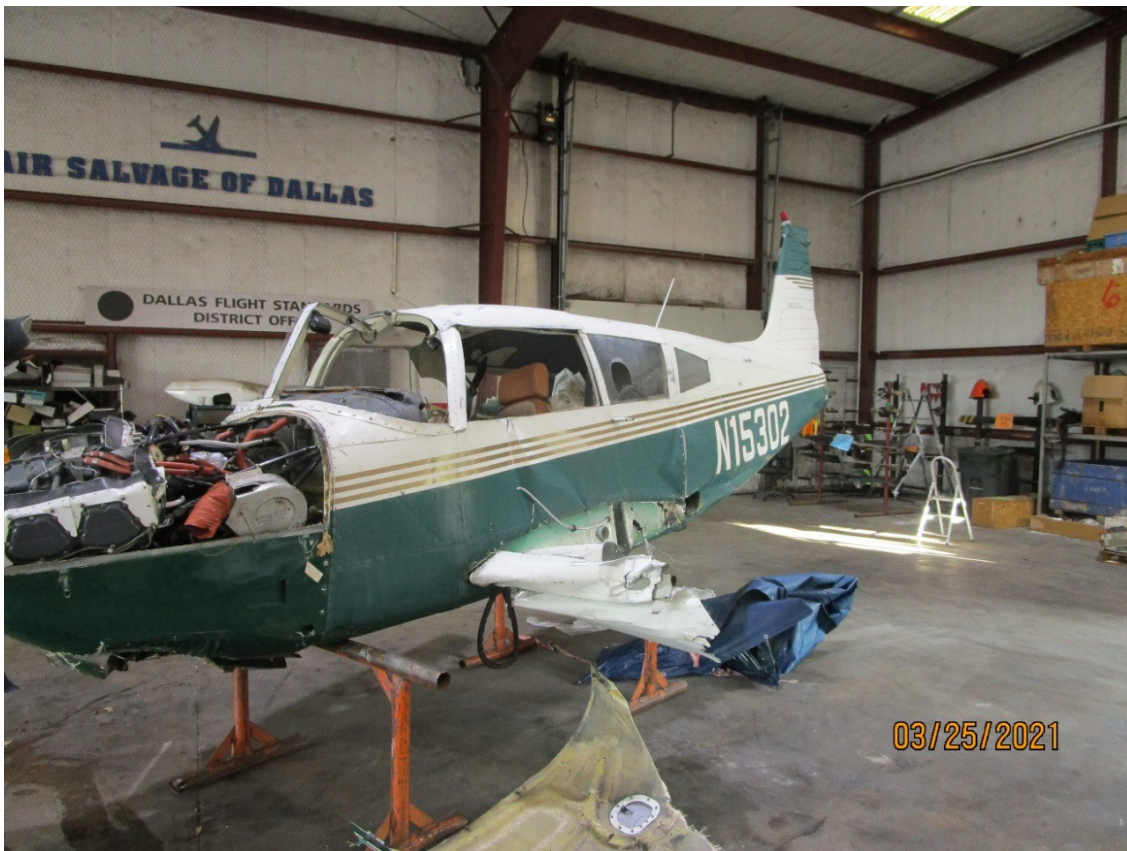
- The engine mount was broken and there was heavy damage to the airplane. An engine test run was not able to be performed.
  - The fuselage (with engine) was placed on stands; the wings which had been moved for transport, were set next to the fuselage.
- The 3-bladed propeller remained attached to the engine crankshaft flange. One blade was twisted and curled back, a second blade had a small bend in the blade tip, the third blade had leading edge damage on the outboard 2 ft of the blade.
- An initial inspection of the engine did not reveal any pre-impact abnormalities.
- The engine driven fuel pump was removed; A lever was attached to the pump and moved; the pump operated. A small amount of residual fuel was present.

Airplane wreckage on stands, ready for inspection

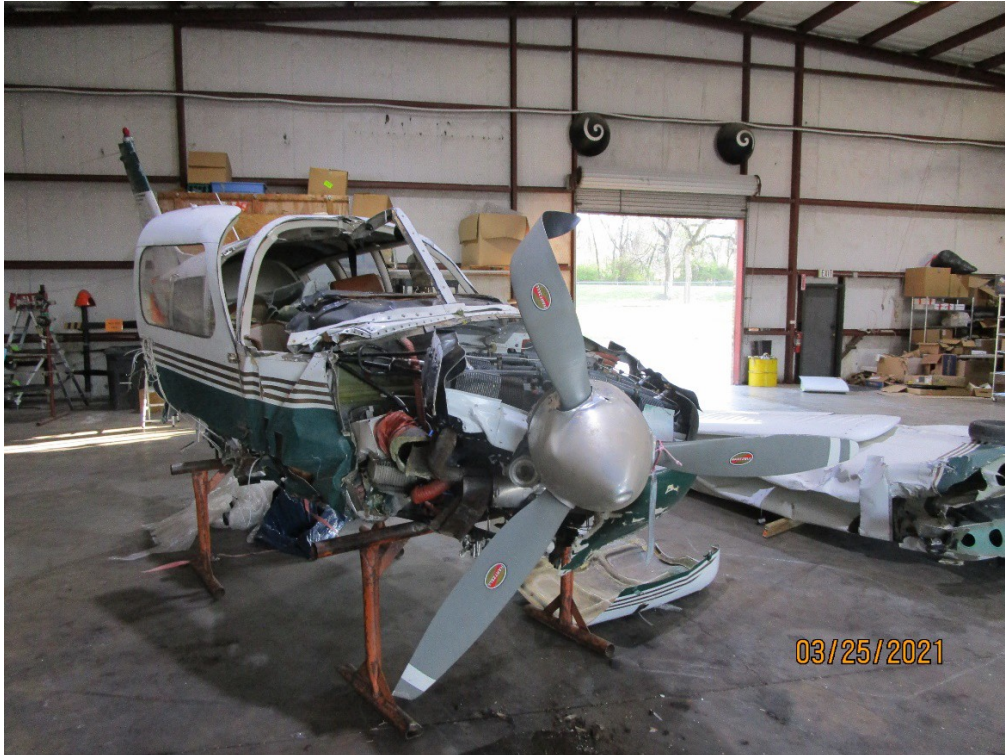
Damage to the three bladed propeller

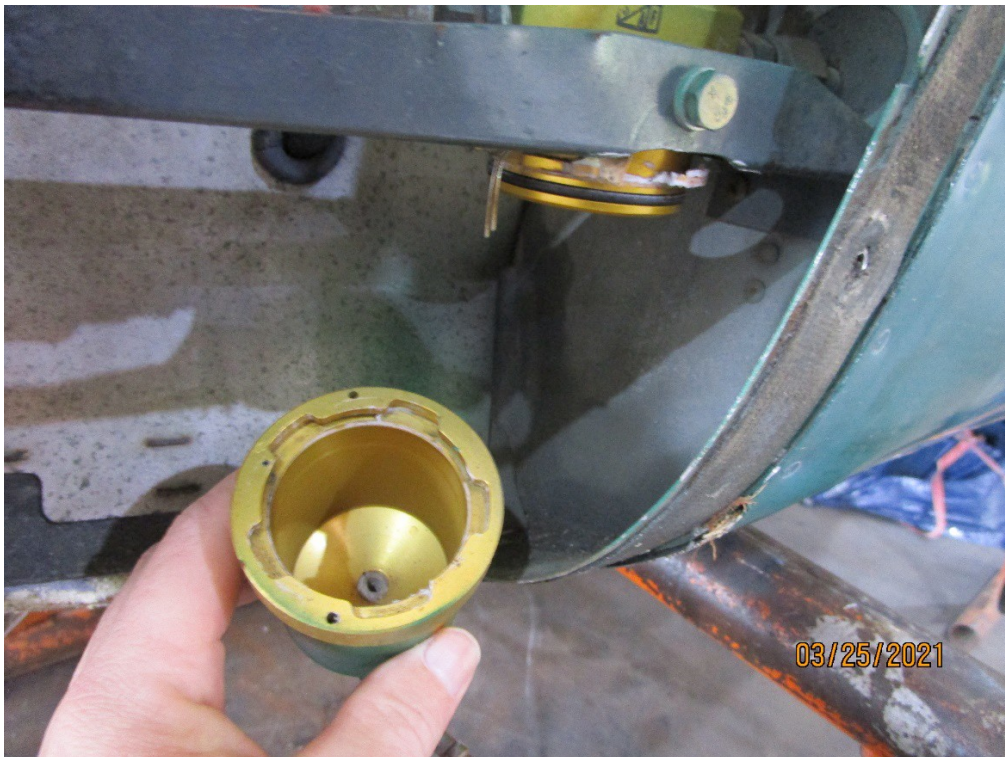
- The gascolator was opened and was dry and free of contaminants.
- Magneto to engine timing appeared to be 20-degrees.
- No preimpact anomalies were noted during the airplane examination.

Clear and dry gascolator

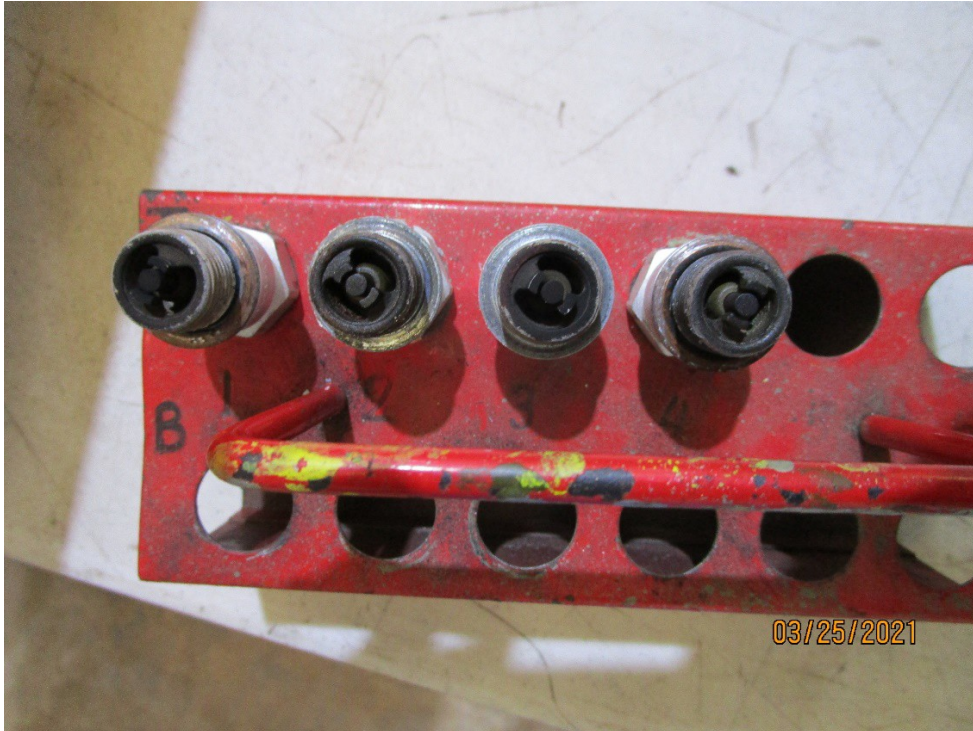
- The top set of sparkplugs were removed; normal wear was observed, the sparkplug electrodes were black in color. The Nos. 1 and 3 plugs were darker than the others

Top set of sparkplugs

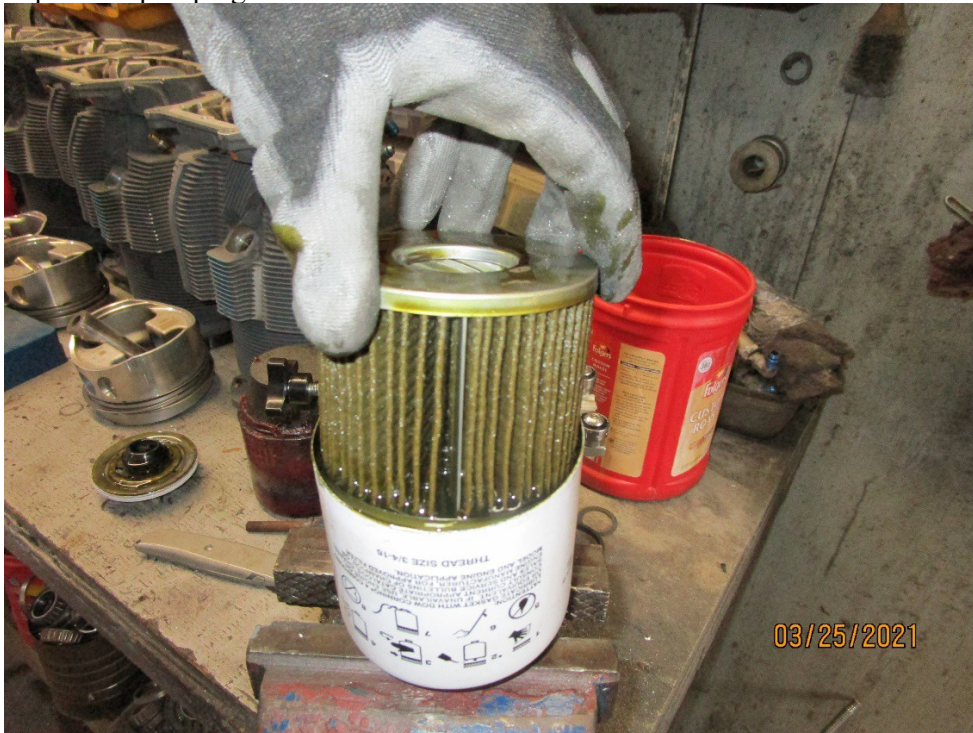
- The oil filter was removed; the filter element was cut opened and inspected: no contaminants were noted.
- The controls remained attached to the fuel servo. The inlet fuel screen was clear of debris.

Oil filter, cut open and element inspected.

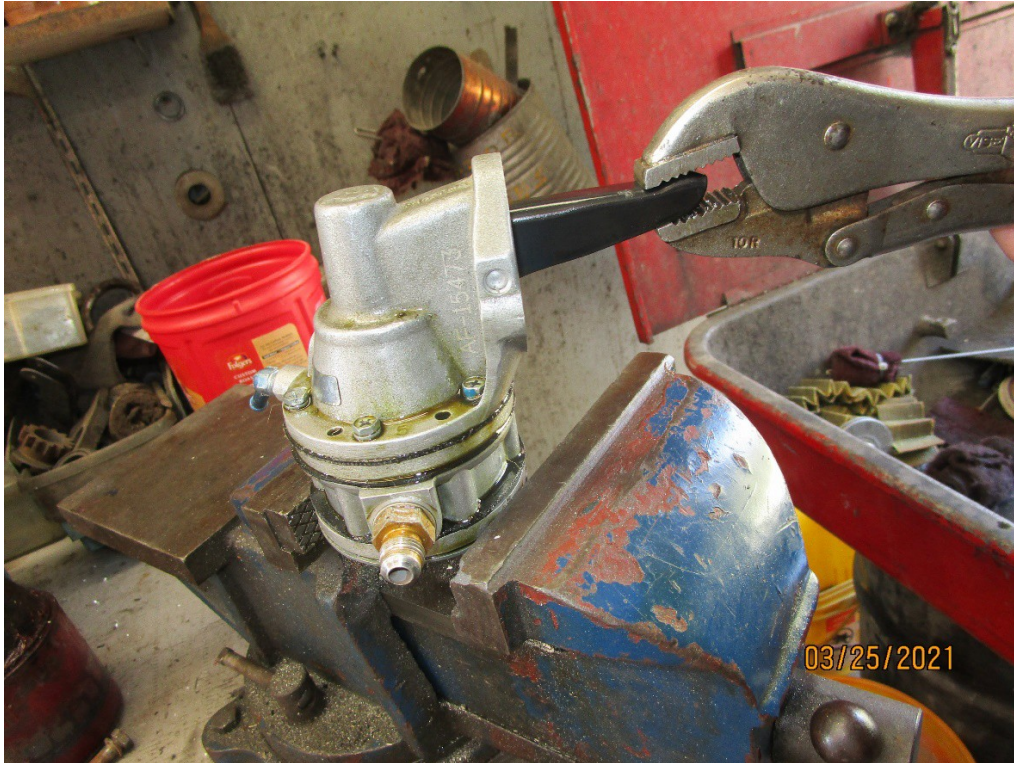
Testing engine driven fuel pump

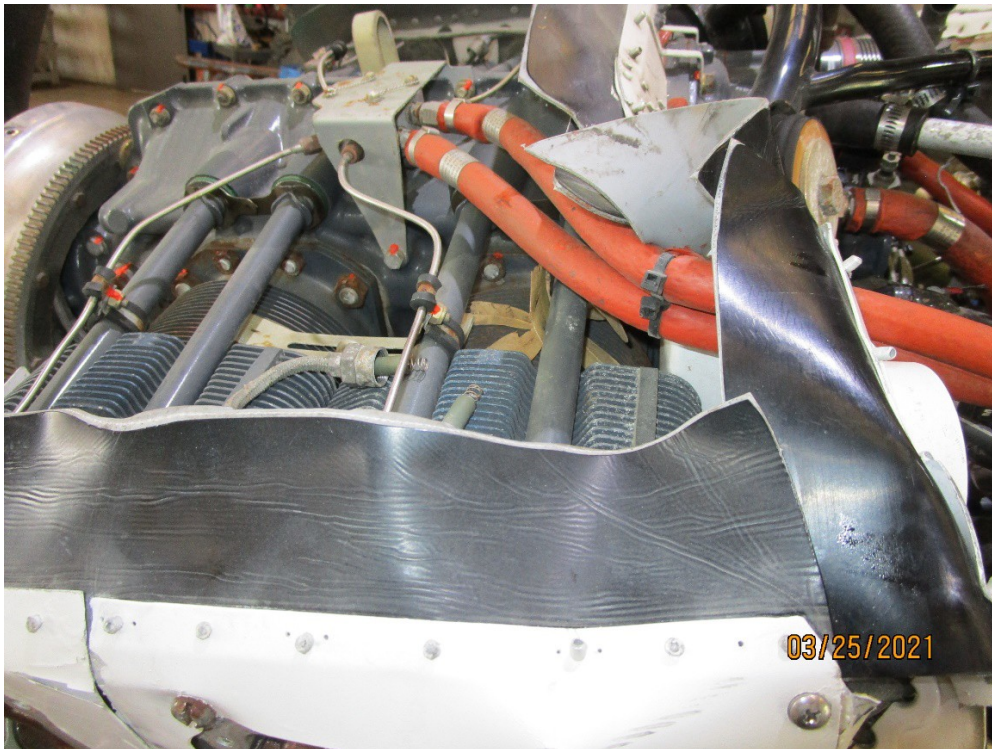
Overview of engine; no visual pre-impact abnormalities noted.

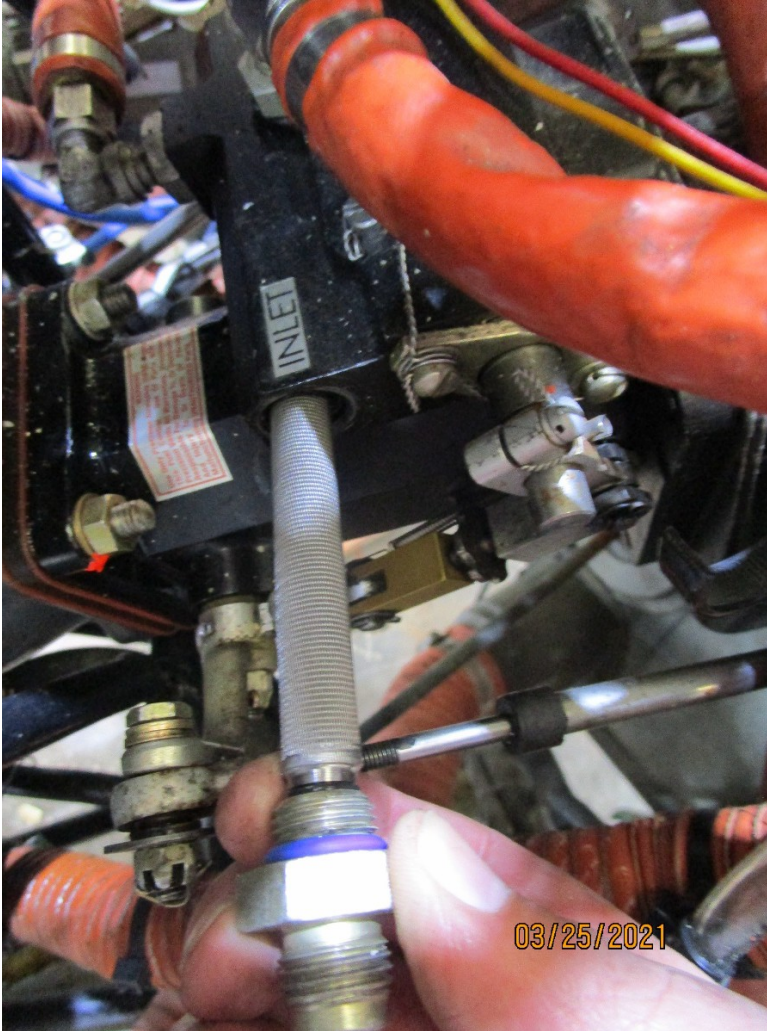
Fuel inlet screen, clear of debris
