## N284S Marathon 206

The writer provided federal oversight for the NTSB, representatives from the Bell and VanHorn Aviation were present.

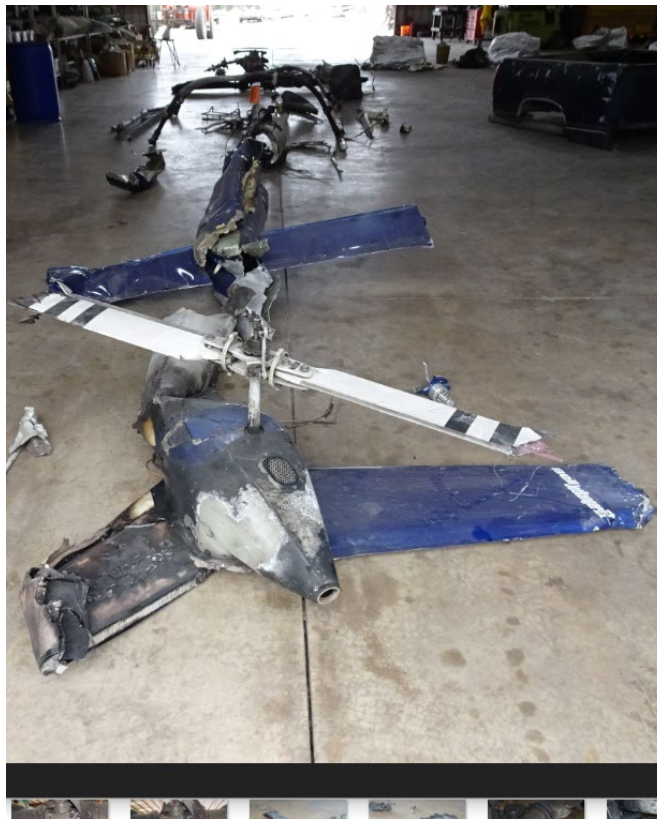
The wreckage was removed from the container and the remaining wreckage components were laid in in a rough representation of the aircraft.

The fuselage/cabin area was predominately been consumed by post impact fire. The flight control continuity could not be fully established due to the control tubes being consumed by post impact fire. The steel connecting hardware of the flight control systems was observed secured and did not exhibit evidence of pre-impact

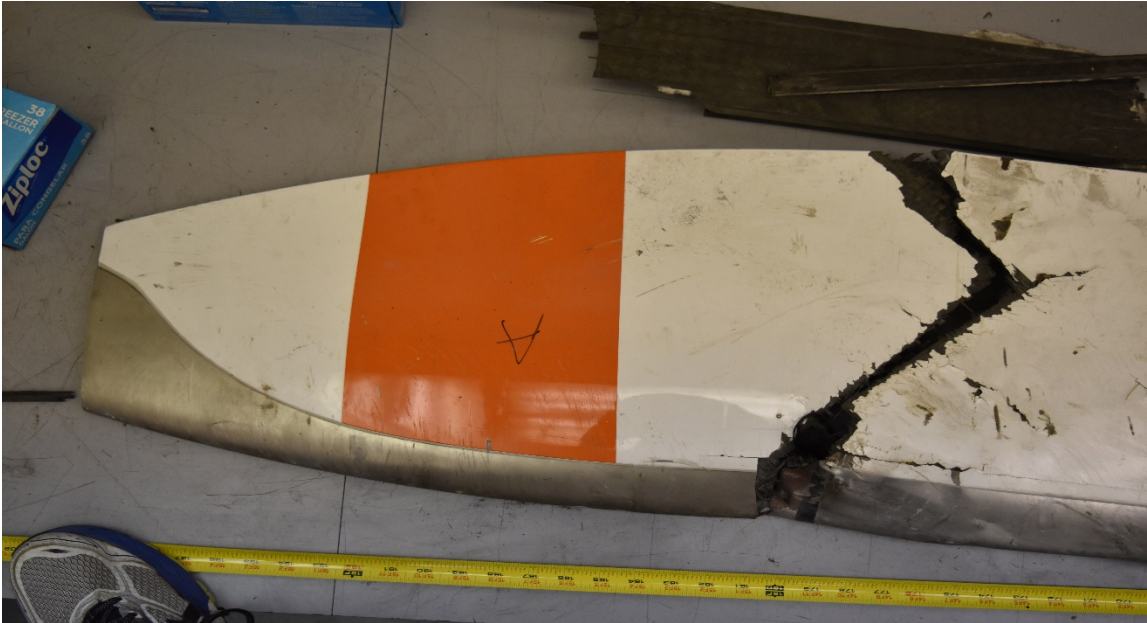
**Outboard tip of Blade A**

Preliminary estimate appears 95+ % of the Blade A was observed with impact damage to the leading edge in several locations. Blade A did exhibit minimal thermal damage from post impact fire. The largest section of blade showed the trailing edge of the blade opened up from impact related forces, the core foam of the blade was observed in the wreck remains. The blade did not exhibit interlaminar shear failure and the separated

areas appear as cohesive failures. The trailing edge of the blade did exhibit indications of what appears to be blue paint transfer in small areas approximately mid point of the trailing edge. The aircraft paint scheme was observed with a similar blue paint.

All Failures appear consistent with impact damage. No evidence of contamination/adhesive failure was observed.

The Blade A remnants were segregated as to Blade A and will be shipped to NTSB Materials laboratory for detailed examination.

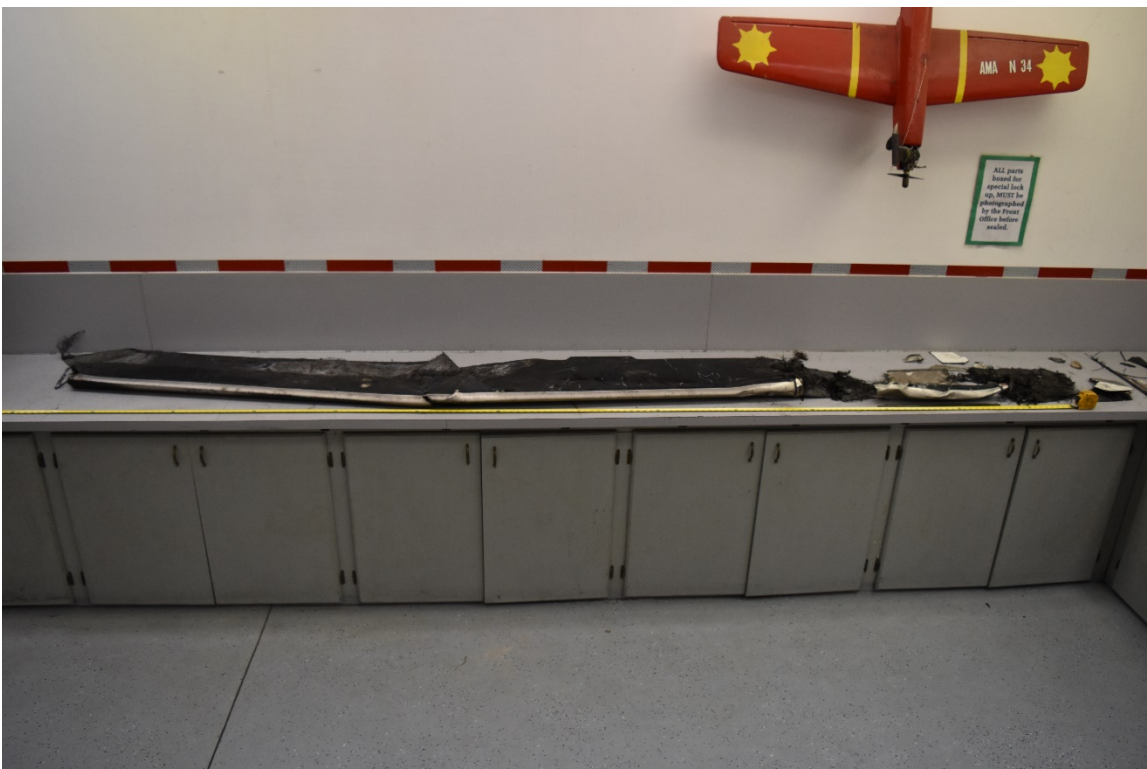
## Overall of Bade B

Preliminary estimate appears 95% of Blade B was observed and exhibited similar leading edge damage, but did have more extensive thermal damage to the blade itself. The carbon fiber material had was observed had yielded the resins from exposure to the post impact fire.

The Blade B remnants were segregated as to Blade **B** and will be shipped to NTSB Materials laboratory for detailed examination.

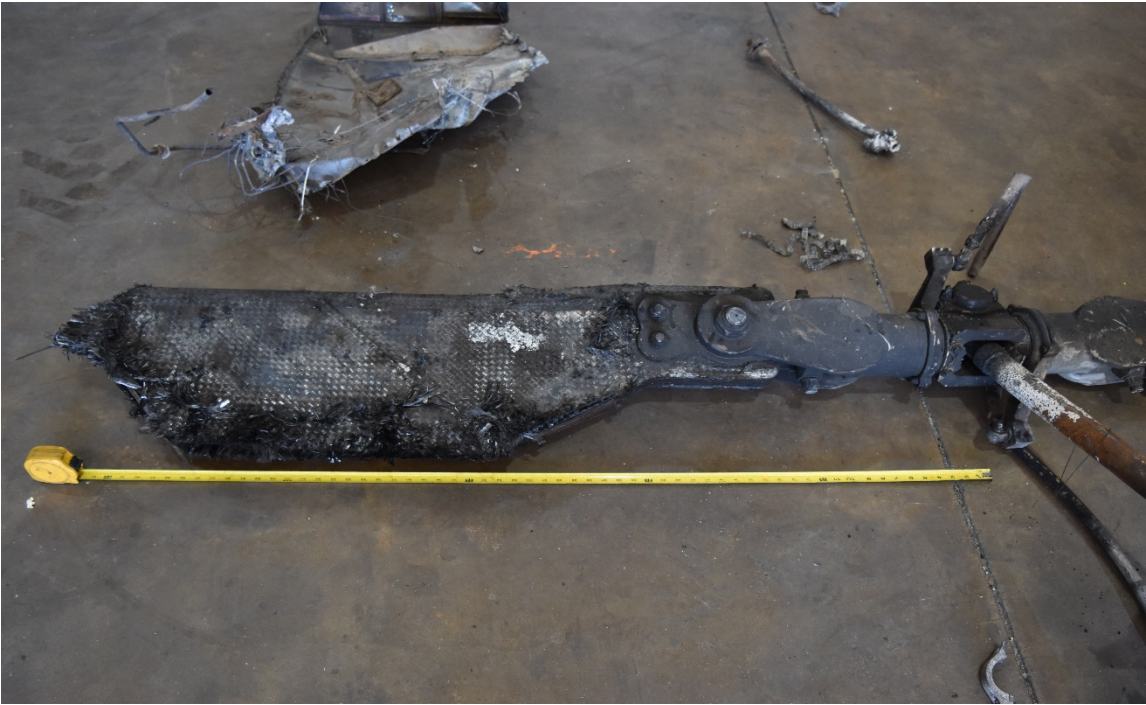
Root section of M/R Blade

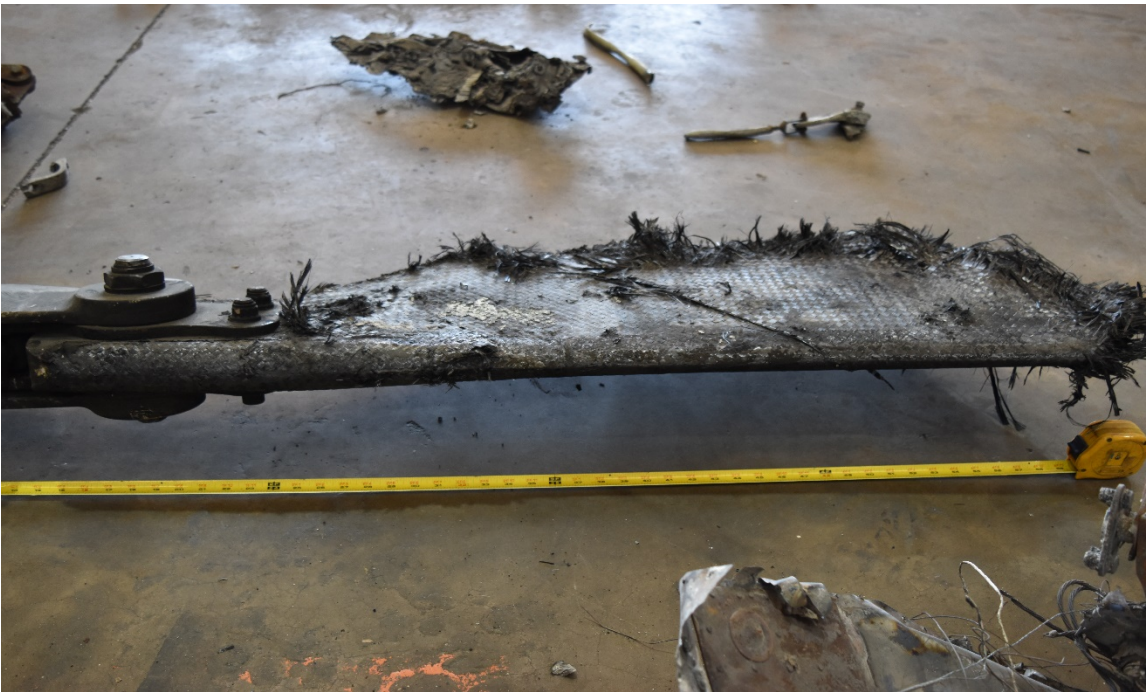
Root Section of the other M/R blade
