**Field Disassembly and Inspection Summary  
Continental IO-550-N(50)  
Serial Number 691410**

**Prepared by David S Johnson, ASI, AFG-CE-05  
August 22, 2020**

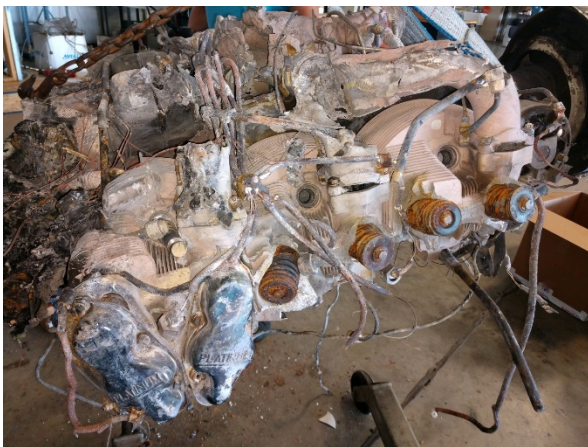
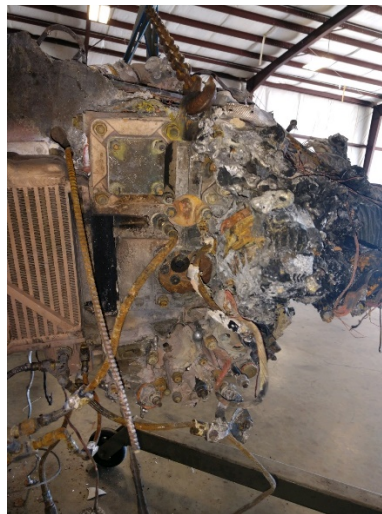
### **Initial Presentation**

The engine exhibited severe impact damage of the cylinders, intake and exhaust systems, accessories, and turbochargers. Damage from fire, including discoloration and melted components, was apparent from cylinders 1&2 rearward, and from the engine case downward. The propeller hub remained attached to the crankshaft mounting flange. The composite propeller blades displayed broomstrawing damage consistent with high-energy impact. All engine controls remained attached to their respective engine components.

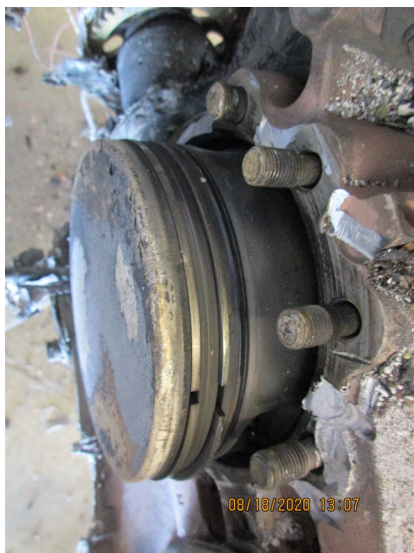
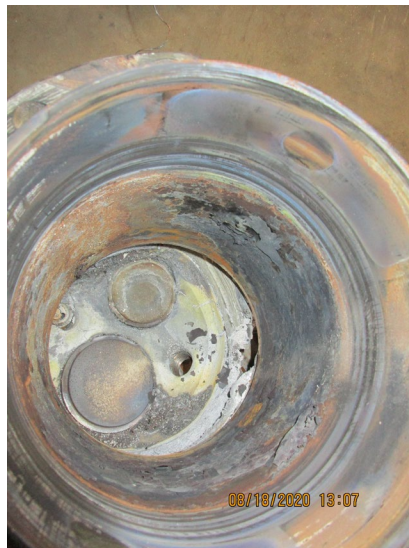
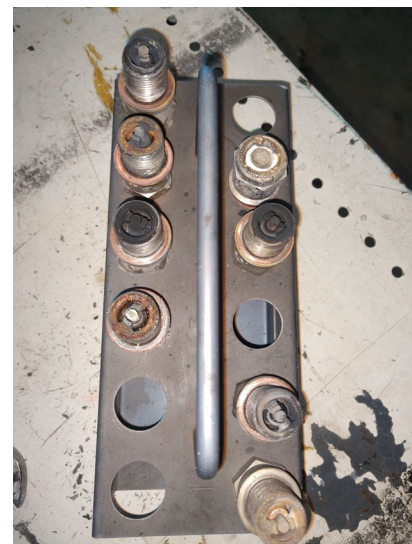
## Cylinders

All cylinders exhibited severe forward impact damage. The head assemblies of cylinders 3, 5, and 6 broke apart on impact. The rocker arm assemblies, including arms, shafts, housings, and covers were found separated from the remainder of the heads. All cylinders were displaced forward, and showed broken mounting studs and through-studs, bent and cracked cooling fins, and severe deformation. Cylinders 1 and 2 exhibited heat deformation consistent with post-impact fire. Cylinder 1 was partially melted on the anterior lower areas, and the cylinder head assembly had expanded and partially melted away from the cylinder assembly. All cylinder components were found, either attached to the engine or at the accident scene.

One set of spark plugs was removed from each cylinder. The spark plugs from cylinders 2, 4, and 6 exhibited dark discoloration, consistent with soot. Several spark plugs were impact damaged, and could not be removed in the field. A borescope inspection of each cylinder was performed, with no remarkable findings. The valve covers were removed from each cylinder where present. No pre-impact defects were found within the valve assemblies.

Cylinders 1, 3, and 5 were removed from the crankcase assembly for examination. The cylinder walls showed damage from the piston assembly's displacement at impact, and oxidation consistent with high-heat fire. The pistons, piston rings, piston pins, connecting rods, pushrods and tubes, and valve components showed no pre-impact anomalies.

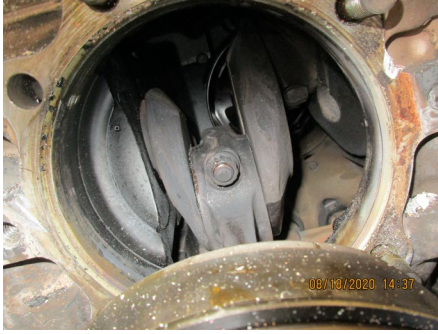
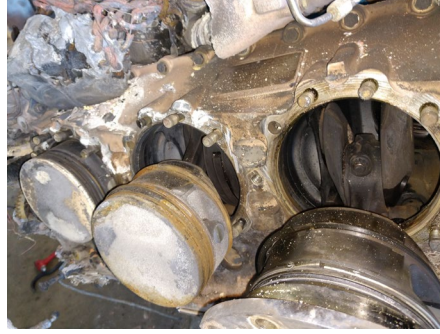
## Crankcase and Internal Components

After the removal of cylinders 1, 3, and 5, the internal components of the engine were examined. The engine could not be rotated. The crankshaft, camshaft, and lifters remained intact and in place, and exhibited only discoloration consistent with fire. No metal debris was found within the crankcase.

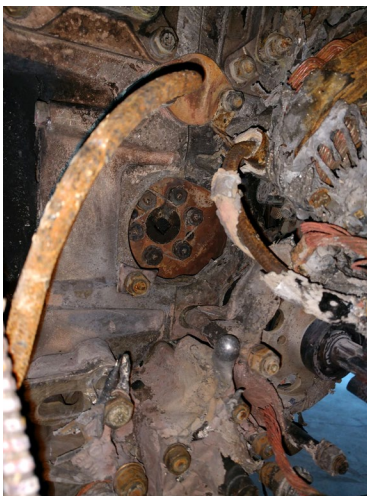
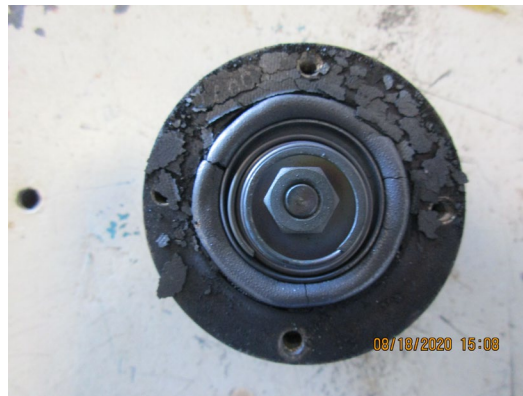
## Fuel System

Much of the fuel system was destroyed by fire, which precluded examination. The fuel filter bowl, fuel selector valve and engine compartment fuel hoses components were not identified, and are presumed to be consumed by fire. The mounting tabs from the engine driven fuel pump were found sheered from their attachment points. The engine driven fuel pump was not found, and is presumed to have been destroyed by fire. The fuel manifold/flow divider remained intact and attached to all related fuel lines. No pre-impact damage was found in the fuel supply line, vent line, or the individual fuel lines between the fuel manifold and each fuel injector. The fuel manifold was disassembled and inspected. All internal components remained intact. The manifold seals were brittle, likely as a result of high heat (fire), but otherwise complete and intact. The filter was free of contaminants. The spring and pintle assemblies moved freely within their housings. The diaphragm was also brittle, but intact and complete.

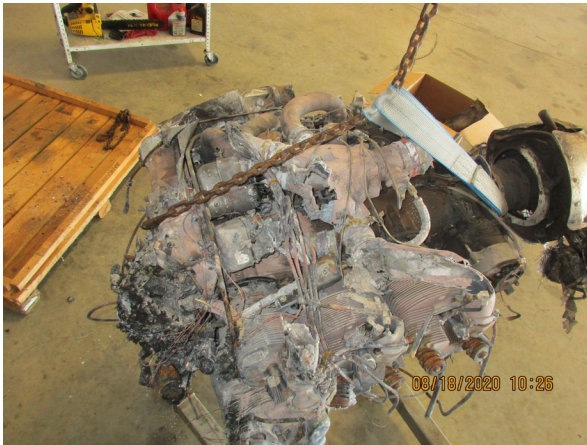
## Ignition System

The left and right magnetos remained attached to their respective mounting pads. Both displayed melting and deformation consistent with post-impact fire. All internal plastic components were melted, which precluded testing. The P-Leads remained attached to their respective studs. All spark plug harness leads remained attached at both the distributor and plug ends. Although much of the harness had melted, the metal shielding remained intact for each lead. No pre-impact anomalies were found with the ignition system.

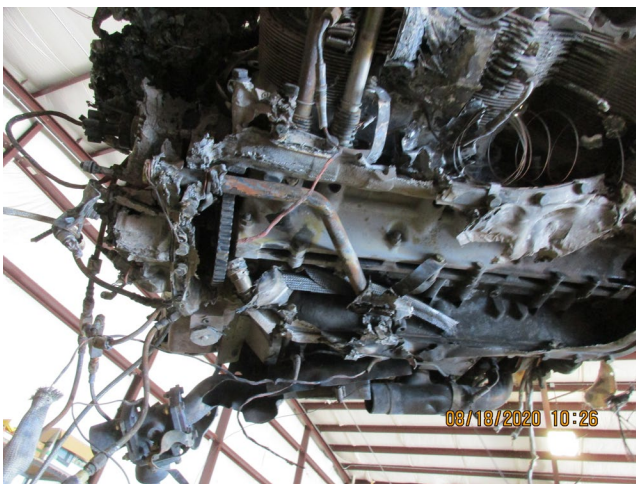
## Lubrication System

Much of the lubrication system was destroyed by fire. The oil pump housing, oil filter, and oil sump housing were largely destroyed by fire, and could not be examined. The oil sump tube within the oil sump remained intact, and displayed only discoloration consistent with post-impact fire. No oil residue was found, and is presumed to have been burned off by fire. No metal debris, pre-impact overheating, scoring, or other evidence of oil starvation was found in any part of the engine.

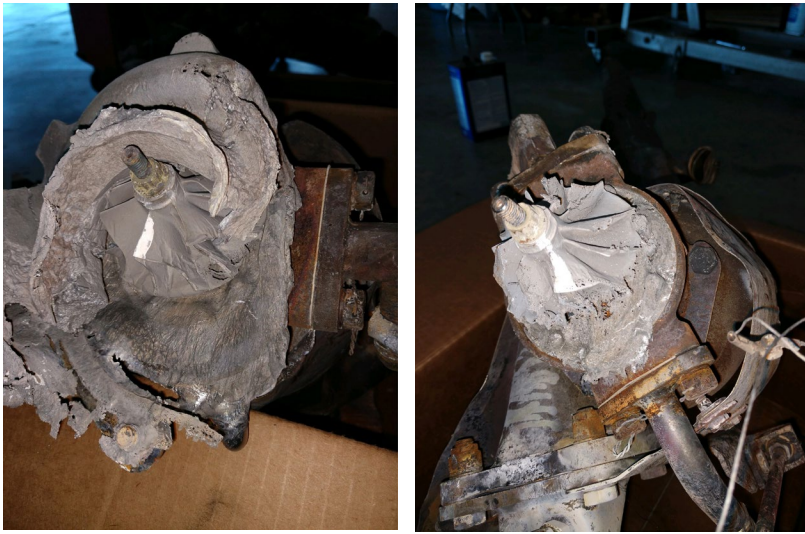
## Turbochargers

The left and right turbochargers were found at the accident site, separated from the remainder of the engine and exhaust system. The left turbocharger remained largely intact. The left impellor and housing displayed scoring and deformation consistent with high-speed rotation at impact. The right turbocharger displayed impact and fire deformation of much of the aluminum housing. The right impellor displayed deformation consistent with high-speed rotation at impact. Both left and right turbochargers remained attached to the exhaust system with V-Band Clamps which remained attached and intact. The lubrication supply and scavenge lines remained attached to both turbochargers. All controller and wastegate components displayed damage consistent with impact forces, and discoloration from fire. No pre-impact anomalies were found with the turbocharger systems.
