# The National Transportation Safety Board

Office of Aviation Safety  
Central Region  
Memorandum for the Record  
FAA Inspector Summary of  
Reported Findings  
CEN20LA343  
Brandon Minnesota  
August 15 2020

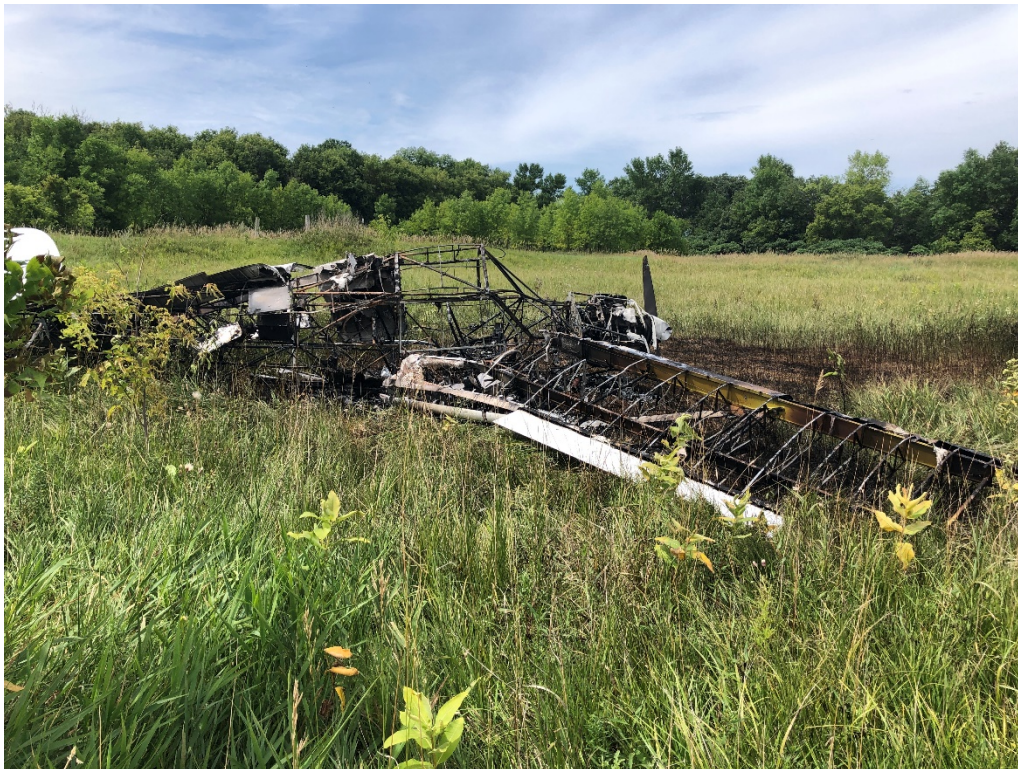
- On scene inspection of the wreckage revealed that the airplane impacted a 4-foot-high steel fence post and the ground. After coming to rest, about 150-feet from the initial impact point, a post-impact fire destroyed the airplane.
- Although there was extensive fire damage, flight control continuity was confirmed from the cockpit to all flight control surfaces.
- Engine control linkages were confirmed.
- Due to the extensive post-impact fire, the engine could not be rotated, and engine drive continuity could not be confirmed.
