# National Transportation Safety Board

## Performance Study

### Specialist Report

Location: Rockford, Illinois  
Date: August 20, 2020  
Time: 1543 central daylight time (CDT)  
Airplane: Beech 200, N198DM  
NTSB Number: CEN20LA352

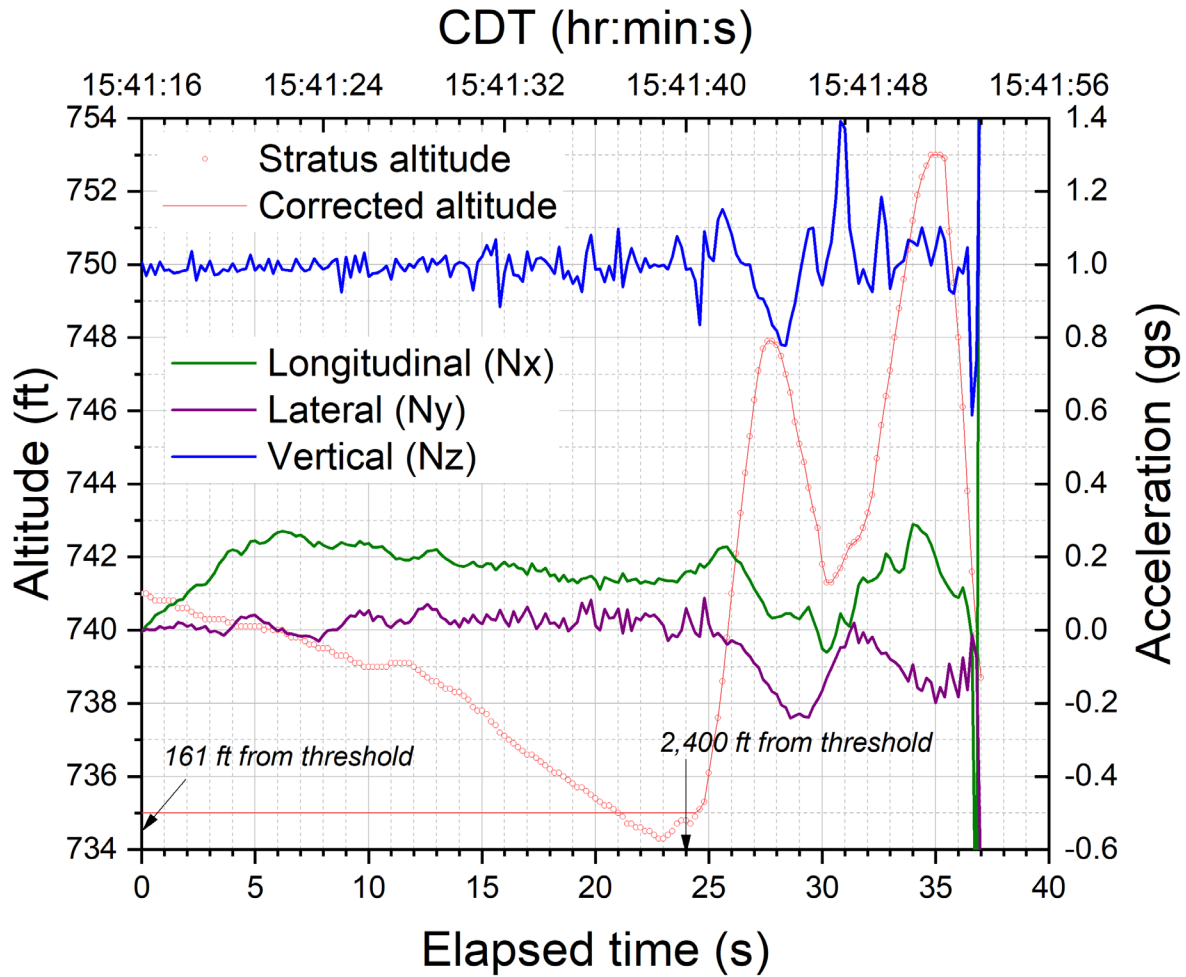
Altitude recorded on the Stratus was not accurate until after take-off. Field elevation at the threshold of runway 19 is 735 ft. Figure 1 shows the recorded altitude relative to mean sea level (msl), corrected altitude, which pins altitude to the ground until after take-off, and accelerations from the AHRS. Elapsed time from the beginning of the take-off run is shown along the bottom axis and correlated to CDT along the top axis (beginning of take-off roll is coincident with 15:41:16). Distance along runway 19 based on recorded GPS position is called out for time zero

and 24 s. Data after time 37 s (15:41:53) became unreliable as can be seen in the acceleration data and was consistent with impact.

**Figure 1.** Recorded and corrected altitude (msl) with Nx, Ny, and Nz accelerations. Time shown in CDT and in elapsed time since the beginning of the take-off roll.

Vertical acceleration shows take-off to be between 24 and 25 s after the beginning of the take-off roll. About 2 s later, Ny recorded a significant left side force on the airplane. The side force was relieved at time 32 s, but then returns.

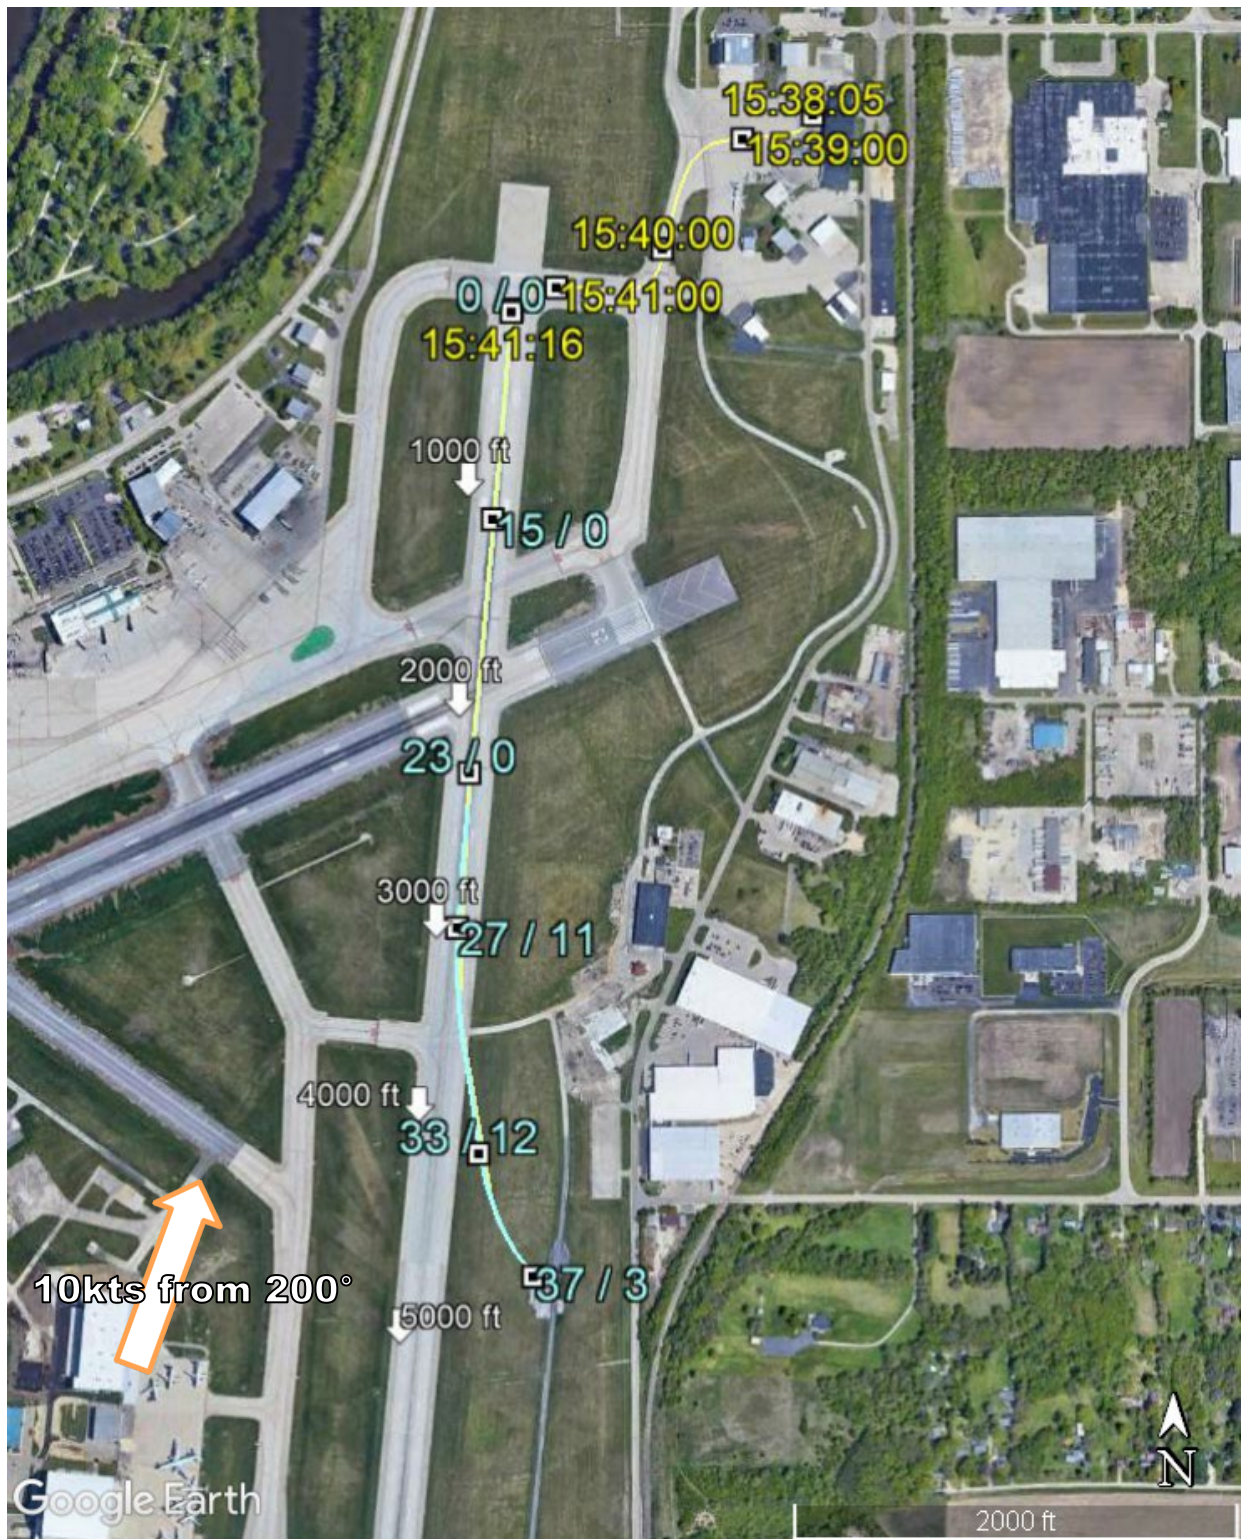
Runway 19 is 8,200 ft long. Figure 2 shows the airplane's taxi with local time in yellow and path along the runway with elapsed time in seconds and height above ground in feet noted. Take-off occurred at about 24 s. Just after 27 s and 3,000 ft down the runway, the airplane's flight path began deviating to the left. Ten seconds later it impacted the ground.

**Figure 2.** Taxi shown with local time in yellow. Accident flight in blue with elapsed time since beginning of take-off roll and altitudes (agl) annotated in blue. Distance along runway shown in white with arrows. Wind is shown with an orange and white arrow.

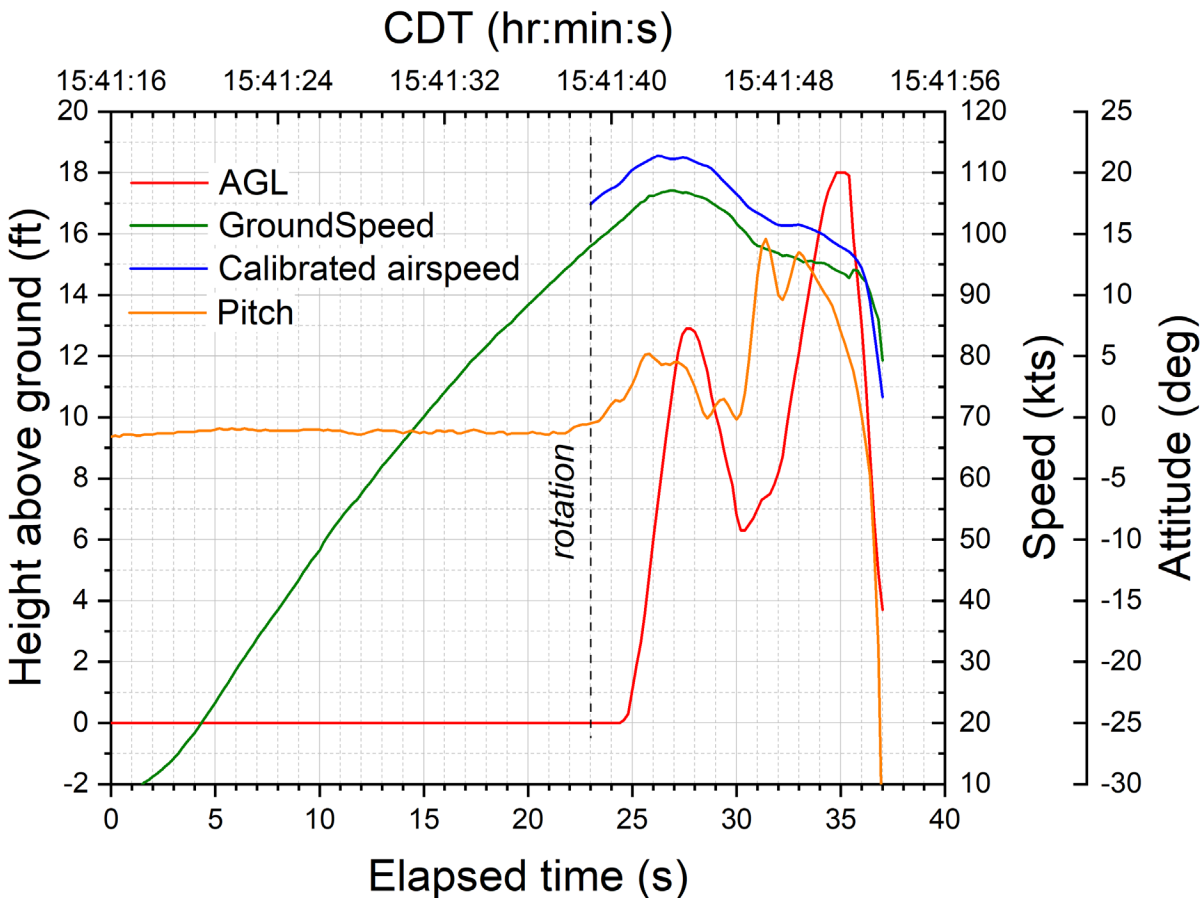
Figure 3 shows height above ground, the recorded groundspeed, calculated airspeed, and recorded airplane pitch. Rotation occurred about 23 s when the airplane's groundspeed was 98 kts and its airspeed was 105 kts. Rotation speed was consistent with guidance. The airplane was less than 20 feet above the ground for the duration of the flight.

**Figure 3.** Height above ground (altitude agl), recorded groundspeed, calculated airspeed, and pitch.

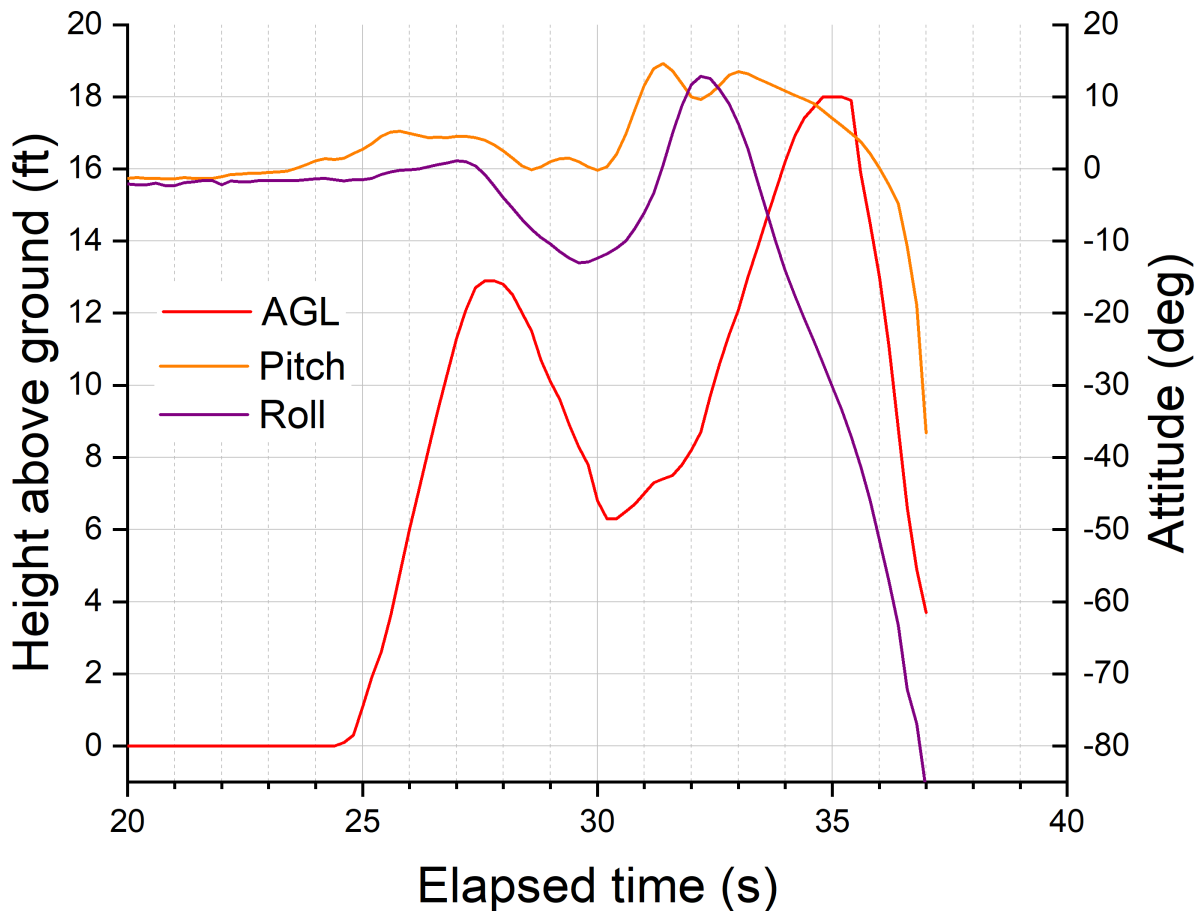
About four seconds after rotation (27 s), the airplane began to descend and lose airspeed while rolling to the left. The airplane began rolling back to the right and climbing again but continued to slow. By elapsed time 33 s (10 s after rotation) the airplane was again rolling left rapidly and after 35 s it was descending.

**Figure 4.** Height above ground (altitude agl), recorded pitch and roll.

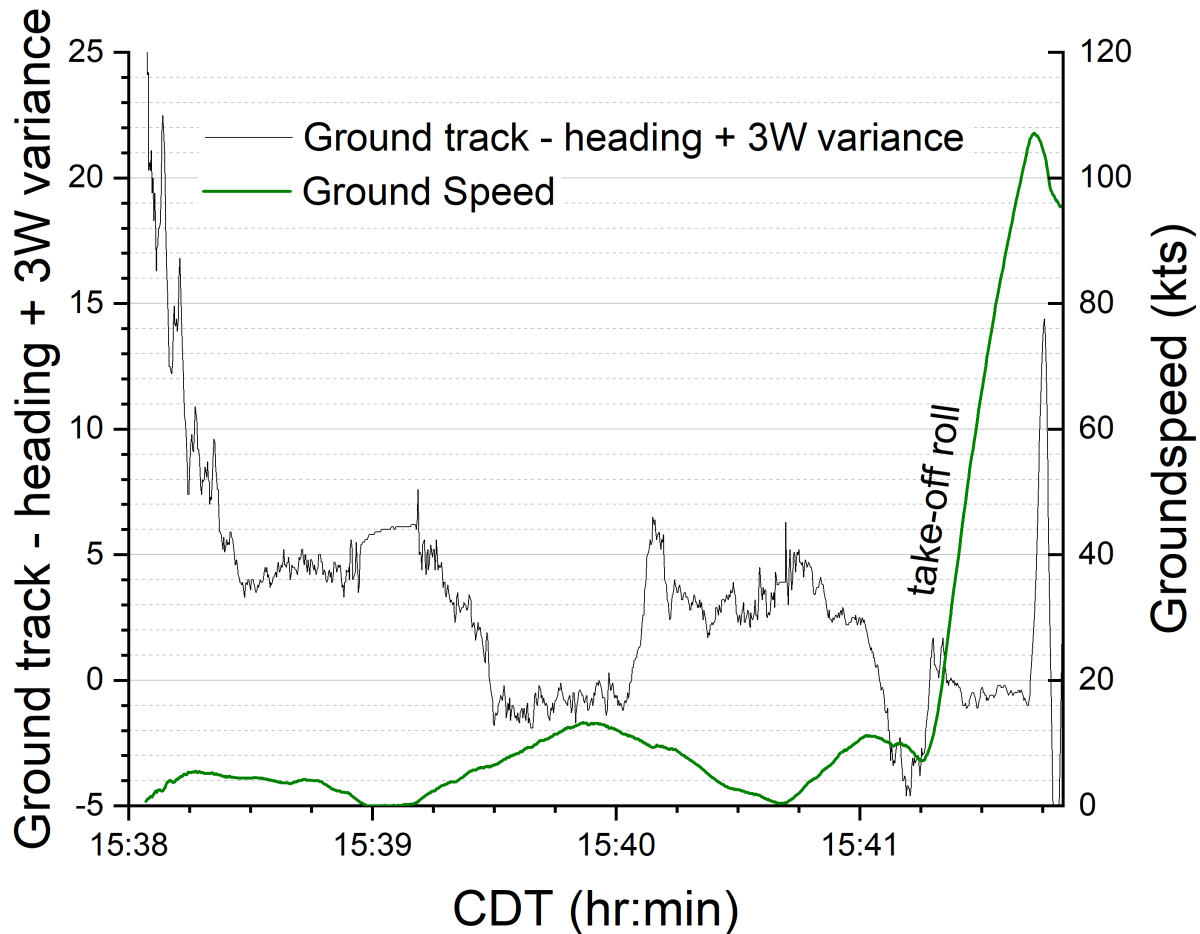
Figure 5 shows the alignment of ground track and heading with the local magnetic variance of  $3^{\circ}$  west taken into account. At the beginning of the data, heading was very different from ground track, but it began to resolve during taxi. During the takeoff roll, the ground track and heading were within a degree of one another.

**Figure 5.** Ground track minus heading plus magnetic variance and groundspeed.

Wind was from  $200^{\circ}$  and the runway's true heading was  $185^{\circ}$ , so the wind was a slight right cross wind. Upon takeoff, it would be expected that the airplane would be slightly nose right of the ground track. However, the difference between ground track and heading show a large increase in yaw to the left. Additionally, as discussed in Figure 1, the lateral ( $N_y$ ) acceleration recorded a significant increase in the side force in that direction on the airplane after 26 s.

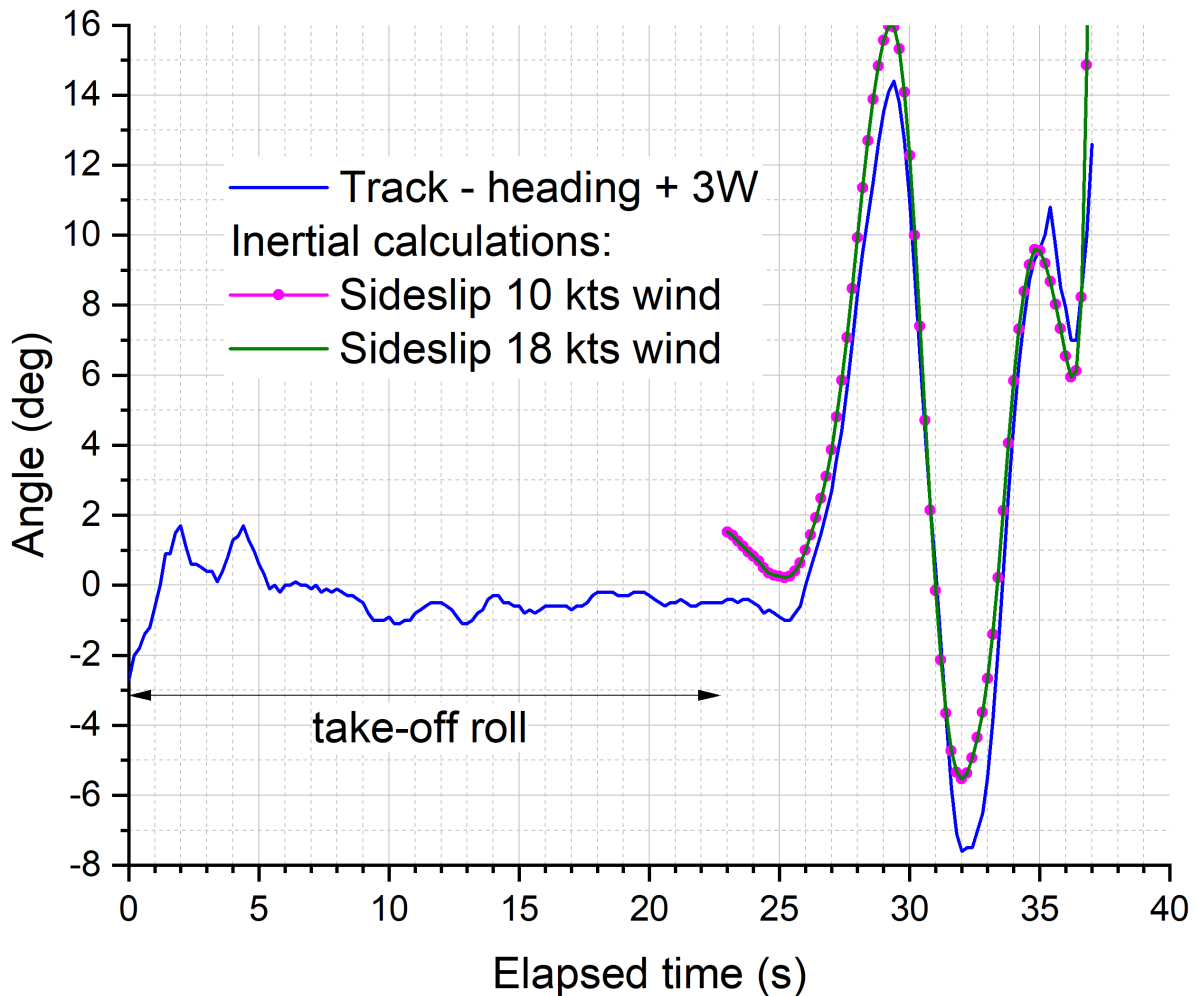
To further investigate the possible increase in sideslip, the x, y, and z directional accelerations from the AHRS on the Stratus were integrated and compared to the flight path recorded by the GPS unit and then corrected to the airplane's center of gravity using B200 moments of inertia and geometry. The results of those calculations were paired with the wind data to calculate the resultant sideslip and are shown in Figure 6. The magnitude of the wind (reported as 10 kts gusting to 18 kts) made little difference in the results, and neither did some possible variations in the location of the Stratus in the cockpit. The calculated sideslip was about  $1^{\circ}$  more than the difference between track and heading.

**Figure 6.** Ground track minus heading plus magnetic variance and groundspeed and calculated sideslip.

One to two seconds after take-off, the airplane encountered a substantial sideslip and corresponding side force to the left which was followed by a left roll and a loss of altitude. The airplane then rolled back to wings level and the sideslip was in the opposite direction at time 32 s and the airplane again climbed. Figure 1 showed that  $N_y$  returned to near zero at this time. However, roll and side force both then increased in the left direction again and the airplane lost altitude and impacted the ground.

Of interest was the possibility that the airplane lost thrust in the left engine. After time 27 s, the airplane lost both altitude and airspeed, consistent with a reduction in power. If left engine thrust was reduced or lost, the right engine would exert a yawing moment on the airplane, driving the nose to the left and inducing a left roll. The airplane's directional control can be maintained by putting in opposite rudder to counteract the sideslip. Starting at time 29 s, the airplane's nose-left sideslip and left side force (Figure 6 and Figure 1) reduced, possibly due to rudder input. Sideslip then went the other direction, possibly due to an overcorrection. After 34 s, the nose left sideslip again increased and the airplane rapidly rolled left.
