**NATIONAL TRANSPORTATION SAFETY BOARD  
OFFICE OF AVIATION SAFETY  
WASHINGTON, D.C. 20594**

**POWERPLANTS GROUP CHAIR'S FACTUAL REPORT  
NTSB ID: CEN20LA352**

Location: Rockford, Illinois  
Date: August 20, 2020  
Time: 1543 Central Daylight Time  
Aircraft: Raytheon Aircraft Company Super King Air B200, Reg. N198DM

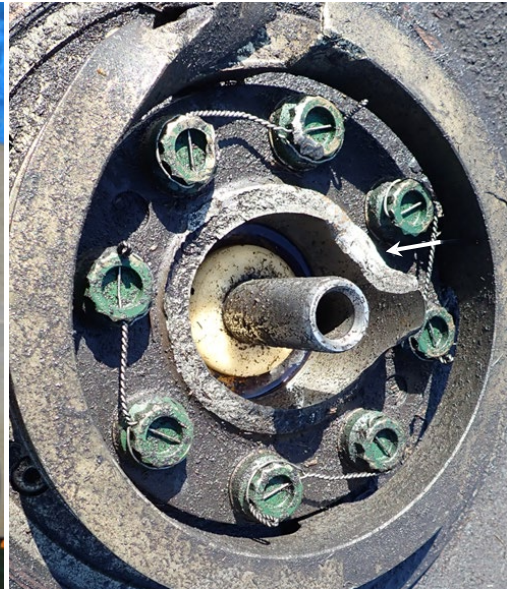
**Figure 2.** Engine propeller shaft, forward fracture surface

The engine propeller shaft was separated just aft of the propeller attachment flange. The flange remained attached to the propeller aft hub half with all attachment bolts lockwired. The shaft fracture surface exhibited features consistent with torsional overload. See Figure 2.

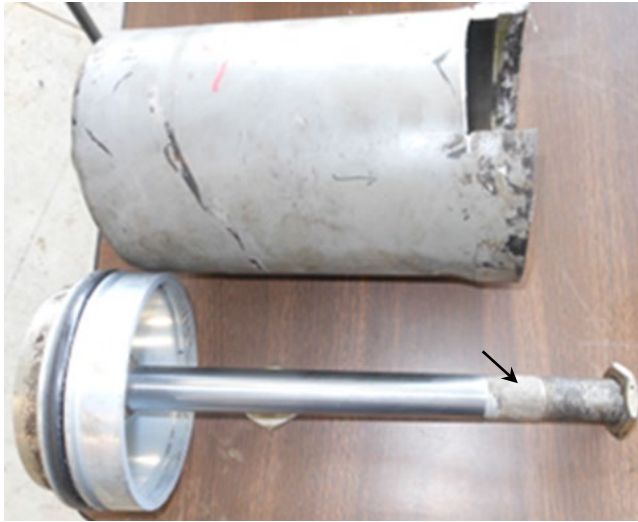
**Figure 3.** Cylinder and piston with pitch change rod

The left propeller hydraulic unit was identified as the unit liberated from FY3746 by matching cylinder thread and hub attachment flange damage. The cylinder was intact.<sup>6</sup> Approximately three inches of the cylinder mounting flange was bent. The piston was inside the cylinder. The piston was dented in line with the cylinder edge damage. The pitch change rod was fractured at the oil transfer hole. The forward section of the pitch change rod remained attached at the piston; the aft section of the pitch change rod was bent and was assembled to the fork. The bent section of the cylinder mounting flange was cut out to facilitate removal of the piston. See Figure 3.

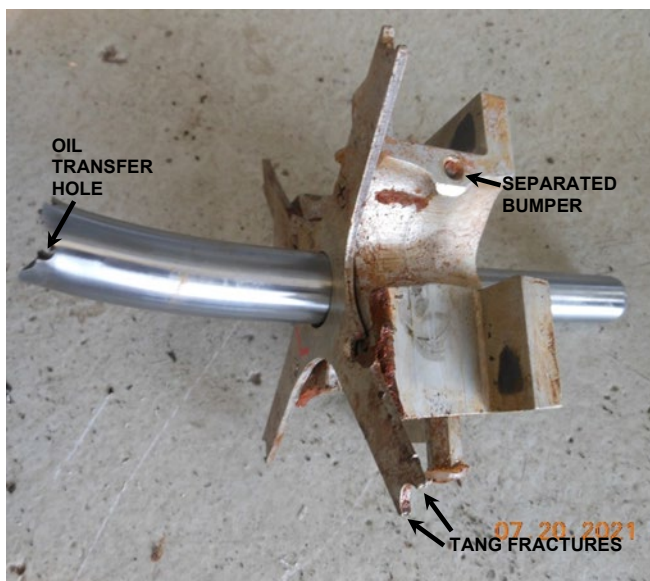
**Figure 5.** Fork and pitch change rod

The fork assembly surfaces were corroded. Two fork bumpers were fractured off. Three of the beta plate forward finger tangs were fractured off; the fourth forward finger tang was not completely separated but it was bent forward. See Figure 5.

The bumpers and three of the tang pieces were found inside the hub.

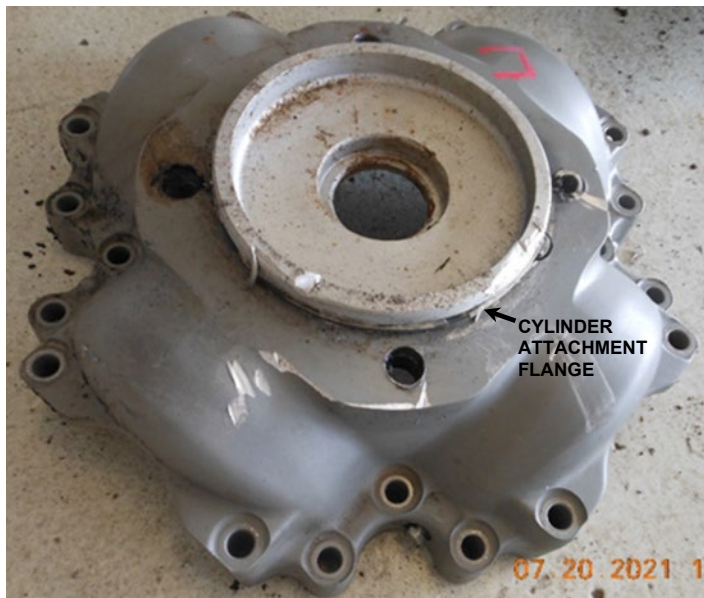
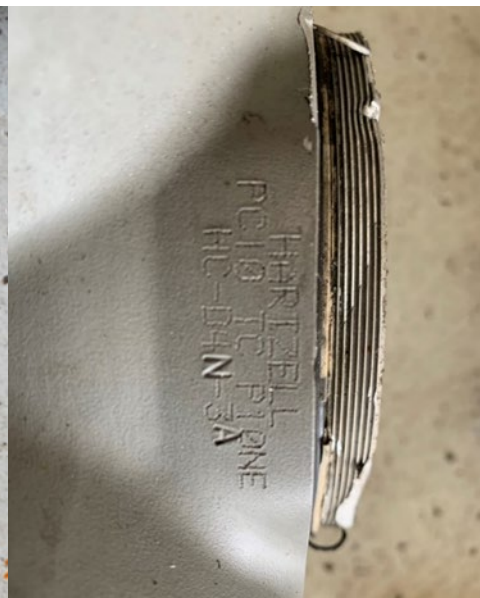
The hub castings were intact. The forward hub half cylinder attachment flange was marred and distorted. The forward pitch change rod bushing was fractured. The aft pitch change rod bushing was intact. The preload plate mounting features were marred or fractured. See Figures 6 and 7.

**Figure 6.** Forward hub half

**Figure 7.** Closeup view of forward hub cylinder attachment flange damage

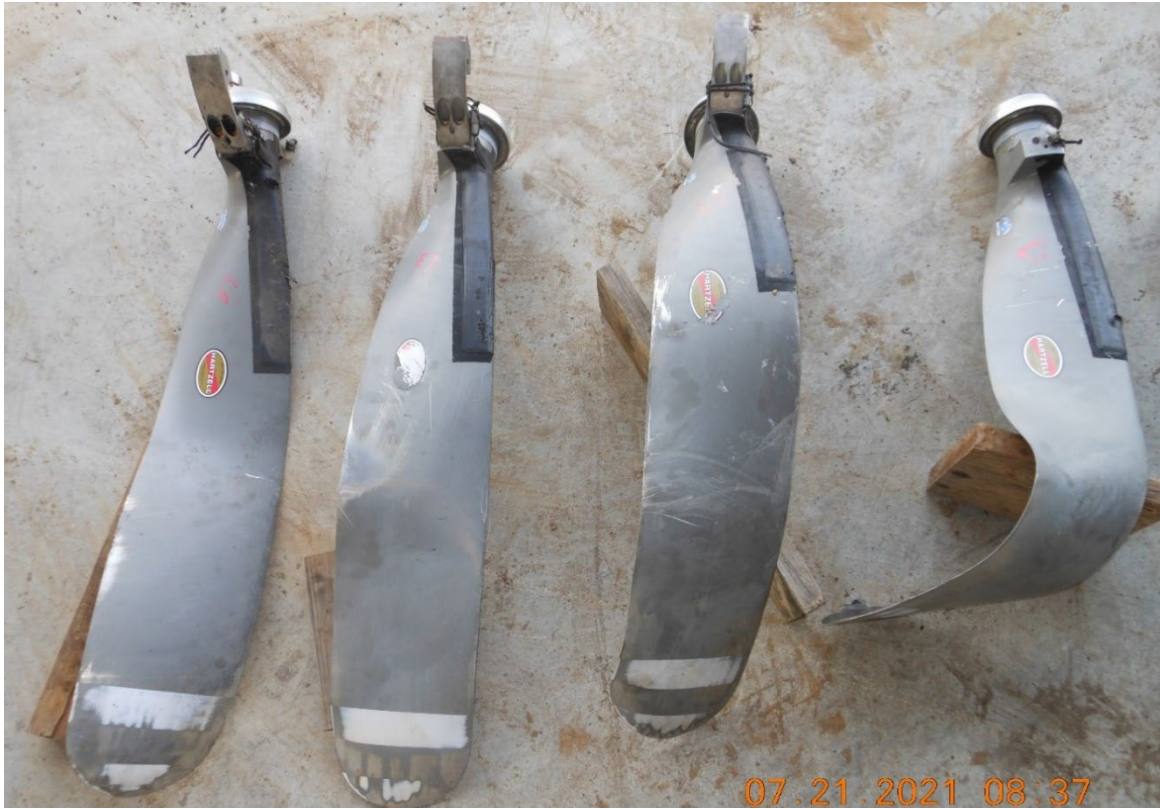
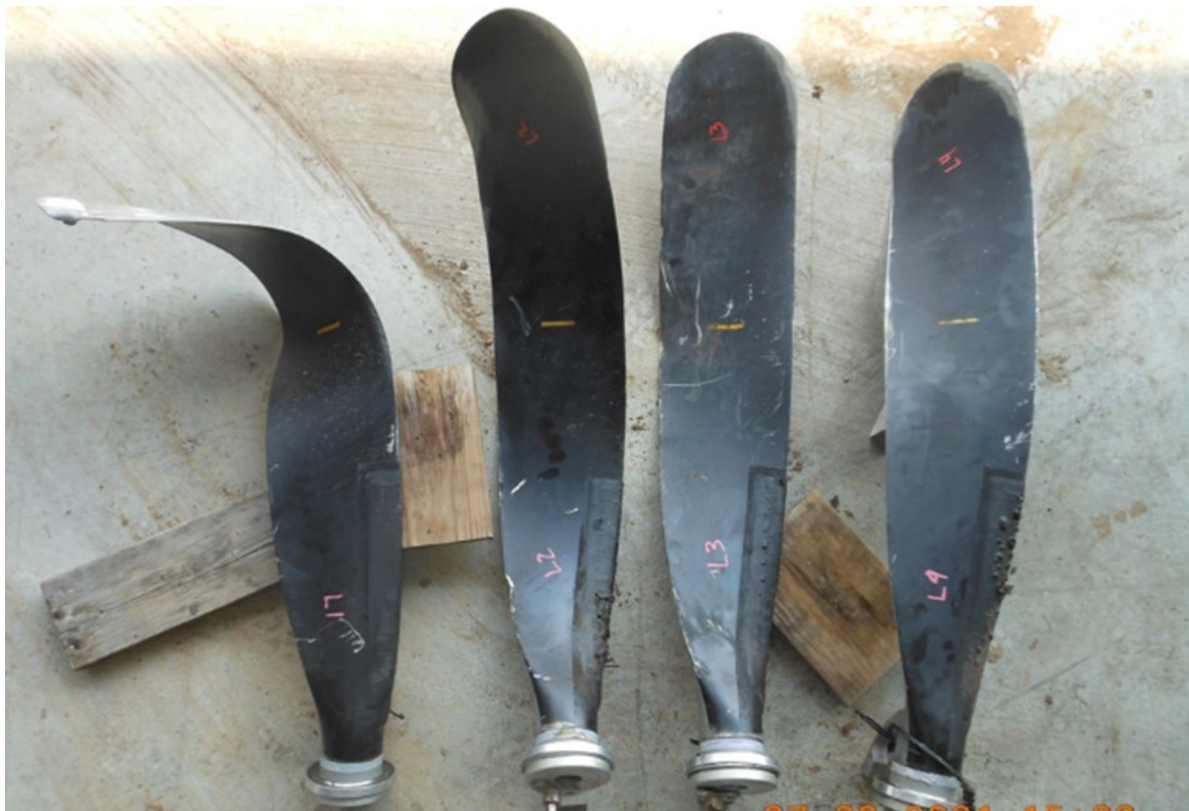
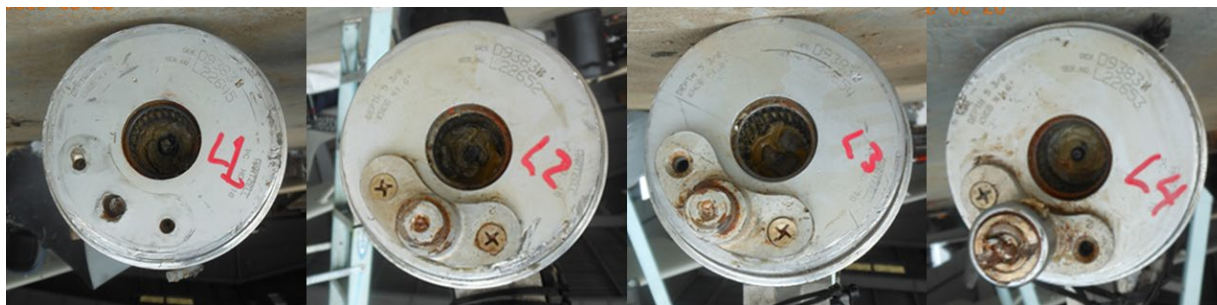
The blade deice boots displayed various cuts and varying degrees of heat damage. All blade retention bearings were intact. All blade pitch change knob/bracket assemblies were damaged or liberated. See Figures 8 through 10.

**Figure 8.** Left propeller blades, camber sides

**Figure 9.** Left propeller blades, flat sides

**Figure 10.** Left propeller blade butts, showing pitch change knob/bracket damage

The L1 blade was bent aft, opposite the direction of rotation, and was twisted toward low pitch. The blade camber side was scored chordwise from the tip to 20 inches inboard. The face side was scored chordwise near the tip along the leading edge (LE). There was a two-inch wide impact/bend at the tip LE that was deformed toward low pitch. The blade trailing edge (TE) was not remarkable. The pitch change knob bracket was missing from the blade butt; the dowel pin hole and one screw hole were deformed in the direction opposite low pitch.<sup>7</sup> The counterweight was missing; the counterweight mount boss hole was distorted, and the boss was damaged in the direction of propeller rotation. The counterweight was not recovered.

The L2 blade was bent aft, opposite the direction of rotation. The blade camber side was abraded chordwise from the tip to 12 inches inboard. The face of the blade was scored chordwise near the tip along the LE. The LE was nicked and gouged in the deice boot area. The TE was nicked and exhibited local bending. The pitch change knob bracket assembly was missing the cam follower/bearing, which was recovered inside the hub. The counterweight was intact.

The L3 blade was bent aft. The blade camber side was scored chordwise from the tip to 16 inches inboard. The face of the blade was scored chordwise near the tip along the LE. The LE was nicked. The TE was nicked and exhibited local bending. The pitch change knob cam follower was fractured, and one bracket screw head was pulled/missing. The counterweight was intact.

The L4 blade exhibited “S” bending. The tip was bent aft and was twisted toward low pitch. The camber side of the blade was scored chordwise from the tip to 21 inches inboard. The face of the blade was scored chordwise near the tip along the LE. The leading and trailing edges were nicked. One pitch change knob bracket screw was missing, and the cam follower was frozen. The counterweight was intact.

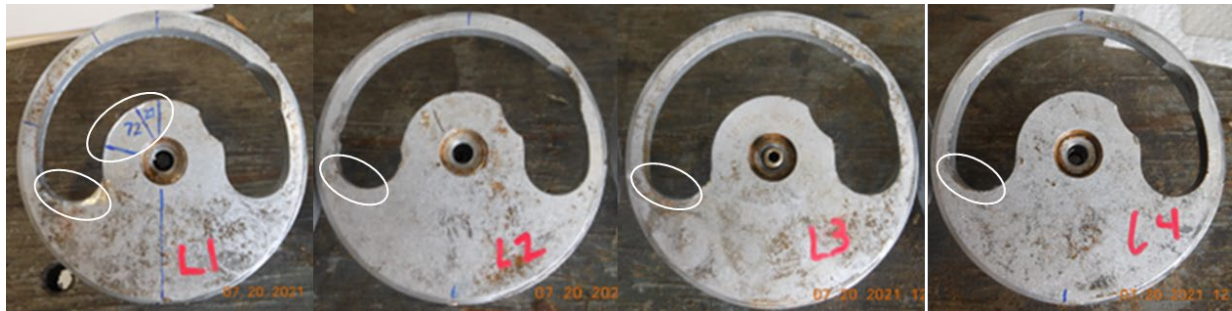
**Figure 11.** Left propeller preload plates showing knob impact marks at the low pitch slot ends and L1 fork/bracket impact marks

All left propeller preload plate retention lips were sheared off. All of the left propeller pitch change slots were damaged at the low pitch end of the pitch change knob slot consistent with forceful

blade rotation toward low pitch. The L1 plate also exhibited knob contact marks along the inboard edge of the slot forward of the hub split line beginning at 27° with the last recognizable knob mark at 72° degrees. See Figure 11.

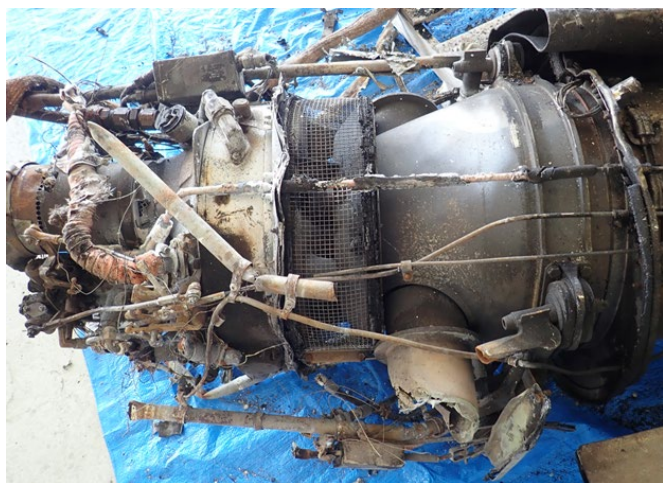
**Figure 13.** Left engine center firewall and aft

The engine was covered with soot. The components aft of the center fire seal mount ring exhibited light to moderate thermal damage, including the rear mount ring assembly. See Figure 13.

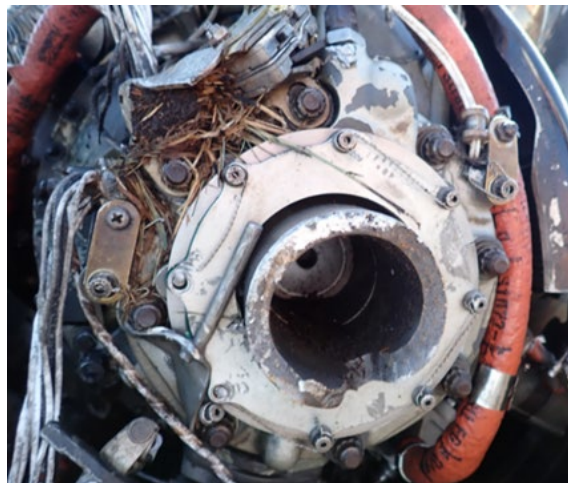
**Figure 14.** Engine propeller shaft fracture surface

The forward end of the propeller driveshaft was fractured off. The fracture surface features were consistent with torsional overload. See Figure 14.

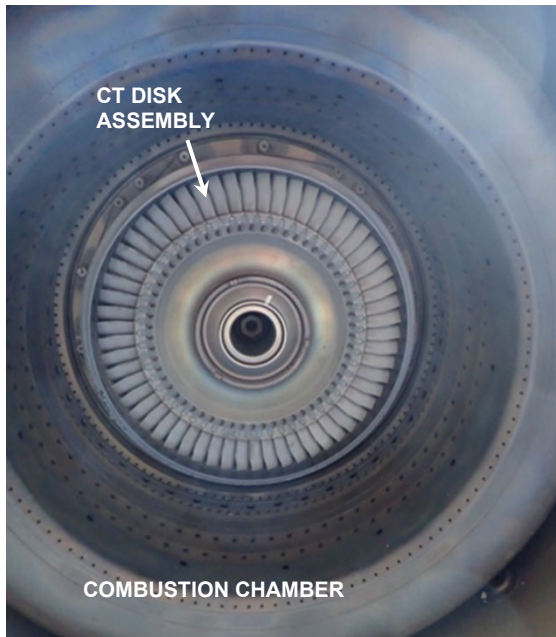
**Figure 15.** Engine forward of the C flange separation showing engine hot section

The engine was separated at the C-flange. The combustion chamber liner appeared in good condition. The small exit duct was not accessed. See Figure 15.

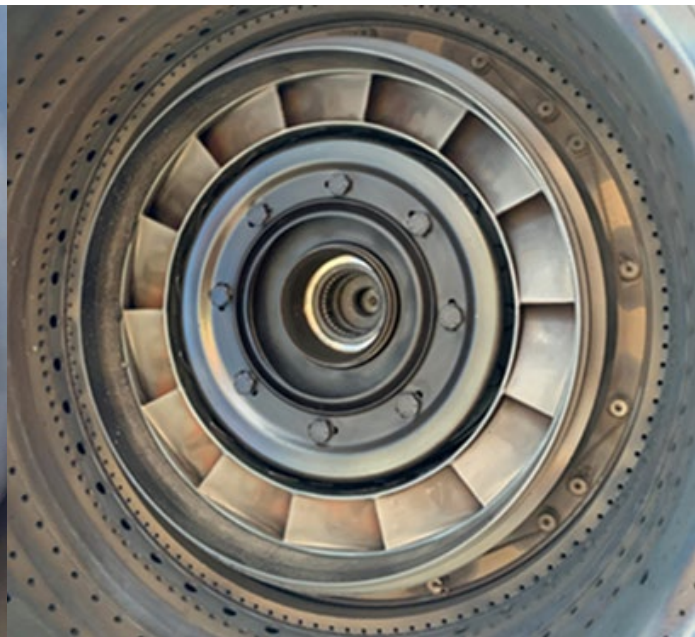
**Figure 16.** View of CT vane assembly downstream side after CT disk removal

The CT vane ring was in typical in-service condition. The vane ring shroud (CT disk blade path) exhibited light rub with material transfer. See Figure 16.

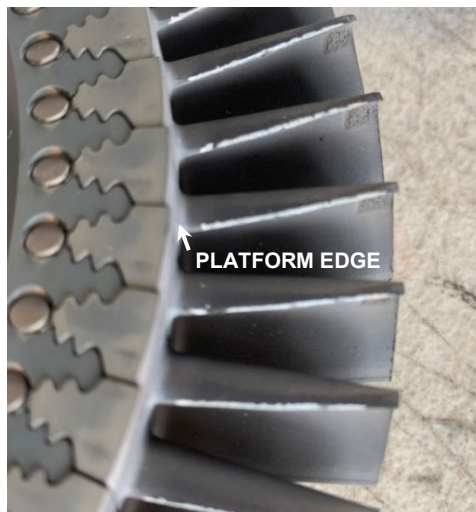
**Figure 17.** CT disk assembly upstream face showing LE blade contact

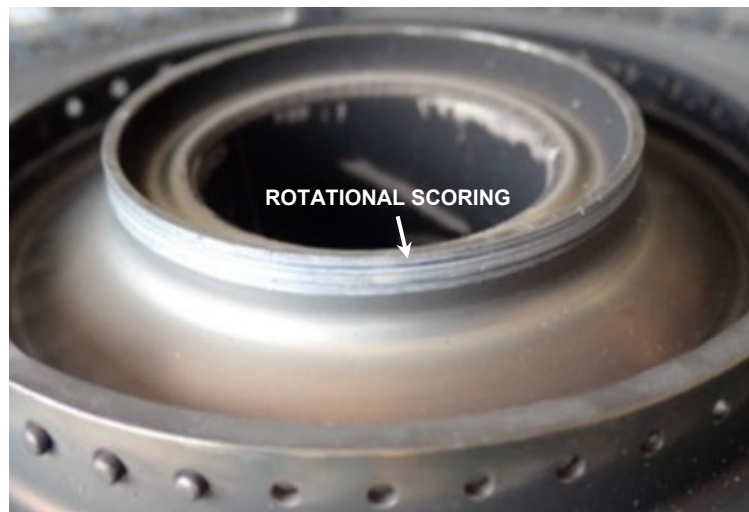
The downstream face of the CT disk was circumferentially scored along the disk retaining bolt bore lip outside surface. See Figure 18.

**Figure 18.** CT disk downstream face showing circumferential scoring to retaining bolt bore lip

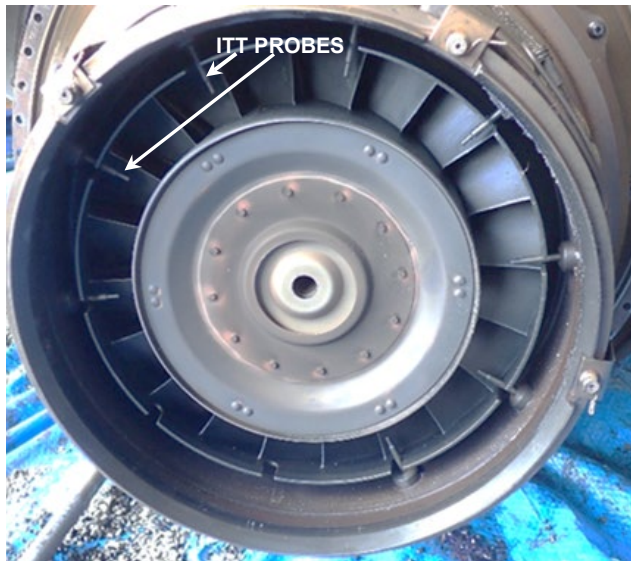
The PT vane housing and the interstage turbine temperature (ITT) harness and (eight) ITT probes were in good condition. See Figure 19.

**Figure 19.** Upstream side of PT S1 vane assembly in PT stator housing. ITT probes are shown.

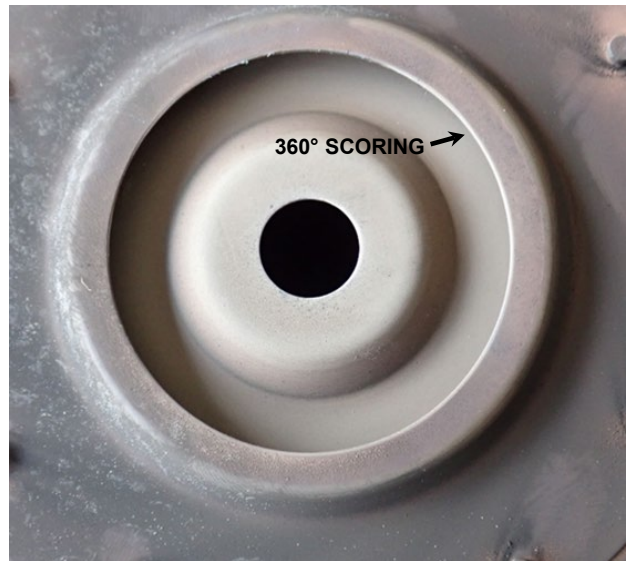
The PT S1 vane airfoil LEs exhibited operational/ thermal distress cracks. The center baffle lip was scored 360°. See Figure 20.

**Figure 20.** Upstream PT S1 vane ring 360° center baffle lip scoring

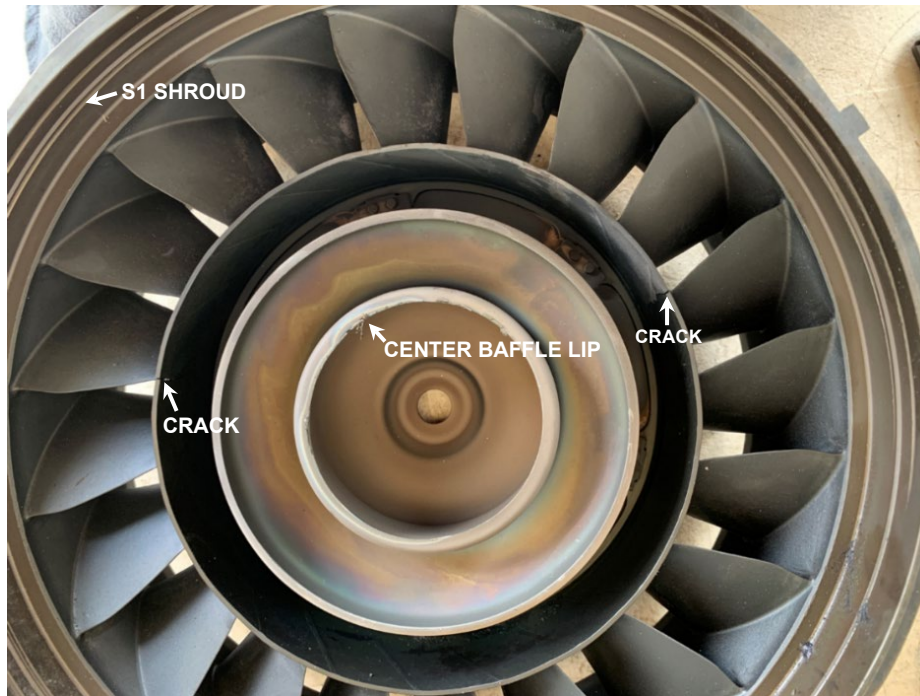
The downstream side of the PT S1 vane ring was rubbed 360° along the center baffle inner lip with local burring at the inboard edge. There were two axial cracks in the vane ring inner shroud. The PT S1 shroud (blade path surface) lands were scored over most of their circumference (310° or more). See Figure 21.

**Figure 21.** PT S1 vane ring assembly downstream side showing 360° scoring along center baffle lip, inner shroud cracks, and blade path scoring

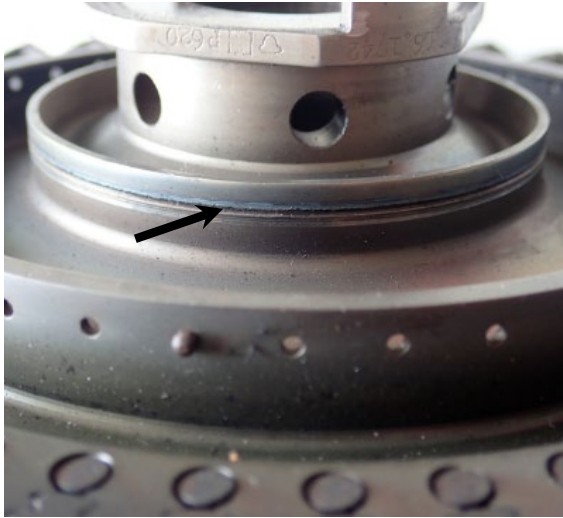
The PT S1 disk upstream face exhibited 360° scoring along the lip adjacent to the retaining nut. See Figure 22. Sulfidation-type damage was observed at the blade platform roots. The PT S1 blade tip knife edges seals were worn. See Figure 23.

**Figure 22.** PT S1 disk assembly upstream face showing 360° scoring

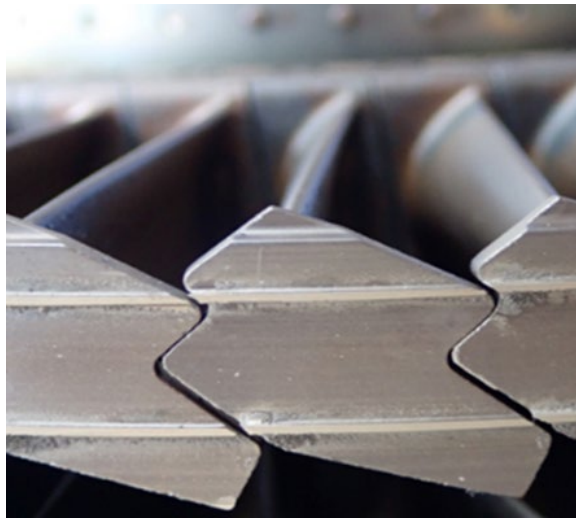
**Figure 23.** PT S1 blade tip knife edge wear

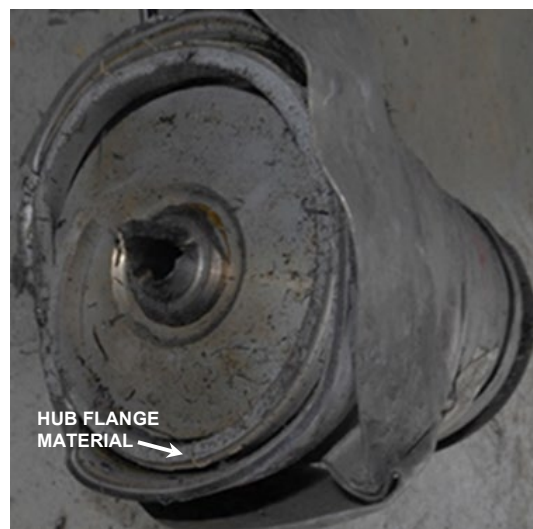
A section of cylinder attachment flange was attached to one of the recovered hydraulic units, identifying it as the hydraulic unit that separated from FY3747. See Figure 26.

**Figure 26.** Hydraulic unit with liberated hub attachment flange

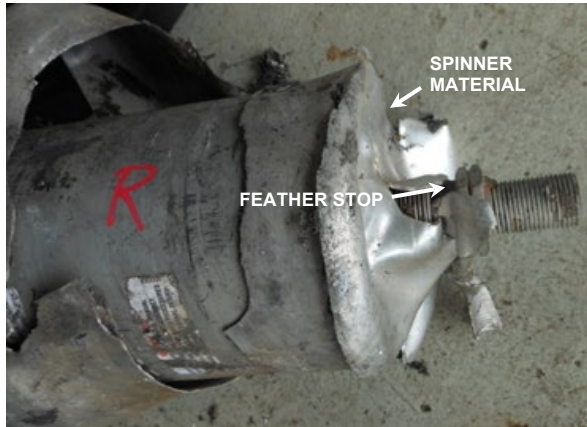
The feather stop nuts were intact and undamaged. They were positioned approximately 0.53 inch from the reverse stop sleeve. The lockwire was broken but the torque stripe was aligned. See Figure 27. The hydraulic unit was not disassembled.

**Figure 27.** Hydraulic unit showing feather stop and forward section of pitch change rod

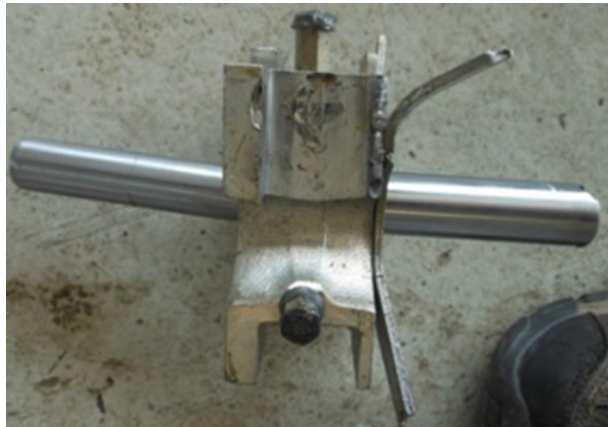
**Figure 28.** Fork and aft section of pitch change rod

One fork bumper was fractured off. Two beta pickup plate arm fingers were bent forward, and one screw head was fractured. See Figure 28. One forward finger tang was fractured off; all the aft tangs displayed impact dents characteristic of forceful rotation toward high pitch. The bumper and tang were recovered inside the hub.

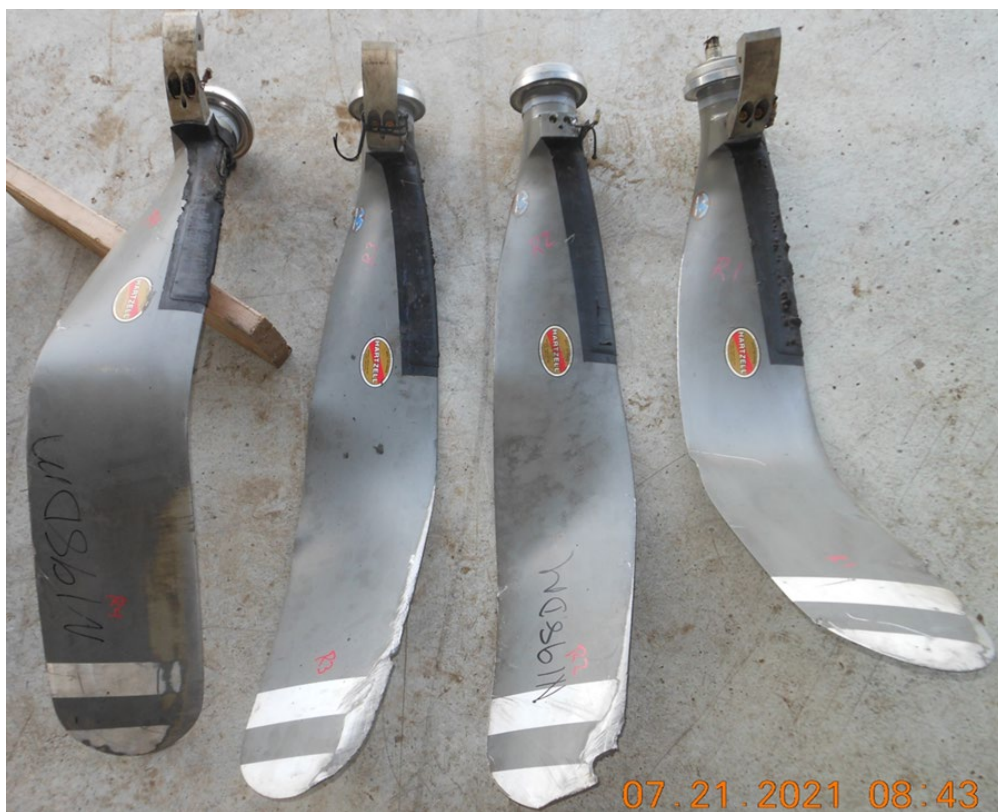
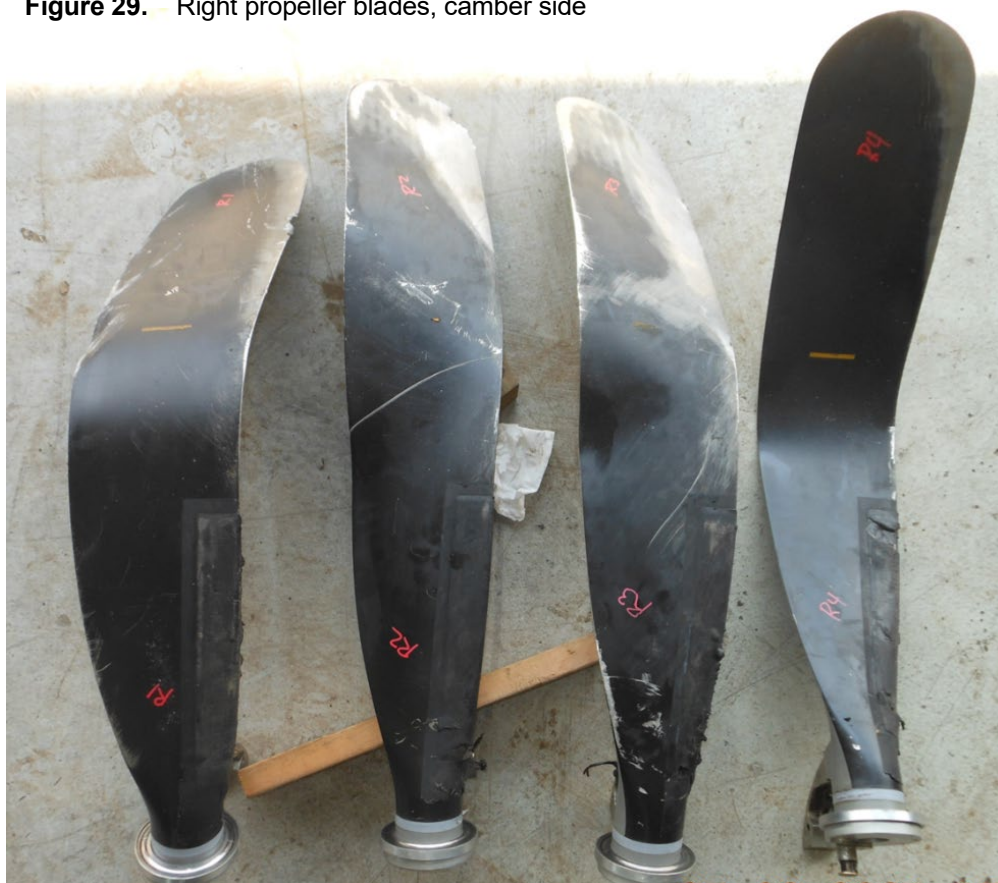
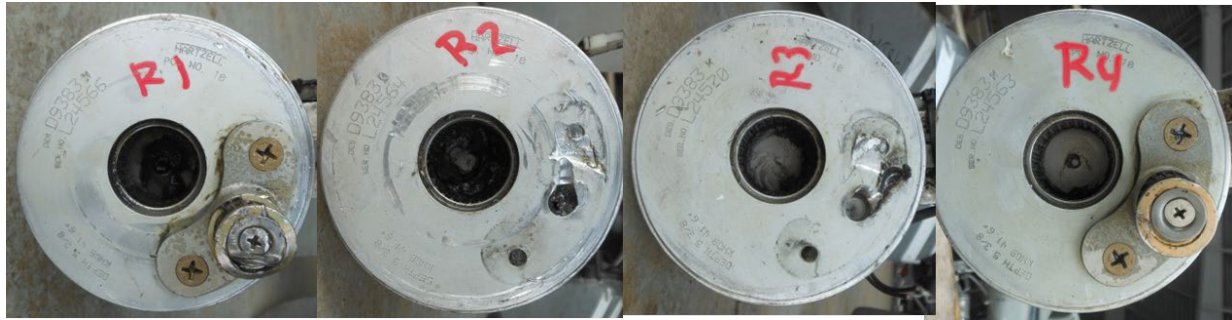
The blade deice boots displayed various cuts and varying degrees of heat damage. All blade retention bearings were intact. See Figures 29 through 31.

**Figure 31.** Right propeller blade butts, showing condition of pitch change knobs and bracket attachments

The R1 blade was bent forward in the thrust direction and was twisted toward high pitch. Both the camber and face sides were scored chordwise along the LE; the camber side LE scoring was isolated to the mid blade-to-tip area. The LE was nicked and gouged; a chunk was missing between 7 inches from the tip to 9 inches from the tip. The LE was deformed in both the high and the low pitch directions. The TE was nicked and locally bent. The pitch change knob cam follower was fractured; the knob remained attached. The counterweight was intact.

The R2 blade was bent forward in the thrust direction, opposite the direction of rotation, and twisted toward high pitch. The camber side exhibited local chordwise scoring along the LE from mid blade to the tip. The face side was scored chordwise from 11 inches inboard to the tip. The LE was nicked and gouged with small pieces missing including an approximately 0.5-inch piece of the tip. This damage was deformed in the high pitch direction. The TE exhibited buckling and wave-type bending. The pitch change knob bracket was fractured off and the dowel pin hole was deformed in the direction opposite high pitch; both bracket screw heads were sheared off. The counterweight was fractured off (recovered on site).

The R3 blade was bent forward in the thrust direction, opposite the direction of rotation and twisted toward high pitch. The camber side was scored chordwise near the LE from mid-blade to the tip and the face of the blade was scored chordwise from mid-blade to the tip. The LE was gouged with chunks of material missing. The damaged areas were deformed toward both high and low pitch. The TE was locally bent with buckling wave-type characteristics. The pitch change knob bracket was fractured off, with attachment hole deformation in the direction opposite high pitch. The counterweight was intact.

The R4 blade was bent aft. The camber side was scored chordwise from mid-blade to the tip and the face of the blade was scored chordwise along the LE from mid-blade to the tip. The LE was randomly nicked; the TE was unremarkable. The pitch change knob cam follower was fractured; the bracket remained attached with screws intact. The counterweight was intact.

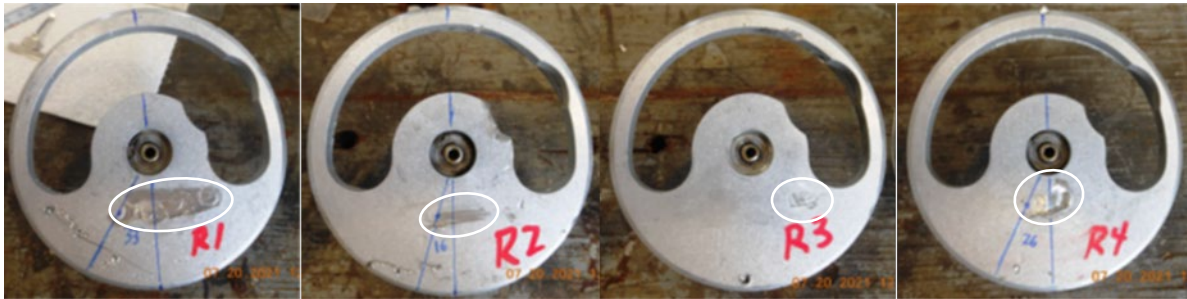
All right propeller preload plate retention lips were sheared off. There were no knob impact marks at the low pitch ends of the plate slots. The face of each plate exhibited groupings of multiple marks from fork bumper impacts. The R1 plate displayed a bumper mark at 33° forward of the hub split line (F) and additional marks progressing aft in the high pitch direction. The R2 plate showed a bumper mark 16° F with a smearing mark in the aft direction. The R3 plate had bumper marks near the feathered range of travel. The R4 plate displayed a bumper mark at 26° F and additional marks progressing aft toward high pitch. See Figure 32.

**Figure 32.** Right propeller preload plates showing impact marks

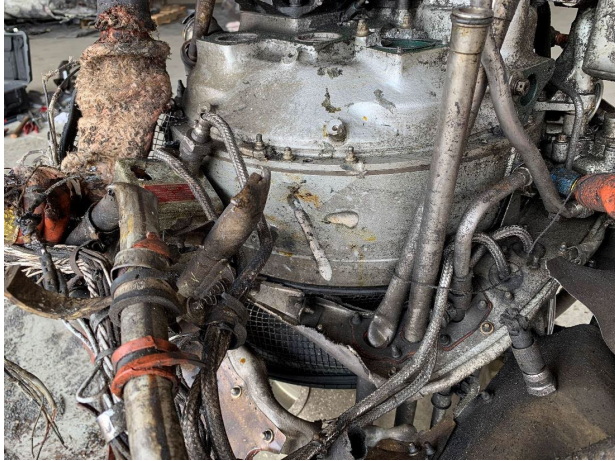
The right engine exhibited light thermal damage and was coated with soot from the C flange and aft to the AGB. The inlet case was gouged at 8 o'clock and external components in the area were crushed/displaced. See Figure 33. The No. 3/4 bearing and RGB scavenge pumps were missing. The inlet screen rubber was thermally damaged. The top of the gas generator case was buckled and deformed. See Figure 34. The mounts appeared undamaged. The first stage compressor blades were inspected through the engine inlet with no visible damage found. There were no uncontainments.

**Figure 34.** Damage to inlet case and engine externals

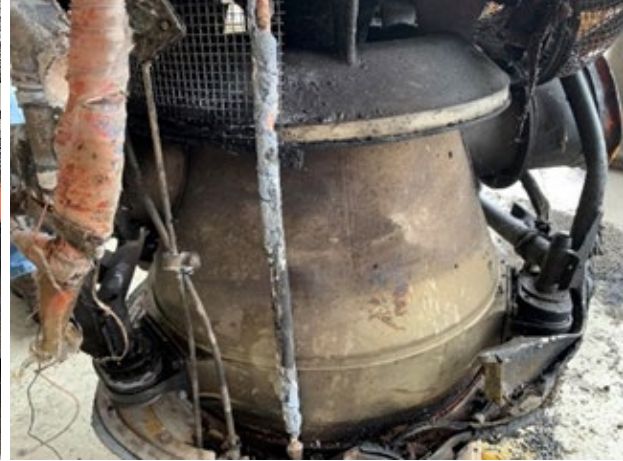
**Figure 35.** Gas generator case distortion

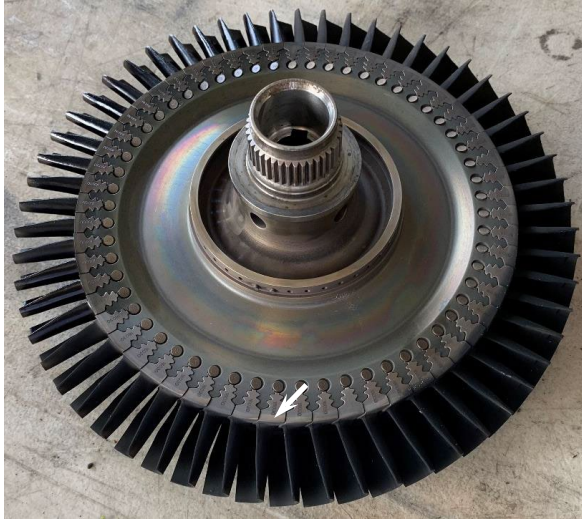
The CT disk assembly upstream face showed intermittent, light polishing along the blade outboard fir tree root platform edges. Light blade tip rub was noted. See Figure 38.

**Figure 38.** CT disk upstream face showing intermittent rub

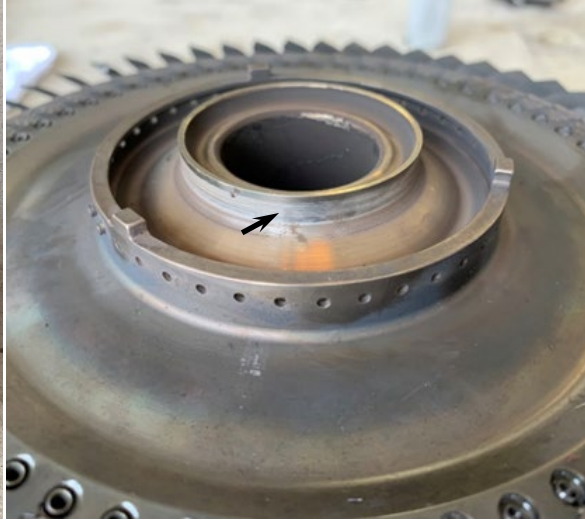
The CT disk downstream face exhibited light circumferential scoring along the retaining bolt bore lip outer surface. See Figure 38.

**Figure 39.** CT disk assembly downstream face bore lip scoring

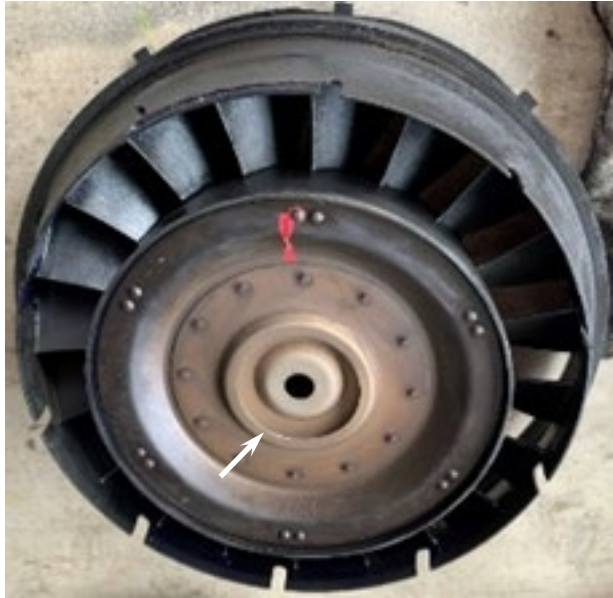
**Figure 40.** PT S1 vane ring upstream side showing inner baffle rub

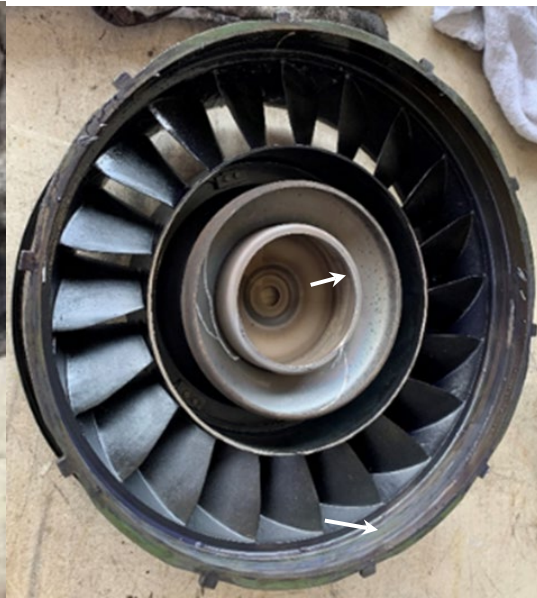
The downstream side of the PT S1 vane ring exhibited 360° rub along the inboard edge of the center baffle feature, with local burring. The shroud housing was rubbed 135° (from 5 to 2 o'clock). See Figure 41.

**Figure 41.** PT S1 vane ring downstream side showing rub along the center baffle edge and arc or scoring along the shroud/blade path

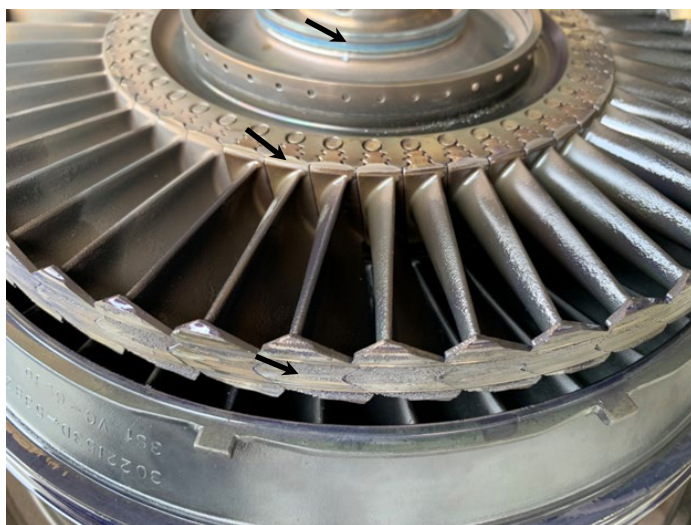
The upstream surface of the PT S1 disk assembly was rubbed and burred along the blade roots and platform edges. The lip adjacent to the retaining nut was rubbed 360°. The blade shroud knife edges were worn away. See Figure 42.

**Figure 42.** PT S1 disk assembly showing 360° scoring

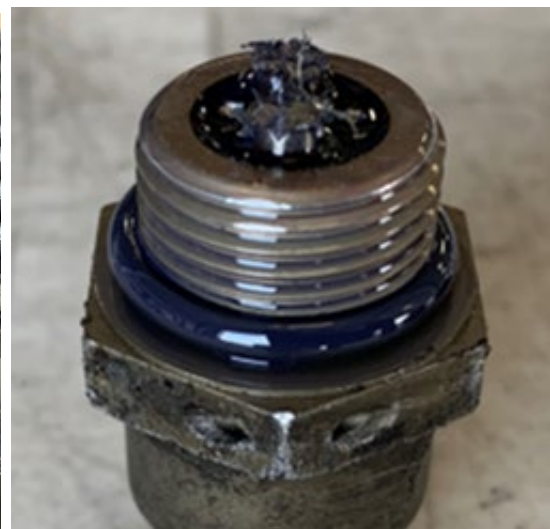
**Figure 43.** Ferrous debris on RGB plug

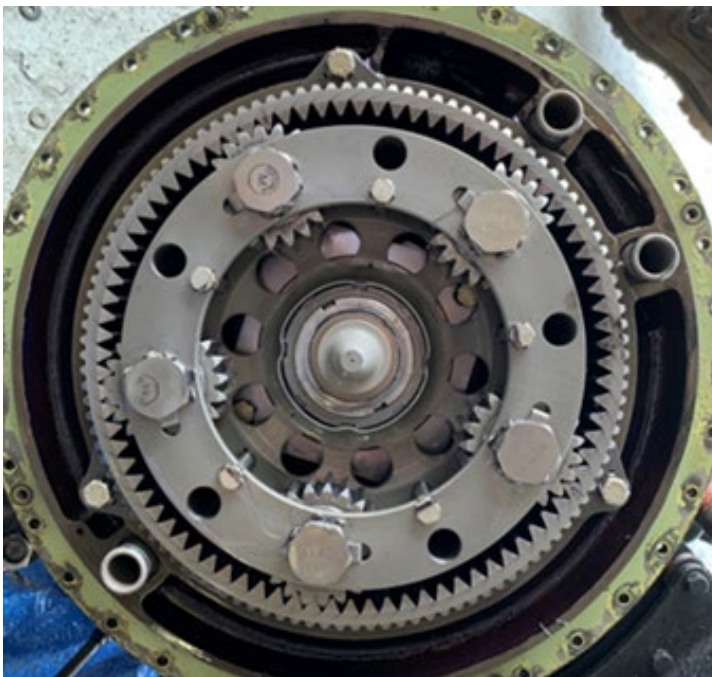
The S2 planetary gearing turned smoothly when rotated. No anomalies were noted. The S2 planetary gear retention hardware exhibited heavy rotational scoring. Figure 45.

**Figure 45.** S2 planetary gearing showing rotational damage to gear retention hardware

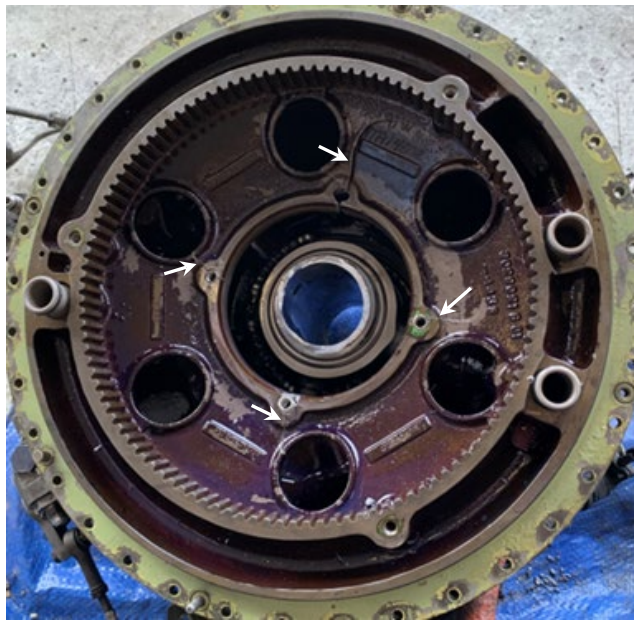
A propeller shaft fracture was found. The separation was forward of the S2 sun gear. The RGB front case No. 5 bearing retention bolt holes were fractured. See Figure 46.

**Figure 46.** RGB front case with S2 planetary gear carrier removed showing cracked bearing retention bolt holes and propeller shaft fracture

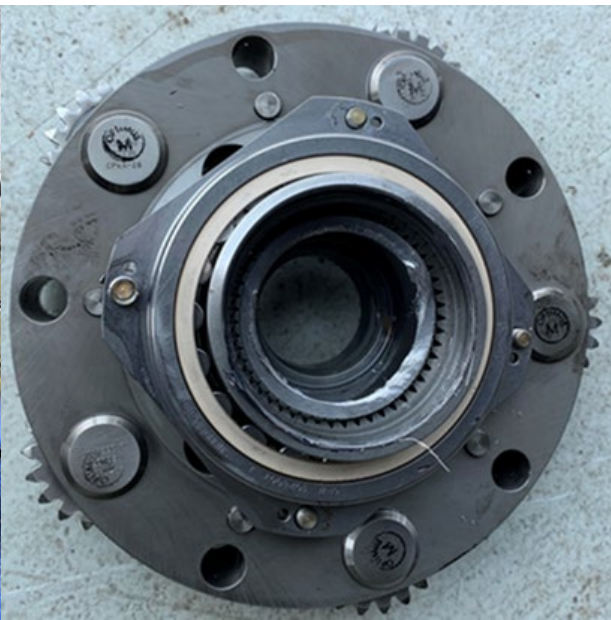
The No. 5 bearing turned freely. There was light polishing on both ends of the rollers. The S2 planetary gear carrier exhibited rotational damage forward of the plane of the shaft fracture. See Figure 47.

**Figure 47.** Forward side of S2 planetary gear carrier showing flanged bearing assembly and propeller shaft separation fracture
