## **NATIONAL TRANSPORTATION SAFETY BOARD**

### **INVESTIGATION SUMMARY**

**CEN20LA353**

Location: Inverness, Mississippi  
Date: August 20, 2020  
Aircraft: Air Tractor 602, N604MG  
NTSB IIC: Joshua Lindberg, CEN

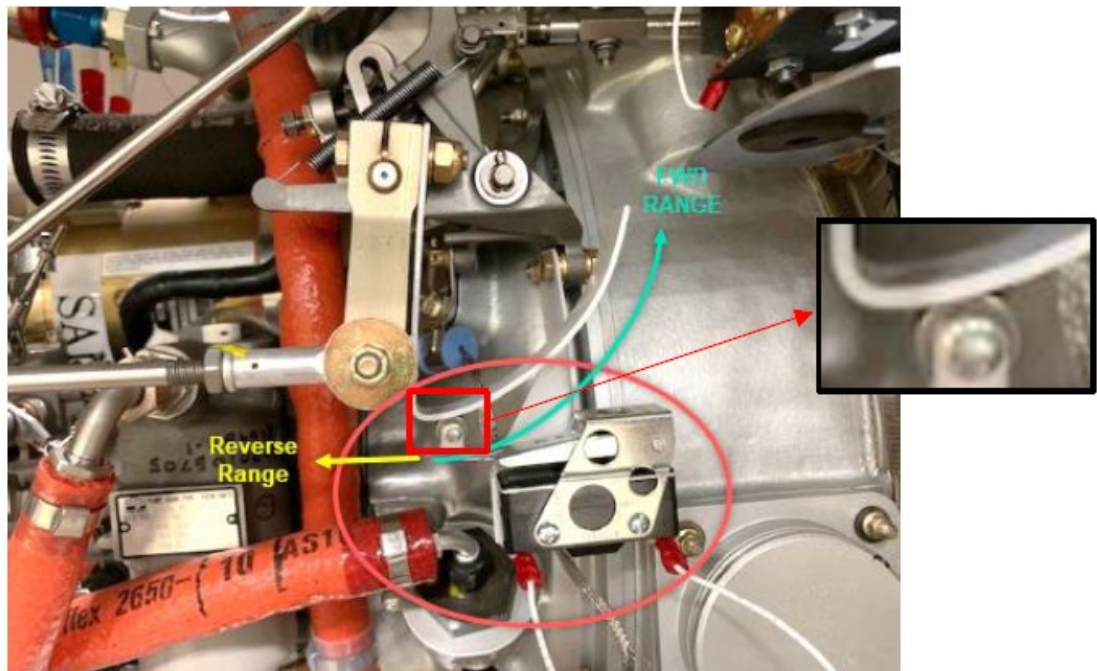
**Image 1**  
Courtesy of Air Tractor

The beta switch (circled red in image 1) is normally closed (there is positive contact between the ramp/bracket and the switch roller, see inset to image 1).

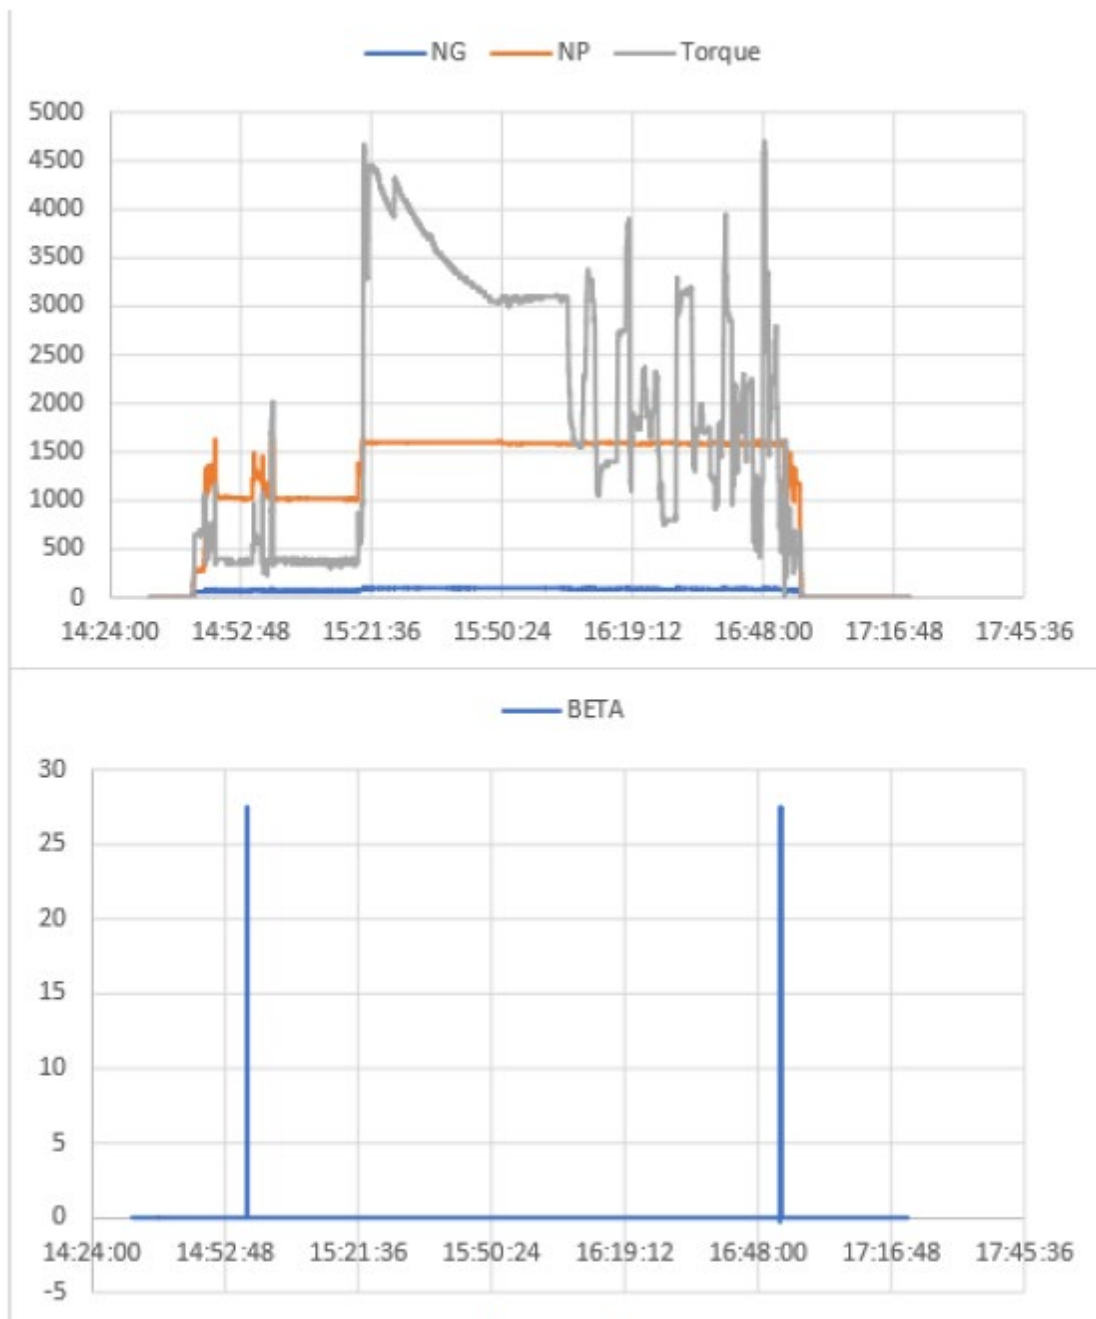
**Image 2**  
Courtesy of Air Tractor

When the power control lever (PCL) is in the forward position (forward of the idle stop position), the ramp/bracket that is attached to the PCL input retains the switch in closed position (0 volts). Once the PCL is moved through beta (aft of the idle stop position), into reverse, the ramp/bracket is forward of the switch, which opens (28 volts), and indicates in the cockpit that the PCL is in beta/reverse range. A sample graph to show correlation of voltage to beta switch position is shown in image 2.

If bus voltage is provided (28 volts) then the PCL was moved to the beta/reverse range. In summary, the indication of beta/reverse in cockpit and corresponding “PROP BETA” input in MVP-50T flight data is based on a commanded position of the PCL, not the actual position of the beta valve.

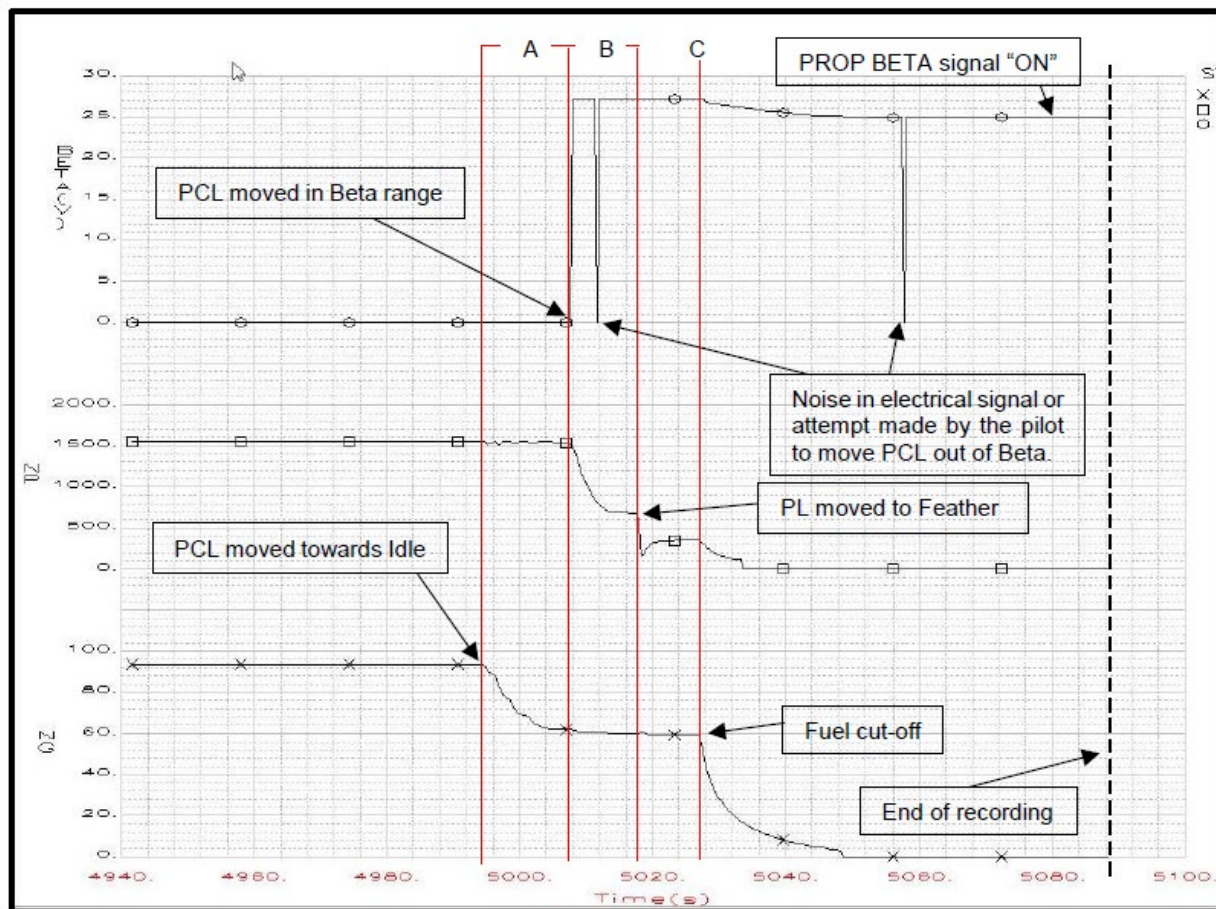
**Graph No. 3**  
Final approach

The Graph No. 3 section “A” shows the engine compressor speed ( $N_g$ ) reducing to idle. During this period, a slight fluctuation of the propeller speed ( $N_p$ ) is observed as the propeller governor tried to maintain  $N_p$ . The PCL was then moved in beta range towards reverse at the end of section “A”/beginning of section “B”, as shown with the “PROP BETA” signal (28V) and sudden drop in  $N_p$ . The Graph No. 3 section “B” shows a reduction of the  $N_p$  from ~1600 RPM to ~700 RPM. Then based on the  $N_p$ , the propeller lever (PL) was moved to the feather position at the end of section “B”. Based on the  $N_g$ , the engine condition lever (CL) was moved to the cut-off position. (“C”, Graph No. 3).

When the PCL is actuated aft of the idle stop position and into the beta range it reduces the propeller blade angle below the flight idle position. Under some flight conditions blade angles below flight idle result in blade aerodynamic forces that cause the propeller servo pressure to decrease and the propeller to become uncontrolled by the propeller governor. In this condition the propeller blade angle would be aerodynamically forced – without pilot action – to the max reverse stop. When the propeller blade angle moves to the reverse stop, the beta ring moves to the most-forward position. If the propeller is not controlled by the governor/beta valve at this point, movement of the PCL out of beta range moves the beta valve to its max forward stop without corresponding aft movement of the propeller beta ring. With the beta ring and beta valve in those positions, no further movement of the reversing cable/reversing cam would be possible, and the cam box could get jammed. The cam box is the intermediate linkage between

the cockpit levers, the propeller governor and the fuel control unit. If the cam follower pin is in the reversing range of the cam when this occurs, it will prevent forward movement of the PCL. The MVP-50T data captured during the accident flight shows evidence of the PCL was moved in beta to the reverse position during the final approach. It is also showing that beta signal was still “ON” even after engine shutdown. This shows that the cam box was stuck in beta mode.
