**Air Tractor, Inc.**  
**Accident Investigation**

**Airframe Accident Report**

**CEN20LA357**

**8/21/20**  
**Blytheville, AR**

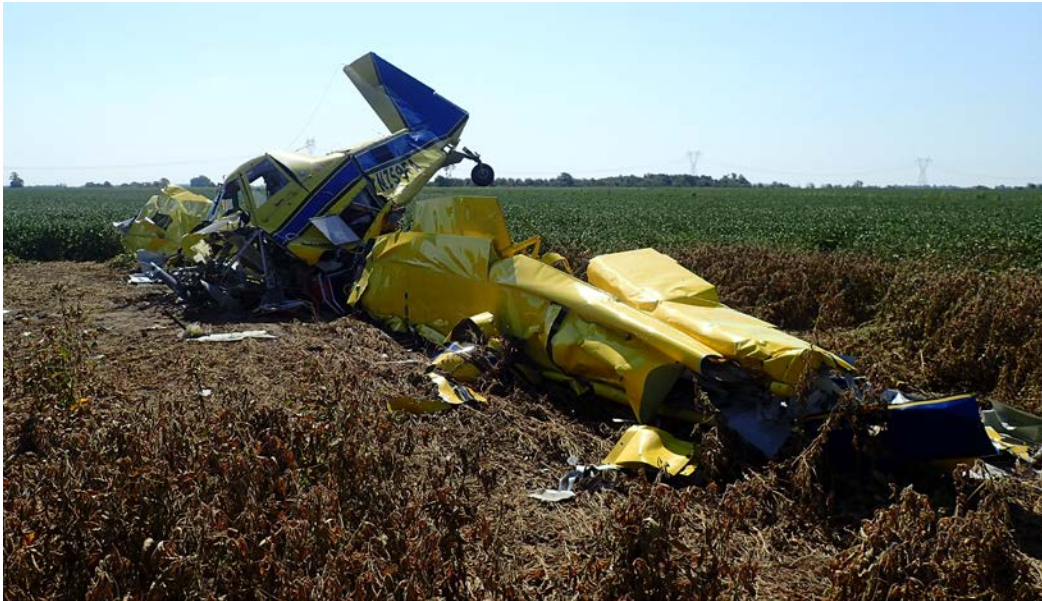
The aircraft was found upright position with heavy crush damage to the forward fuselage and wings. The aft fuselage and empennage were found with minimal crush damage. The fuselage was found on a northern heading with the tail bent to the right. No horizontal debris trail or ground scars were found leading up to the wreckage. The forward fuselage was found with a magnetic heading of 3°. The aft fuselage was found with a magnetic heading of 328°.

**Overview of Wreckage (Looking Southeast)**

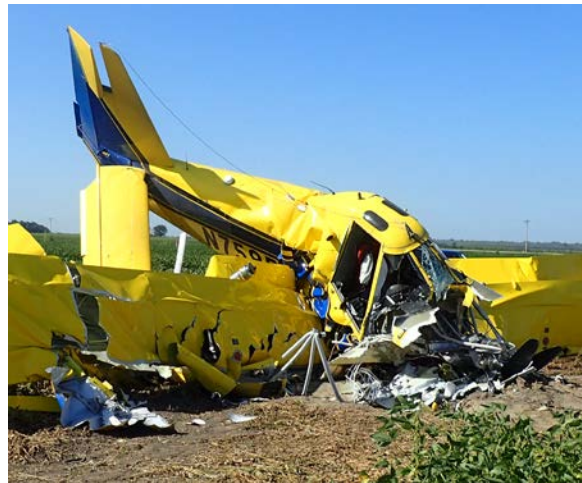
The fuselage was found upright with crush damage. The airplane was equipped with AmSafe Inflatable Restraints (airbags), which were found in the deployed state. The restraints were found unbuckled.

**Fuselage Wreckage**

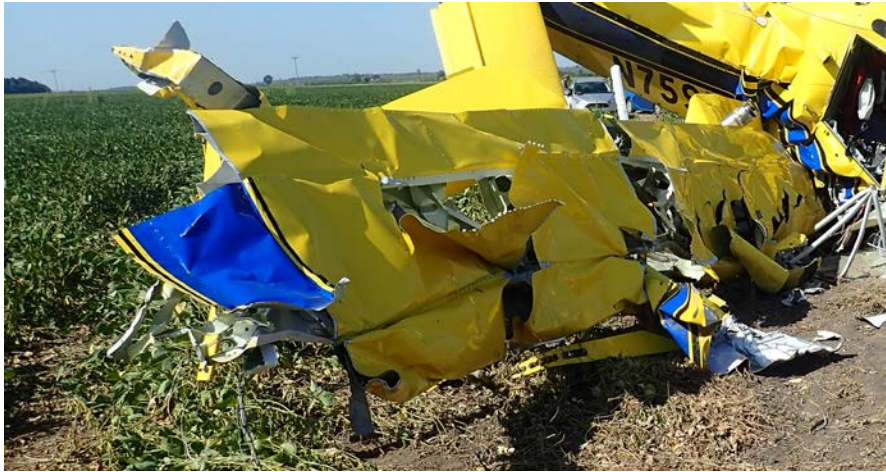
The wings were found with crush damage in the aft direction. The right wing tip was found separated from the wing just south of the wing wreckage. Both flaps and both ailerons were found attached to the wings. The flaps and ailerons exhibited deformation and damage.

**Right Wing Wreckage**

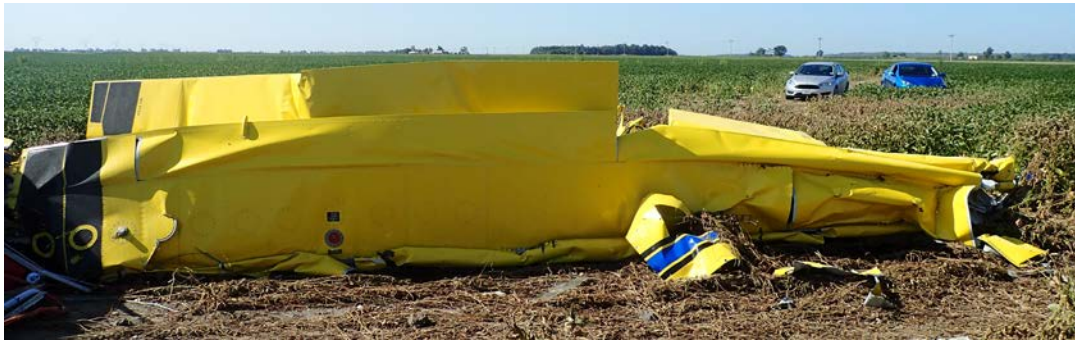
**Left Wing Wreckage**

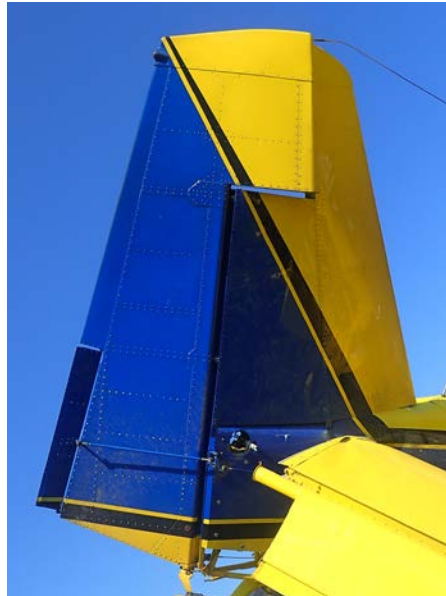
The empennage surfaces were present near the aft end of the fuselage. The vertical fin remained attached to the aft fuselage. The rudder remained attached to the vertical fin. The vertical fin and rudder were found with relatively little damage.

**Vertical Stabilizer and Rudder Wreckage**

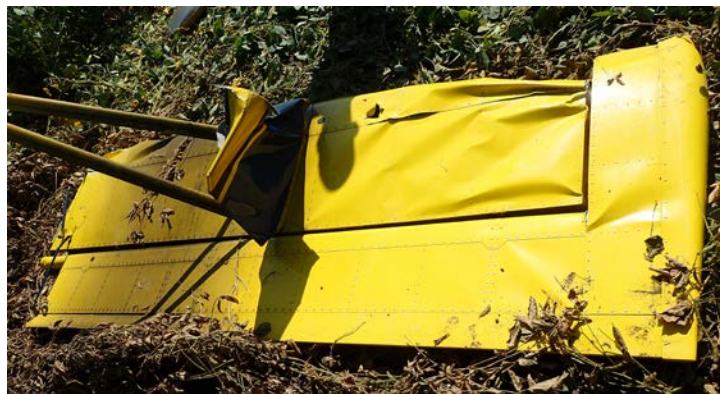
The left horizontal stabilizer was found separated from the aft fuselage attach points. The right horizontal stabilizer was found attached to the fuselage. The right rear horizontal stabilizer attach point was found separated. The left and right horizontal stabilizers were found with crush damage to the forward inboard corners. This damage is consistent with rapid deceleration in the forward direction which would cause the forward inboard portion of the stabilizer to crush against the fuselage. The left and right elevators were found attached to the horizontal stabilizers.

**Left Horizontal Stabilizer and Elevator Wreckage**

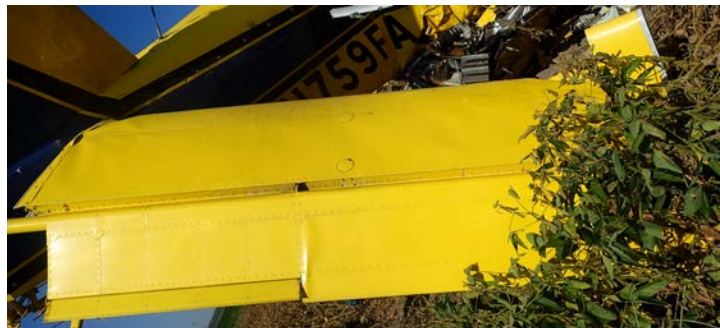
**Right Horizontal Stabilizer and Elevator Wreckage**

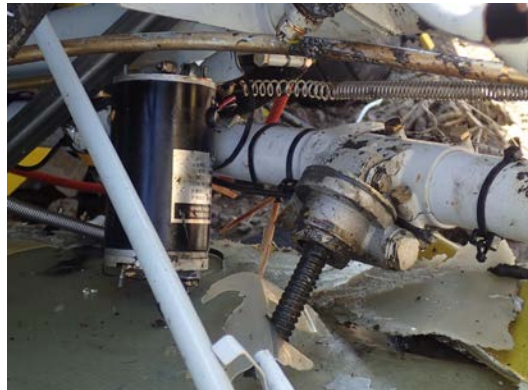
The pre-impact position of the flap actuator could not be determined due to impact damage. The flap actuator was found with an extension of 3 1/4 inches which corresponds to 27° of flaps. The flap actuator pushrod was found to be separated at the near actuator tee assembly. The actuator tee assembly was found loosely connected to the flap torque tube. The right flap controls were continuous to the control horn except for a separation in the pushrod near the aft rod end. The left flap controls were continuous to the control horn except for a separation in the arm at the end of the torque tube.

**Flap Actuator Gearbox**

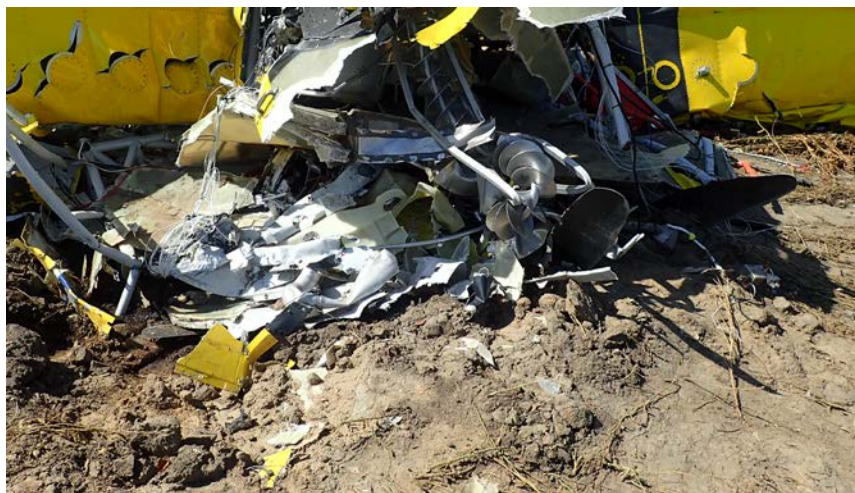
The powerplant was found with the main wreckage. The powerplant was not examined due to the condition of the wreckage.

**Engine and propeller Wreckage**

The engine was equipped with a five-bladed constant speed, fully reversable, propeller. Three of the propeller blades were found with the wreckage. The remaining blades were not located due to the condition of the wreckage.
