# NATIONAL TRANSPORTATION SAFETY BOARD

## MATERIALS LABORATORY FACTUAL REPORT

Report No. 21-057

Place : St. Louis, Missouri  
Date : August 22, 2020  
Vehicle : Cessna 180, N7620A  
NTSB No. : CEN20LA360  
Investigator : Michael Folkerts (AS-CEN)

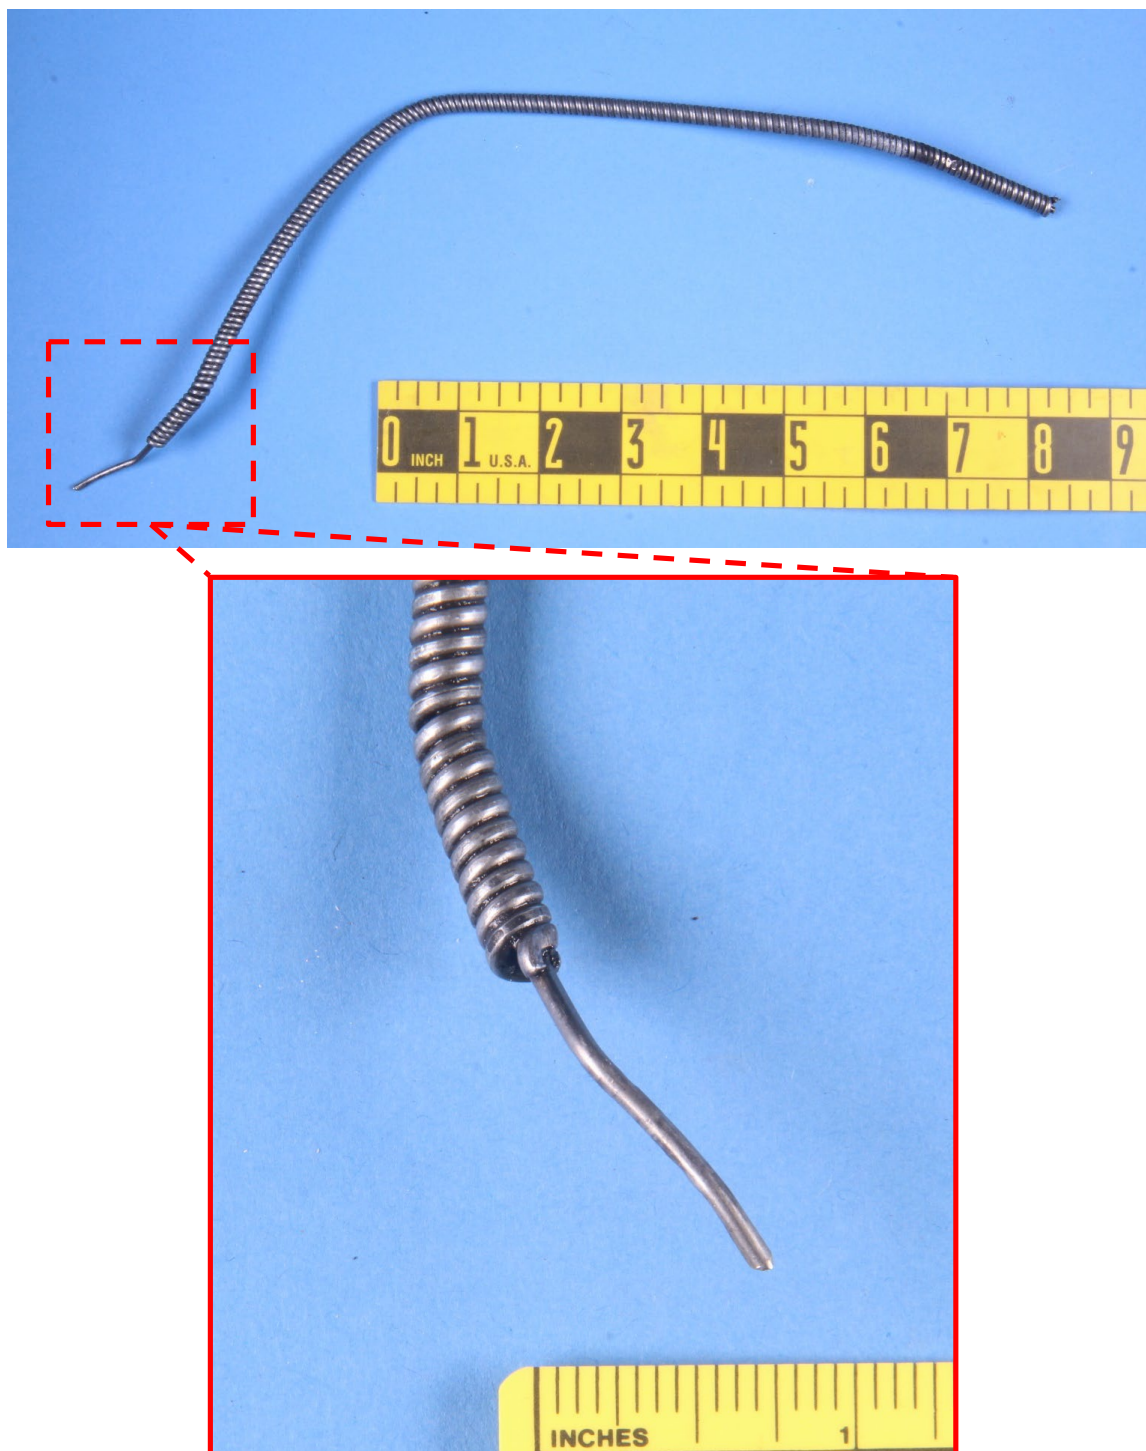
The section of mixture cable is shown in Figure 1. The central wire extended approximately 1 inch out of the surrounding external coil. The wire was stuck fast inside the external coil and could not be extended further without causing damage. Consequently, evidence of pull-thru could not be determined.

Figure 1: Overall (top) and close-up (bottom) photos of the submitted section of mixture cable.

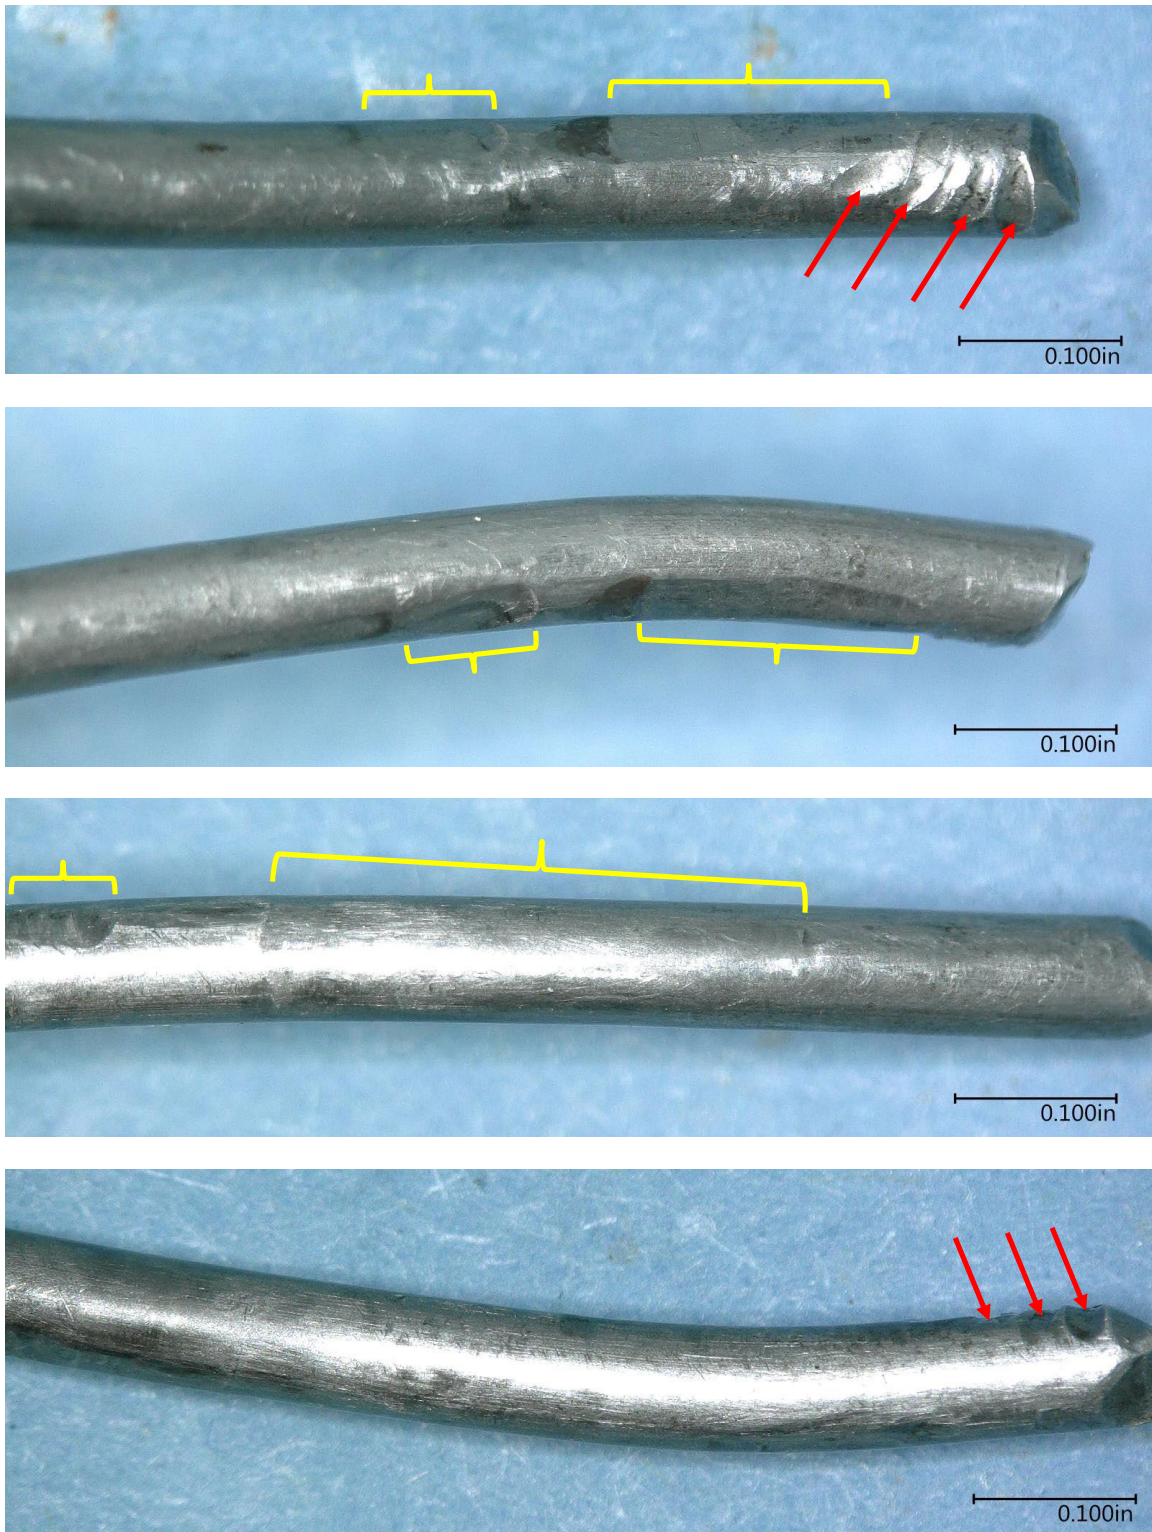
Figure 2 shows the end of the central wire that clamped inside the mating bolt and nut assembly. Multiple flat areas, indicated by yellow brackets, were observed around the outer diameter (OD) of the wire. The end of the wire was V-shaped, which is consistent with a shearing cut made by opposing blades. Several grooves, indicated by red arrows, were observed adjacent to the cut end, possibly due to prior miscuts of the wire. No kinks or sharp bends were observed in the exposed wire end.

Figure 2: Digital microscope images of the central wire. The yellow brackets indicate flat areas on the OD of the wire. The red arrows point to grooves adjacent to the V-shaped wire end.

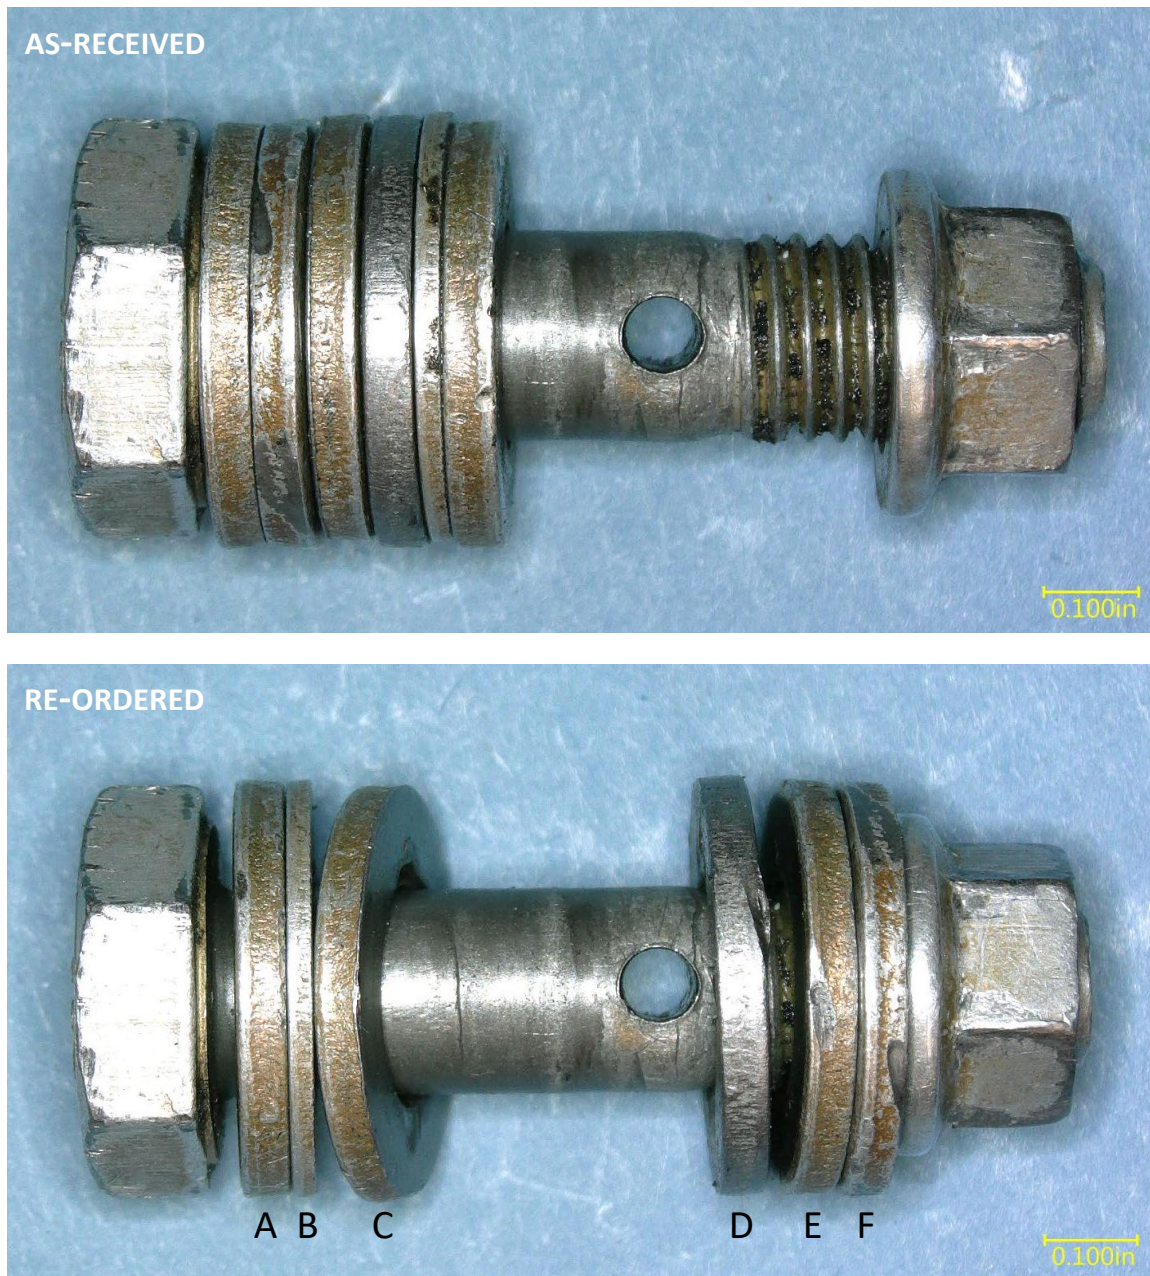
The submitted bolt, nut, and washers are shown in the as-received configuration in the top image of Figure 3. Photos of the hardware taken during the on-scene examination prior to disassembly showed the washers in a different stack-up configuration. The washers were examined and re-ordered to match the on-scene photos, and the resulting original configuration is shown in the bottom image of Figure 3. The washers were labeled A–F from the bolt head to the nut, as indicated.

Figure 3: Digital microscope images of the bolt, nut, and washers in the as-received and re-ordered configurations (top and bottom images, respectively). The washers were labeled A – F as indicated.

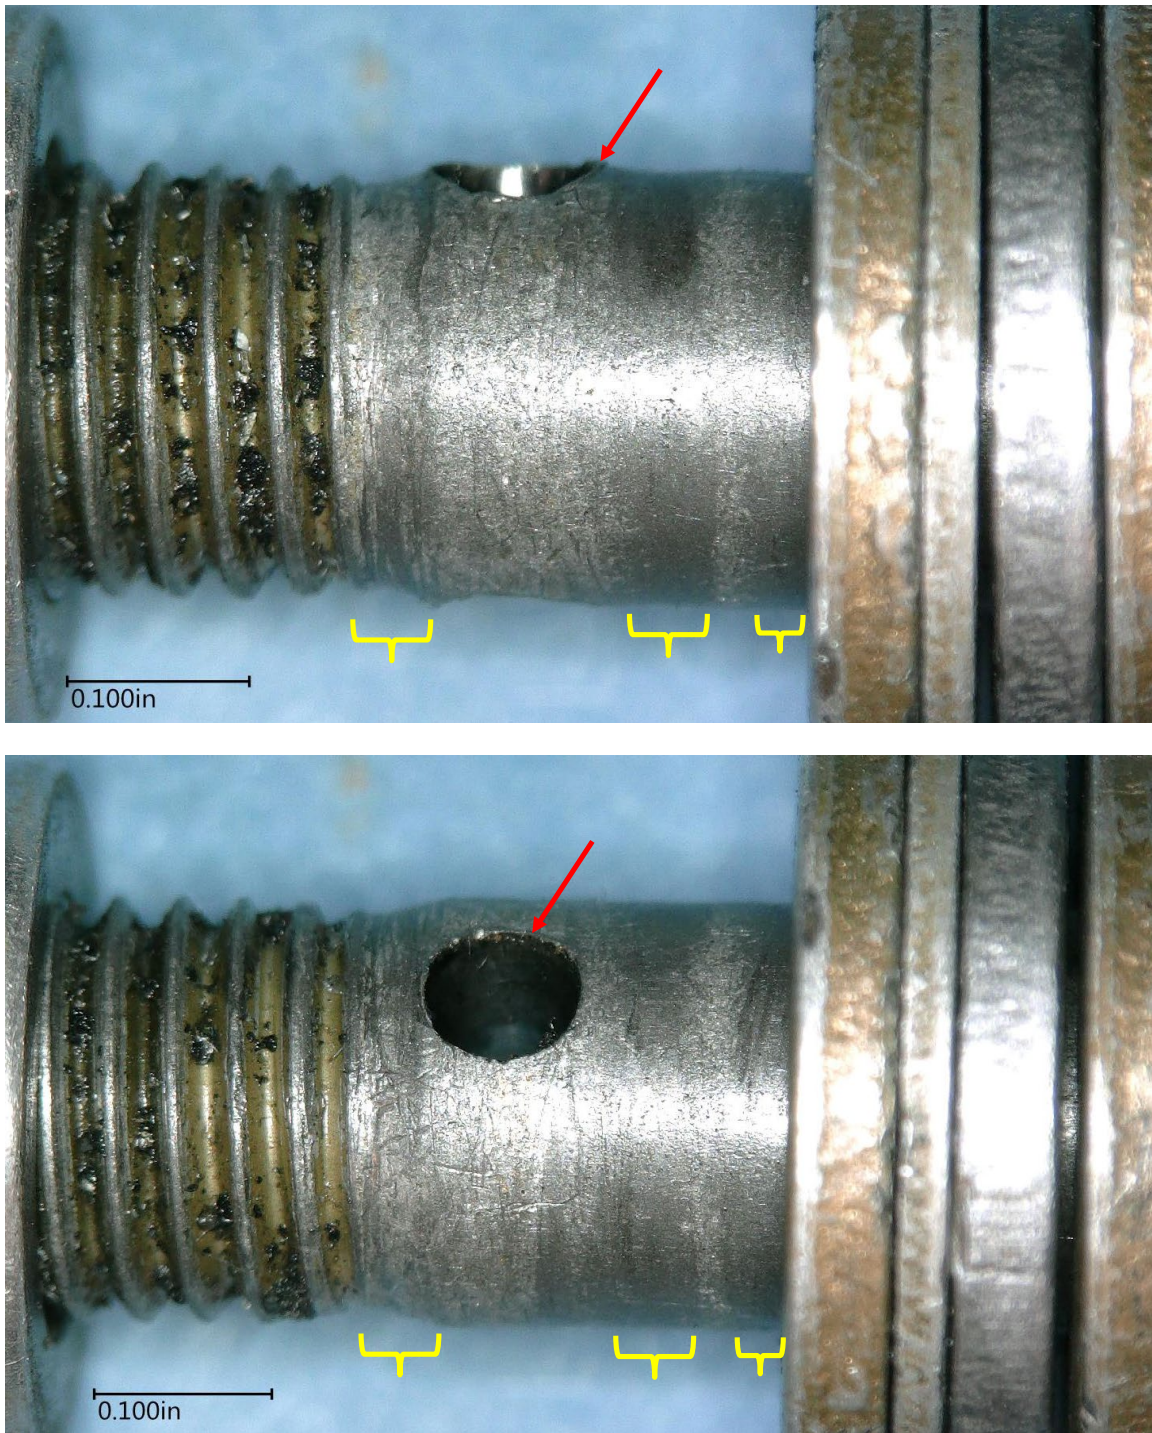
Bands of wear were observed on the OD of the bolt, consistent with rub damage from the mating washers. The bands of wear are indicated by yellow brackets in Figure 4. Red arrows point to rolled material around the edge of the hole in the bolt. The rolled material was consistent with contact from a wire being inserted through the hole and pressed up against the edge during clamping. The threads on the bolt were intact and no flattening was observed.

Figure 4: Digital microscope images of the OD and center hole in the bolt. The yellow brackets indicate bands of circumferential wear. The red arrows point to rolled material along the edge of the hole.

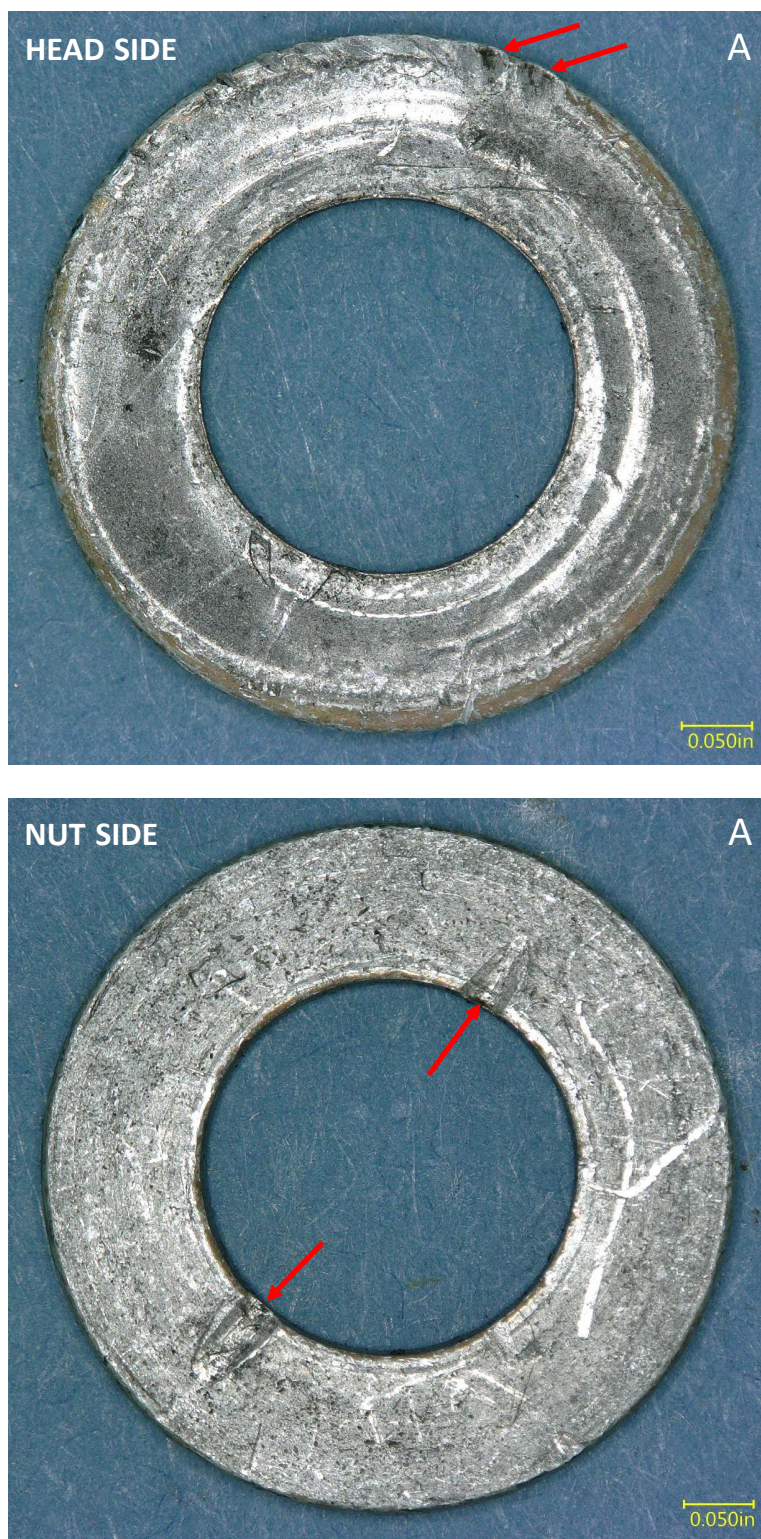
The disassembled washers are shown in Figures 5-10. The faces of the washers had circumferential wear marks consistent with rub damage from mating washers. Grooves were observed on the washers, as indicated by the red arrows. The grooves were consistent with contact from the mating wire threaded through the bolt. Most of the washers had multiple grooves on them, including ones that were not touching the wire in the stack-up configuration at the time of the accident.

Figure 5: Digital microscope images of the faces on washer A. The red arrows point to grooves observed from contact with a mating wire.

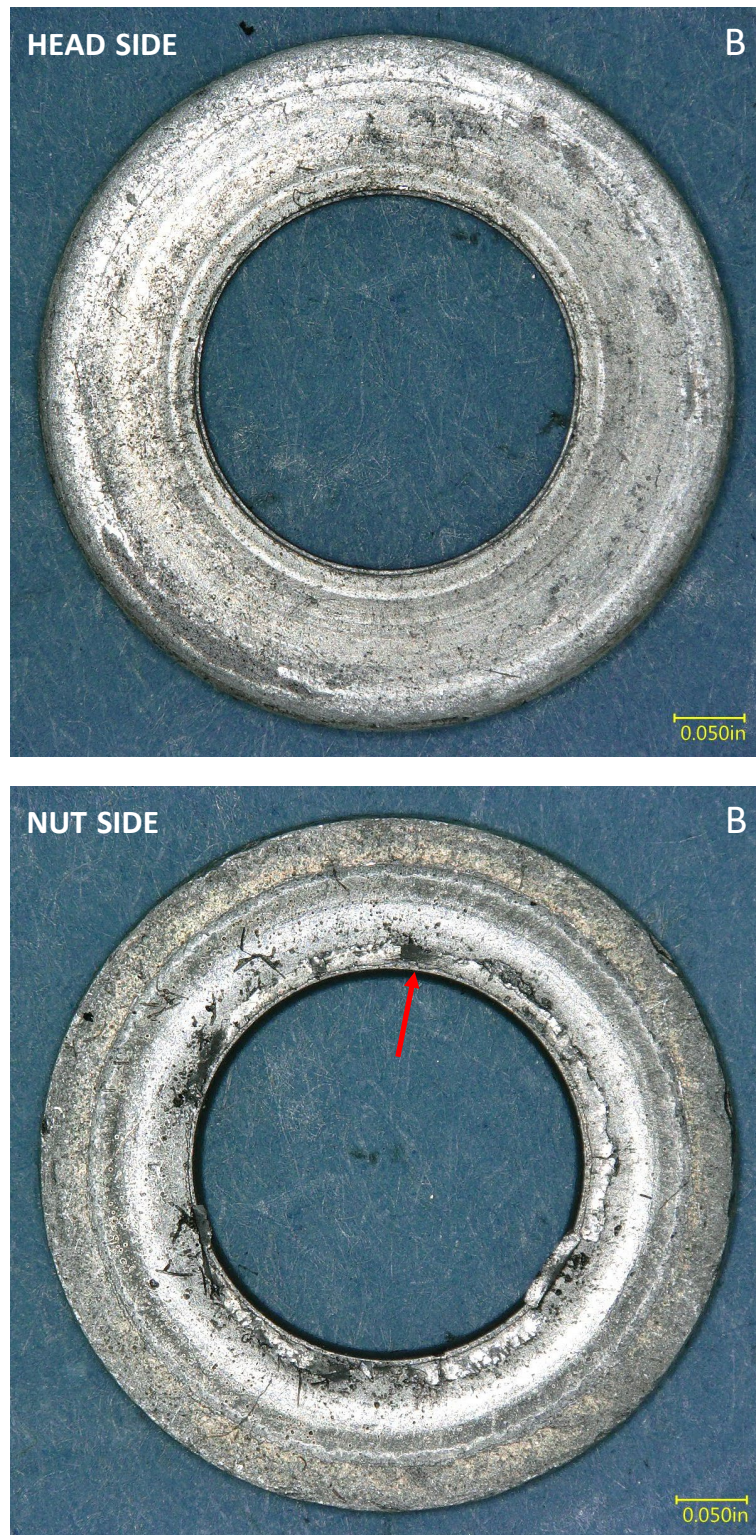
Figure 6: Digital microscope images of the faces on washer B. The red arrows point to grooves observed from contact with a mating wire.

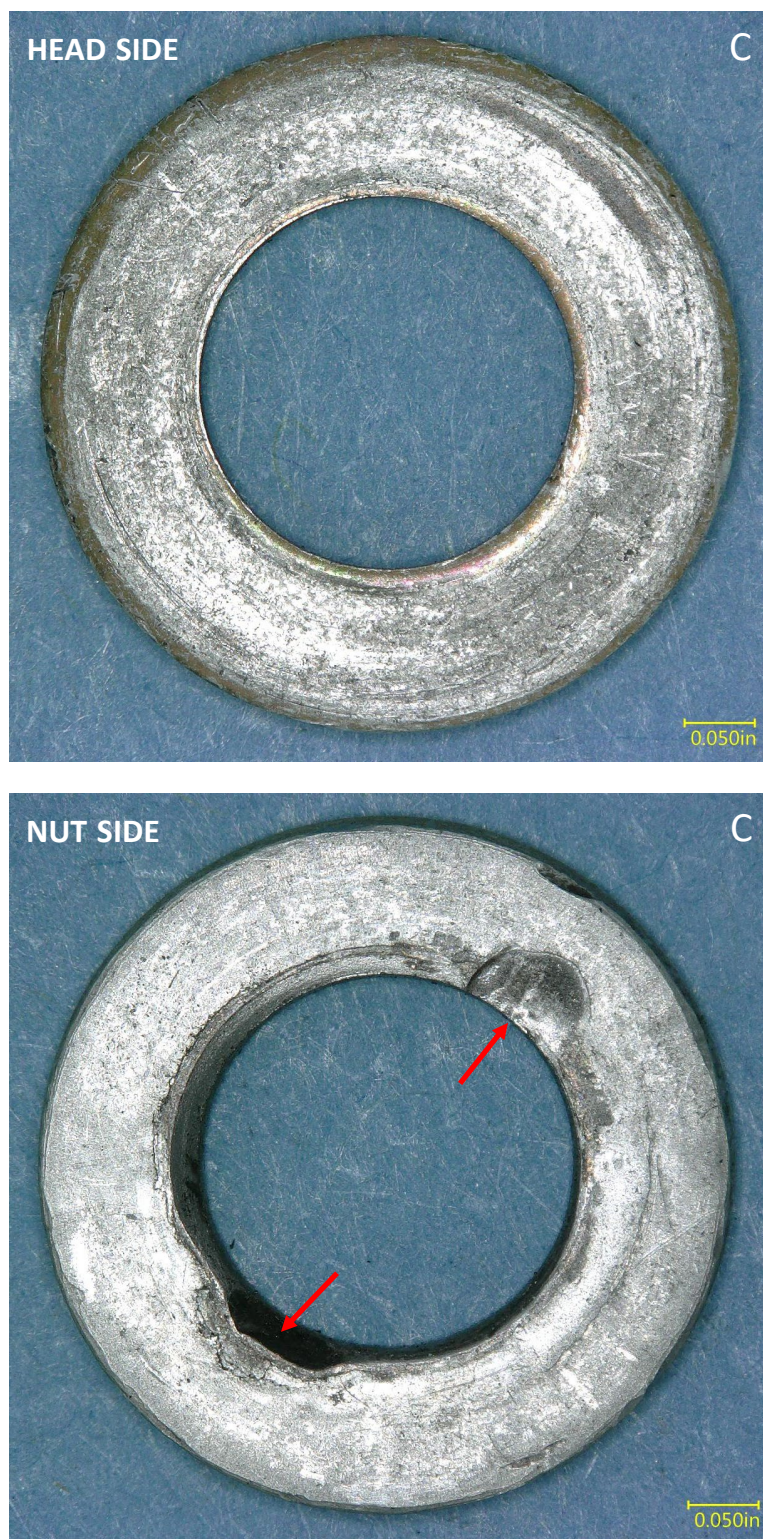
Figure 7: Digital microscope images of the faces on washer C. The red arrows point to grooves observed from contact with a mating wire.

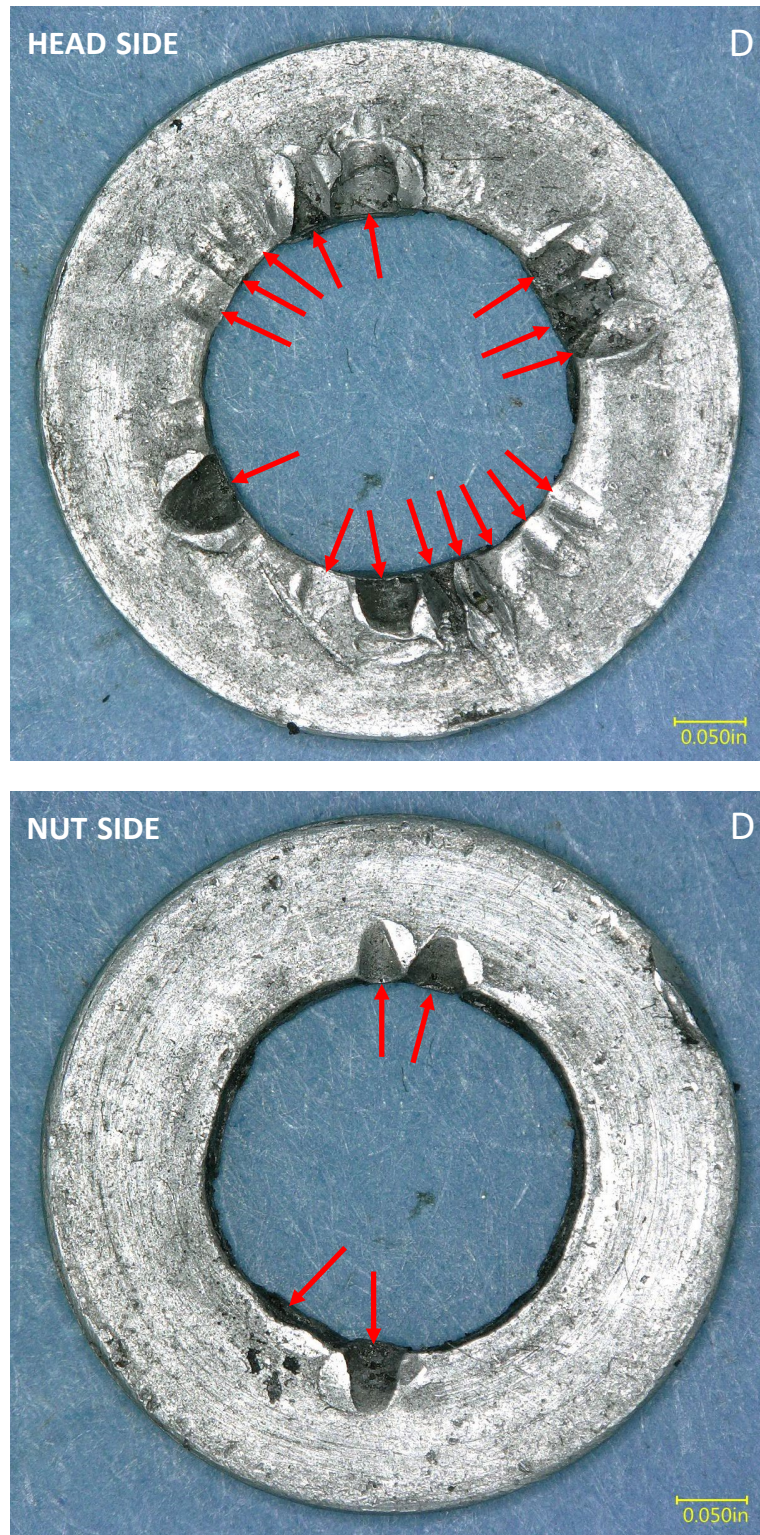
Figure 8: Digital microscope images of the faces on washer D. The red arrows point to grooves observed from contact with a mating wire.

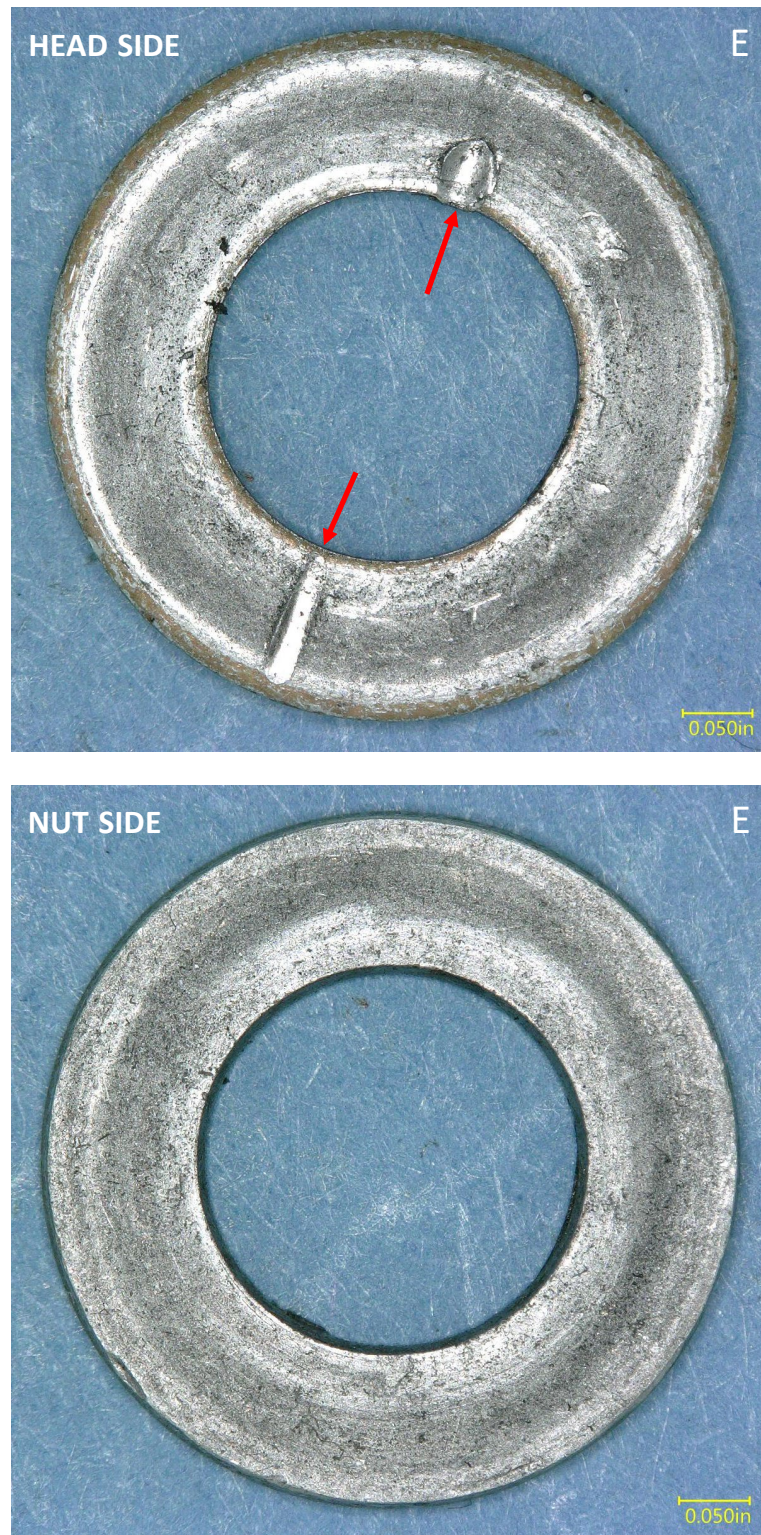
Figure 9: Digital microscope images of the faces on washer E. The red arrows point to grooves observed from contact with a mating wire.

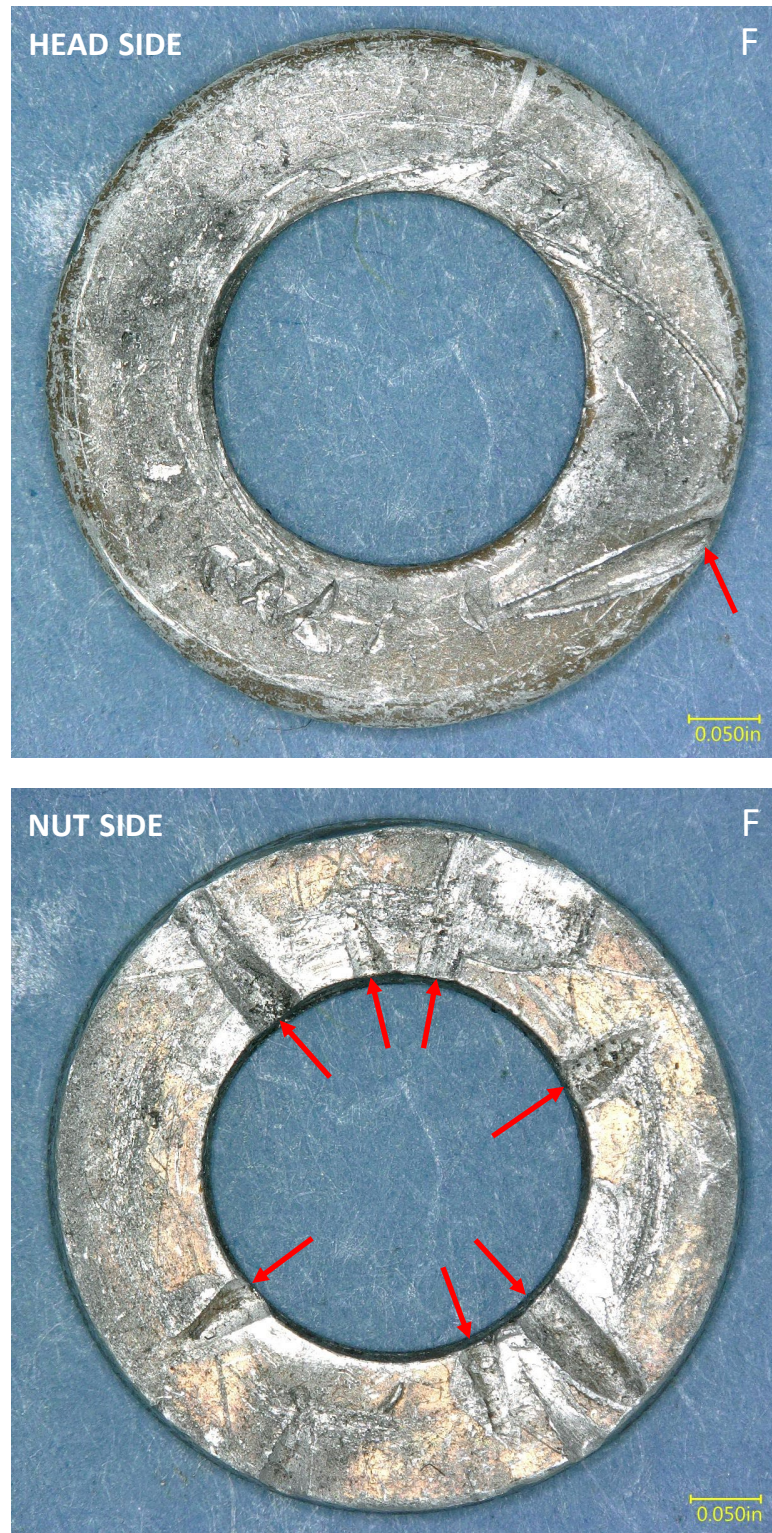
Figure 10: Digital microscope images of the faces on washer F. The red arrows point to grooves observed from contact with a mating wire.
