**Photo 1 – Accident Airplane**

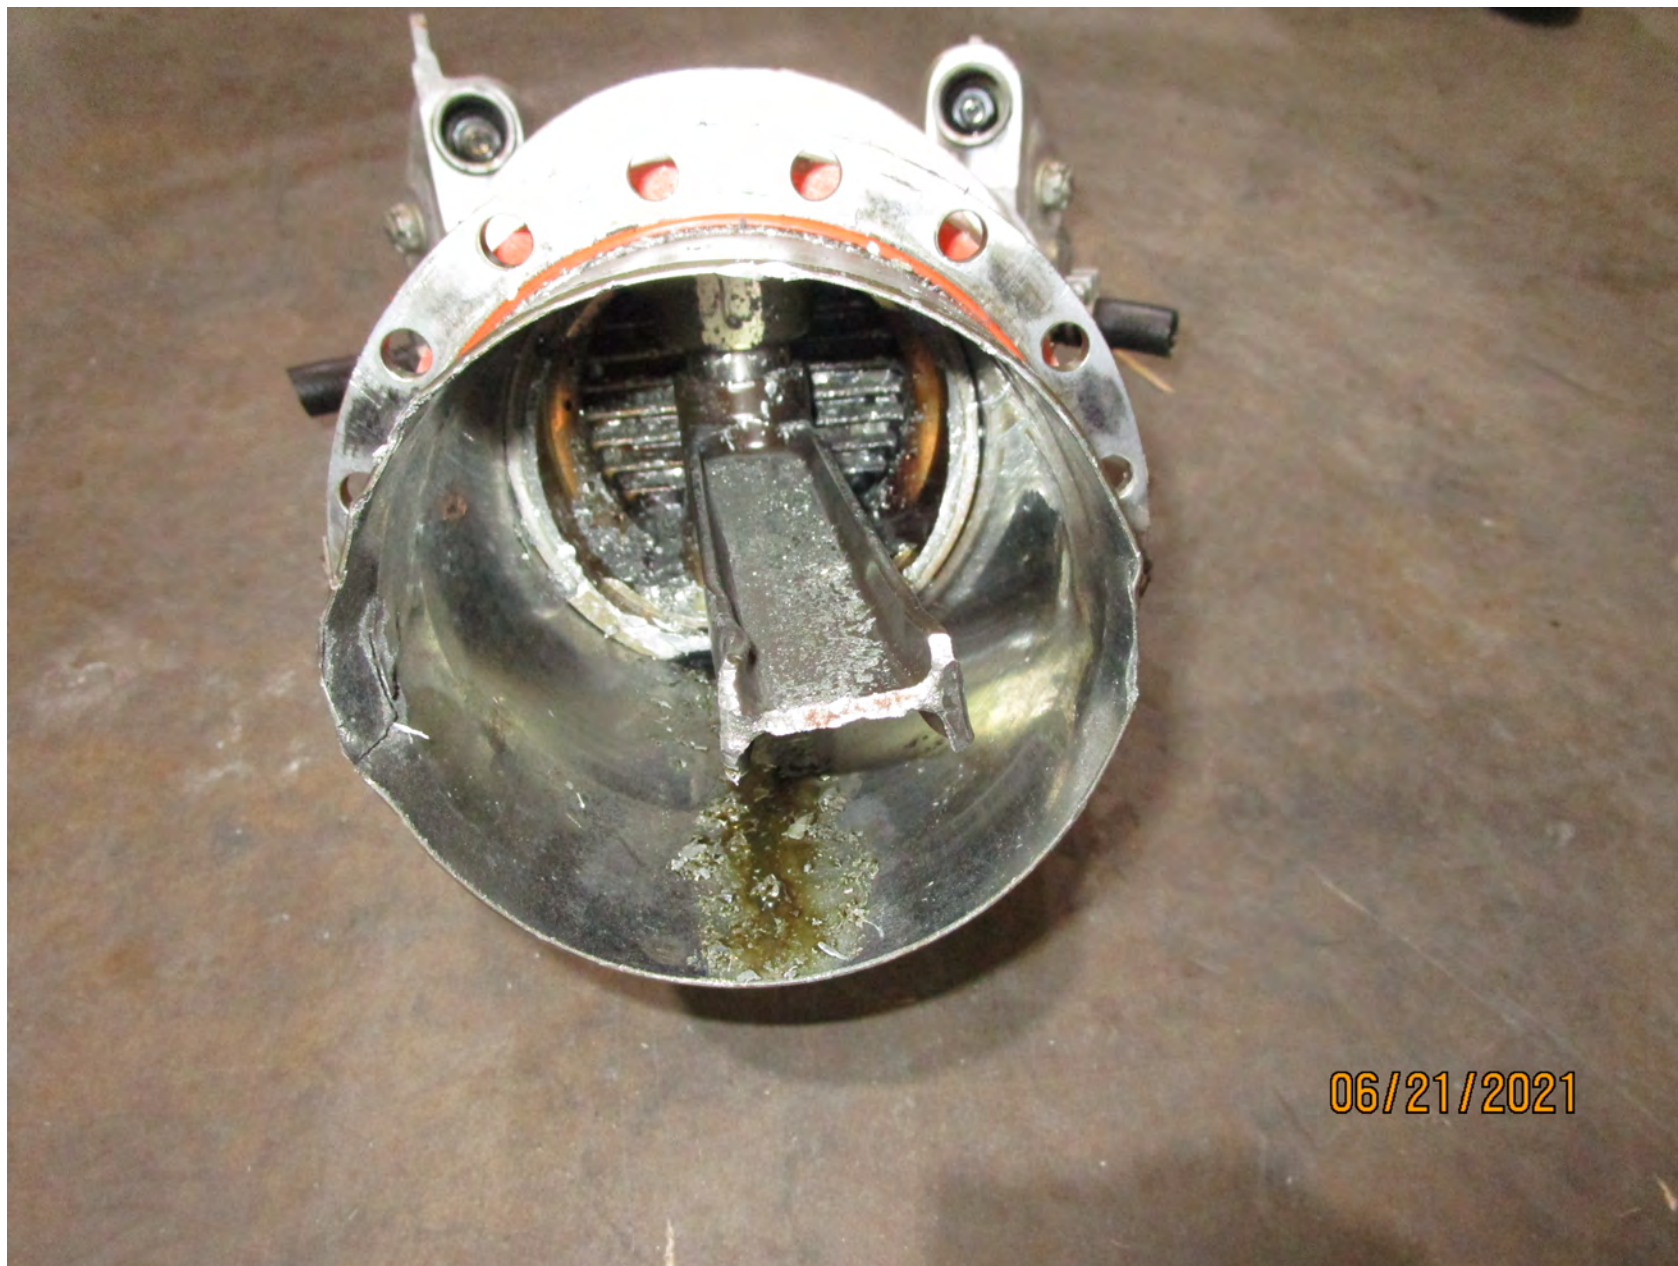
**Photo 2 – Removed cylinder with broken connecting rod**

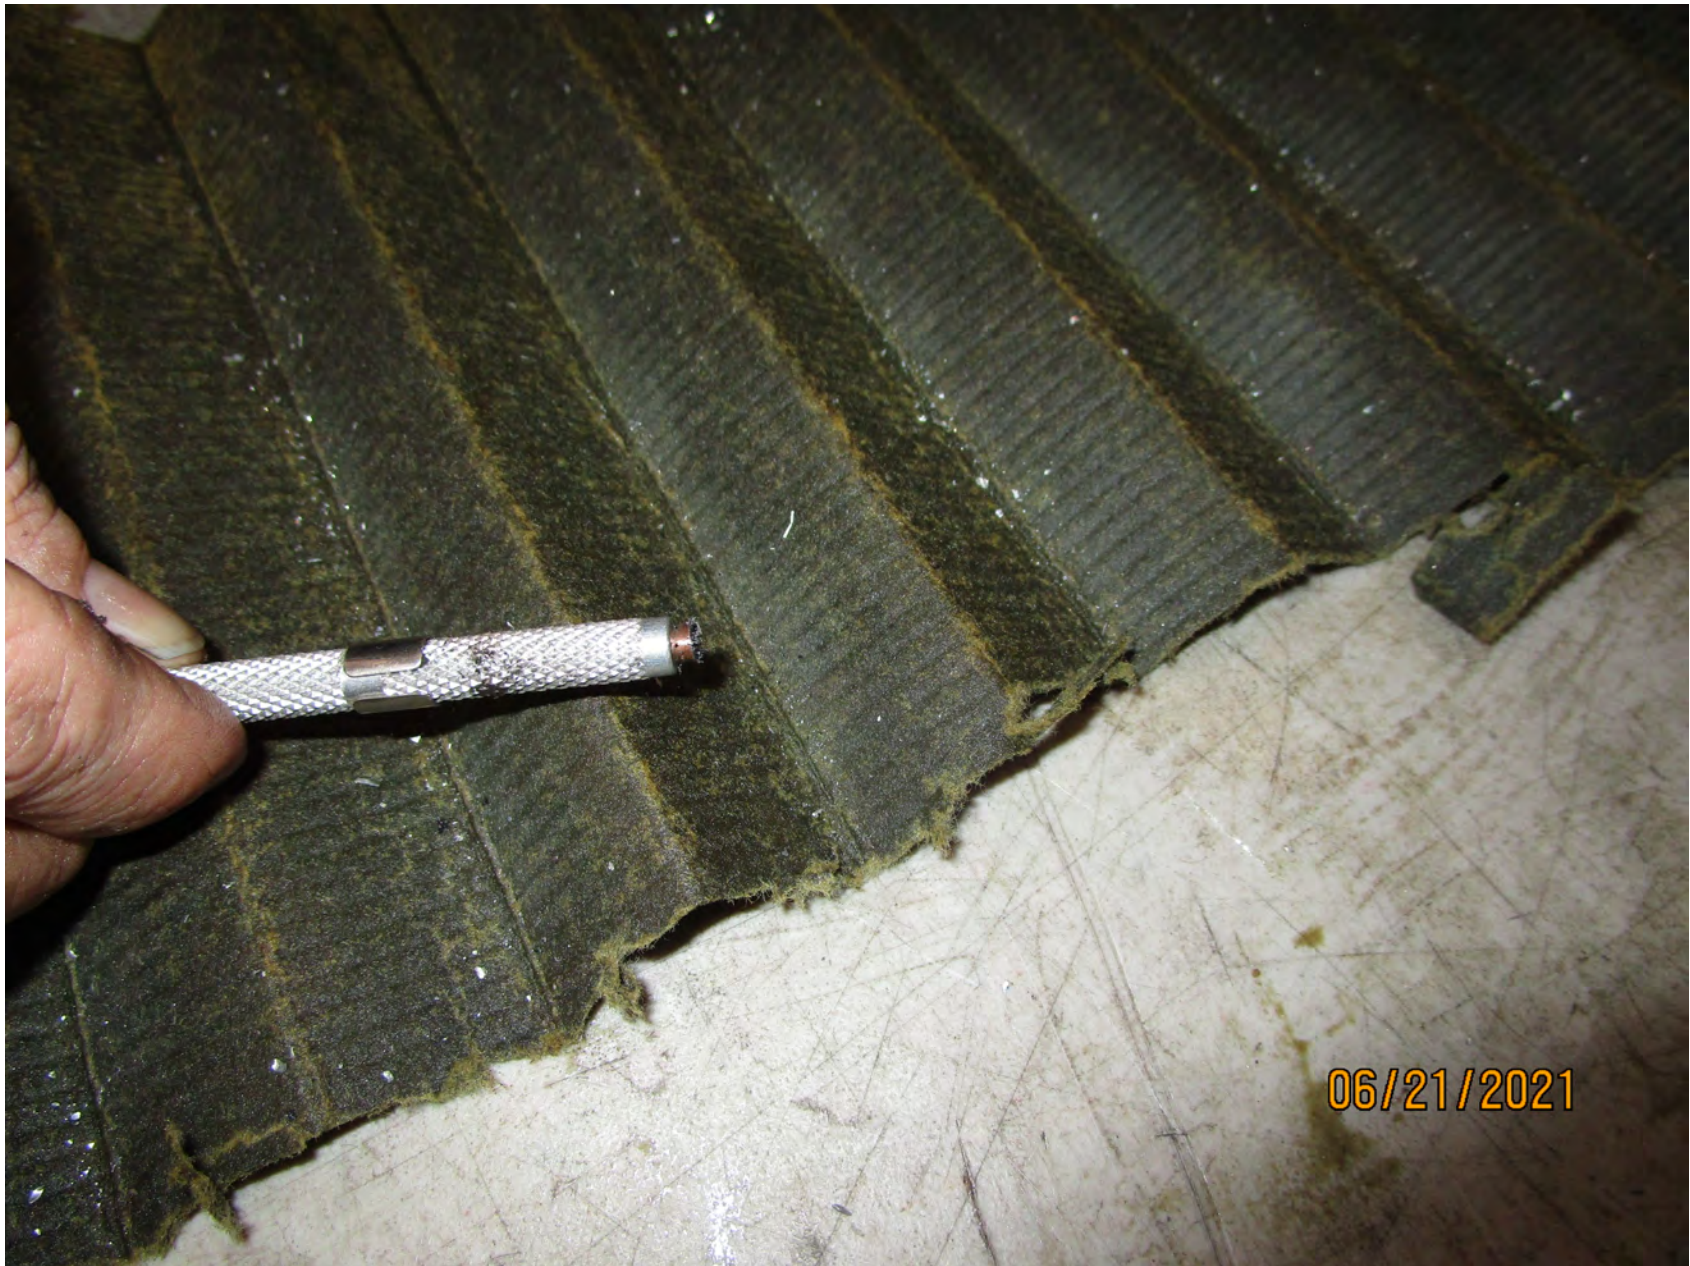
**Photo 3 – Oil filter element**

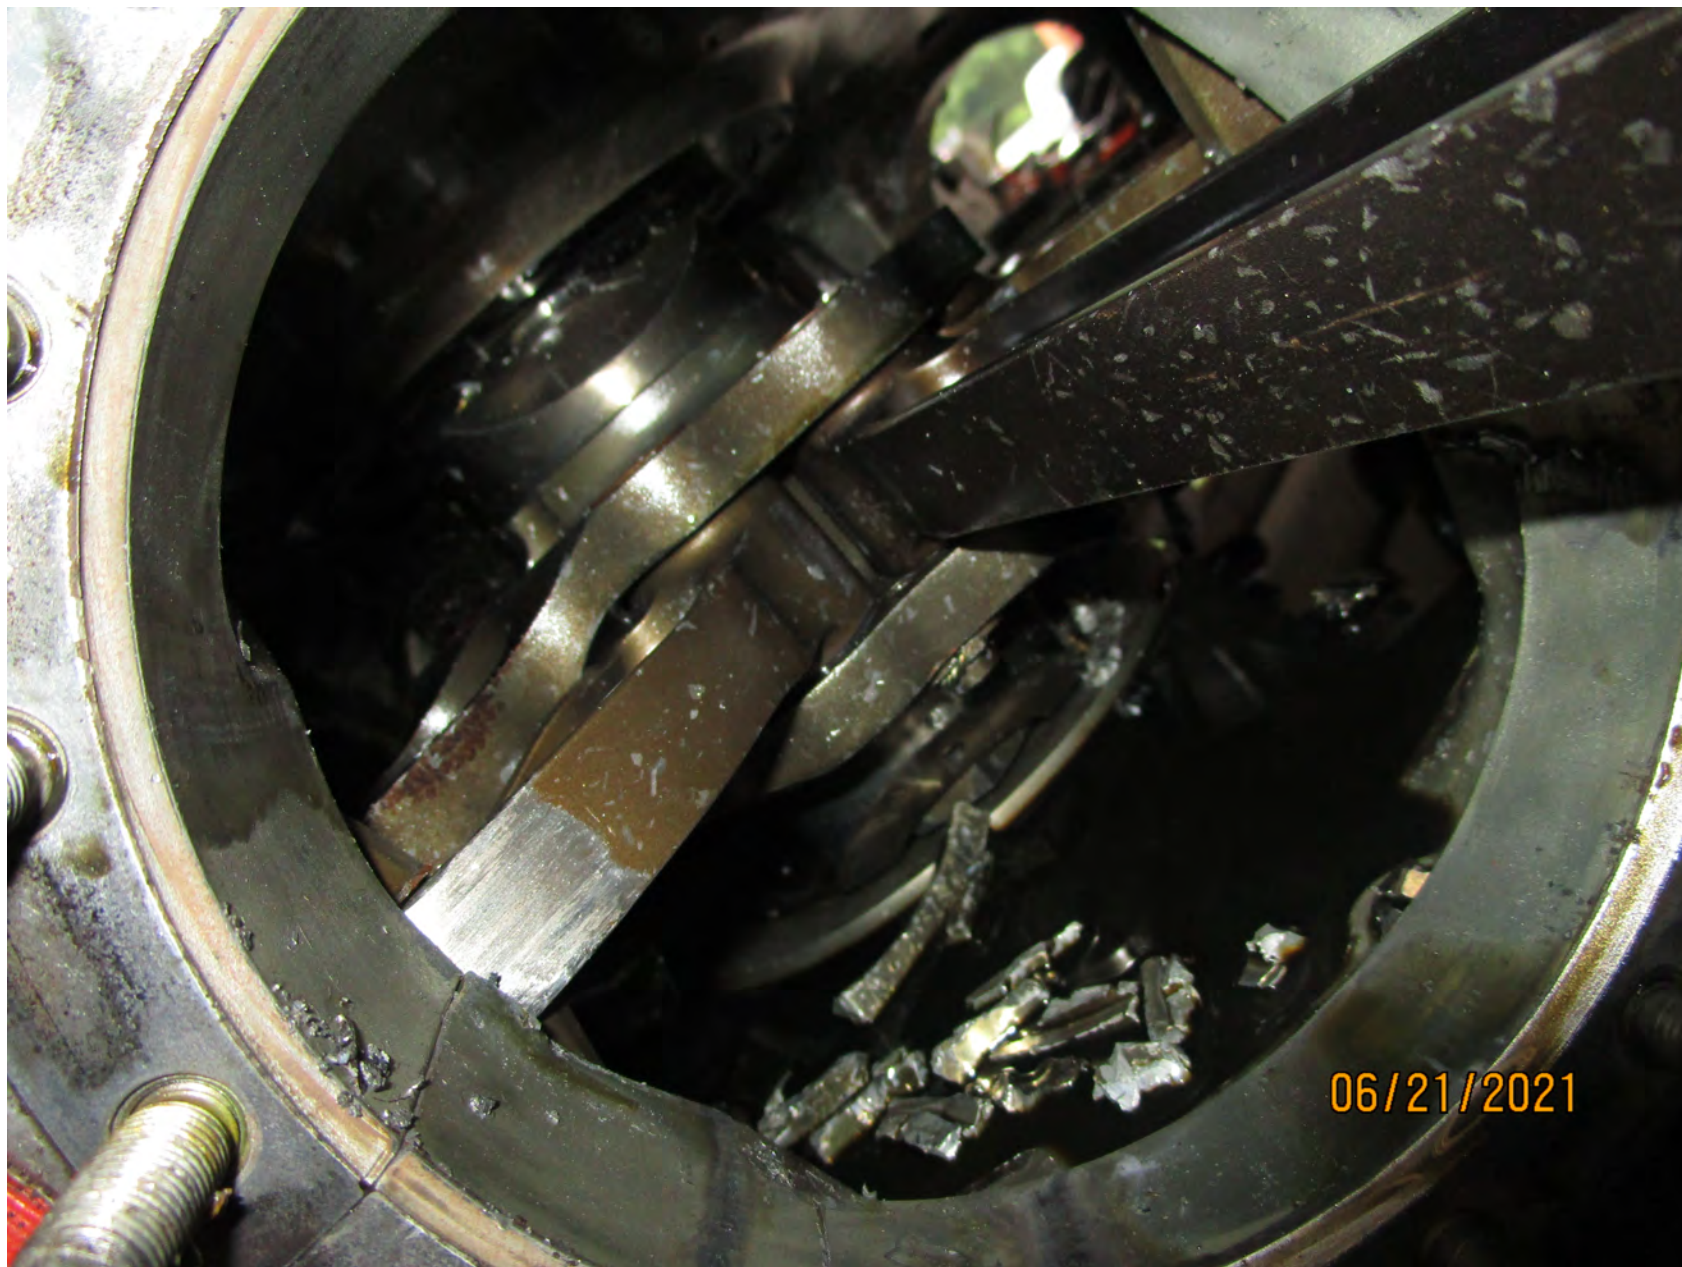
**Photo 4 – View looking inside engine**

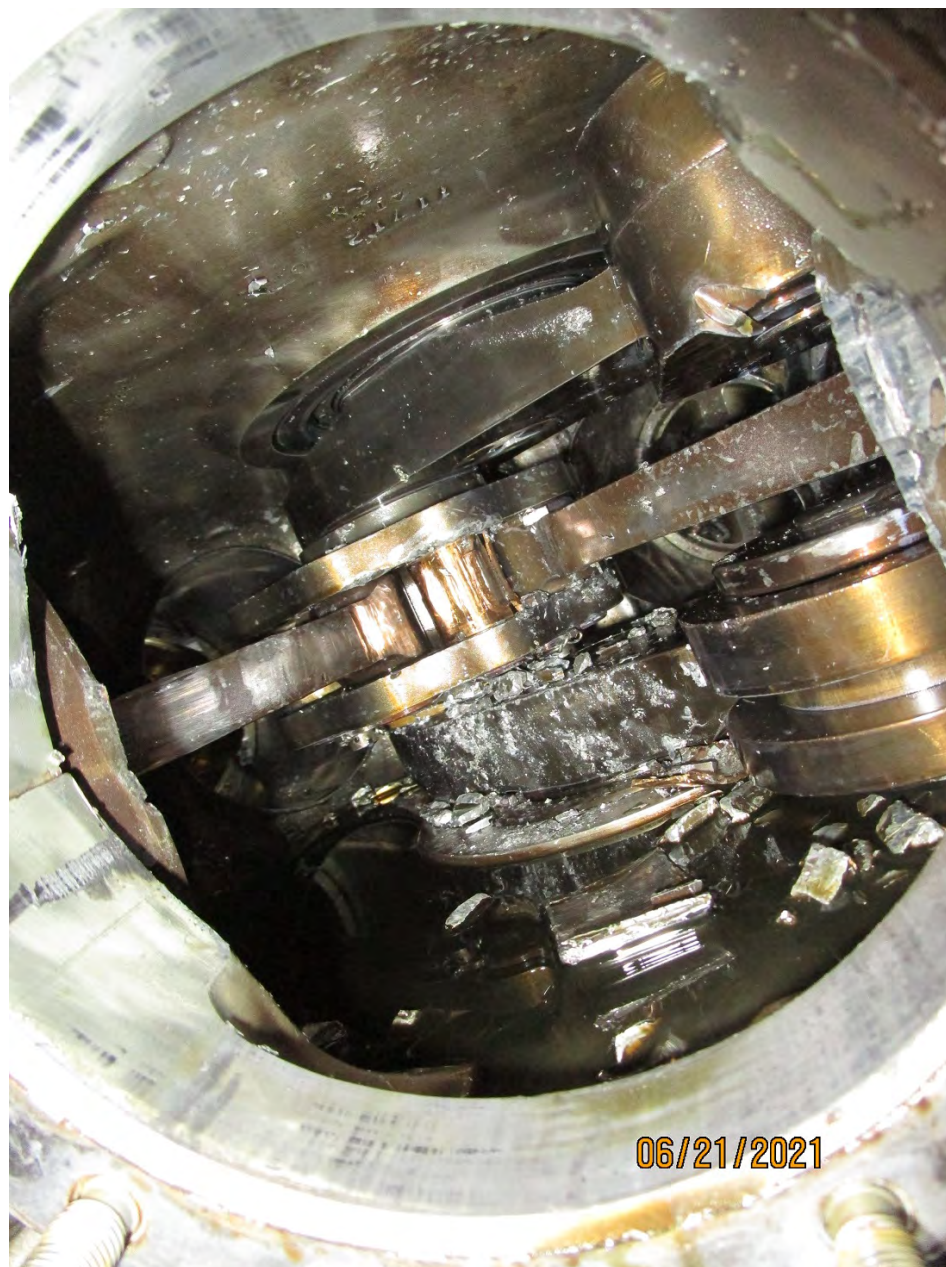
**Photo 5 – View looking inside engine**

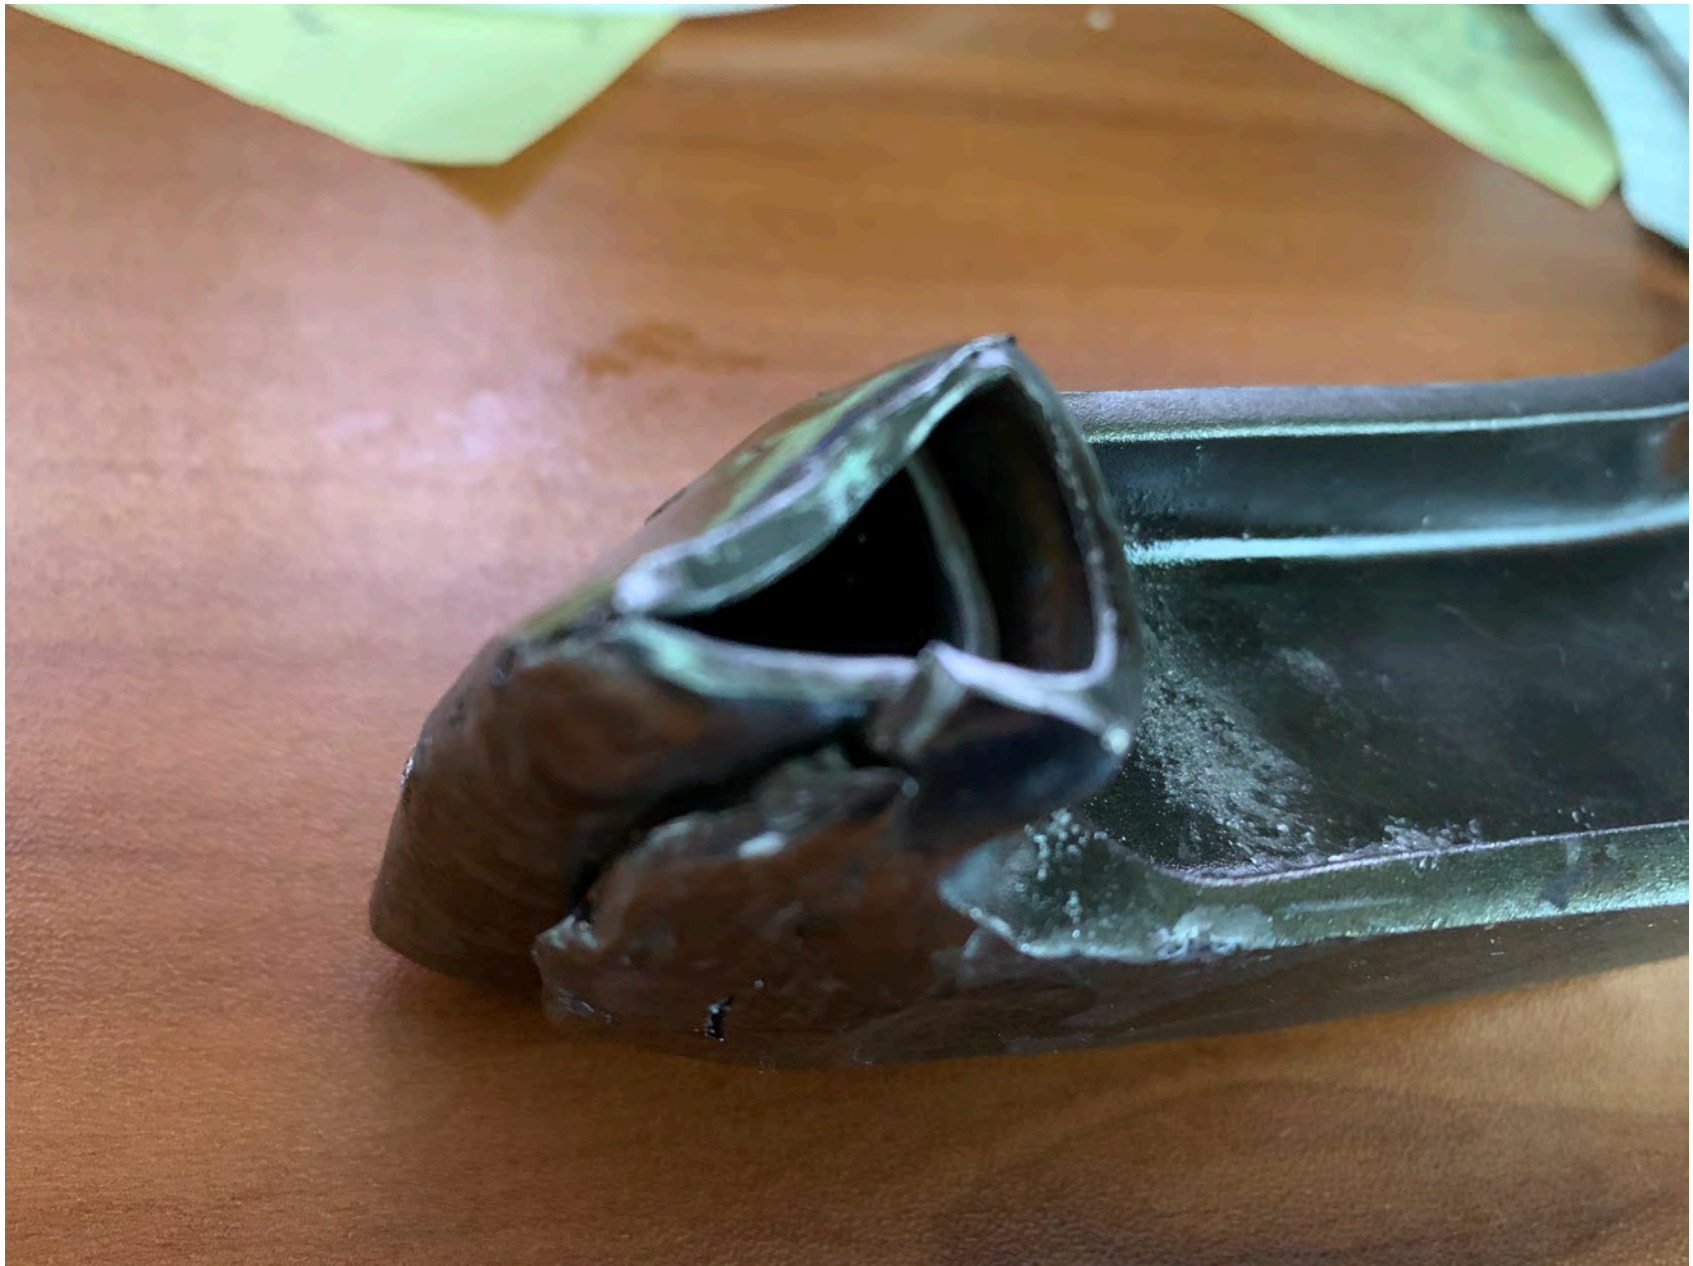
**Photo 6 – Damaged connecting rod**
