# NATIONAL TRANSPORTATION SAFETY BOARD

## MATERIALS LABORATORY FACTUAL REPORT

Report No. 21-064

Place : Ogallala, Nebraska  
Date : August 24, 2020  
Vehicle : Grumman G-146B Ag Cat, N2437D  
NTSB No. : CEN20LA364  
Investigator : Craig Hatch, AS-CEN

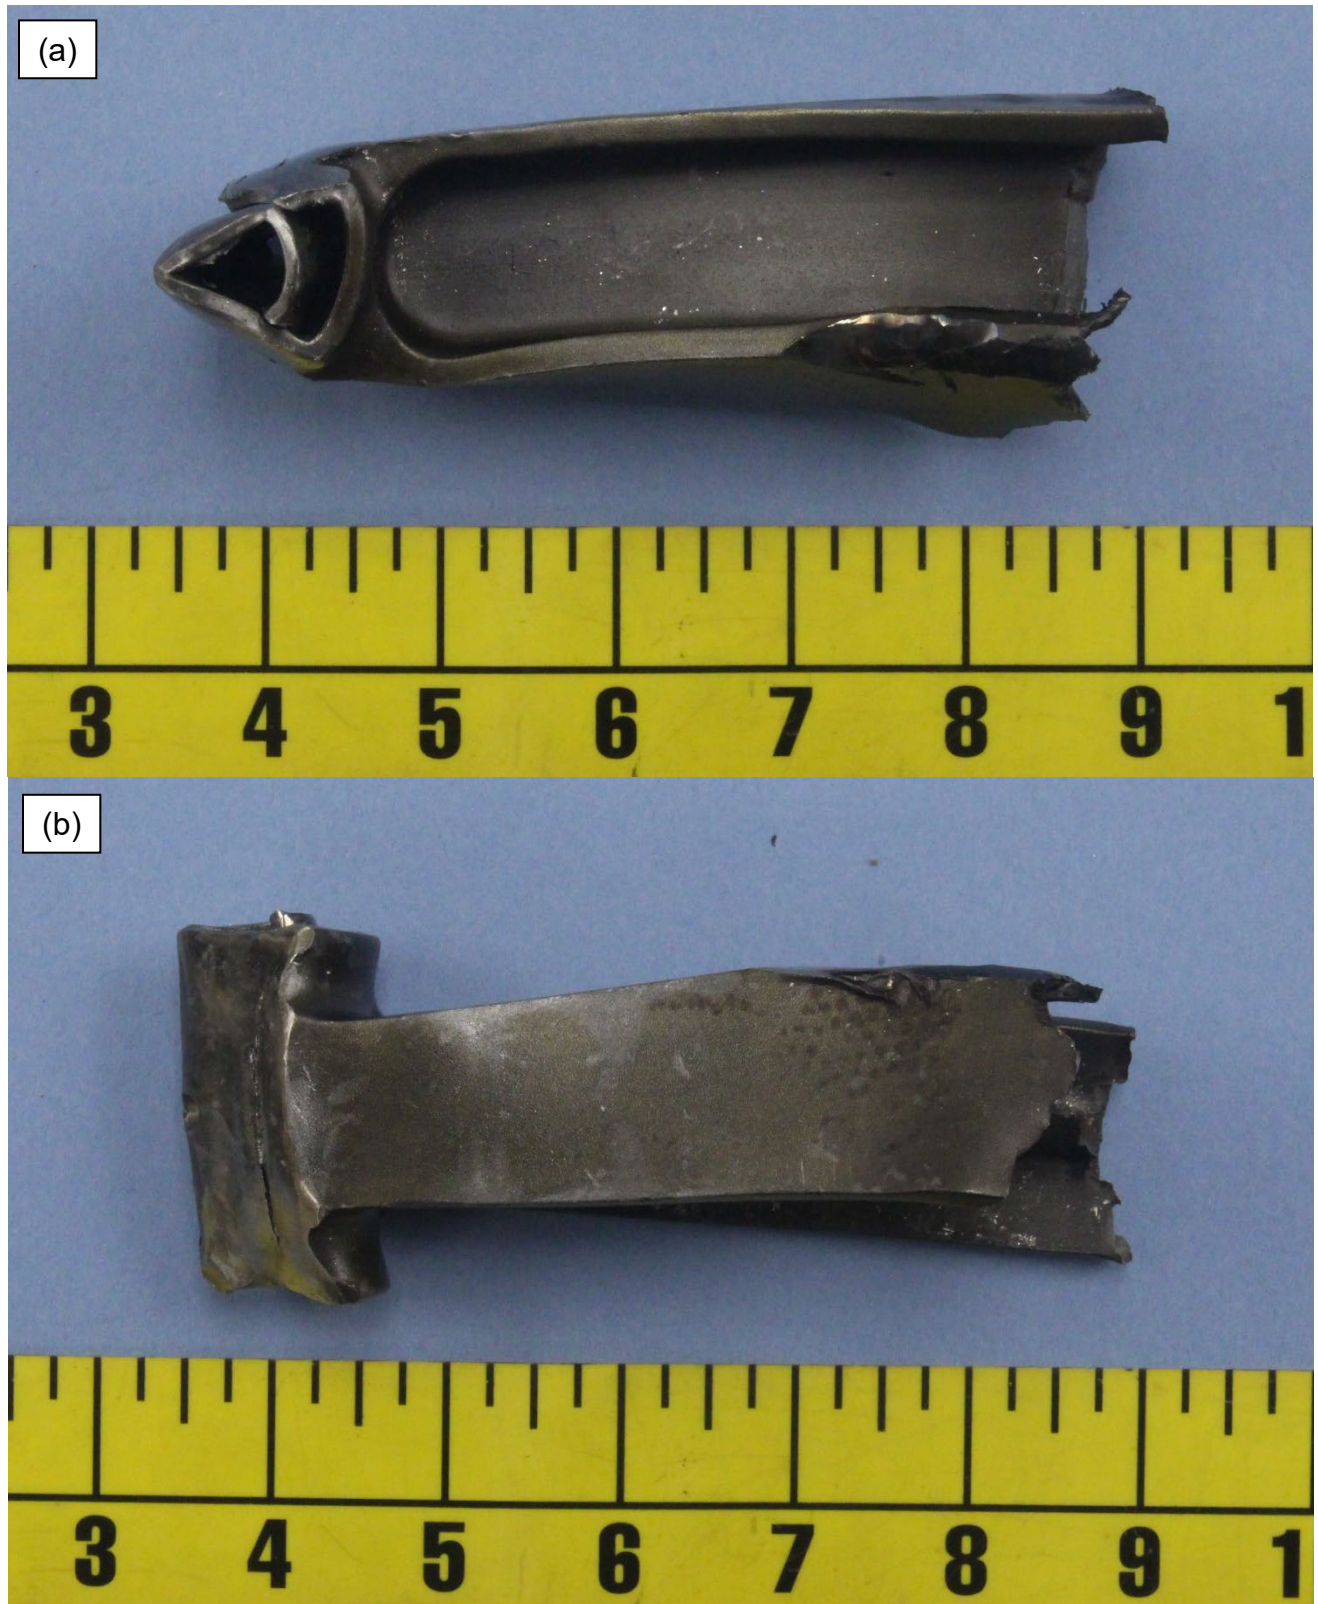
Figure 1 shows the connecting rod remnant, as received, from the side showing the web and oriented to show one of the flange faces. The remnant comprised only the upper 5 inches of the section that had connected to the piston pin. The pin hole bore had fractured and deformed inward, as illustrated in Figure 1a. Besides deformation of the pin connection, the rod exhibited deformation in multiple directions, consistent with indications of tension, bending, and torsion or twisting.

Figure 1 – View of the connecting rod remnant from (a) the side (web) and (b) a flange face.

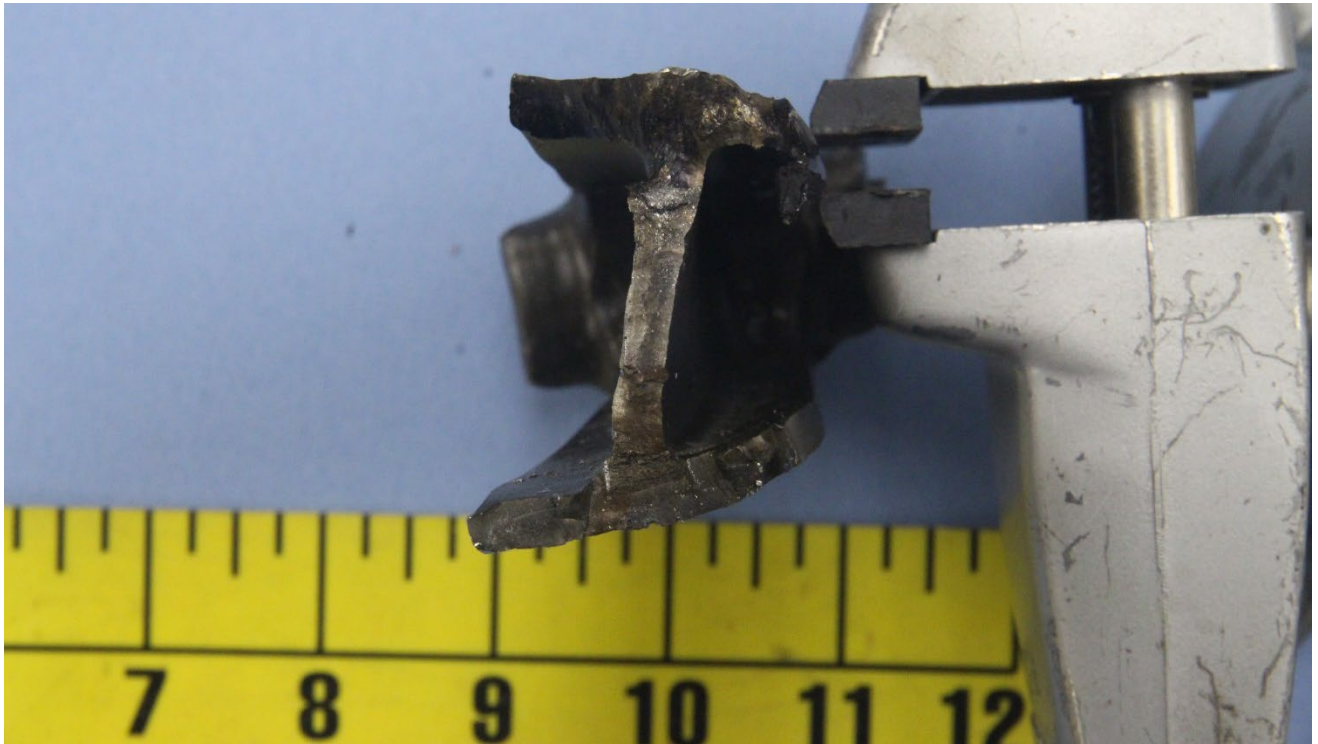
Figure 2 shows the fracture surface, viewed as received. The orientation of the fracture surface was perpendicular to the longitudinal direction of the rod, shown in Figure 1. The Figure 2 view of the fracture surface demonstrates some of the plastic deformation of the part, with both flanges and the web exhibiting indications of deformation. The ends

of the flanges on the right side of the figure exhibit crushing inward, whereas the flange ends on the opposite side were flared outward. In addition, the web was bent away from the crushed flanged edge, consistent with bending and compression towards the right side of the figure.

Figure 2 – View of the fracture surface of the connecting rod fragment, as received.

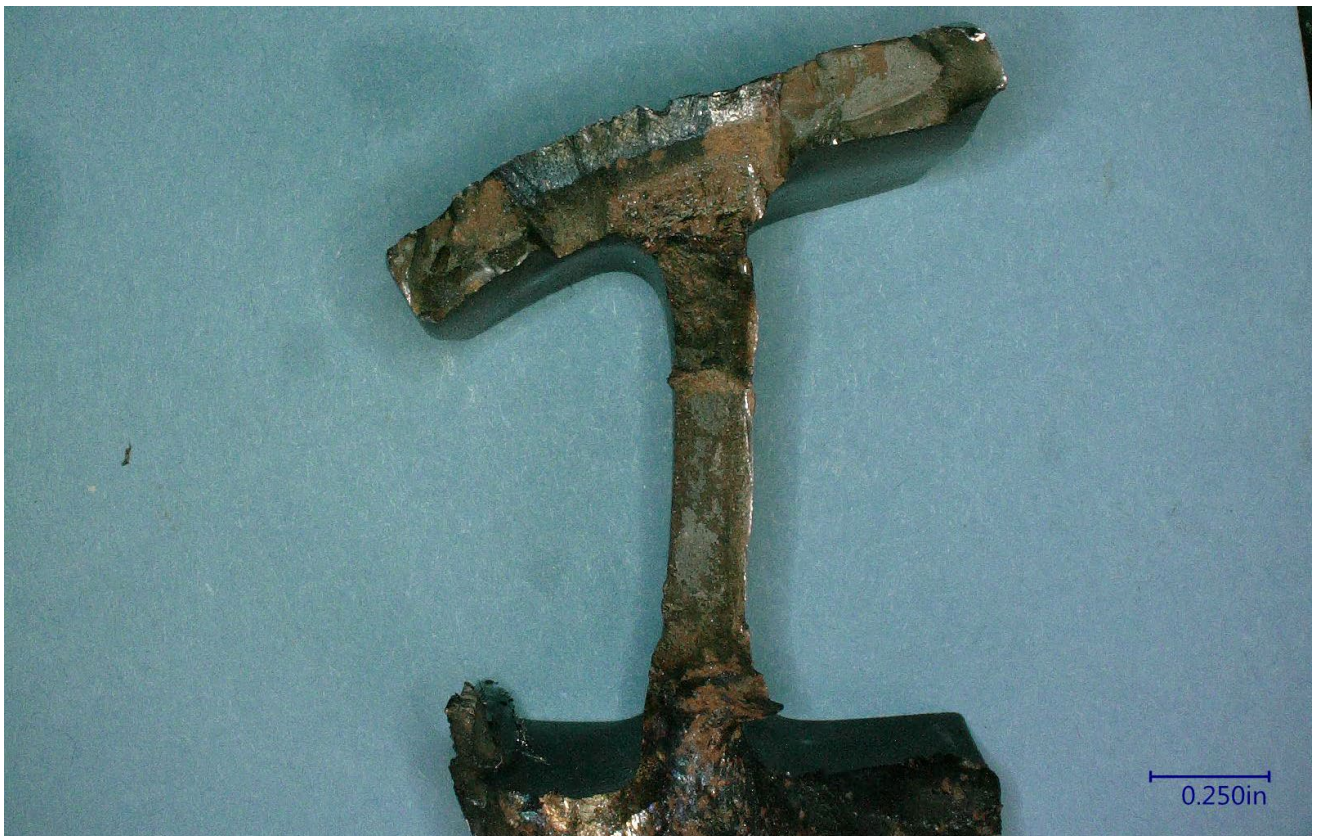
The end of the fracture surface was sectioned from the rod remnant and is shown post-sectioning after cleaning with acetone in Figure 3. Much of the fracture surface exhibited a surface brown-rust color, consistent with post-fracture oxidation. Most of the fracture surface exhibited a rough, fibrous texture with a dull luster. The web area exhibited an approximate 45° slanted fracture orientation, and the lower flange area in Figure 3 exhibited a mottled, reflective appearance. The features on the lower flange in Figure 3 were consistent with post-fracture smearing and batter.

Figure 3 – The fracture surface from Figure 2, after sectioning from the rod fragment.

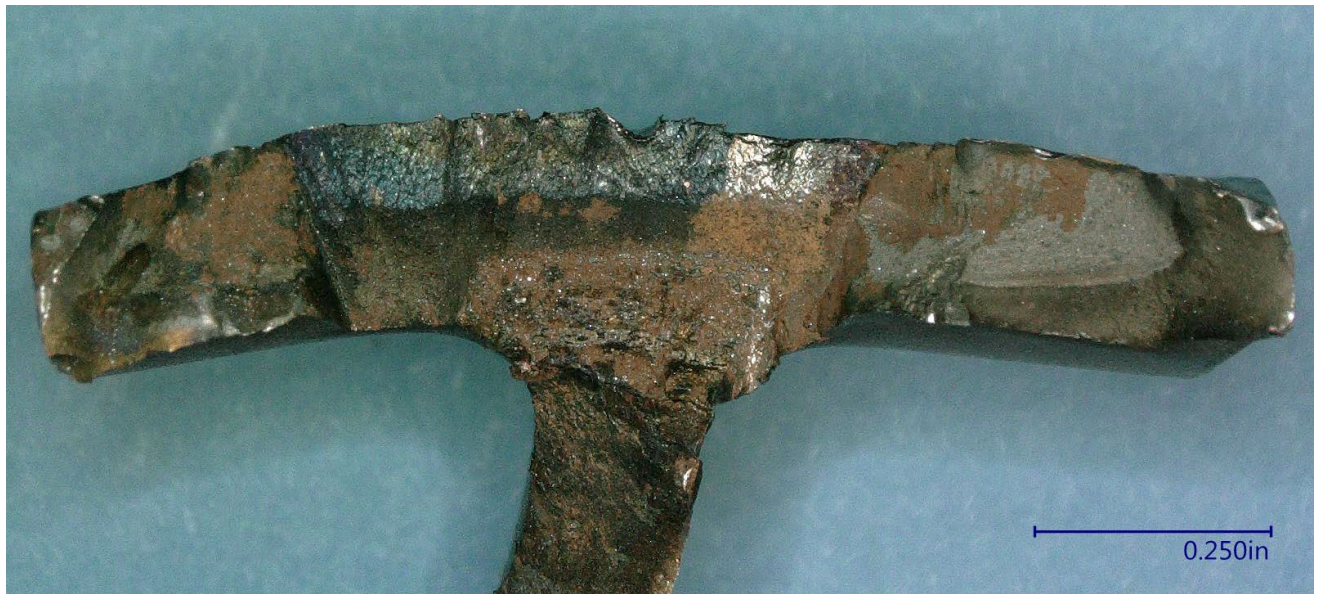
The upper flange sectioned fracture surface in Figure 3 is highlighted in Figure 4. An initial visual examination of this flange appeared to exhibit distinct fracture regions. However, after cleaning in an ultrasonic bath with an Evapo-Rust® solution, the fracture surface exhibited more uniform features, illustrated in Figure 5.<sup>2</sup> This flange exhibited slanted orientations on the ends, with stepped and angled levels along the center above the web. The centermost upper areas in Figure 5 were more reflective than the surrounding areas.

Figure 4 – Closer view of the upper flange in Figure 3, after sectioning but before cleaning.

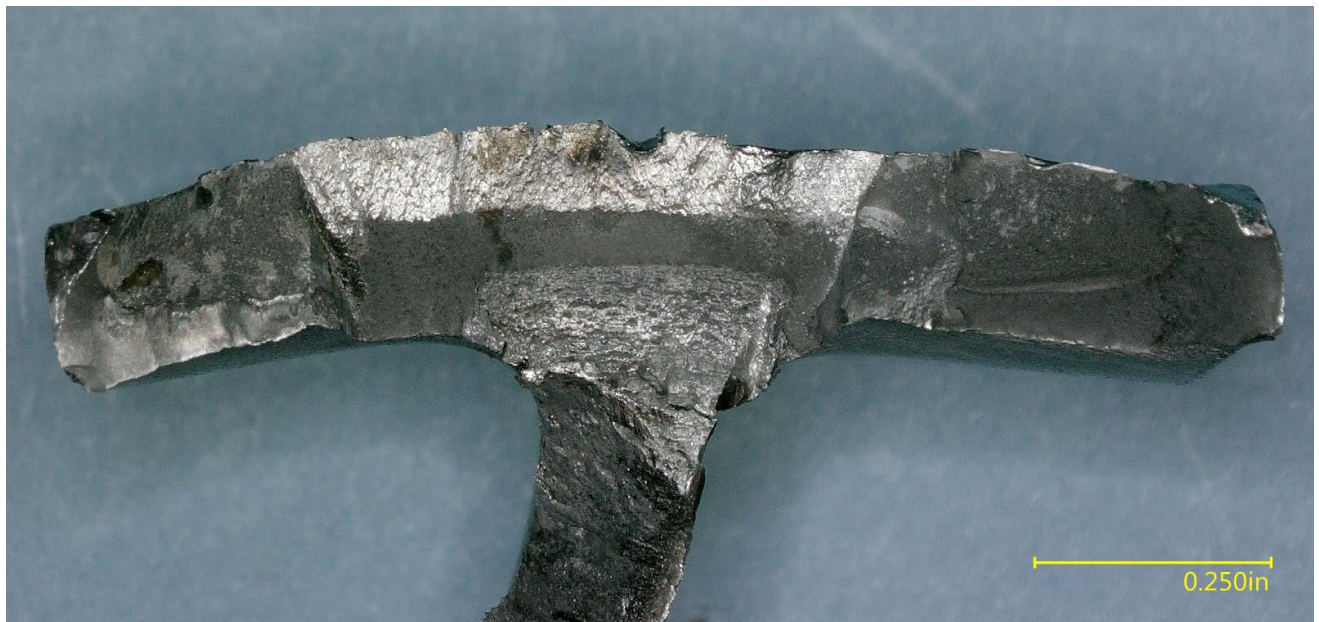
Figure 5 – The flange section shown in Figure 4, after cleaning.

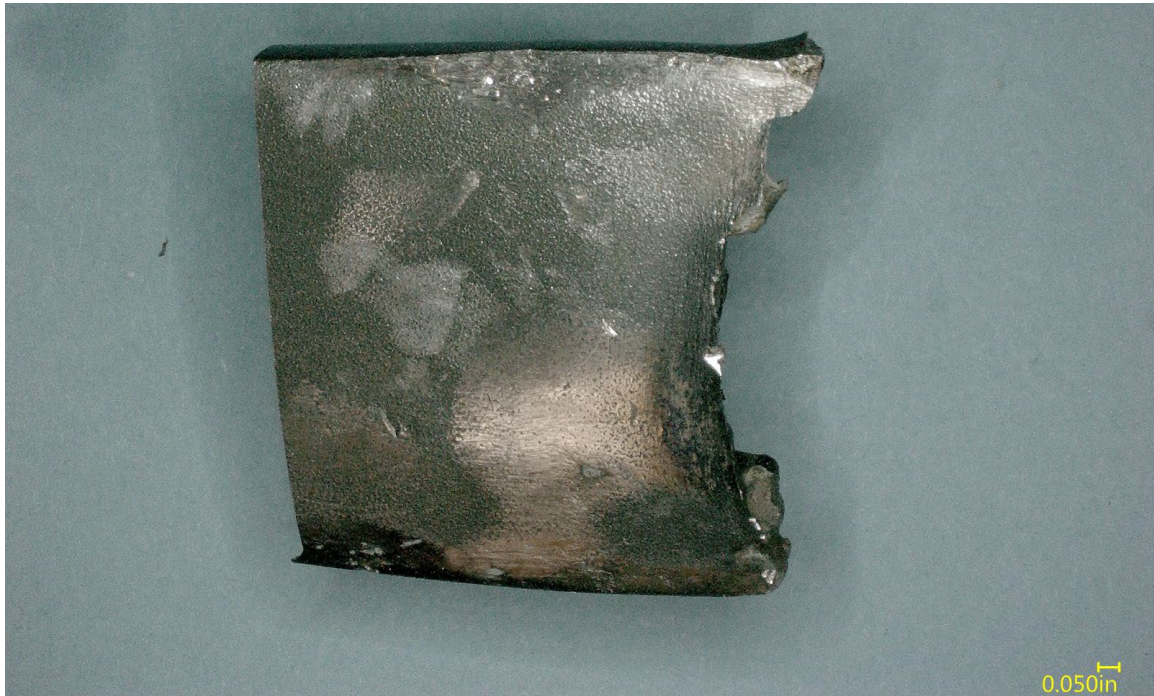
The upper face of the flange is illustrated in Figure 6. This demonstrated that the centermost area was recessed with respect to the ends of the flange. Further, there were parallel cracks next to the fracture surface particularly along the centerline. This area had been plastically deformed upward, as illustrated in Figure 7, the side view. These features were consistent with upward bending and local compression on the upper flange face. The side view in Figure 7 also demonstrated the angled orientation of the fracture surface along the web.

Figure 6 – Planar view of the face of the flange in Figure 4, showing deformation near the fracture.

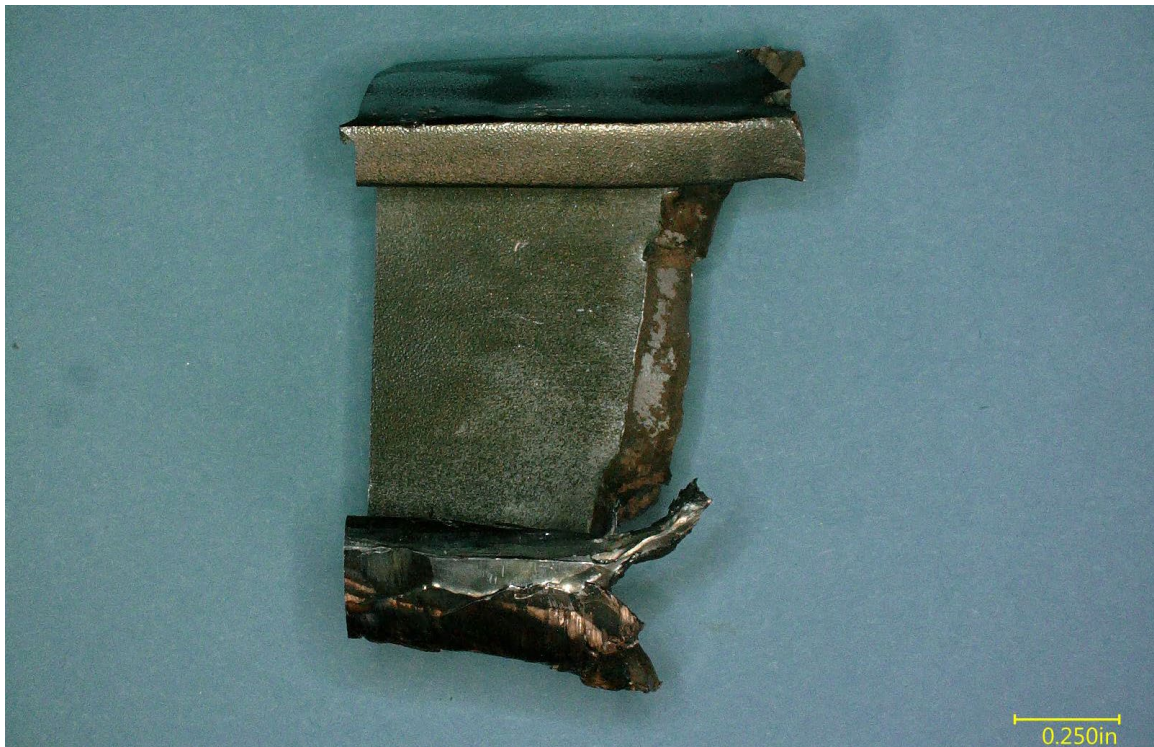
Figure 7 – Side view of the rod fragment fracture surface section, demonstrating the slanted fracture orientation on the web.

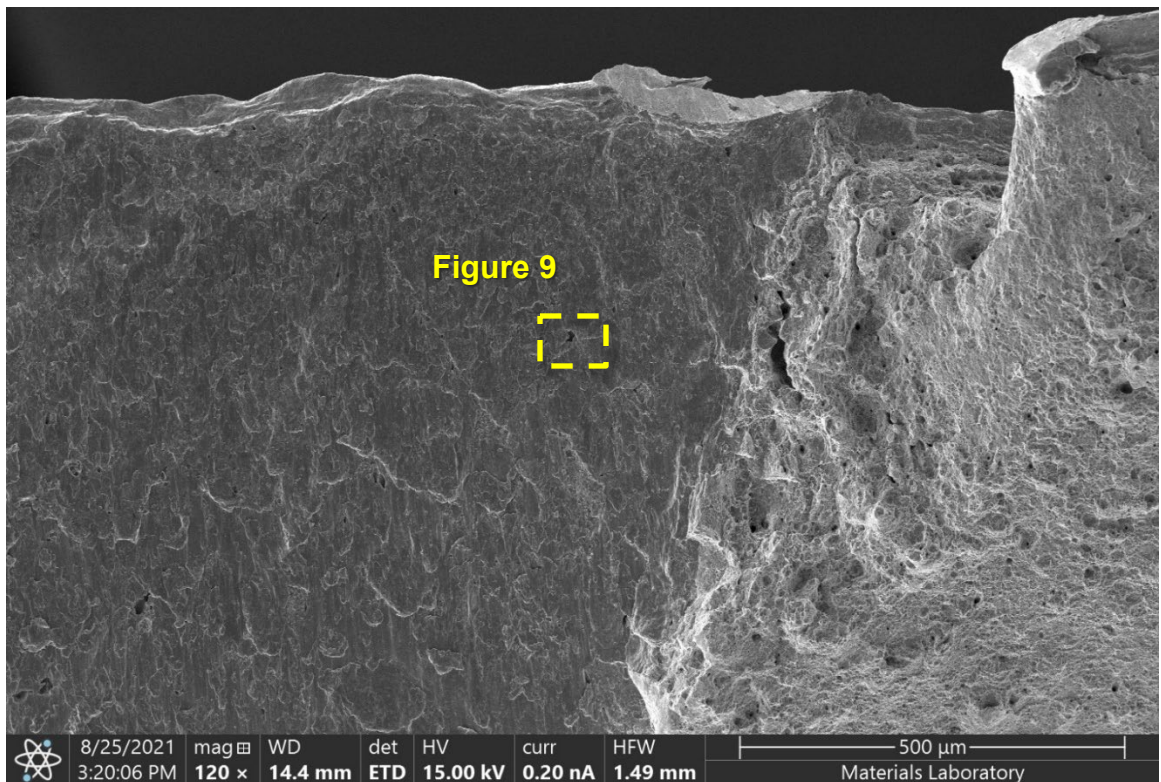
The fracture surface was examined using a scanning electron microscope (SEM). Figure 8 shows an area towards the right of the center reflective region shown in Figure 5. This area showed a flatter morphology than the protruding area to the right and exhibited features reminiscent of a cascading flow downward.

Figure 8 – Secondary electron (SE) micrograph of the central area of the flange fracture.

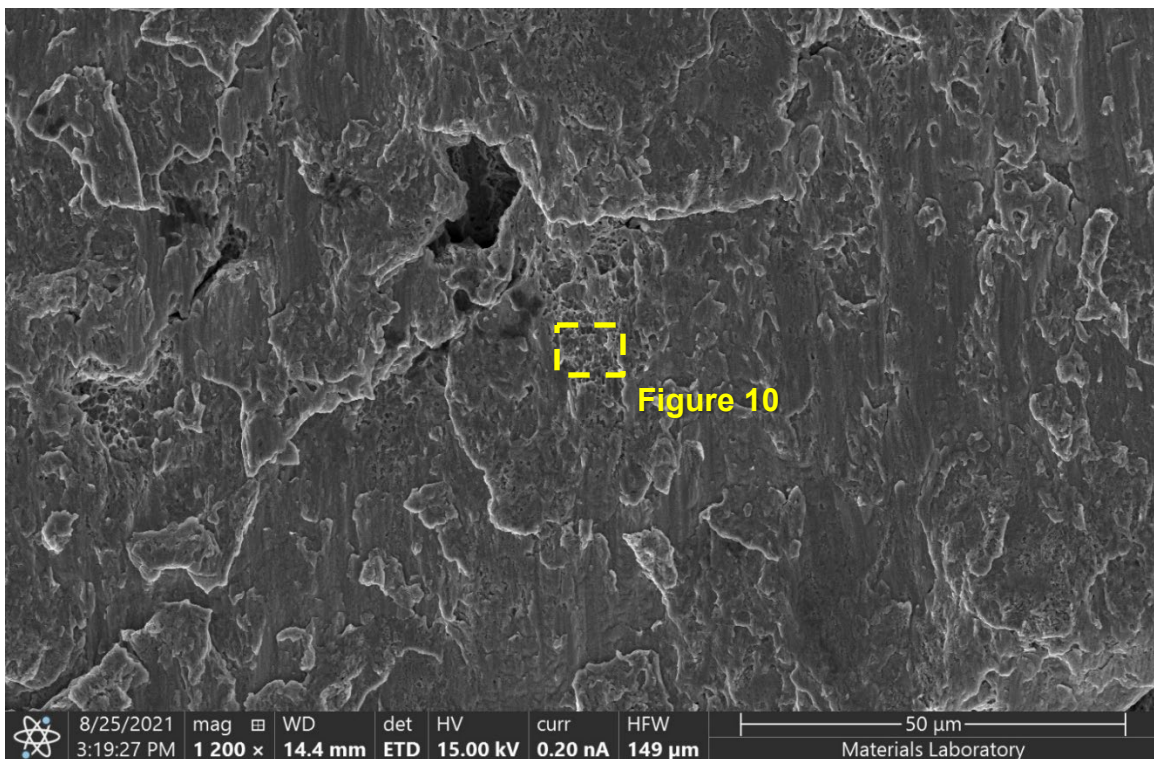
Figure 9 shows a closer view of the area in the yellow box in Figure 8. The region exhibited repeated vertical streaks and areas of material folded over adjacent areas. These features were consistent with smearing, or post-fracture damage. Isolated areas in Figure 9 were still undamaged though, as illustrated in Figure 10. This area exhibited dimpled rupture, consistent with fracture from overstress.

Figure 9 – SE micrograph of the boxed area in Figure 8, showing vertical smearing.

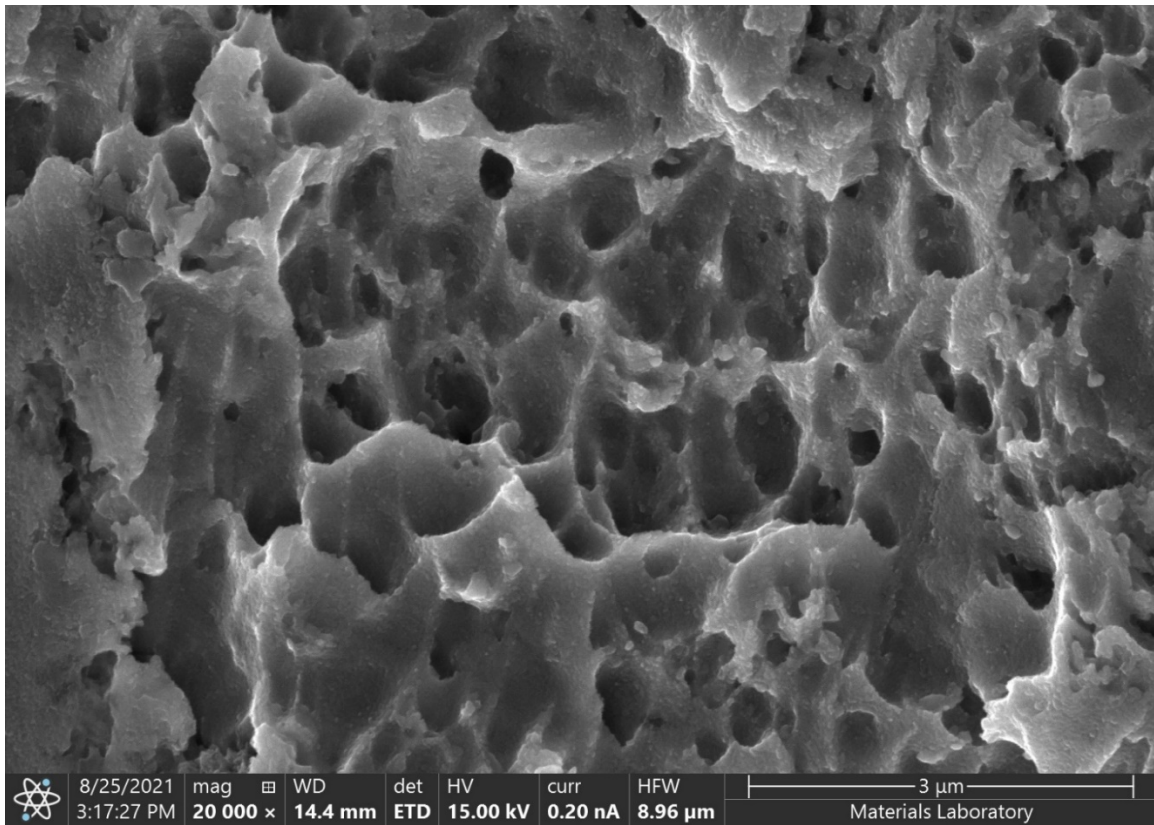
Figure 10 – SE micrograph of the boxed area in Figure 9, showing dimpled rupture.

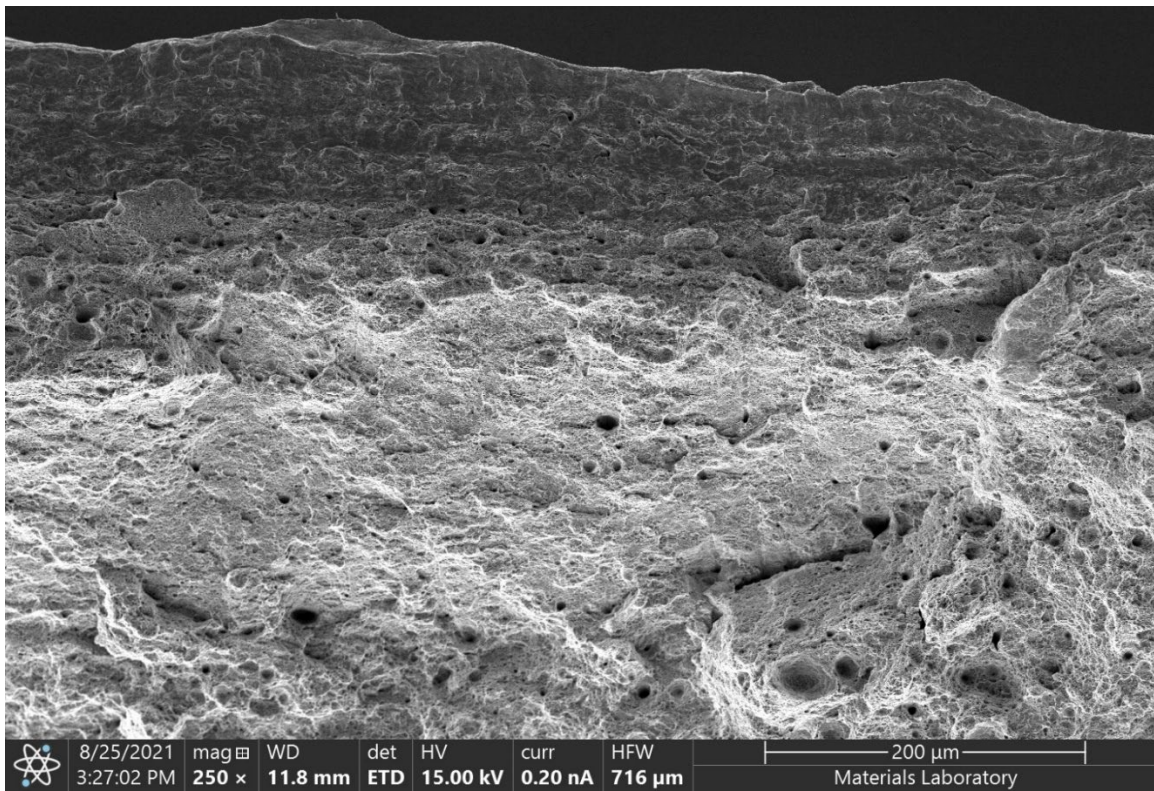
An area adjacent to the upper surface edge towards the right flange end is shown in Figure 11. This area was of note due to the flatter surface morphology and vertical-oriented parallel marks. A closer view of this area is shown in Figure 12. This region

Figure 11 – SE micrograph of the edge of the fracture area shown in Figure 14.

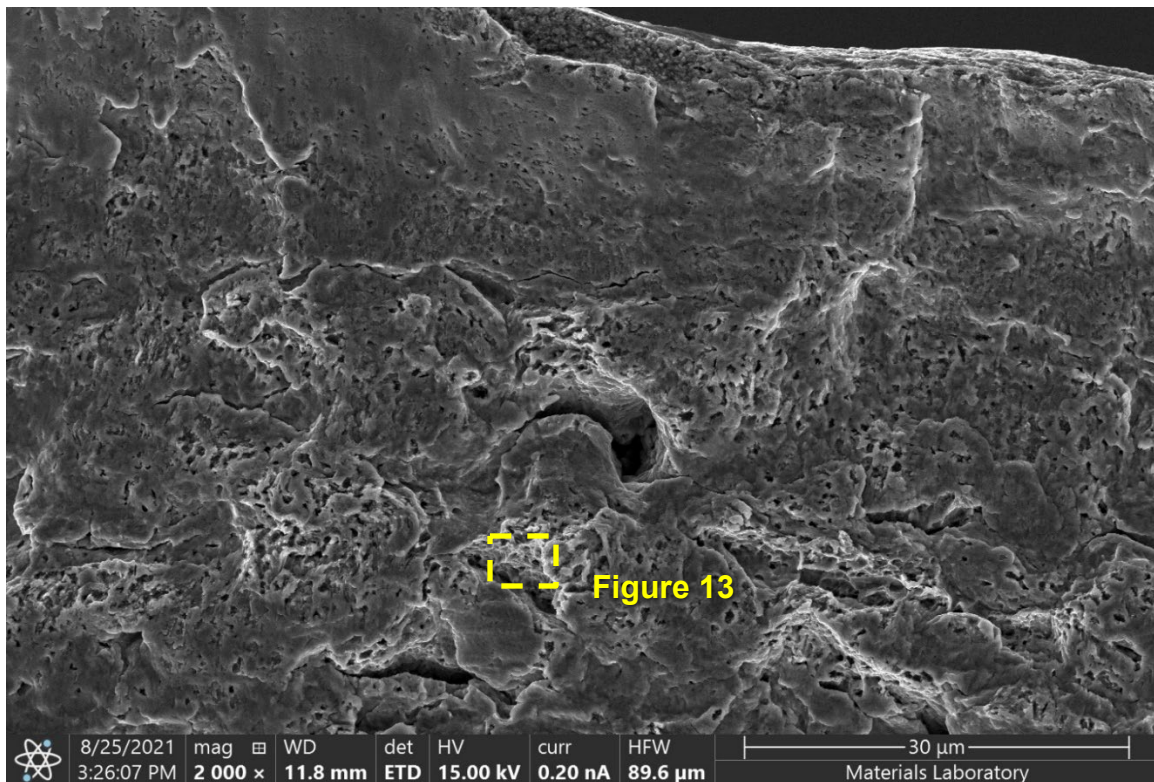
generally exhibited localized smoothing and small, oblong divot features—these were consistent with the underlying material after the surface oxide product had been removed. Some small areas in larger recesses were relatively undamaged, as shown in Figure 12. These areas exhibited dimpled rupture, consistent with overstress fracture (see Figure 13).

Figure 12 – SE micrograph of the smoother near-edge area in Figure 11.

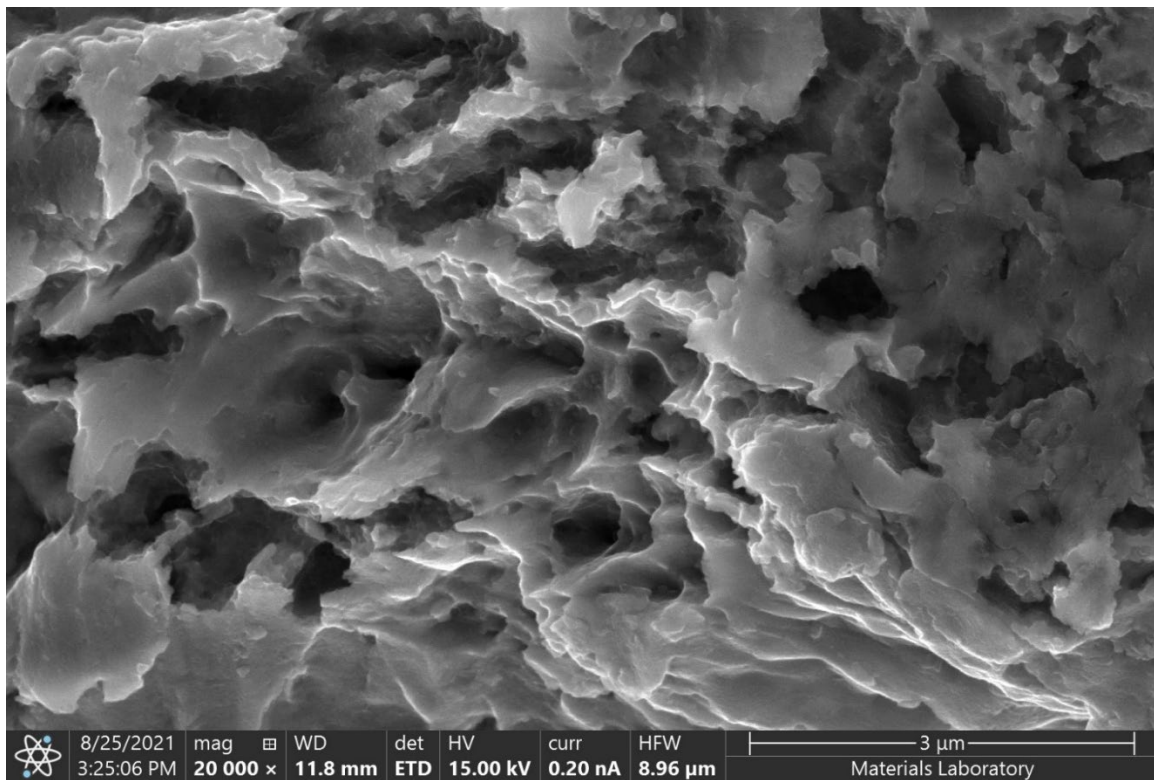
Figure 13 – SE micrograph of dimpled rupture in the boxed area in Figure 12.

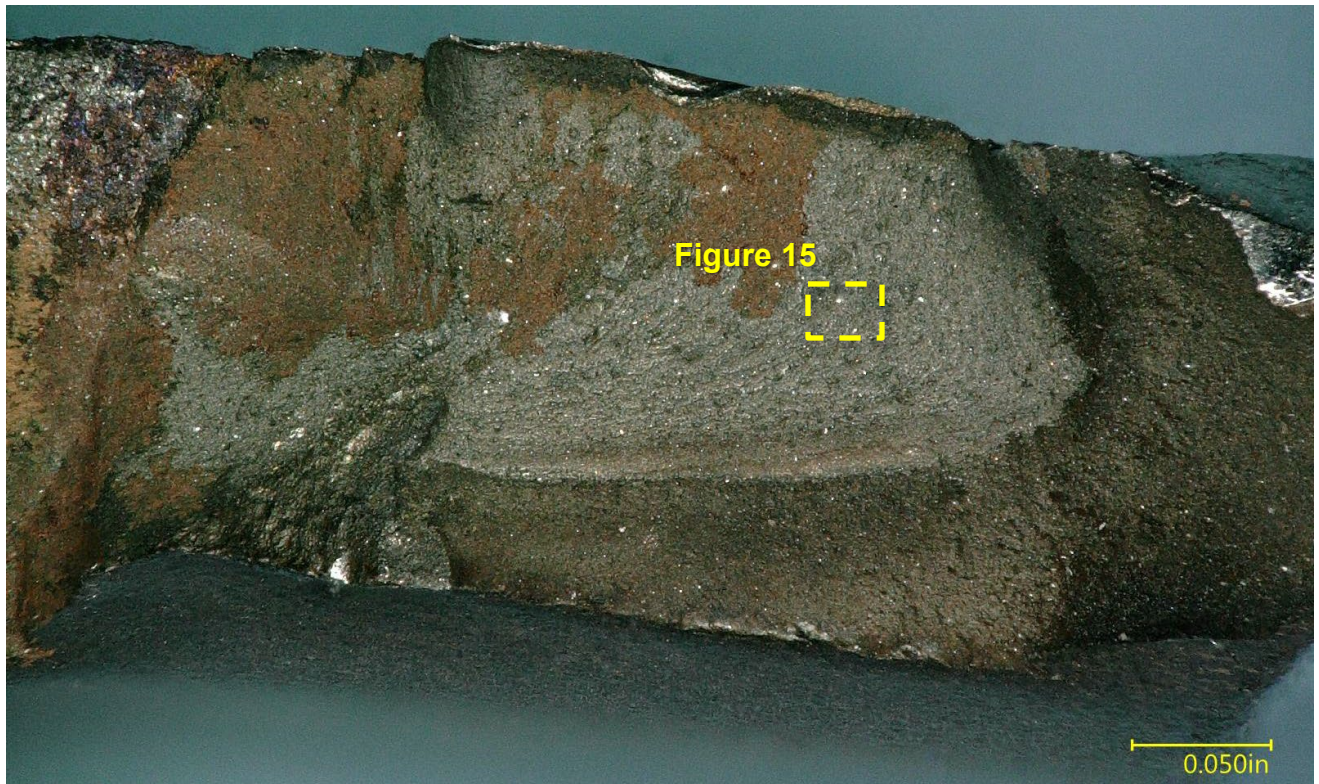
Prior to cleaning the right side of the upper flange fracture surface (shown in Figure 14) showed a circular or thumbnail-like shape. This area was examined using a SEM, as shown in Figure 15. This region exhibited an undulating morphology, with a radial pattern, consistent with emanating from inward towards the upper face edge. Figure 16 shows a closer view of the center of this area, exhibiting pock-marked features. A closer view of these features revealed them to be dimpled rupture, consistent with overstress fracture. There were areas that exhibited a lamellar appearance, consistent with the underlying material microstructure exposed after removal of the oxide on the fracture surface.

Figure 14 – View of the right side of the flange fracture surface in Figure 4, before cleaning.

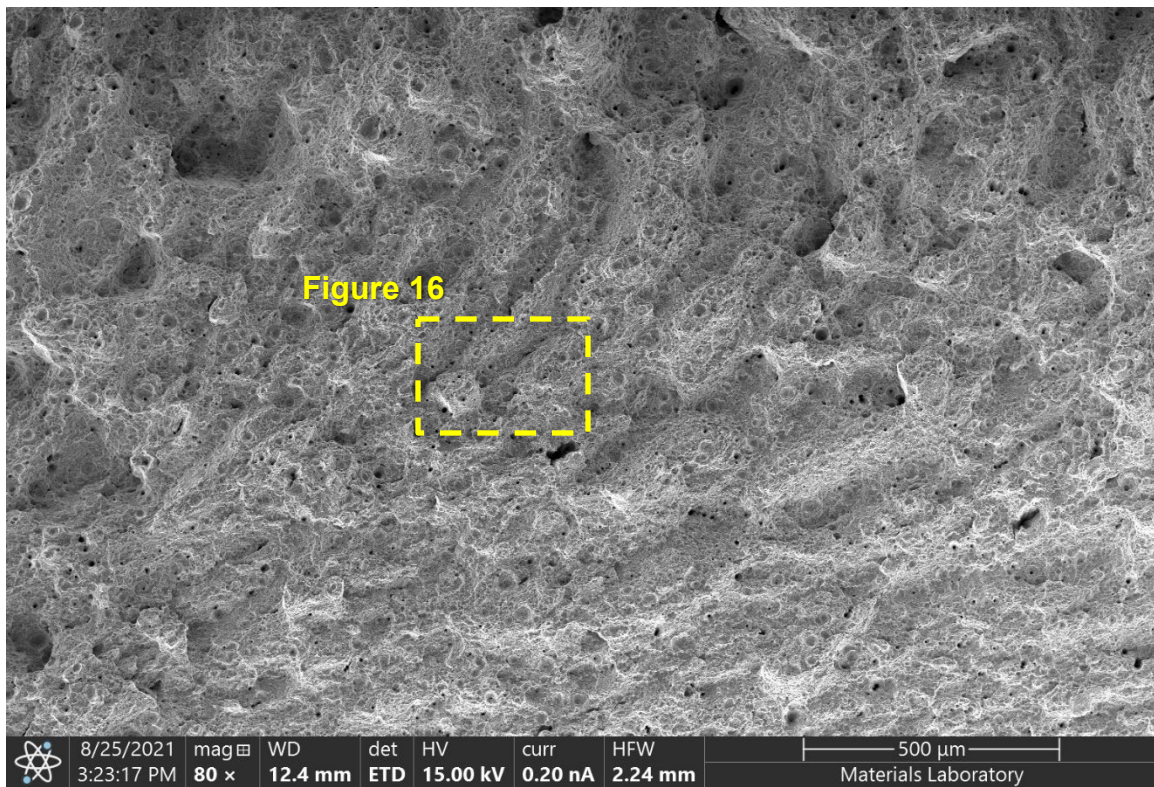
Figure 15 – SE micrograph of the middle of the area shown in Figure 14.

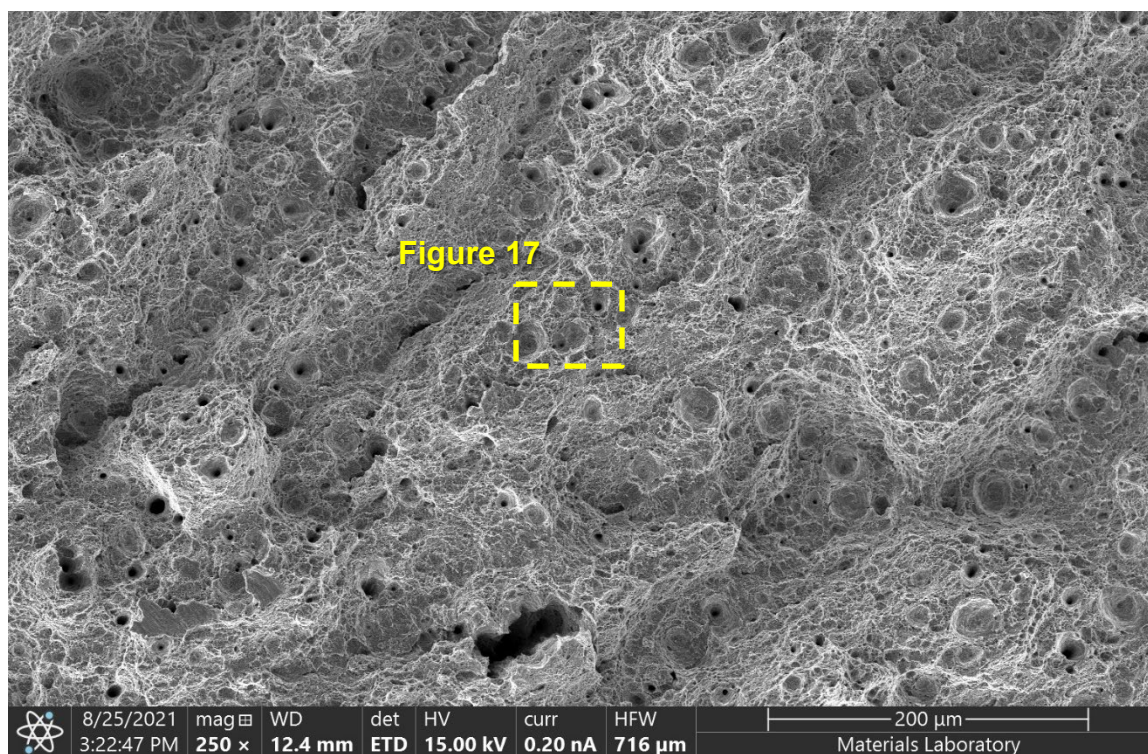
Figure 16 – SE micrograph of a closer view of the ridge features in Figure 15.

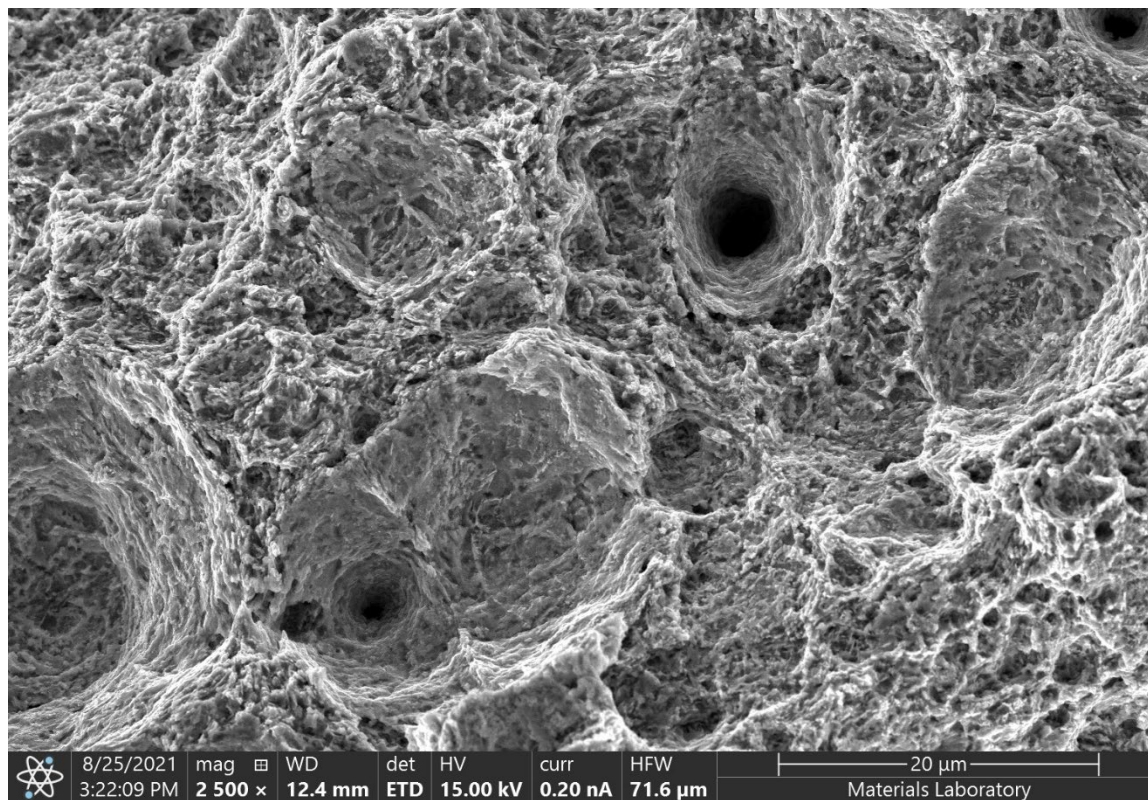
Figure 17 – SE micrograph of the boxed area in Figure 16, showing the remnants of dimpled rupture features after surface cleaning.

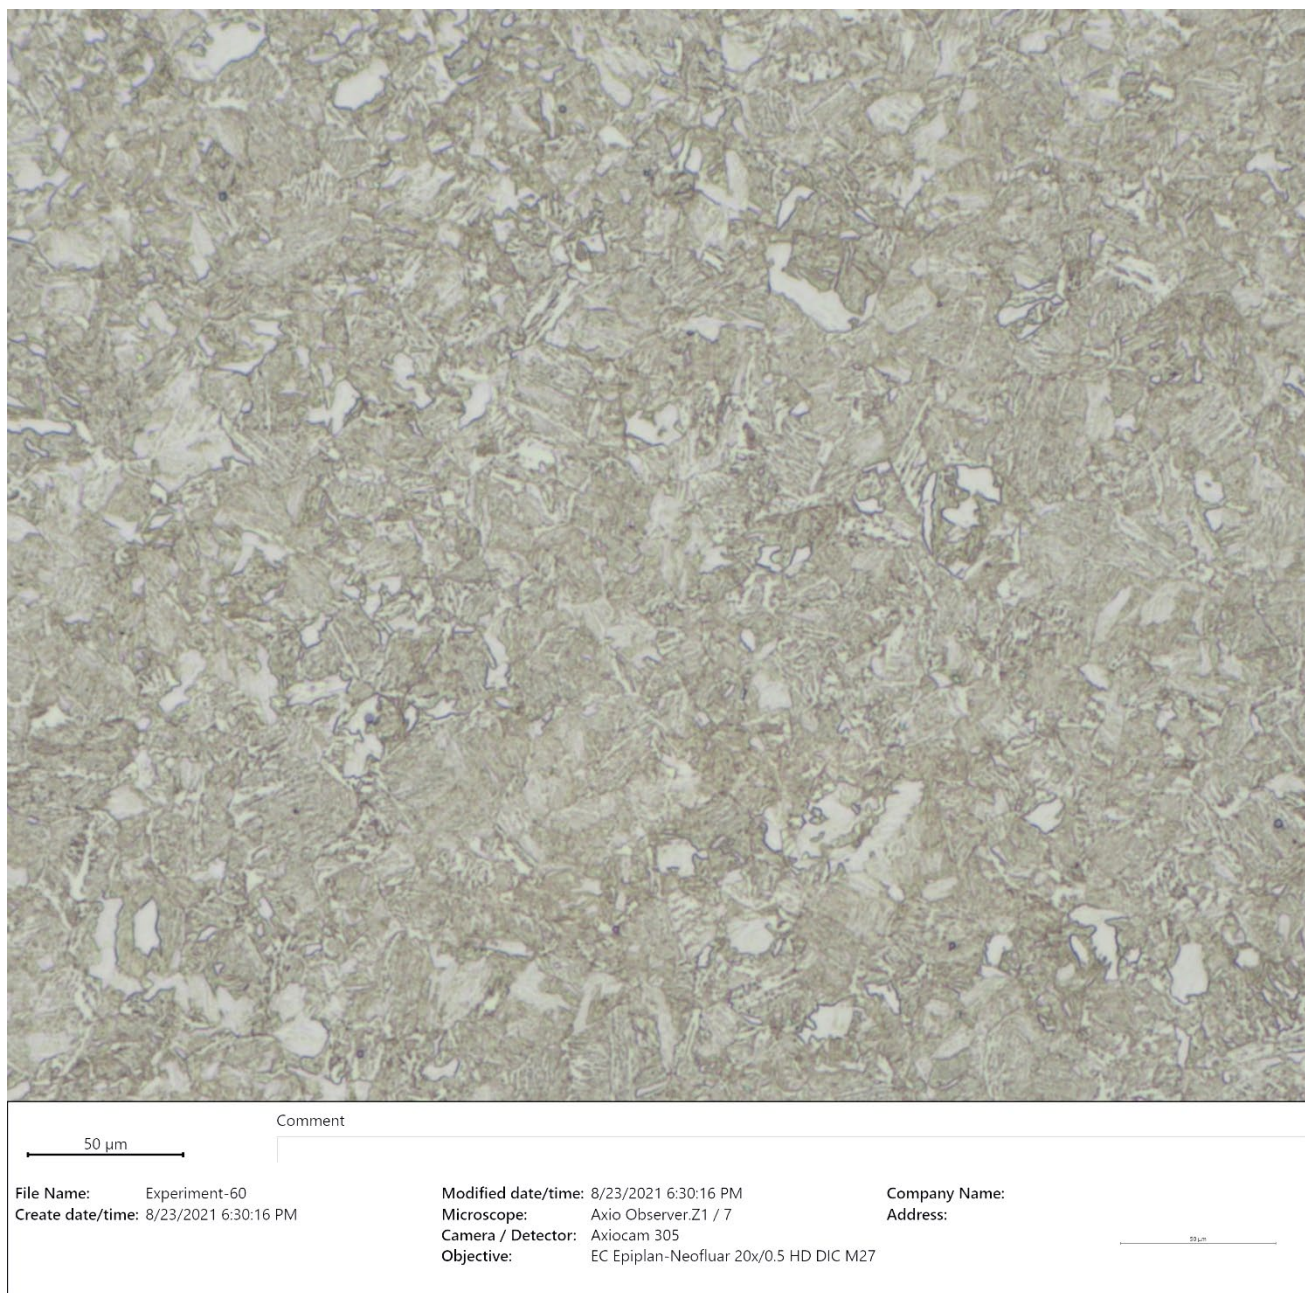
Another section of the connecting rod was mounted, polished, and etched with 2% Nital to examine the microstructure.<sup>3</sup> Figure 18 shows a typical area of the core microstructure, examined along the web/flange transition away from the rod surface. The microstructure exhibited tempered martensite and proeutectoid ferrite, consistent with a quench and tempered medium-low carbon steel. Figure 19 shows an area of the microstructure along the surface at the top of the flange face. This microstructure was comparable to that of the core, indicating a lack of decarburization or any underlying surface treatments to the part.

Figure 18 – Bright-field (BF) optical micrograph of a typical area of the rod microstructure from an area of the core, or away from the surface (~500X, etched 2% nital).

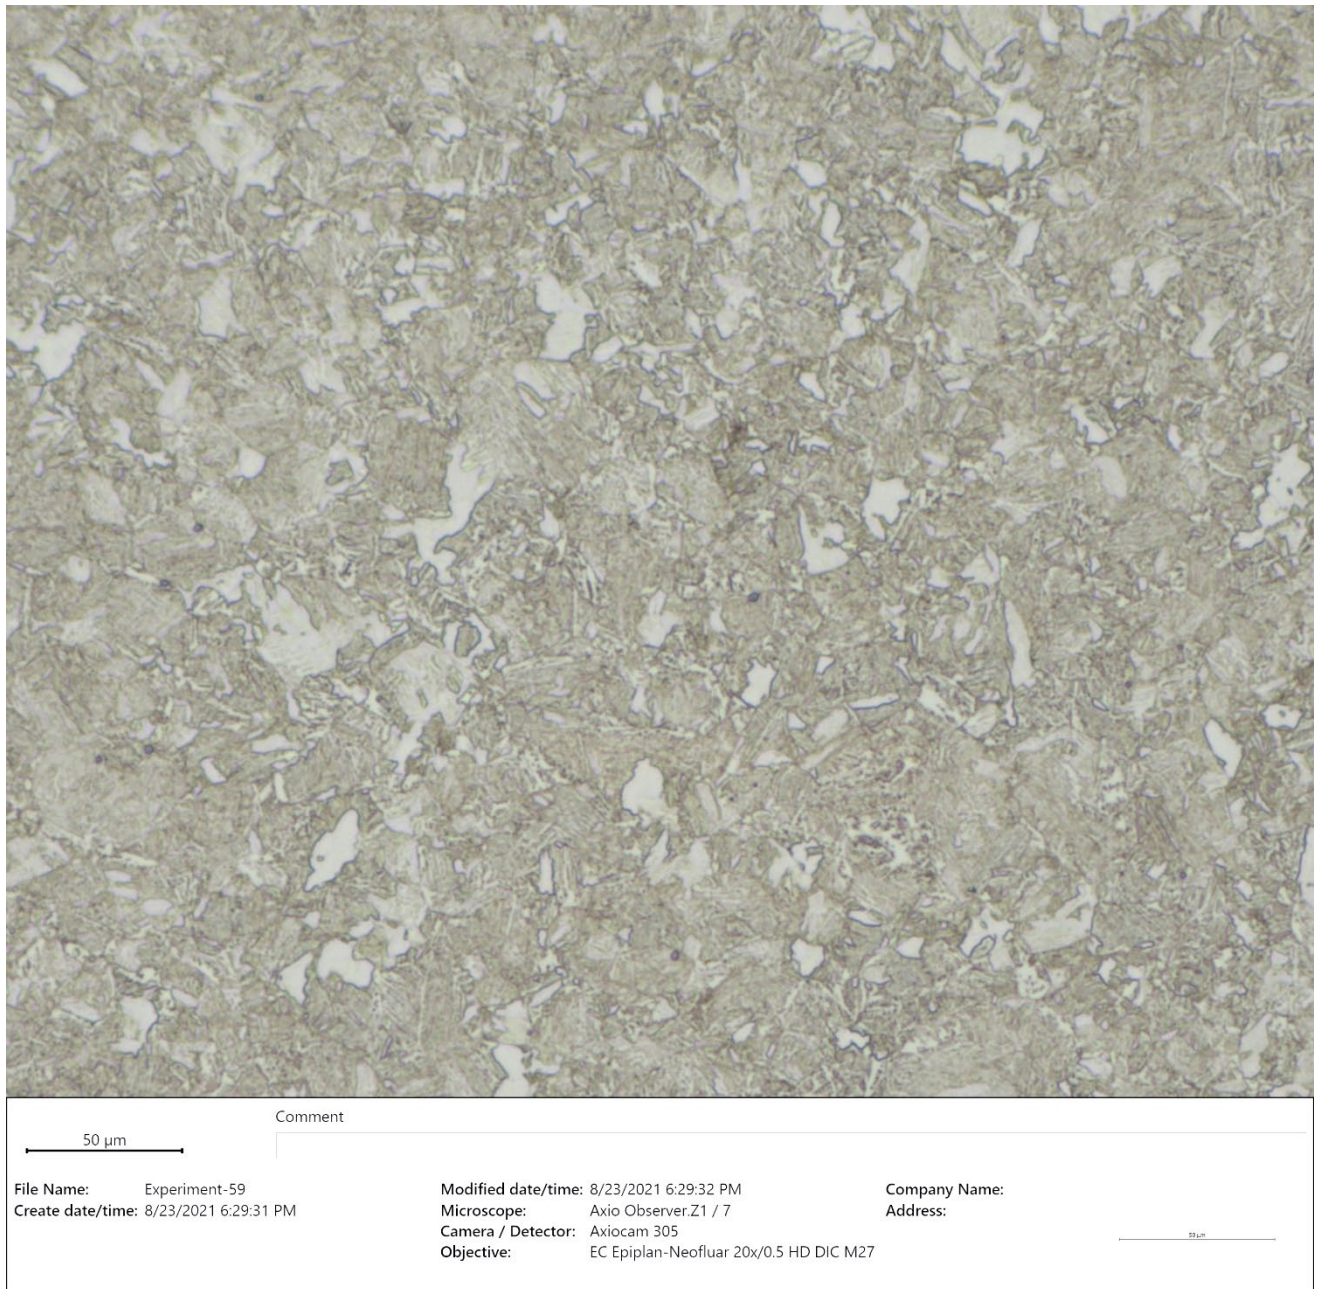
Figure 19 – BF optical micrograph of a typical area of the rod microstructure adjacent to the surface (~500X, etched 2% nital).
