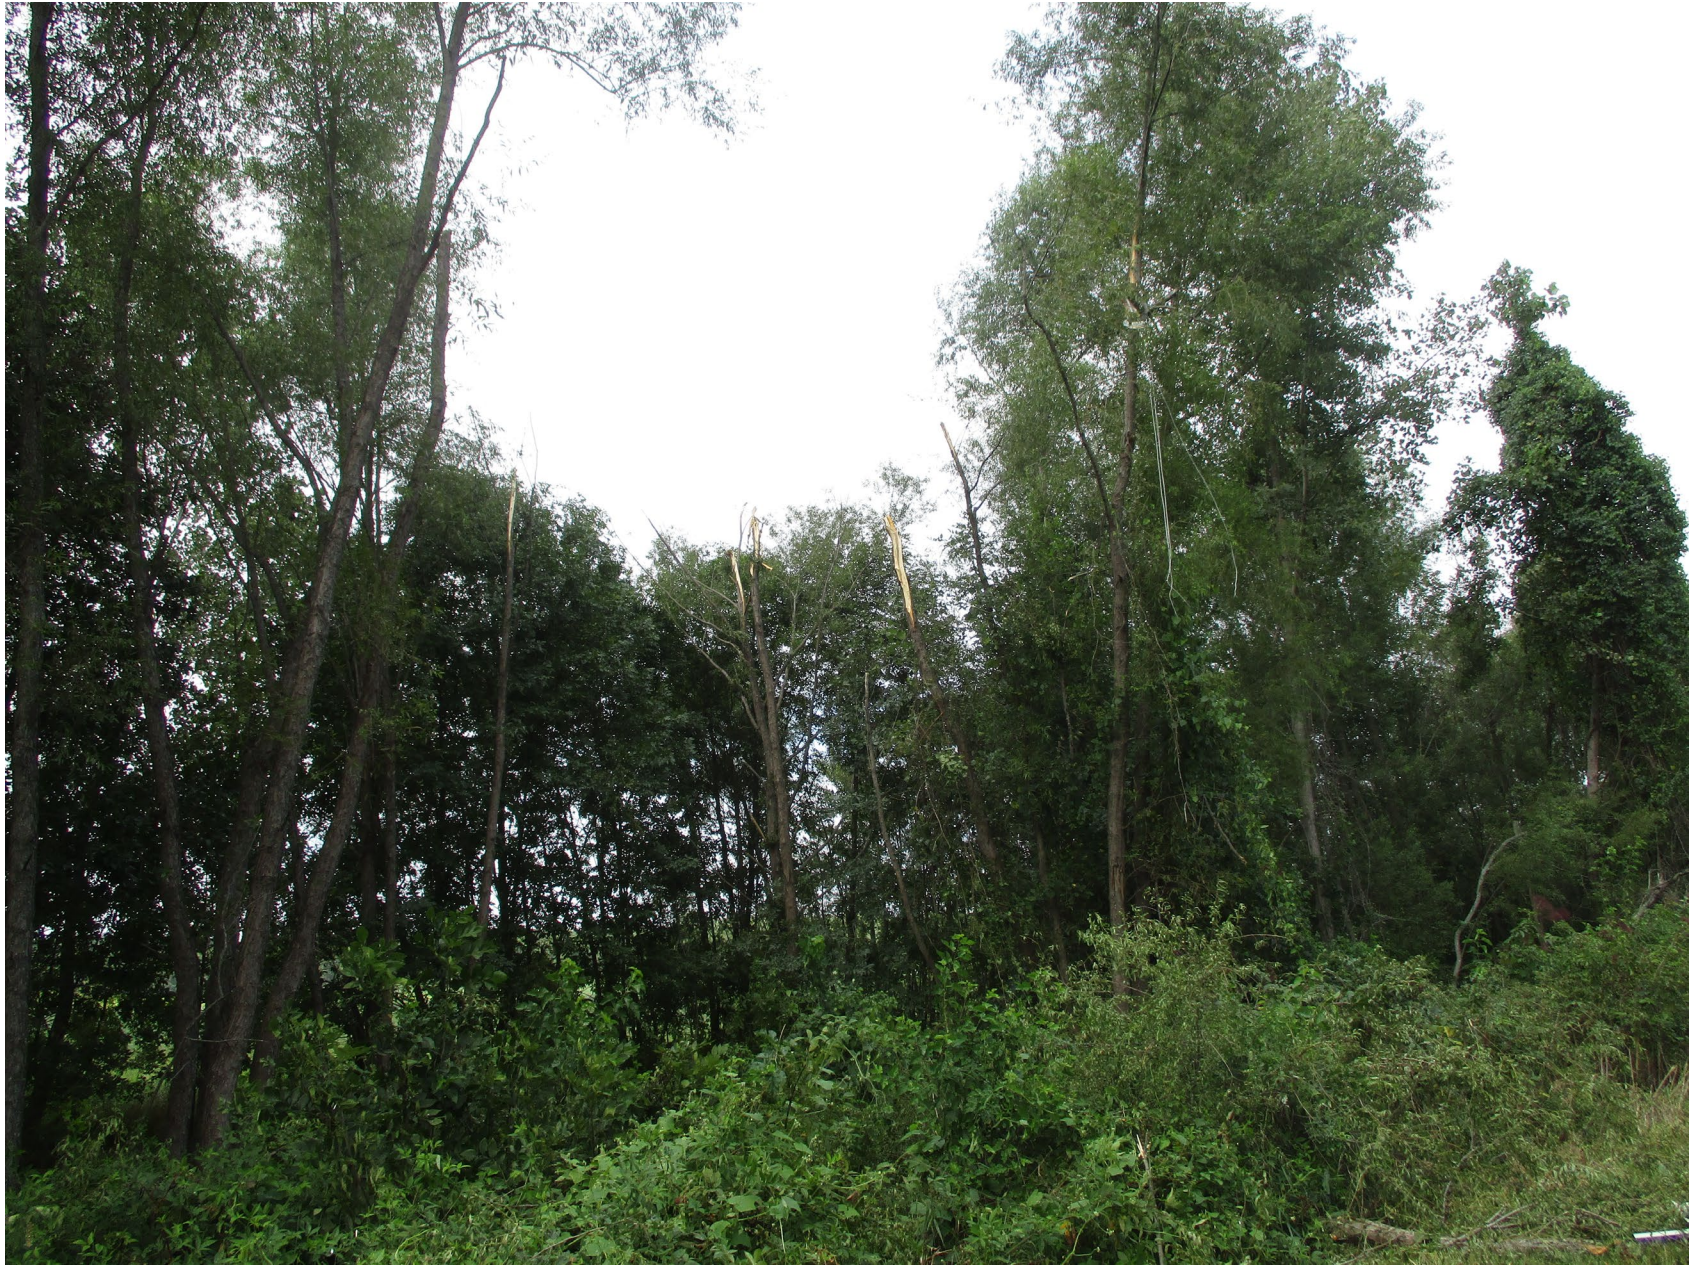
**Photo 1 – Initial Tree Impacts (photograph provided by FAA)**

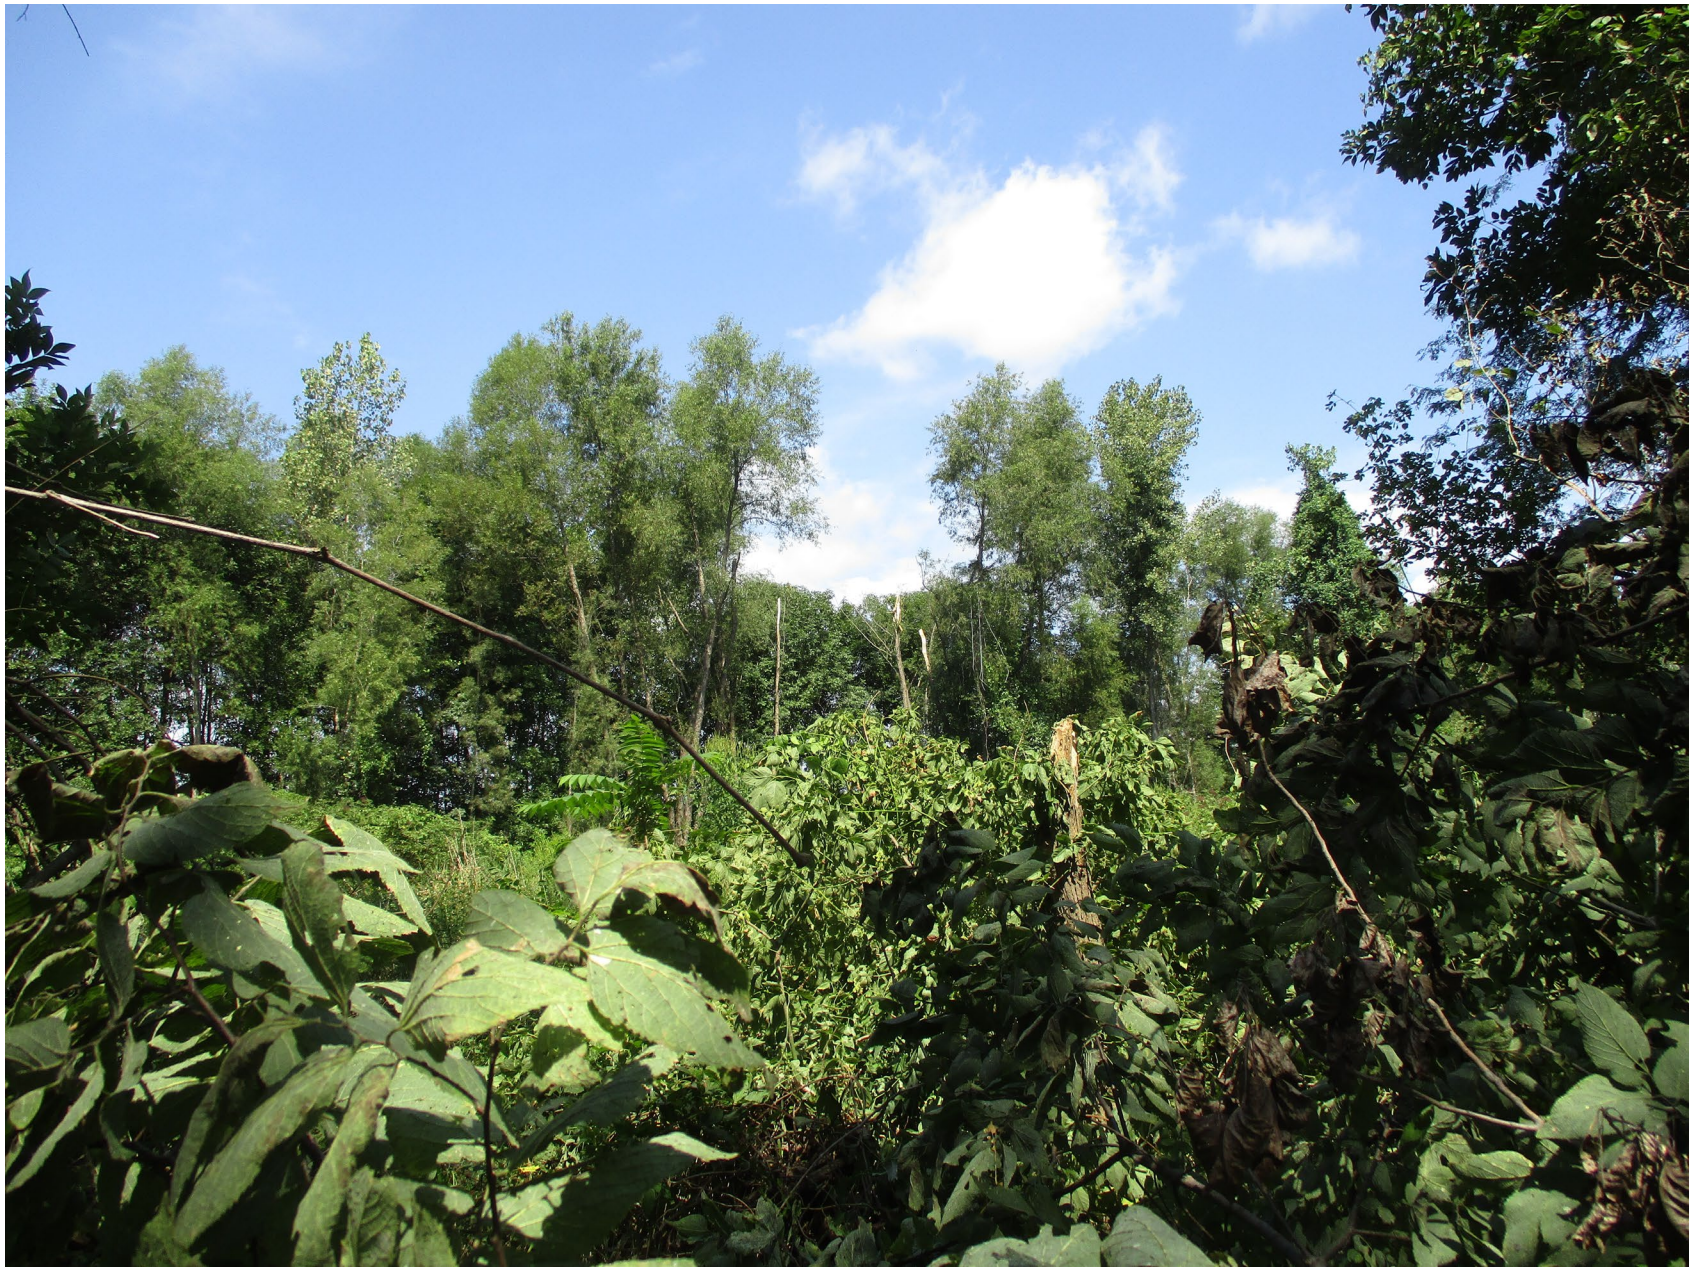
**Photo 2 – Initial Tree Impacts (photograph provided by FAA)**

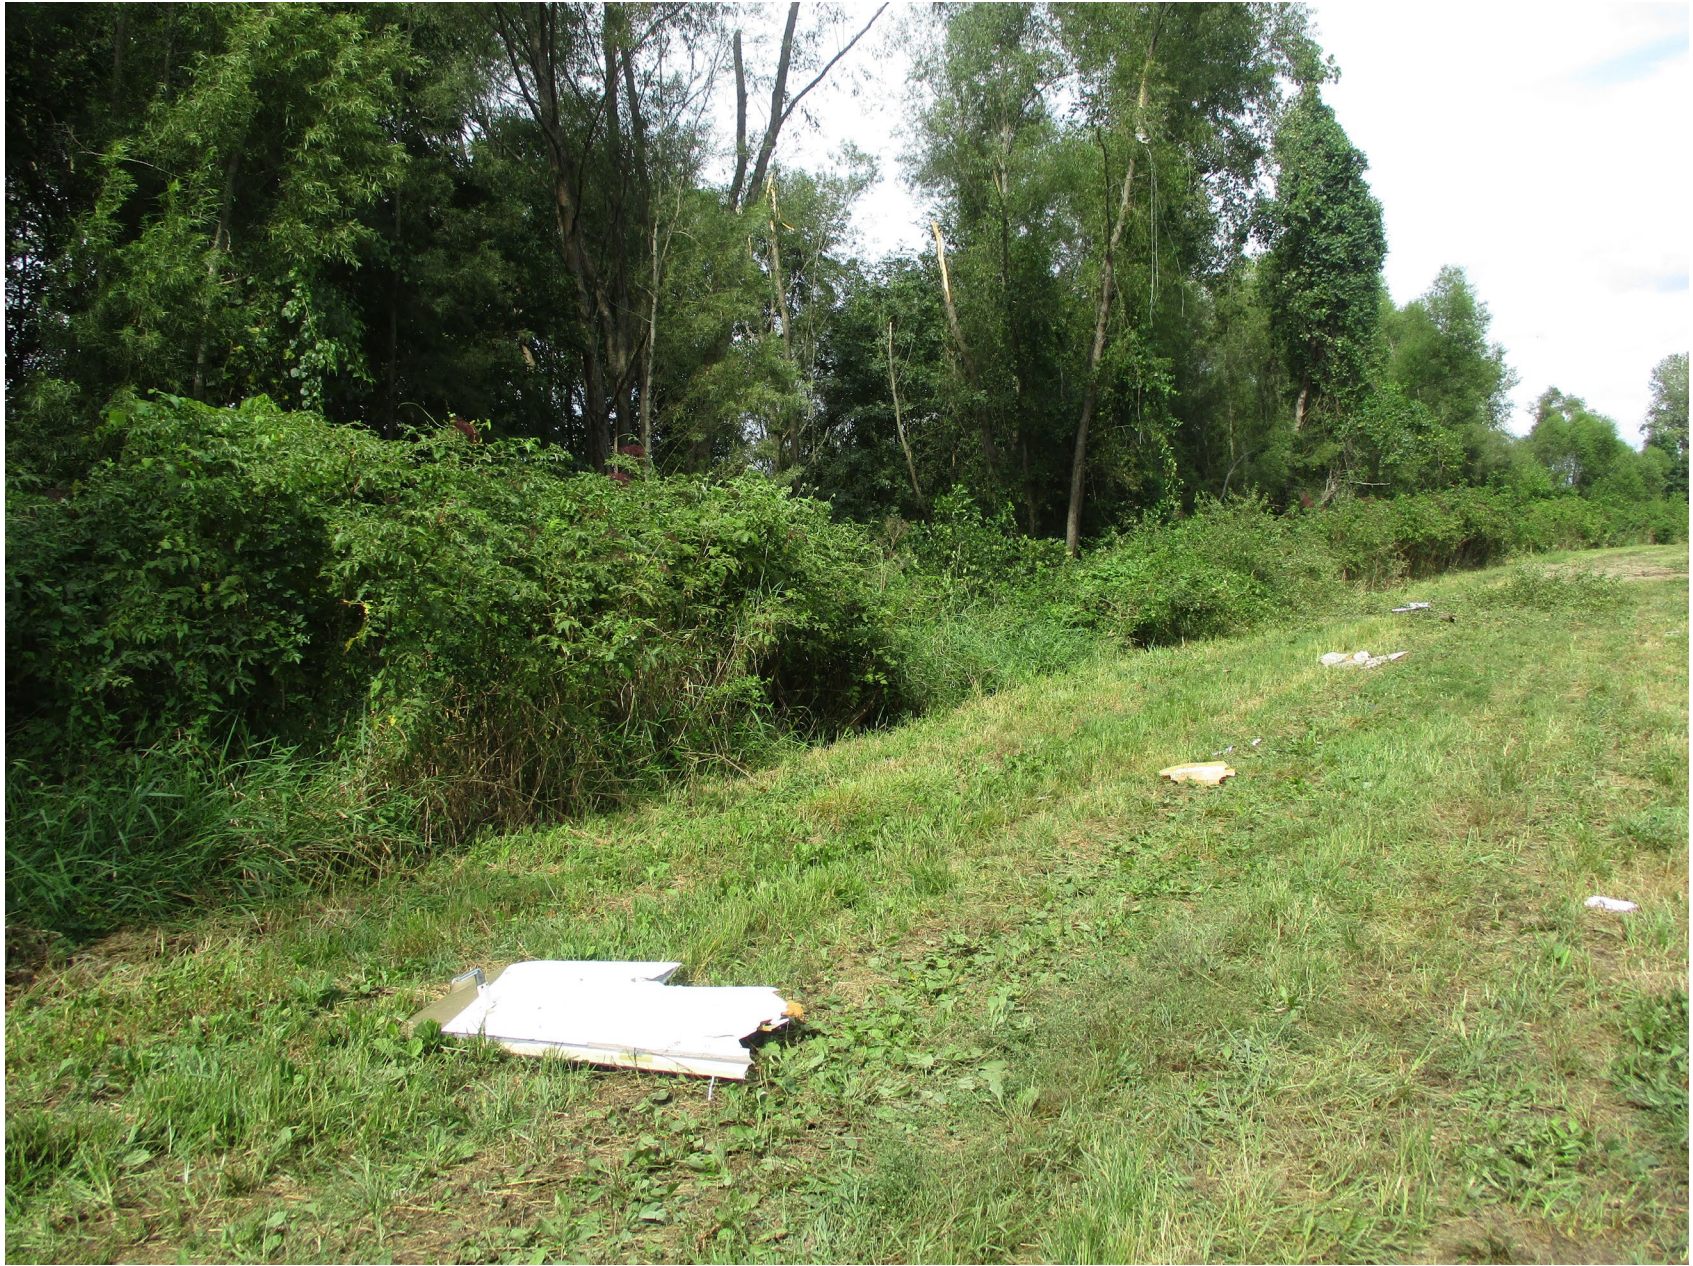
**Photo 3 – Airframe Debris (photograph provided by FAA)**

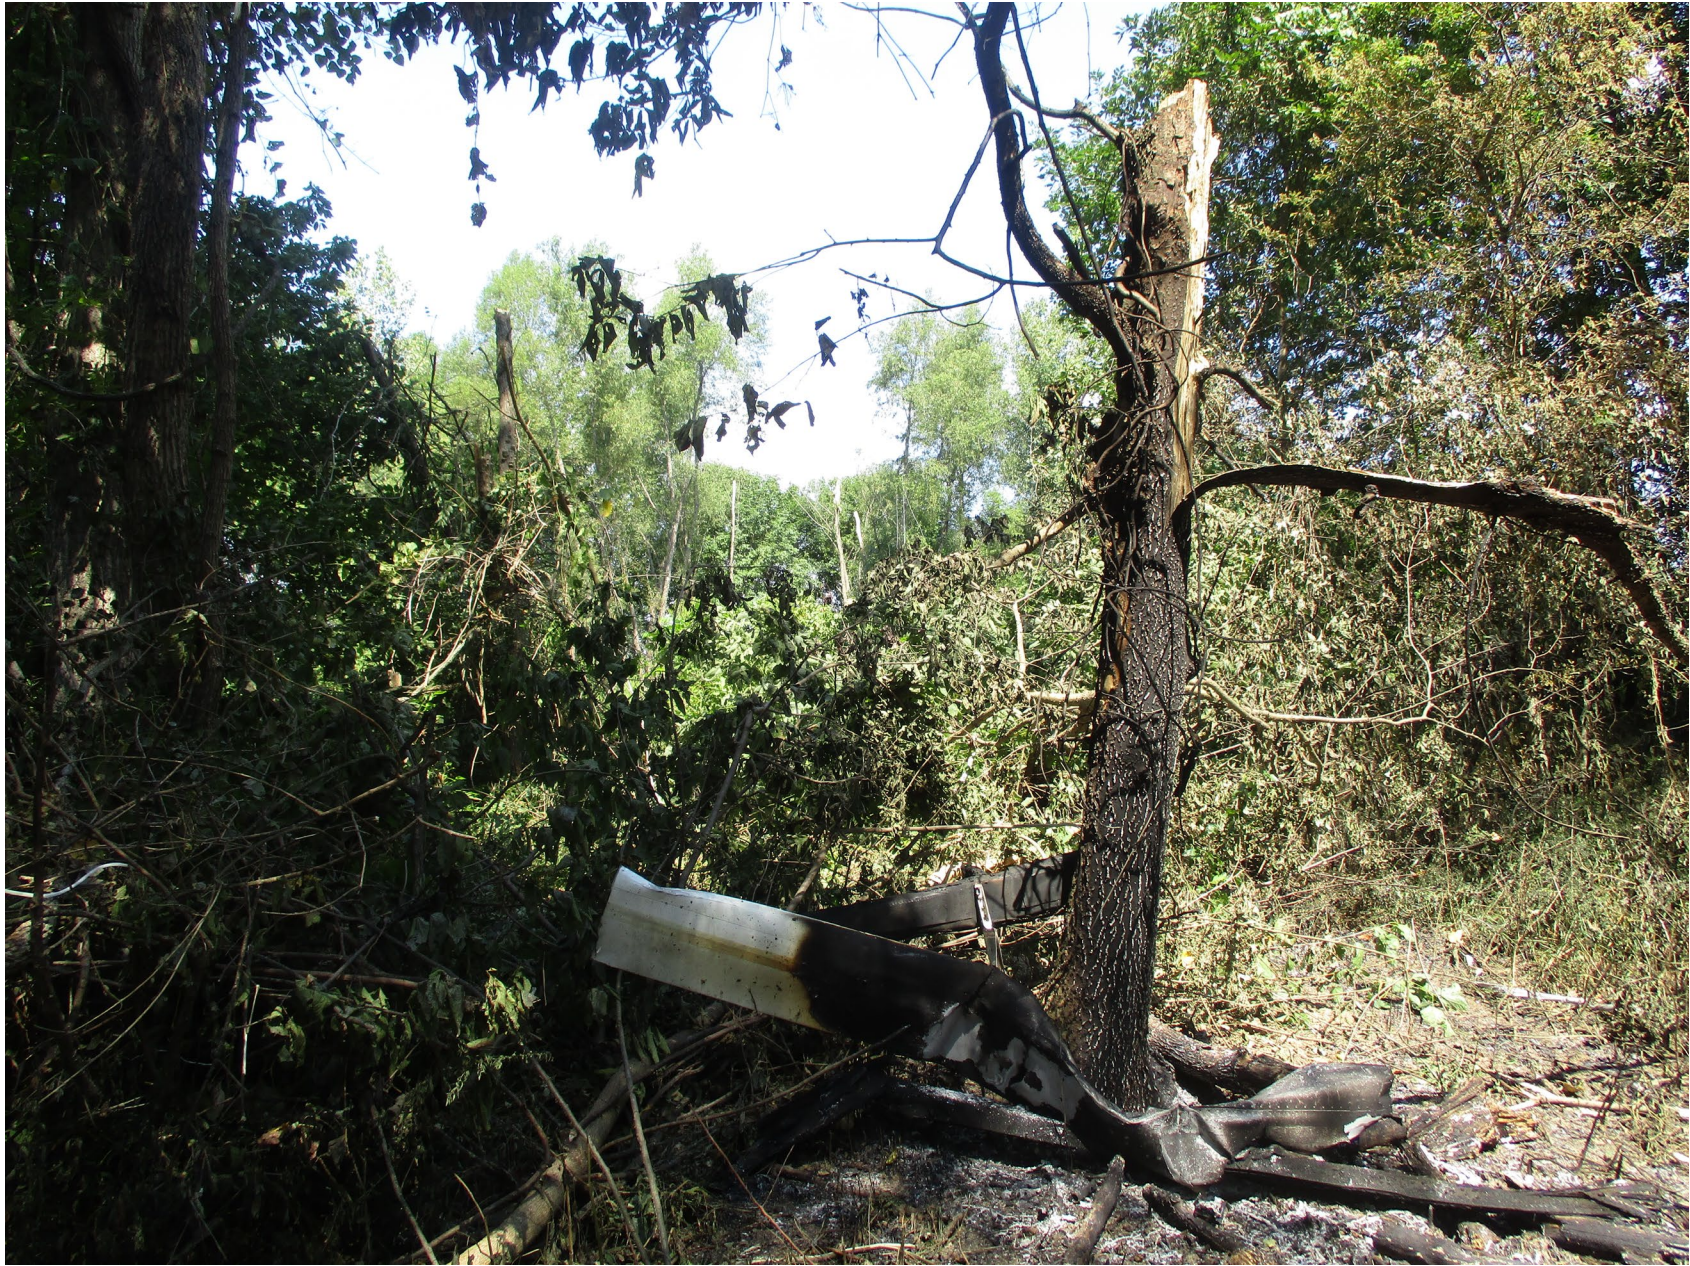
**Photo 4 – Wreckage Debris Path (photograph provided by FAA)**

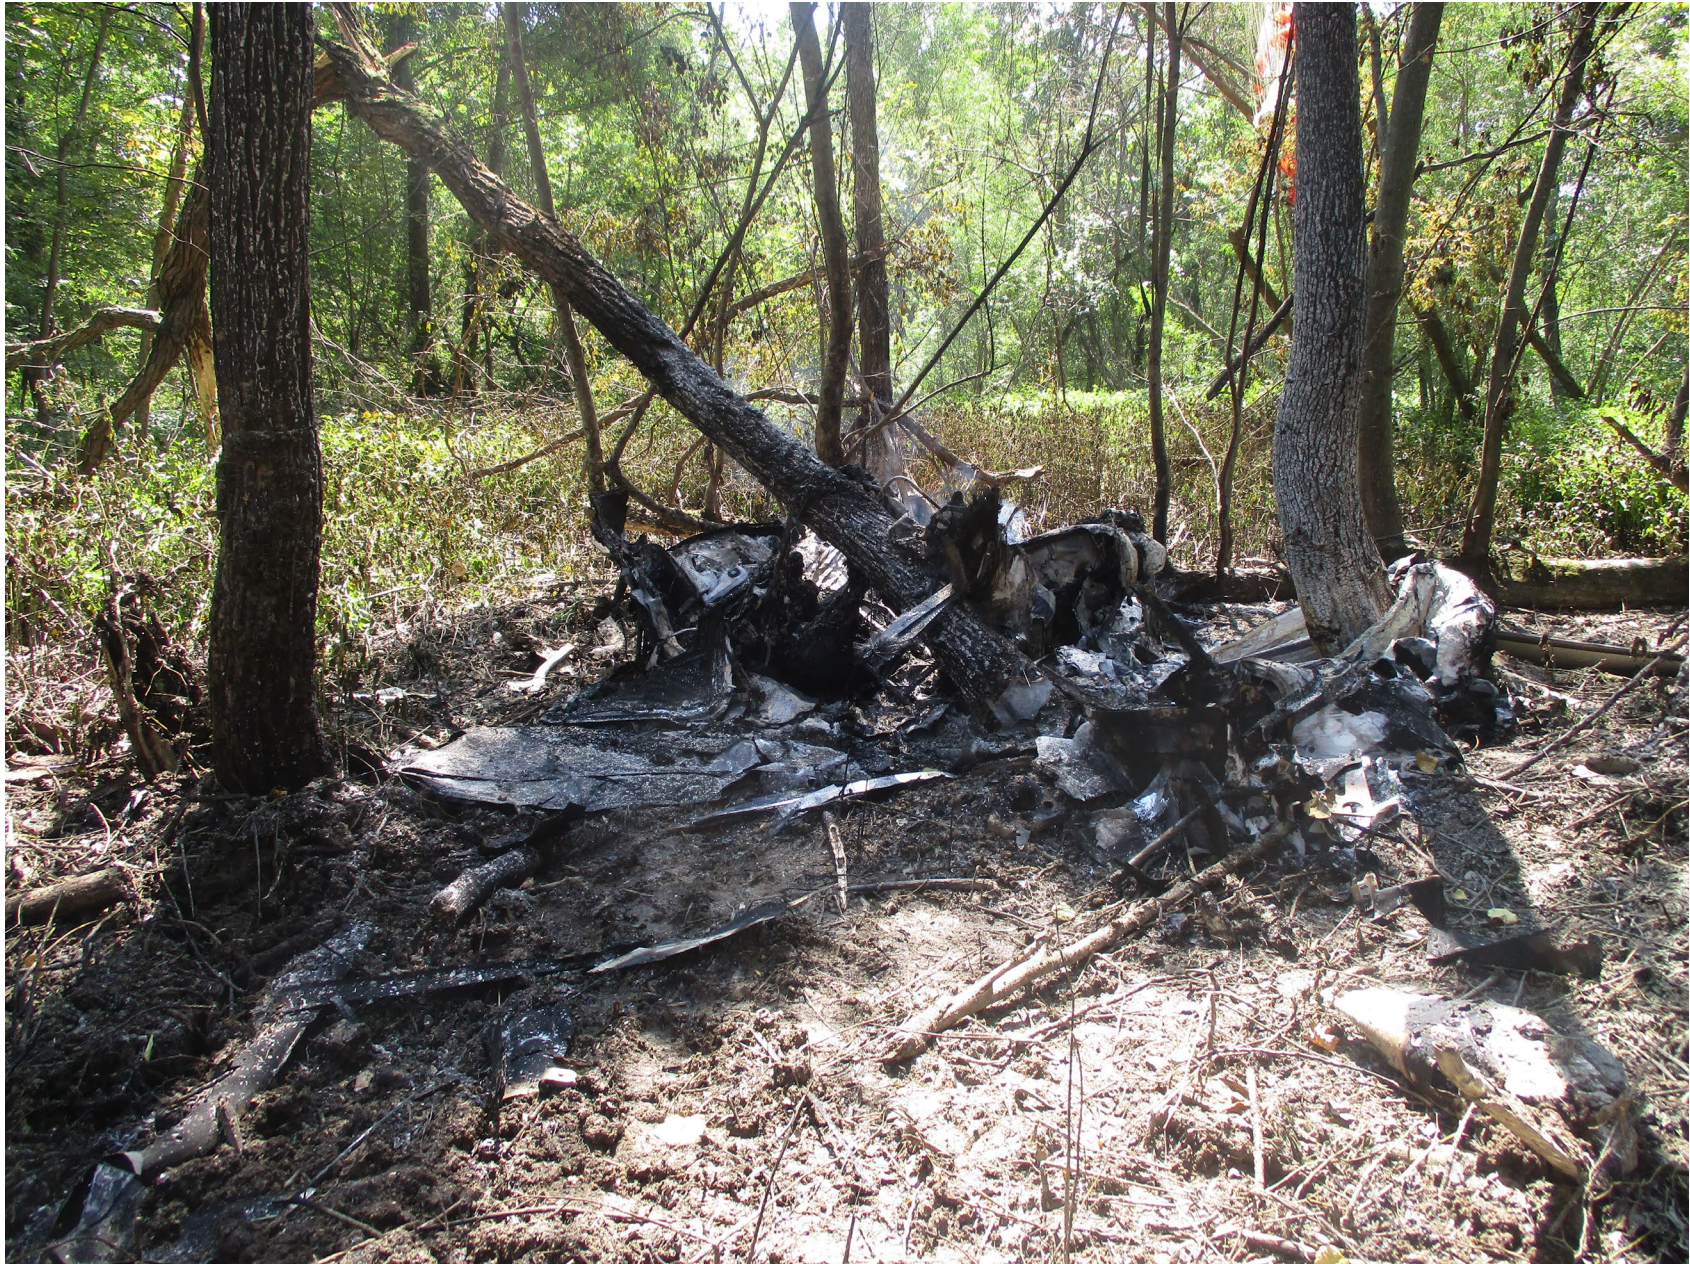
**Photo 5 – Main Wreckage (photograph provided by FAA)**

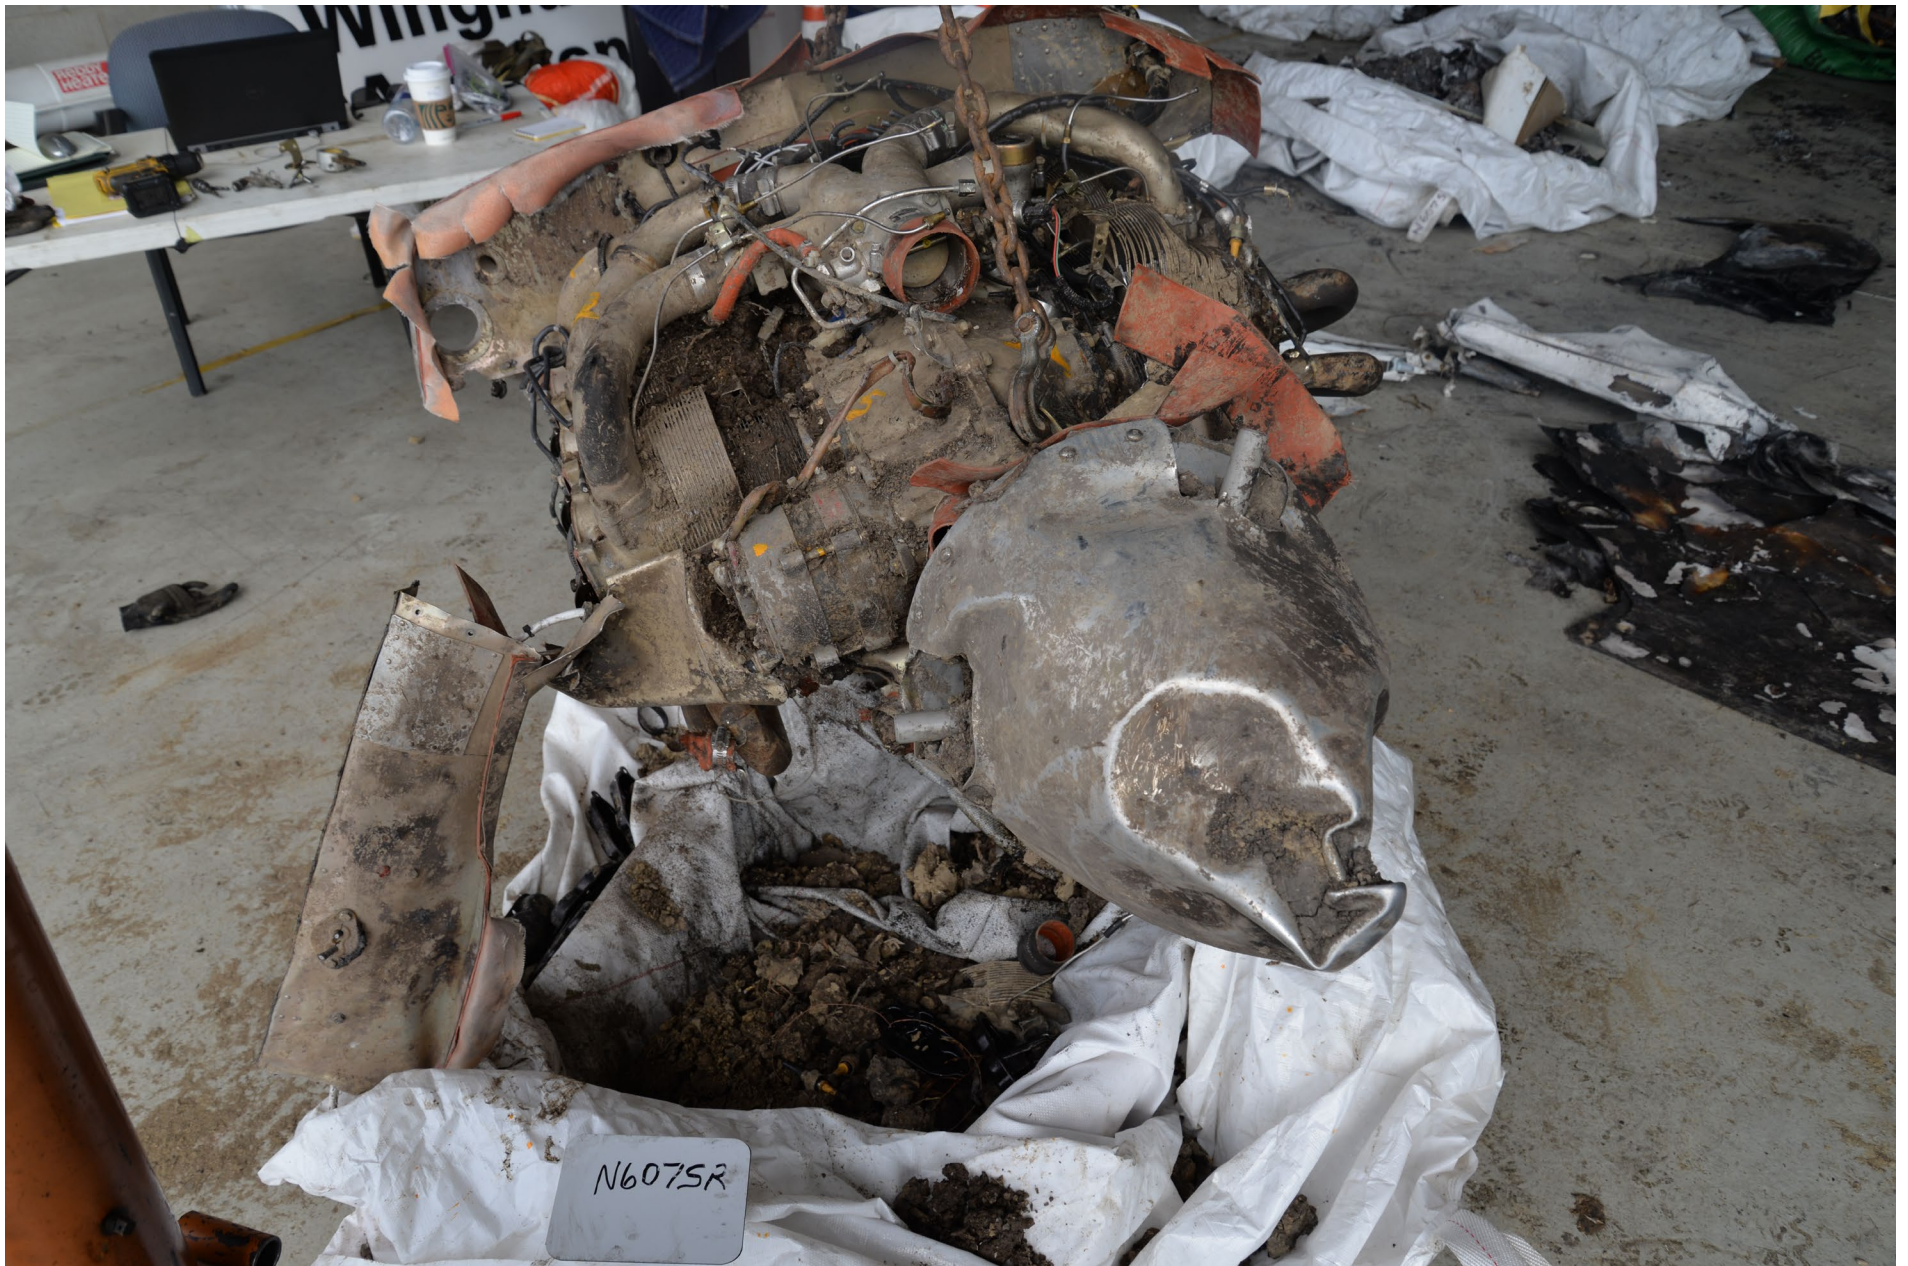
**Photo 6 – Engine and Propeller Assembly (photograph provided by Cirrus Aircraft)**
