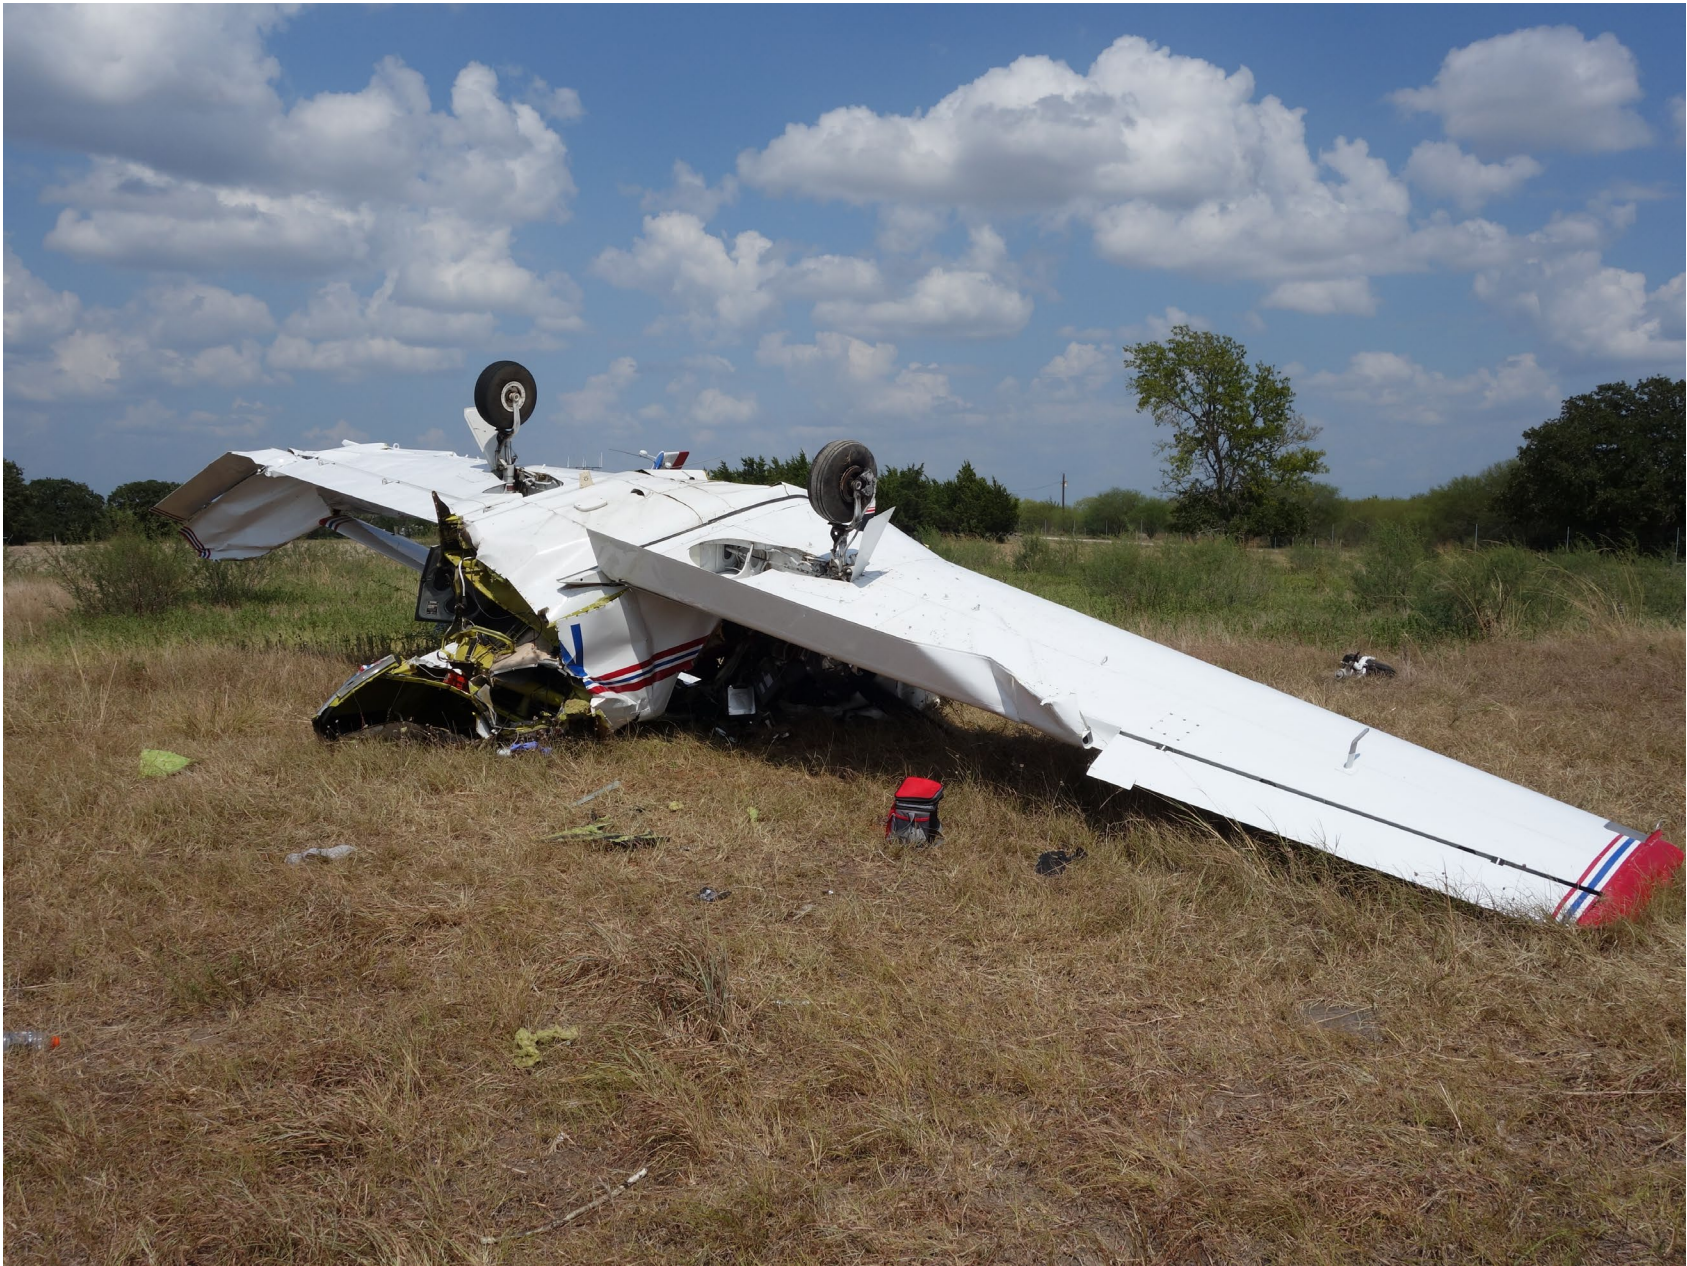
**Photo 1 – View of the wreckage at the accident site (courtesy of Piper Aircraft).**

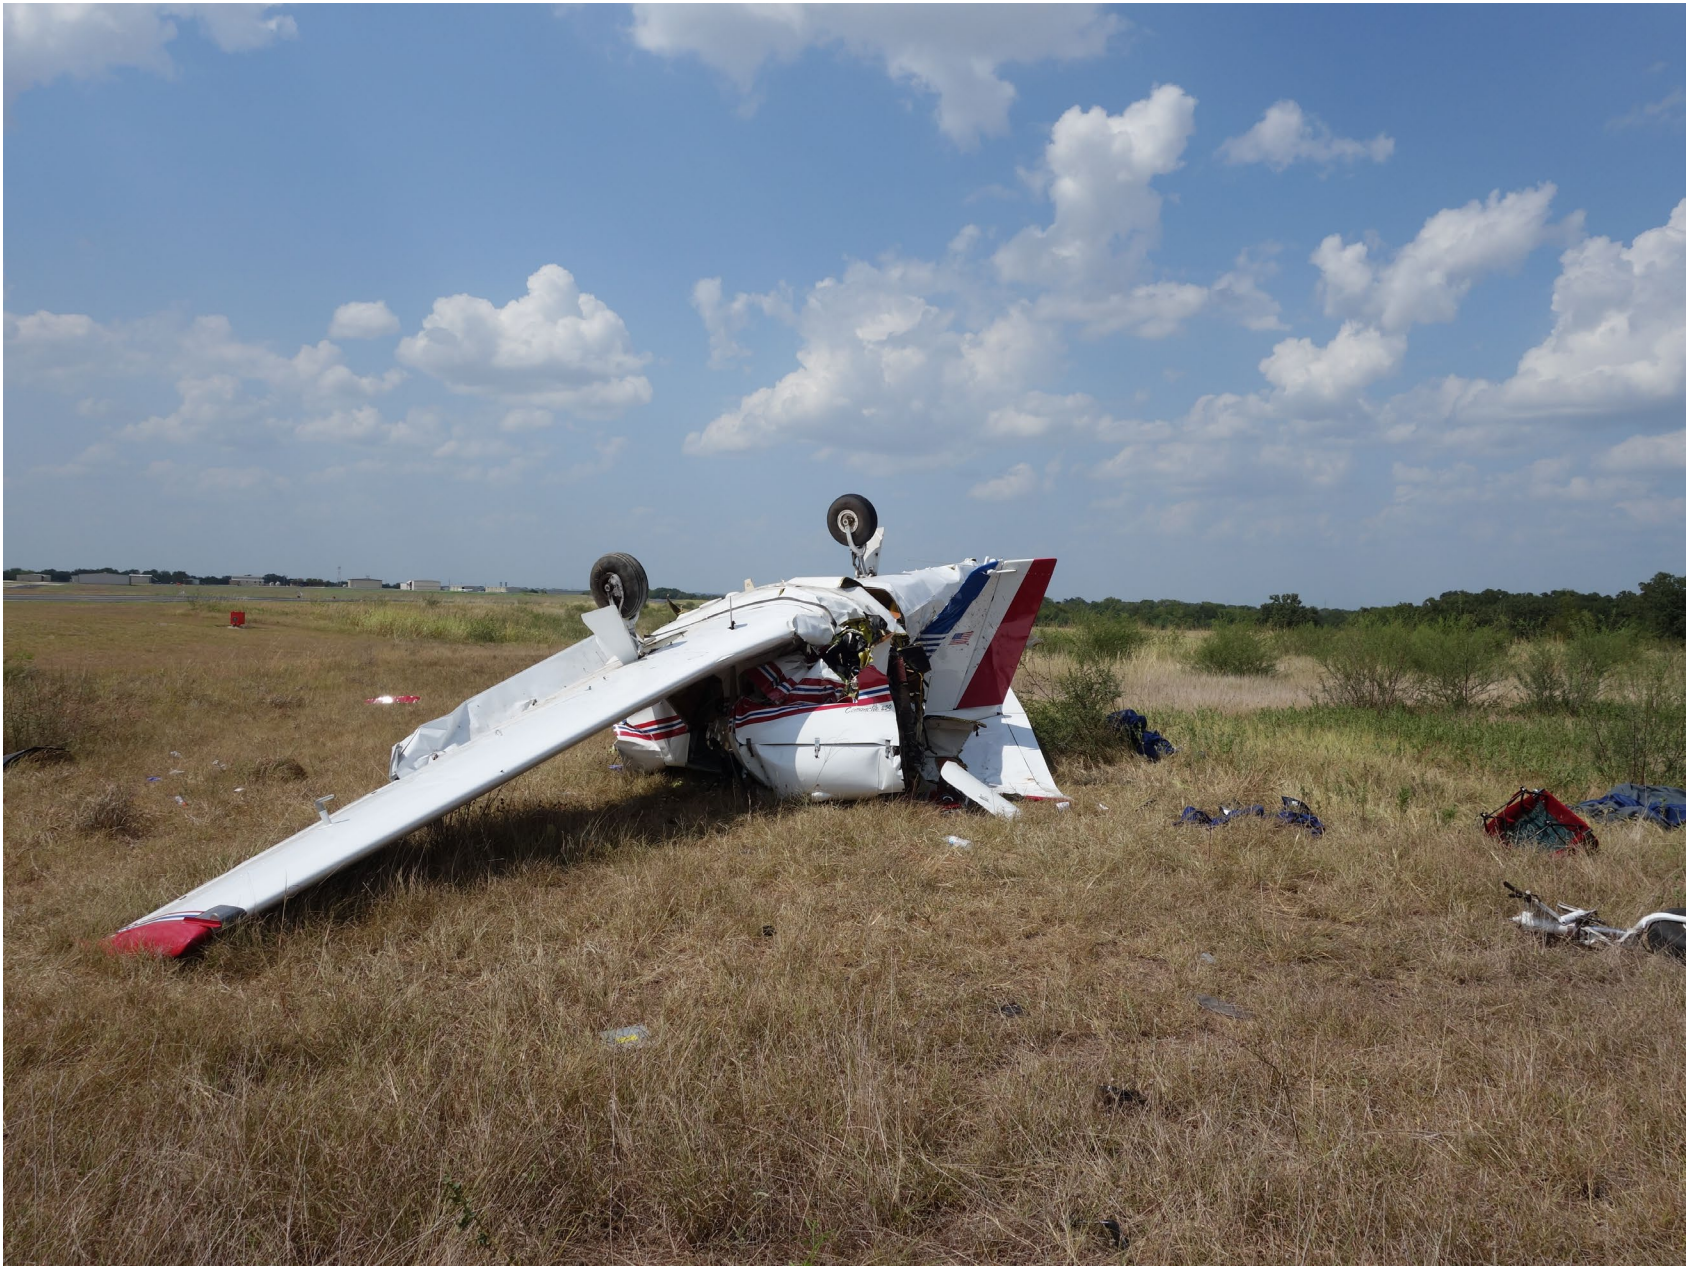
**Photo 2 – View of the wreckage at the accident site (courtesy of Piper Aircraft).**

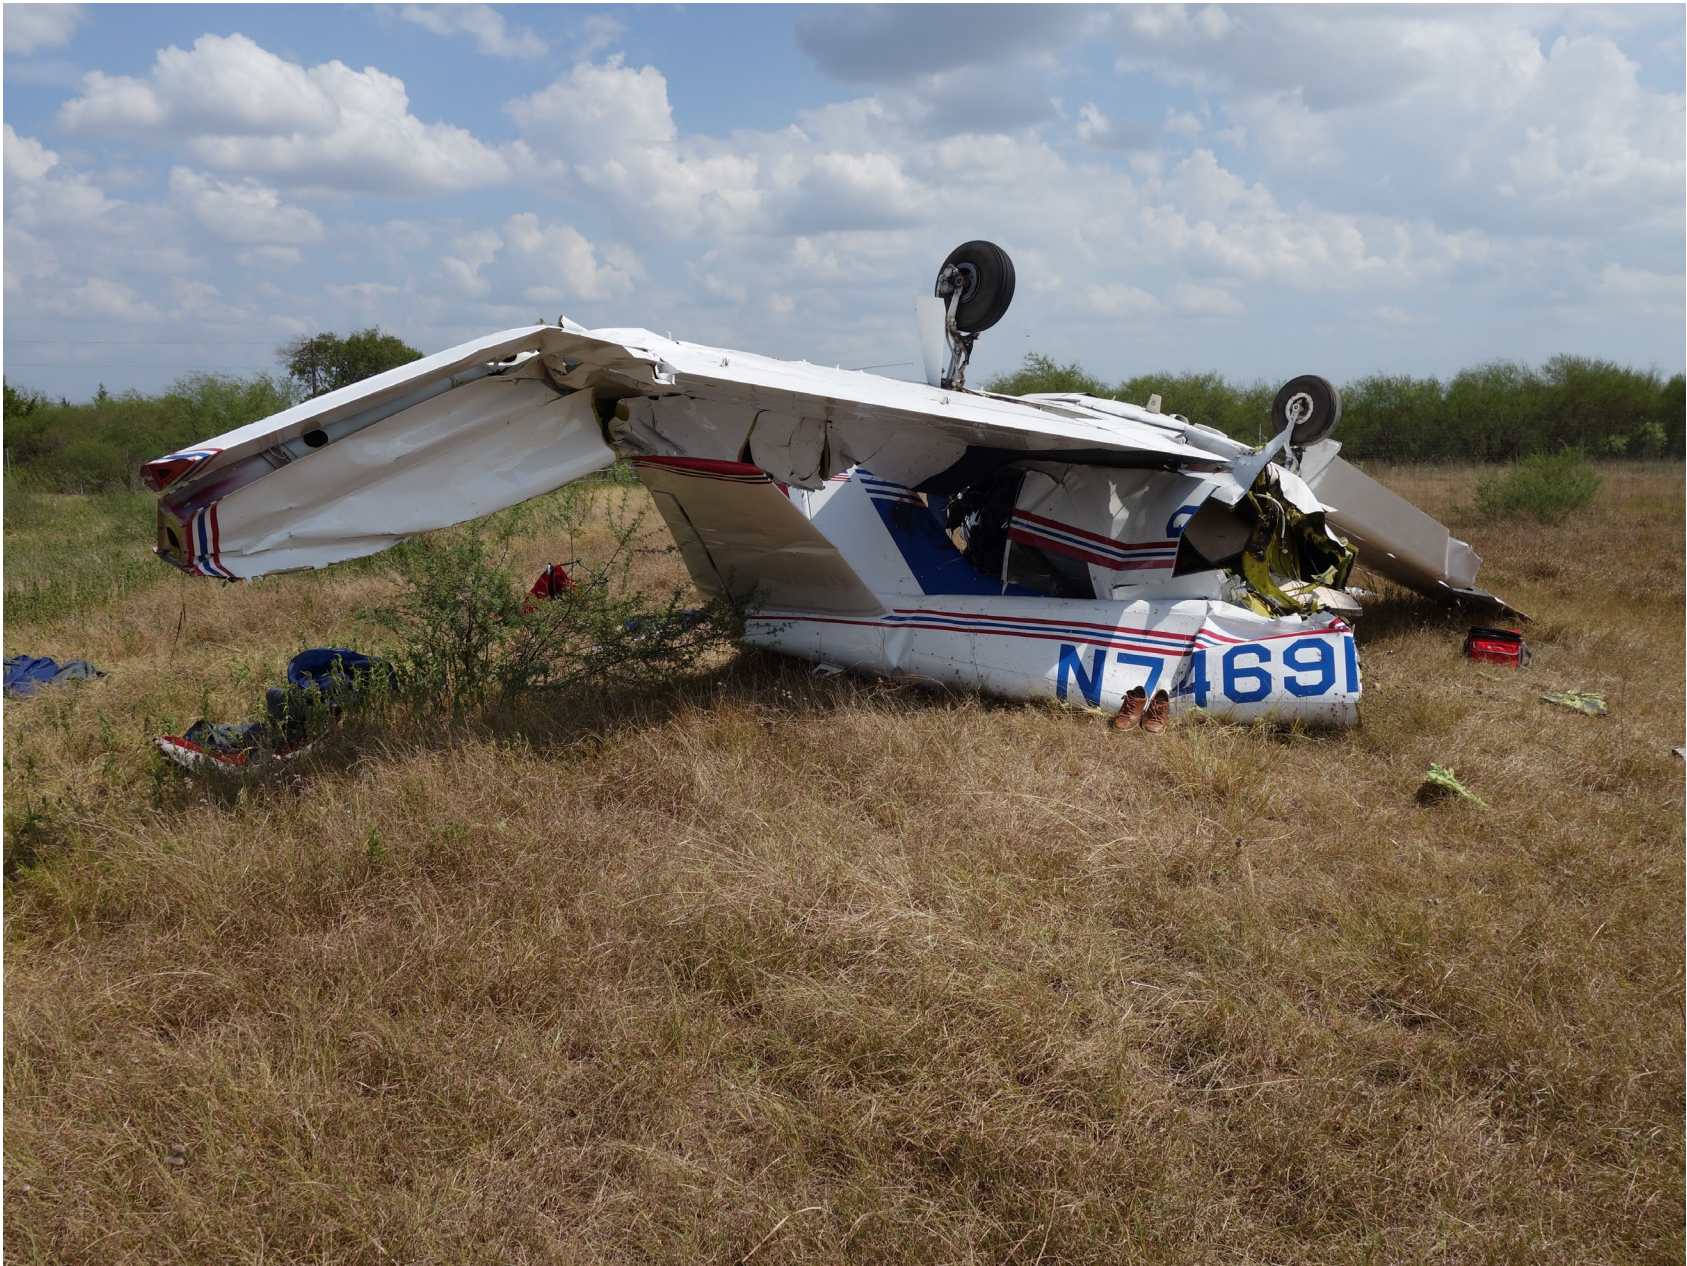
**Photo 3 – View of the wreckage at the accident site (courtesy of Piper Aircraft).**

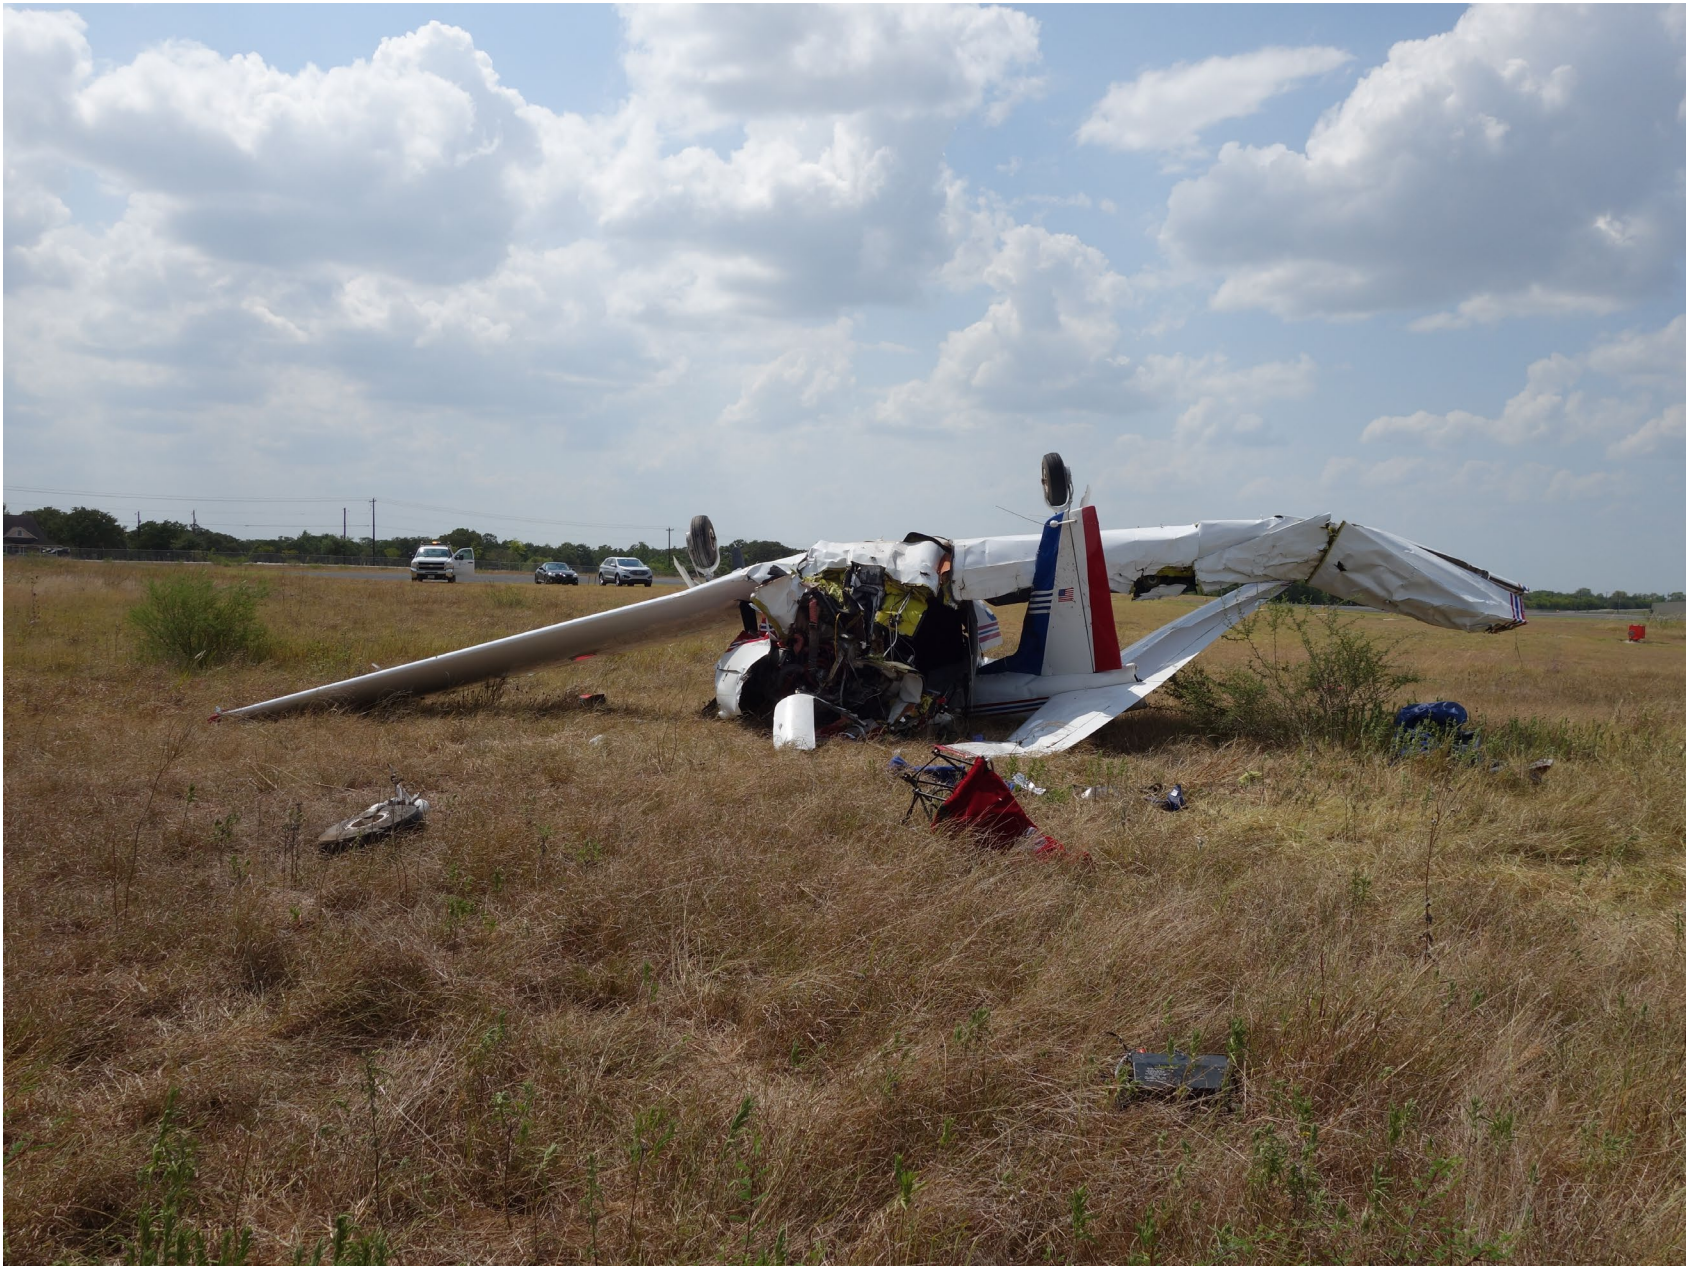
**Photo 4 – View of the wreckage at the accident site (courtesy of Piper Aircraft).**

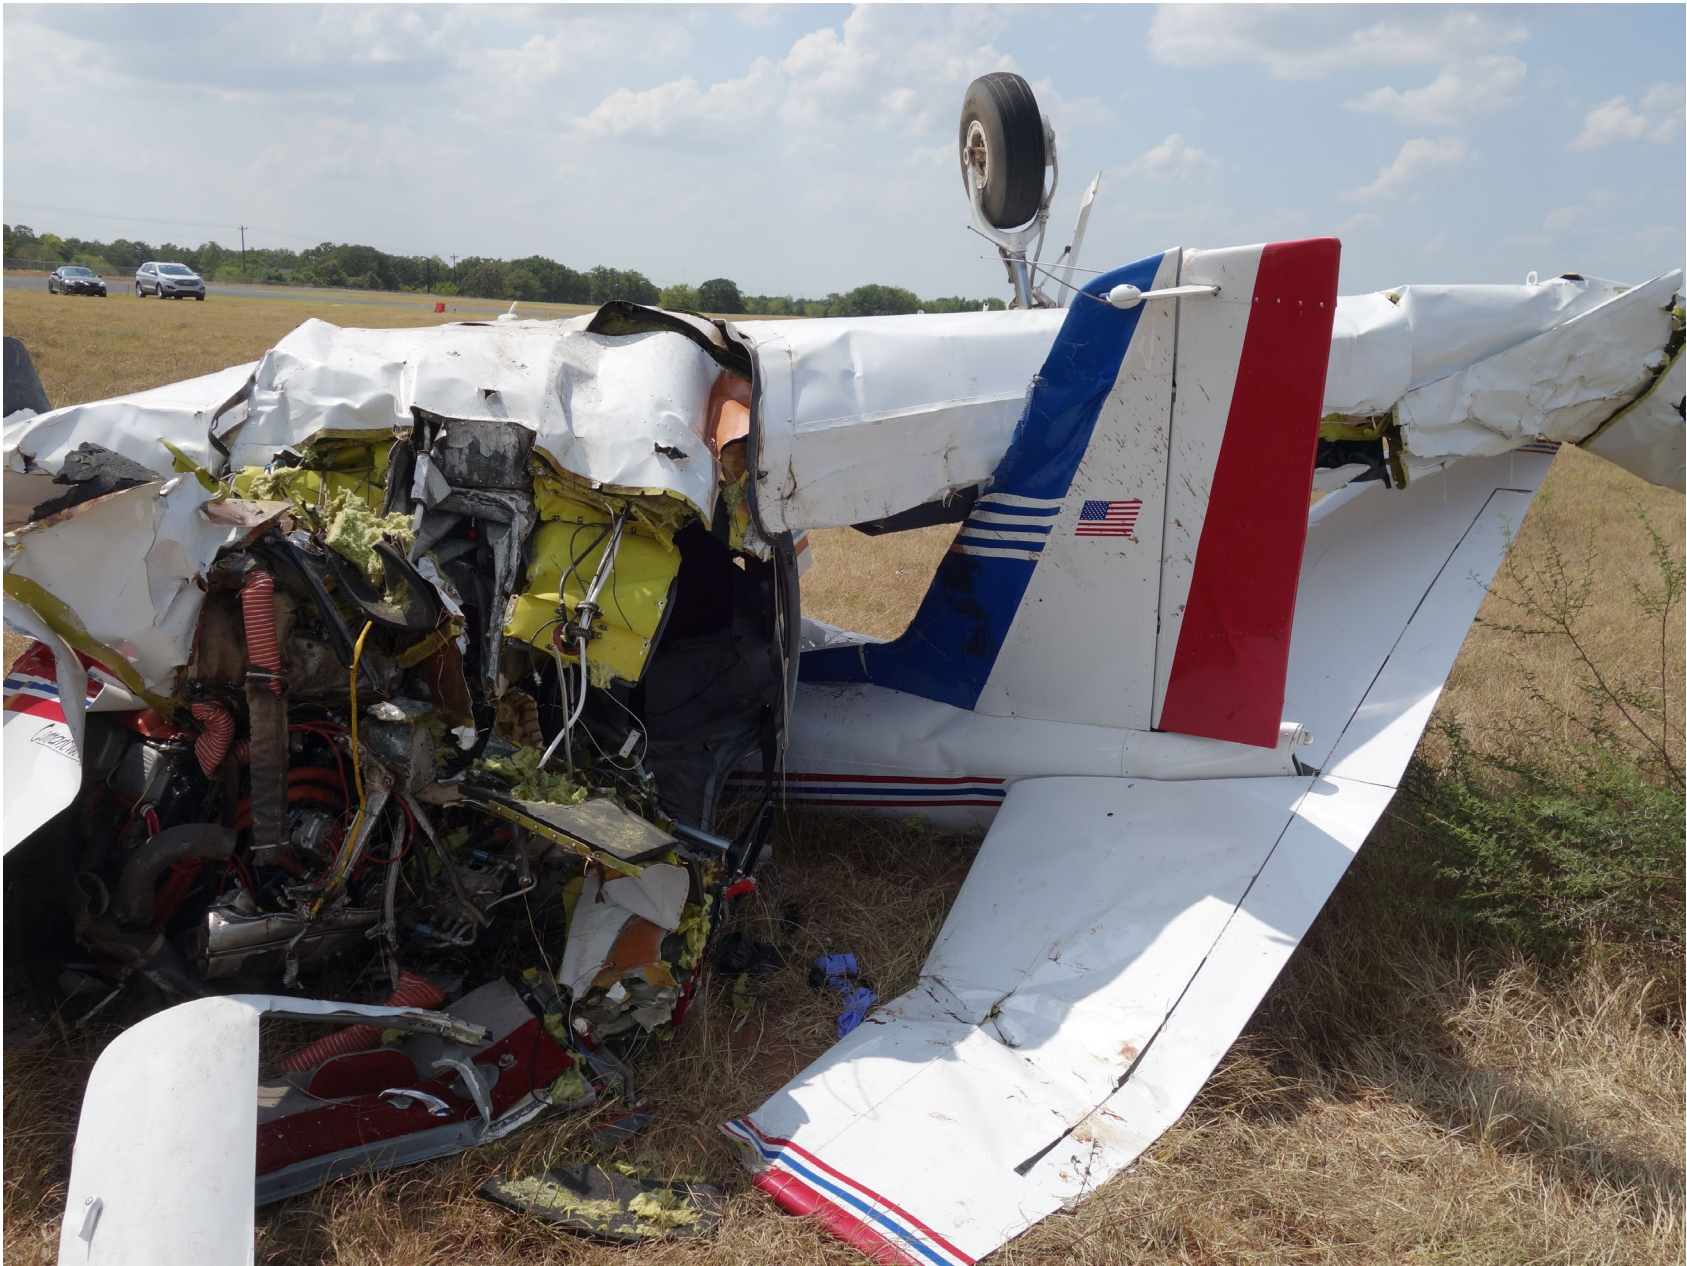
**Photo 5 – Close up view of the wreckage at the accident site (courtesy of Piper Aircraft).**

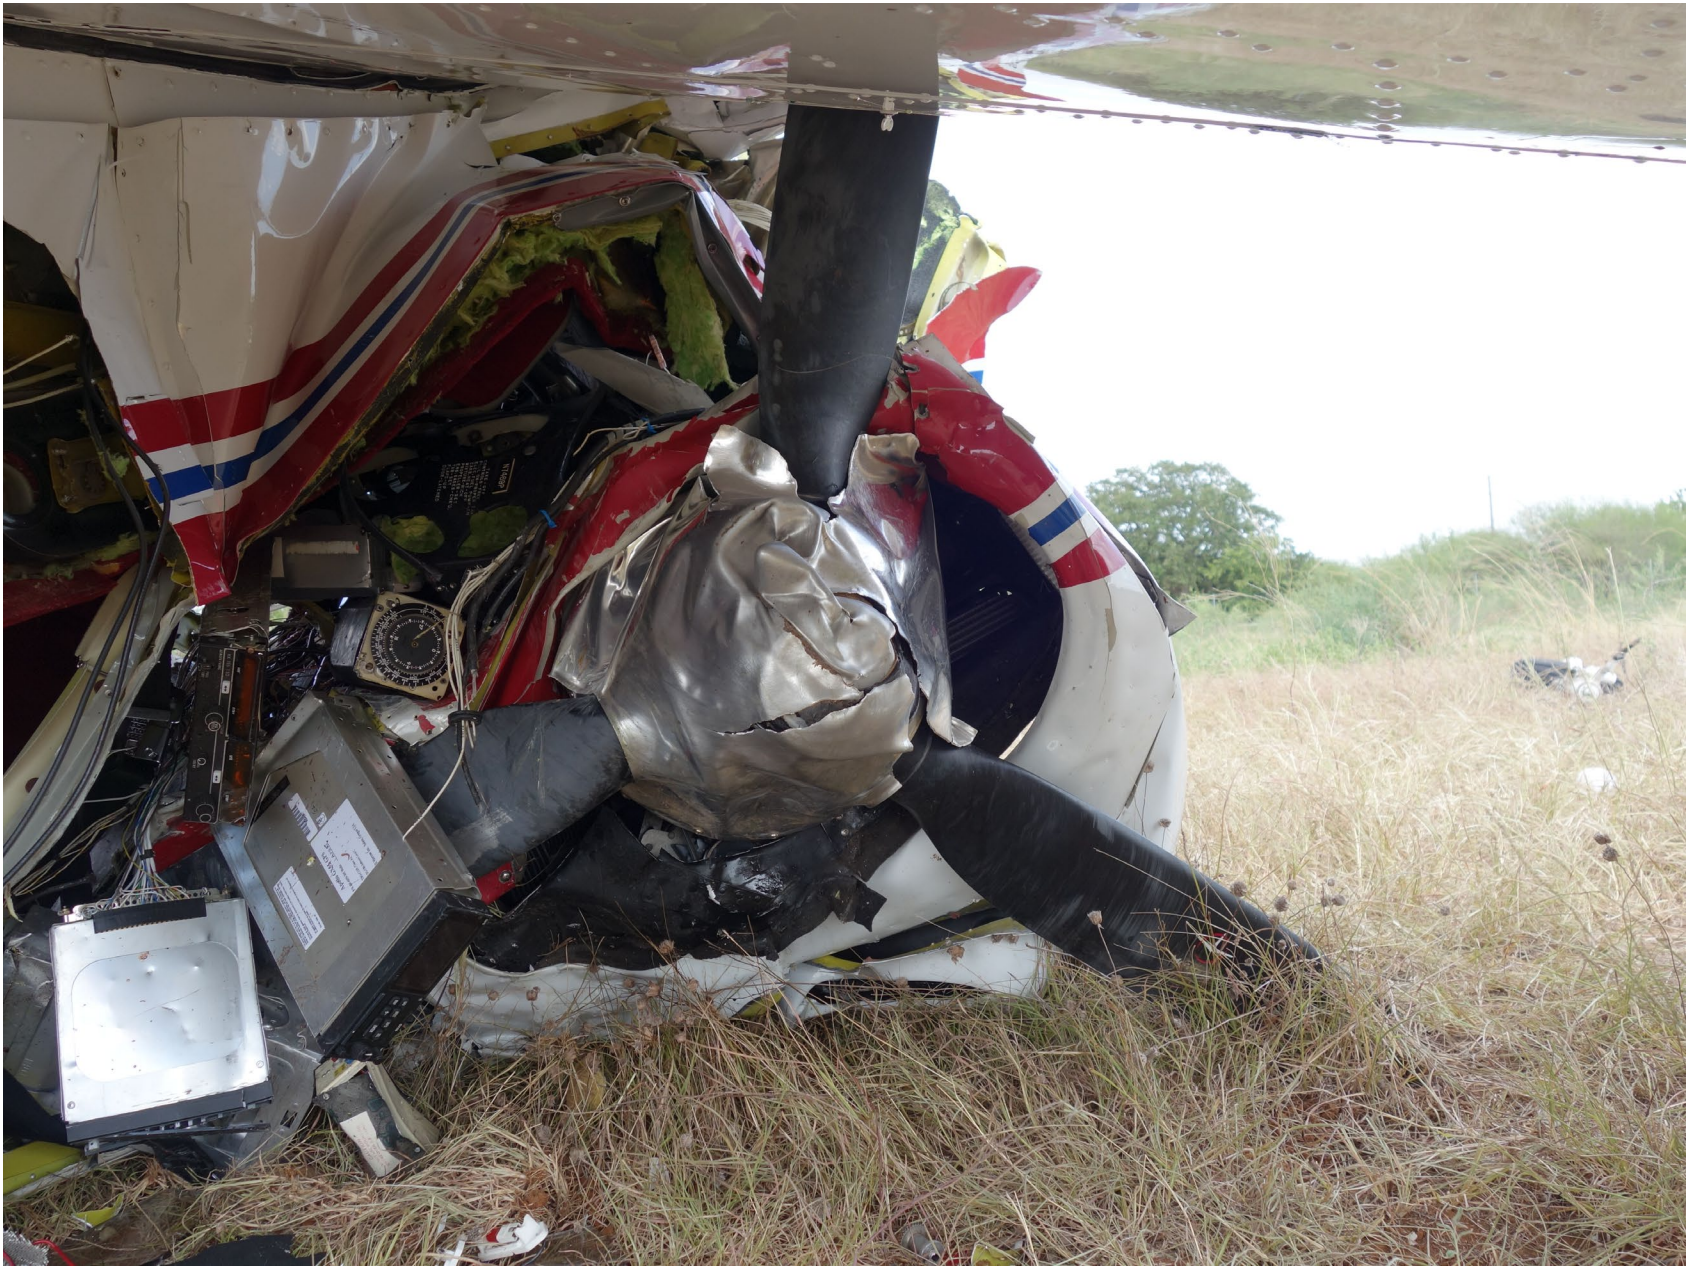
**Photo 6 – Close up view of the propeller at the accident site (courtesy of Piper Aircraft).**

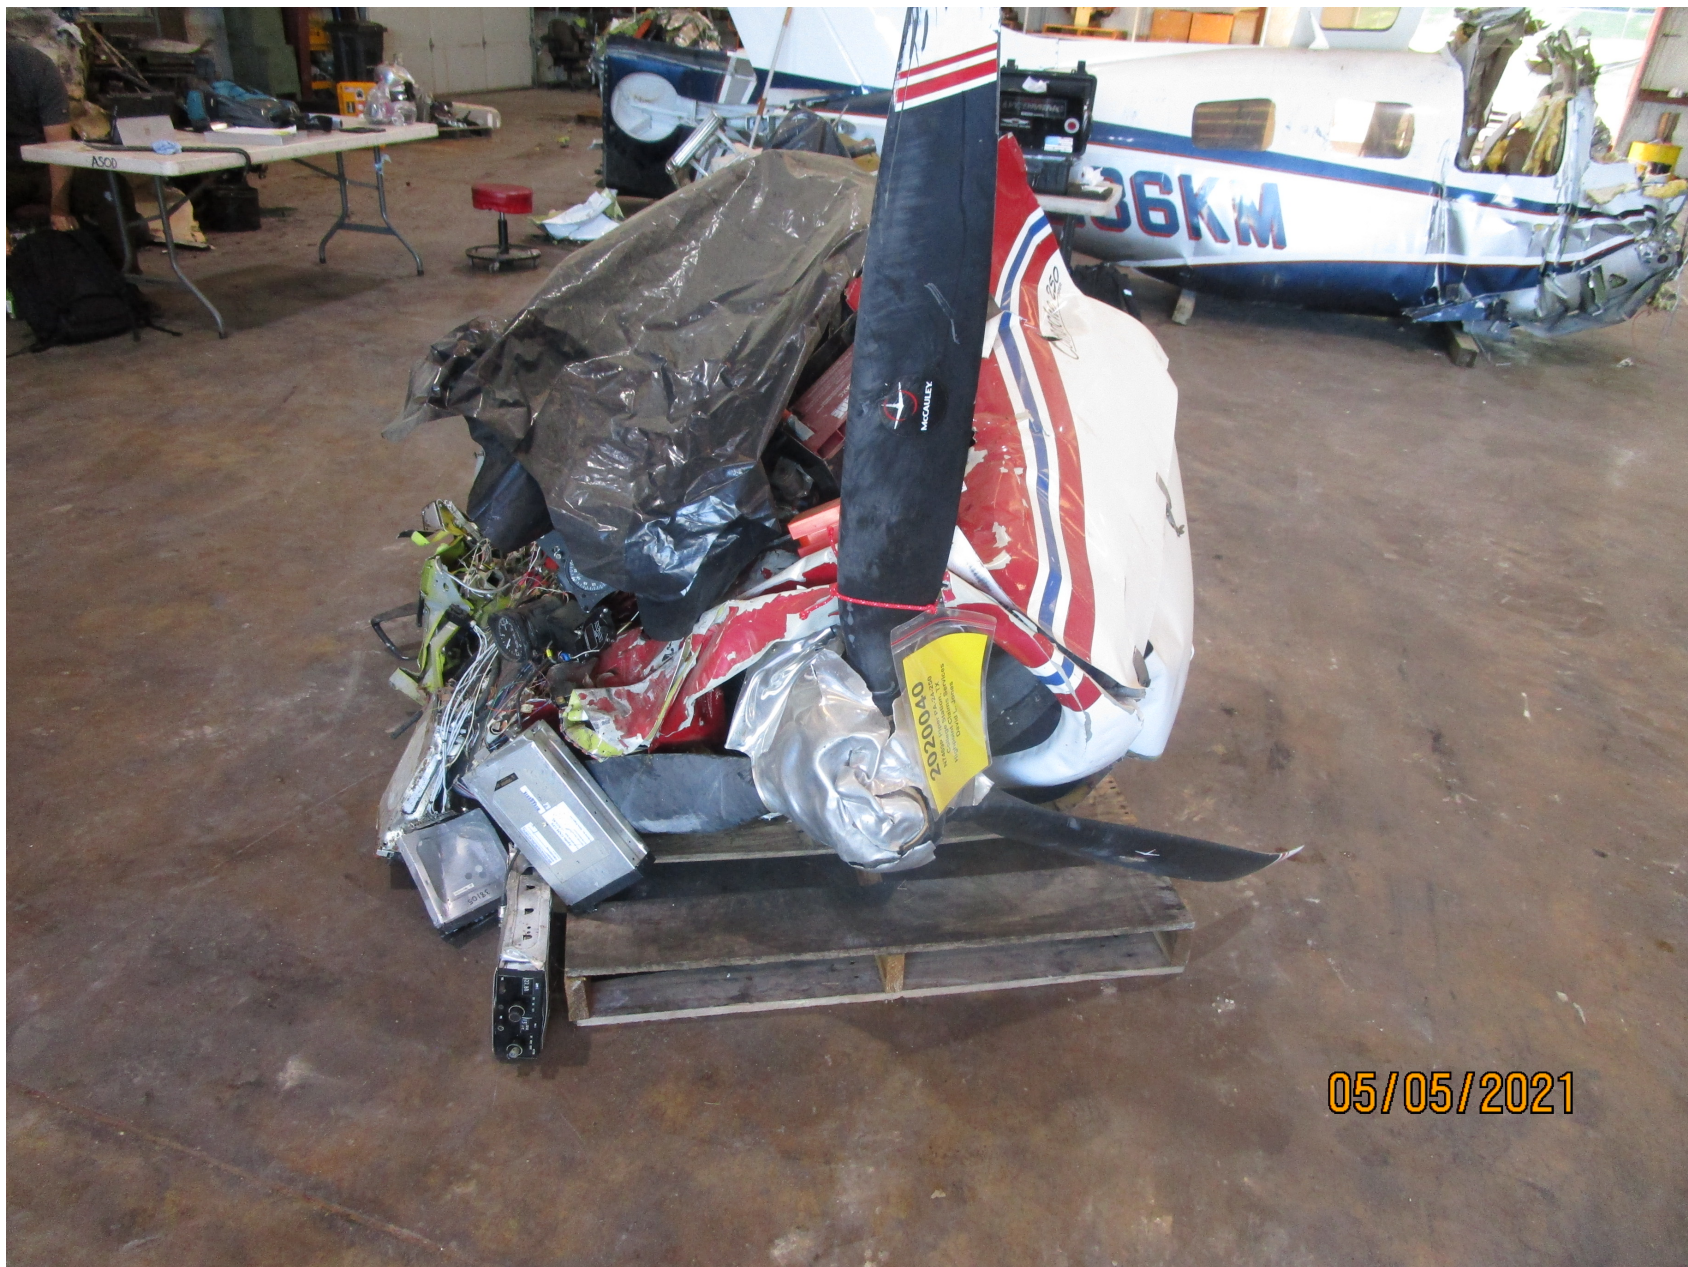
**Photo 7 – View of the engine and the propeller after they were recovered from the accident site (courtesy of the National Transportation Safety Board).**

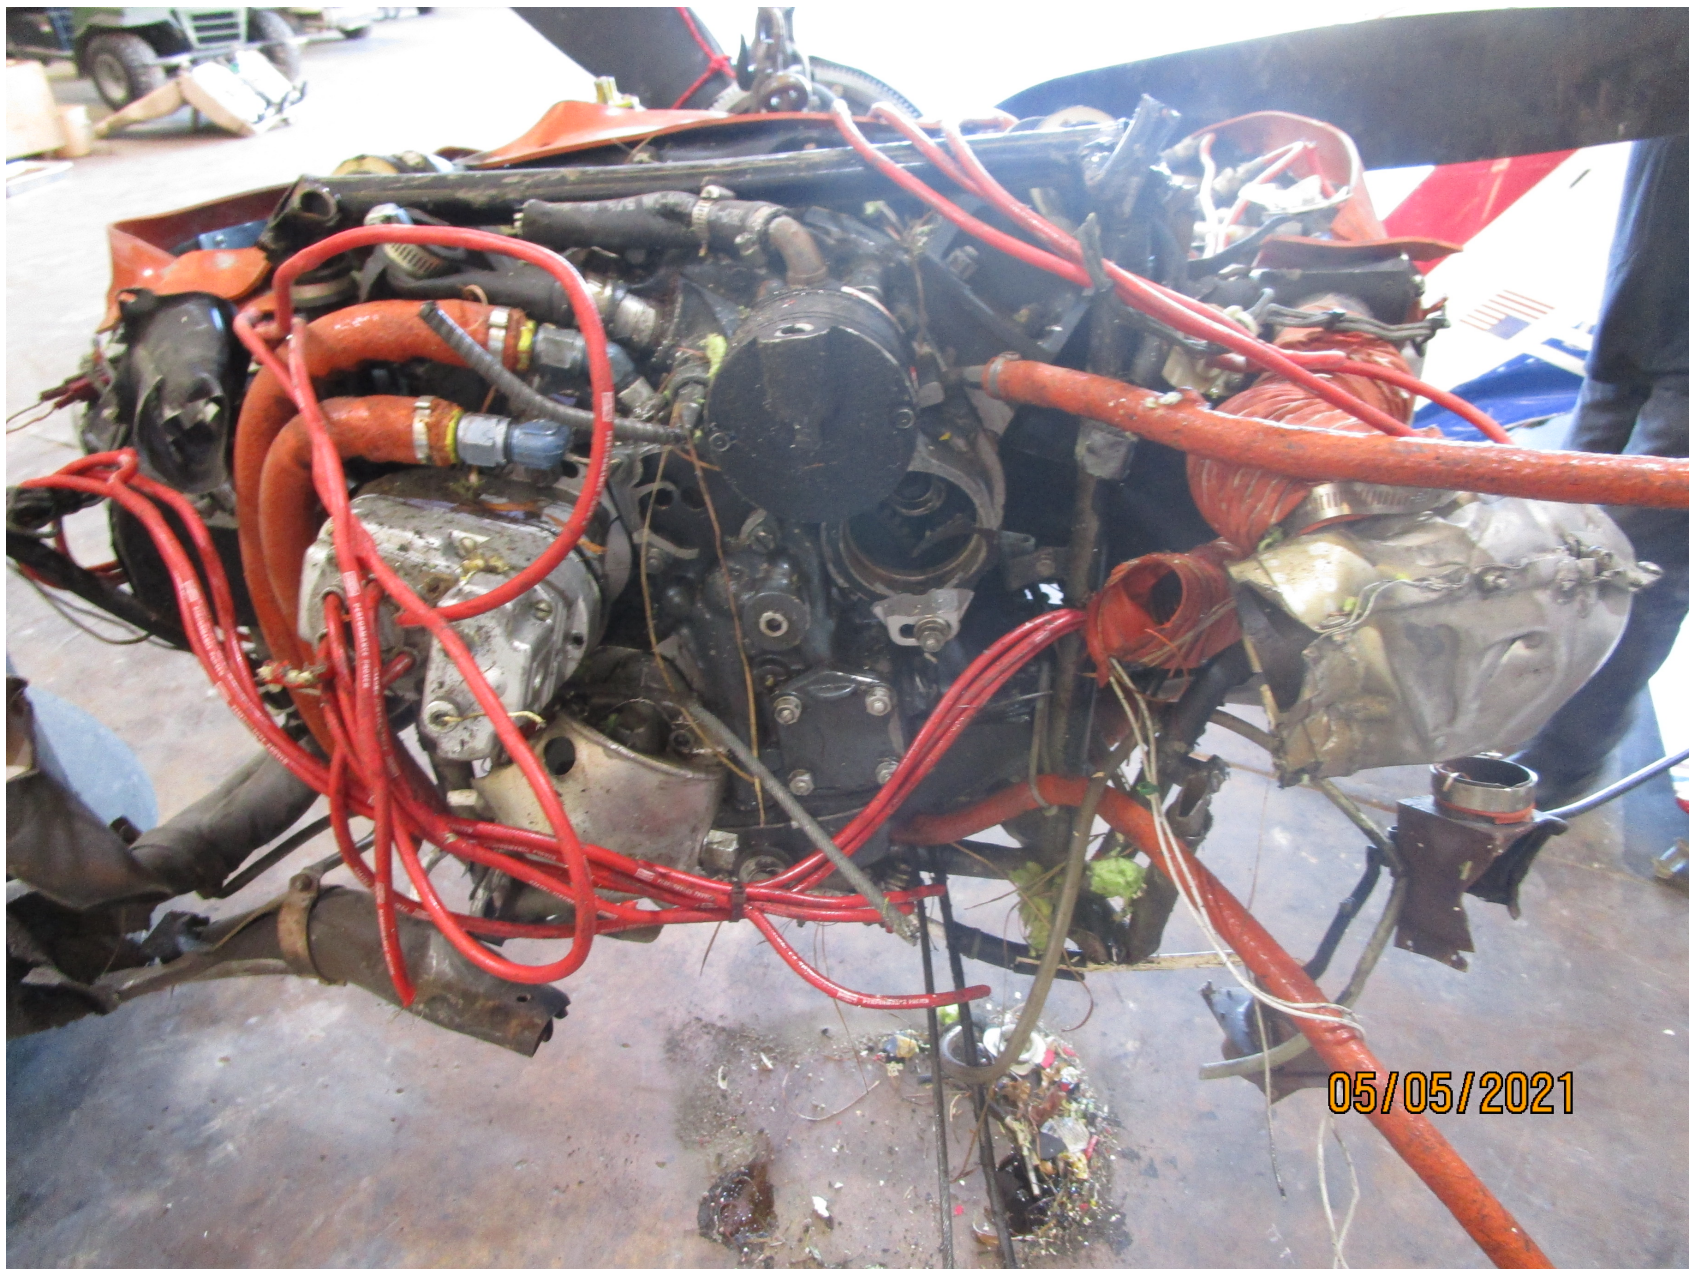
**Photo 8 – Rear view of the engine (courtesy of the National Transportation Safety Board).**

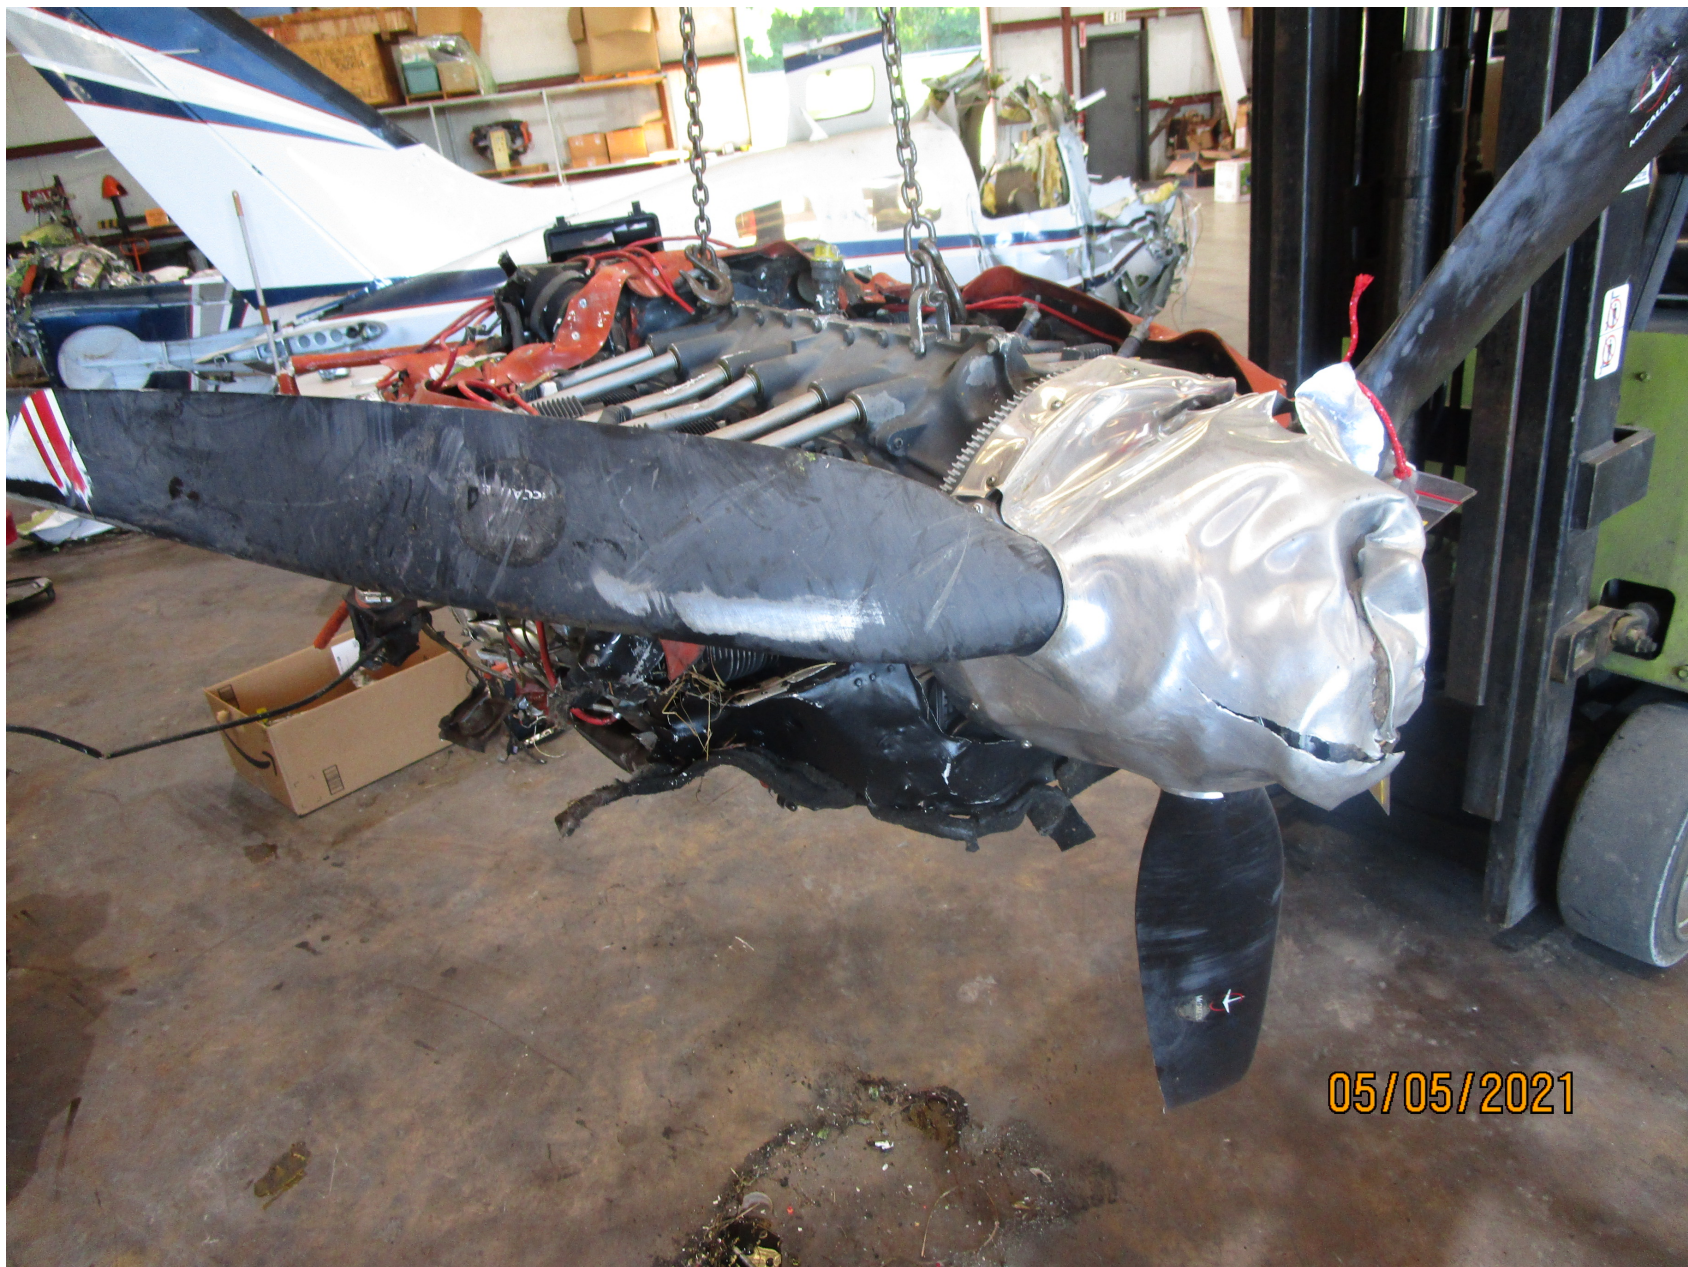
**Photo 9 – Front view of the engine (courtesy of the National Transportation Safety Board).**

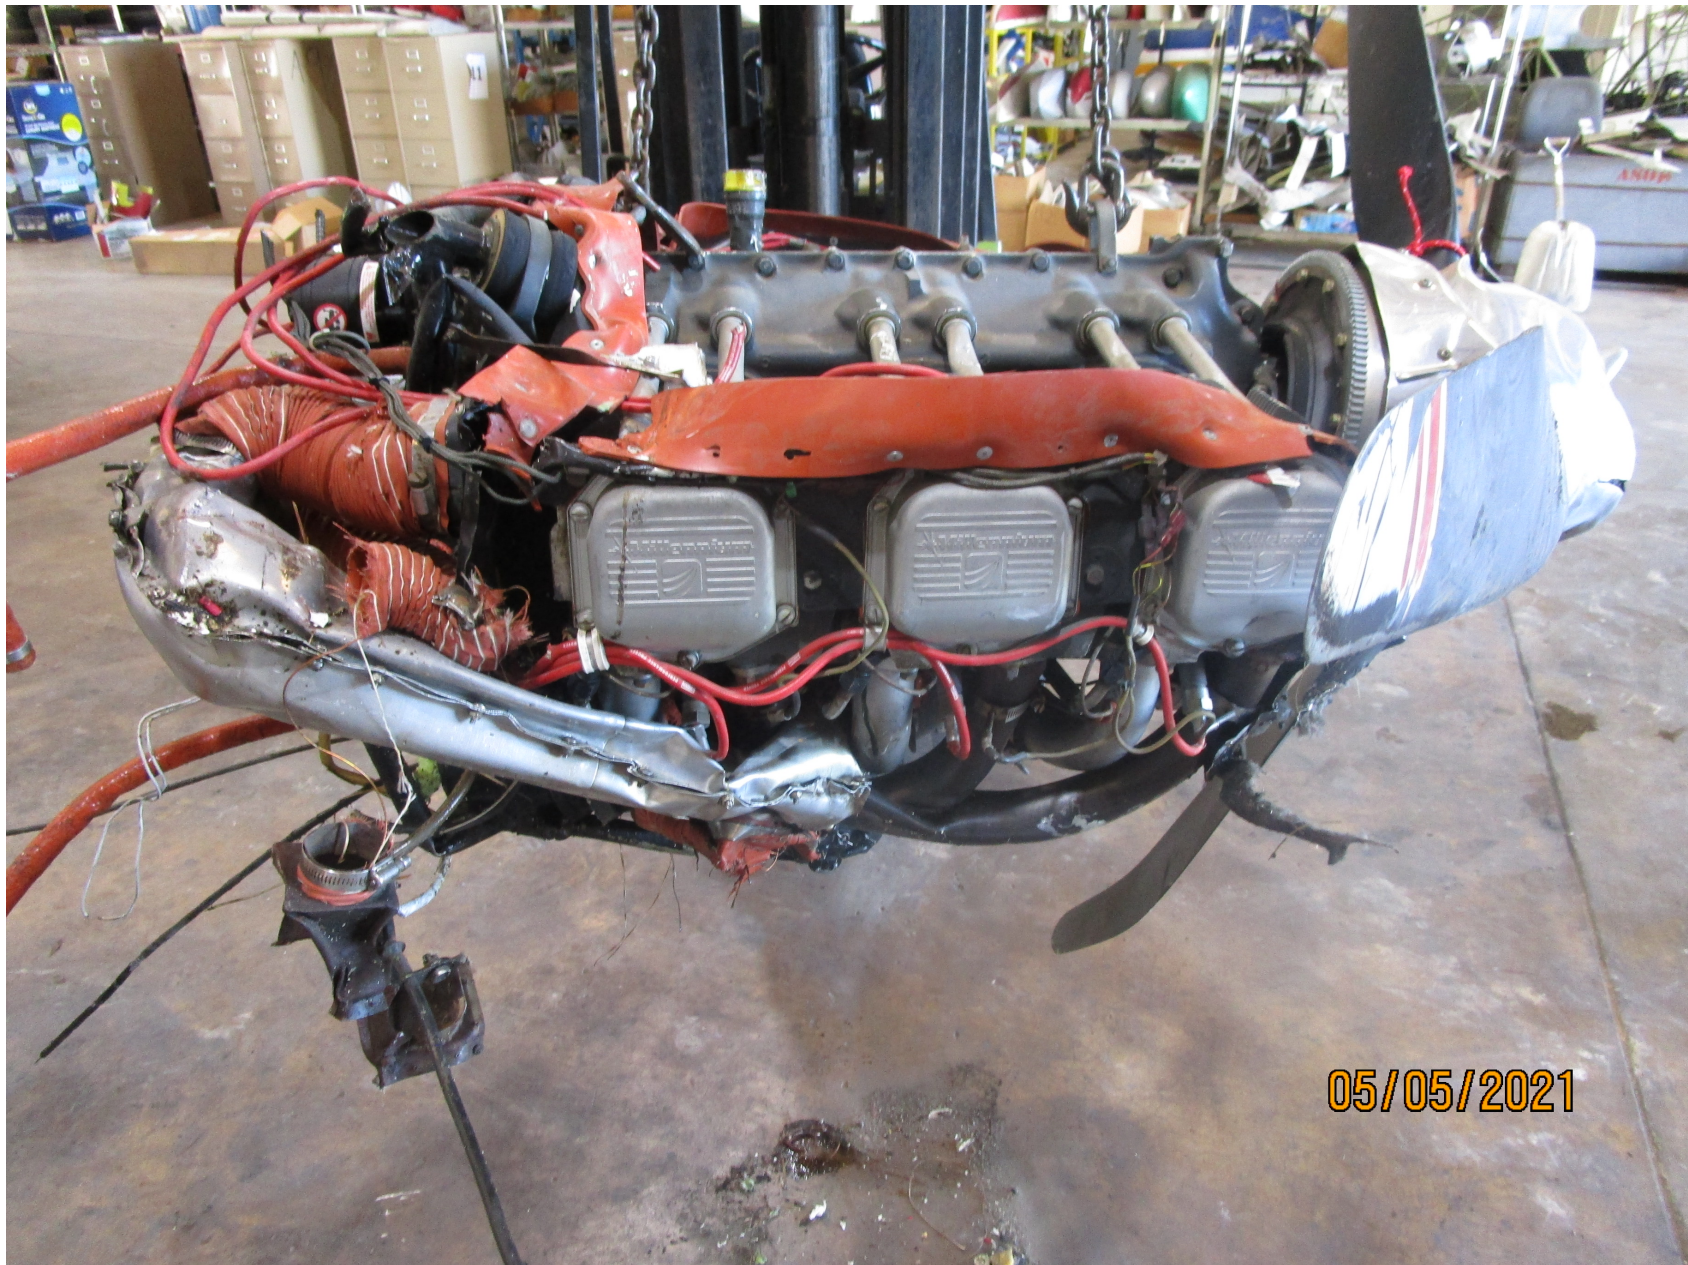
**Photo 10 – Right side view of the engine (courtesy of the National Transportation Safety Board).**
