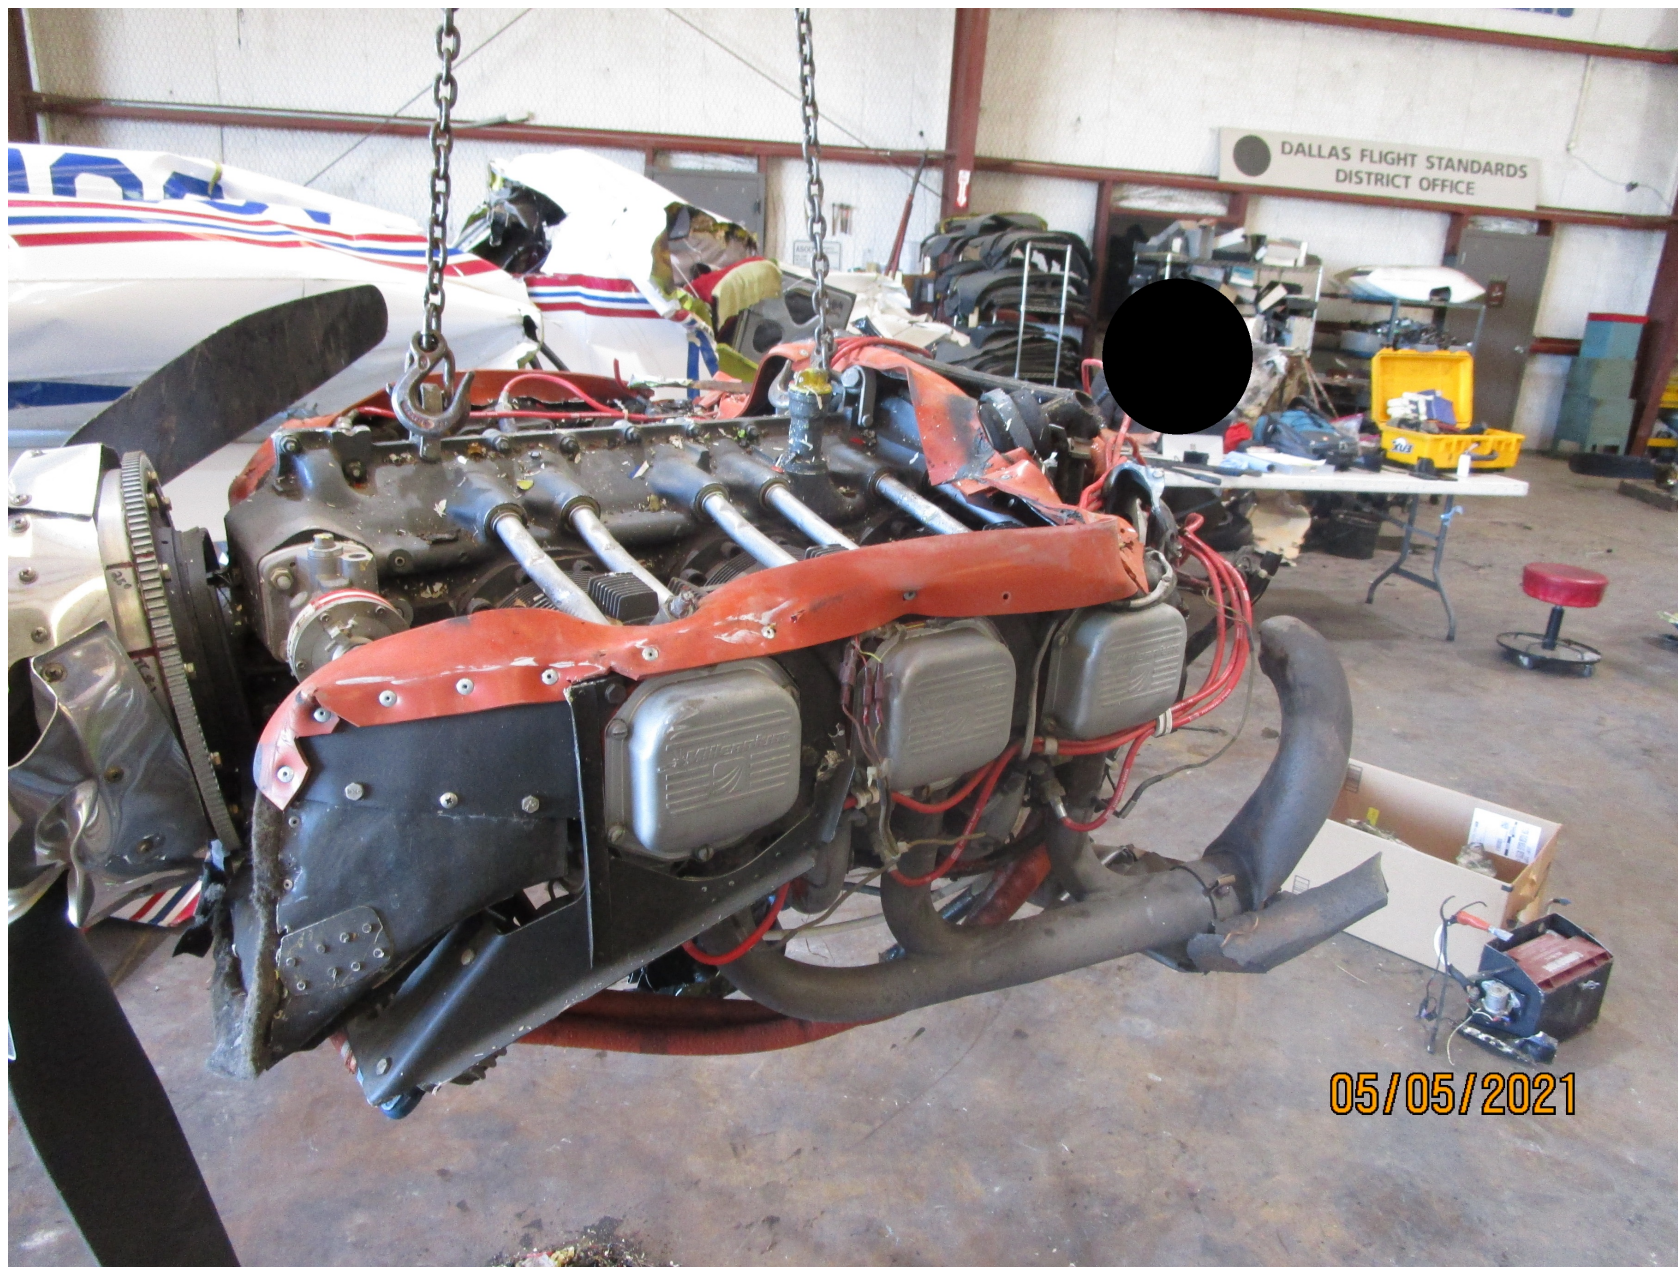
**Photo 11 – Left side view of the engine (courtesy of the National Transportation Safety Board).**

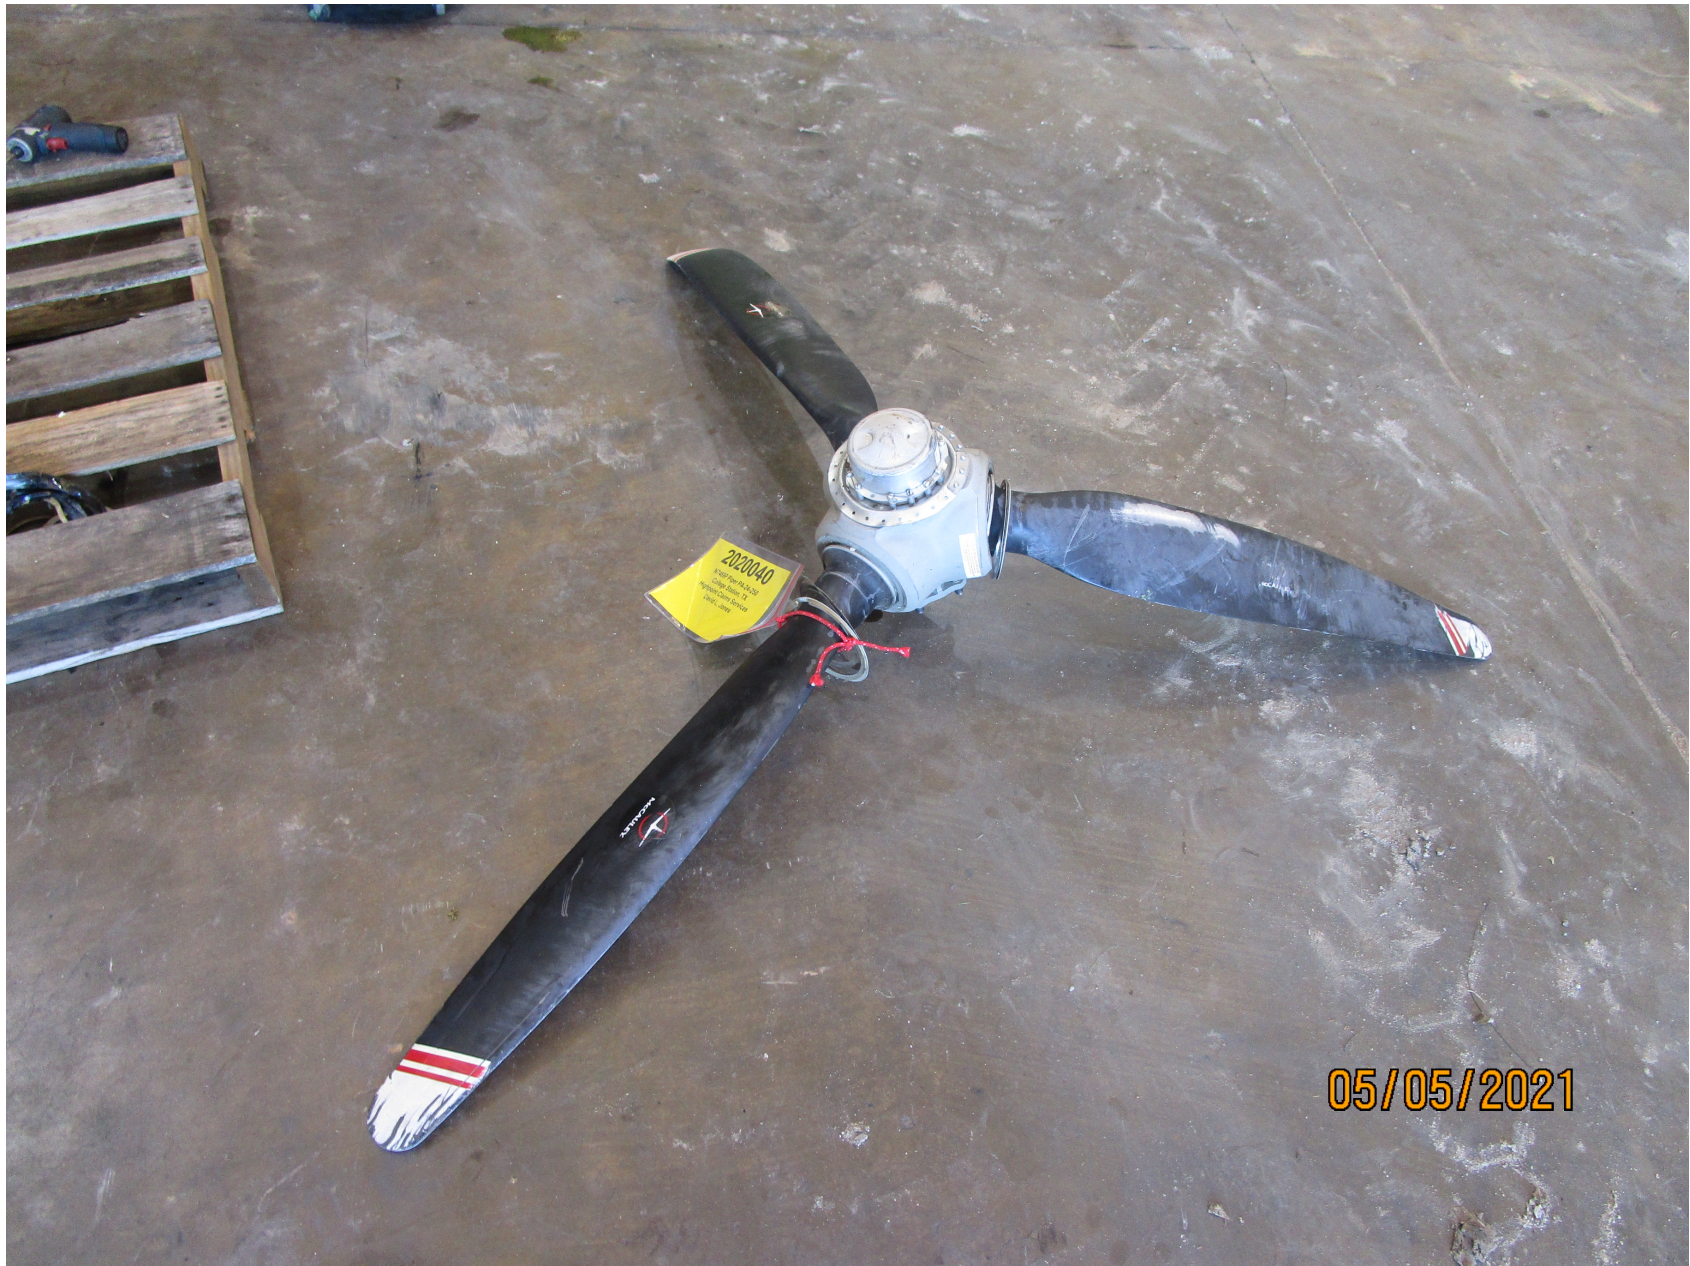
**Photo 12 – View of the propeller removed from the engine (courtesy of the National Transportation Safety Board).**

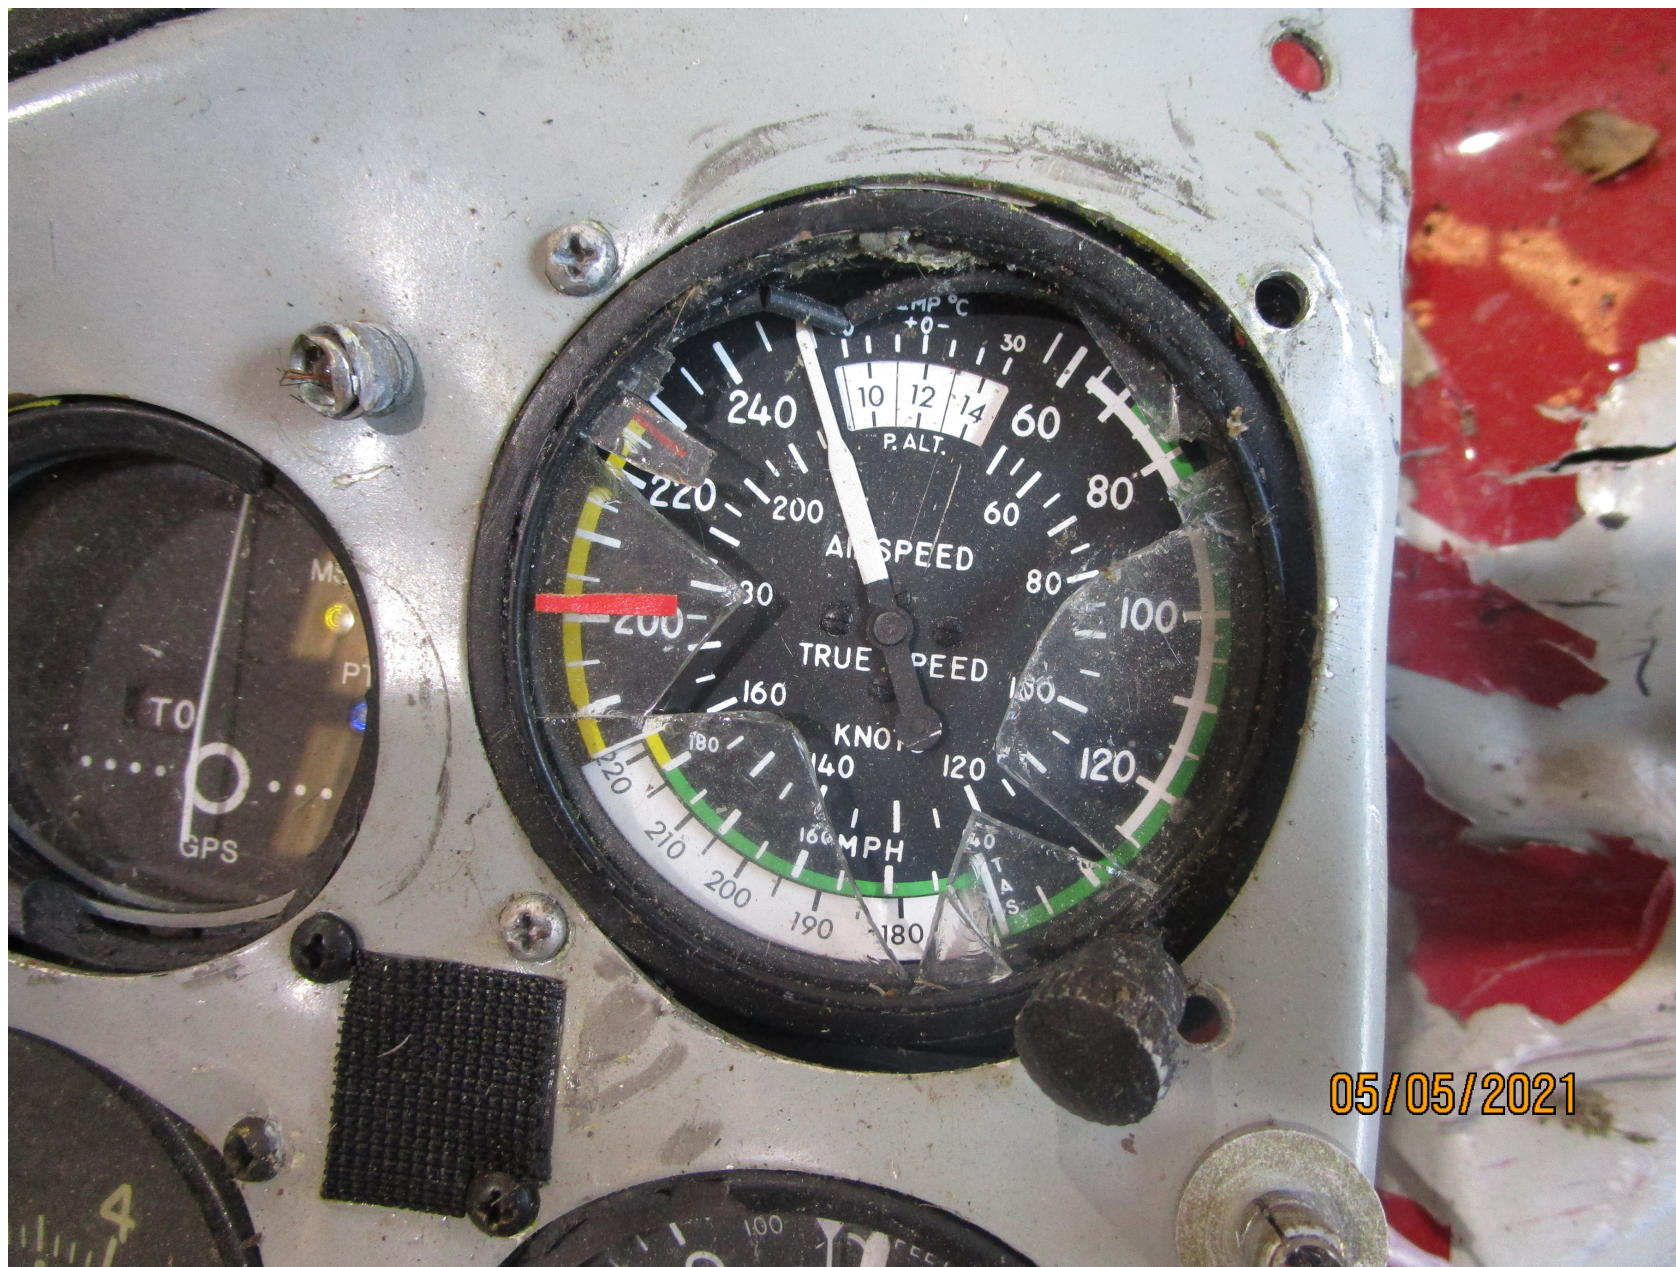
**Photo 16 – Image of the damaged airspeed indicator, showing a needle slap marking (courtesy of the National Transportation Safety Board).**
