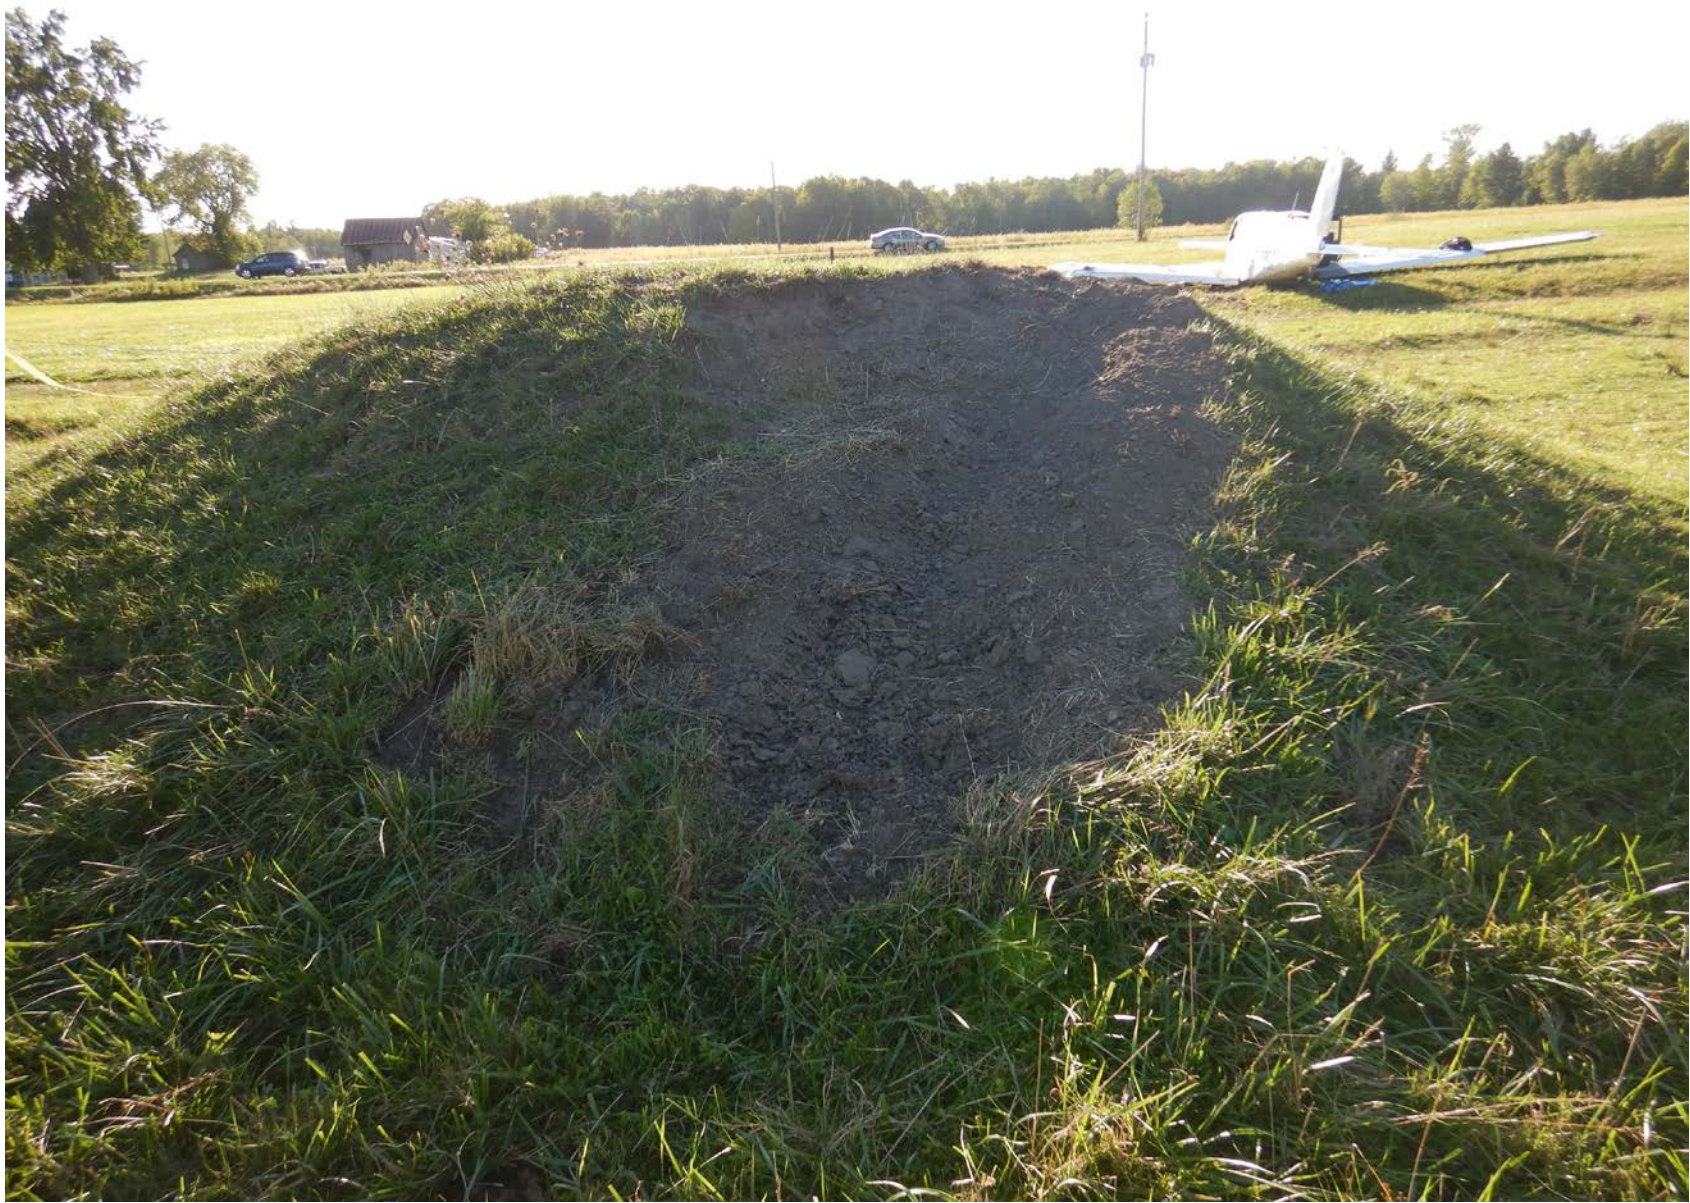
**Photo 1 – Dirt mound struck by N5939P during forced landing. Airplane is in background**

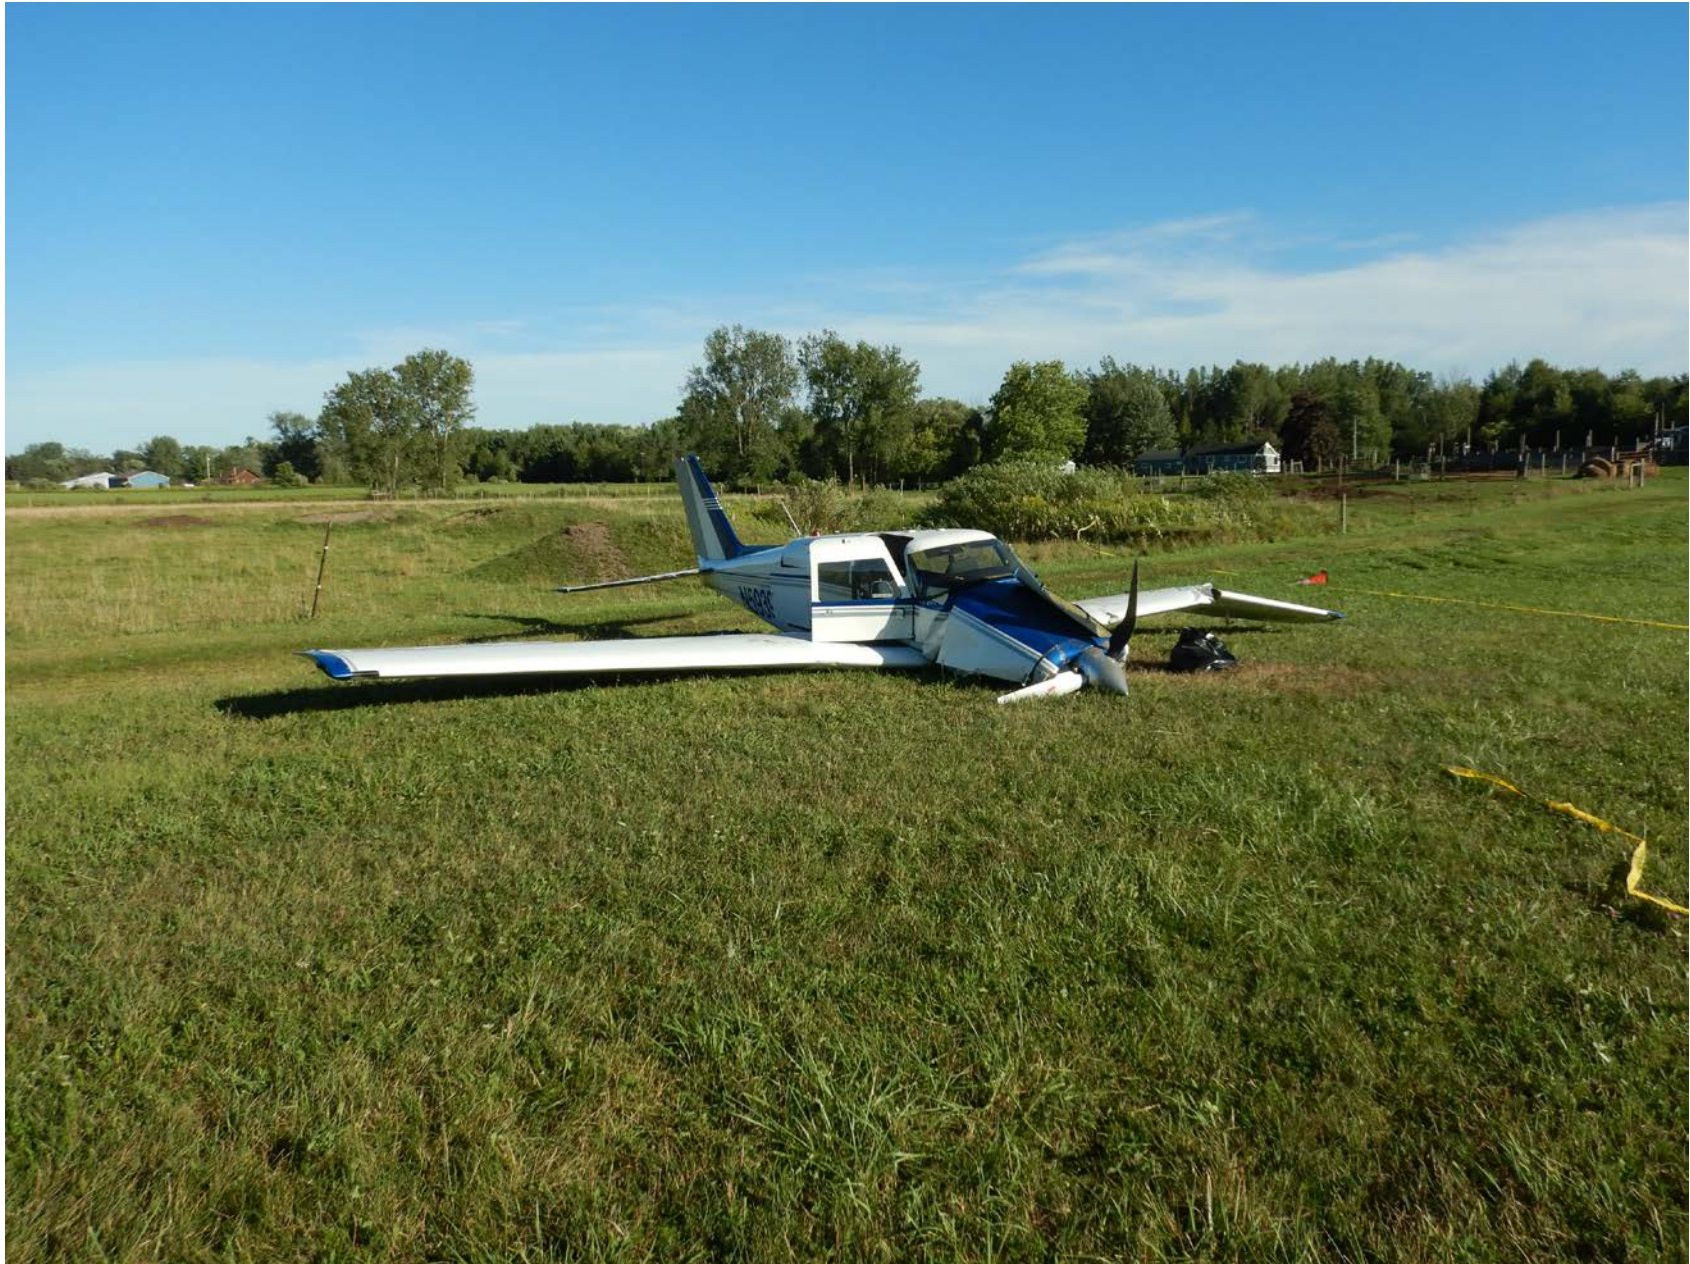
**Photo 2 - Right front of airplane with struck dirt mound in the background**

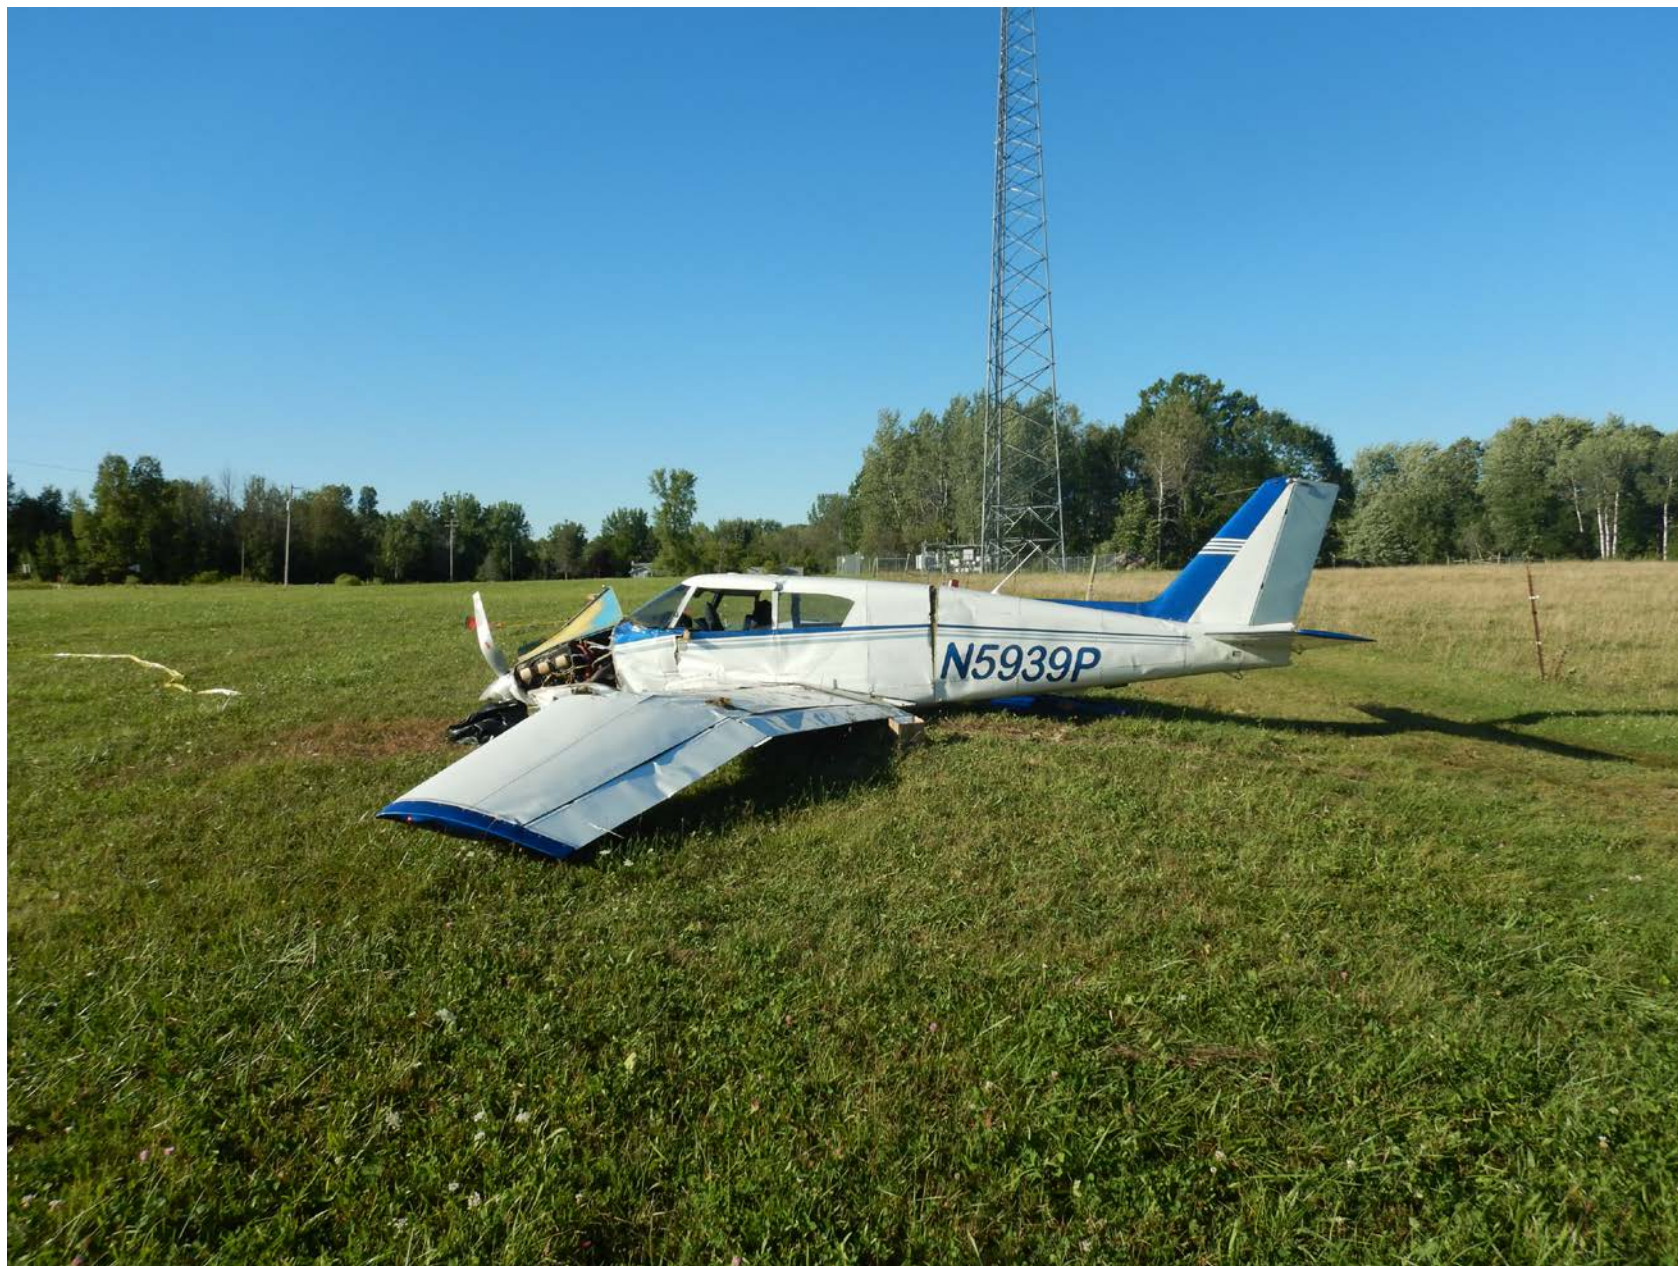
**Photo 3 - Left side of airplane with circumferential break in the fuselage and buckled left wing**

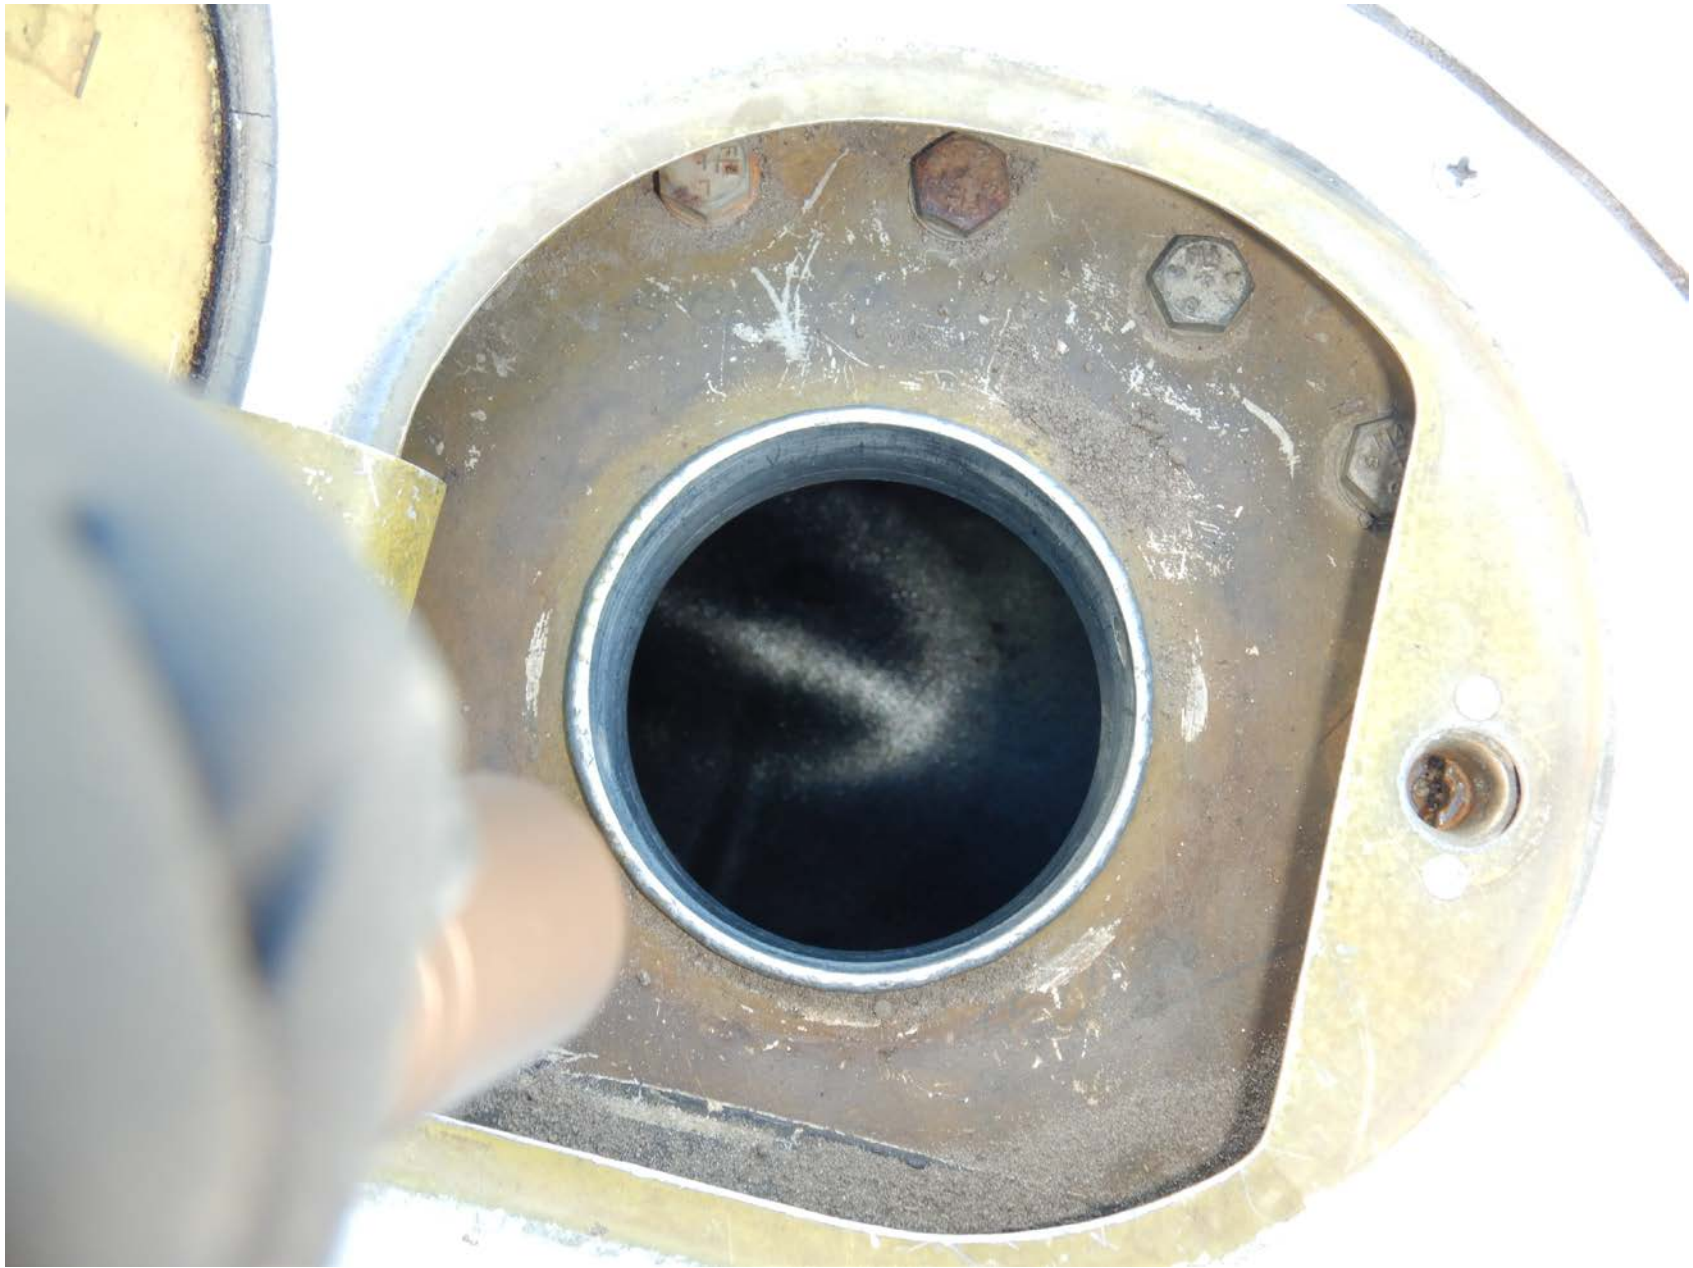
**Photo 4 - Inside the left fuel tank. Note the left fuel tank bladder was breached. During recovery of the aircraft, fuel was seen streaming from the left wing root, and there was a fuel blight underneath the left wing**

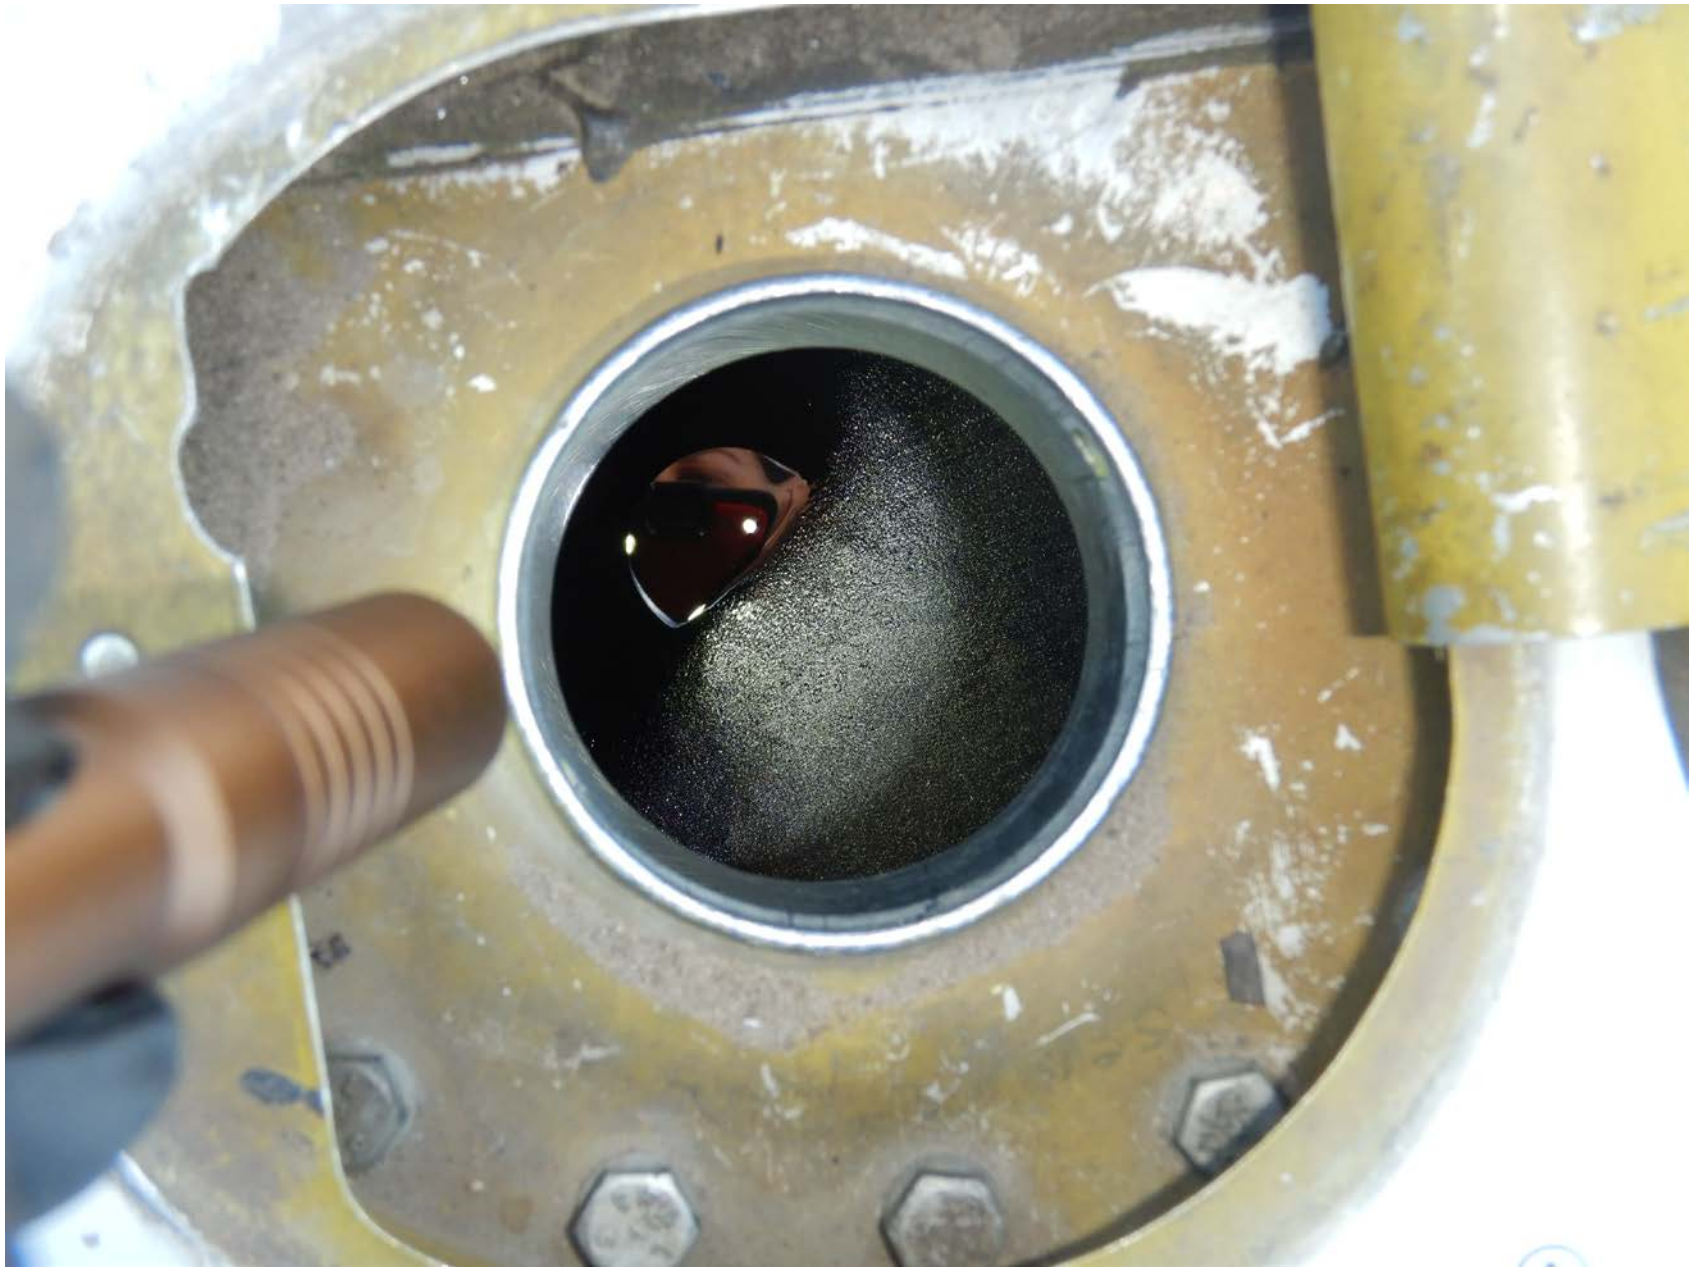
**Photo 5 - Inside the right fuel tank. Fuel tank bladder was not breached but contained no fuel**

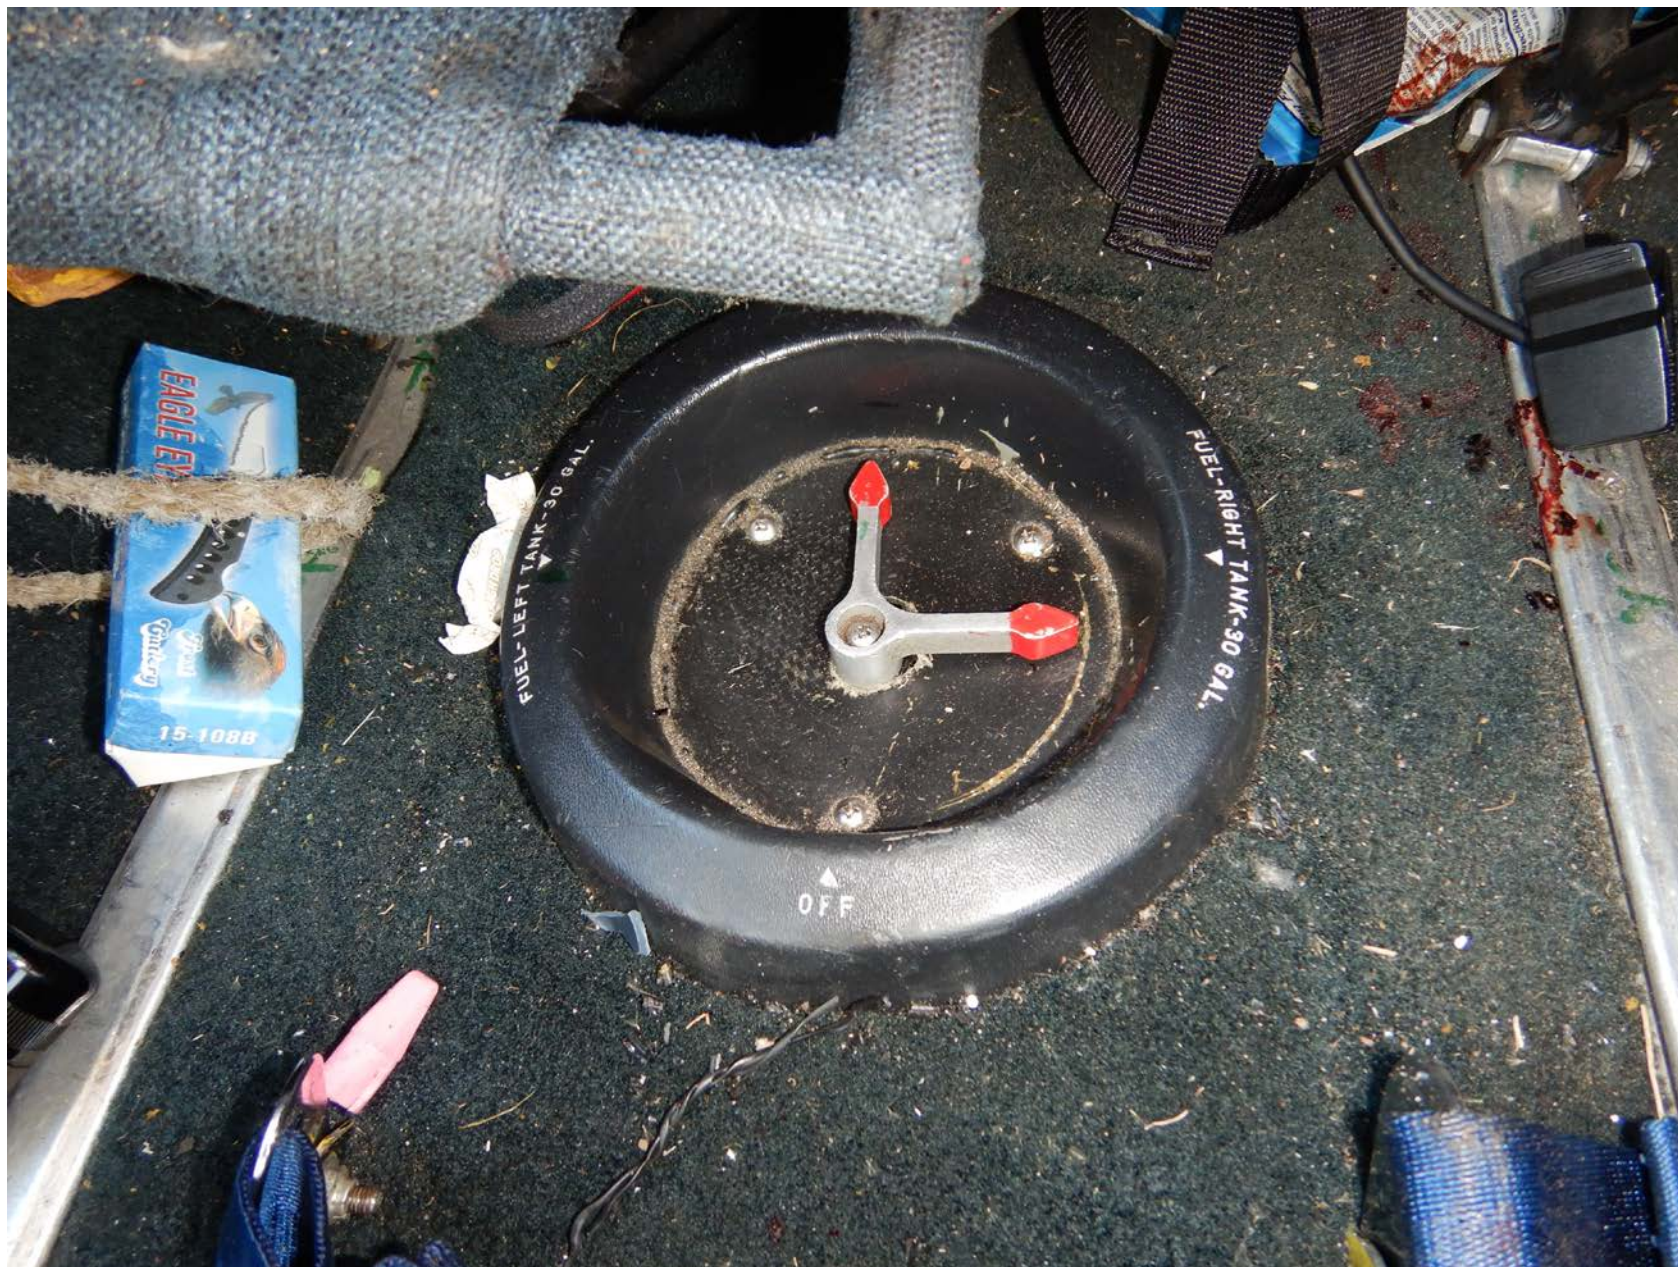
**Photo 6 - The fuel selector, positioned on the right fuel tank. During removal of the fuel selector for testing, fuel came from the left fuel line but not the right fuel line**

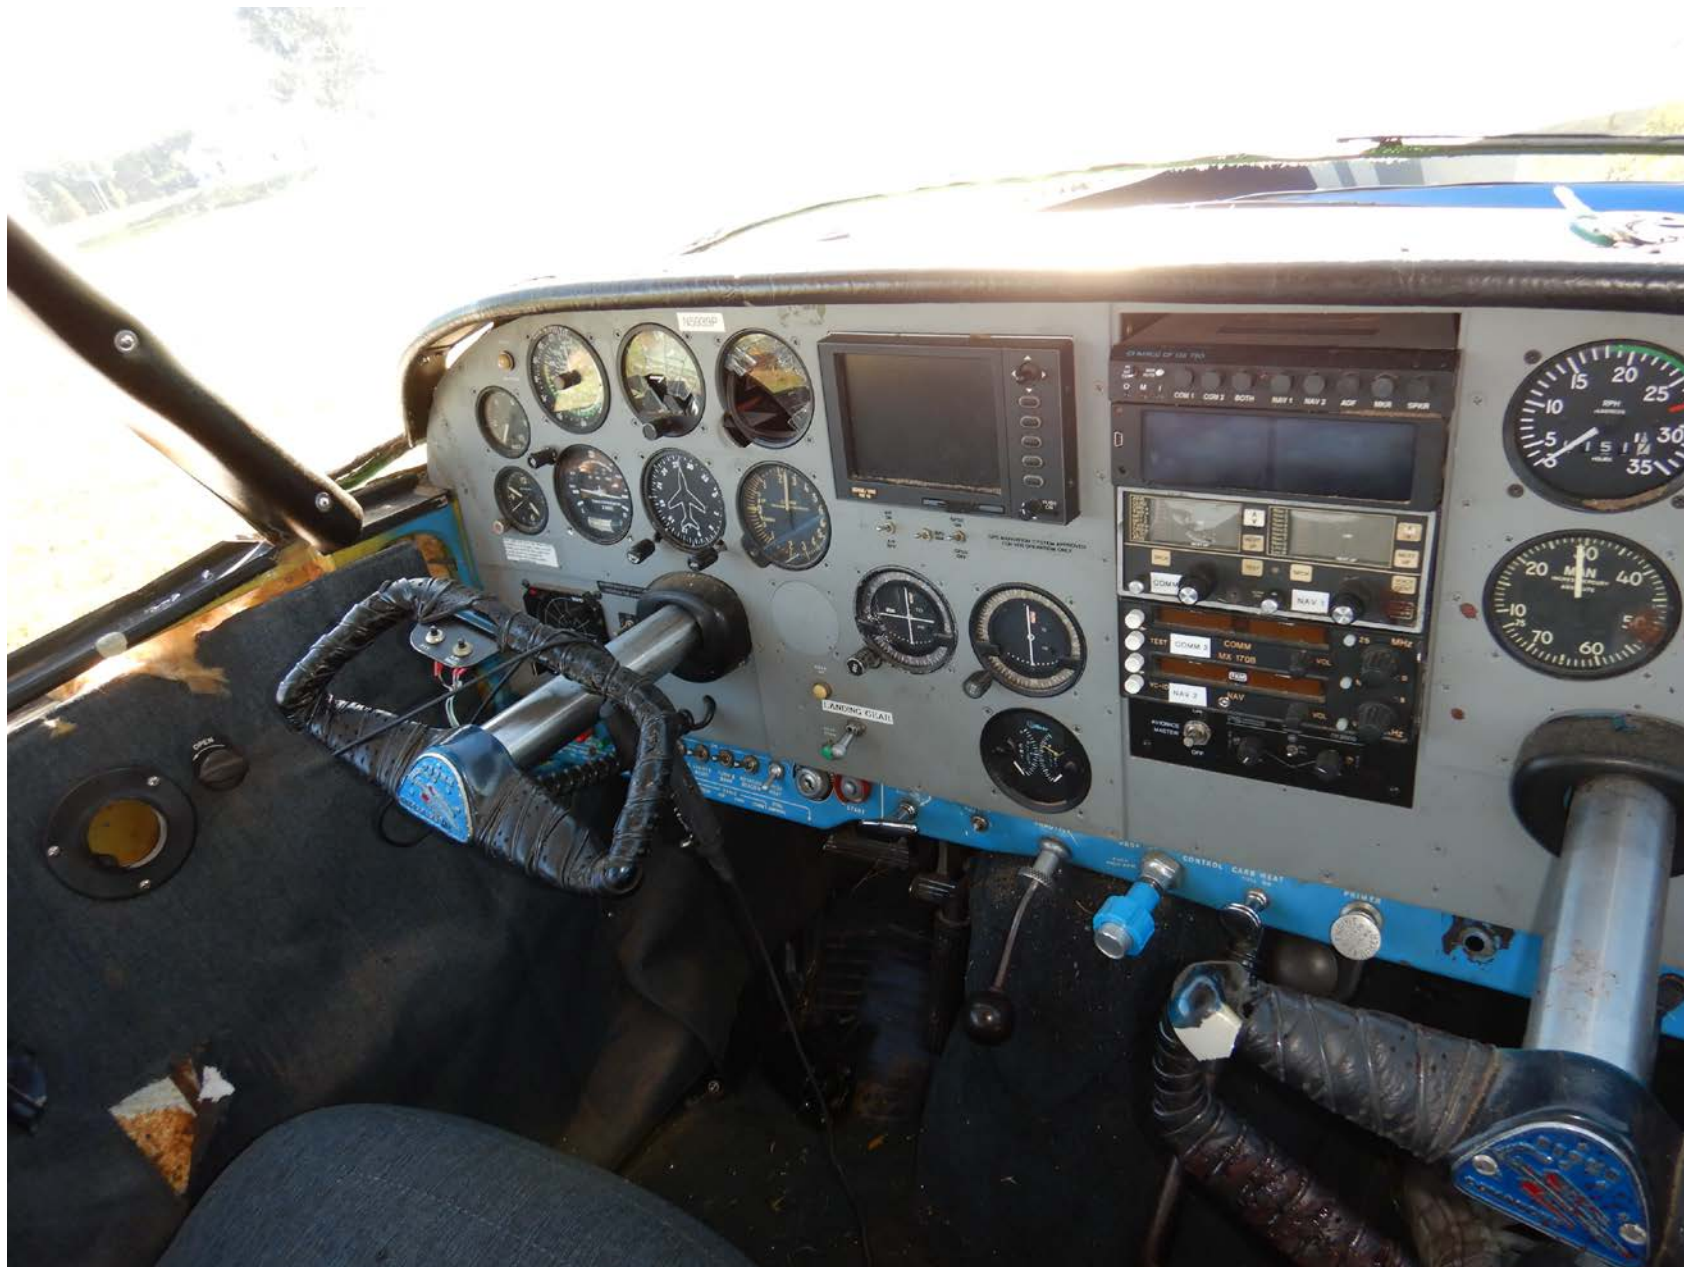
**Photo 7 - The instrument panel. Note propeller control is full forward, the throttle is aft and bent down, the carburetor heat is closed, the primer is in and locked, and the mixture control is broken off**

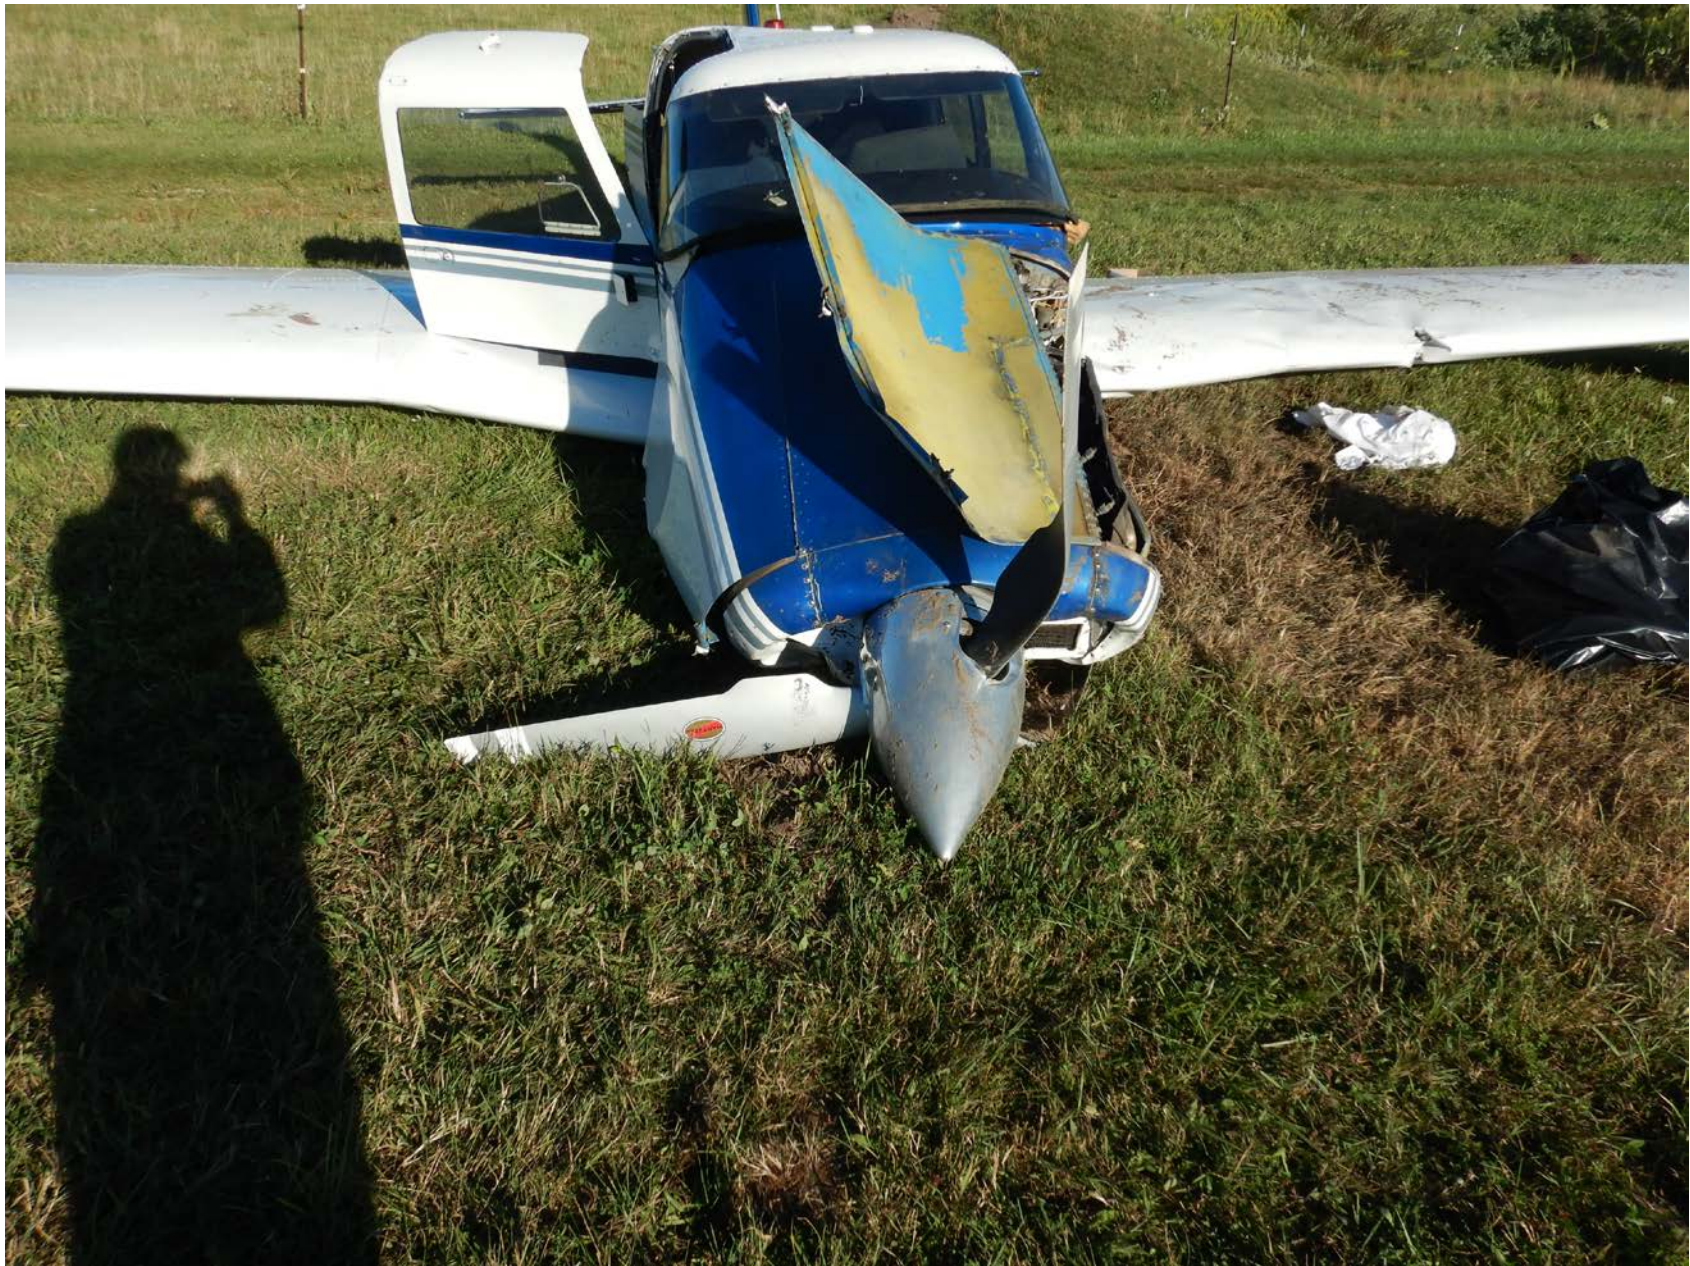
**Photo 10 - The propeller assembly. Looking aft, the 12 o'clock blade is twisted towards the feathered position, the 4 o'clock blade is bent aft underneath the cowling, and the 8 o'clock blade is relatively undamaged**
