# National Transportation Safety Board

## Performance Study

### Specialist Report

Location: Brighton, Colorado  
Date: September 2, 2020  
Time: 12:13 Mountain daylight time (MDT)  
Airplane: Titan Mustang T-51, N153JW  
NTSB Number: CEN20LA375

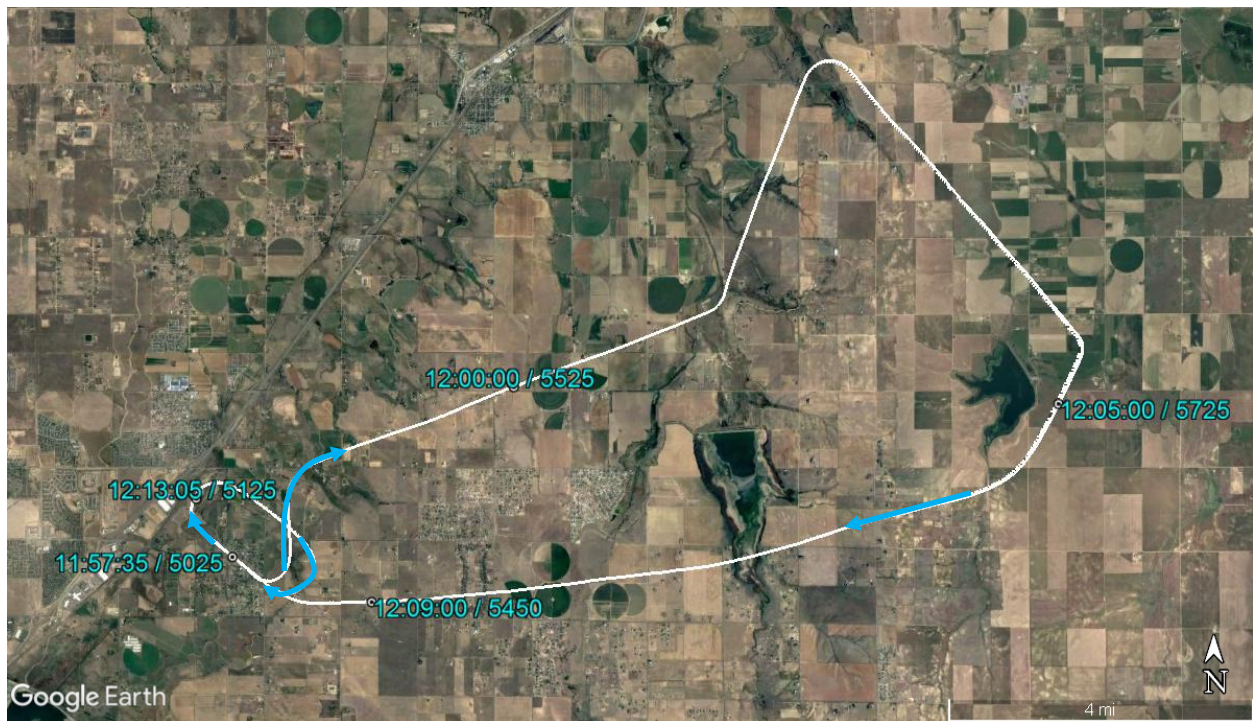
Airplane speeds were calculated using the ADS-B position data and weather data. The airplane was flying in the vicinity of Van-Aire Skyport (CO12). It took off about 11:57 from runway 12 (Figure 1 and Figure 2) and circled the area. Just before 12:10 it descended and flew the length of runway 30. It then circled and repeated the maneuver about 12:12. The airplane crashed just after 12:13:05.

**Figure 1.** Accident flight with select times and altitudes above mean sea level (msl) annotated in blue.

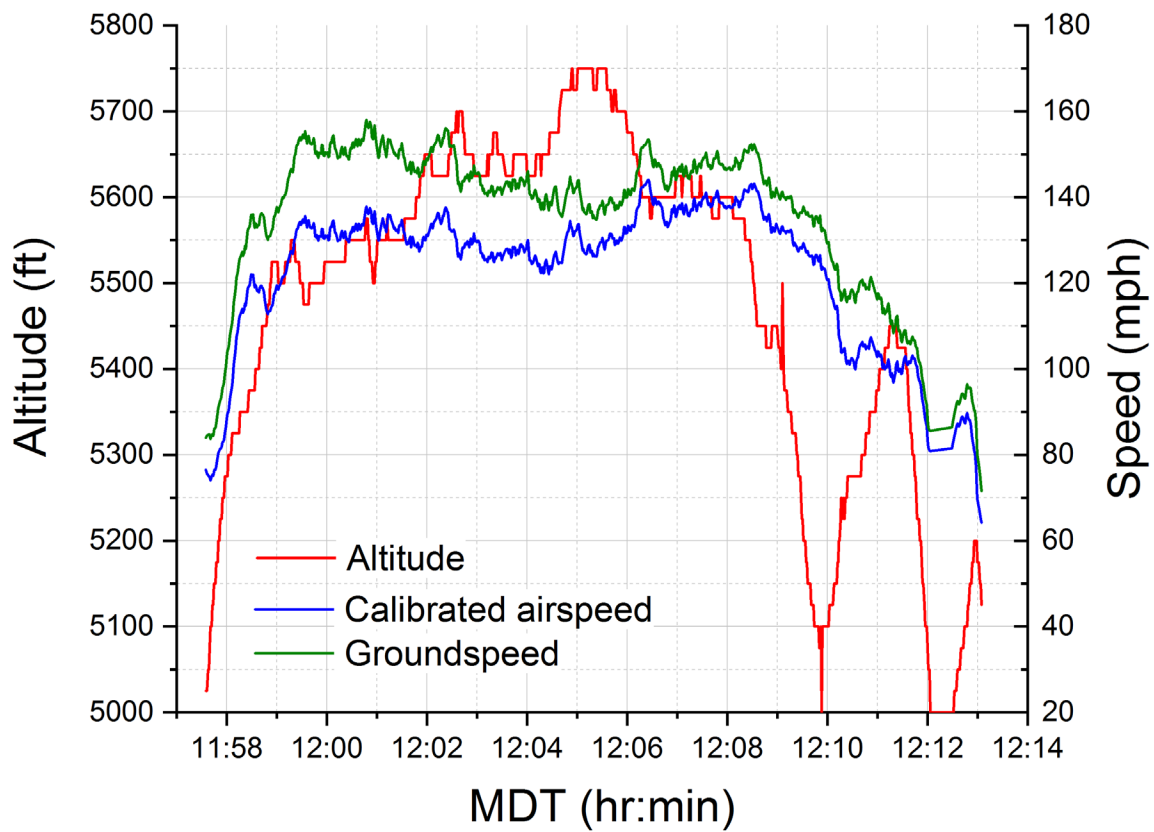
**Figure 2.** Altitude (msl) and calculated groundspeed and calibrated airspeed.

The airplane's airspeed was between 120 and 140 mph (104 and 121 kts) during the first 12 minutes of flight. The airplane then descended and slowed to about 100 mph (87 kts) as it overflew runway 30. It maintained 100 mph as it climbed again and circled. During the second overflight of runway 30 the airplane again descended, and its speed slowed further to about 80 mph (69 kts). During the second overflight there was a 26 second break in data while over runway 30. In Figure 2 this is marked by a flat speed calculation of about 80 mph in airspeed from 12:12:04 to 12:12:30. Details such as altitude of the over-runway portion of flight were not recorded in the ADS-B data.

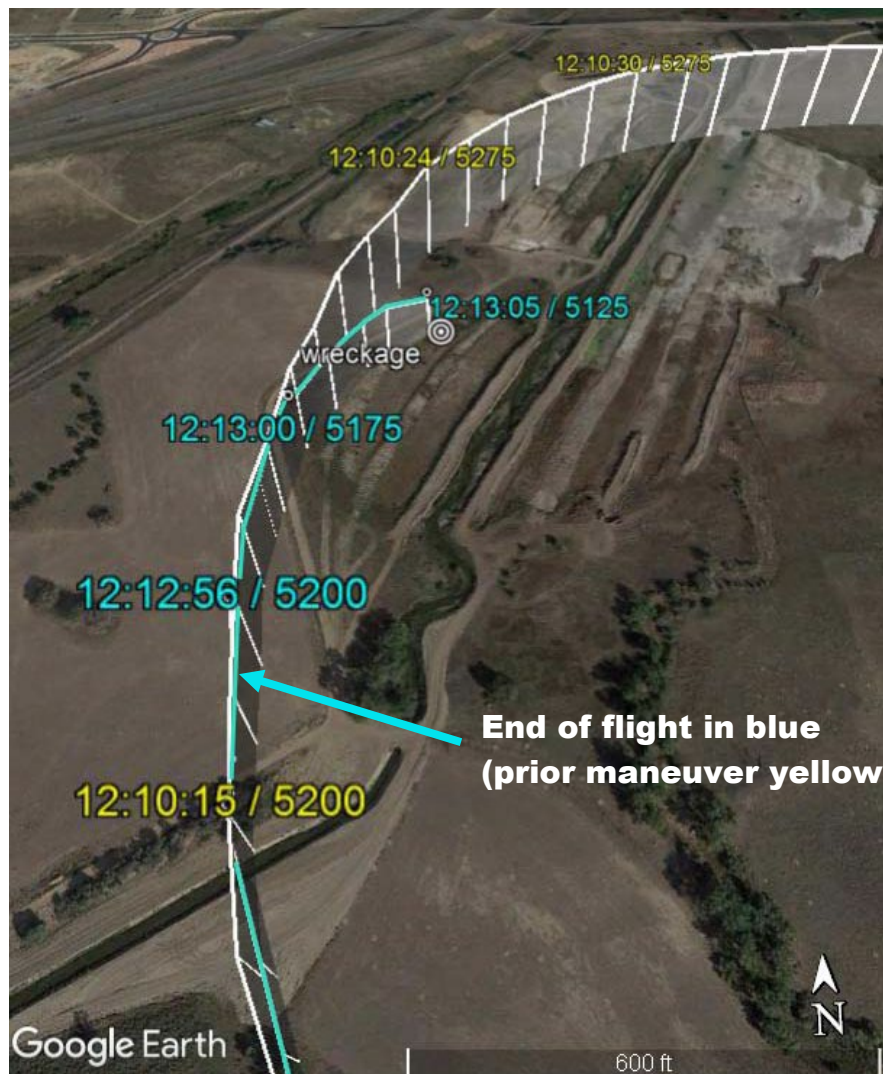
As the airplane climbed the last time, airspeed increased to about 90 mph (78 kts) at 12:12:47. The airplane then began to slow as it continued climbing. At 12:12:56 the airplane reached 5,200 ft msl (about 175 ft above ground level) (Figure 3) and maintained that altitude for four seconds while the airplane slowed below 70 mph. At 12:13 the airplane descended and slowed while turning in towards the right and deviating from the earlier path. Data ended at 12:13:05 and the wreckage was located just beyond the last data point.

**Figure 3.** End of flight path labeled in blue. Earlier maneuver labeled in yellow.

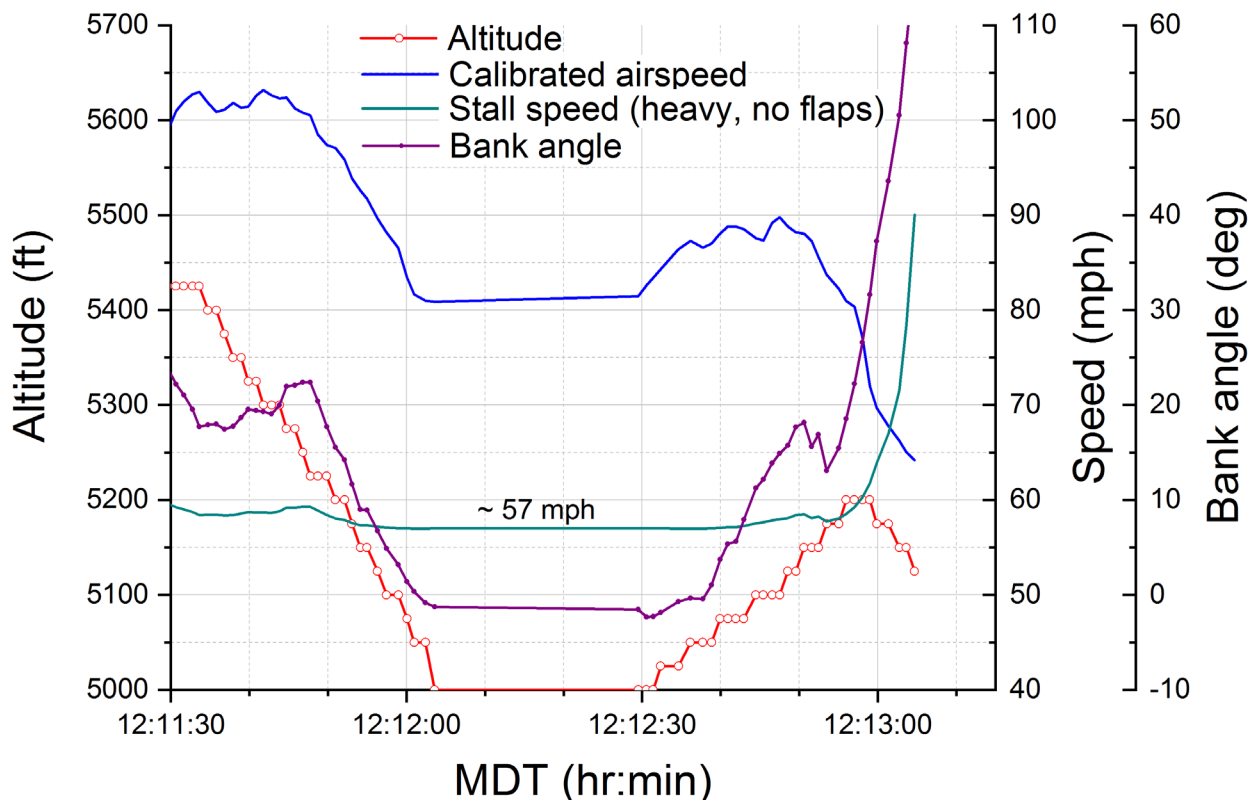
Titan Aircraft provided lift data as a function of airplane weight for no flaps and full flaps settings. A worst-case power-off stall scenario was calculated for a heavy weight of 1,900 lbs and no flaps which resulted in a wings-level stall speed of 57 mph. Airplane bank angle was calculated using the flight path and a simple aerodynamic model. Figure 4 shows the heavy, no flaps stall speed as a function of bank angle. As the airplane goes from wings-level over the runway into the right turn, the stall speed rises. However, the airplane's speed was more than 10 mph higher than the stall speed when the airplane stopped climbing. Not until the stall speed increased with the tightening of the right turn and increasing bank angle did the airplane's speed drop below stall. This indicates that aerodynamic stall did not cause the loss of altitude and change in flight path.

**Figure 4.** Altitude, calculated airspeed, and bank angle from the end of flight.

The airplane slowed during the initial overflight of runway 30 to an airspeed of about 100 mph and then slowed again to 80 mph during the second and final overflight of the runway. It cannot be determined from the data available why the airspeed for the second overflight was lower than the first or why it continued to lose speed during the final climb. The airplane began to descend and deviate from the earlier flight path at a speed greater than the reported stall speed (accounting for bank angle), indicating that aerodynamic stall did not cause the loss of altitude and change in flight path.
