## Memorandum of Record

**Date:** 3/16/2021  
**Subject:** CEN20LA378, N5178, Cessna C340A Windshield Examination

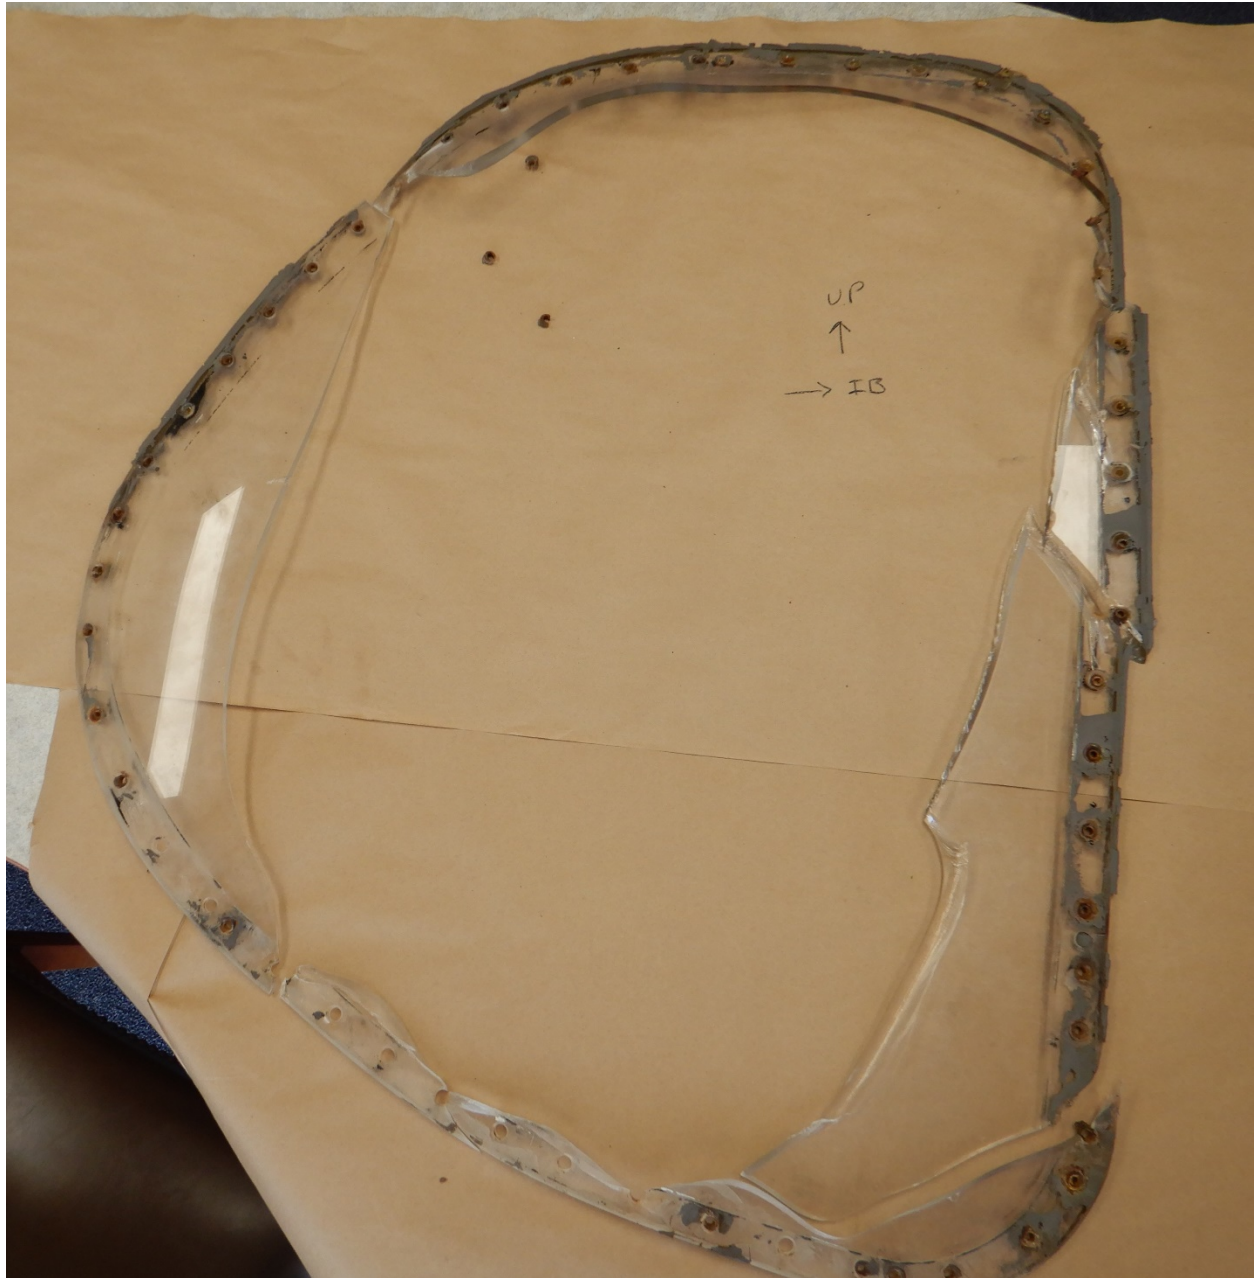
Figure 1

The remnants of damaged windshield were sent to the NTSB IIC for examination. The remnants consisted of six pieces of the acrylic windshield that comprised the complete outer circumference of the windshield. The windshield remnants measured approximately 35 inches tall by 31 inches wide when laid out on a flat surface as oriented when installed. About 21 inches by 31 inches of windshield material within the recovered remnants was not accounted for (see figure 1).

The remnants showed no significant signs of aging and no signs of crazing were visible. Examined fracture surfaces were consistent with overstress separation. The origination point of the failure could not be identified on the available remnants.
