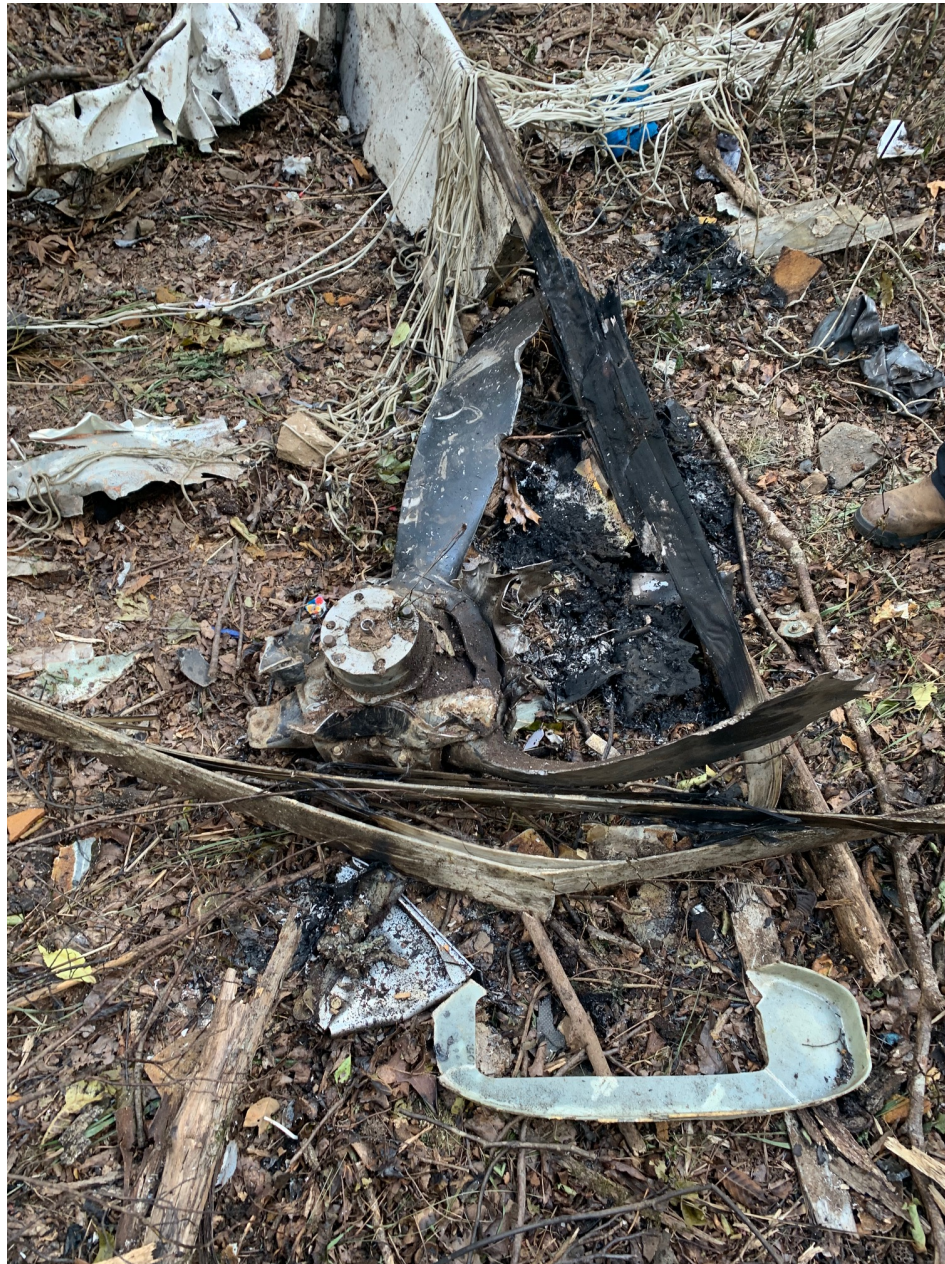
**Photo 1 – Supplied view of the propeller in the debris field.**

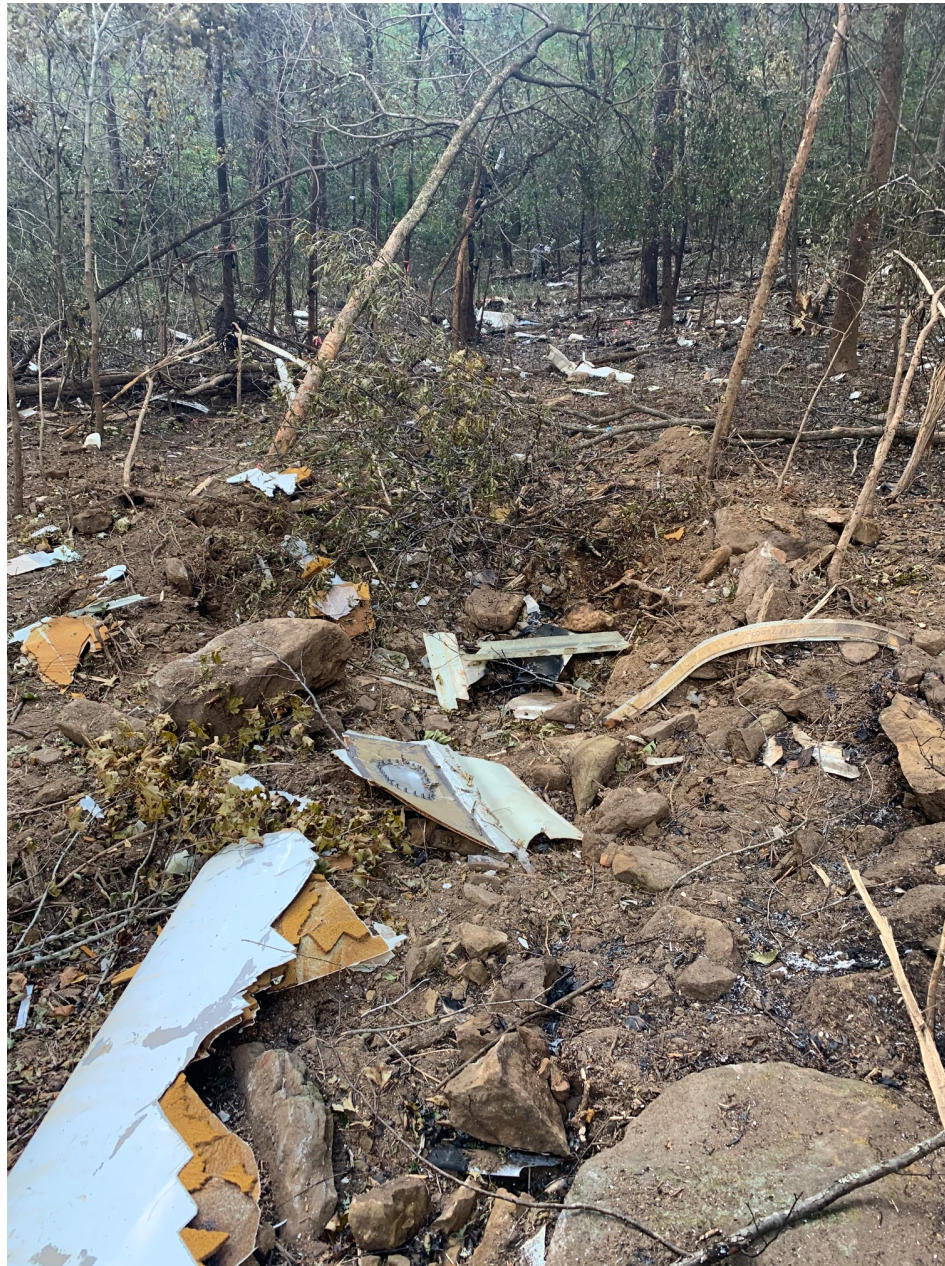
**Photo 2 - Supplied view of the debris path through the woods.**

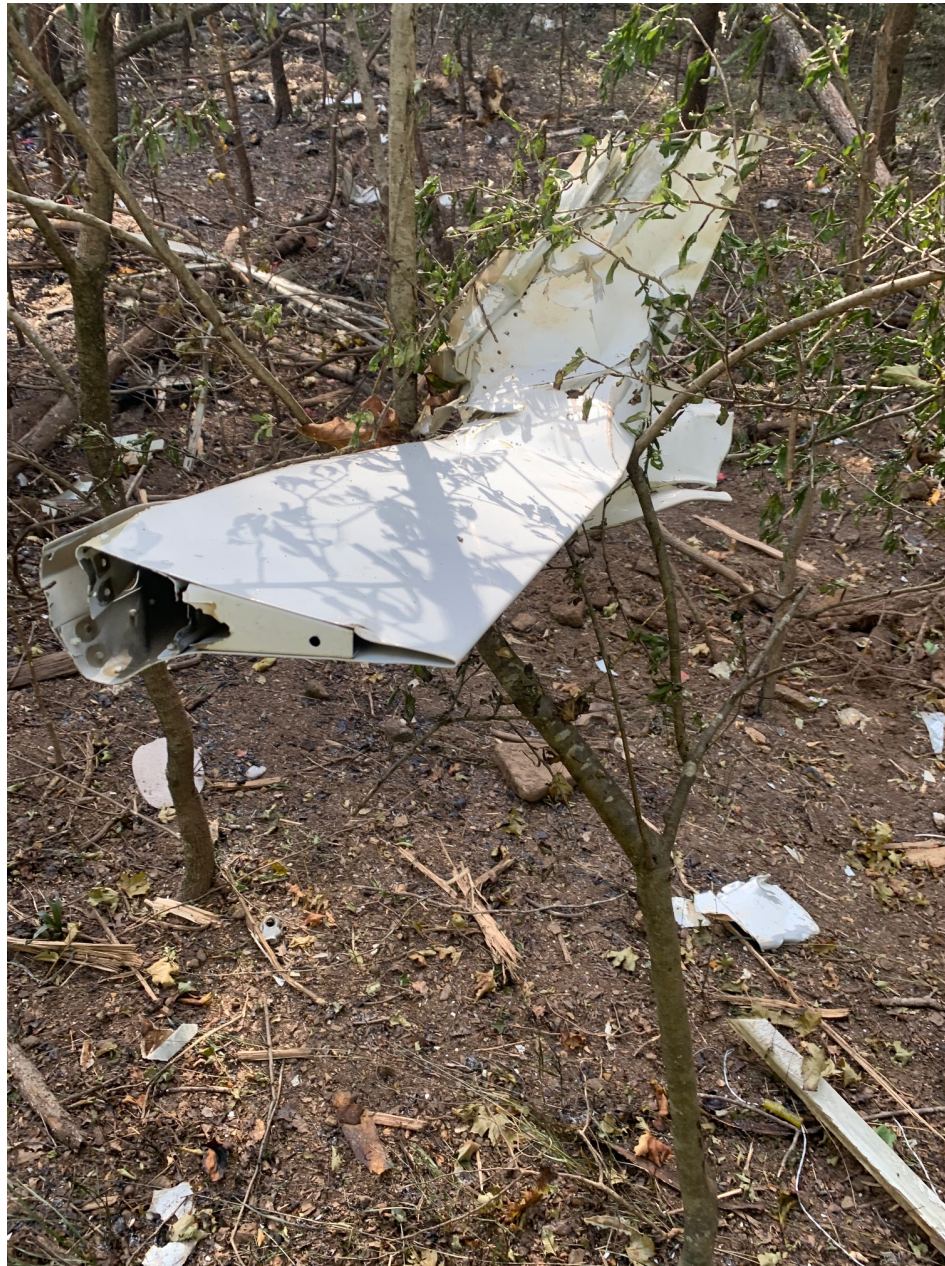
**Photo 3 - Supplied view of a separated control surface in the debris path.**

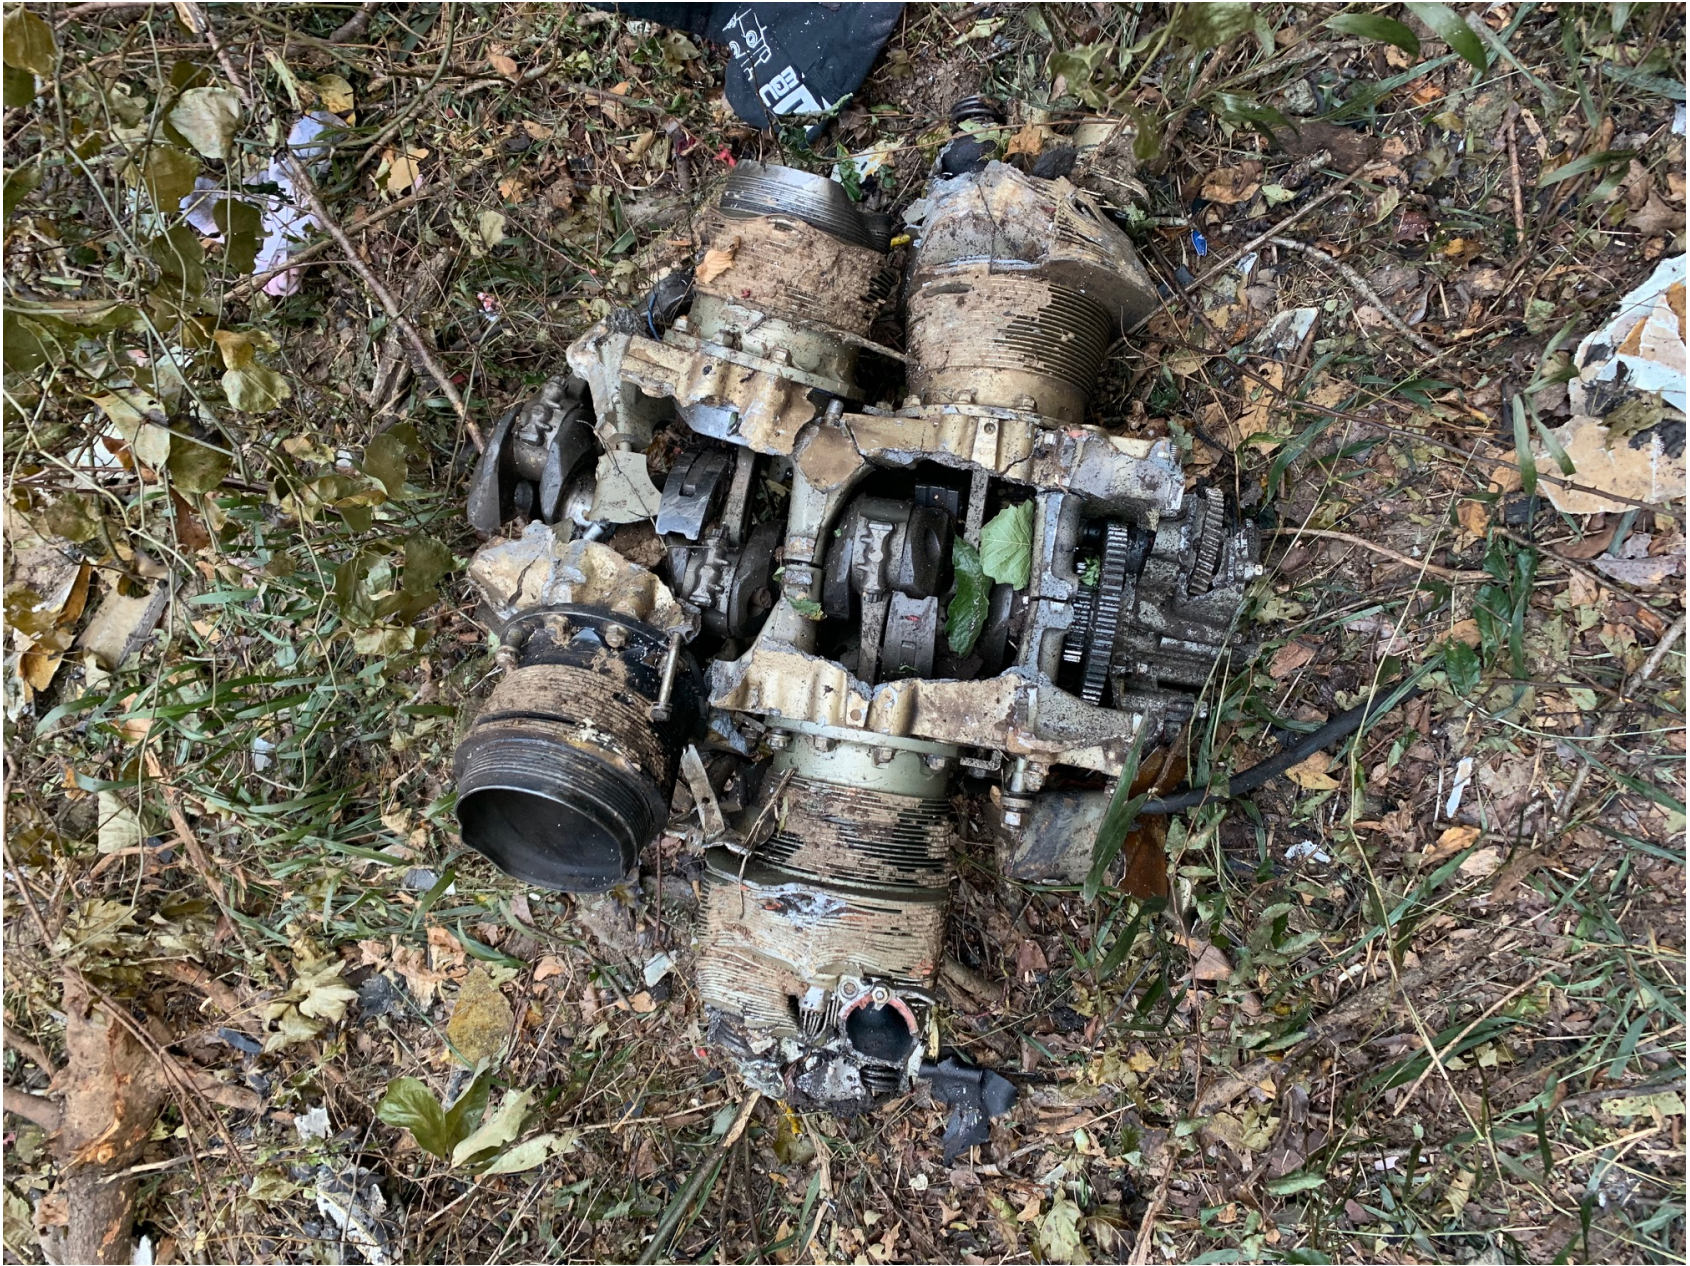
**Photo 4 - Supplied view of the engine at the accident site.**

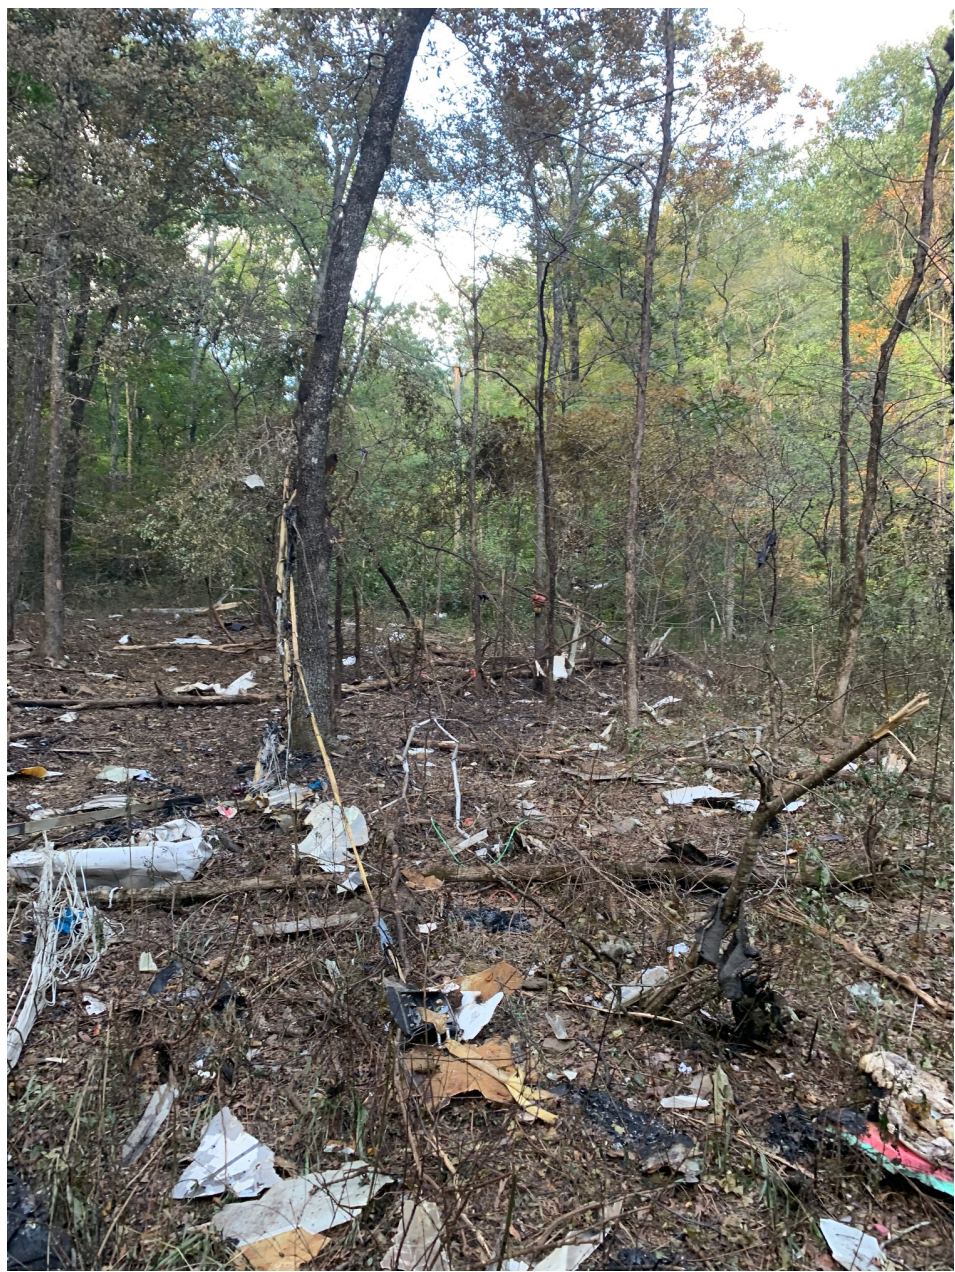
**Photo 5 - Supplied view of the debris path through the woods.**

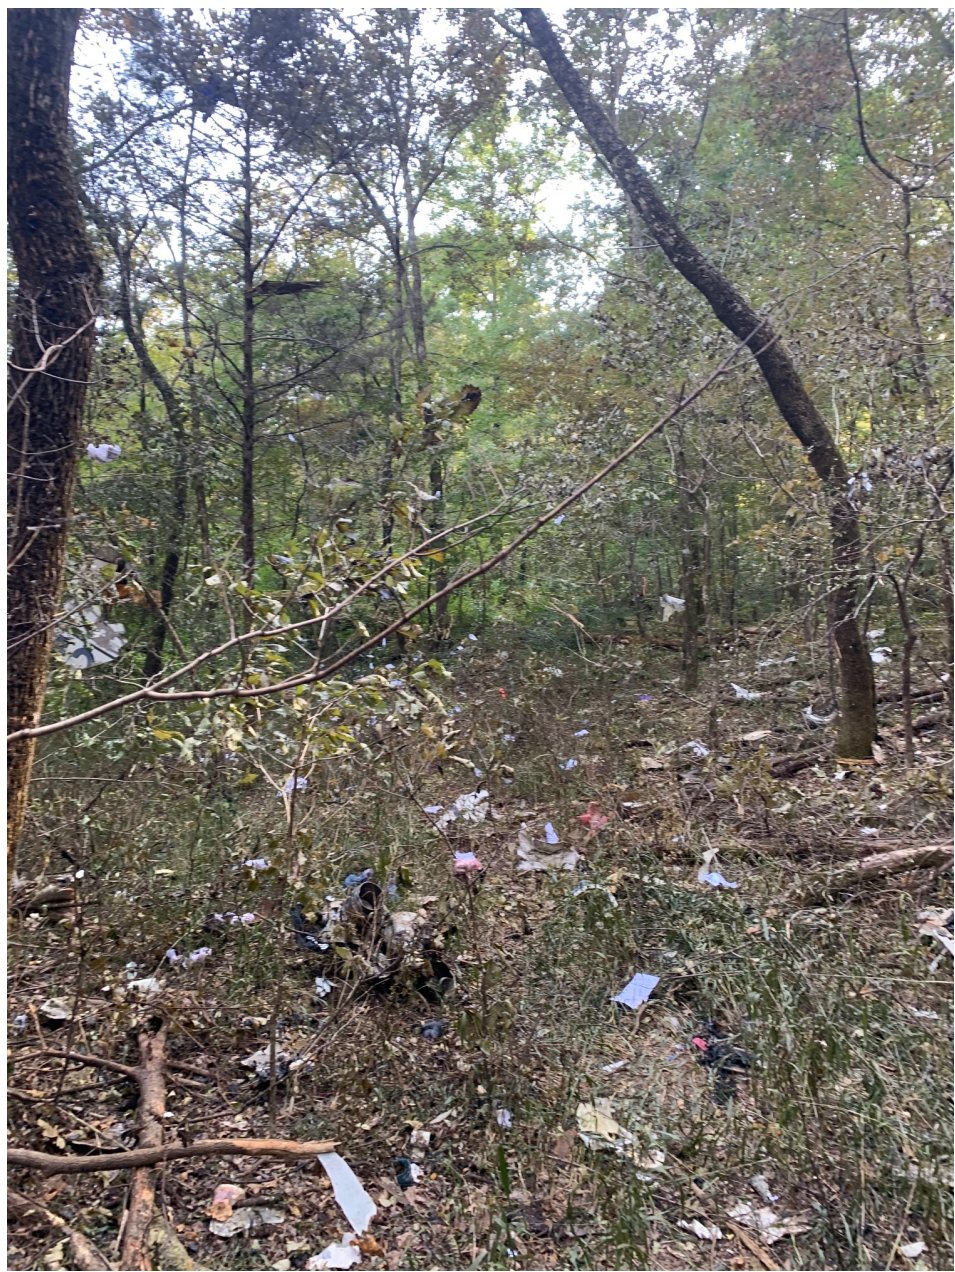
**Photo 6 - Supplied view of the debris path through the woods.**

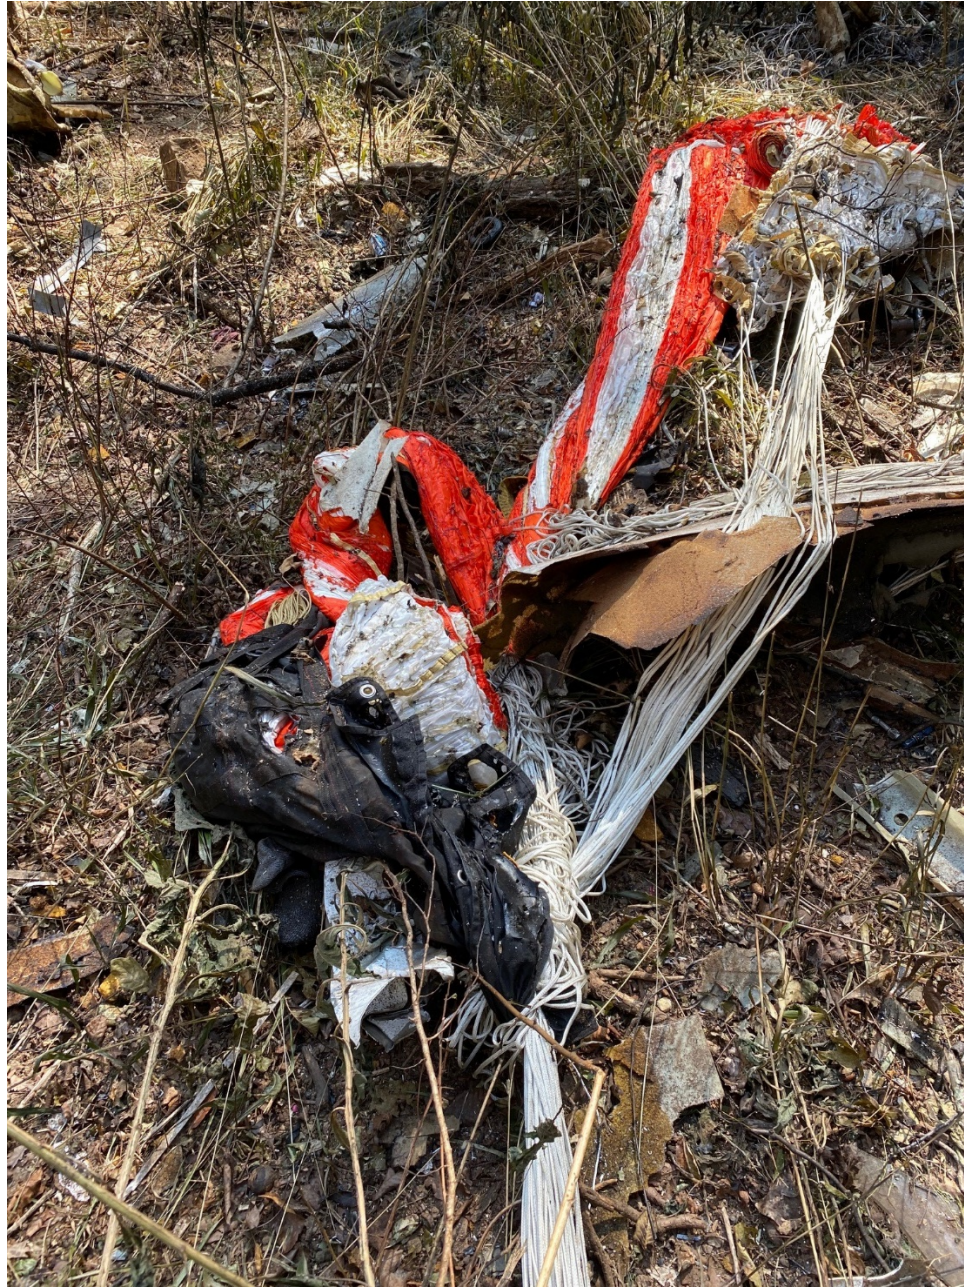
**Photo 7 - Supplied view of the CAPS parachute in the debris field.**

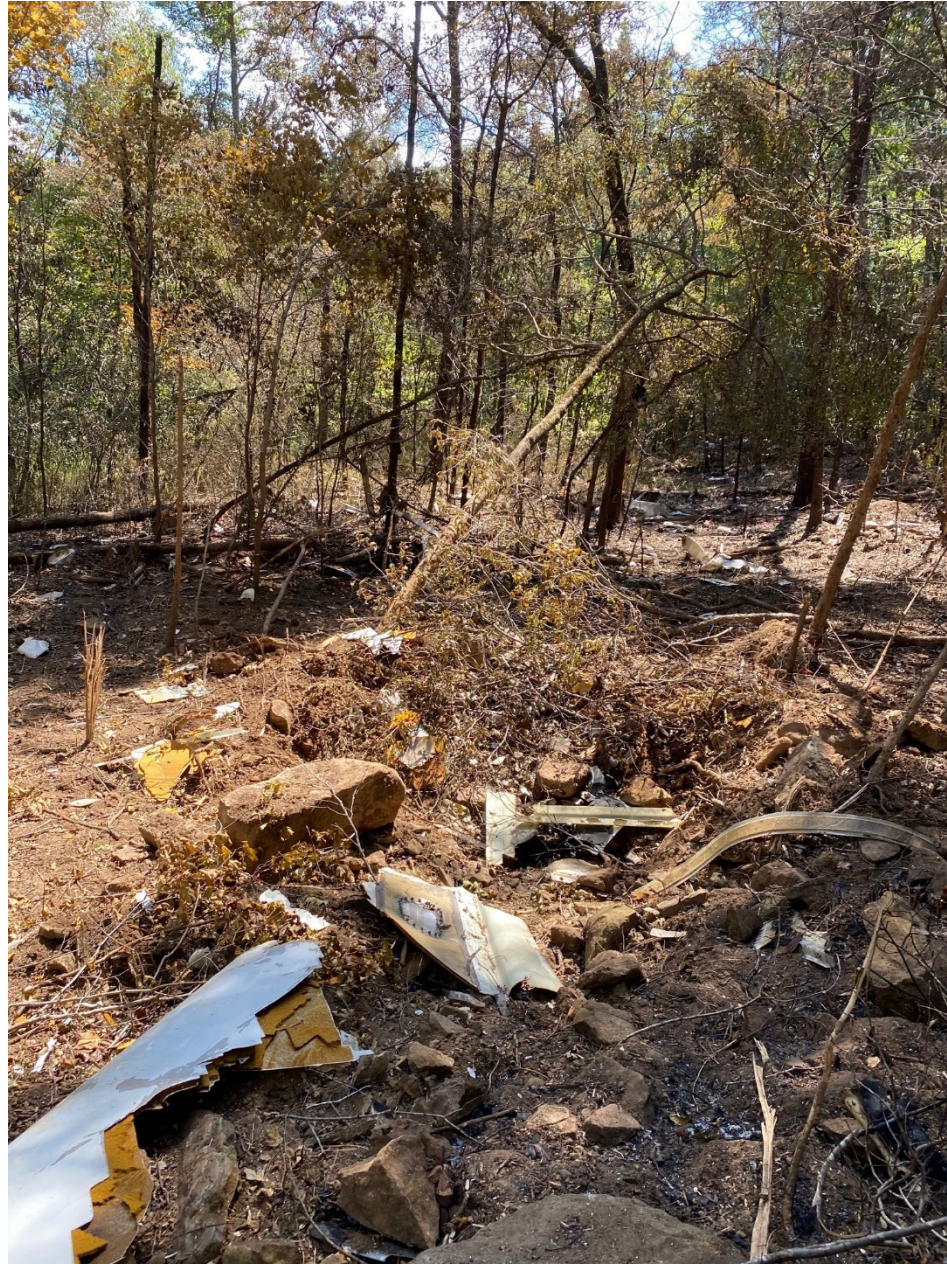
**Photo 8 - Supplied view of the debris path through the woods.**

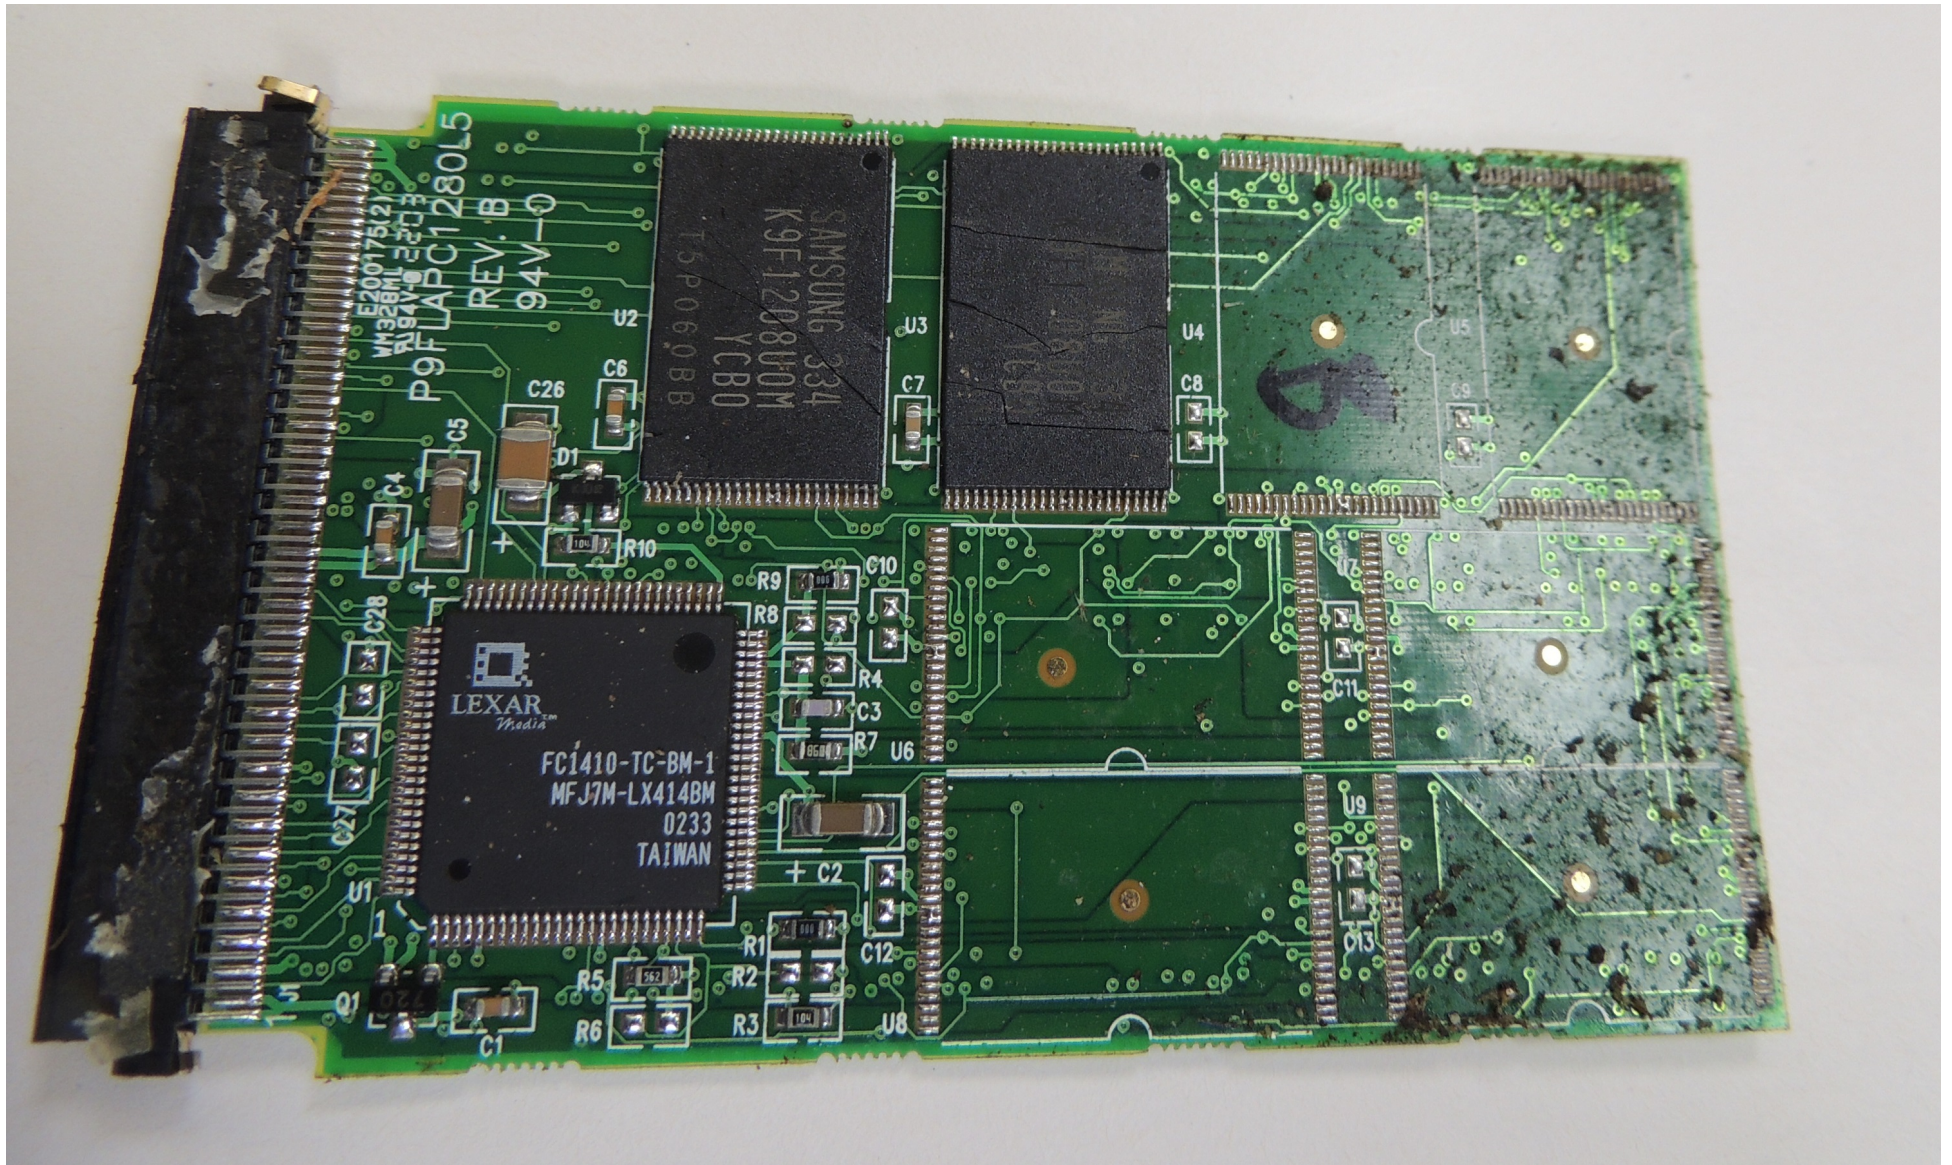
Photo 9 - Supplied view of the compact flash exhibiting cracked NVM.

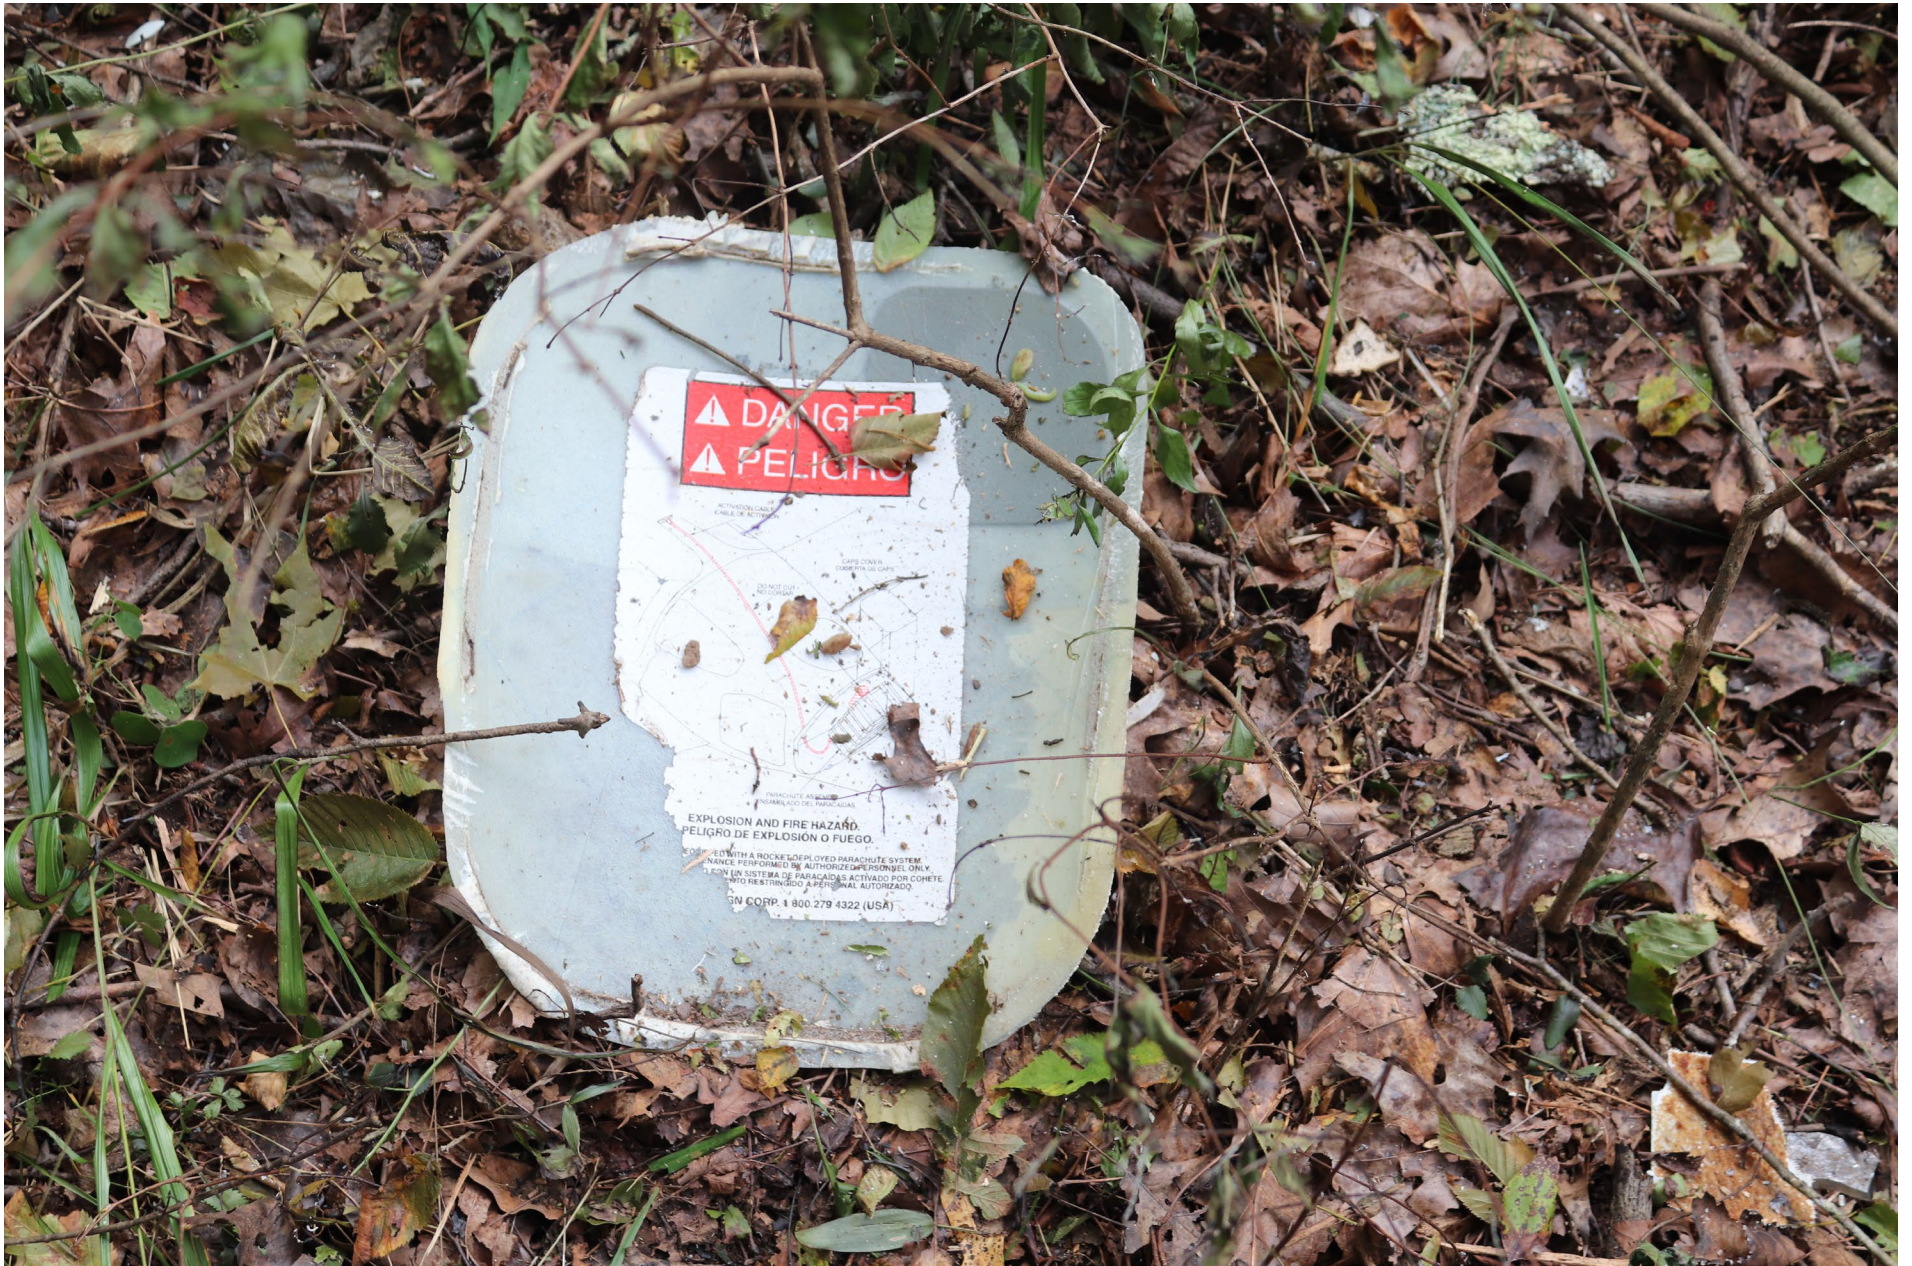
**Photo 10 - Supplied view of the CAPS cover.**
