**NATIONAL TRANSPORTATIONS SAFETY BOARD  
Office of Aviation Safety  
Washington, DC 20594**

**SUMMARY OF ENGINE/AIRFRAME EXAMINATION**

**-- CEN20LA380 --**

Aircraft: N4636D, Beech 35

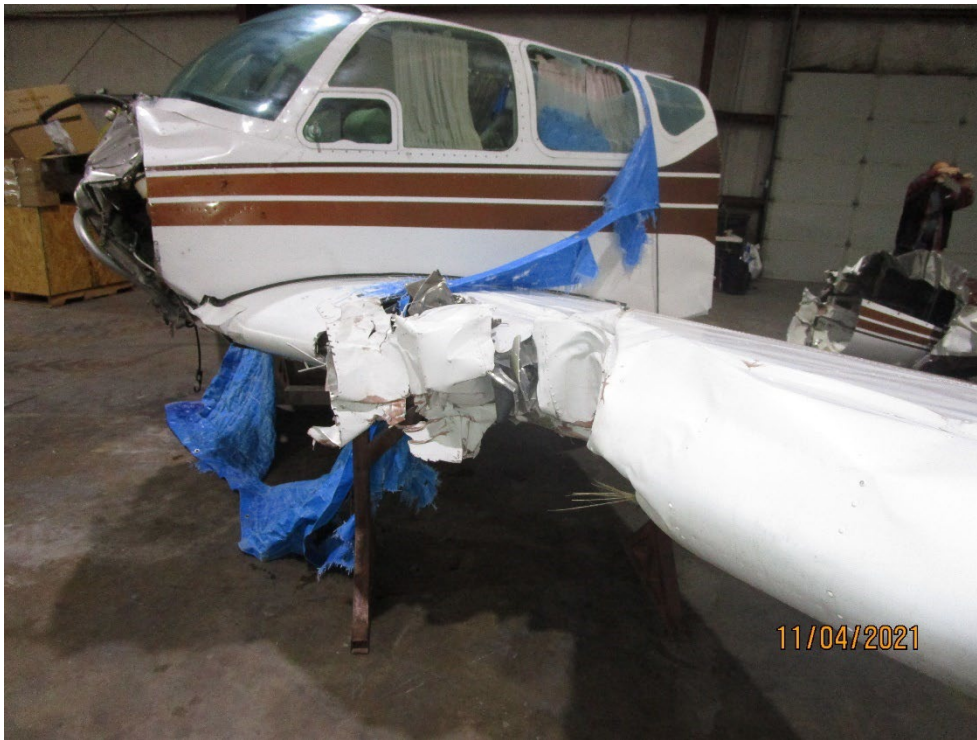
Fuselage on stands

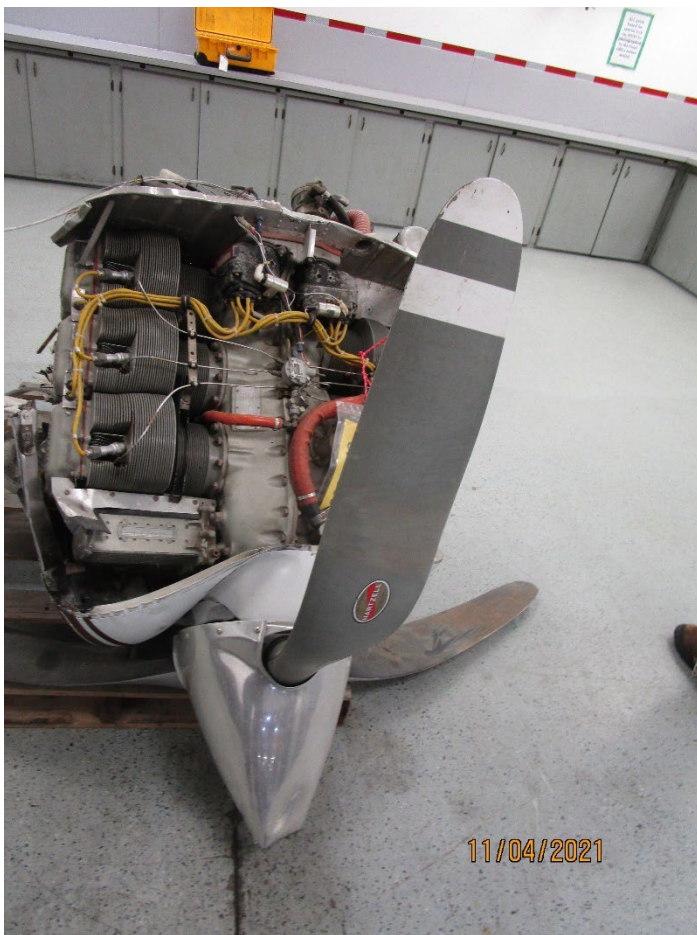
- A visual inspection of the engine did not discover any preimpact anomalies
- Fuselage took heavy impact damage to the front, during the accident
- Prior to the exam, and after the accident, the wreckage set outside in the yard;
  - Evidence of water was found in the fuel system strainer, along with the remotely mounted engine oil filter adapter
- A JPI engine monitor was removed, for potential download later
- The top set of sparkplugs were removed and appeared, normal and light grey in color
- The fuel manifold and fuel injectors (6) were clear of debris
- The throttle body fuel screen, had a small of debris on it
- The fuselage fuel screen, had water drain from it and had evidence of water contamination
- The engine oil filter was cut open; no evidence of metal contamination was noted
  - Water with the oil in the oil filter and fuel system was likely from outside storage in rain.

Engine, separated from fuselage and ready for examination
