Date of Inspection: September 29, 2020

Location: ODX Evelyn Sharp Field - Ord, Nebraska

Aircraft: N57607 Piper PA-36-285 SN: 36-7660006

Engine: Lycoming IO-720-A1B, NO. L 1315-54A

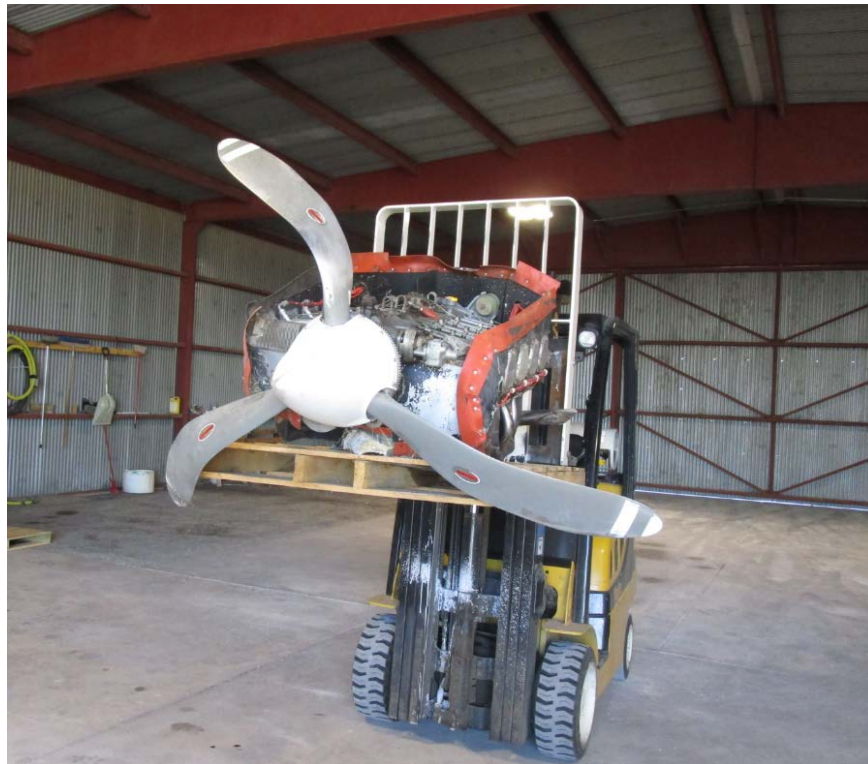
**NOTE:** The engine was removed from the aircraft and placed on a pallet prior to this inspection.
