# The National Transportation Safety Board

Office of Aviation Safety  
Central Region  
Memorandum for the Record  
Wreckage Examination  
Findings  
CEN20LA383  
Henderson Texas  
September 5 2020

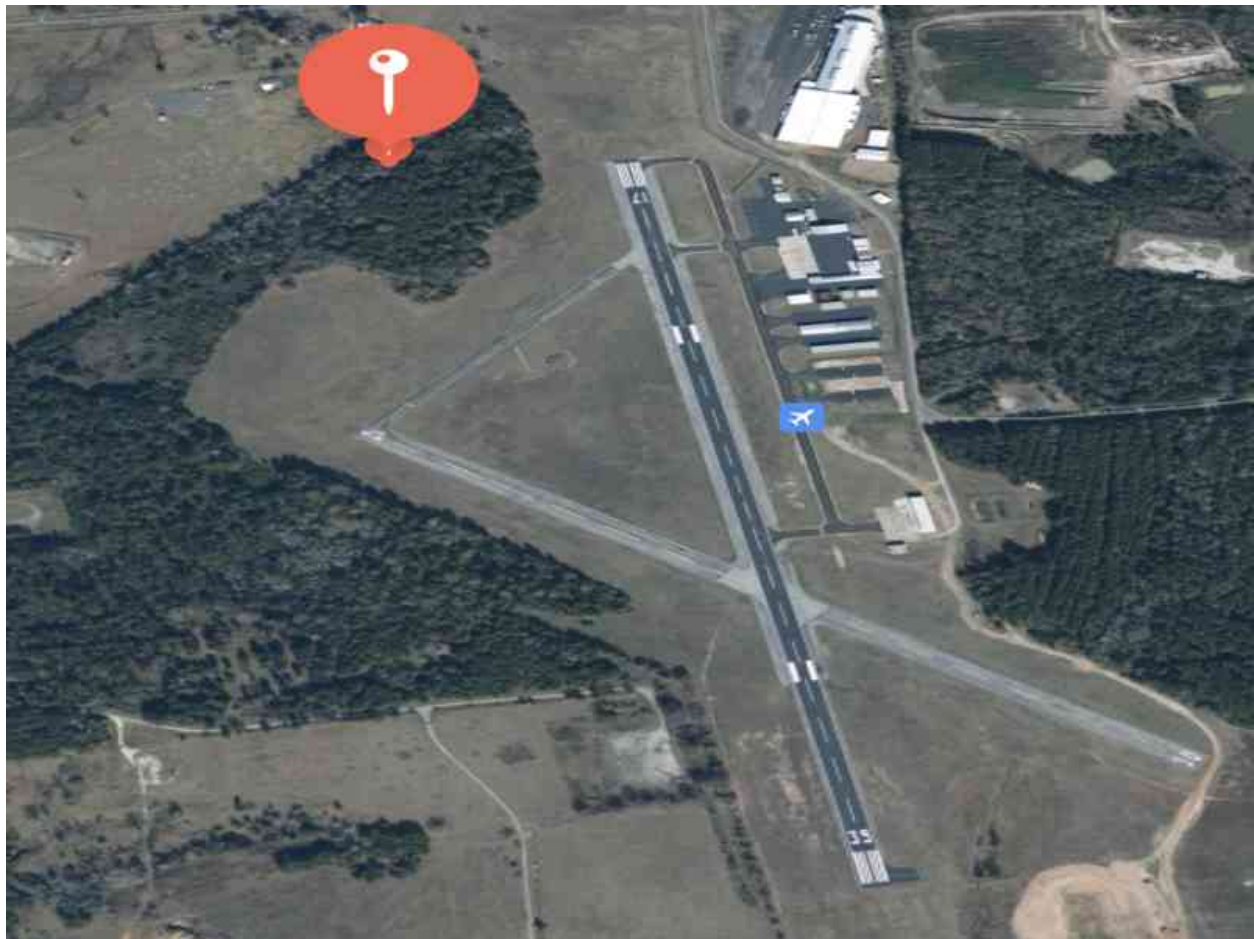
- The airplane wreckage was found amidst trees in a densely wooded area to the left of the departure end of runway 35 at RFI. The airplane was about 80-degrees nose down, with the empennage resting against a tree.

- The upper and lower wings were substantially damaged, and the forward section of the fuselage and engine compartment were buckled. The aft section part of the empennage and vertical stabilizer were buckled.
- One of the wooden propeller blades was splintered consistent with rotation at impact, and one blade was broken at the tip.
