# **National Transportation Safety Board**

## **Performance Study**

| Airplane: | Vans RV9, N94KJ |
| NTSB Number: | CEN20LA399 |

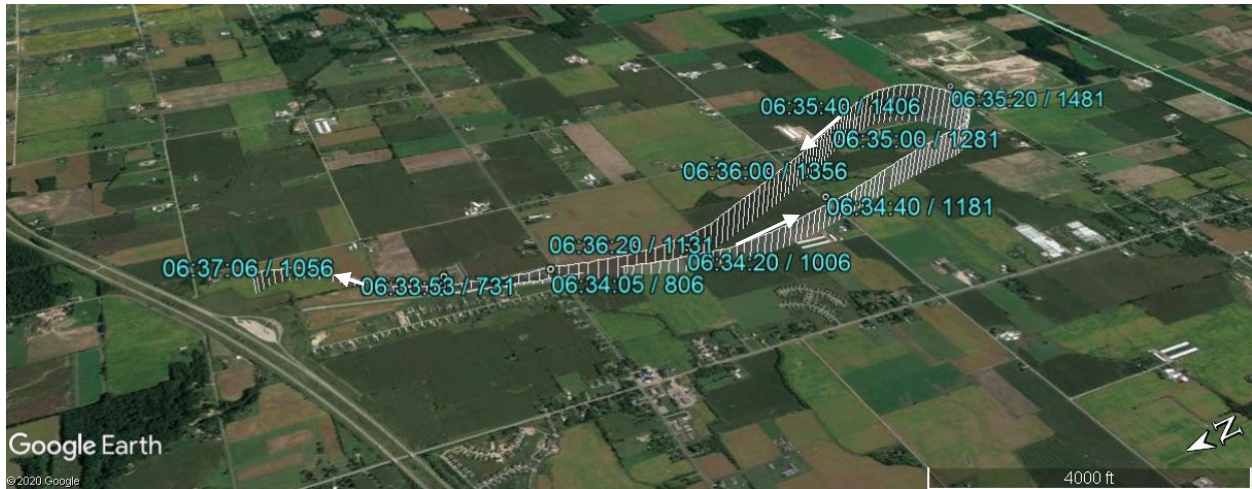
The aircraft took off from Ottawa Executive Airport Runway 20 just before 06:34 EDT (Figure 1 and Figure 2). While climbing, the airplane made a 180° left hand turn back to the runway. The airplane descended, overflew the runway, and began a second climb before the flight ended just after 06:37.

**Figure 1.** Accident flight in blue with select times and altitudes (msl) annotated in blue.

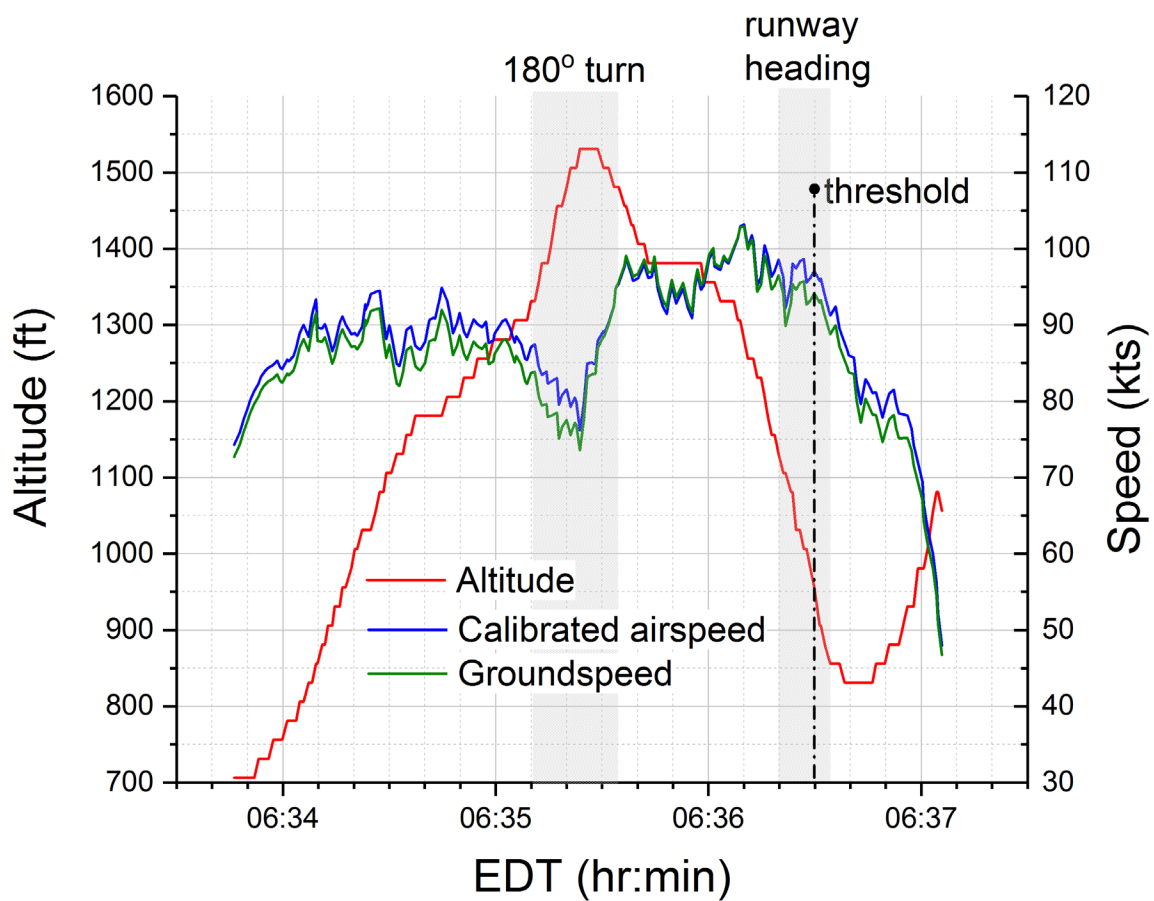
**Figure 2.** Altitude (msl) and calculated groundspeed and calibrated airspeed. The 180° turn and time of runway alignment are highlighted.

The airplane maintained an airspeed of about 90 kts during the initial take-off climb. Just after 06:35, the rate of climb increased, the airspeed decreased to about 75 kts, and the airplane began the 180° turn back to the runway. It continued to climb while turning until 06:35:25 when it reached a maximum altitude of 1,530 ft. During the descent, airspeed increased to between 90 and 100 kts. While descending the airplane aligned with Runway 2. At 06:36:30 at an airspeed of 95 kts, it crossed over the threshold at an altitude of about 950 ft msl, more than 200 ft above the runway surface. The airplane continued to descend and slowed to about 80 kts before making a slight right turn off the runway heading and beginning a climb.

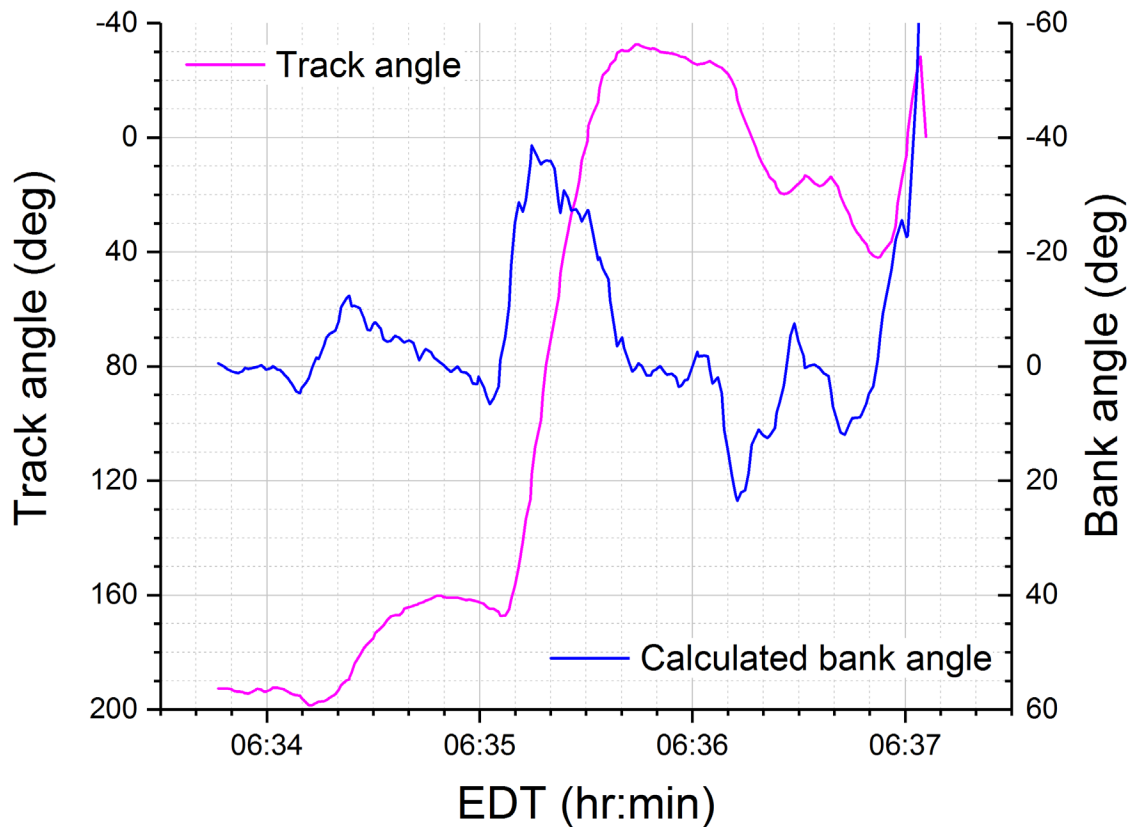
Since lift varies with airspeed squared, the stall speed varies with the square root of the load factor so that in a banked turn, the stall speed increases. A bank angle of 45° results in a load factor of 1.414 and the airplane's stall speed would increase from the wings level 42 kts to 50 kts. Figure 3 shows the track angle and calculated bank angle of the airplane for the flight. The airplane's final left turn necessitated a bank angle greater than 60° left wing down, placing the airplane's final calculated speed below the likely banked stall speed.

**Figure 3.** Track angle and calculated bank angle.
