**NATIONAL TRANSPORTATION SAFETY BOARD  
Office of Aviation Safety  
Washington, DC 20594**

**SUMMARY OF AIRFRAME EXAMINATION**

**CEN20LA401**

Location: Kokomo, Indiana  
Date: September 20, 2020  
Time: 10:57 am central daylight time  
Aircraft: Piper PA-32-301 (S/N 32-8006051) N8213X

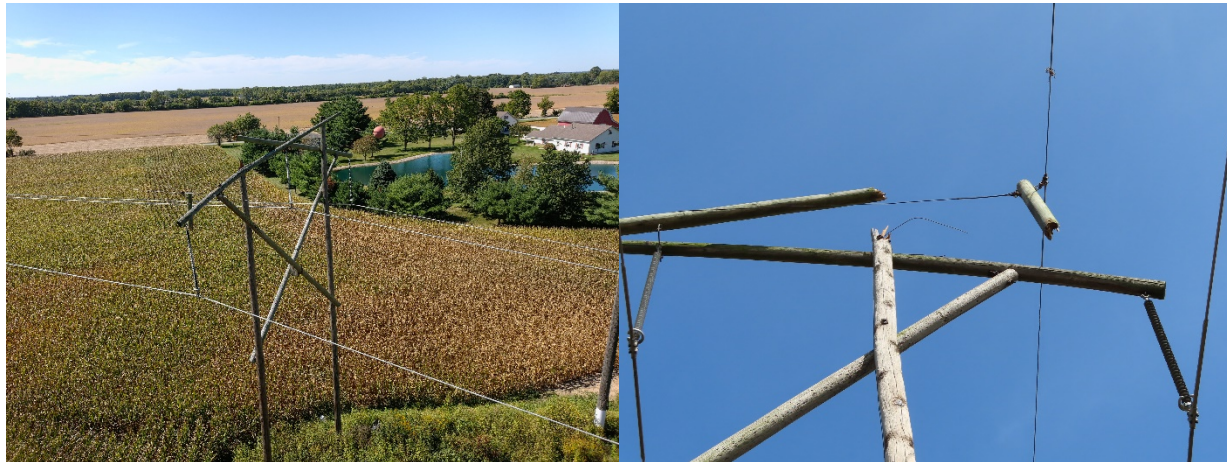
According to a witness, who was taxiing his airplane about 1,000 ft from the approach end of the runway, the airplane appeared low on approach. He noted the flaps were extended and the engine was running. He saw the airplane's nose-gear and the right main landing gear clip the utility pole. The airplane then yawed to the right and "cartwheel over on itself." The witness stated it did not appear the airplane tried to regain altitude to climb over the power lines before impact. The airplane came to a rest inverted in a corn field below the power lines. The airplane immediately caught fire upon impact with the ground.

Figure 1: Broken Utility Pole

The utility pole was about 79 ft in height and was located about 570 ft north of the runway end. The utility line was demarcated with an orange, ball-like marker. The runway has a 20:1 approach slope to a 292 ft displaced threshold.

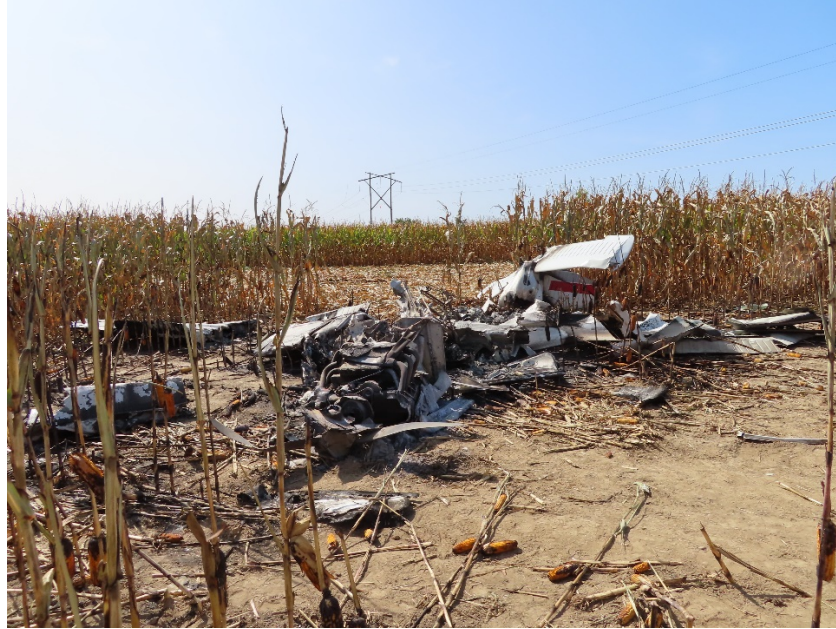
Figure 2: Airplane Wreckage

The aircraft impacted a wooden pole, est. 79 ft tall and a dual pole utility tower, est. 61 ft tall on final approach to runway 18 of the Glendale Airport. The aircraft came to rest inverted on an easterly heading and a post-impact fire ensued. The aircraft was mostly consumed by the fire.
