**Photo 1 – Accident Scene, Airplane Wreckage and Wood Dual Pole Utility Tower. Photo from FAA**

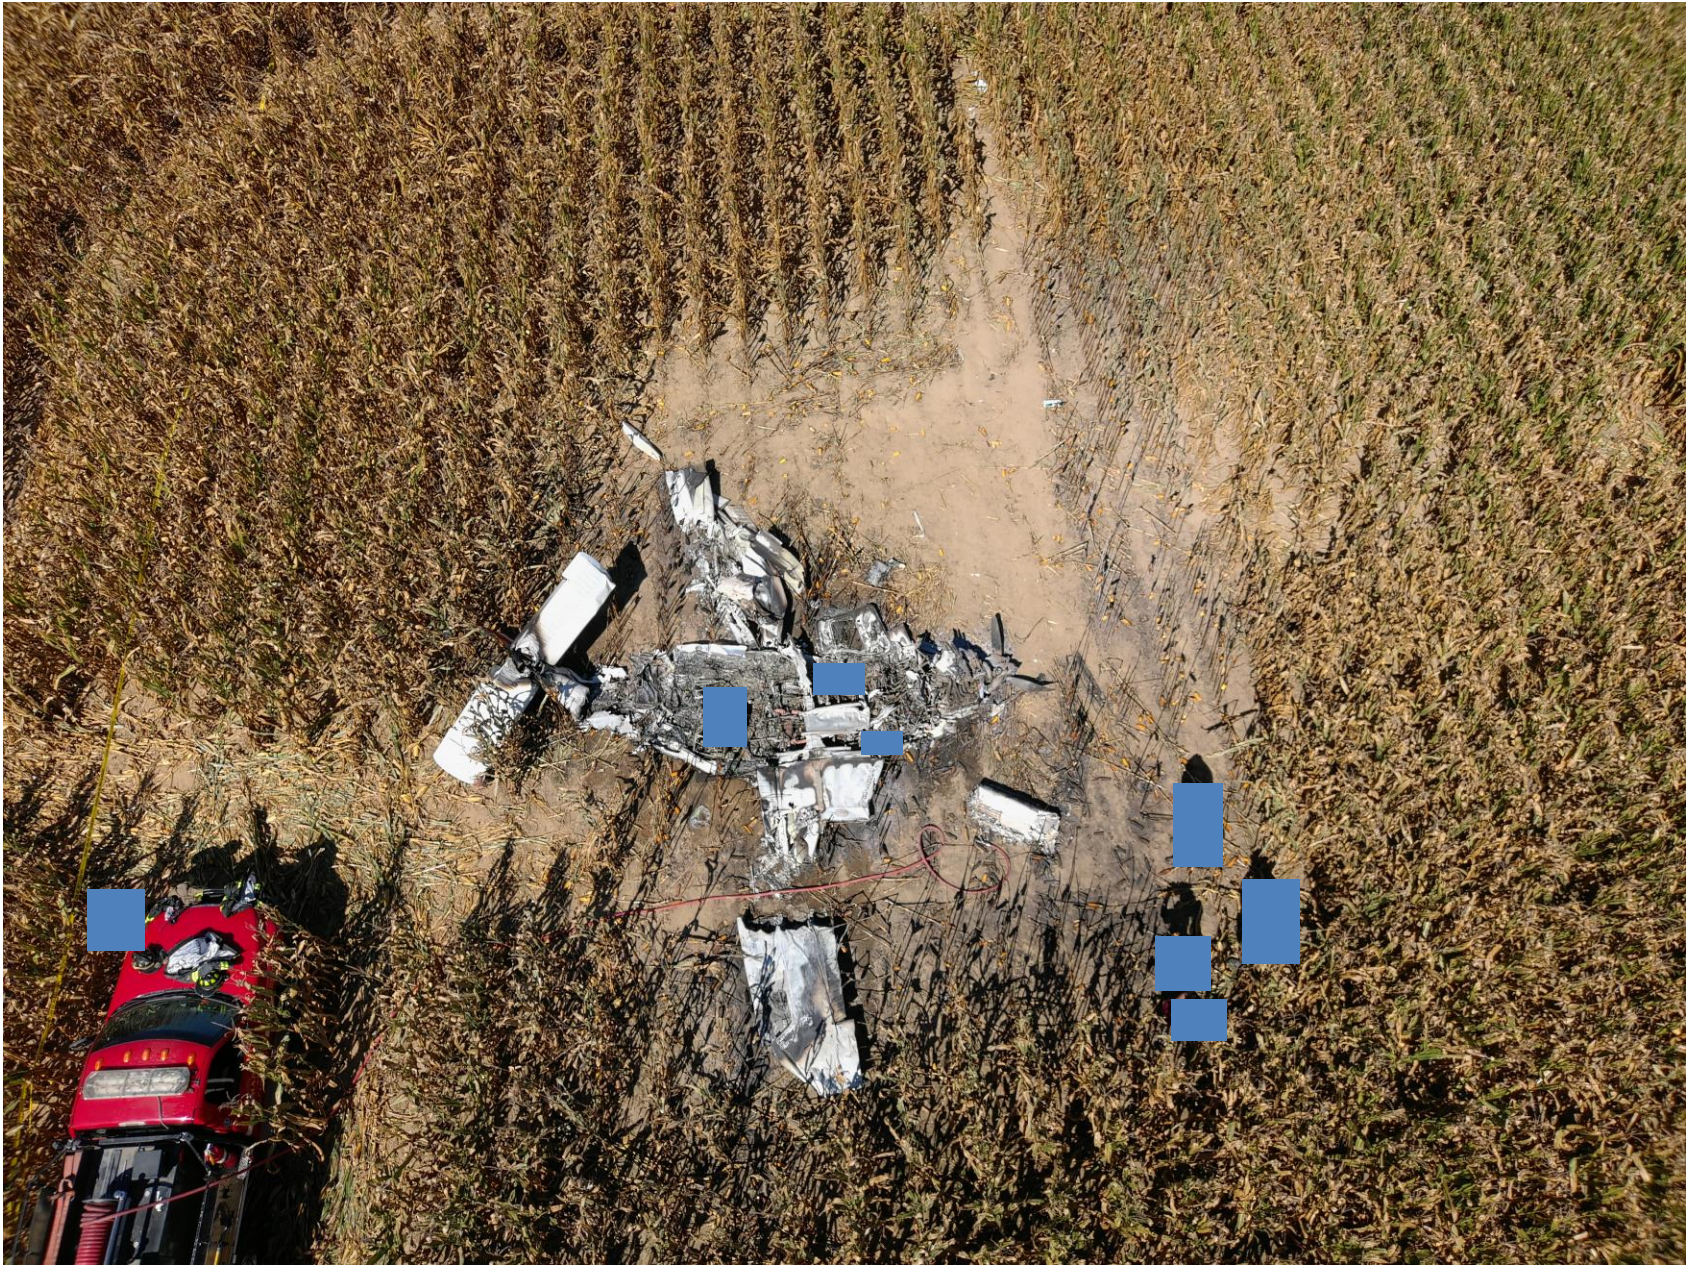
**Photo 2 – Airplane Wreckage, Overhead View. Photo from FAA**

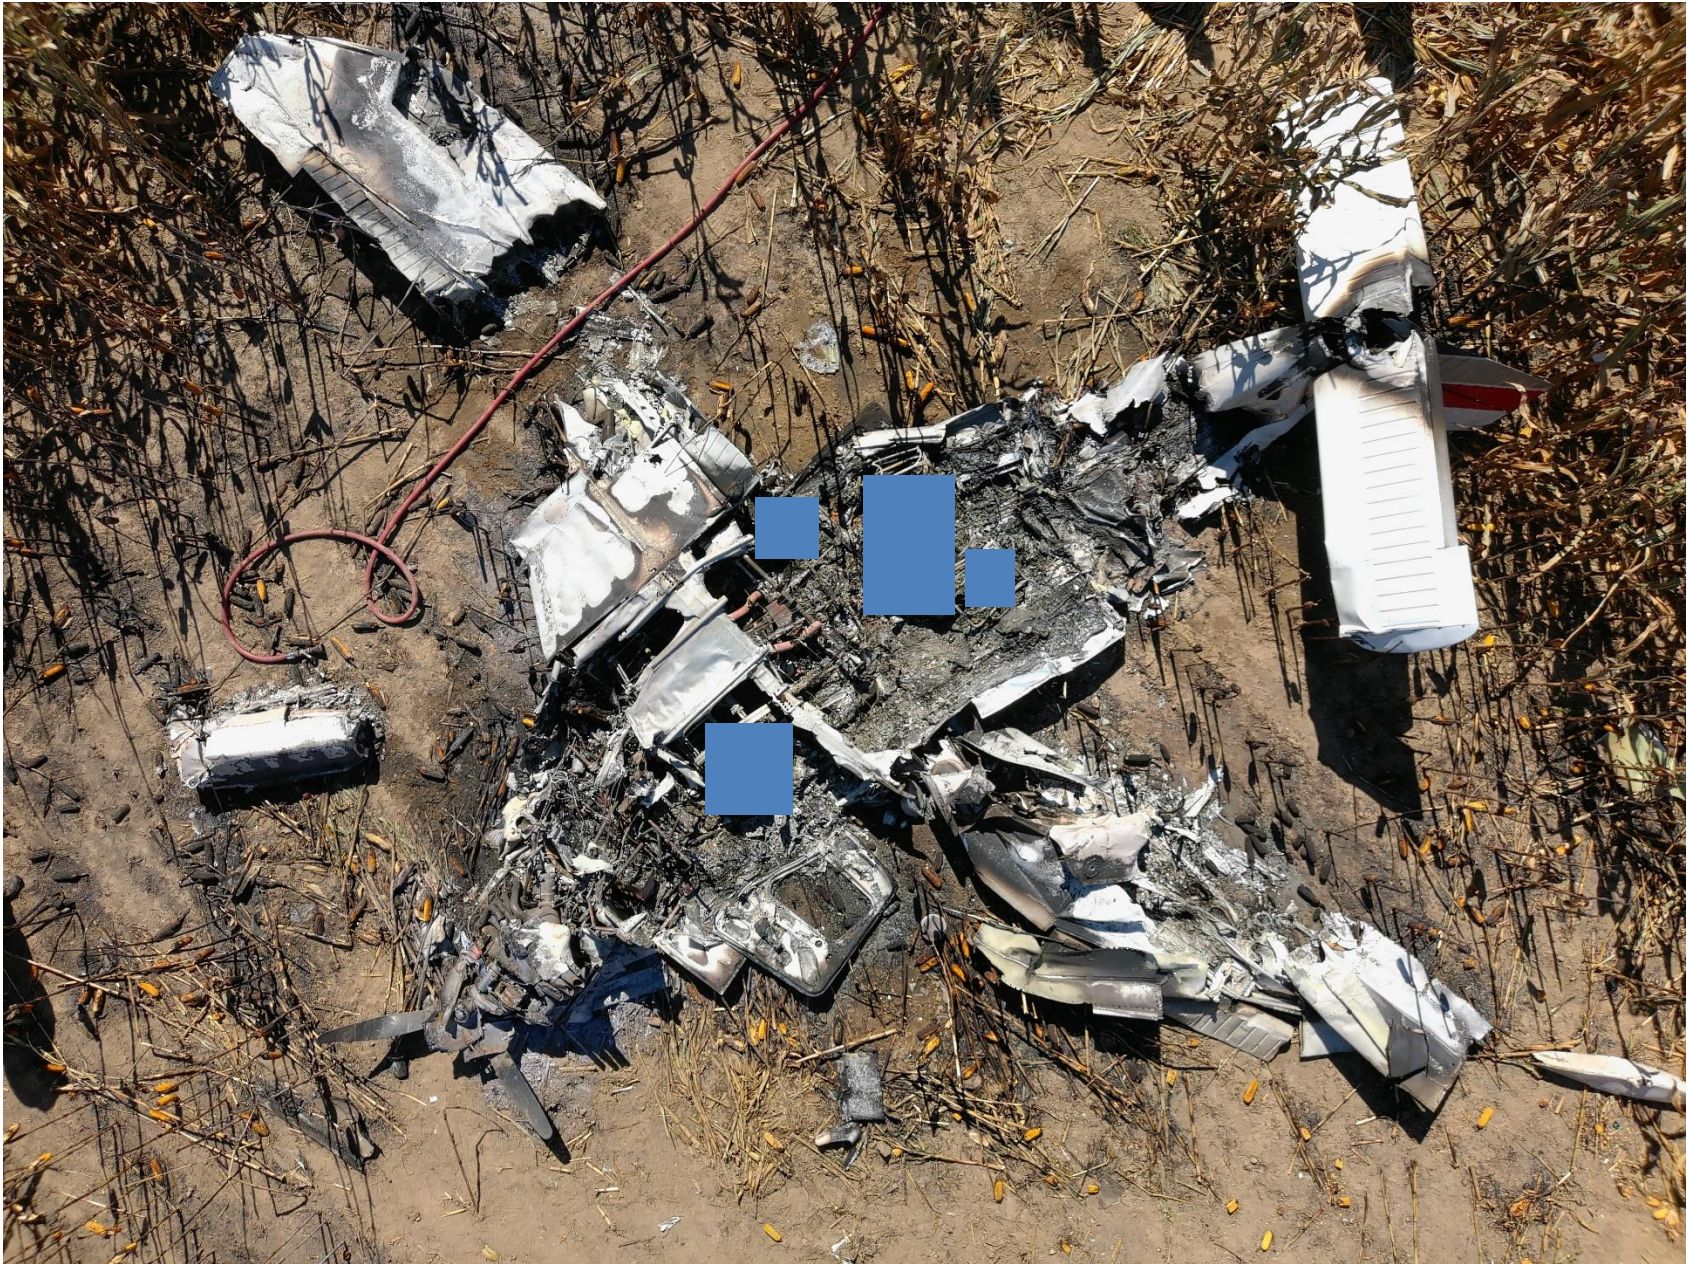
**Photo 3 – Airplane Wreckage, Detailed Overhead View. Photo from FAA**

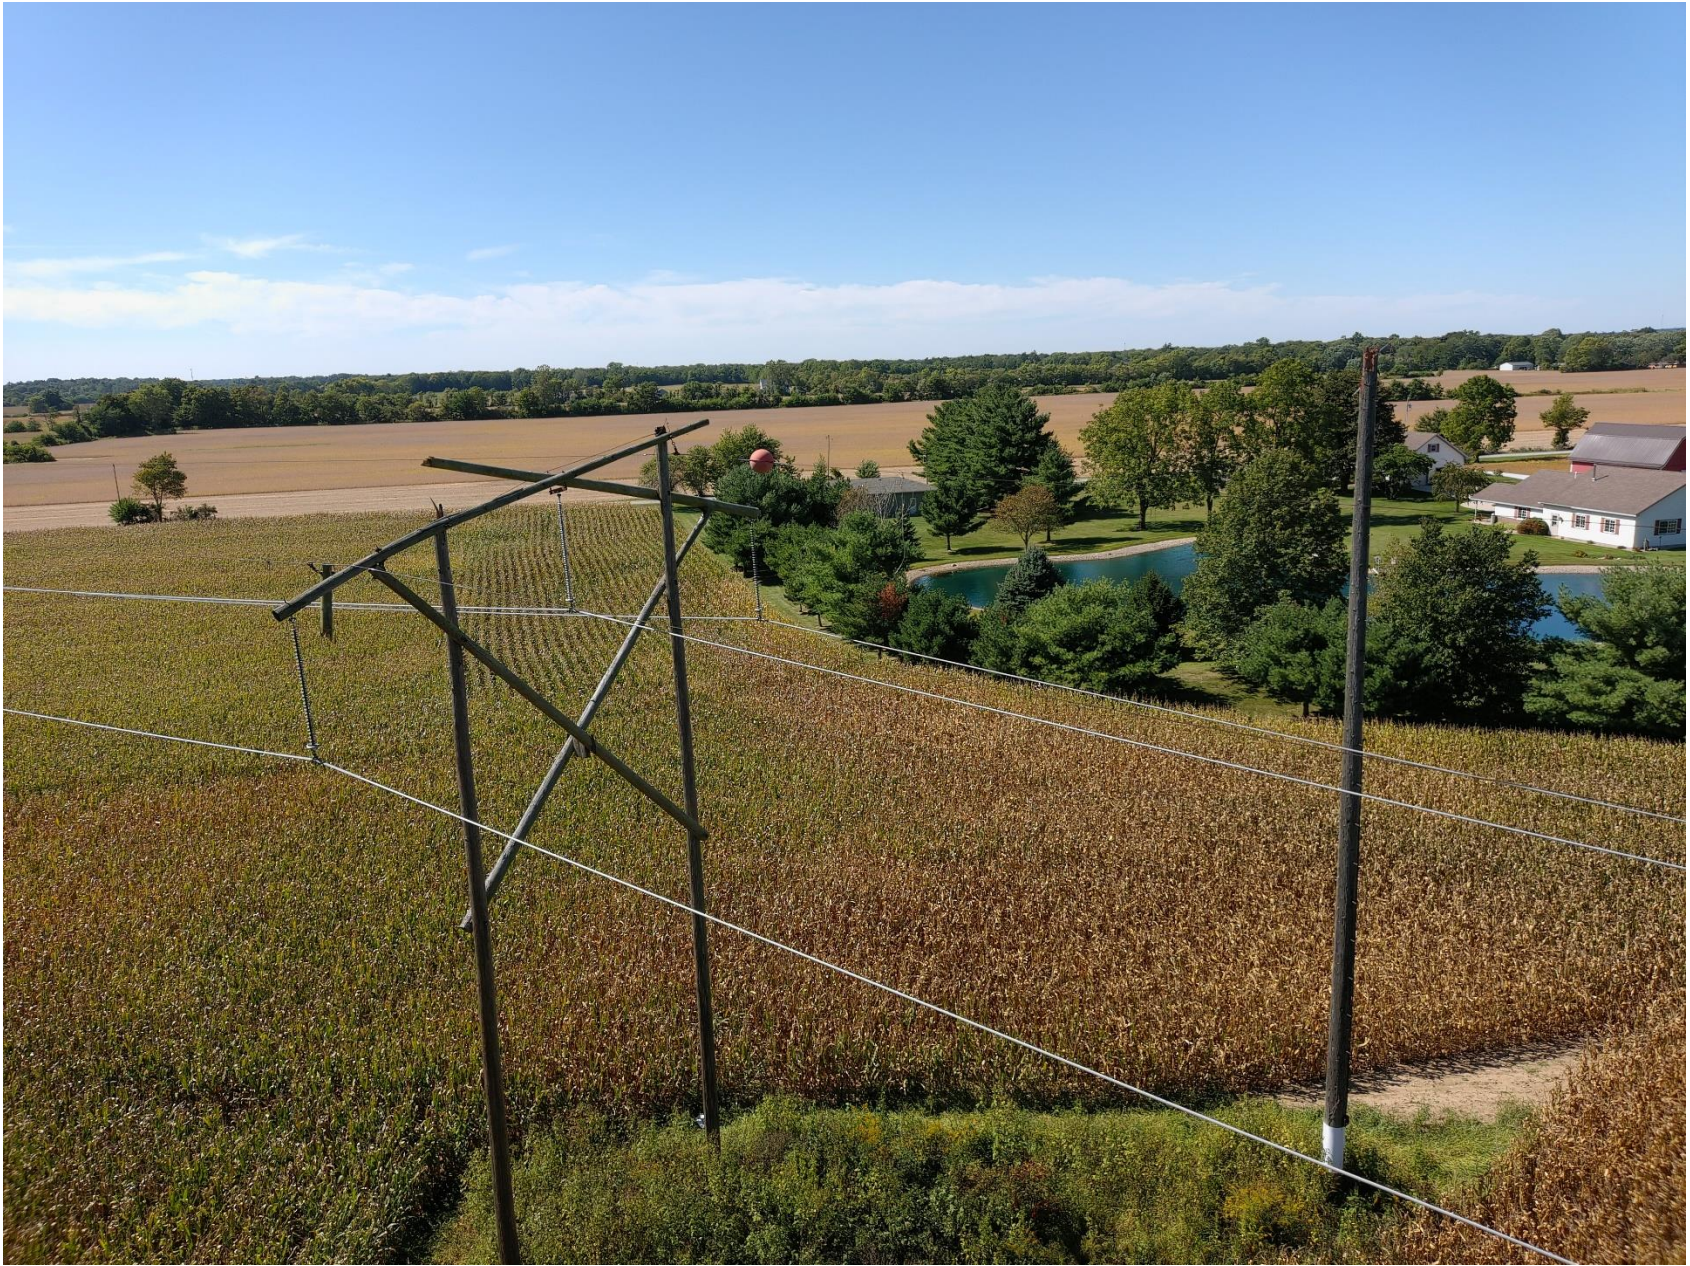
**Photo 4 – Wood Pole and Dual Pole Utility Tower Damage, Photo from FAA**

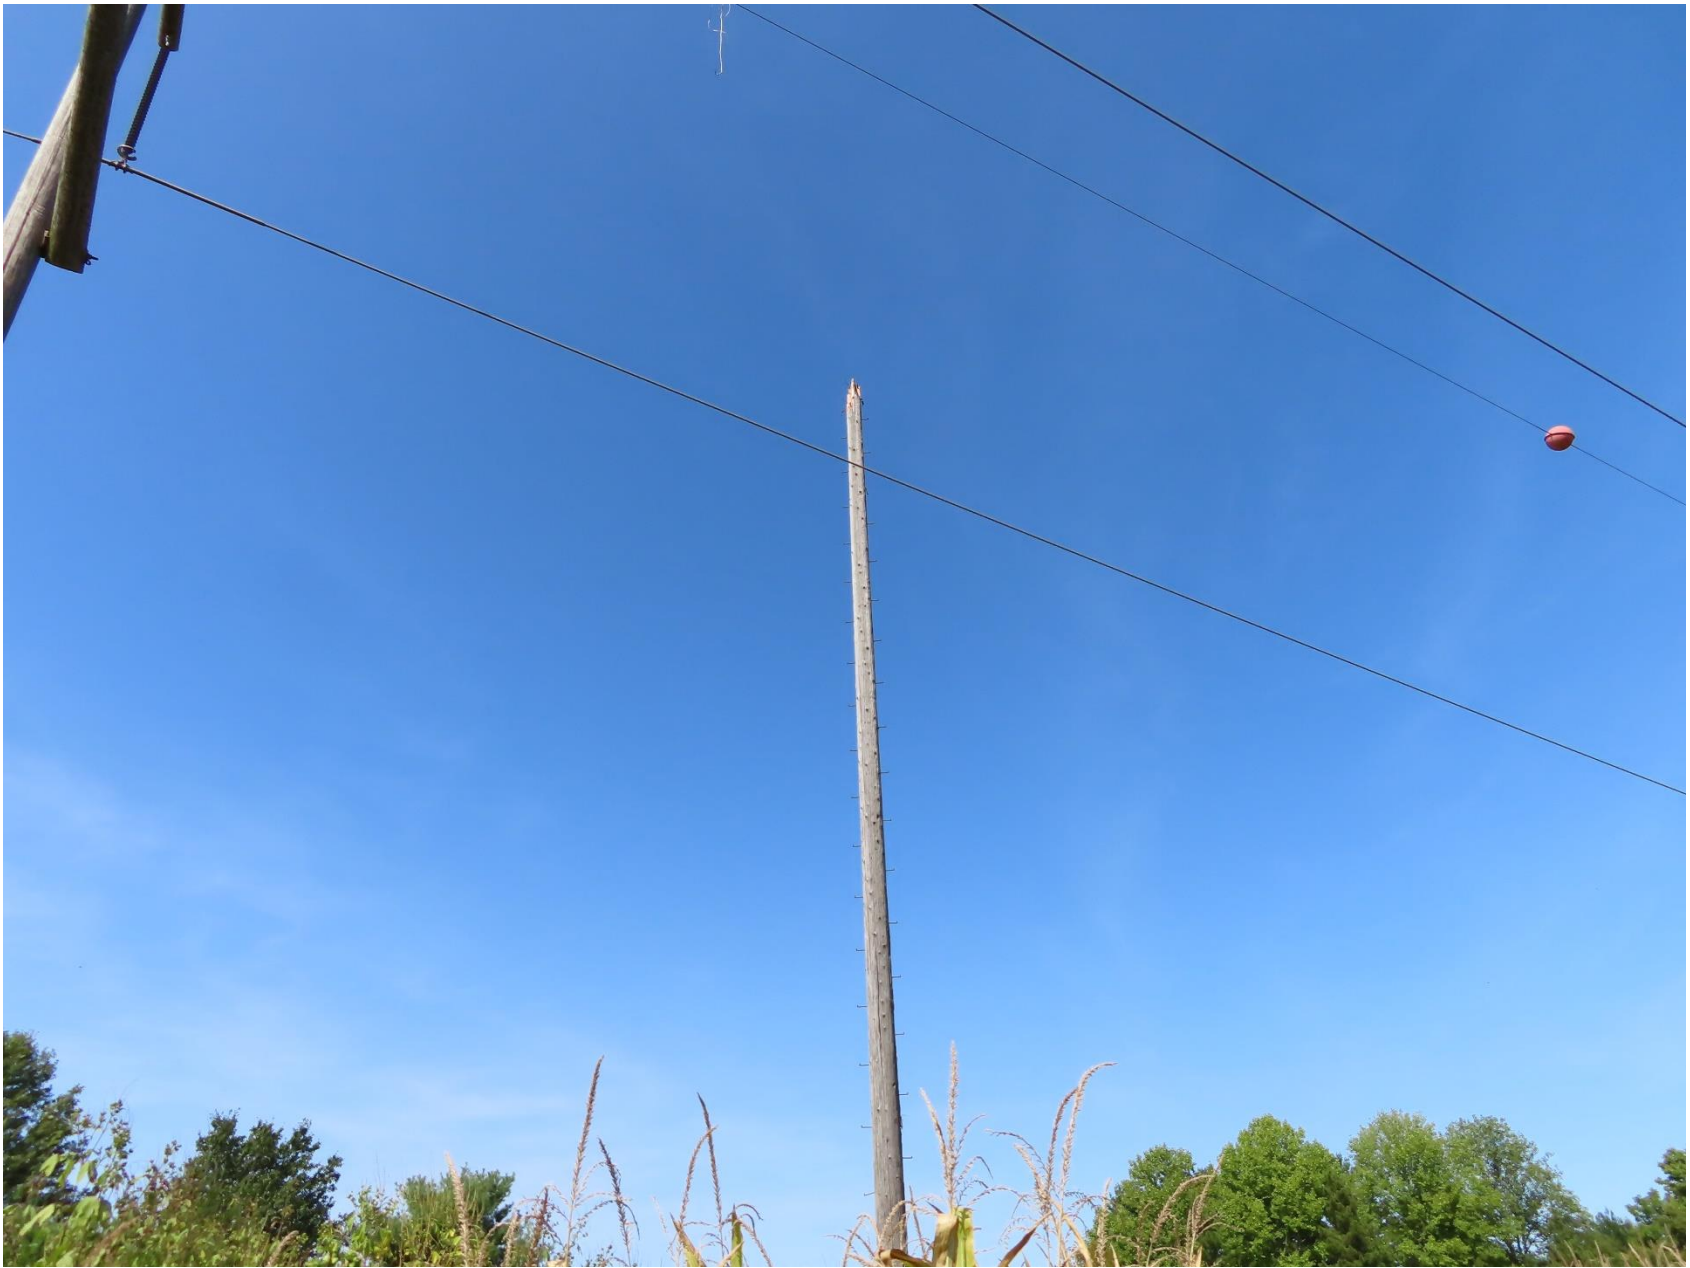
**Photo 5 – Single Wood Pole Damage. Photo from Piper Aircraft**

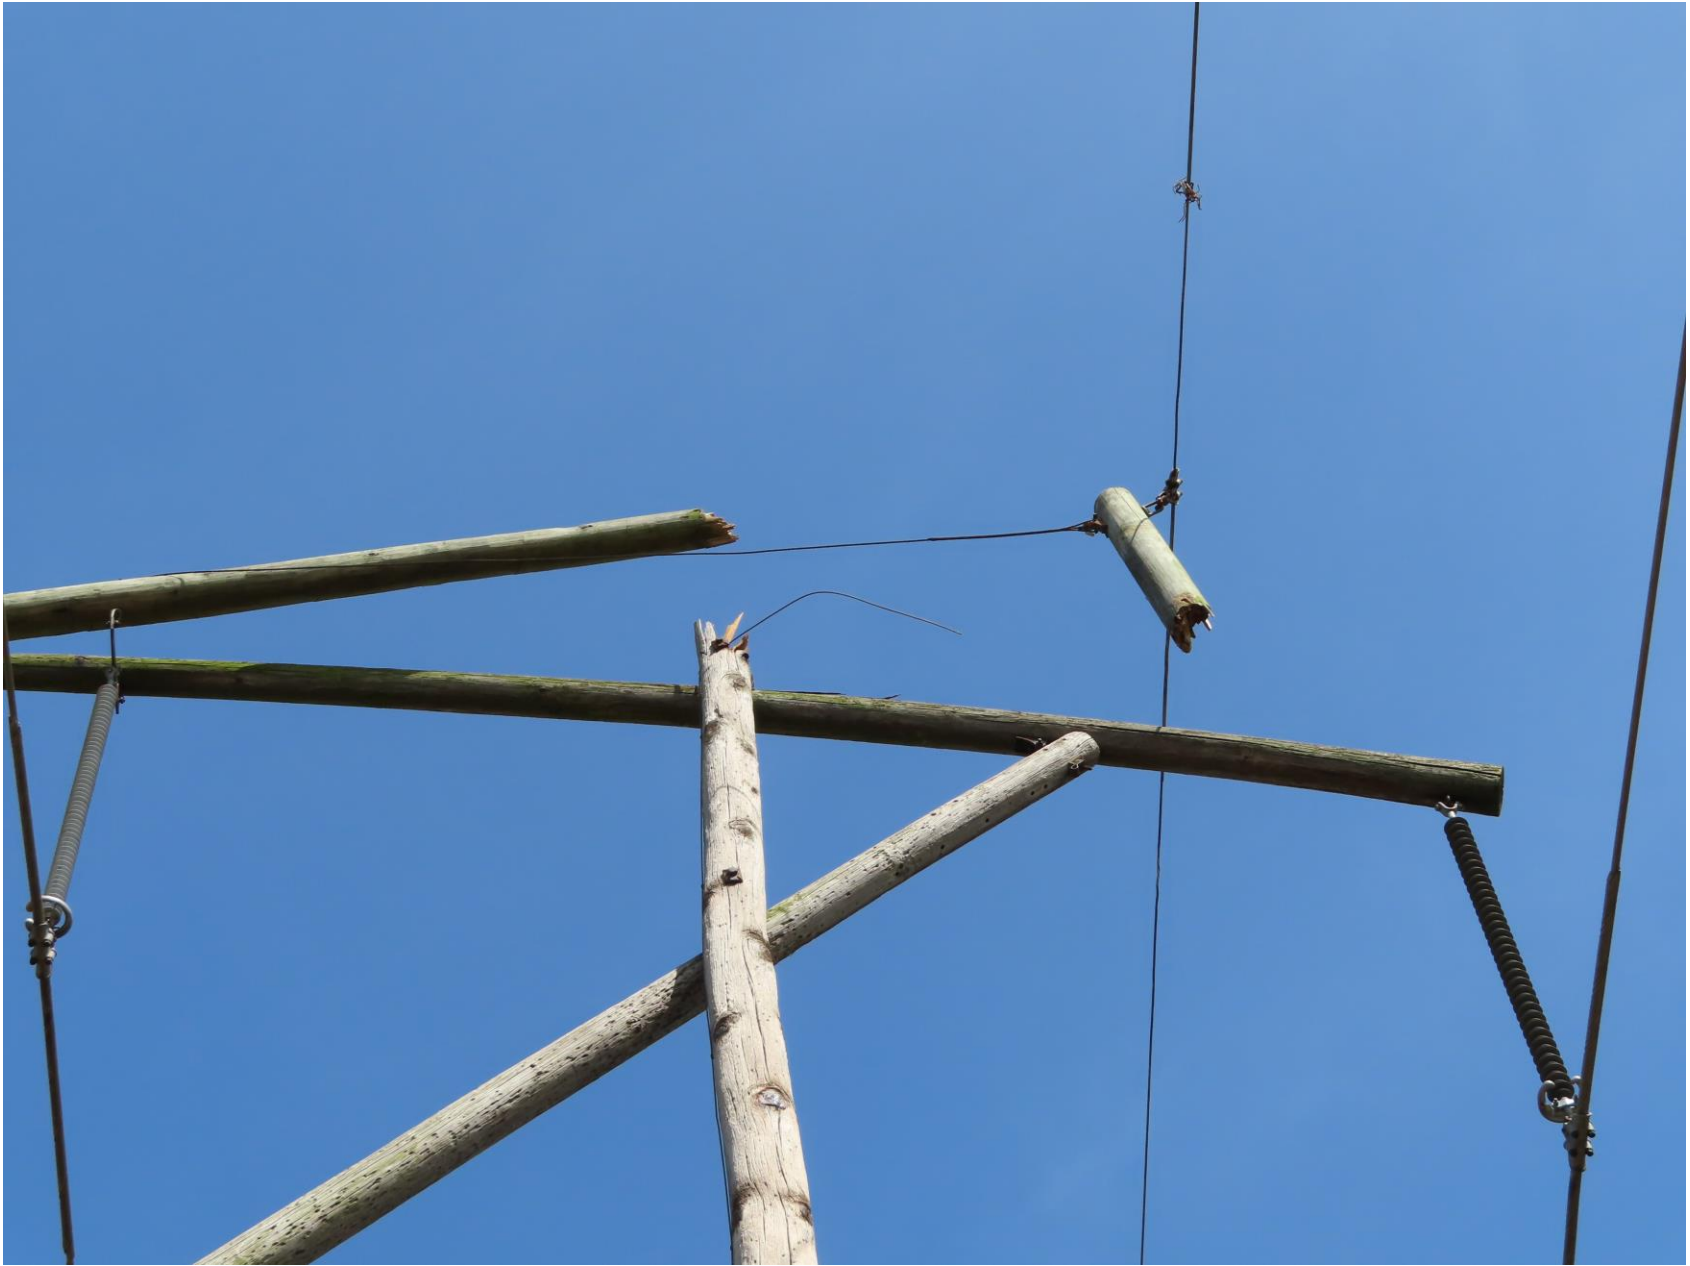
**Photo 6 – Dual Pole Utility Tower Cross Pole Damage. Photo from Piper Aircraft.**

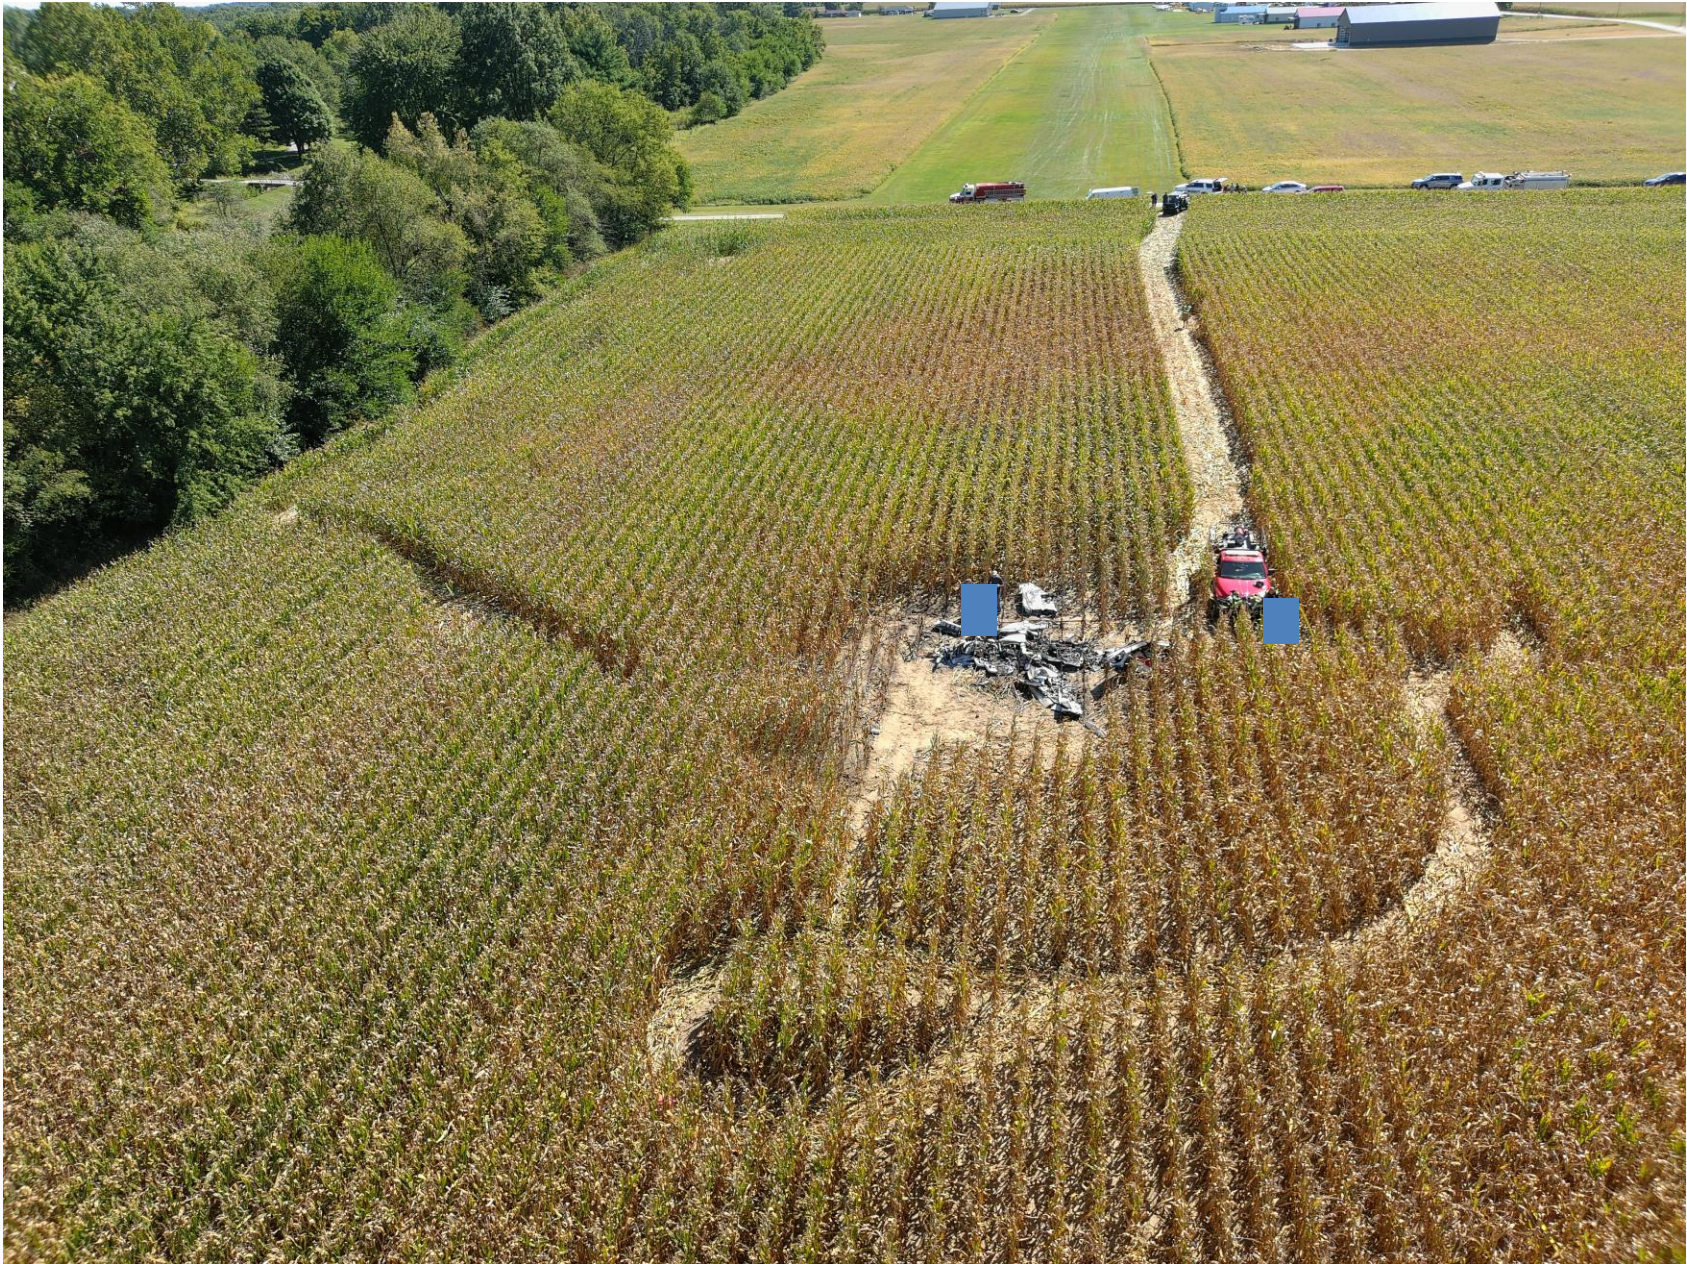
**Photo 8 – Airplane Wreckage with Glenndale Airport in the Distance. Photo from FAA**
