# **NATIONAL TRANSPORTATION SAFETY BOARD**

## **Attachment 1 – Pratt & Whitney Canada Accessories Accident Report**

**CEN20LA402**

## ACCESSORIES ACCIDENT REPORT

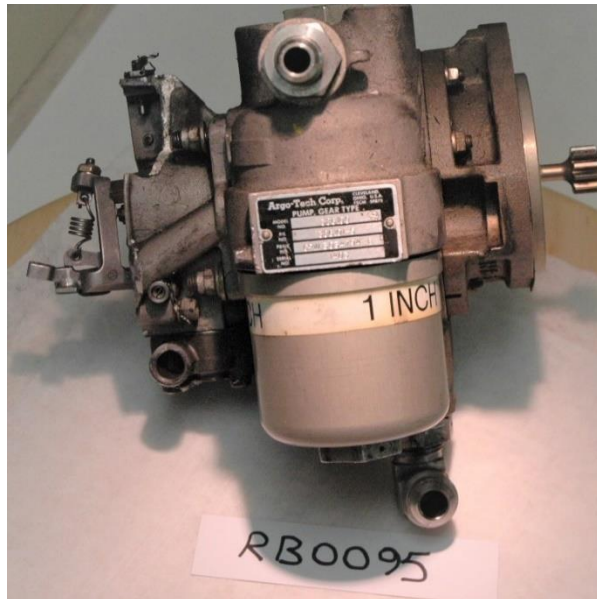
The exterior of the fuel pump was soiled (figure 1). The driveshaft turned with typical resistance, but rotation was restricted. The fractured fuel control unit (FCU) drive-body was attached to the mounting face of the pump (figure 2). One of the FCU attachment nuts was not completely tightened and the washer was missing. The FCU drive-body was removed to ascertain the cause of the restricted rotation. Following removal of the FCU drive-body remains from the fuel pump full rotation of the fuel pump driveshaft was restored. There was no evidence of bearing grease dilution at the fuel control unit mounting flange. There were gouges on the exterior of the outlet filter bowl. There was a label marked 1 INCH around the outlet filter bowl.

Figure 1  
Fuel pump as received

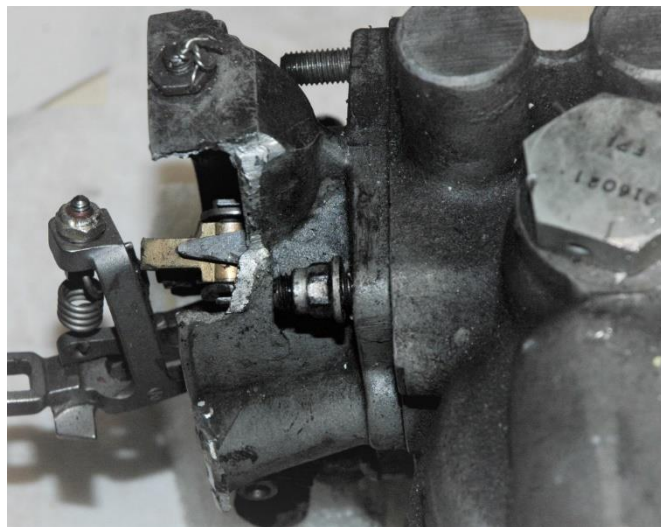
Figure 2  
Remains of the fuel control unit drive-body attached to the fuel pump

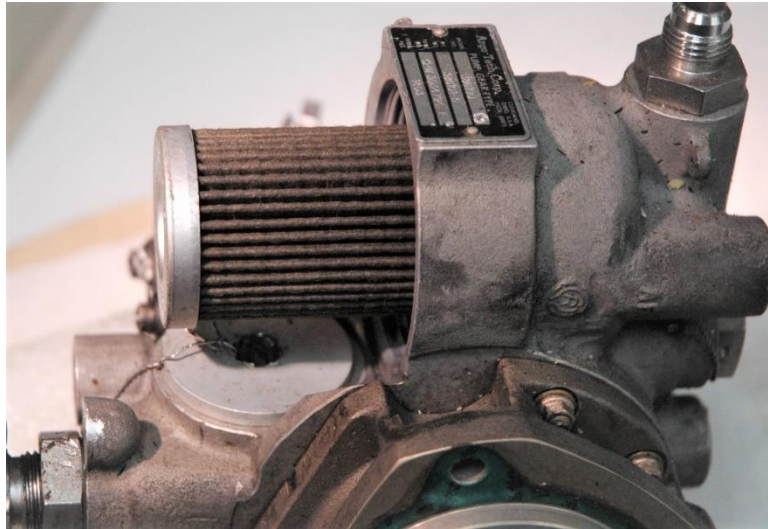
Lockwire was missing from the outlet filter bowl and the bowl could be removed by hand. The outlet filter element was present. The pleats were darkened but there was no obvious debris in the pleats (figure 3). There was typical dark powdered residue in the filter head and the filter bowl (figure 4). Lockwire was present at all other locations.

Figure 3  
Fuel pump outlet filter

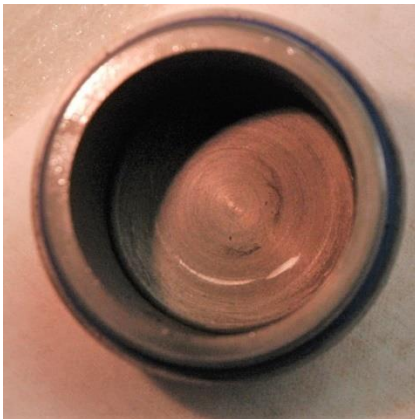
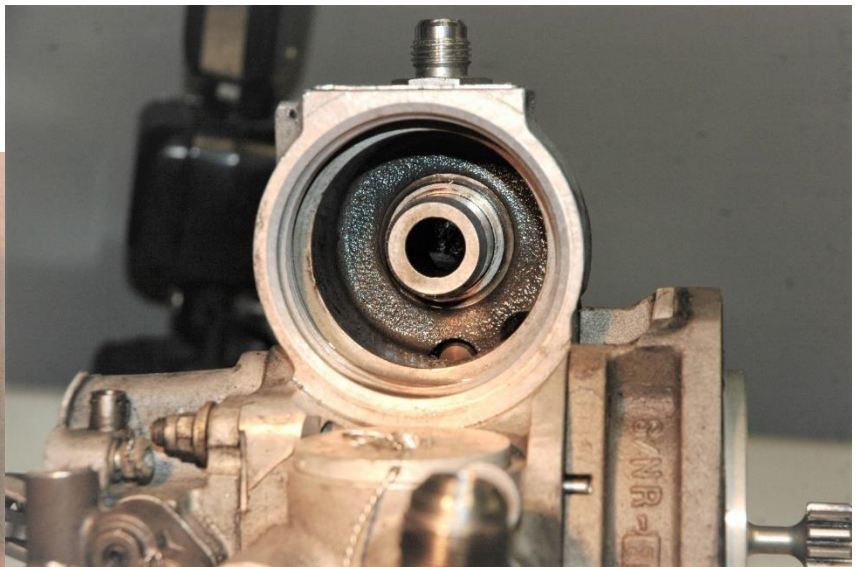
Figure 4  
Fuel pump outlet filter bowl and filter cavity

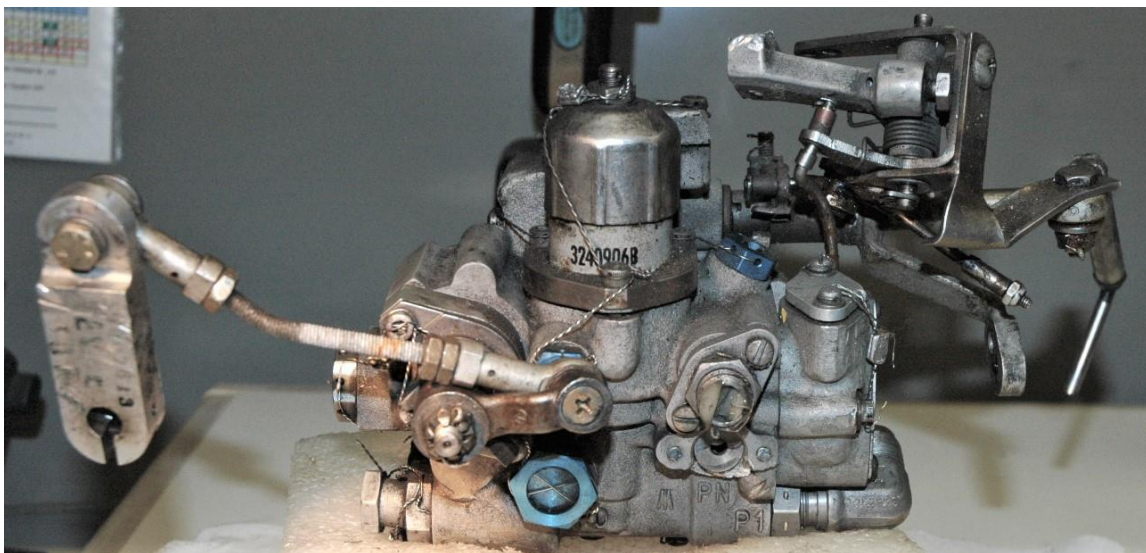
The fuel control unit (FCU) was soiled (figure 5). The FCU drive-body was fractured and was received attached to the fuel pump. Rotation of the FCU driveshaft was restricted due to interference between the governor flyweights and the governor lever (figure 6). The governor lever was bent and side-loaded against one of the eccentric pivot screws. The plastic drive-coupling was present and intact (figure 7). The air adapter inlet was fractured. The condition lever bracket was fractured from the top of the flow-body. The fracture surface was clean with no obvious smearing. The condition lever linkage was deformed at many locations. The throttle lever shaft was bent, and movement of the throttle lever was restricted. The part-power trim stop was in the stowed (flight) position. The minimum pressurizing valve housing was incomplete, and the valve was exposed. The index mark of the Sg dome was in-line with the datum line on the bypass valve collar. The manual override (MOR) lever linkage was attached to the MOR. The MOR was bent, and the deformation restricted the movement of the lever. The MOR stop screw was missing. Lockwire was present at all locations. The lockwire seals were marked AEL (Honeywell).

Figure 5  
Fuel control unit (FCU) as received

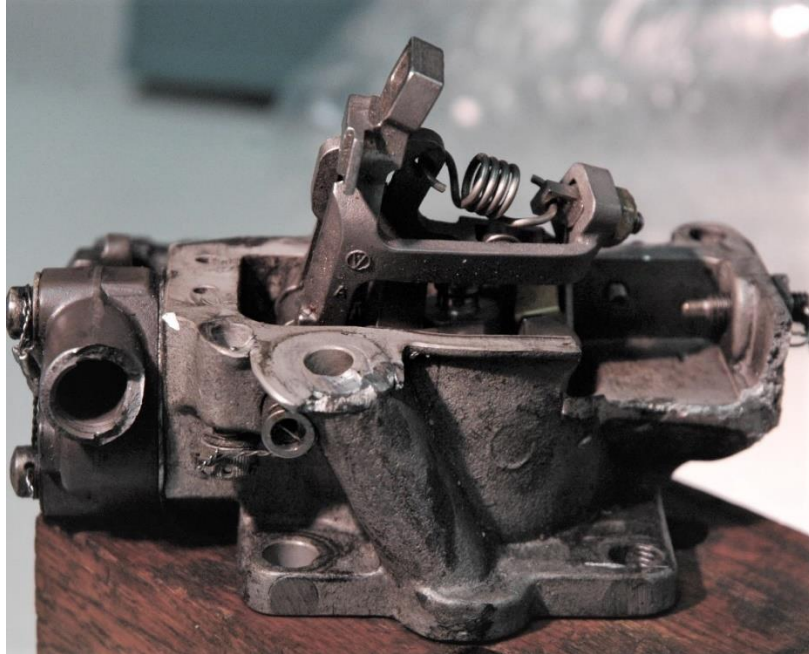
Figure 6  
FCU drive-body

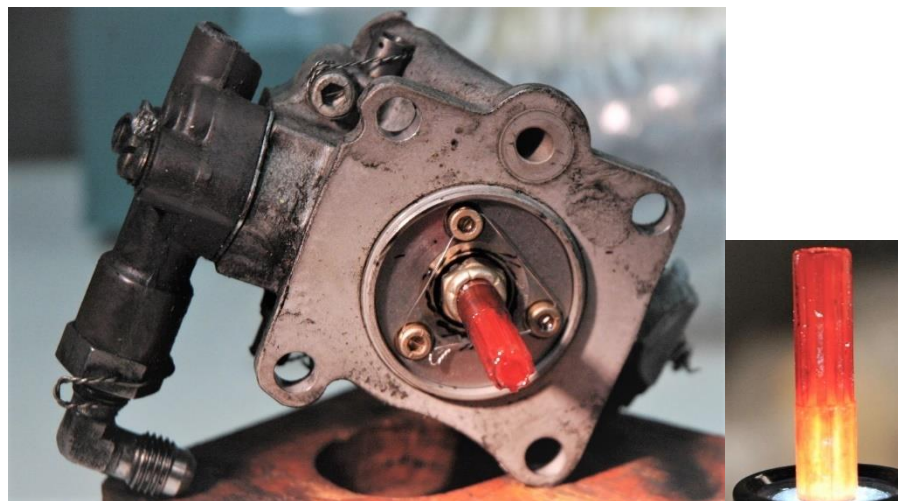
Figure 7  
FCU plastic drive-coupling

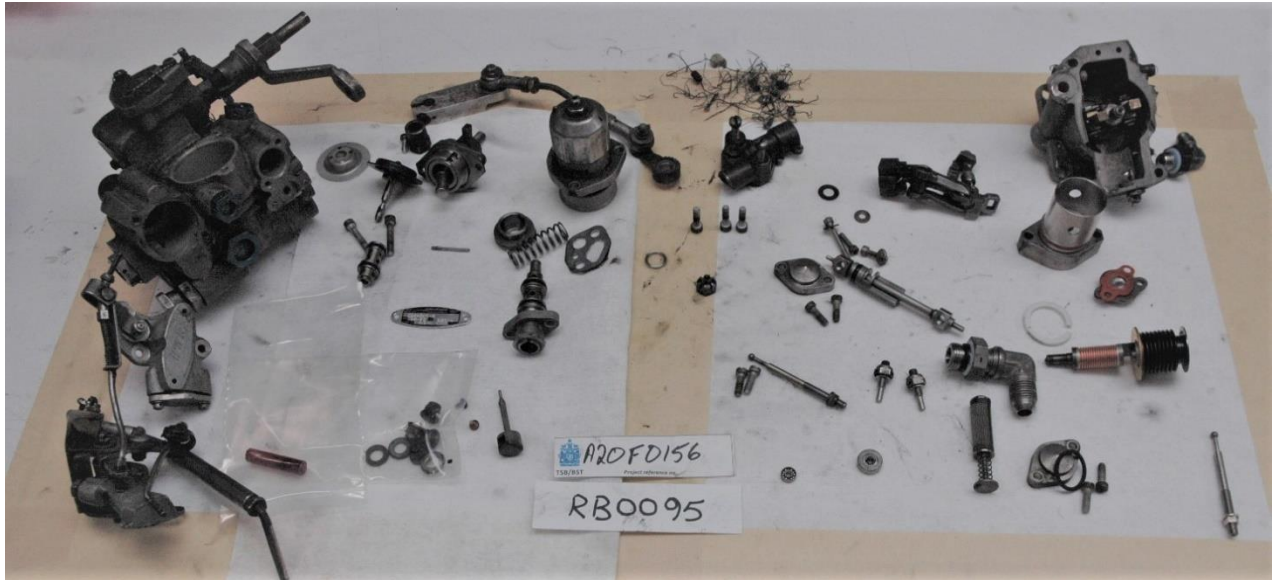
The remains of the FCU were disassembled (figure 8). There was no debris in the Py outlet. There was no obstruction in the Pa bleed, Py orifice and Py bleed. The cut-off valve was correctly orientated. The bypass valve diaphragm was marked 4Q99 indicating that it was manufactured in the 4<sup>th</sup> quarter of 1999 (figure 9) and was not within the 6-year life limit recommended by Honeywell at the time of the event. The rubber of the diaphragm was pliable and there was no evidence of blistering or leaks. There was no debris or broken wires in the fuel inlet screen. There were no burrs or obstructions in the bypass valve sleeve. There was no obstruction in the metering valve and the metering valve fell freely in the sleeve. The torque-tube was tested and confirmed to have no leaks. The ratio levers were straight. The length of the acceleration bellows was within 0.007in of the length marked on the end plate confirming that the acceleration bellows was not leaking (figure 10). The governing bellows was tested and confirmed to have no leaks. There was no marking on the back of the identification plate. This in combination with the marking on the lockwire seals indicates that the FCU had not been serviced since it was issued from Honeywell.

Figure 8  
FCU disassembled

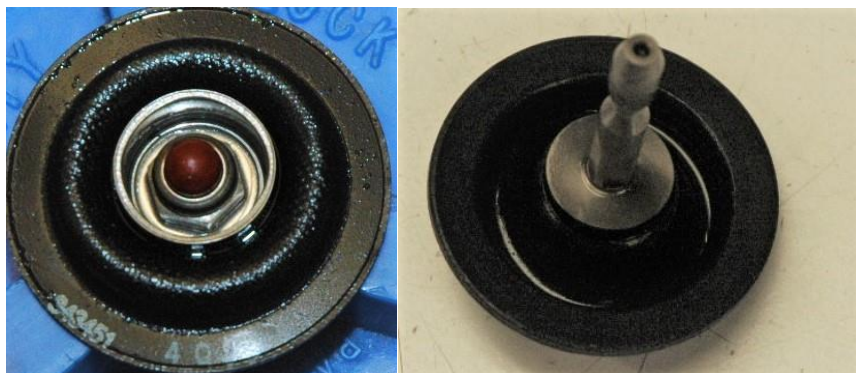
Figure 9  
FCU bypass valve and diaphragm

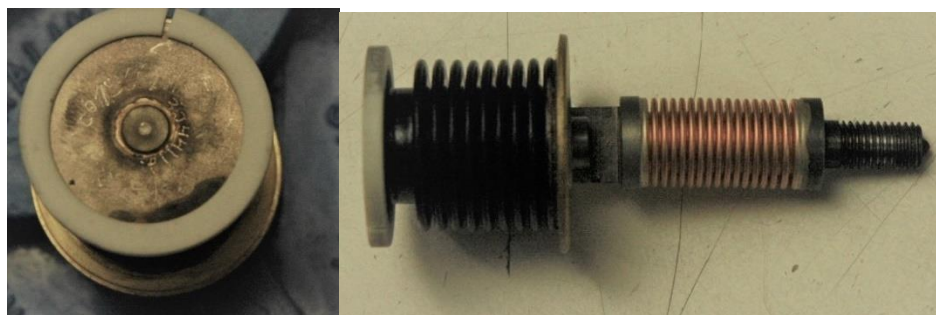
Figure 10  
FCU bellows

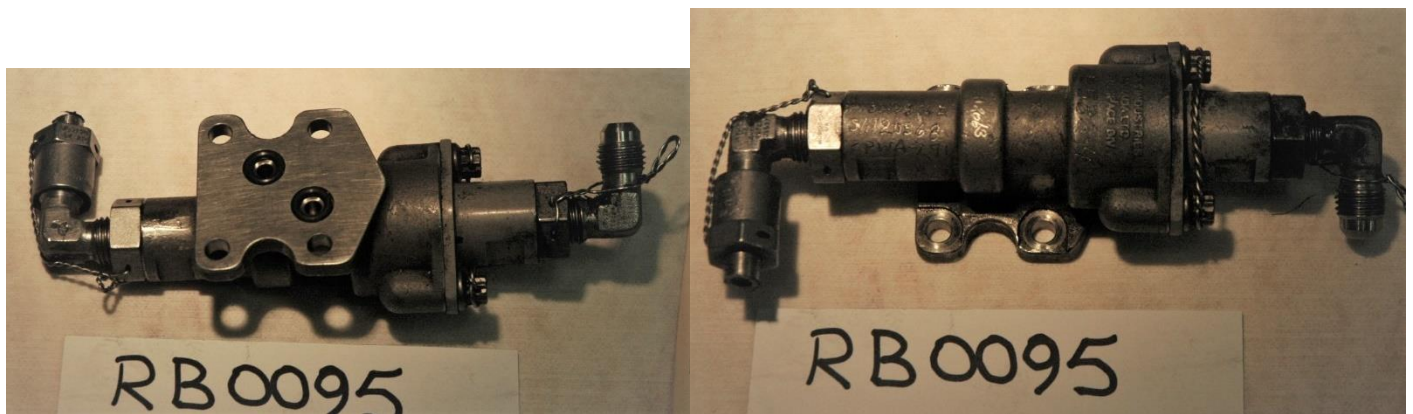
The exterior of the flow divider valve (FDV) was lightly soiled (figure 11). The valve body appeared to be slightly distorted. The packings were present and intact in the bores of the fuel manifold adapter mating face. There were no significant scratches on the adapter mating face. A fractured end of the fuel inlet pipe was present in the nipple at the fuel inlet elbow. Lockwire was present at all locations.

Figure 11  
Flow divider valve (FDV) as received

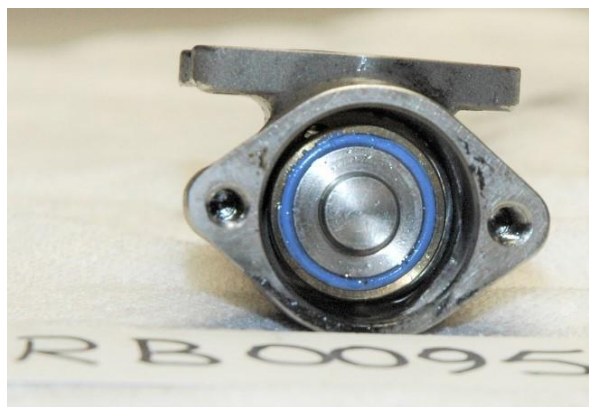
The FDV was disassembled in-order to determine why the dump valve was opening prematurely (figure 12 and 13). The packings were present and intact. The primary valve did not slide freely in the housing due to distortion of the housing.

Figure 12  
FDV primary valve in the housing

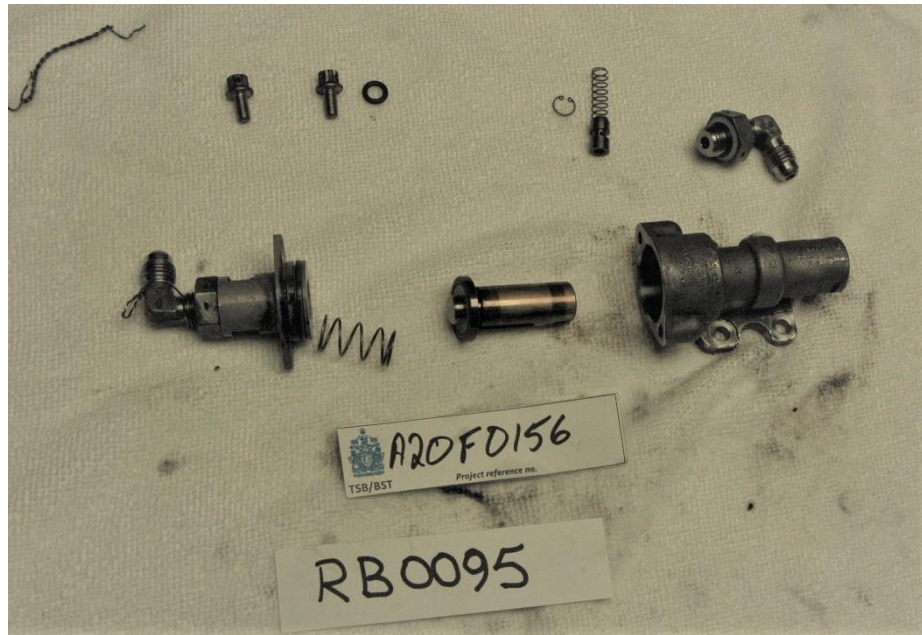
The FDV was tested in accordance with Triumph overhaul manual 73-10-01 Rev. 7. It was not possible to complete the test program because the FDV dump valve was opening before the secondary transfer valve.

Figure 13  
FDV disassembled

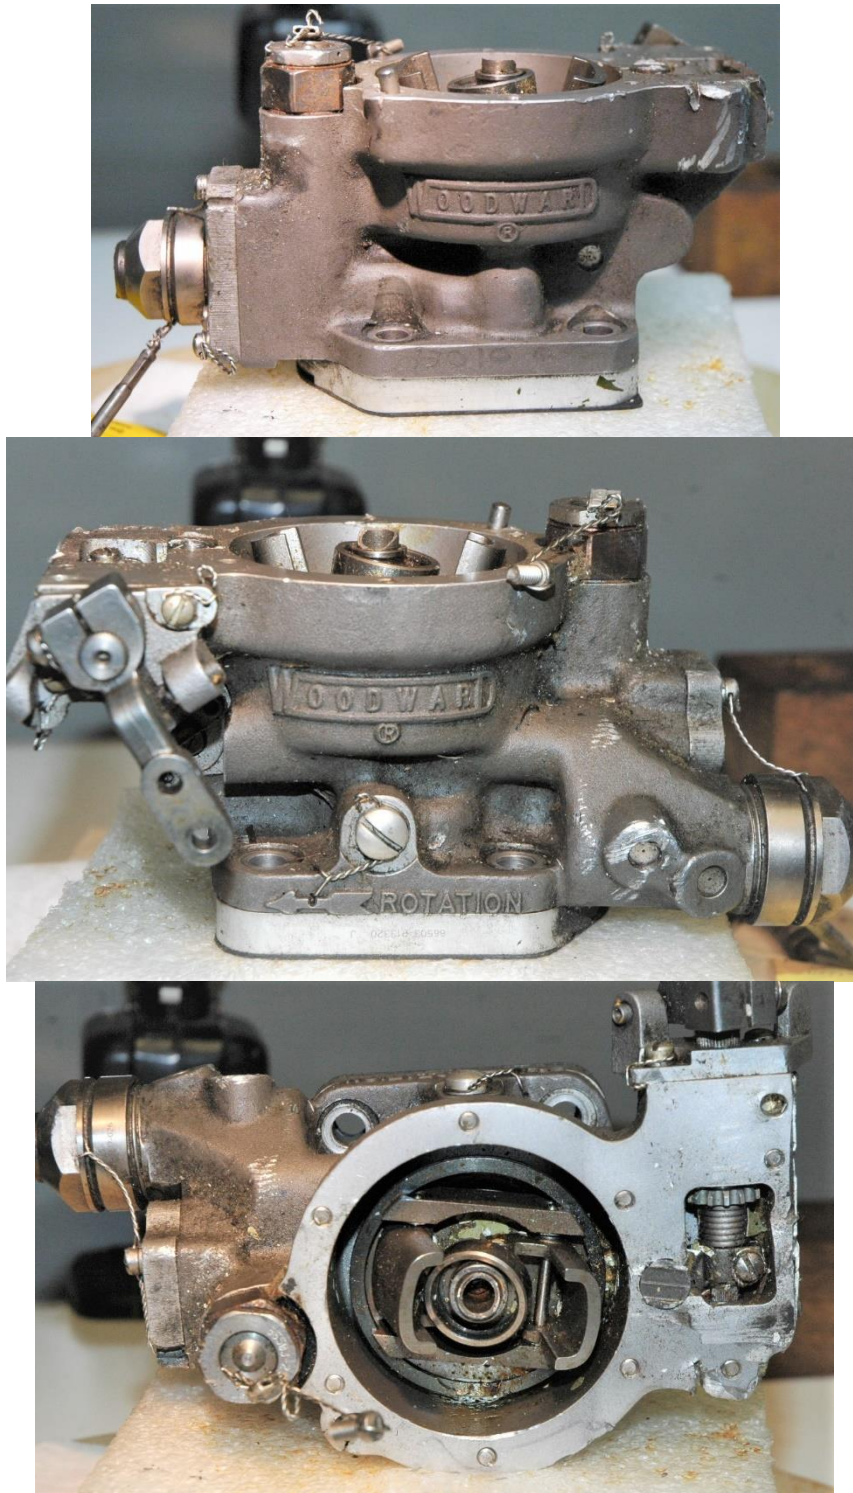
The exterior of the propeller governor (CSU) was soiled, and the cover and the pilot-valve were incomplete (figure 14). The rotation of the driveshaft was restricted. There were numerous impact marks on the main body. The reset post was incomplete. The ends of the beta-valve clevis were missing (figure 15). The reset arm moved freely over the full range and returned under the influence of its spring. The speed setting lever moved freely in the remains of the cover and returned under the influence of its spring (figure 16). The driveshaft bearing inner and outer races were present on the driveshaft, but the balls and ball-cage were missing. There was debris inside the ball-head cavity. A bent section of linkage was attached to the speed-setting lever. The clevis of the beta-valve was fractured. The fracture surfaces were clean with no evidence of smearing. Minor debris was present in the base-gasket screen.

Figure 14  
Propeller governor (CSU) as received

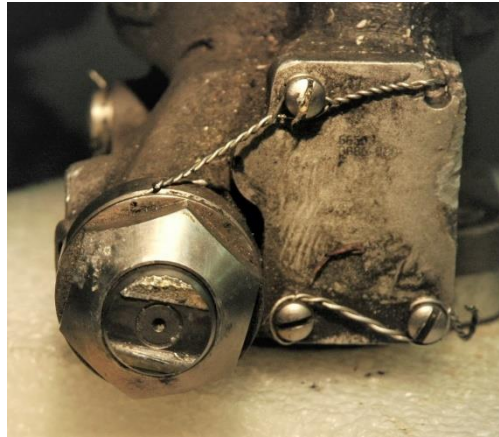
Figure 15  
CSU beta-valve

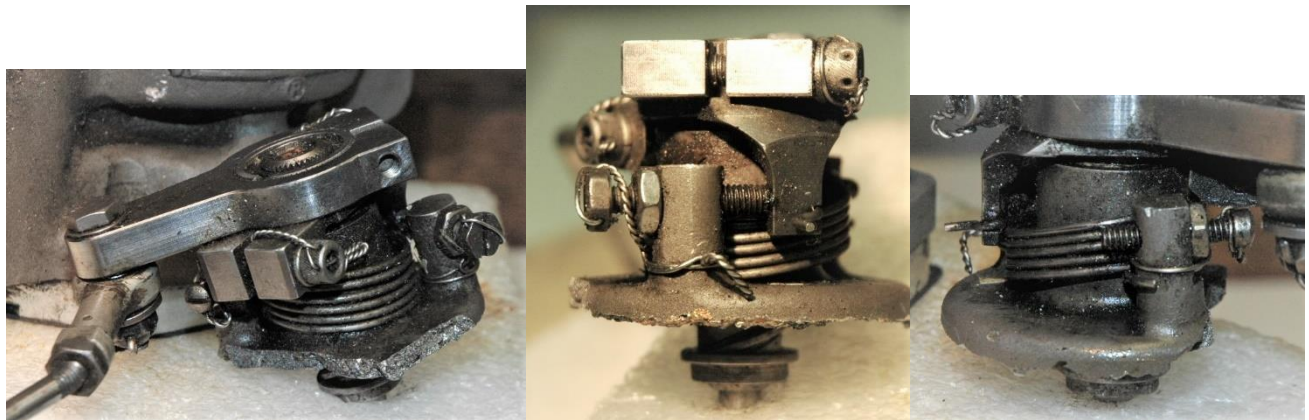
Figure 16  
CSU speed setting lever and remains of the cover

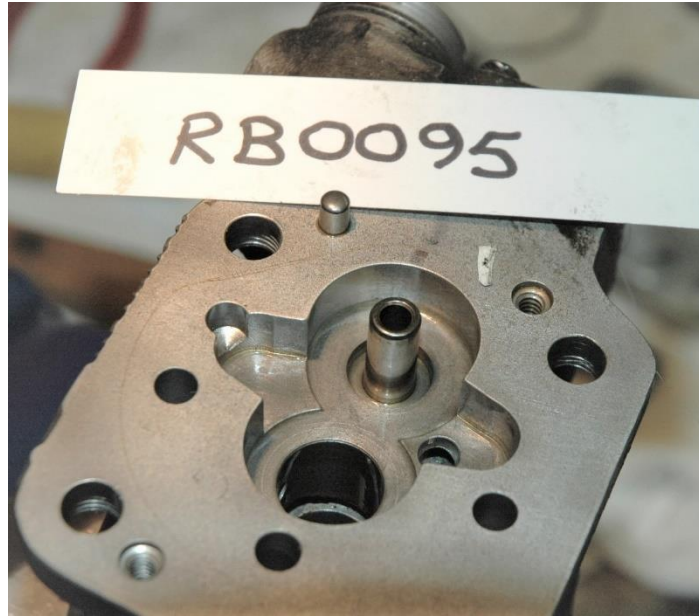
The remains of the CSU were disassembled (figure 17). The base-packing was present and intact (figure 18). There was gear-wipe evident in the driven-gear pockets (figure 19). There were no scars in the ball-head cavity. The ball-head pins, bearings and retaining clip were present. The toes of the ball-head were present and intact, and the flyweights fell freely and evenly. Organic debris was present under the ball-head. Organic debris was present in the reset post pocket. Surface corrosion was present on the lower end of the pilot-valve. There was no surface corrosion observed on the remains of the beta-valve.

Figure 19  
CSU gear pockets

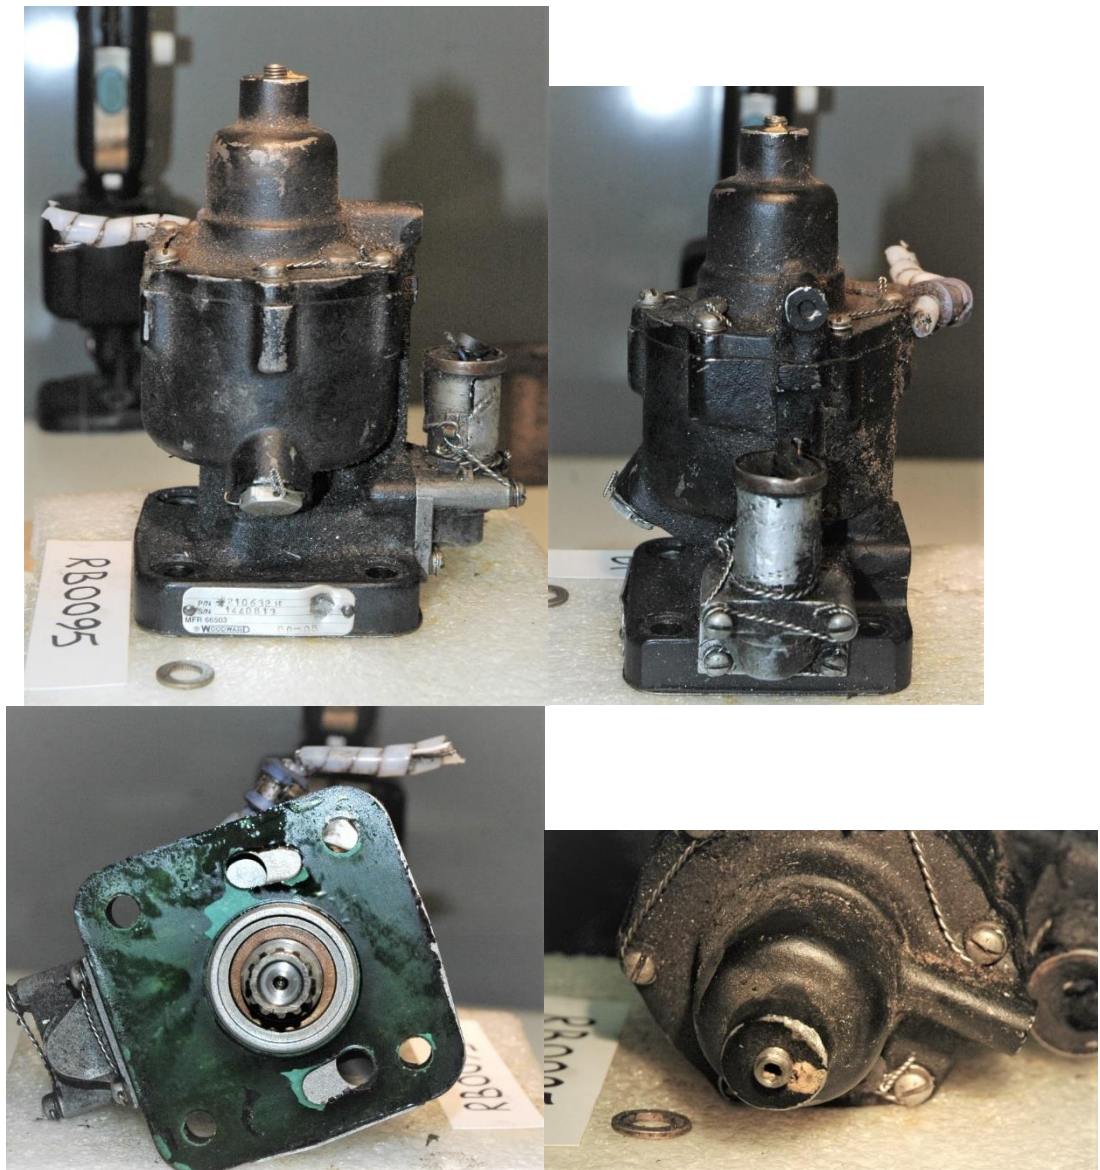
The exterior of the over-speed governor (OSG) was soiled (figure 20). The driveshaft turned with slight resistance initially, but freed-up after a few rotations. There was broken yellow anti-tamper paint on the pilot-valve stop screw. There was a dent in the identification plate. The identification plate was marked 00-08 indicating that the OSG had been serviced in August 2000. The end of the reset solenoid electrical connector was missing.

The unit was received and an as received visual inspection was conducted. During the inspection it was noted that all lockwire, seals, and torque sealant were foreign indicating the originals had been removed after leaving the Woodward facility. Also, it was noted that the unit was dirty and had a damaged reset solenoid. However, the damage was not significant enough to prevent running an as received test on the unit (Figure 20).

Figure 20  
Over-speed governor as received
