**NATIONAL TRANSPORTATION SAFETY BOARD**  
**Office of Aviation Safety**  
**Washington, D.C. 20594**

**POWERPLANT GROUP CHAIRMAN'S FACTUAL REPORT**

**NTSB No: CEN20LA402**

Aircraft: Piper PA-46-310P, N236KM

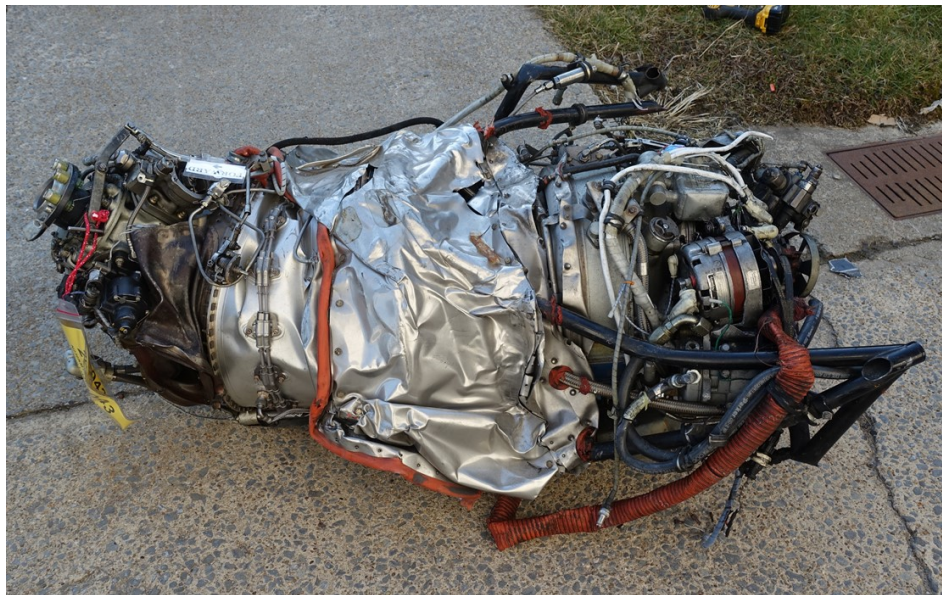
**Photo 2- Left Side of Engine, as Received**

The engine was secured in a shipping container when the team arrived at PWC- Bridgeport (**Photo 1**). Due to the condition of the engine, the teardown was completed on an outdoor concrete pad (**Photos 2, 3, and 4**). The center firewall was deformed around the engine and multiple airframe components including: the starter, alternator, air conditioning compressor, wiring, and parts of the mount structure remained attached to the engine. A cutting wheel and saw were used to remove some of the airframe components so the external engine condition could be documented (**Photo 5**).

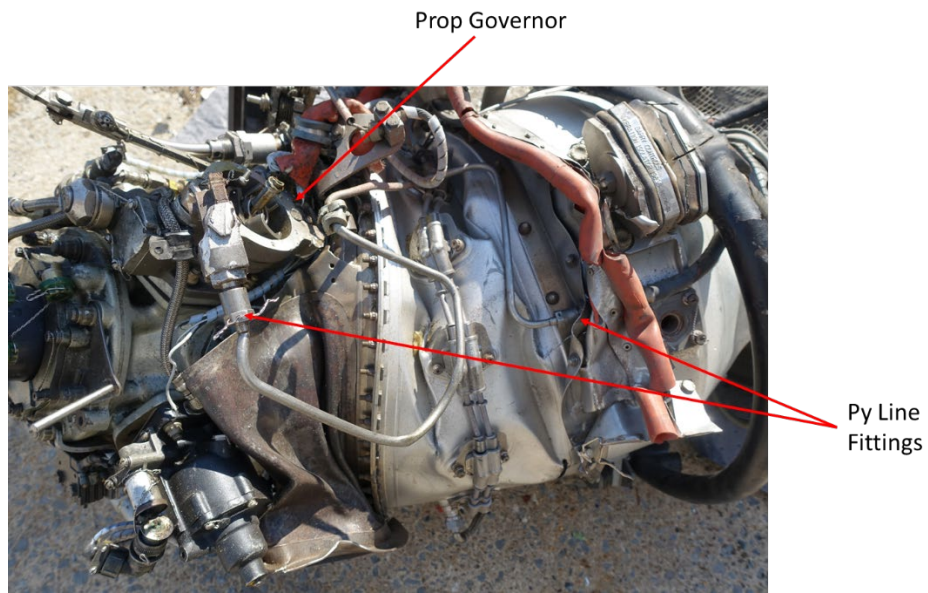
**Photo 6- Turboprop Governor and Py Line Fittings**

There were no indications of uncontained engine failure or fire damage. The engine cases exhibited severe impact damage and buckling. The reduction gearbox (RGB) was bent upwards and to the left relative to the engine centerline, consistent with a nose down impact. The top section of the turboprop governor housing was fractured but remained attached to the prop control linkage. The Py<sup>3</sup> line was complete from the turboprop governor to the FCU. The Py line fittings at the turboprop governor, on both sides of the center firewall, and the FCU were secure but could be backed off without a wrench (finger tight torque) (**Photo 6**). The P3<sup>4</sup> line to FCU fitting was also finger tight. The reversing linkage was deformed but was complete except for the cam box which was fragmented. The FCU was partially separated from the fuel pump and remained tethered to the engine by the control lines. The chip detector plug was removed from the reduction gearbox (RGB) and the oil filter was removed from the inlet case and there was no debris accumulation observed (**Photo 7**). The fuel filter was removed from the fuel pump and appeared discolored but there were no obstructions and the fuel smelled normal (**Photo 8**). There was fuel remaining in the filter bowl and a small amount of shiny particulate was visible in the fuel when viewed under light.

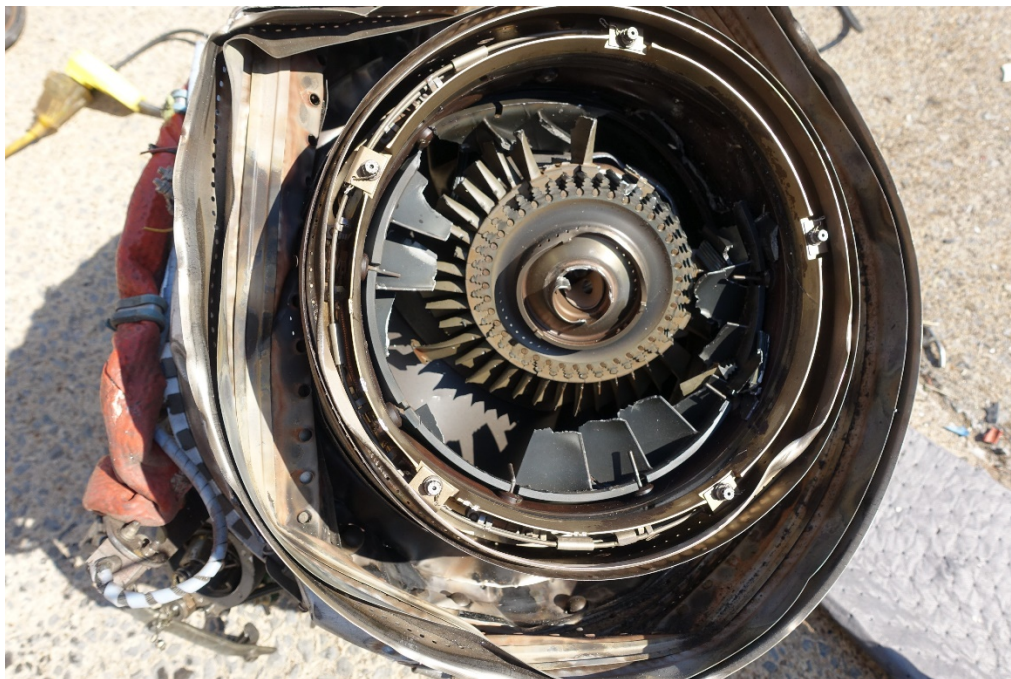
**Photo 9- Power Turbine Rotor and Nozzle Impact Damage**

The PT rotor disk blades and nozzle vanes were fractured. The PT shaft was deformed/bent (**Photo 9**). All fracture surfaces that were visually examined appeared rough and dimpled consistent with overload failure.

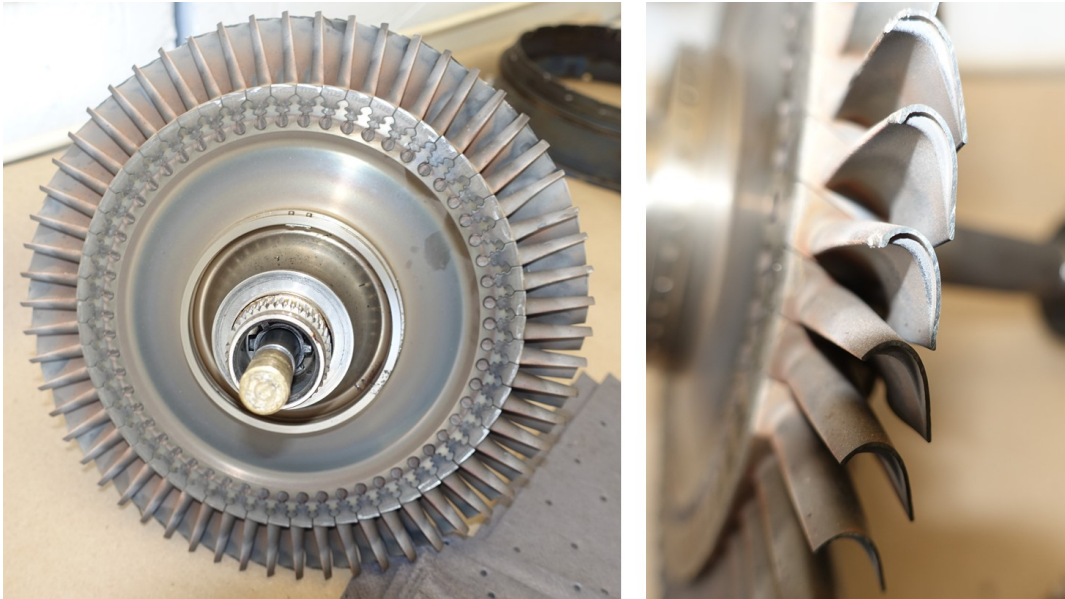
**Photo 10- (L) CT Rotor Disk, (R) Blade Leading Edge Close up**

The CT rotor disk blades and nozzle vanes were all present and complete (**Photo 10**). The CT vane shroud had static CT rotor blade tip impact marks from the 2 to 12 o'clock positions (**Photo 11**). The forward face of the CT blade platform also had static witness marks from contact with CT vane ring (**Photo 12**).

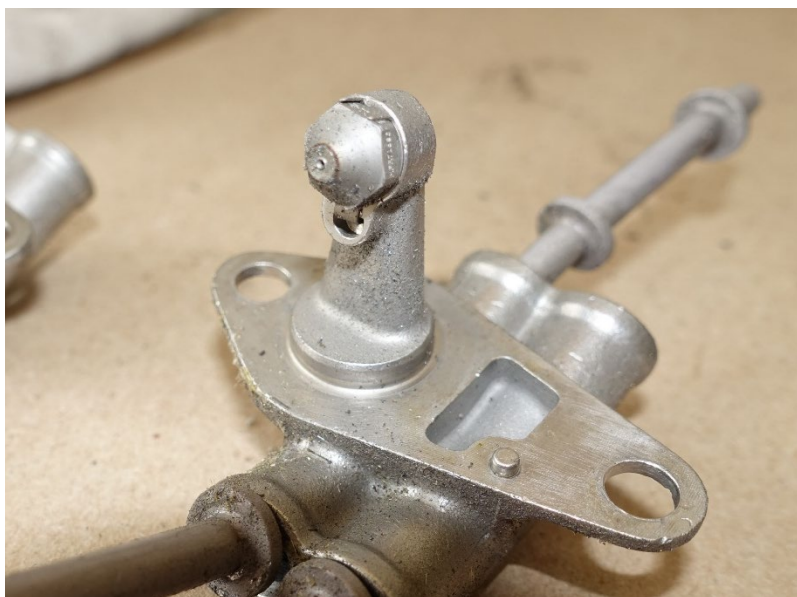
**Photo 13- Fuel Nozzle**

The combustion liner was deformed but there was no evidence of thermal damage, uneven wear, or fuel nozzle streaking. Two fuel nozzles were removed, and no coking was visible (**Photo 13**). The igniter plugs were removed and functionally checked on a bench with a slave exciter box and both igniters sparked normally.

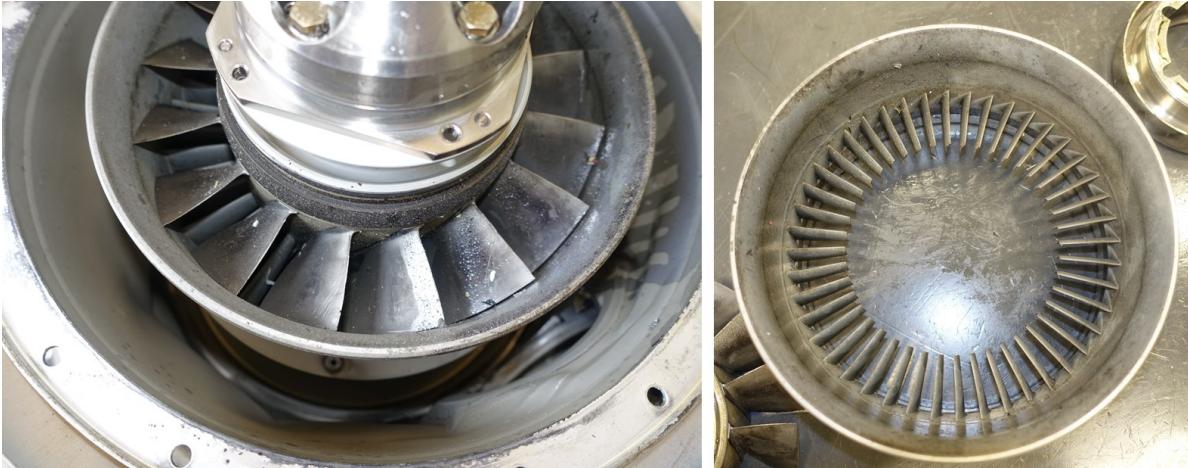
**Photo 14- (L) Compressor 1<sup>st</sup> Stage Rotor Blades, (R) Compressor 1<sup>st</sup> Stage Stator Vanes and Case**

All three stages of axial compressor rotor blades and stator vanes were intact and in good condition. The 1<sup>st</sup> stage rotor had an oily residue and debris on the forward face of the blades (**Photo 14**). The stator case lands did not exhibit circumferential rub damage or witness marks. The centrifugal impeller was in good condition (**Photo 15**). The No. 1 and No. 2 bearings were oil wetted, and the ball/roller elements spun smoothly.

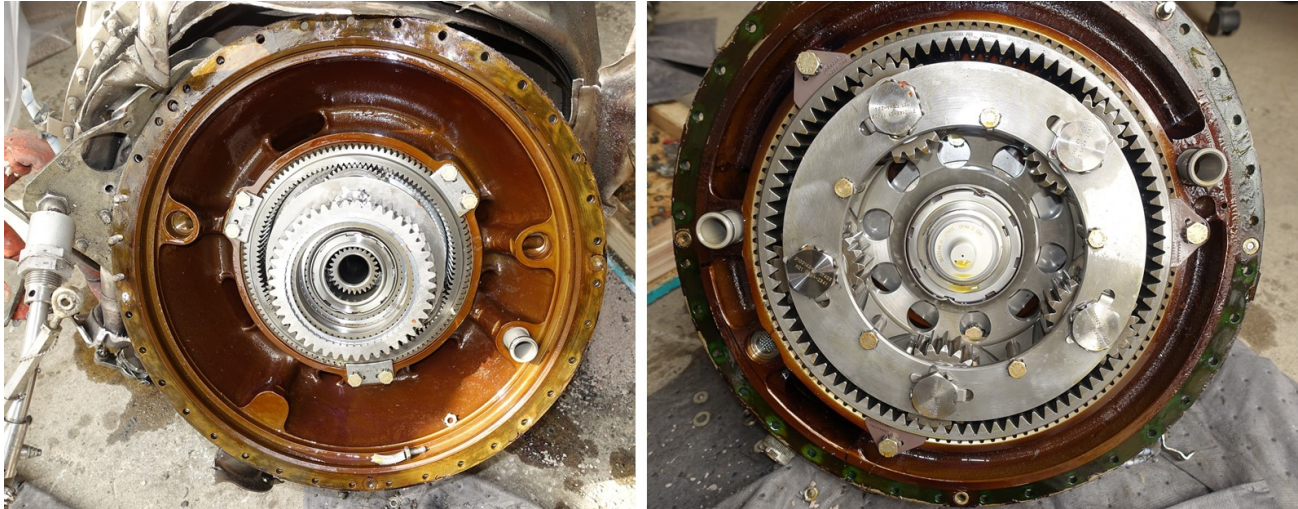
**Photo 16- Reduction Gearbox**

The RGB sun, planet, and ring gears were all present, and unremarkable (**Photo 16**). After removal, the front RGB was rotated by hand and all gearing rotated smoothly. The rear RGB could not be rotated due to impact deformation.

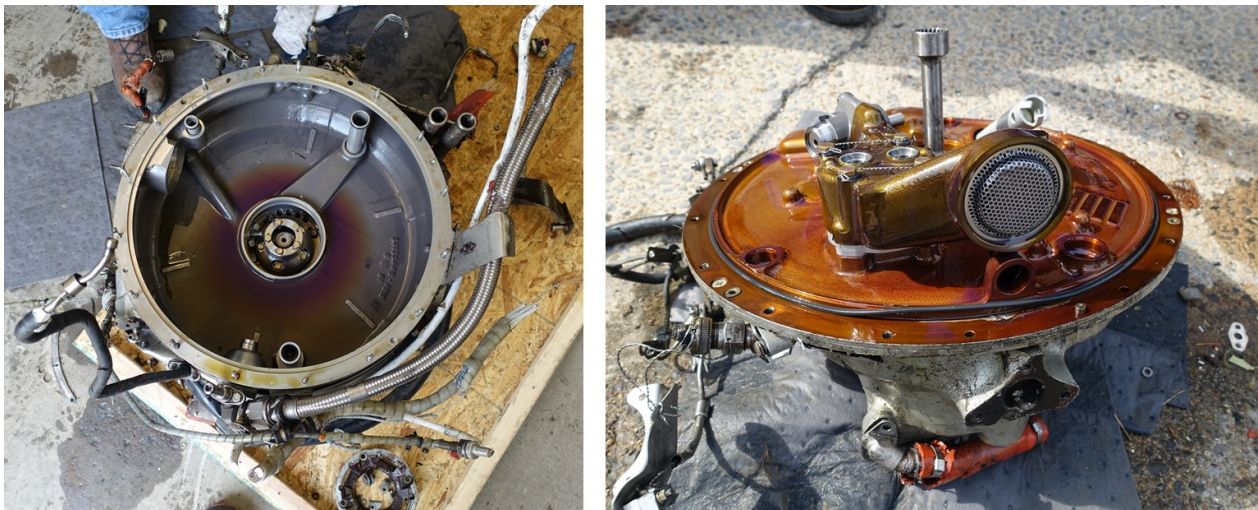
**Photo 17- Accessory Gearbox**

The accessory gearbox coupling shaft was intact and after removal was manually rotated with concurrent rotation of all AGB pad splines. The pressure pump oil screen was clean and there was residual oil remaining the AGB cavity (**Photo 17**).

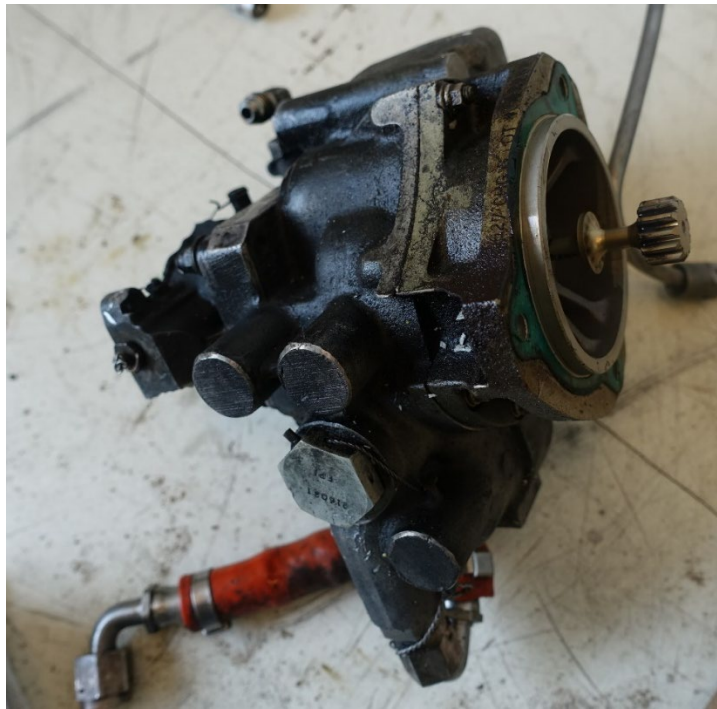
**Photo 18- Fuel Pump Spline**

The fuel pump drive spline was intact and could be rotated by hand (**Photo 18**).

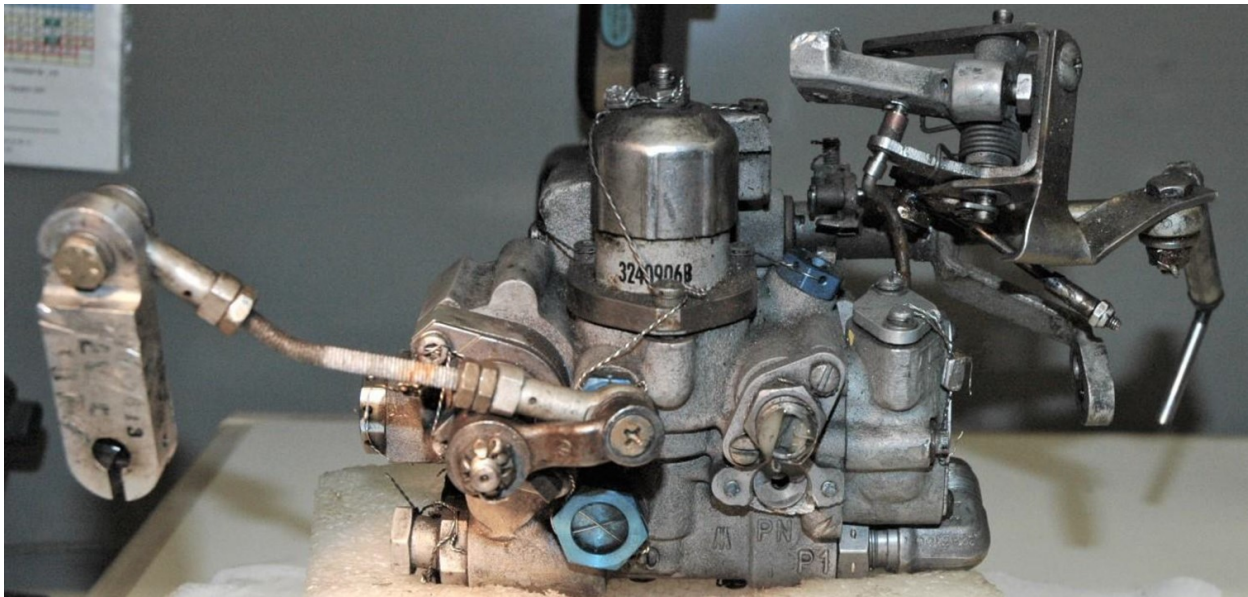
**Photo 19- Fuel Control Unit, as Received at PWC (Photo Courtesy of PWC)**

The FCU and fuel pump were shipped as an assembly. The FCU, part number (P/N) 3122696-03, serial number (S/N) C25444, was separated from the fuel pump for visual examination (**Photo 19**). The FCU drive-body was fractured, and the input drive shaft rotation was restricted due to interference between the governor flyweights and the governor lever. The condition lever linkage was deformed. The throttle lever shaft was bent, and movement of the lever was restricted. Due to impact damage, the FCU could not be bench tested so it was disassembled and there were no internal obstructions or anomalies noted that would have affected FCU operation (**Photo 20**).

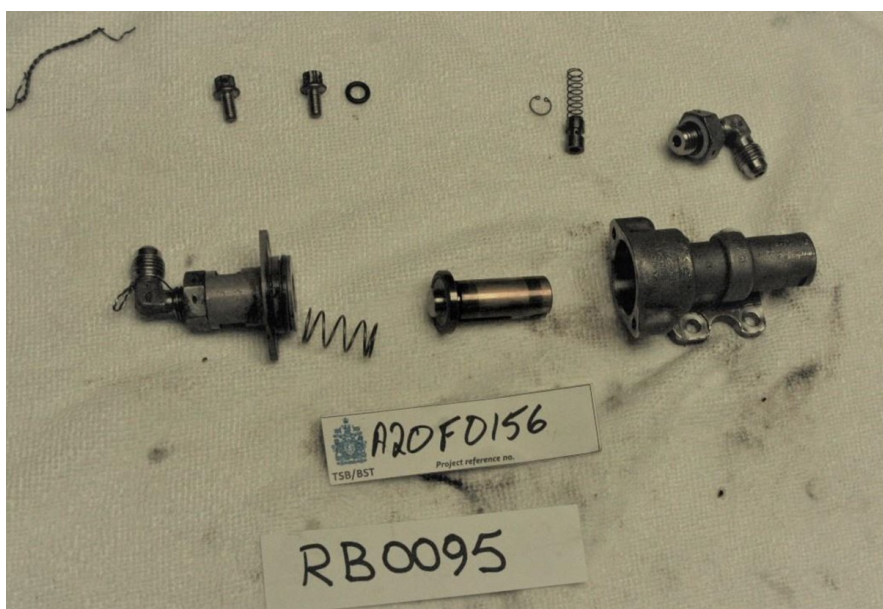
**Photo 22- Flow Divider Valve Disassembled (Photo Courtesy of PWC)**

The FDV, P/N 3019906, S/N 20368, body appeared slightly distorted. The fuel manifold adapter face did not exhibit scratches/deformation and bore o-rings were present and in good condition. The FDV was tested in accordance with Triumph overhaul manual 73-10-01 Revision 7. The test procedure could not be completed because the dump valve opened before the secondary transfer valve. The FDV was disassembled, and the primary valve was unable to slide freely in the FDV housing due to deformation (**Photo 22**). There were no preimpact related anomalies noted that would have affected engine operation.

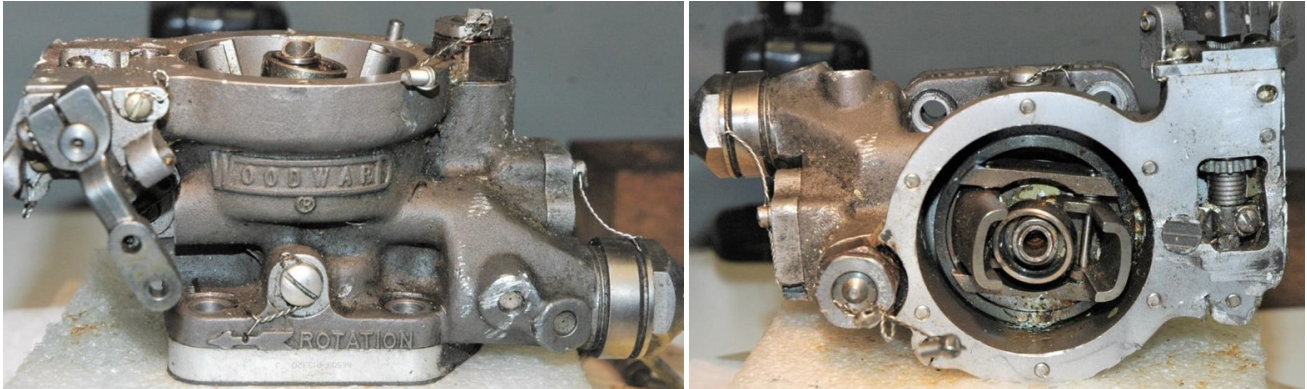
**Photo 23- Turboprop Governor, as Received at PWC (Photos Courtesy of PWC)**

The turboprop governor<sup>5</sup>, P/N 3035926, S/N 12350694AE, exhibited significant impact damage (**Photo 23**). The turboprop governor cover and pilot-valve were missing material. The input driveshaft rotation was restricted. The reset arm and speed setting levers moved freely and returned to position under influence of the spring. The turboprop governor could not be bench tested due to the impact damage, so it was disassembled, and no internal anomalies were noted during disassembly that would have affected turboprop governor operation (**Photo 24**).

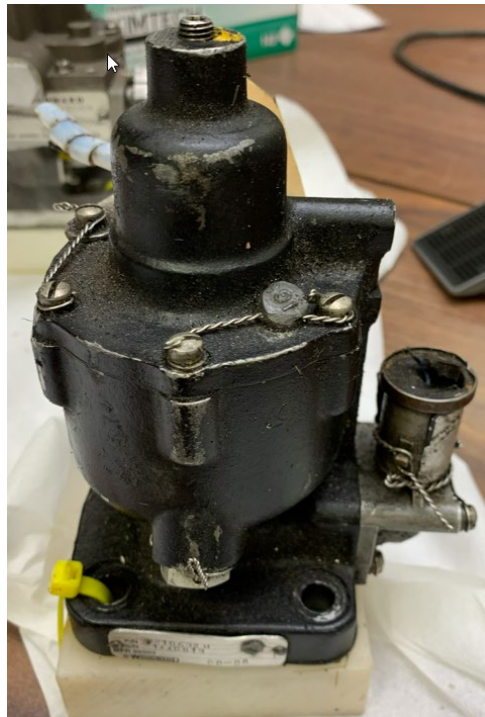
**Photo 25- Overspeed Governor, as Received at Woodward**

The overspeed governor, P/N 210632, S/N 1440813, was tested at Woodward in accordance with test specification procedure (TSP)-847 Revision AC (**Photo 25**). All test points met test specification except “maximum speed” and “internal leakage.” According to Woodward, the maximum speed measurement was within the range of what would be expected after operator field adjustment. During bench testing, there was some external leakage observed that was consistent with impact damage and did not affect governor operation.
