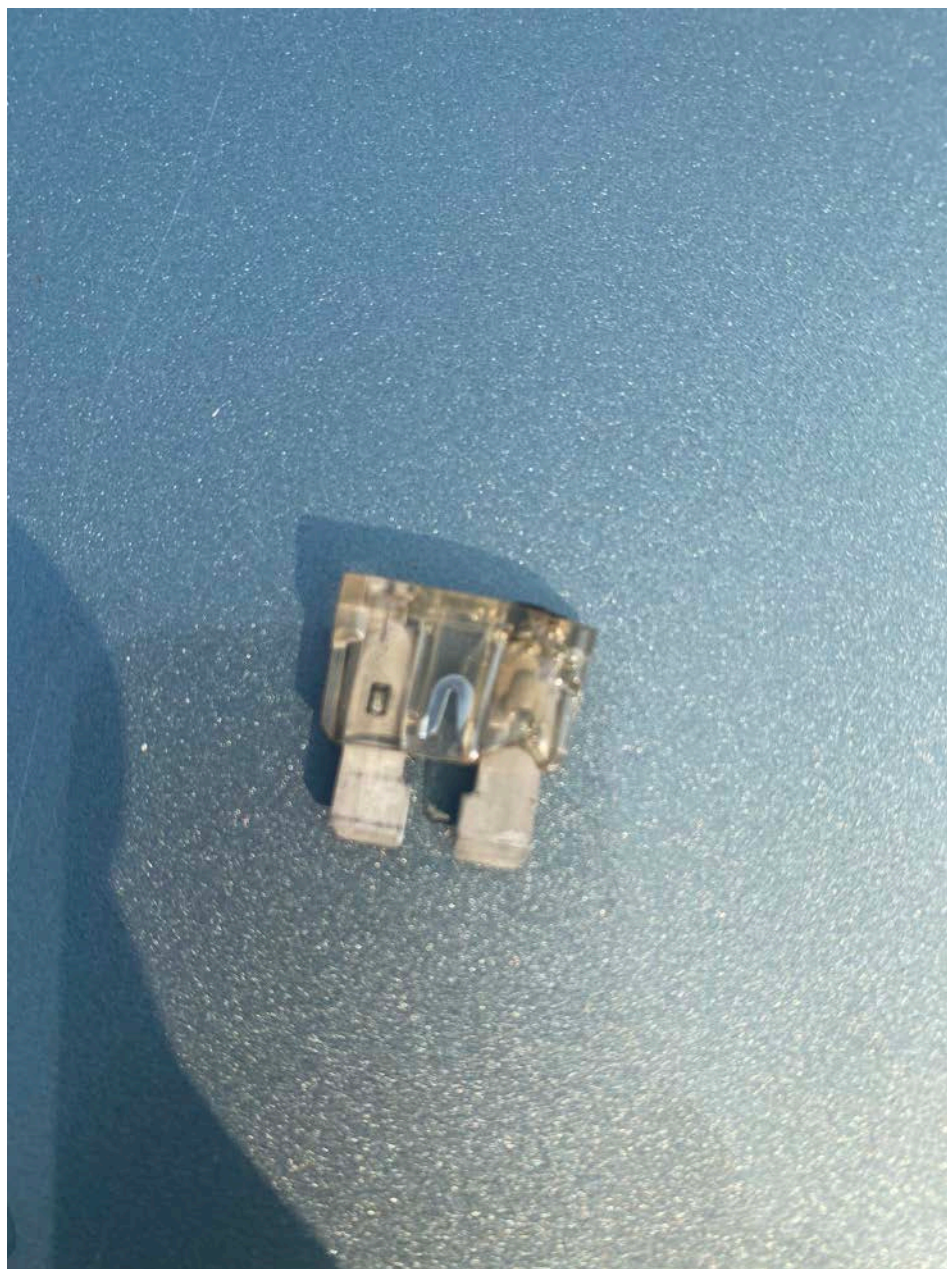
**Photo 3 – Failed Fuse (photo provided by Viking Aircraft Engines)**
