Rotech Flight Safety Ltd. 6235 Okanagan Landing Road  
Vernon, BC V1H 1M5 Canada

## **INVESTIGATION REPORT**

| <b>Date of accident:</b> | September 24 2020 | <b>NTSB file number:</b> | CEN20LA417 |

| <b>Aircraft Make:</b> | Quick Silver | <b>Aircraft registration:</b> | N9045Z |

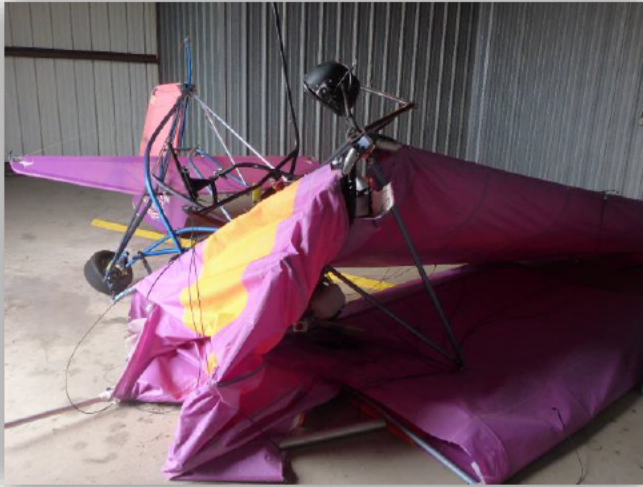
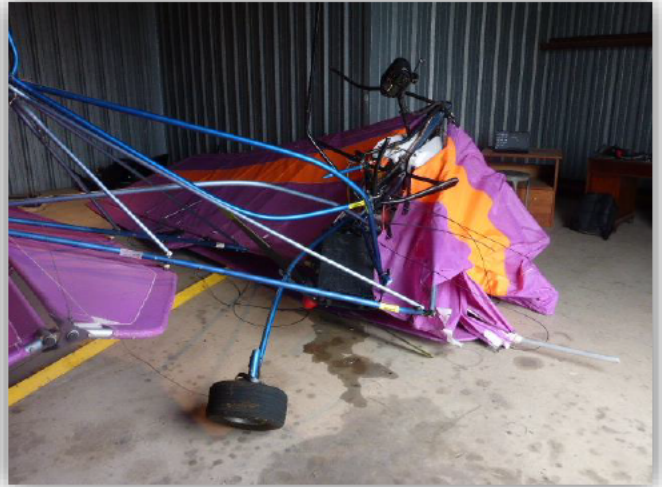
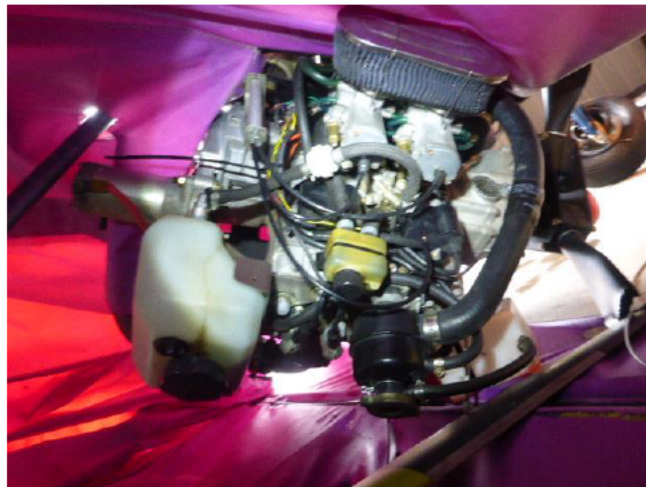
Due to the relocation and storage position of the accident aircraft, the Rotax 582 Mod 90 engine was found inverted (cylinder head and spark plugs facing down). The normal position of the engine in this type of aircraft is with the cylinder head and spark plugs facing upward. The engine and its components appeared to be undamaged and in good physical condition.

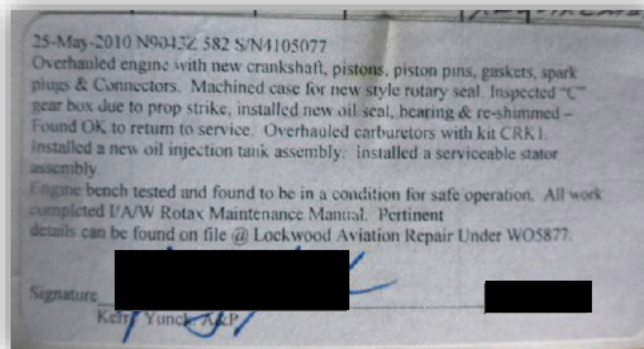
The engine installed in the accident aircraft was a Rotax 582 Mod 90 65 hp, 2-cylinder, 2-stroke liquid-cooled engine. The Rotax 582 is a 48 kW (65 hp) two-stroke, two-cylinder, rotary intake valve, oil injected, liquid-cooled, gear reduction-drive aircraft engine manufactured by BRP-Rotax GmbH & Co. KG. It is for use in non-certified aircraft operating in day visual flight rules. Based on the engine Serial number (4105077), this Rotax 582 Mod 90 engine was manufactured on September 18th, 1992. This would make the engine just over 28 years old from the date of manufacture. During the examination of the engine's maintenance records, it was noted that the engine was overhauled on May 25th, 2010, by a designated Rotax overhaul facility.

In the Rotax 582 Maintenance manual section 10.2) Maintenance schedule page 10-2, it states a general overhaul of the engine is to be carried out every 5 years or every 300 hours whichever comes first. According to the Rotax 582 Maintenance manual, the engine should have received an additional 3 overhauls due to calendar time (every 5 years). No other records of an overhaul were found before or after this May 25th, 2010 log book entry date. The total engine hours since last overhaul (TTSOH) are unknown.

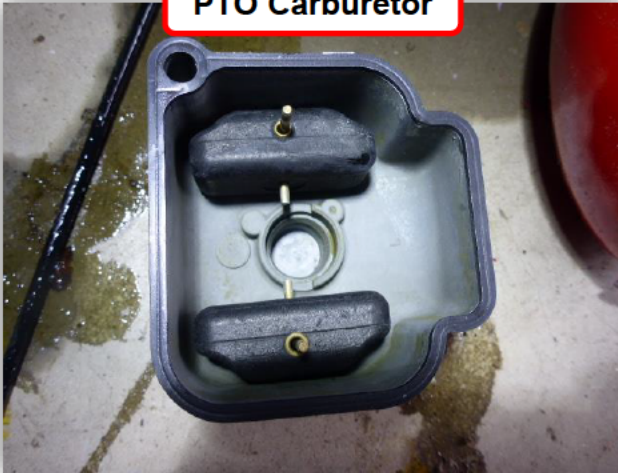
**PTO Carburetor**

**Carburetors:** Both the MAG and PTO carburetor float bowls were removed and internally examined for condition, contamination or any other anomalies. Due to the engine sitting inverted, no fuel was found in either the MAG or PTO float bowls. No contamination or anomalies were observed.

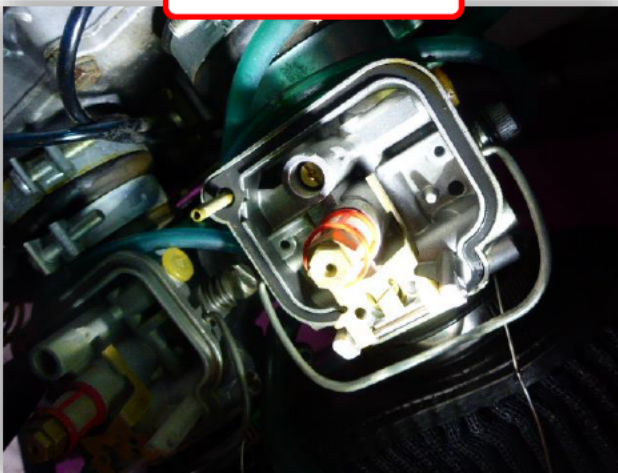
**PTO Carburetor**

The main jets of both the MAG and PTO carburetors were inspected for the correct sizing and blockage. No anomalies or obstructions were found with either of the MAG or PTO main jets and they were to proper size.

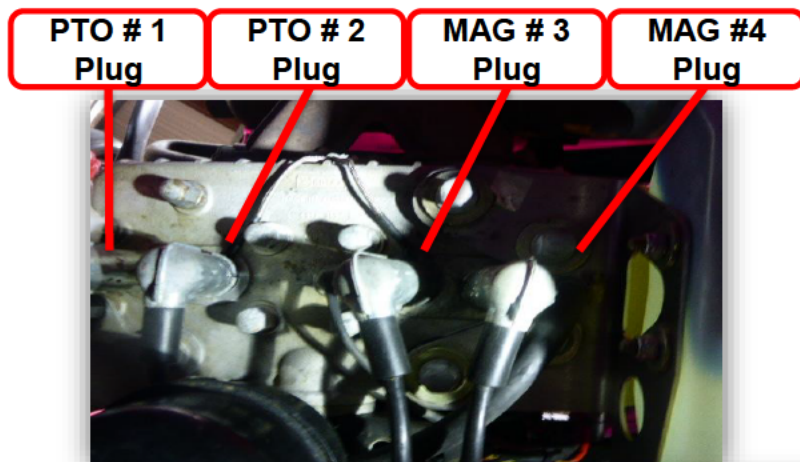
**Spark Plugs:** The spark plugs were removed from the engine and examined for condition and proper type.

- NGK BR8ES
- Good physical condition
- Electrode gap of 0.020
- Non-removable resistor cap
- No anomalies seen

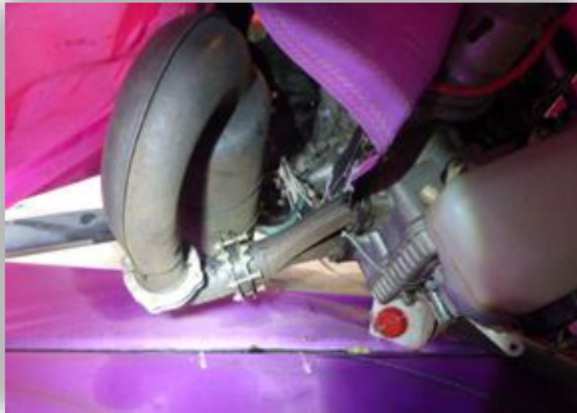
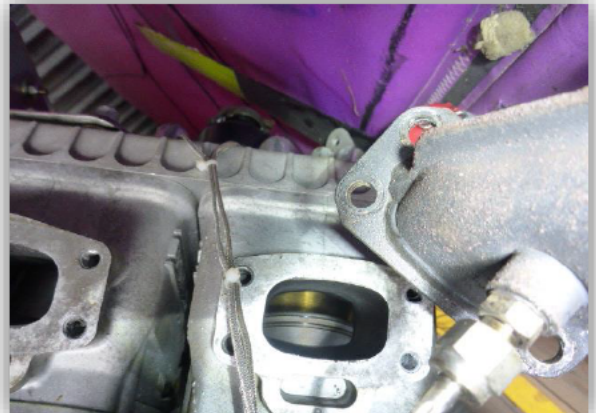
**Exhaust system:** The exhaust system was inspected for condition, modification and defects. No anomalies were seen with the exhaust system. The exhaust system was removed from the engine to inspect the combustion chamber of the MAG and PTO cylinders.

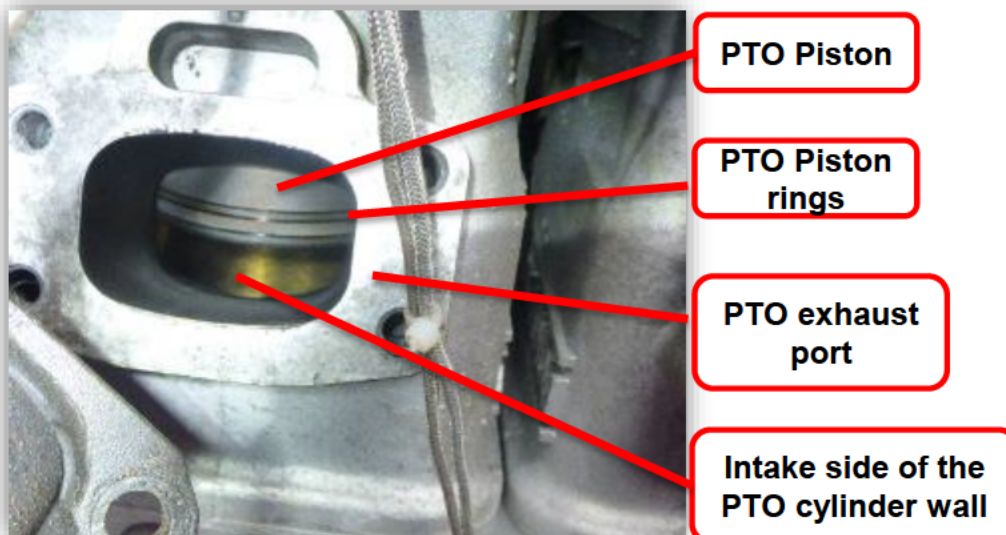
**PTO Piston and Cylinder:** With the exhaust cylinder ports opened, the exhaust side of the PTO piston and intake side of the cylinder could be examined for any anomalies. No vertical scoring or transfer of metal was seen with the PTO piston or the PTO cylinder walls. Both piston rings were free within the respective land grooves of the piston. The crankshaft was rotated to expose the intake side of the cylinder walls. No anomalies were seen with the PTO piston or cylinder.

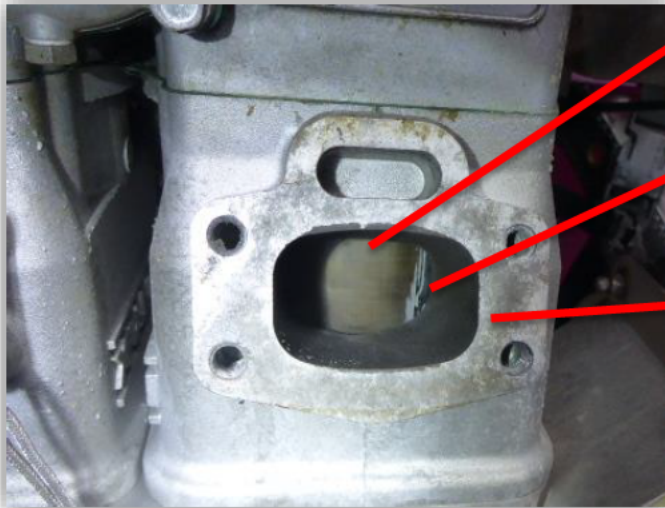
**MAG  
Piston**

**MAG Piston and Cylinder:** With the exhaust cylinder ports opened, the exhaust side of the MAG piston and intake side of the cylinder could be examined for any anomalies.

**Scoring and metal  
transfer seen on corner  
of the piston**

The Rotax 582 engine that was installed into the accident aircraft appeared to have suffered a MAG piston “cold seizure” that may have resulted in a complete or partial loss of engine power.

A cold piston seizure is defined as: Thermo-imbalance of pistons and cylinder due to improper warm-up of engine and excessive temperature differences of the intake and exhaust of engine. The result is the piston expands faster than the cylinder wall. This type of damaged can be identified by the scoring and metal transfer on the corners of the piston and intake side of the cylinder wall.

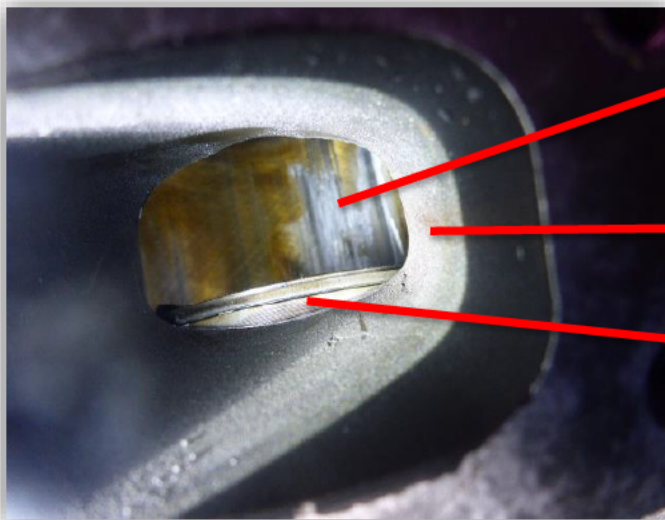
Vertical Scoring and metal transfer was seen on the side of the MAG piston. The crankshaft was rotated and scoring and metal transfer was also found on the intake side of the MAG cylinder wall.

**Vertical scoring and  
metal transfer seen on  
the intake side of the  
MAG cylinder wall**

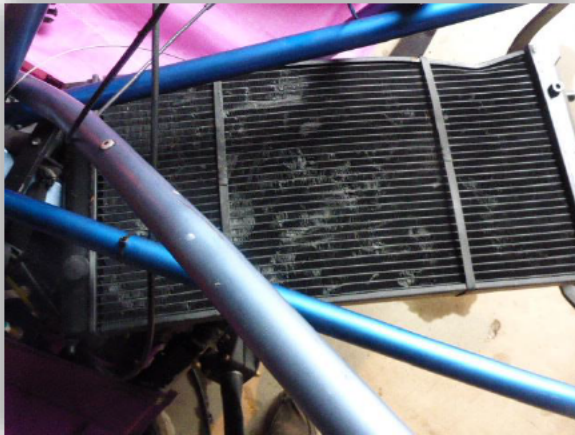
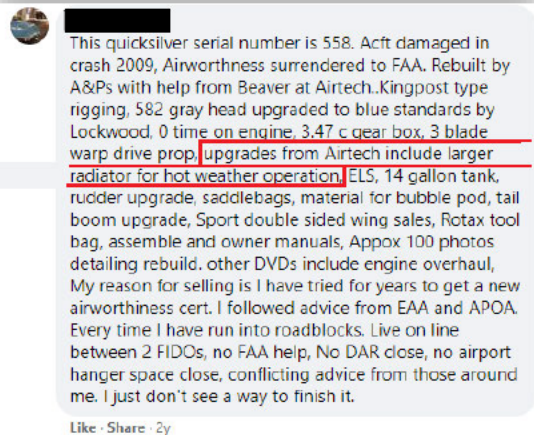
**Coolant System:** The Rotax 582 Mod 90 features liquid cooled cylinder heads, cylinders, water pump and an externally mounted coolant radiator. The coolant radiator was inspected and found to be approximately 1.5 times larger than the Rotax coolant radiator. This larger radiator would have required a longer warm up period in cooler climates. The owner stated that the larger radiator was for hot weather operation.

The engine coolant system radiator was approximately 1.5 times the size (larger) than the Rotax coolant radiator and would have resulted in a longer warm up period in a colder climate.
