**Photo 1 – N81624 at the accident site shortly after the forced landing**

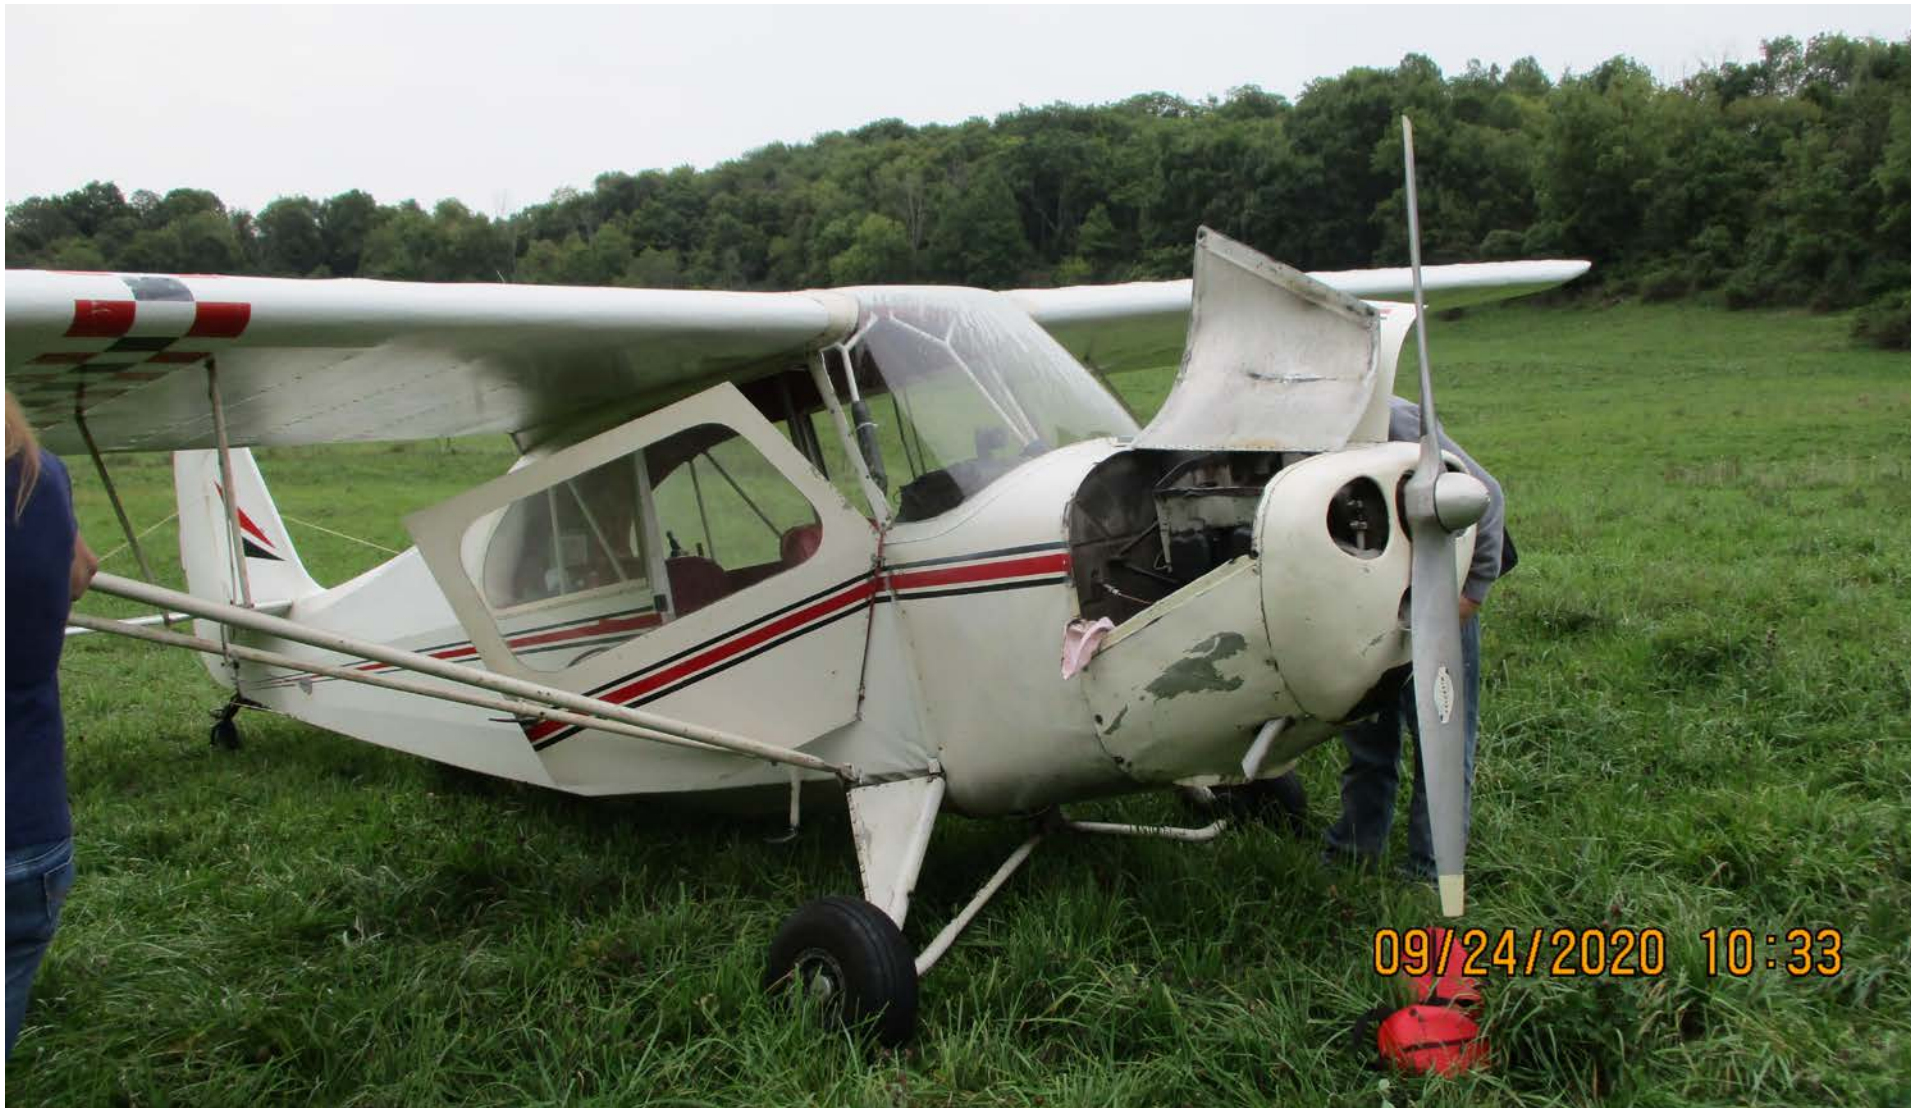
**Photo 2 – N81624 being examined shortly after the forced landing**

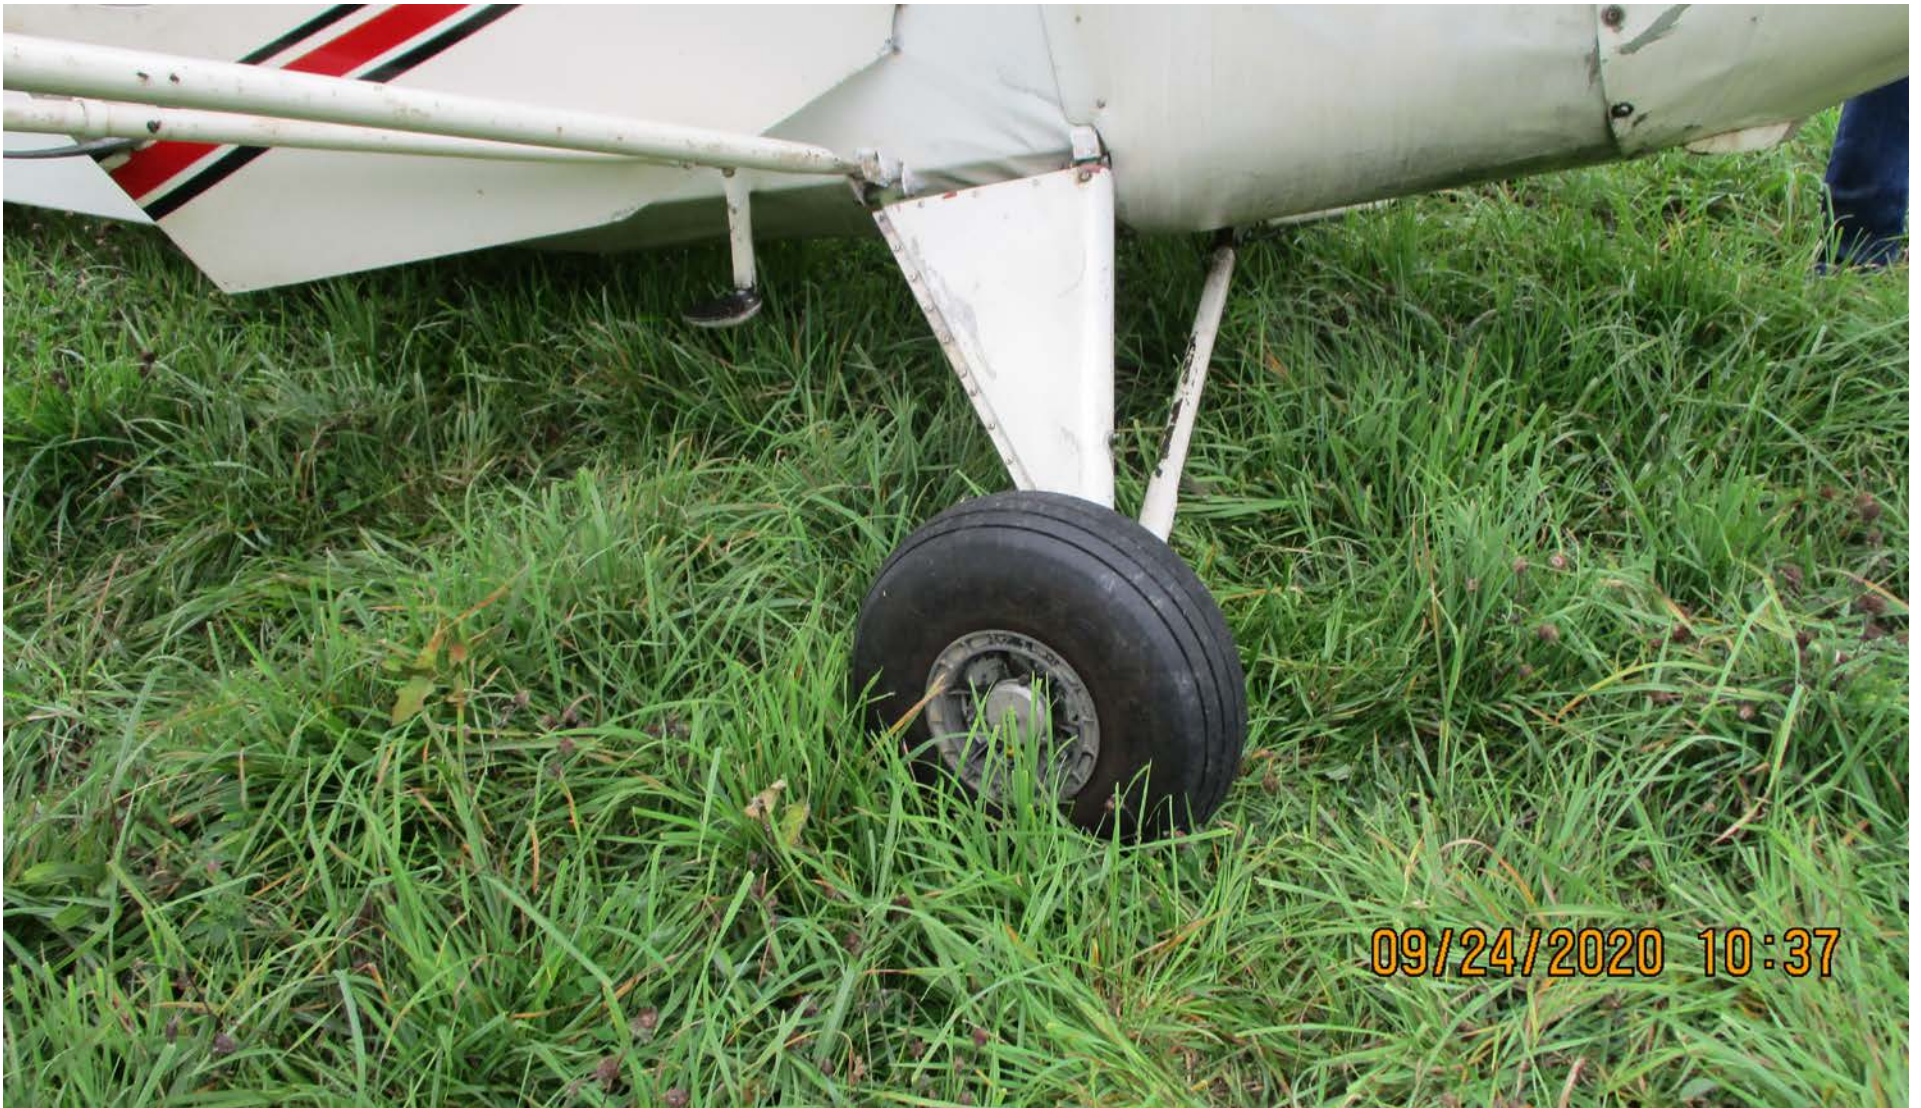
**Photo 3 – Wrinkled fuselage fabric above right main landing gear**

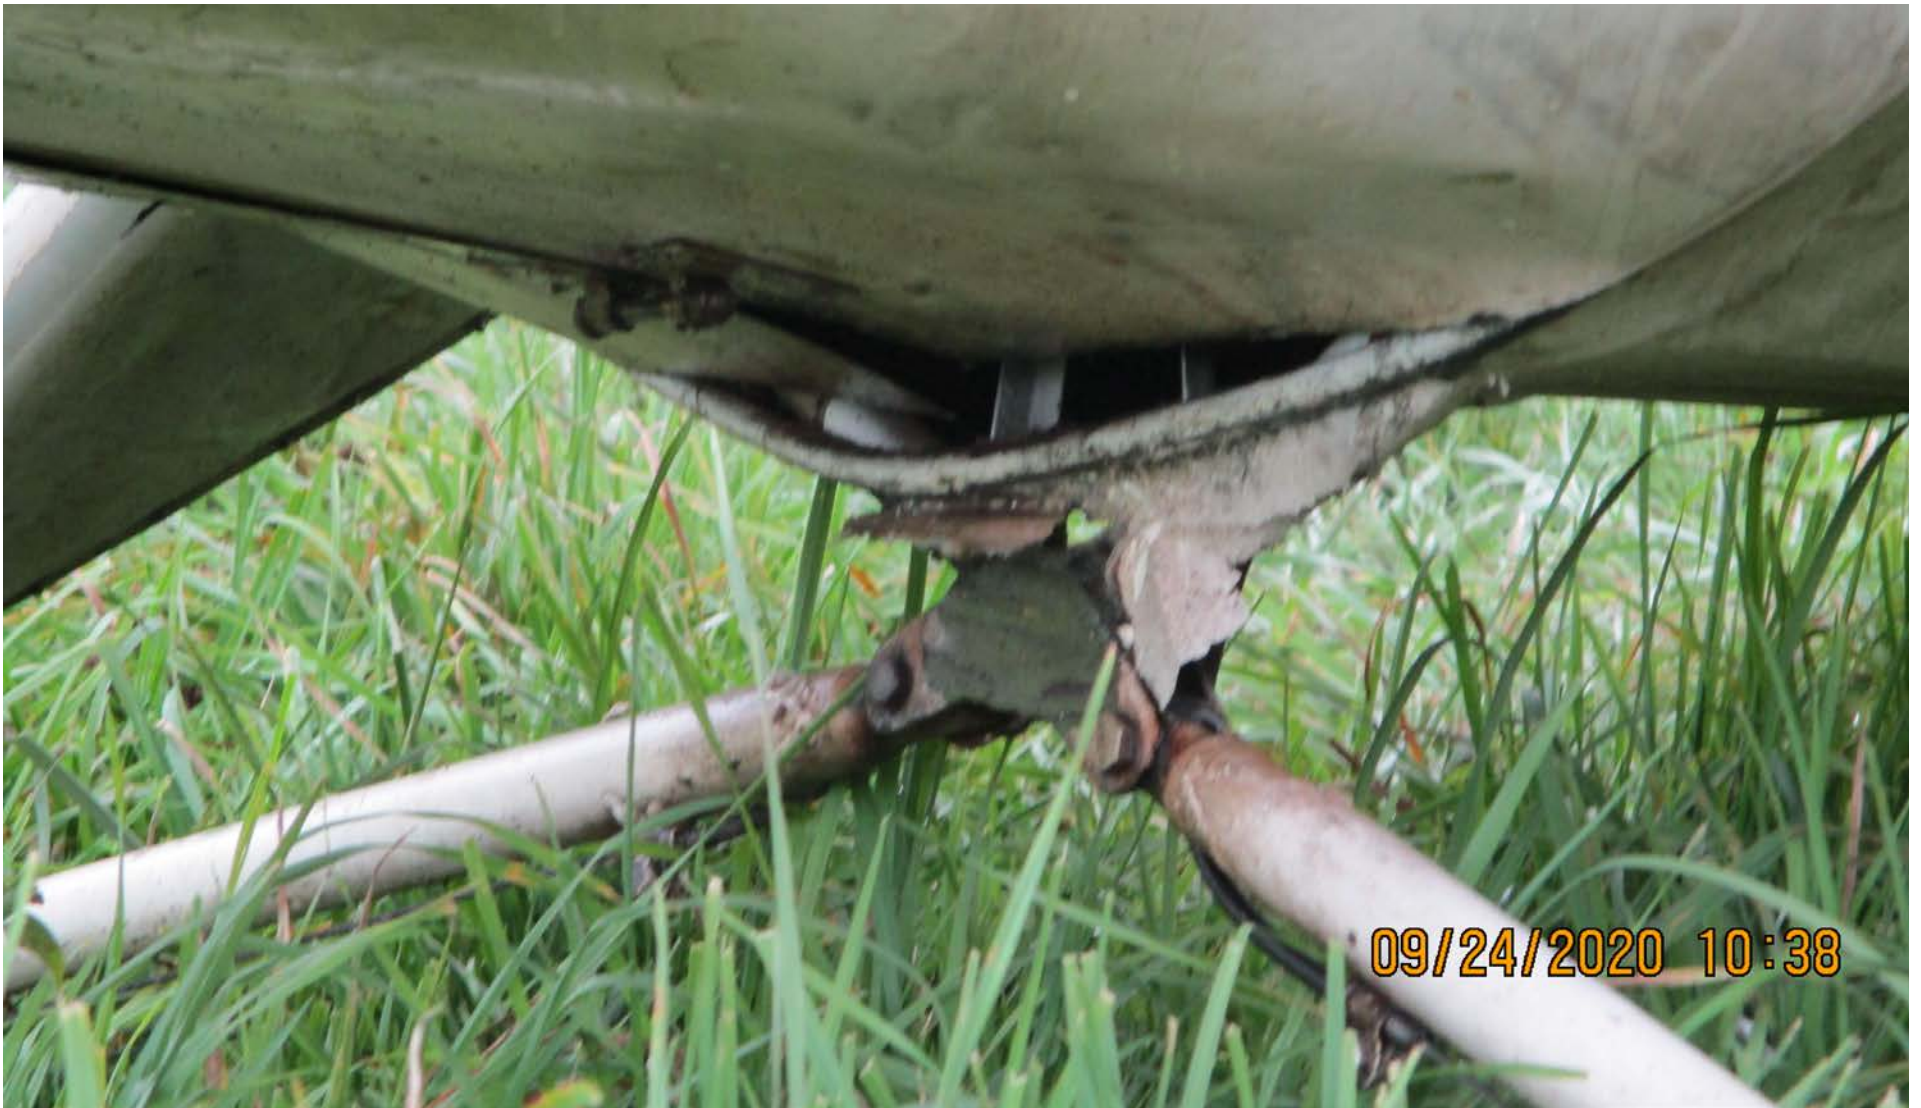
**Photo 4 – Frontal view of fuselage damage and landing gear strut**

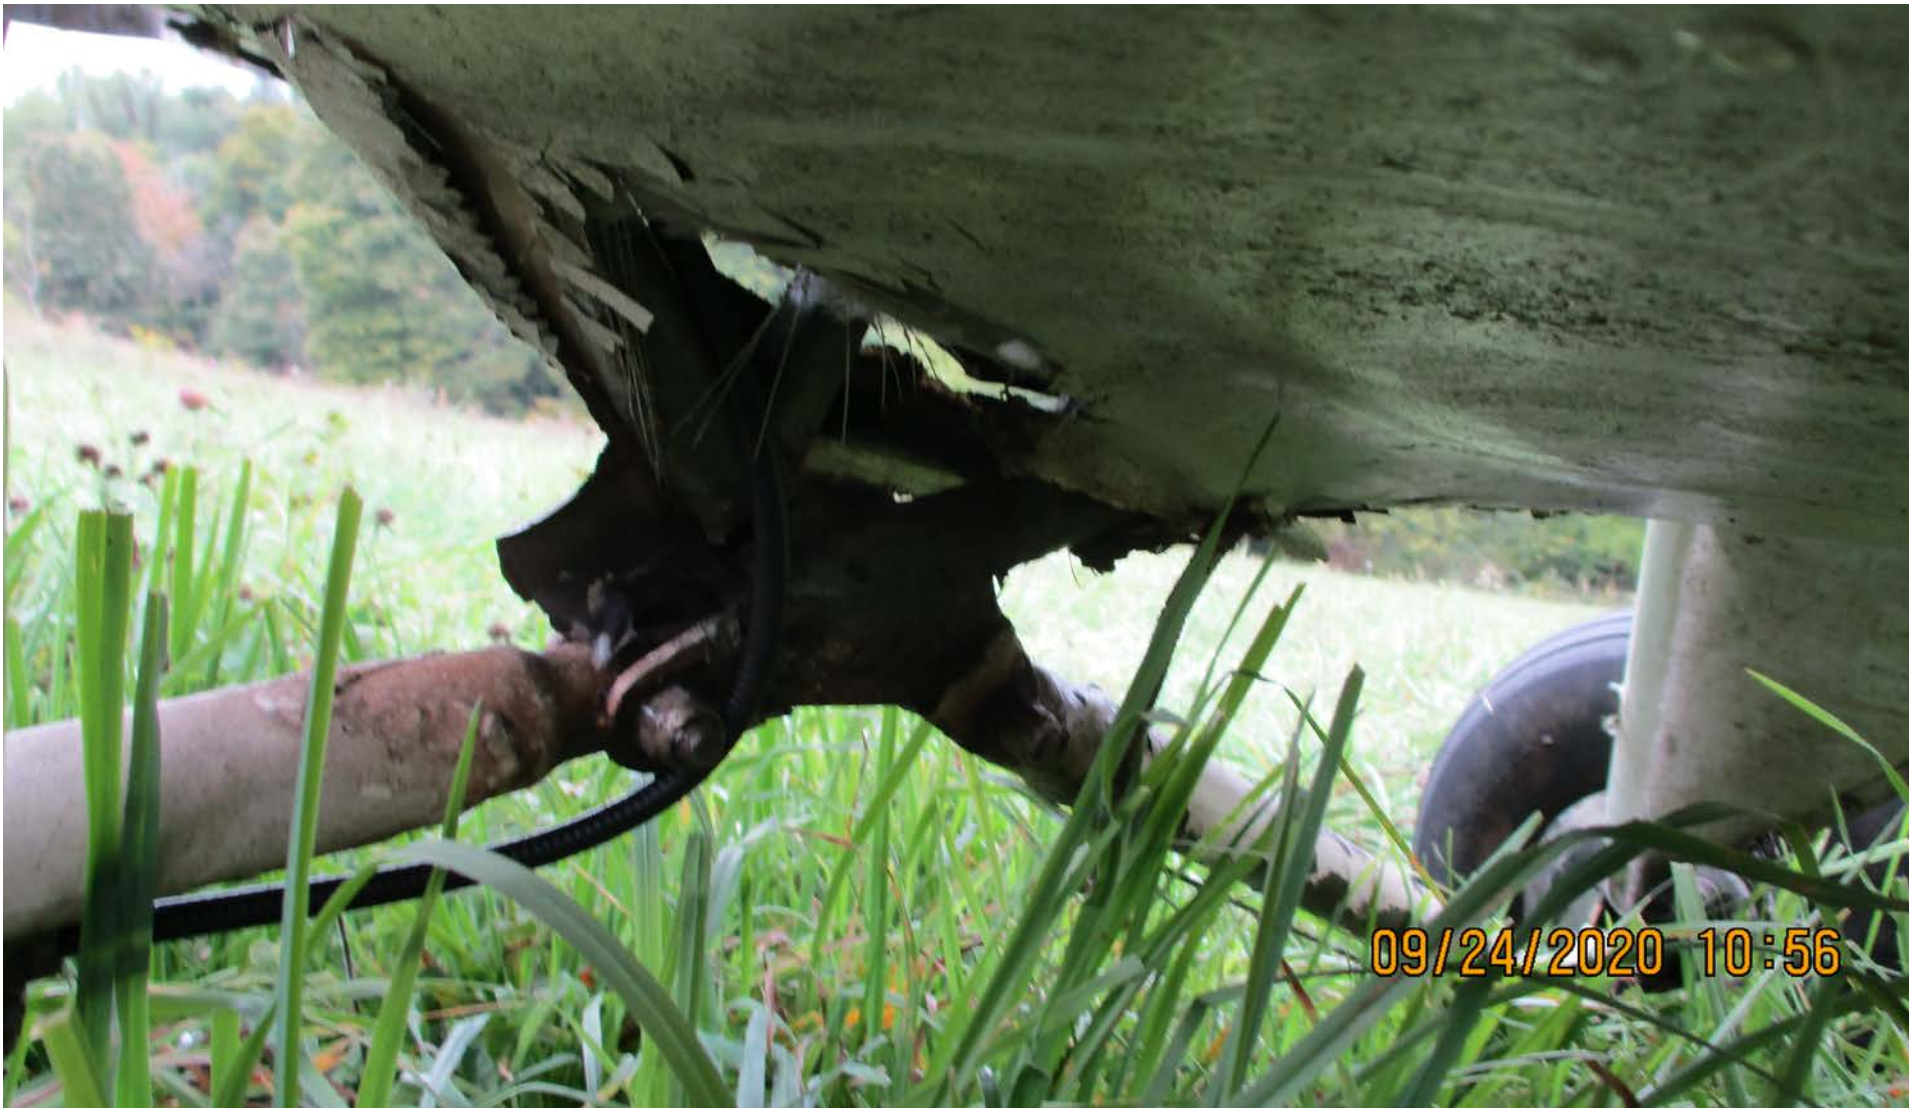
**Photo 5 – Rear view of fuselage damage and landing gear strut**

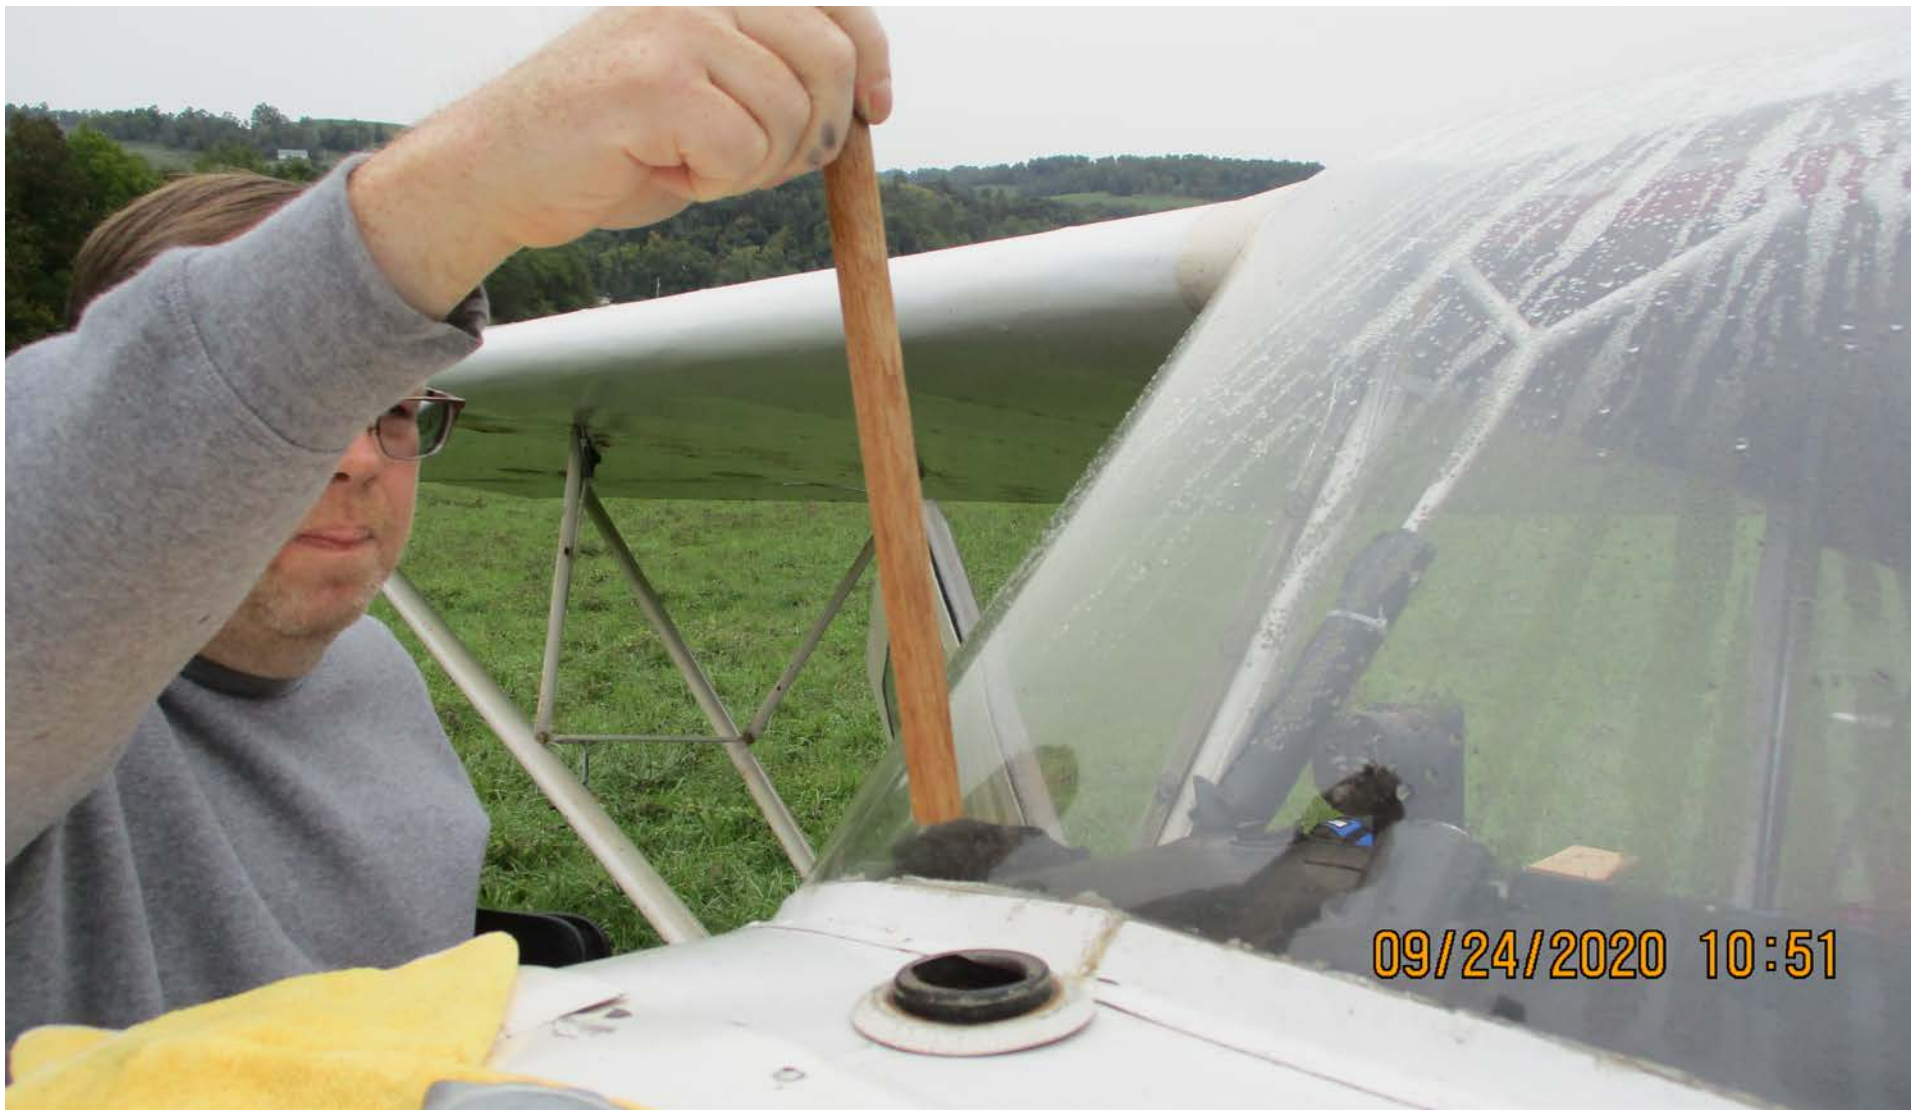
**Photo 6 – Dip sticking the fuel tank. The fuel tank was empty**

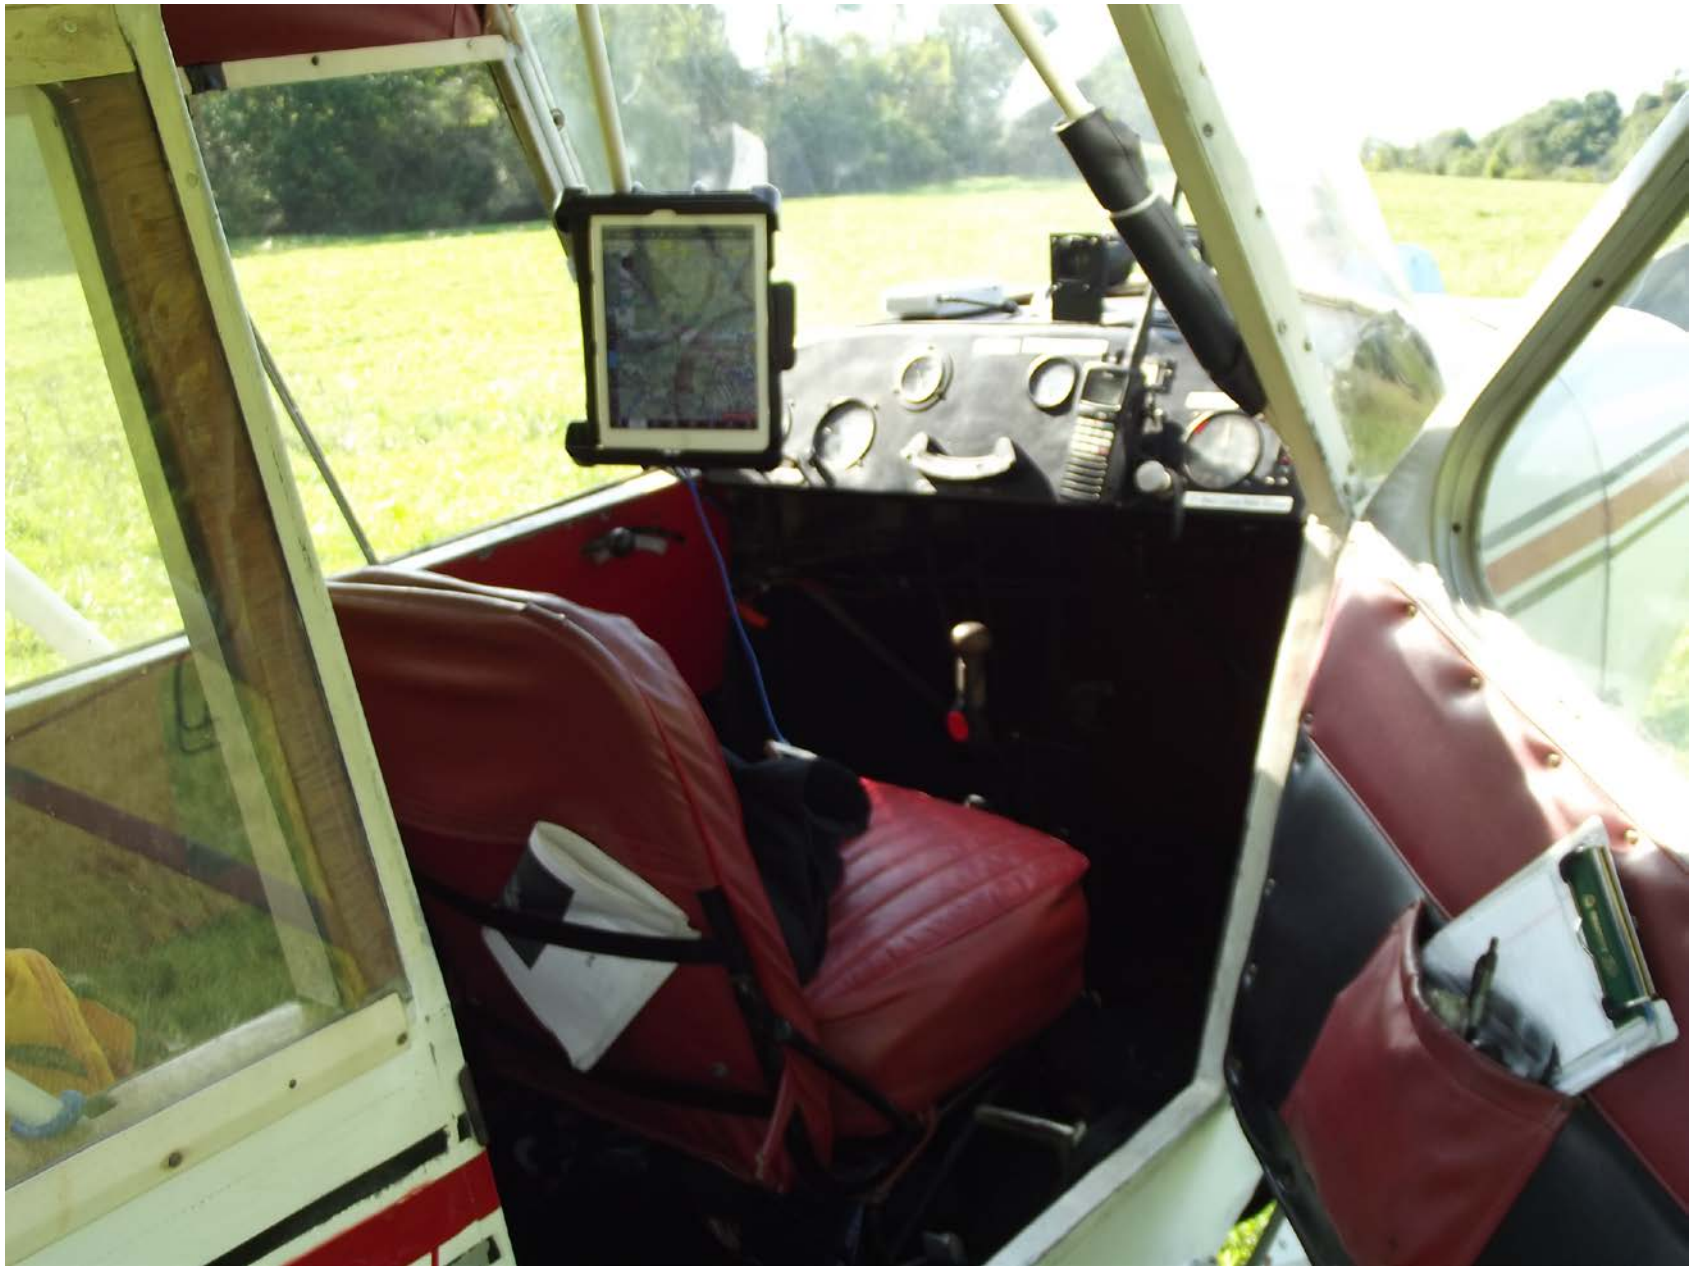
**Photo 7 – The cockpit of N81624. Notice hand-held communications radio and moving map display**
