**NATIONAL TRANSPORTATION SAFETY BOARD**

**Computed Tomography Specialist's Factual Report**

CEN20LA425

Location: Spring, Texas  
Date: September 29, 2020  
Time: 1400 central daylight time  
Airplane: Cessna 172N airplane, N75634

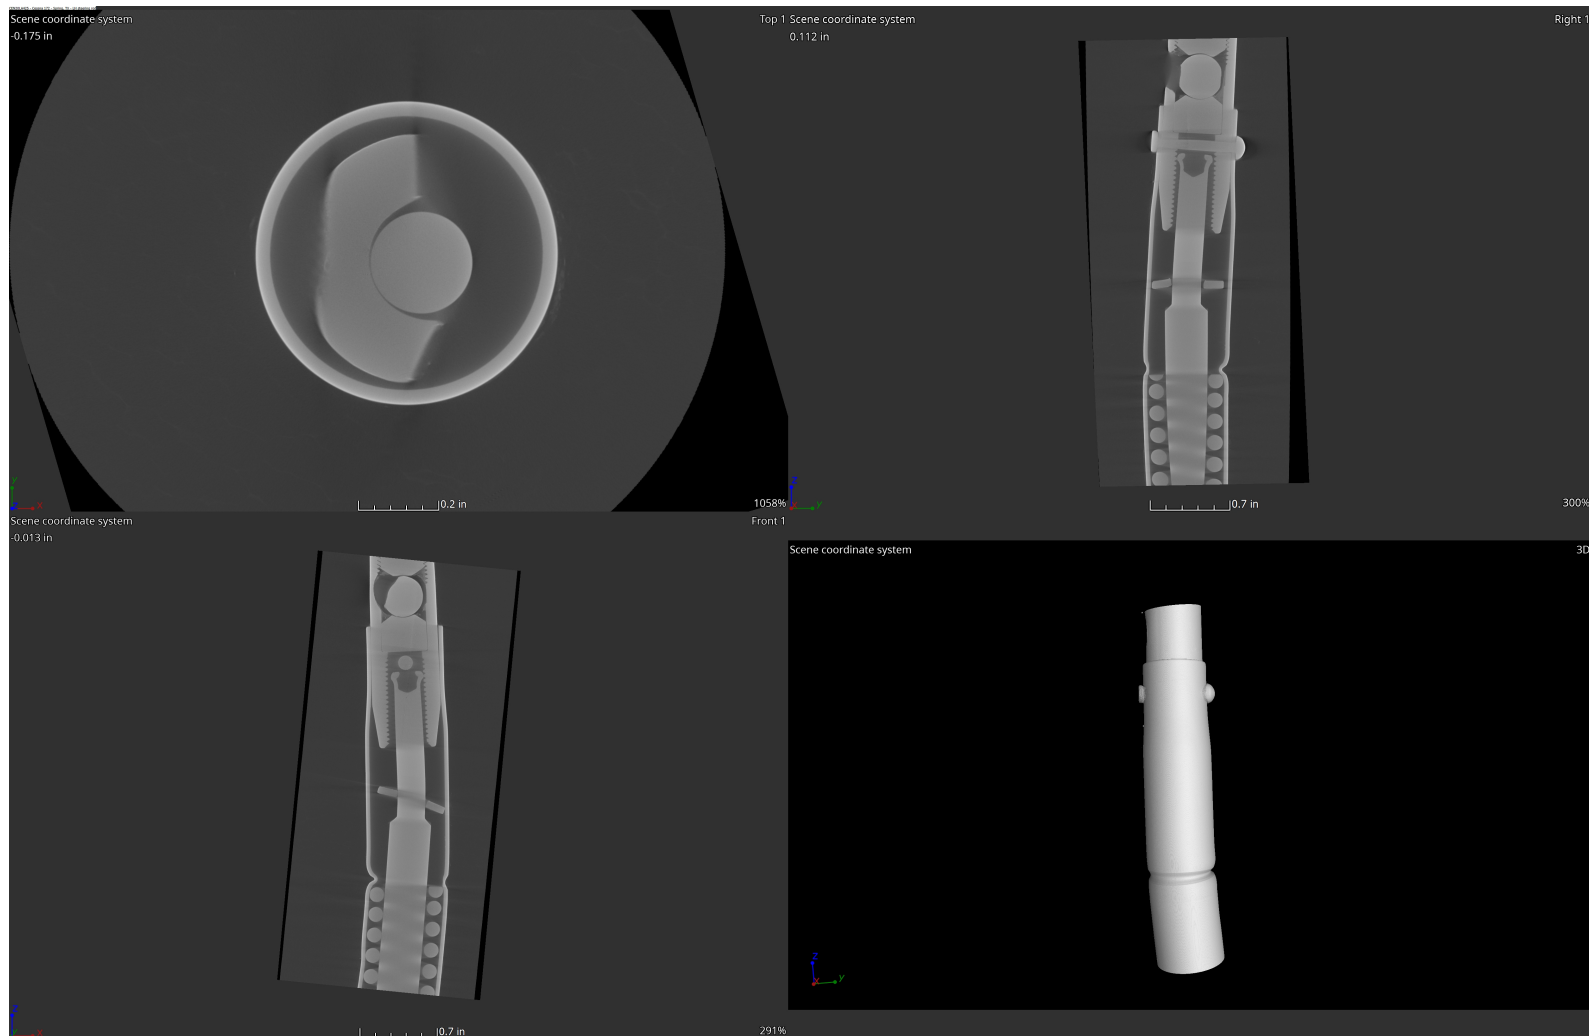
1. In the left steering tube, the internal washer was not captured between the spring and the flared rod end. It was located on the internal rod, but it was on the opposite side of the tube crimp area than the spring.

Figure 1  
Left steering tube - overview

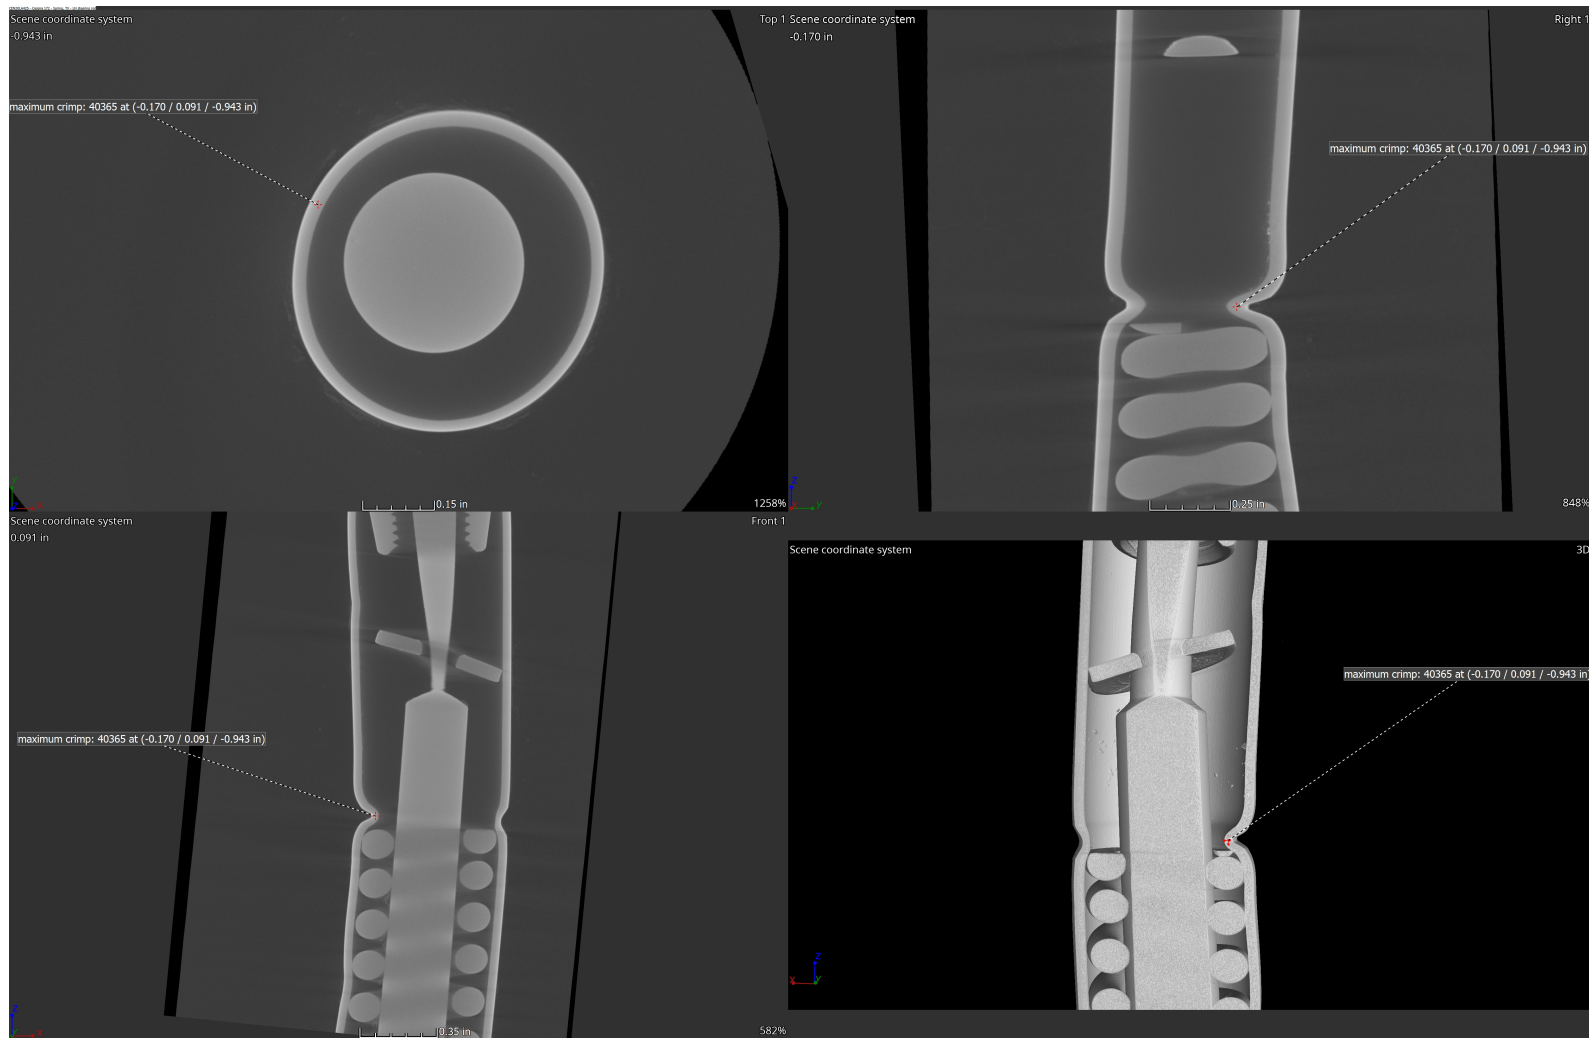
2. In the left steering tube, the tube crimp depth varied throughout the circumference of the tube. The minimum tube crimp depth was approximately at the outer bend radius of the tube, and the maximum tube crimp depth was approximately at the inner bend radius.

Figure 2  
Left steering tube – maximum crimp location

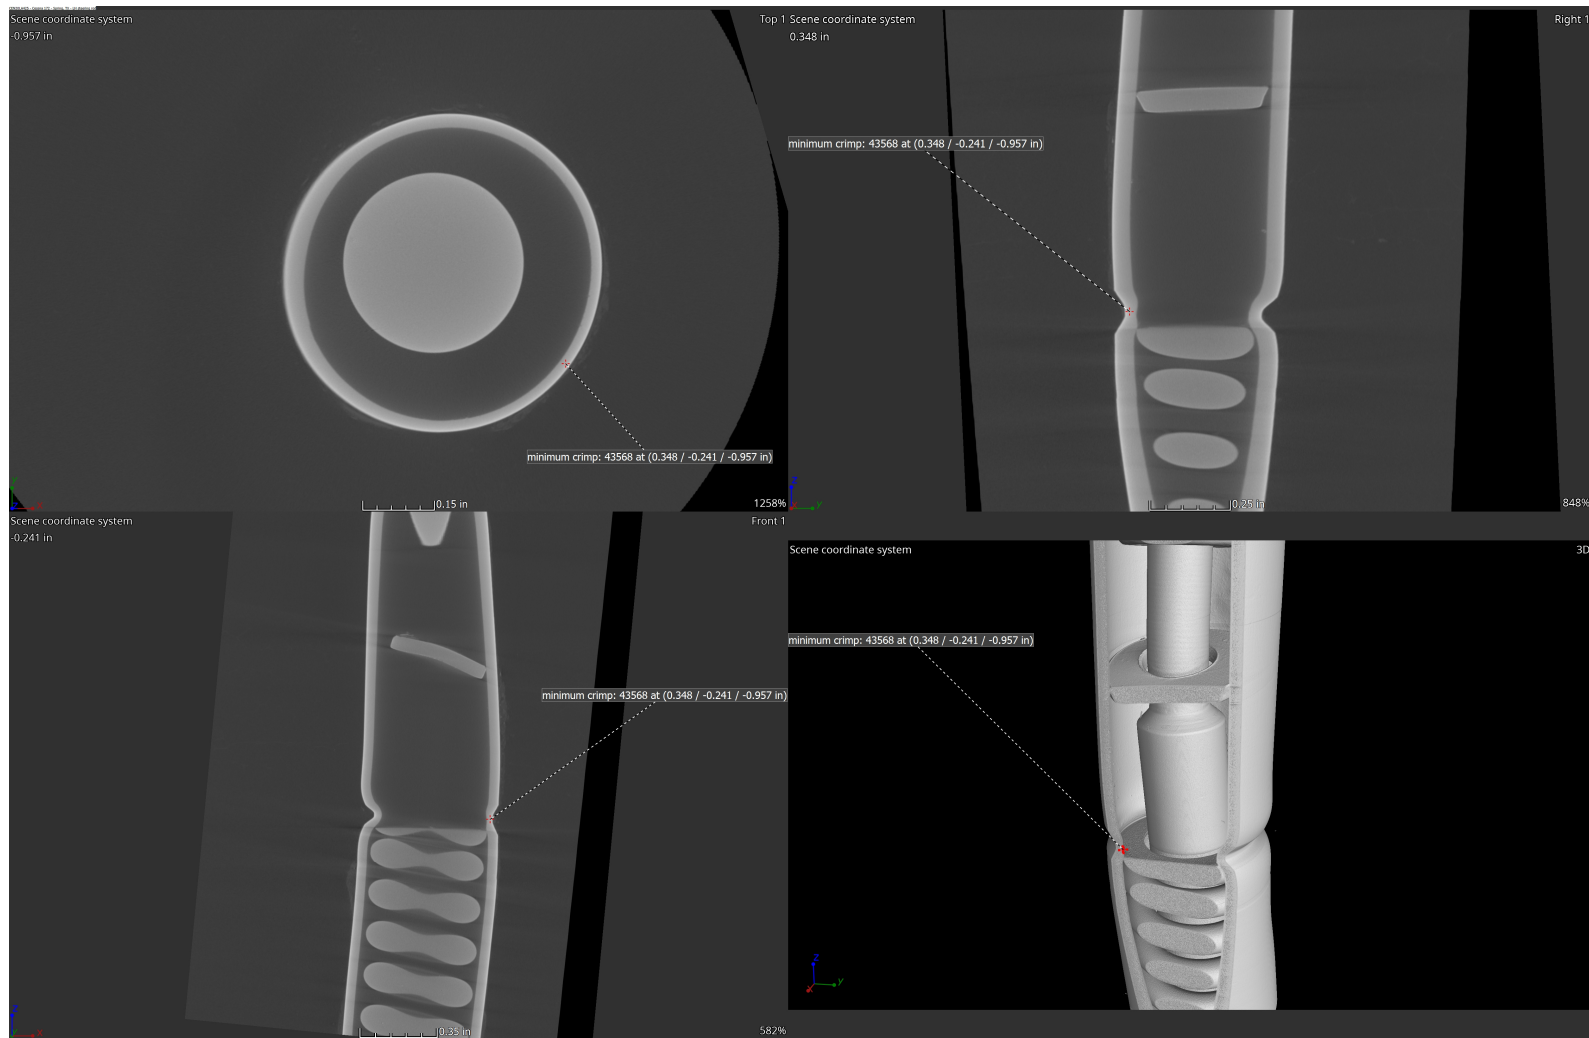
Figure 3  
Left steering tube – minimum crimp location

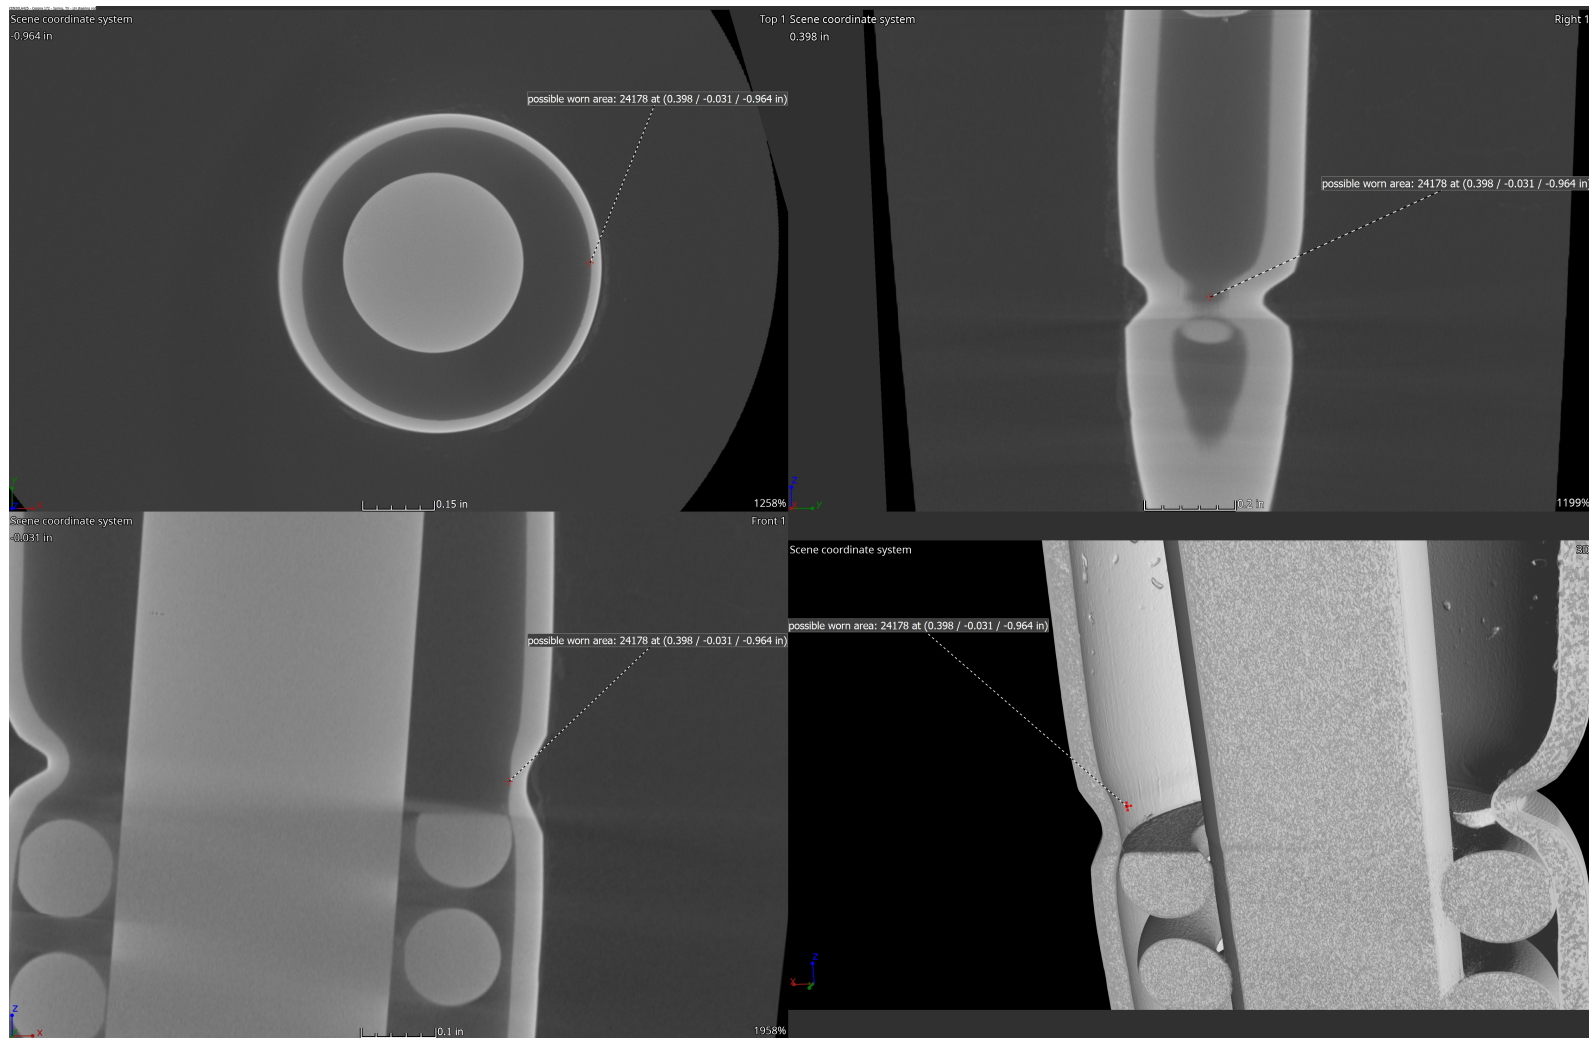
3. In the left steering tube, there were indications of a possible worn area at the minimum tube crimp location.
4. In the left steering tube, there were several indications of unknown material located in and around the washer area and inner tube wall.

Figure 4  
Left steering tube – possible worn area

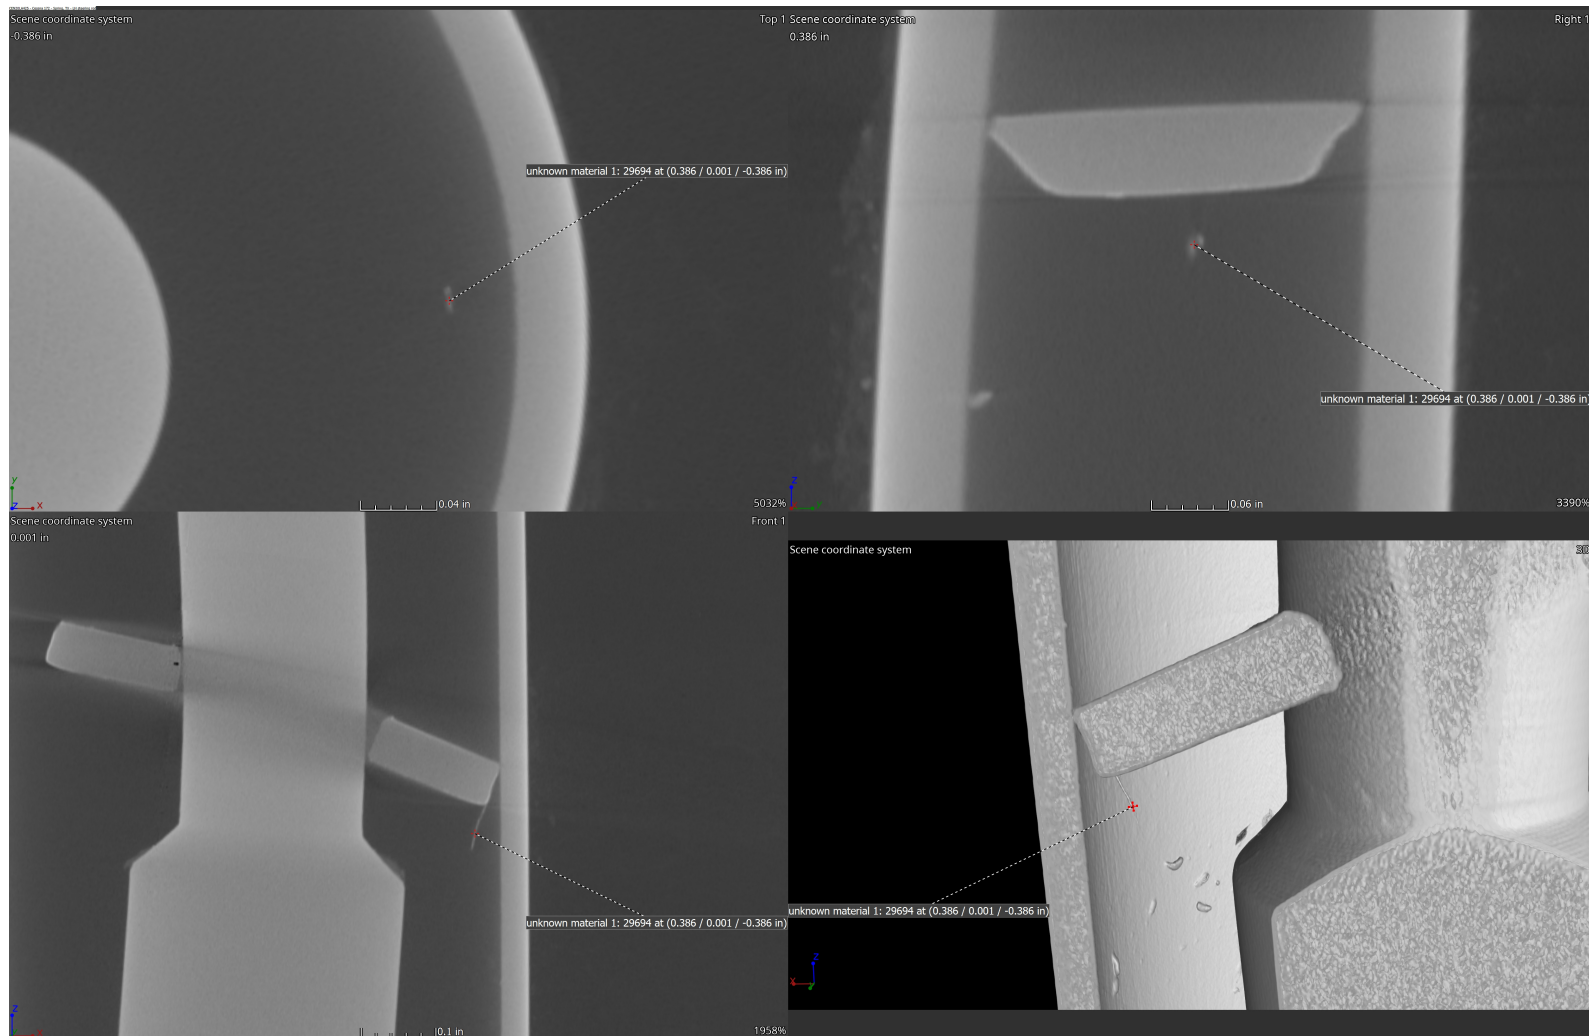
Figure 5  
Left steering tube – unknown material 1

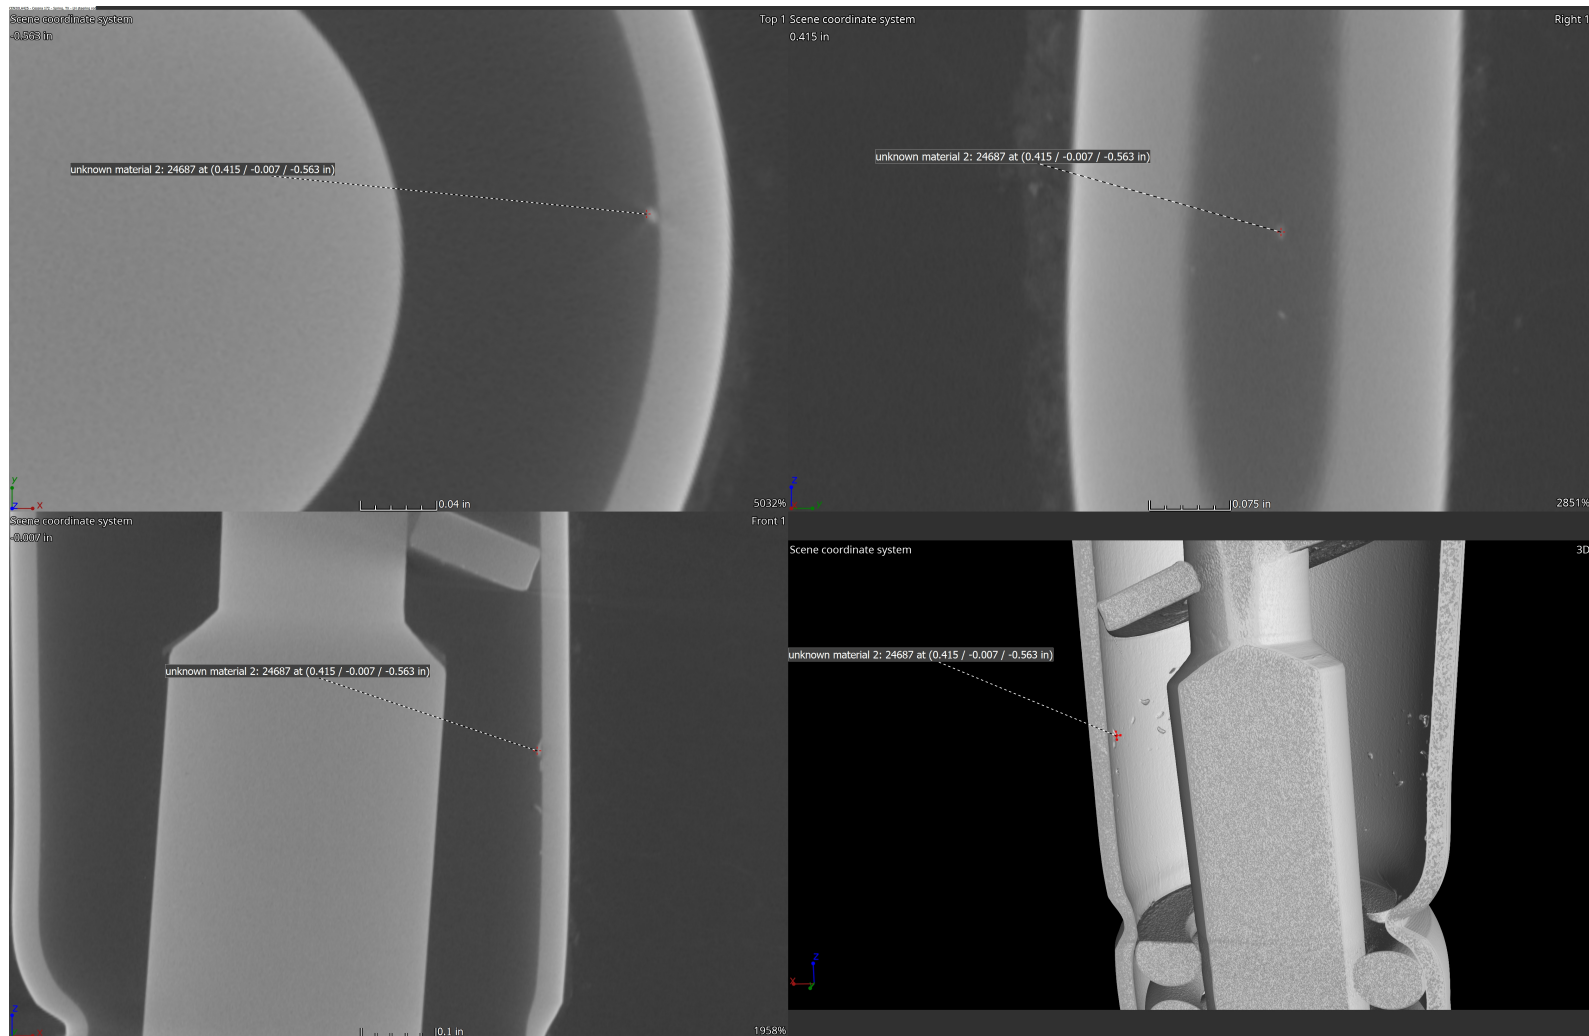
Figure 6  
Left steering tube – unknown material 2

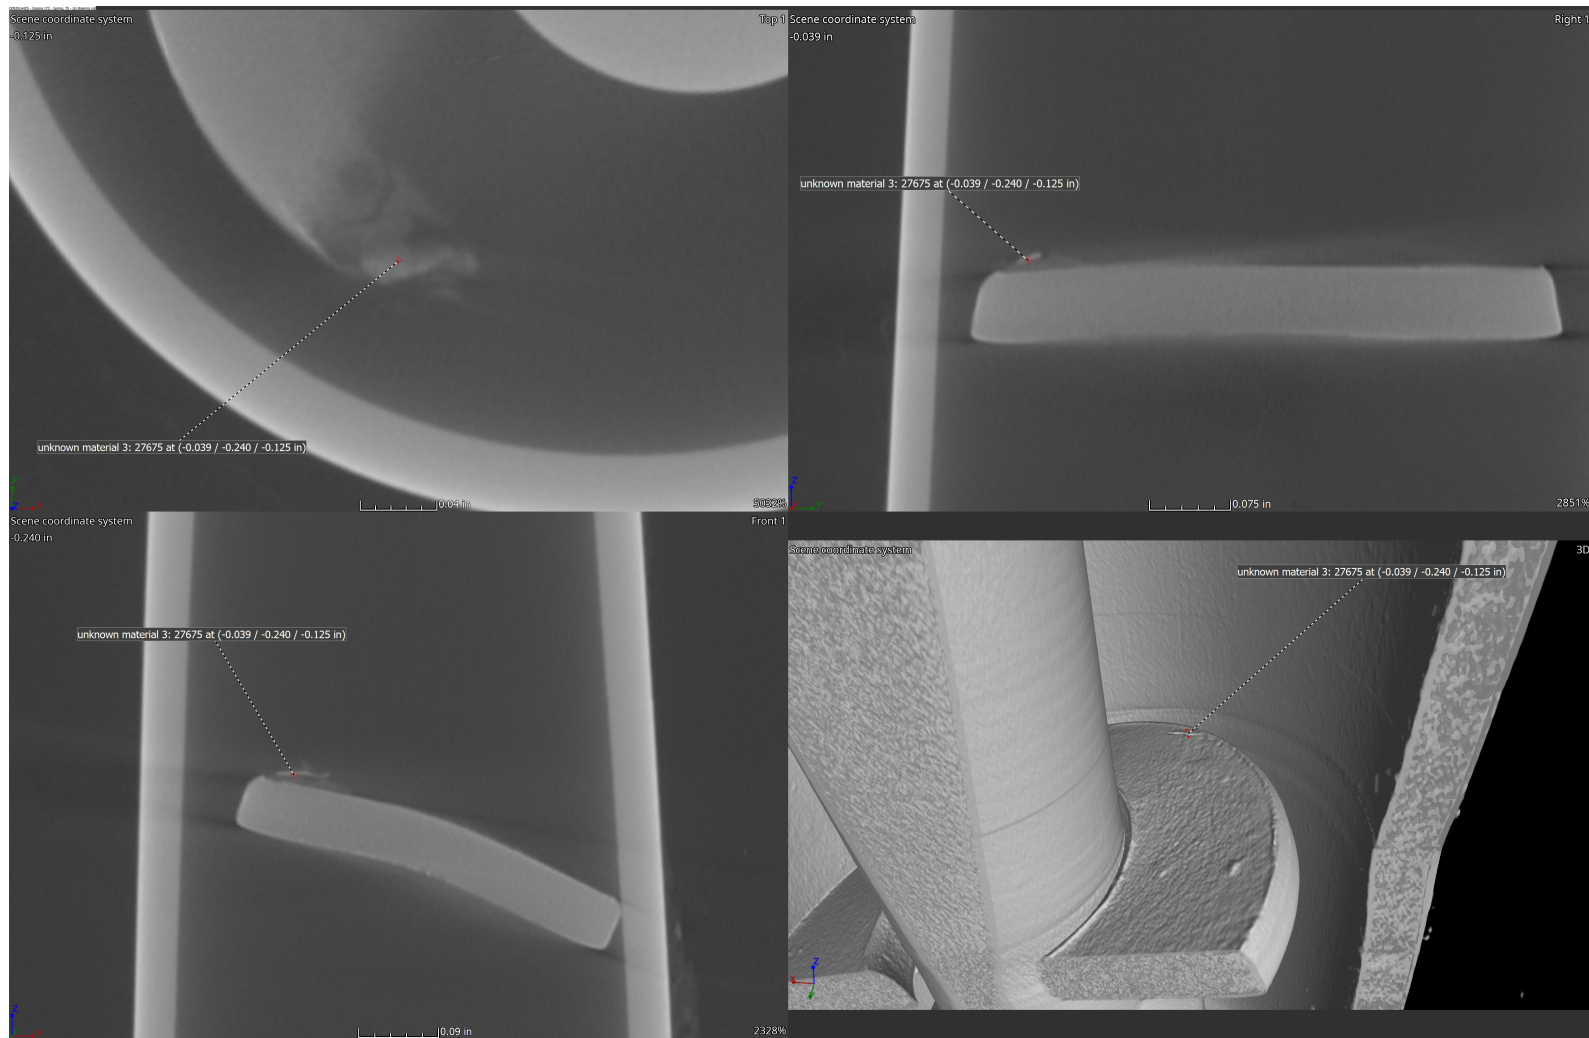
Figure 7  
Left steering tube – unknown material 3

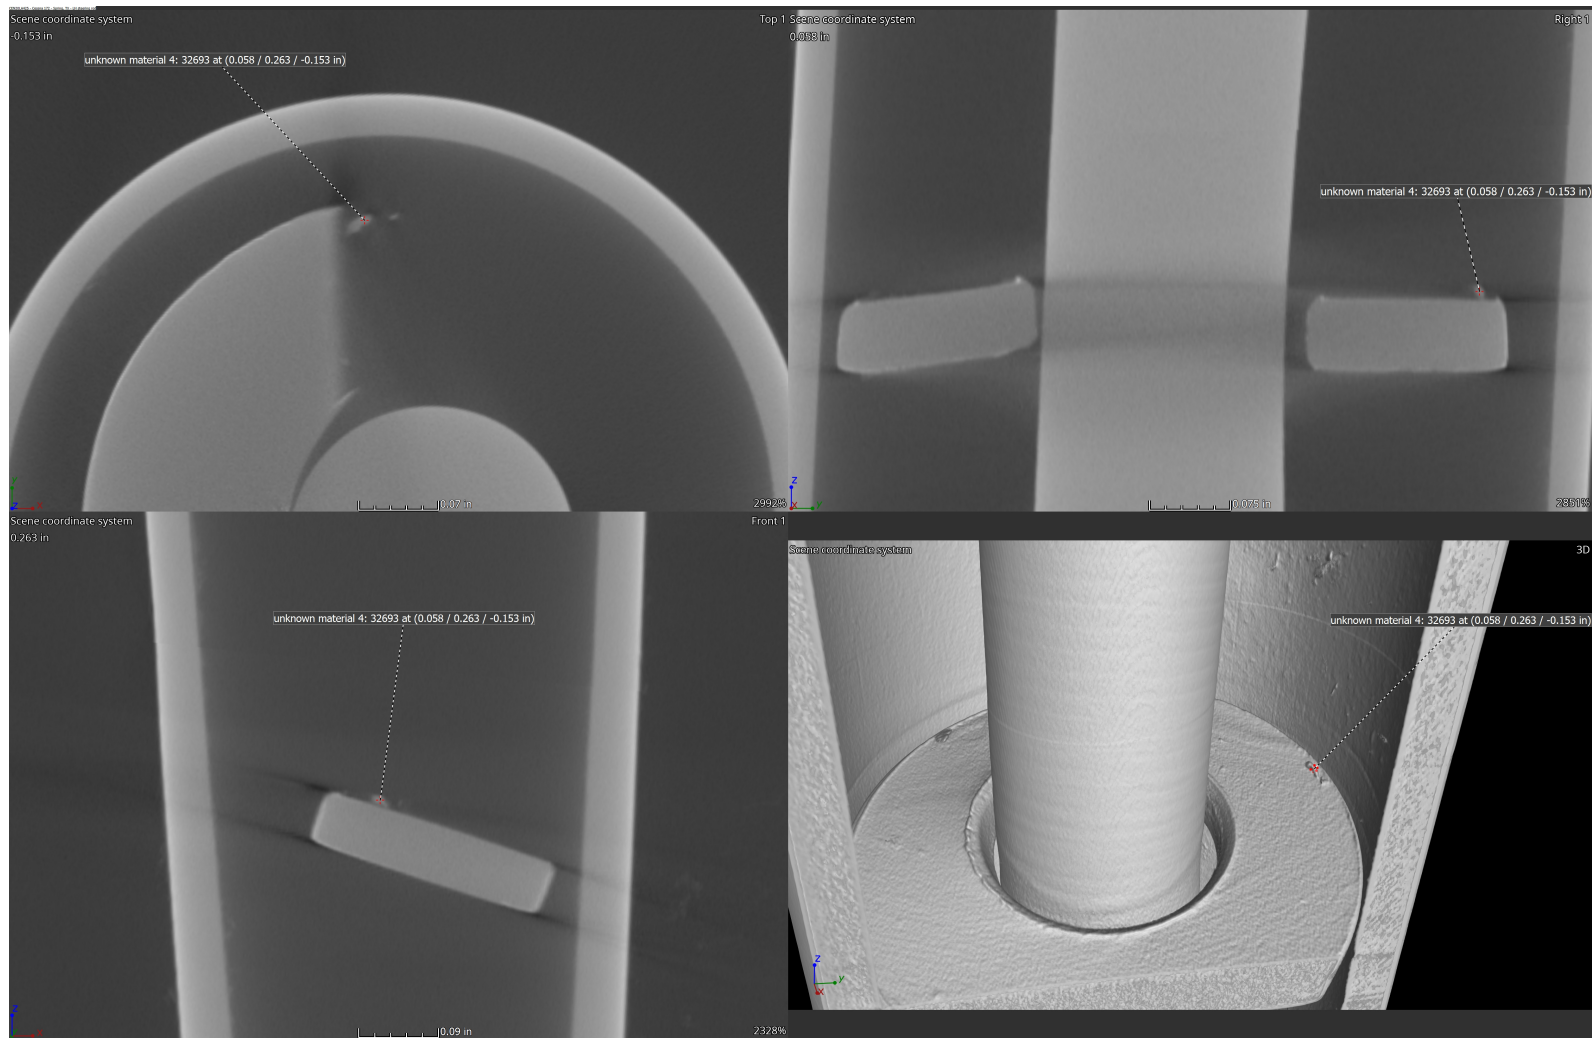
Figure 8  
Left steering tube – unknown material 4

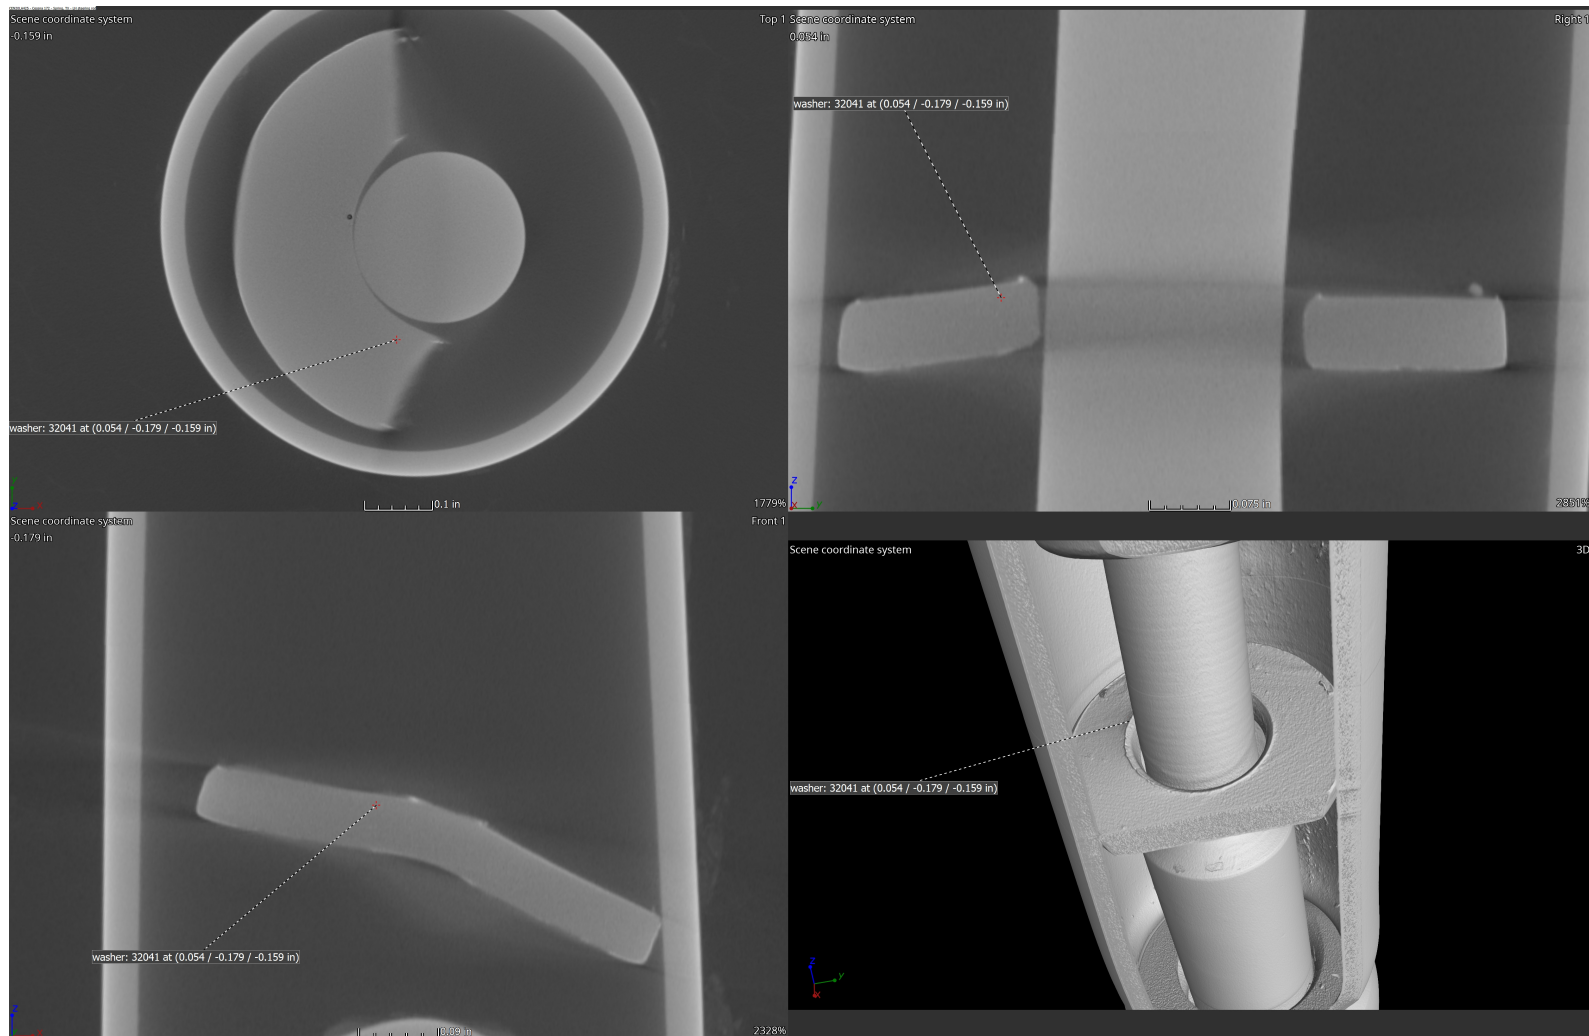
Figure 9  
Left steering tube – washer

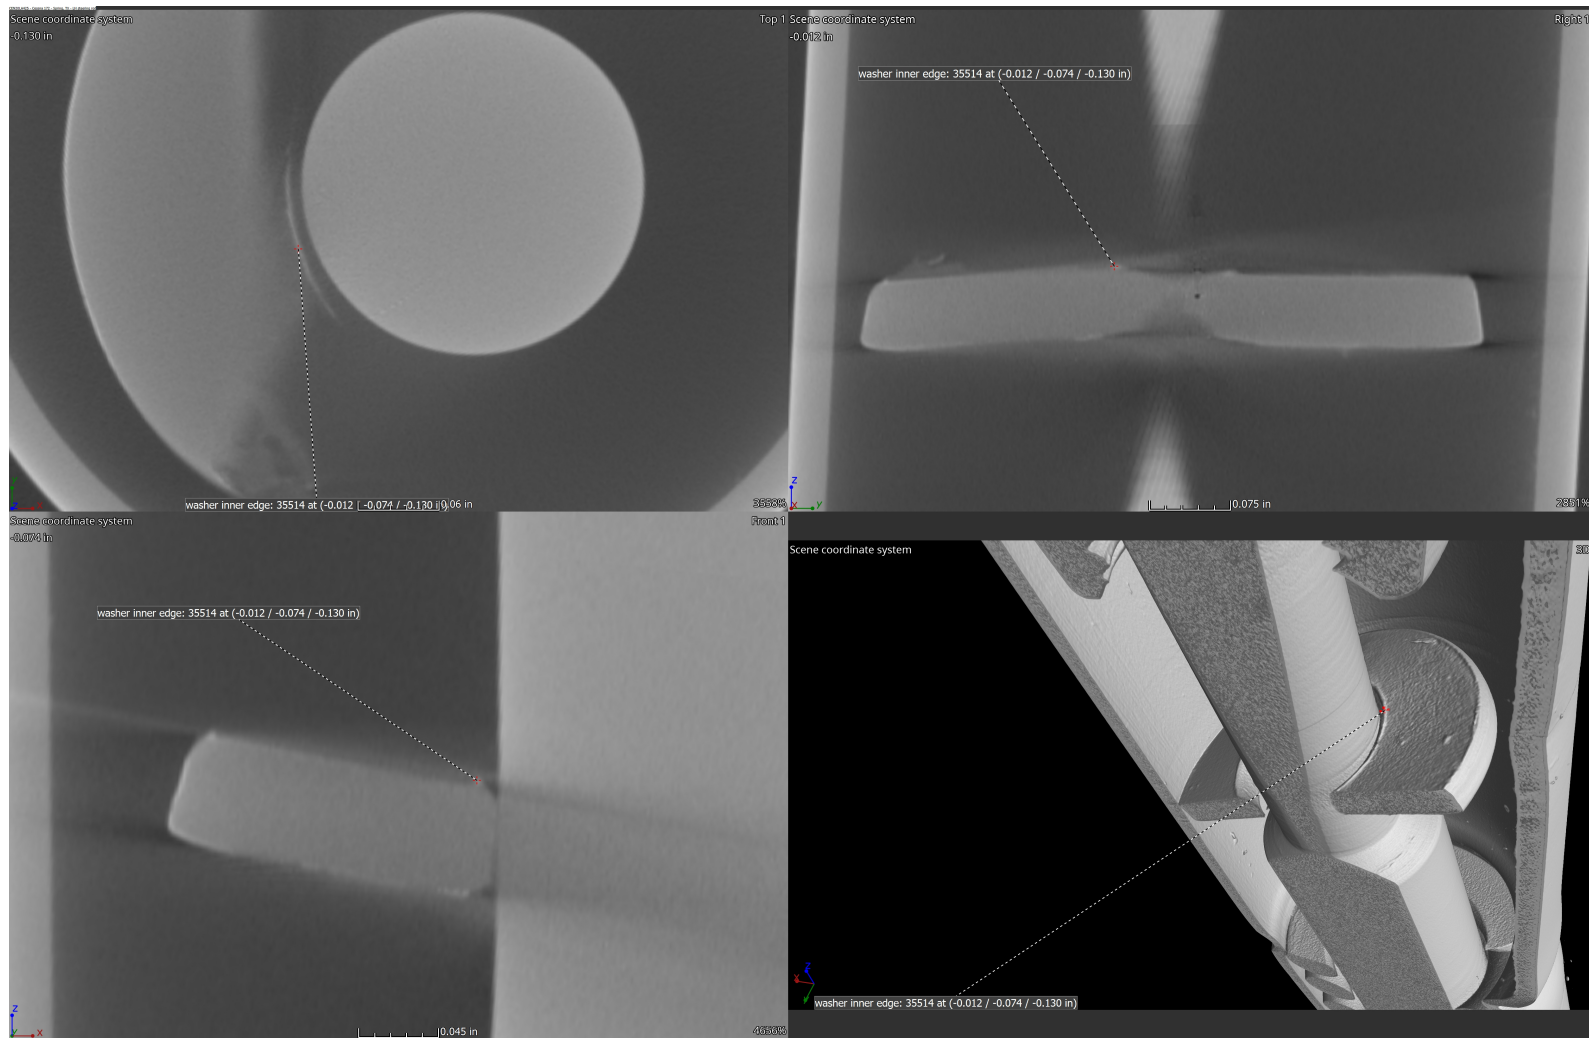
5. In the left steering tube, the washer appeared to be deformed with raised lips around portions of the inner and outer edges.
6. In the right steering tube, the washer appeared to be captured between the spring and flared rod end.

Figure 10  
Left steering tube – washer inner edge

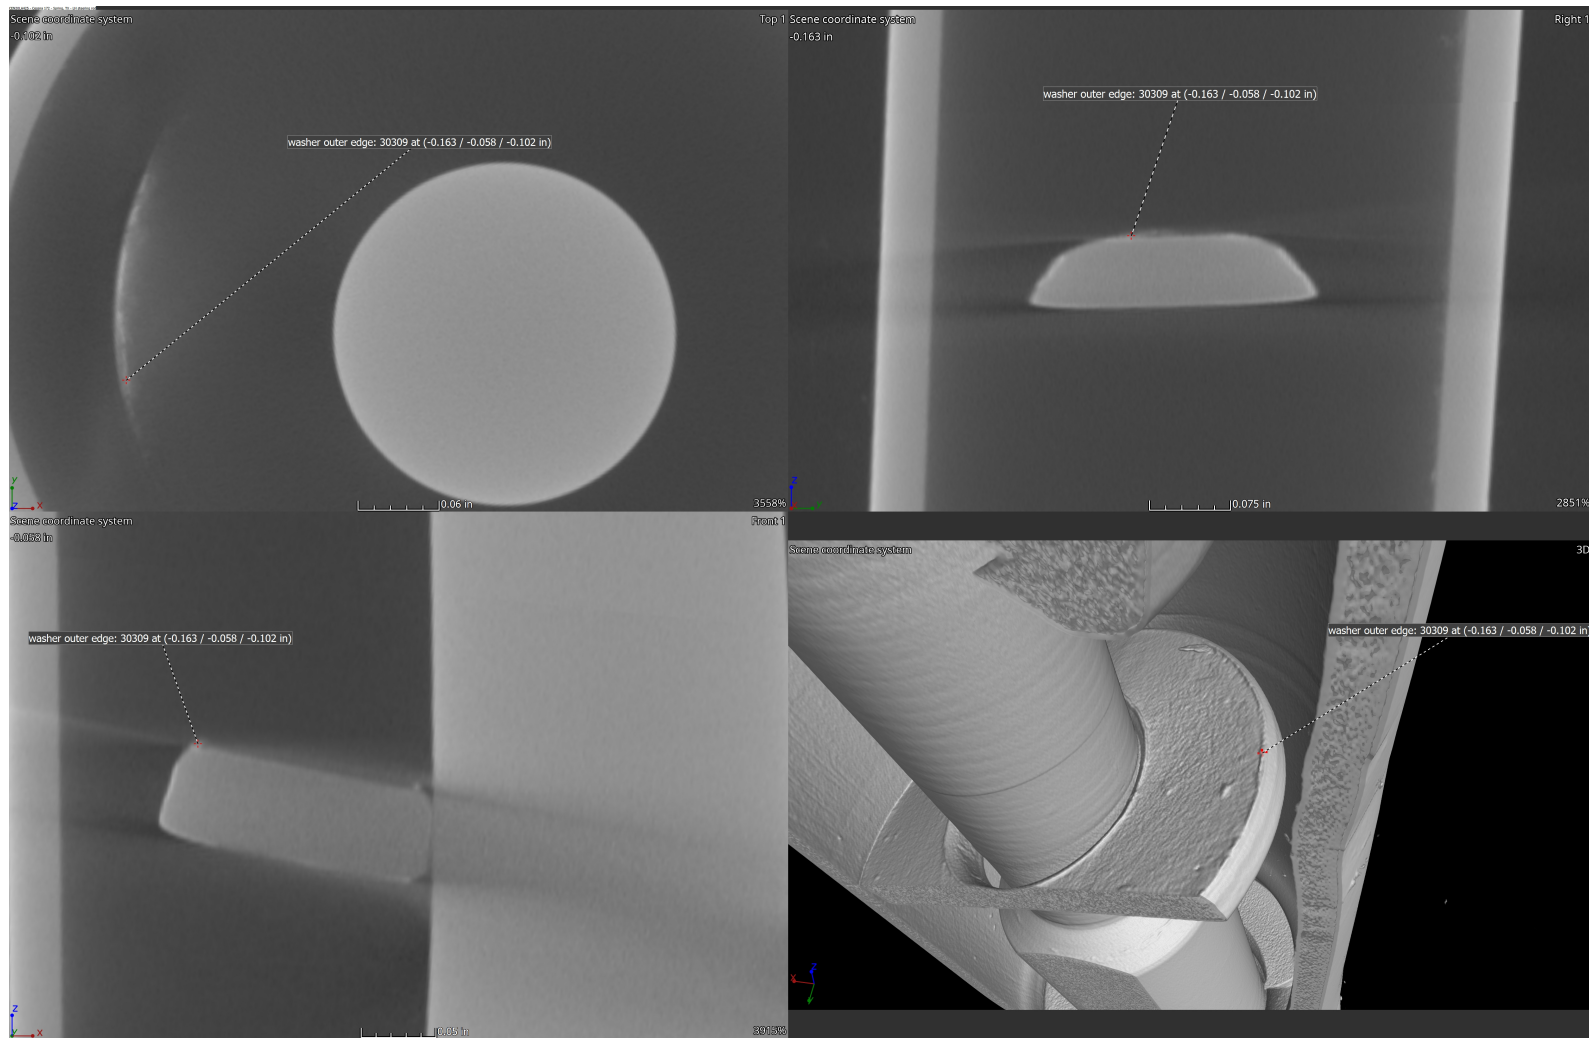
Figure 11  
Left steering tube – washer outer edge

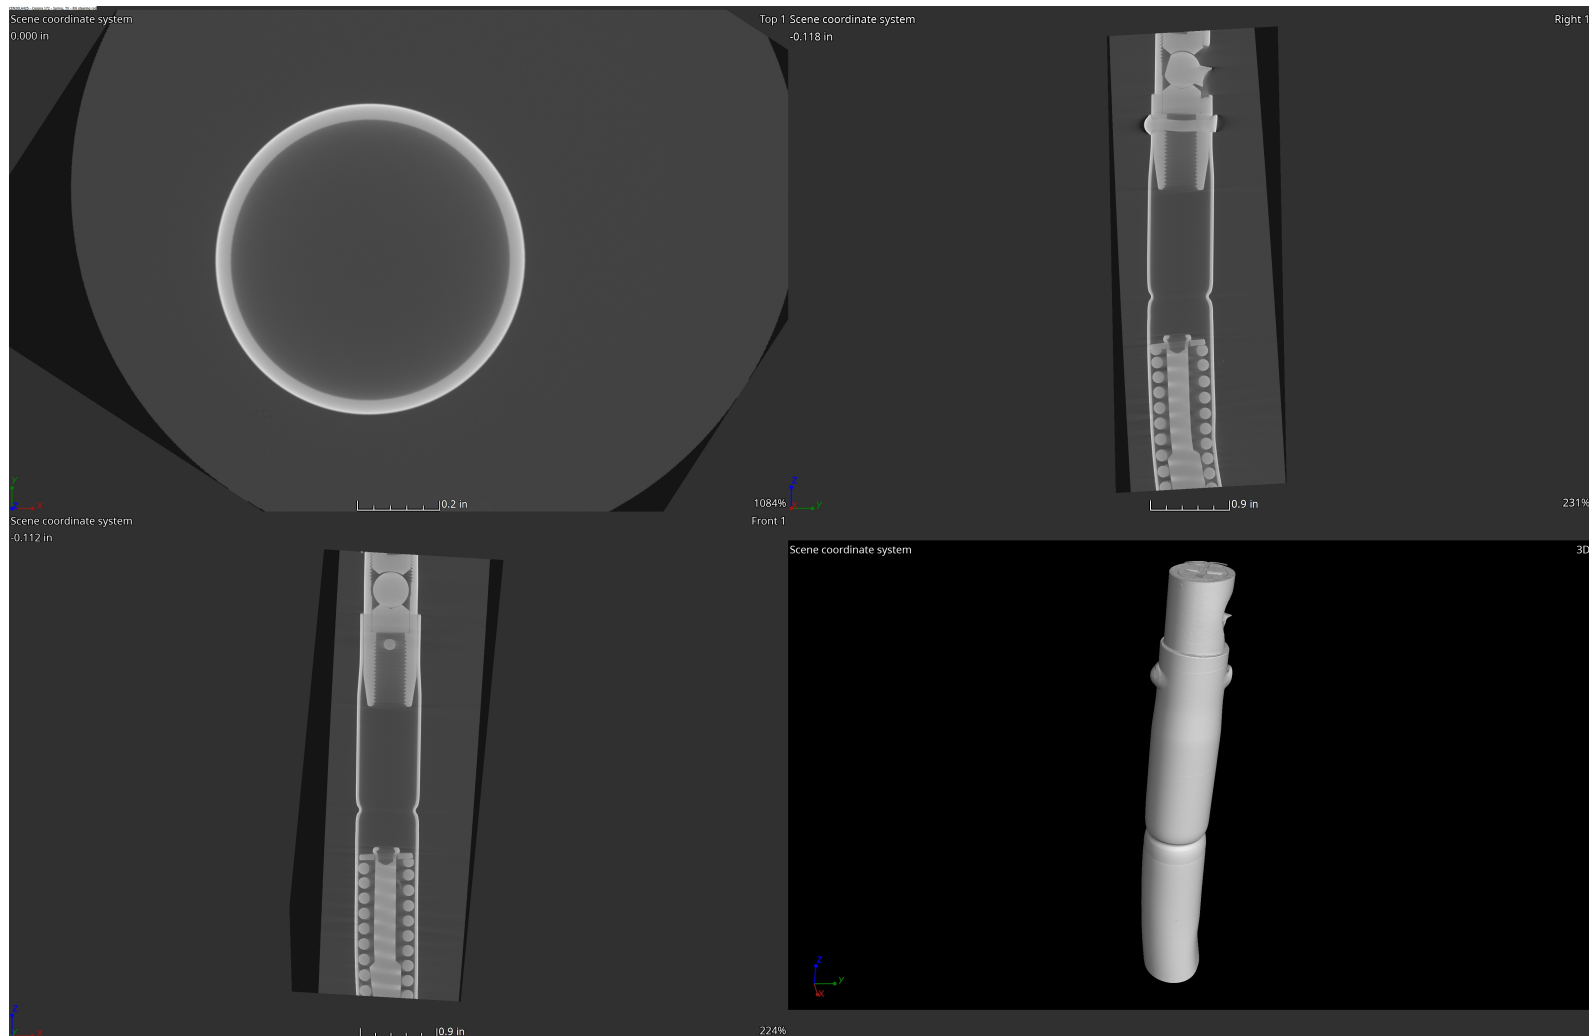
Figure 12  
Right steering tube – overview

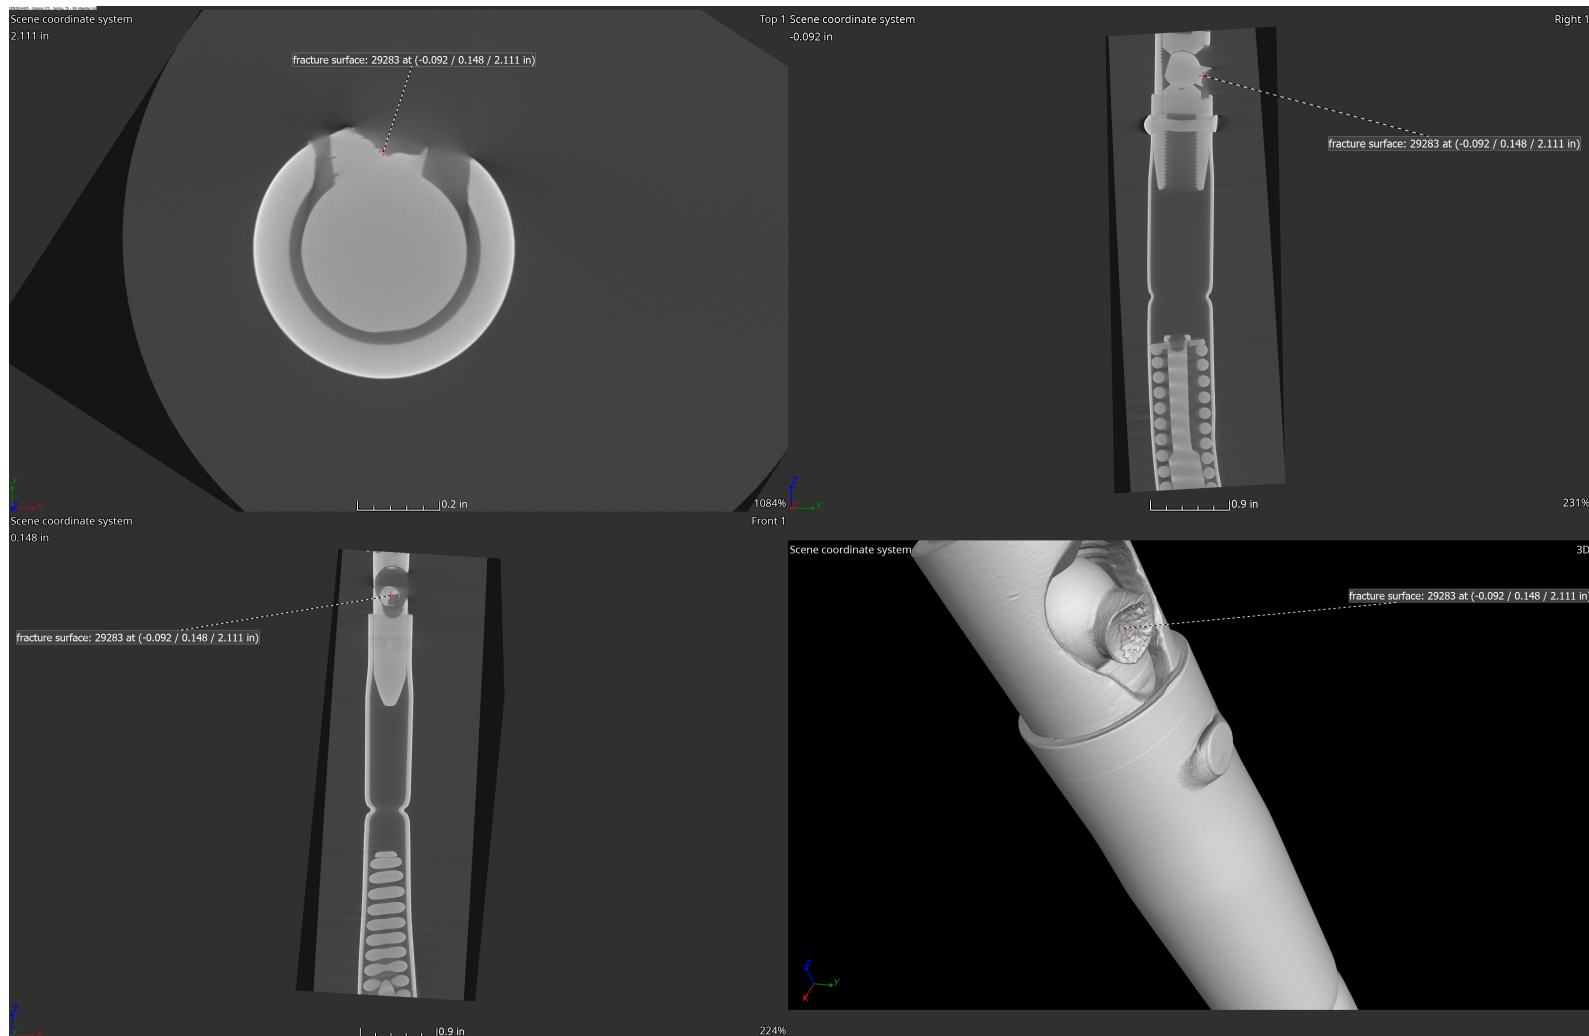
Figure 13  
Right steering tube – fracture surface
