**NATIONAL TRANSPORTATION SAFETY BOARD**

**Computed Tomography Specialist's Factual Report**

CEN20LA425

Location: Spring, Texas  
Date: September 29, 2020  
Time: 1400 central daylight time  
Airplane: Cessna 172N airplane, N75634

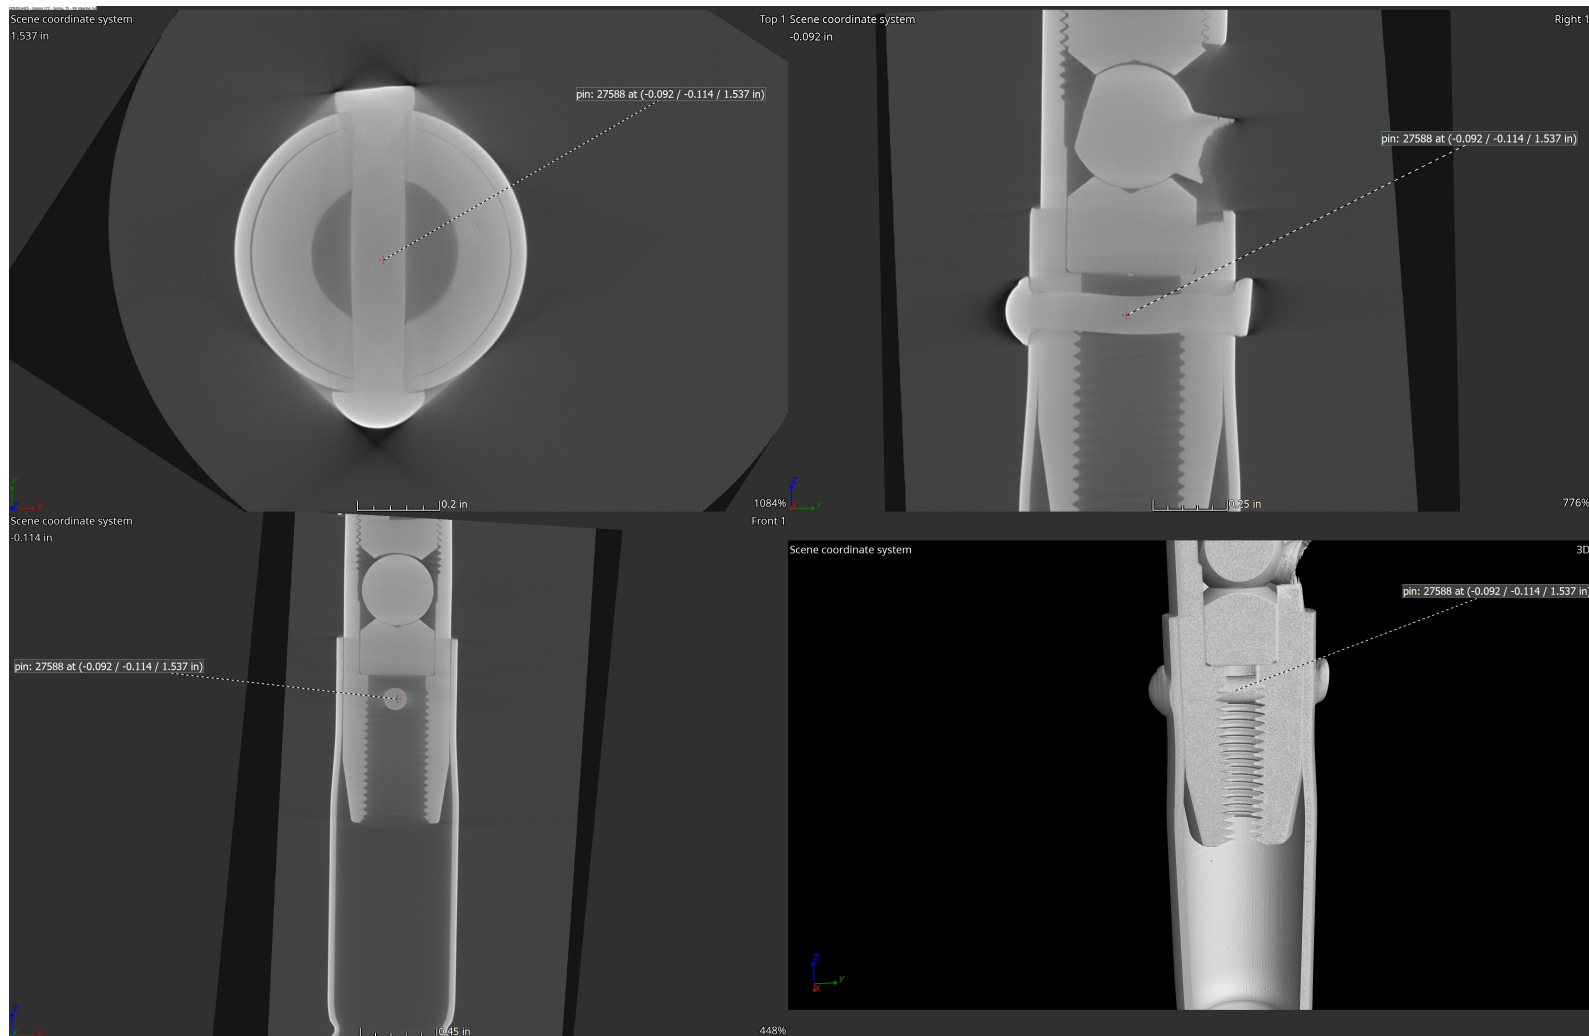
Figure 14  
Right steering tube – pin

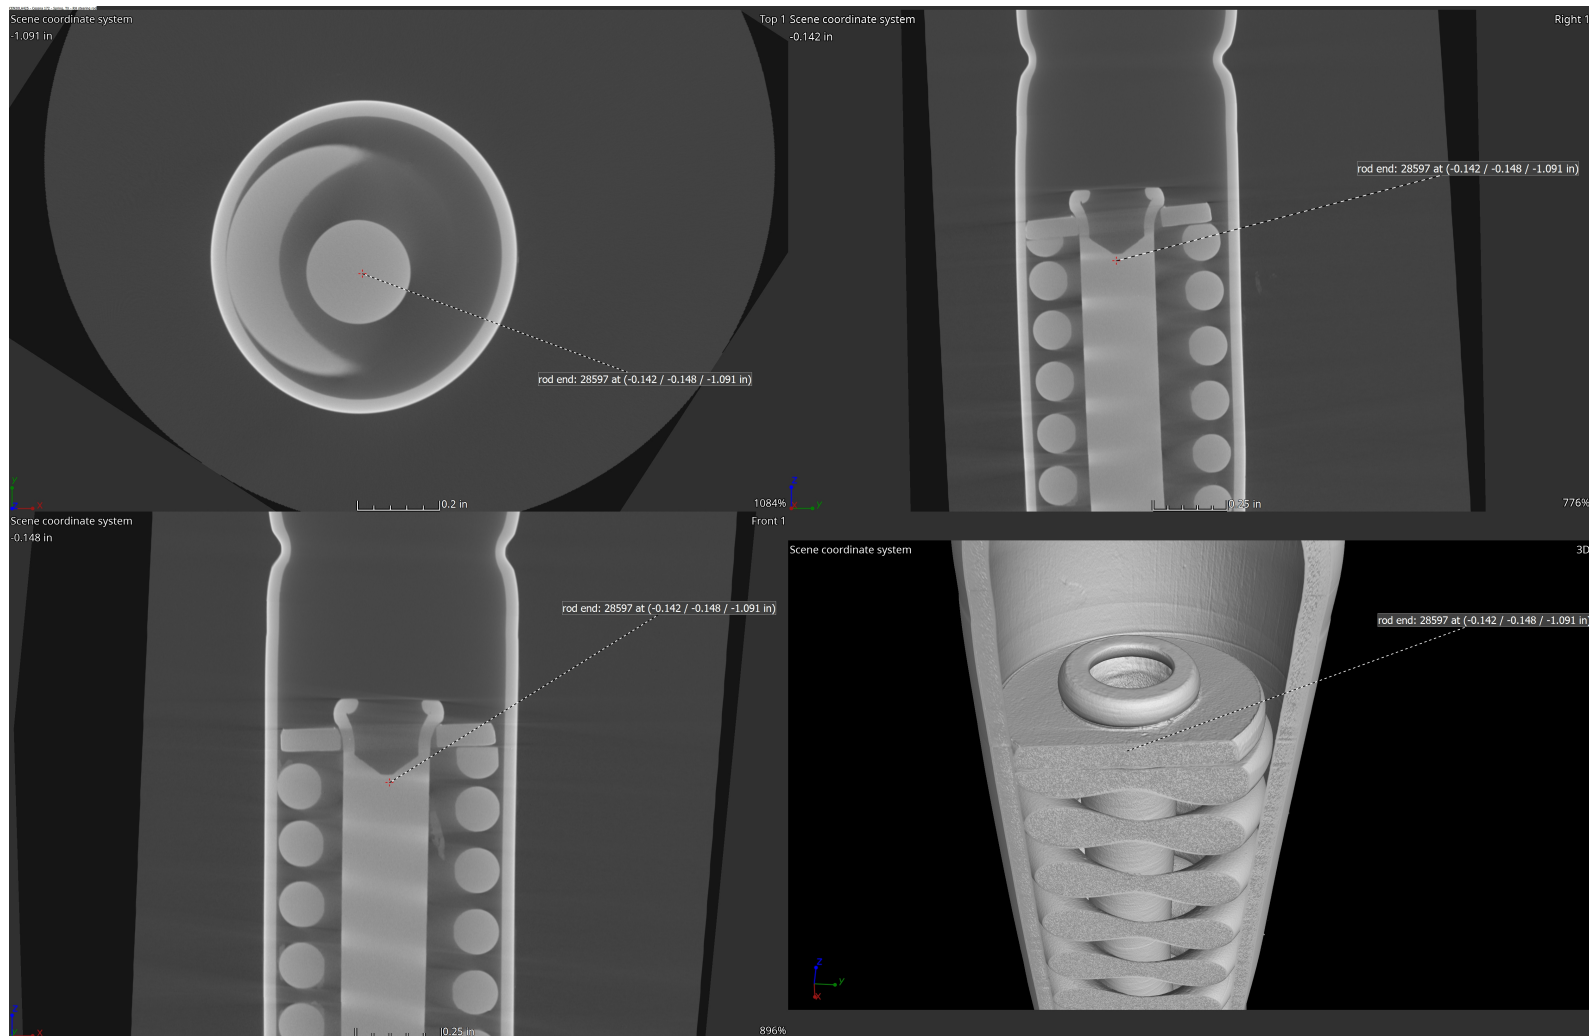
Figure 15  
Right steering tube – rod end

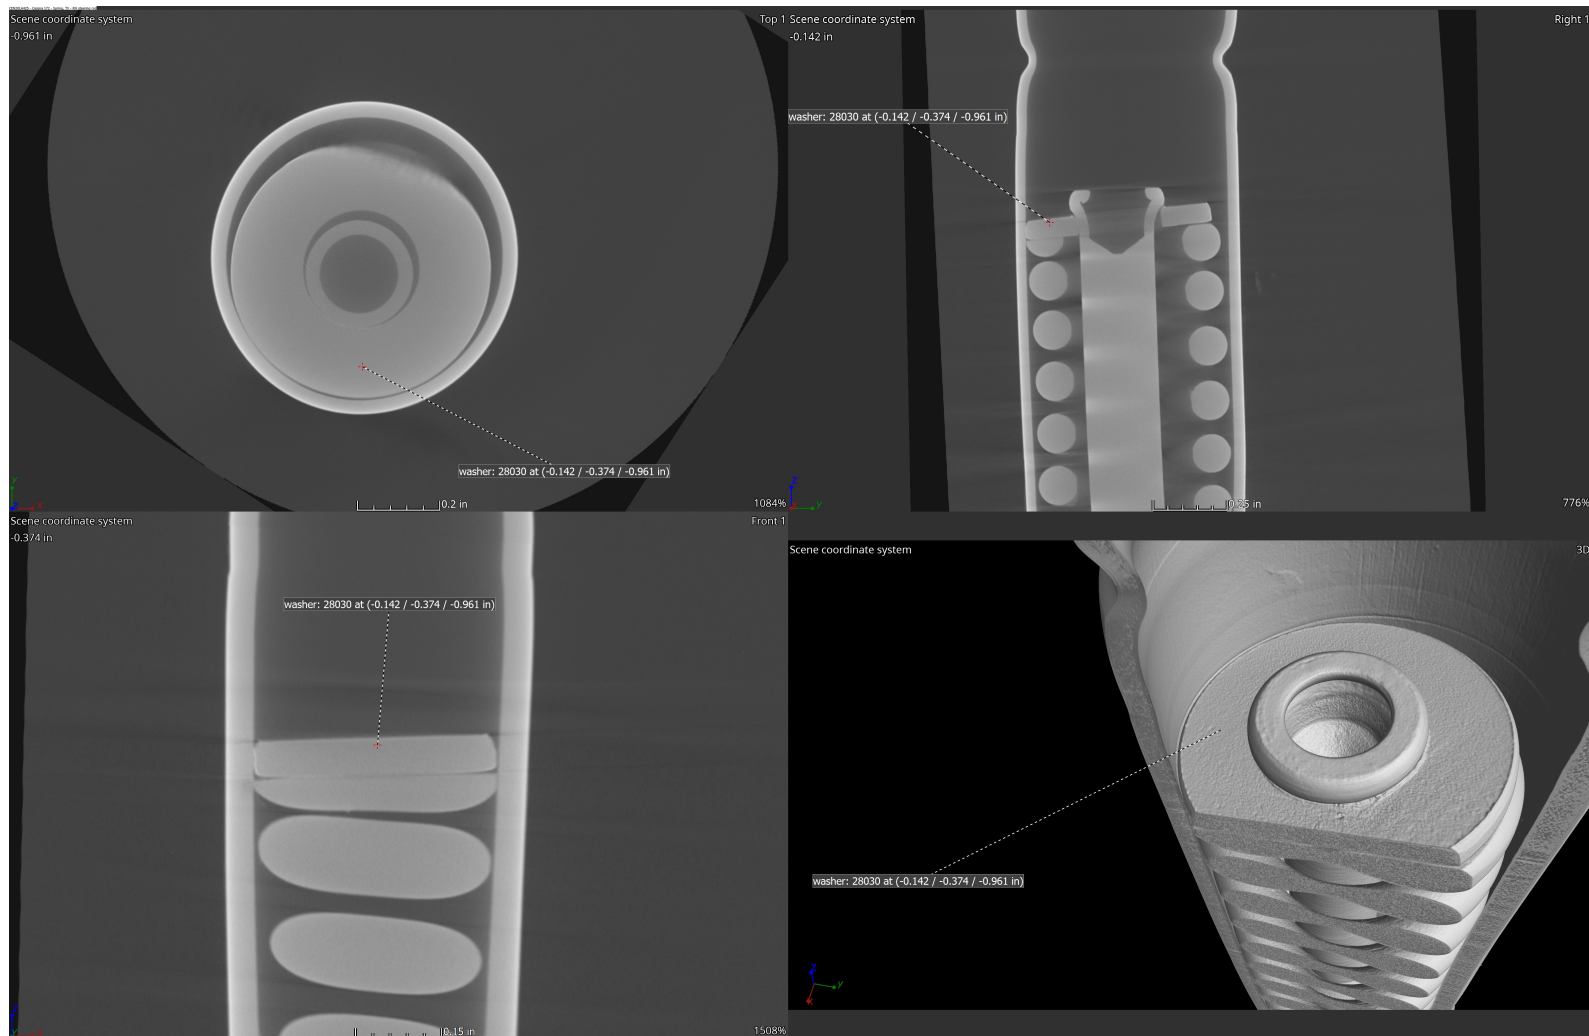
Figure 16  
Right steering tube – washer
