# NATIONAL TRANSPORTATION SAFETY BOARD

## MATERIALS LABORATORY FACTUAL REPORT

Report No. 22-019

Place : Spring, TX  
Date : 9/29/2020  
Vehicle : Cessna 172N, N75634  
NTSB No. : CEN20LA425  
Investigator : Mitchell Gallo

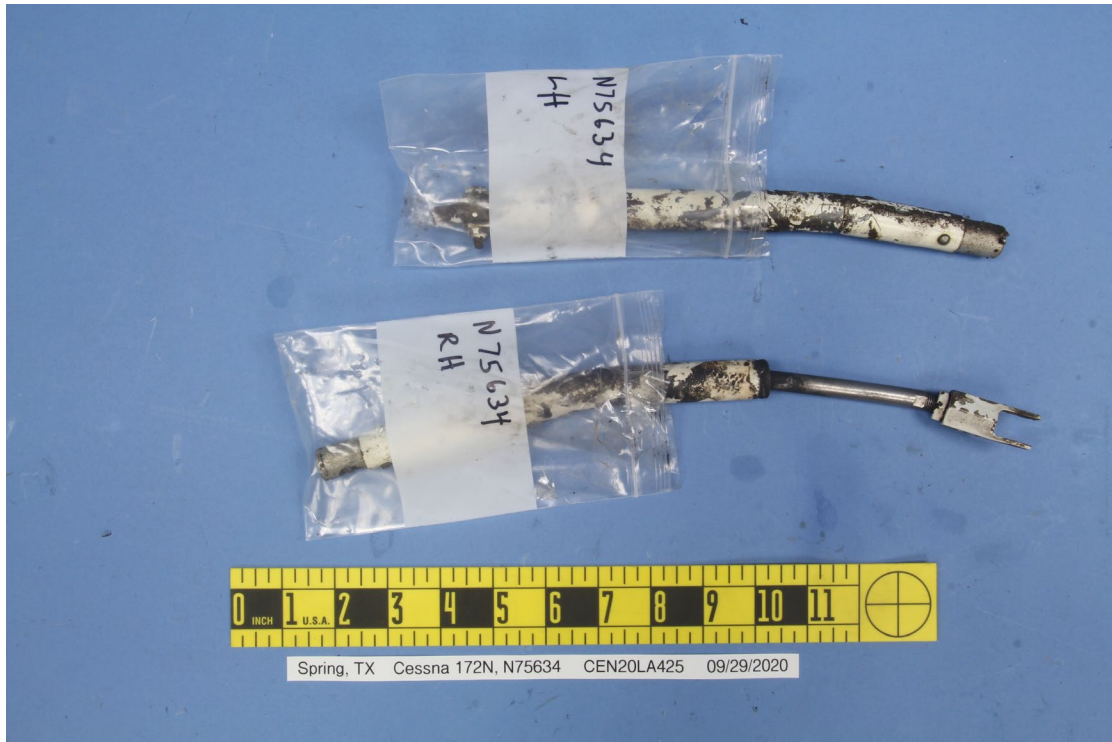
Figure 1: Steering tubes as received.

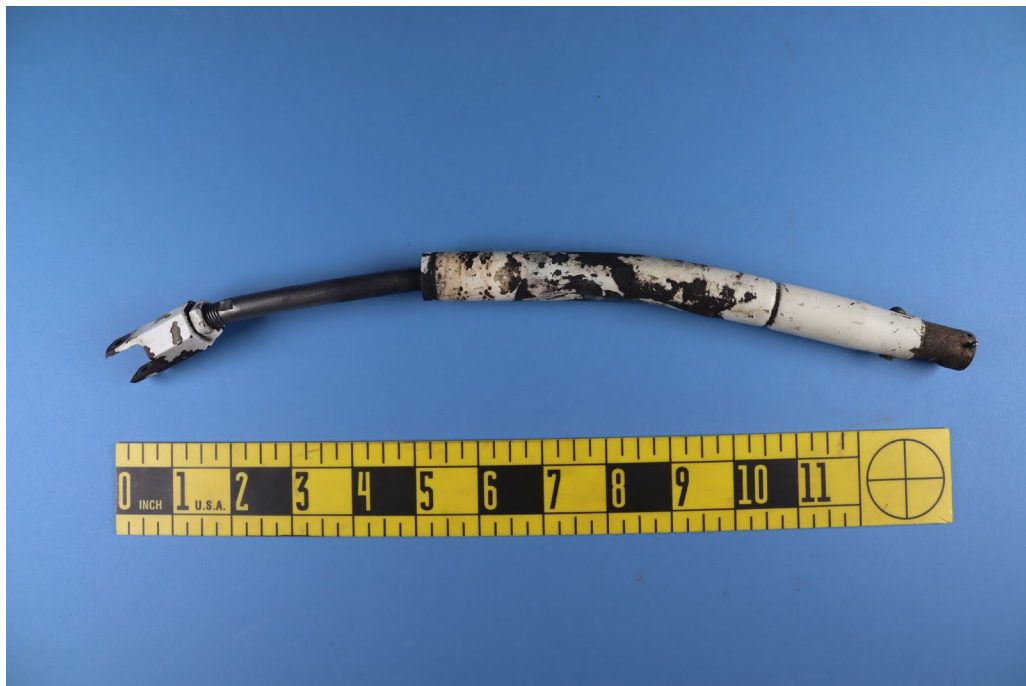
The right and left-hand steering tubes exhibited bending deformation consistent with impact forces. The piston of the right-hand steering tube (Figure 2) was in an extended position while the piston of the left-hand steering tube was in a collapsed position (Figure 3). The steering tubes were sent for computed tomography (CT) scanning prior to their examination in the Materials Laboratory. The CT scanning revealed that the washer on the piston of the left-hand steering tube had slipped past the annular retaining crimp of the tube body and was now located aft of the crimp (Figure 4). This was in contrast with the washer on the right-hand steering tube where the washer was still on the forward side of the annular retaining crimp of the tube which is its intended position (Figure 5). The left-hand tube was sectioned to expose the piston and washer and facilitate the examination of the inner surface of the tube (Figure 6). The inside surface of the tube was examined using a stereo microscope. No evidence of abrasion was observed to suggest that the washer had been residing on the aft side of the annular retaining crimp for a sustained period of time (Figure 7). The annular crimp had also been deformed and become shallower along half of the steering tube's circumference. This reduction in depth of the annular crimp was situated along the outer radius of the bend in the steering tube as can be seen in Figure 4. The washer (Figure 8) exhibited some deformation and a raised lip along a portion of the inner bore consistent with a radial force being imposed on it by the piston. The bending deformation of the left-hand steering tube, the distortion of the annular retaining crimp, and the deformation to the washer are all consistent with the washer having been pushed past the annular retaining crimp due to impact forces.

Figure 2: Right-hand steering tube.

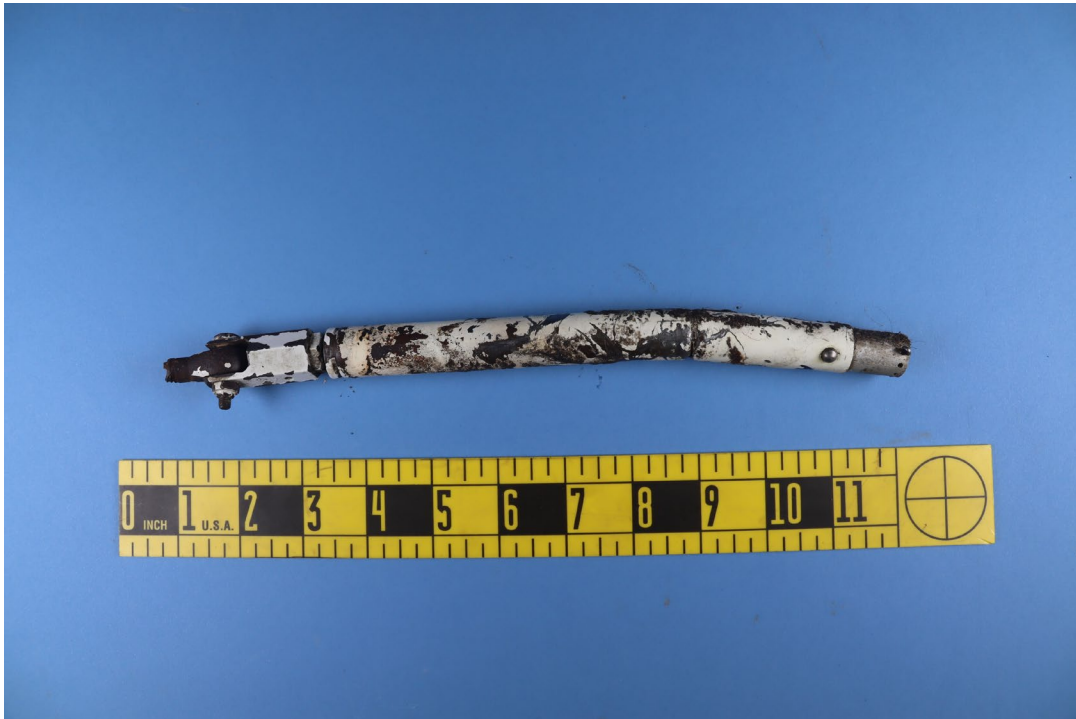
Figure 3: Left-hand steering tube.

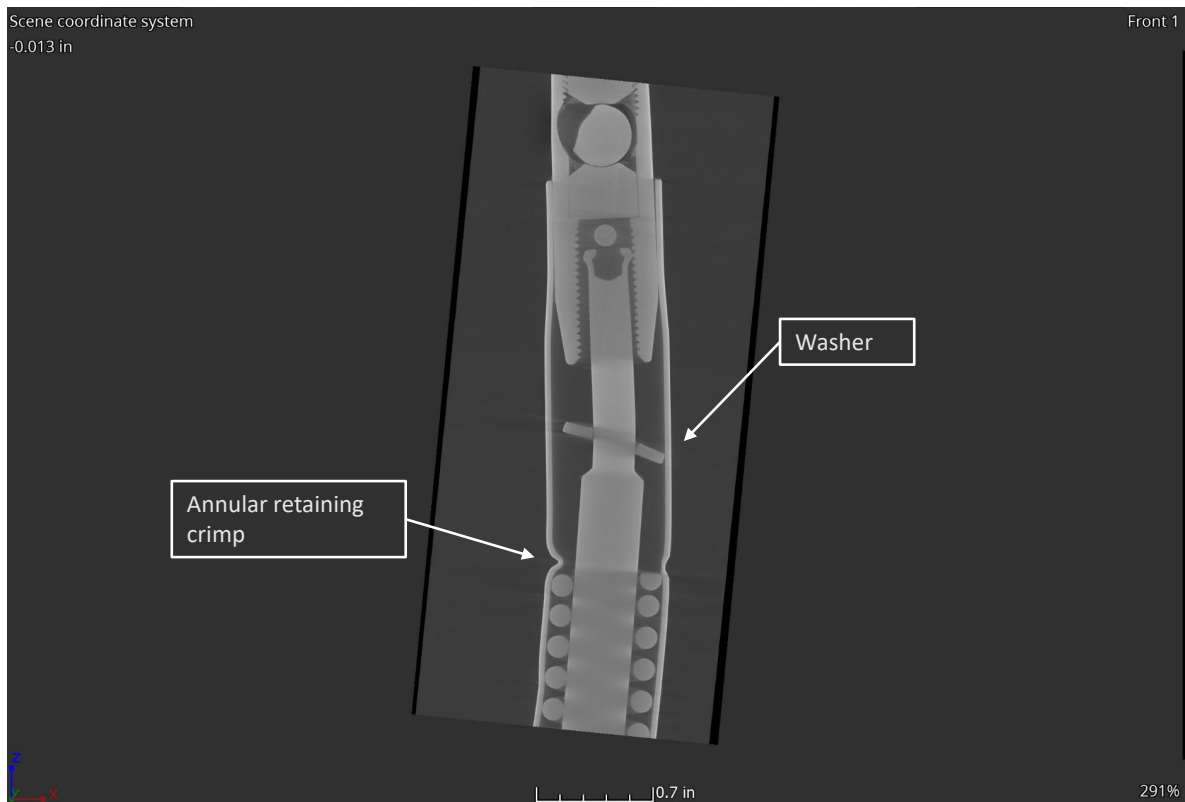
Figure 4: CT image of the left-hand steering tube centered around the annular retaining crimp.

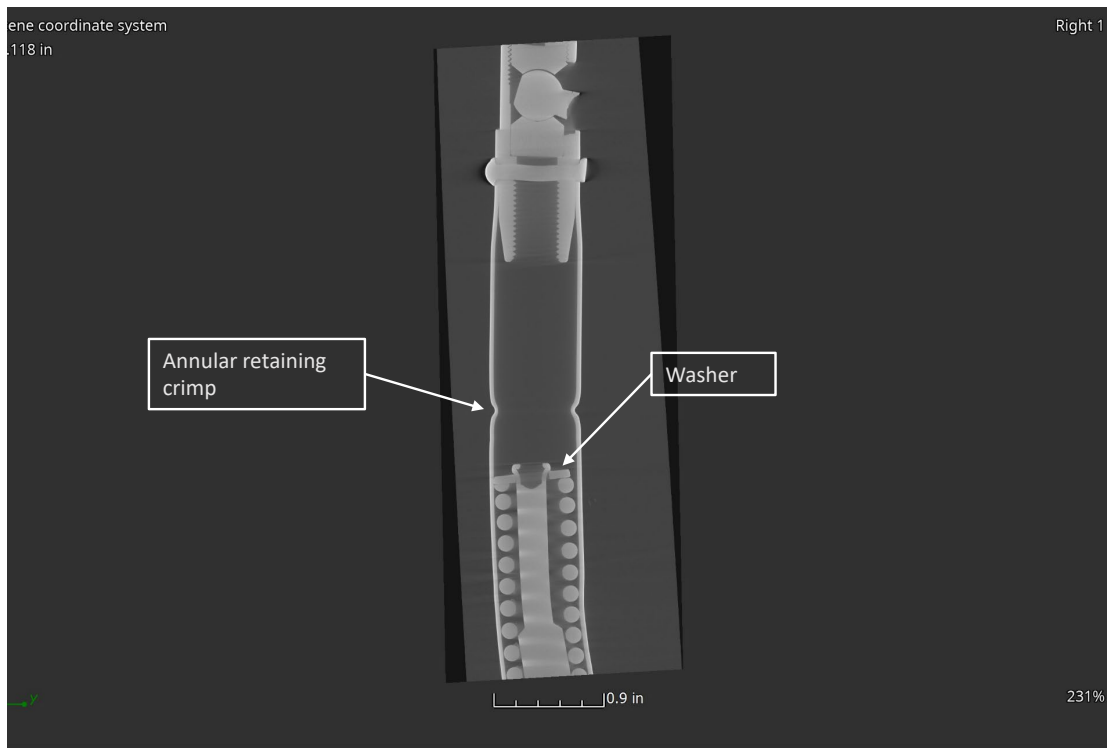
Figure 5: CT image of the right-hand steering tube centered around the annular retaining crimp.

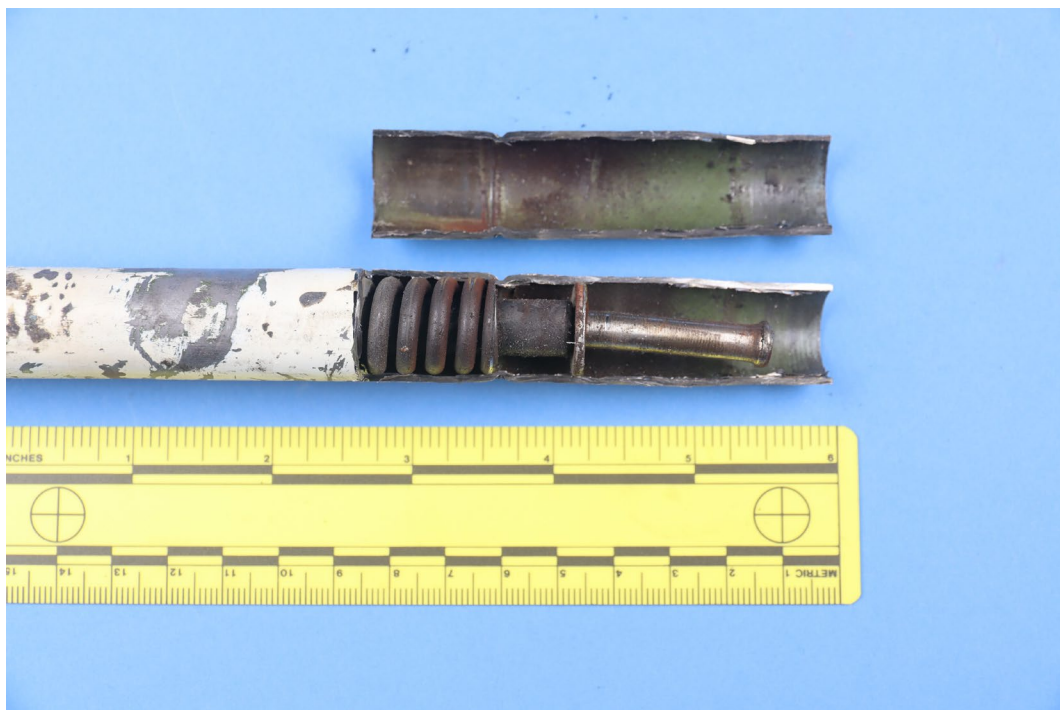
Figure 6: Left-hand steering tube sectioned around the annular crimp.

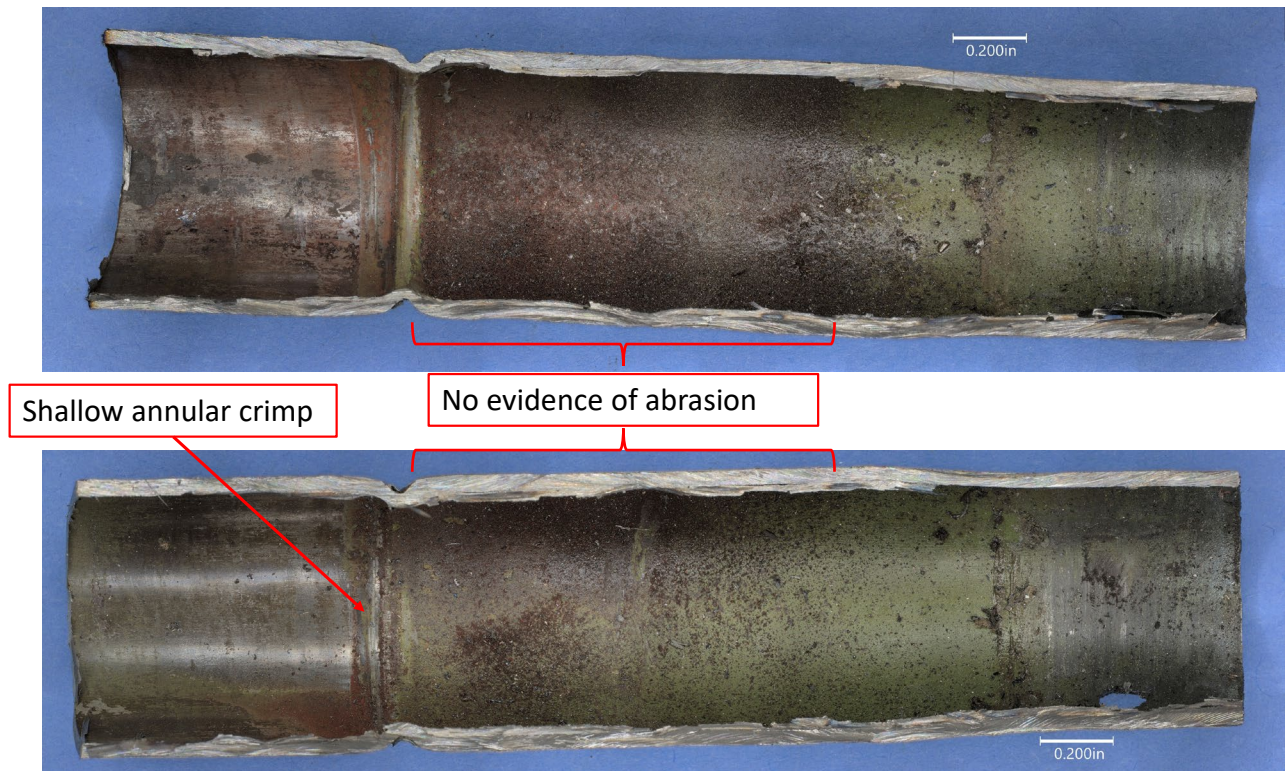
Figure 7: Inner surface of the left-hand steering tube around the annular crimp.

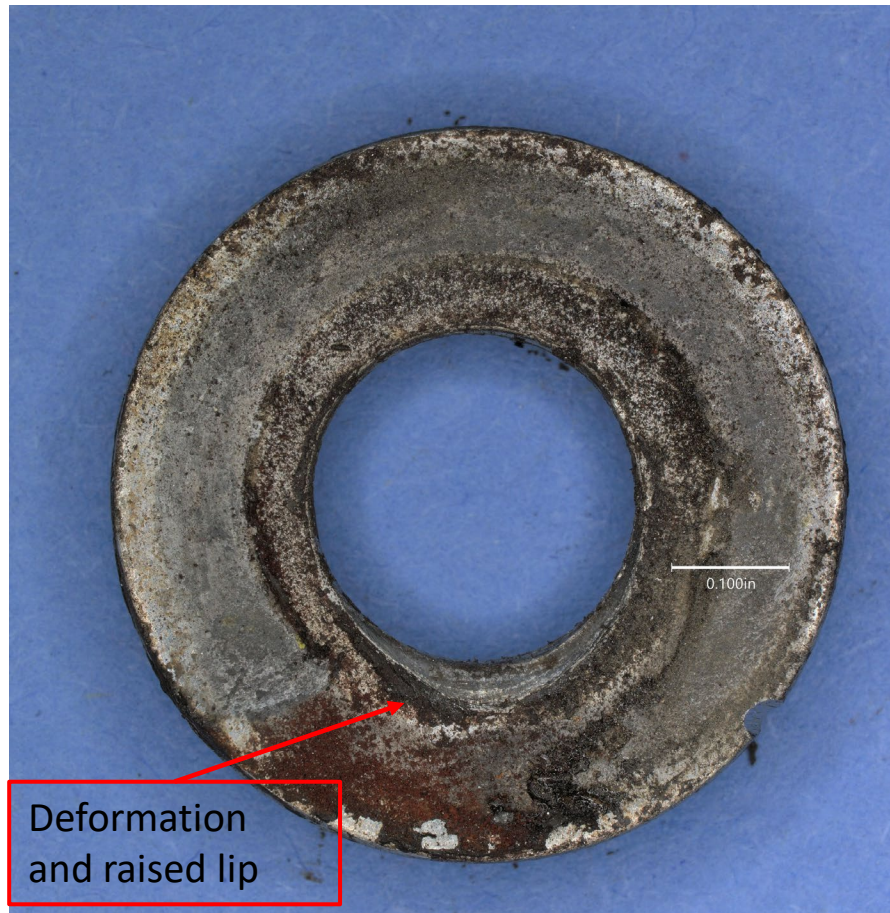
Figure 8: Washer from left-hand steering tube.
