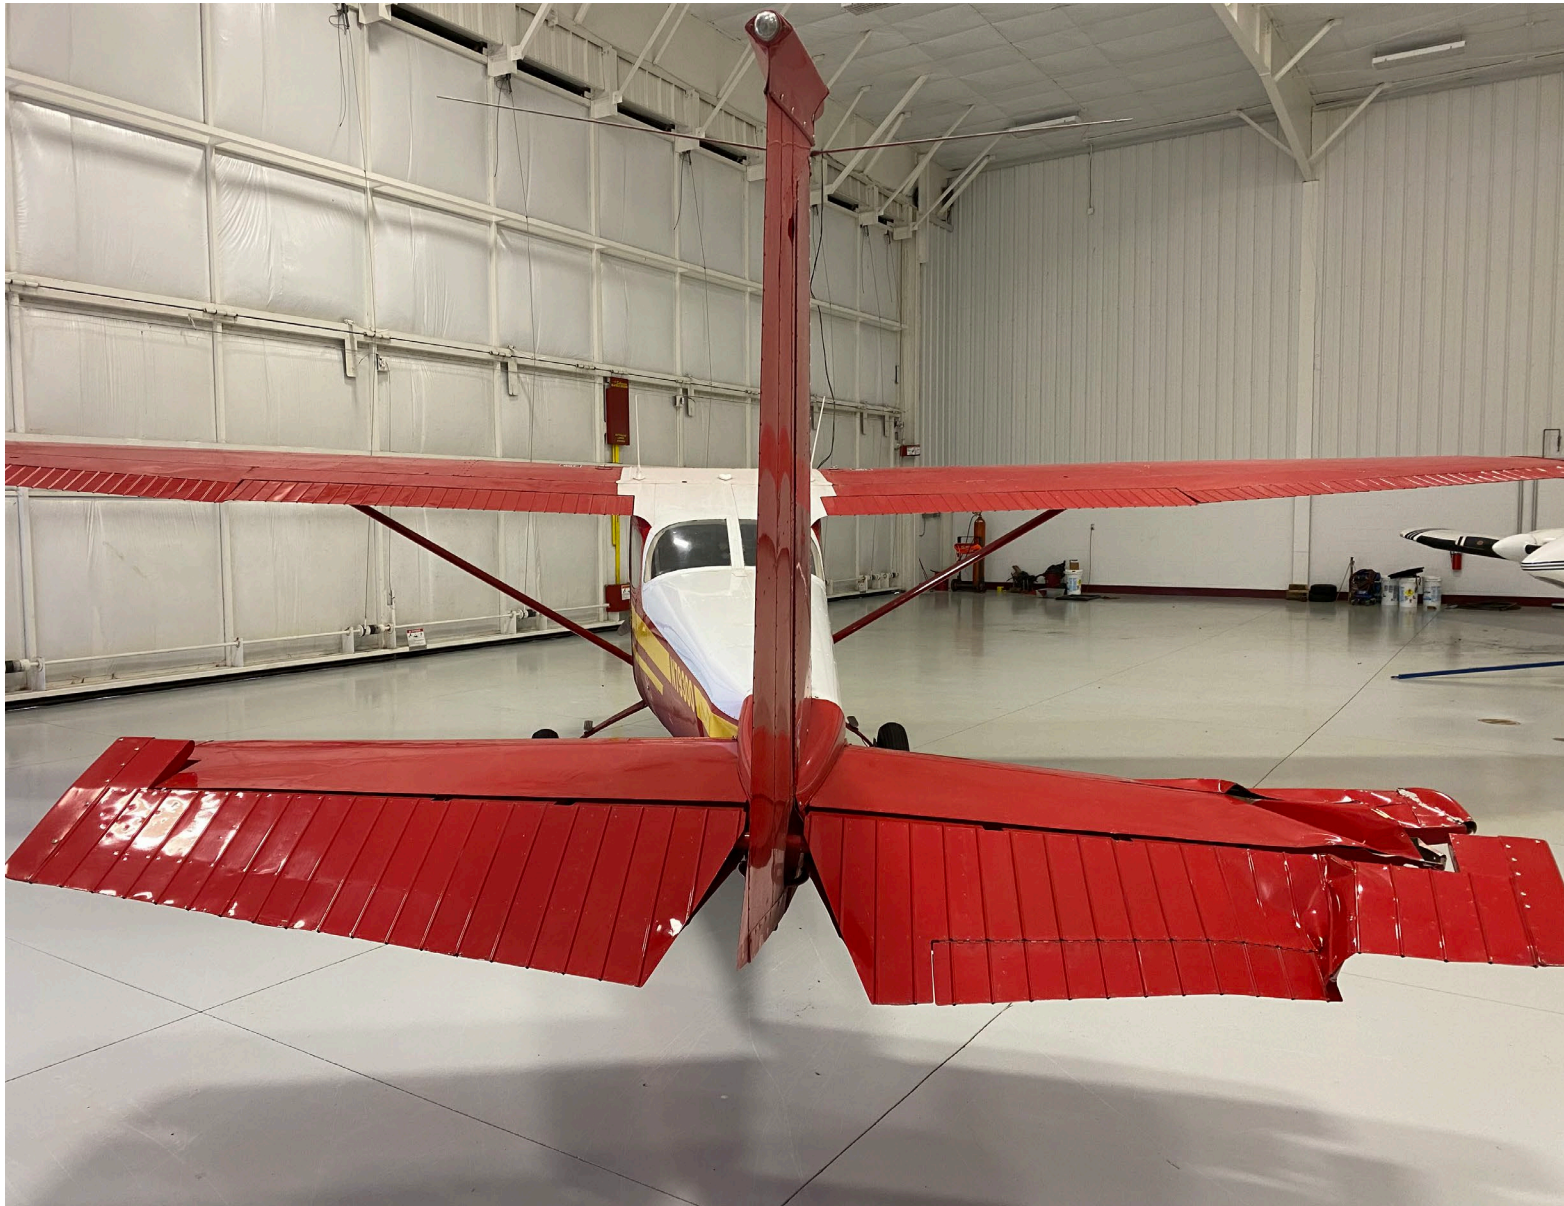
**Photo 1 – Damage to Right Horizontal Stabilizer**

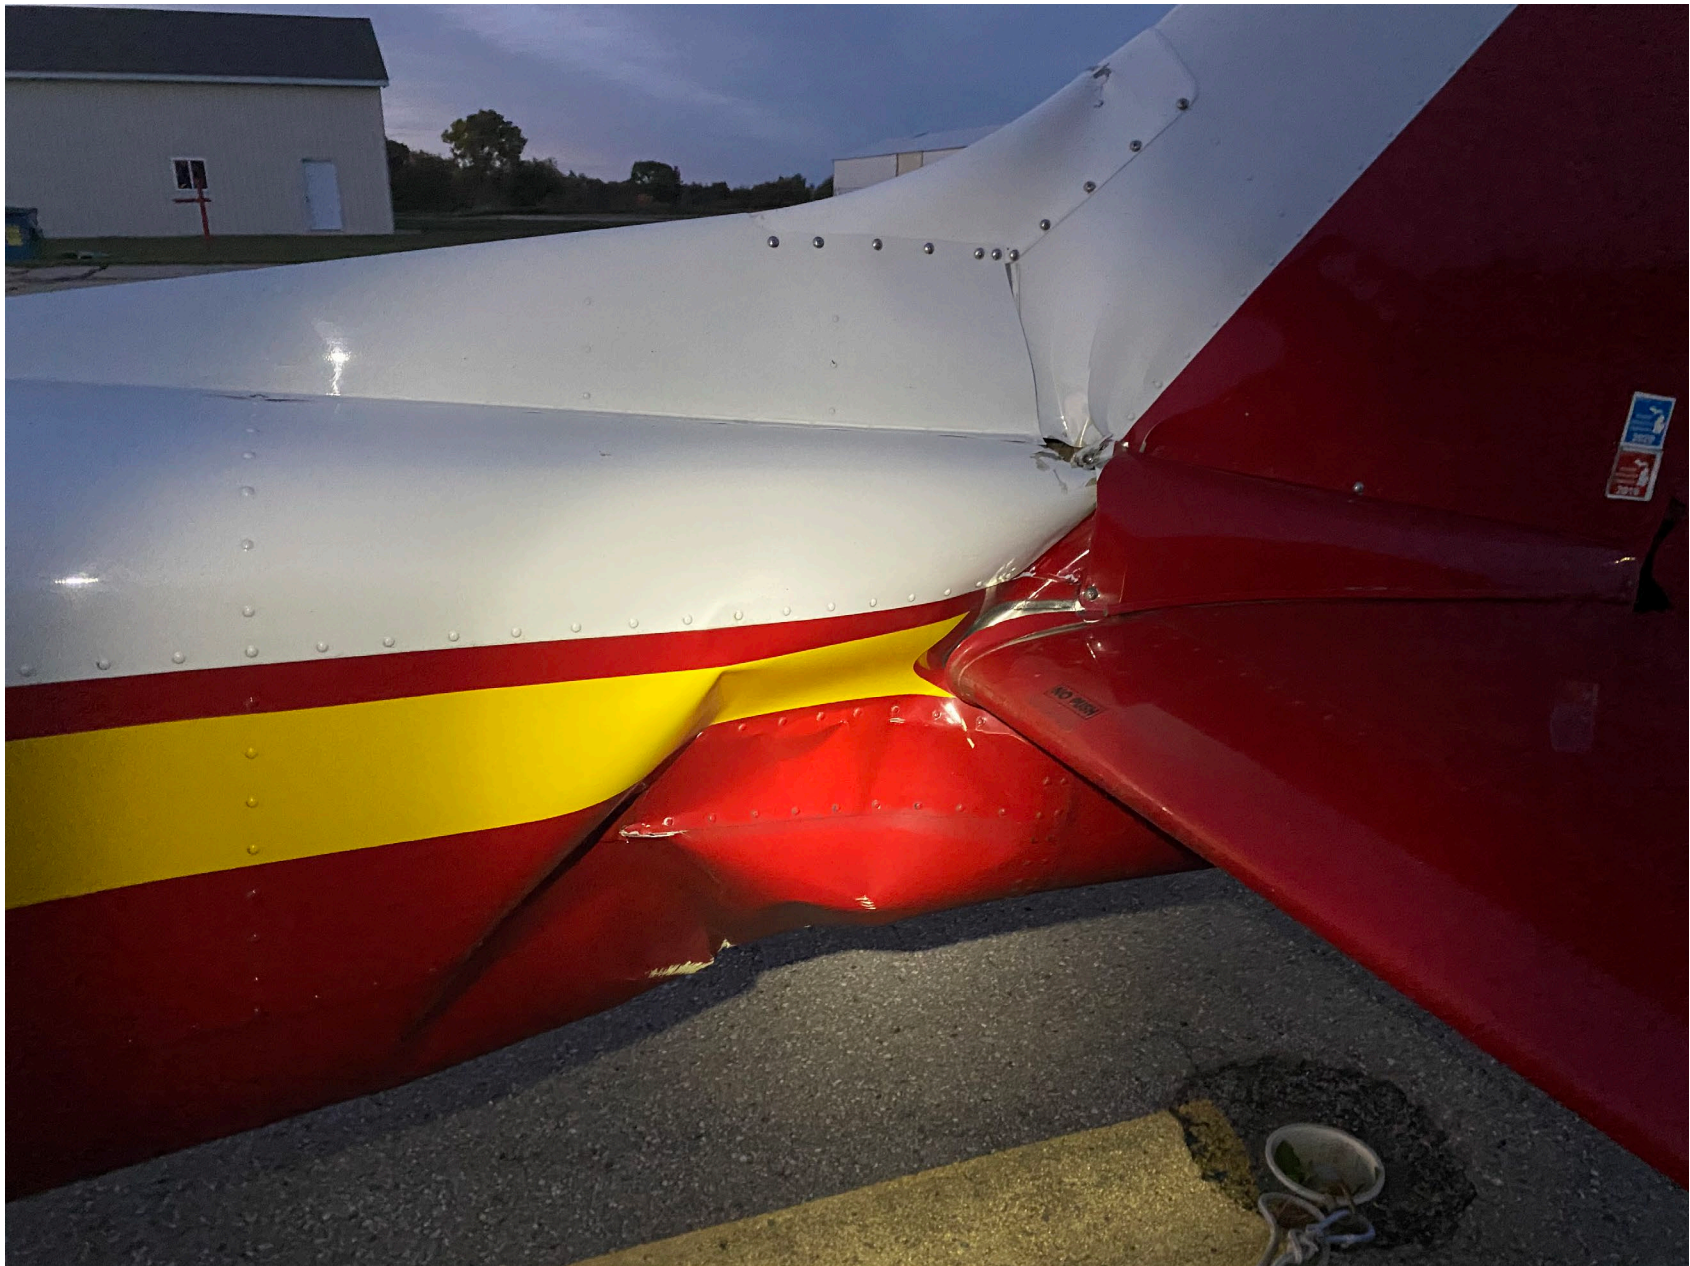
**Photo 2 – Damage to Emppenage**

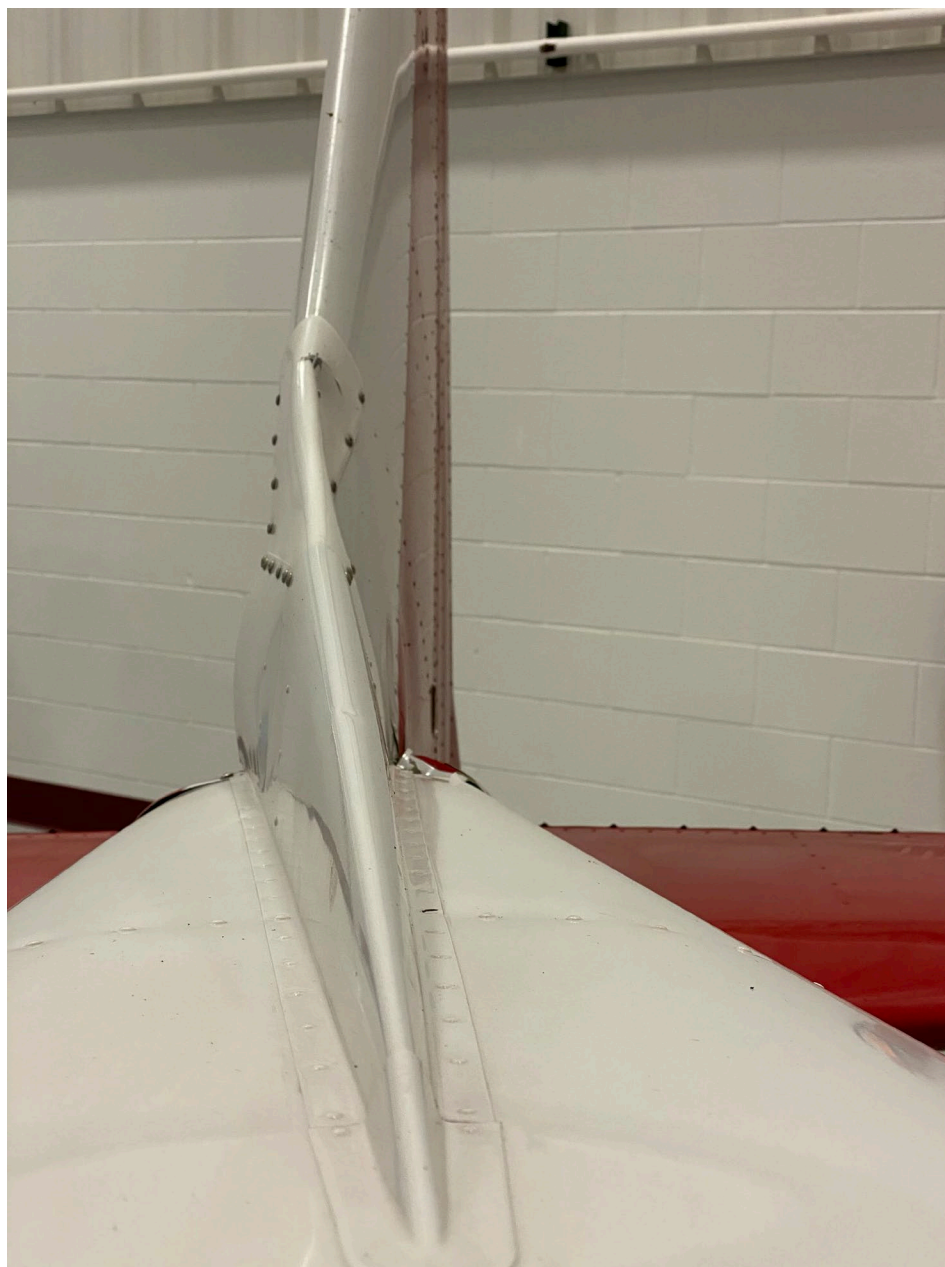
**Photo 3 – Damage to Vertical Stabilizer**
